New Optical Inspection Results at JLab

An in-depth update since Chicago meeting ILC08

Rong-Li Geng

TILC09, April 17-21, 2009, Tsukuba, Japan

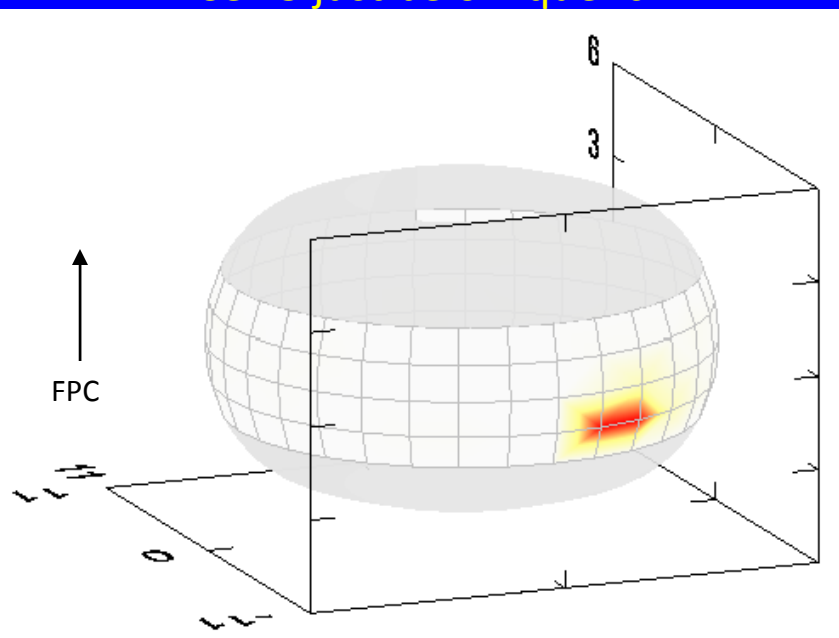
Cell 3 just below quench

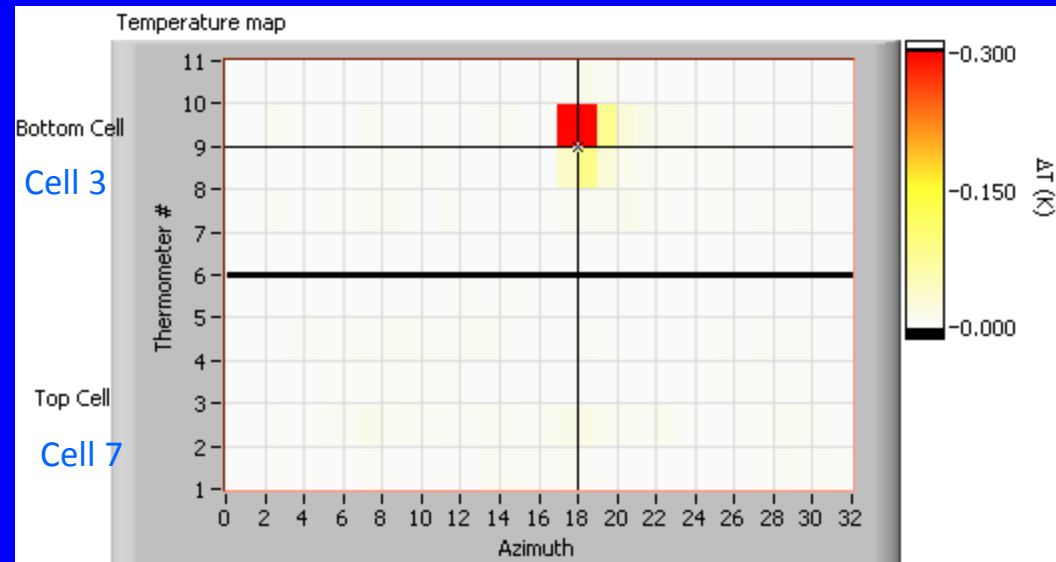
T-map just below quench

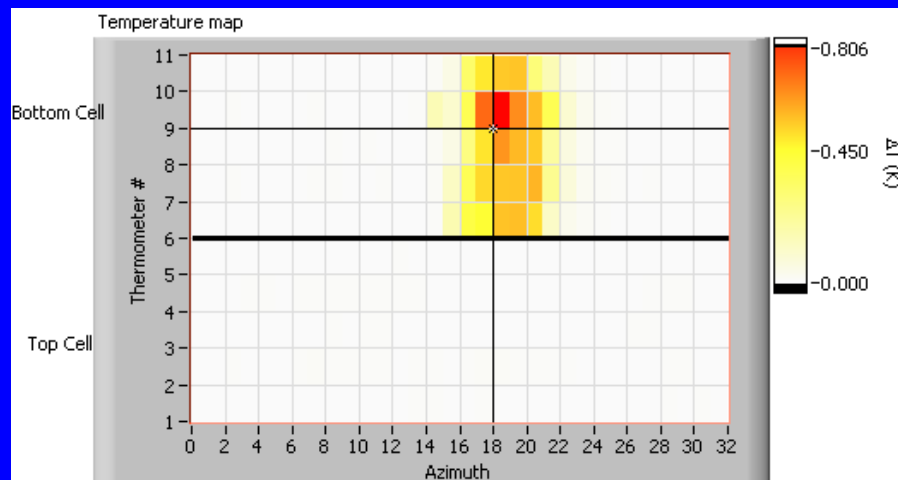
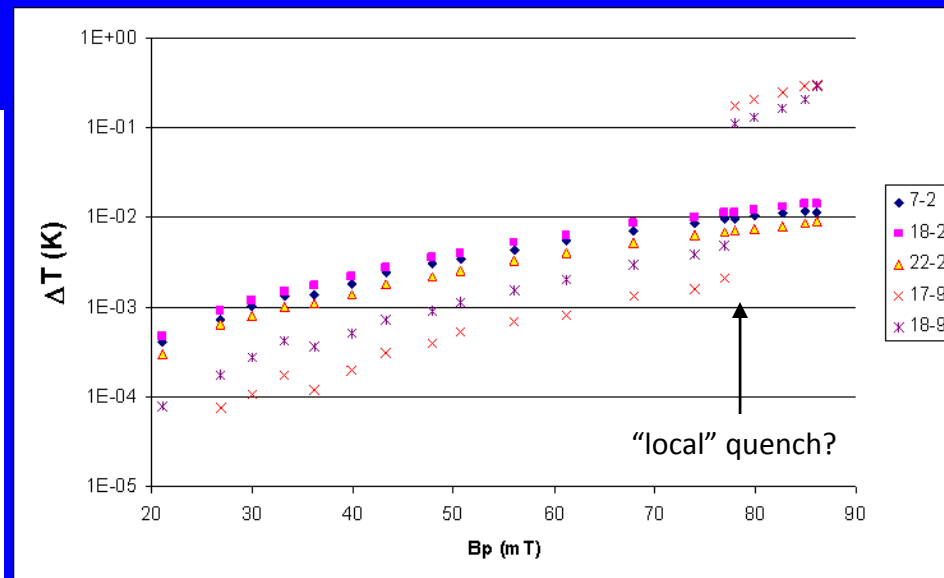
T-map during quench

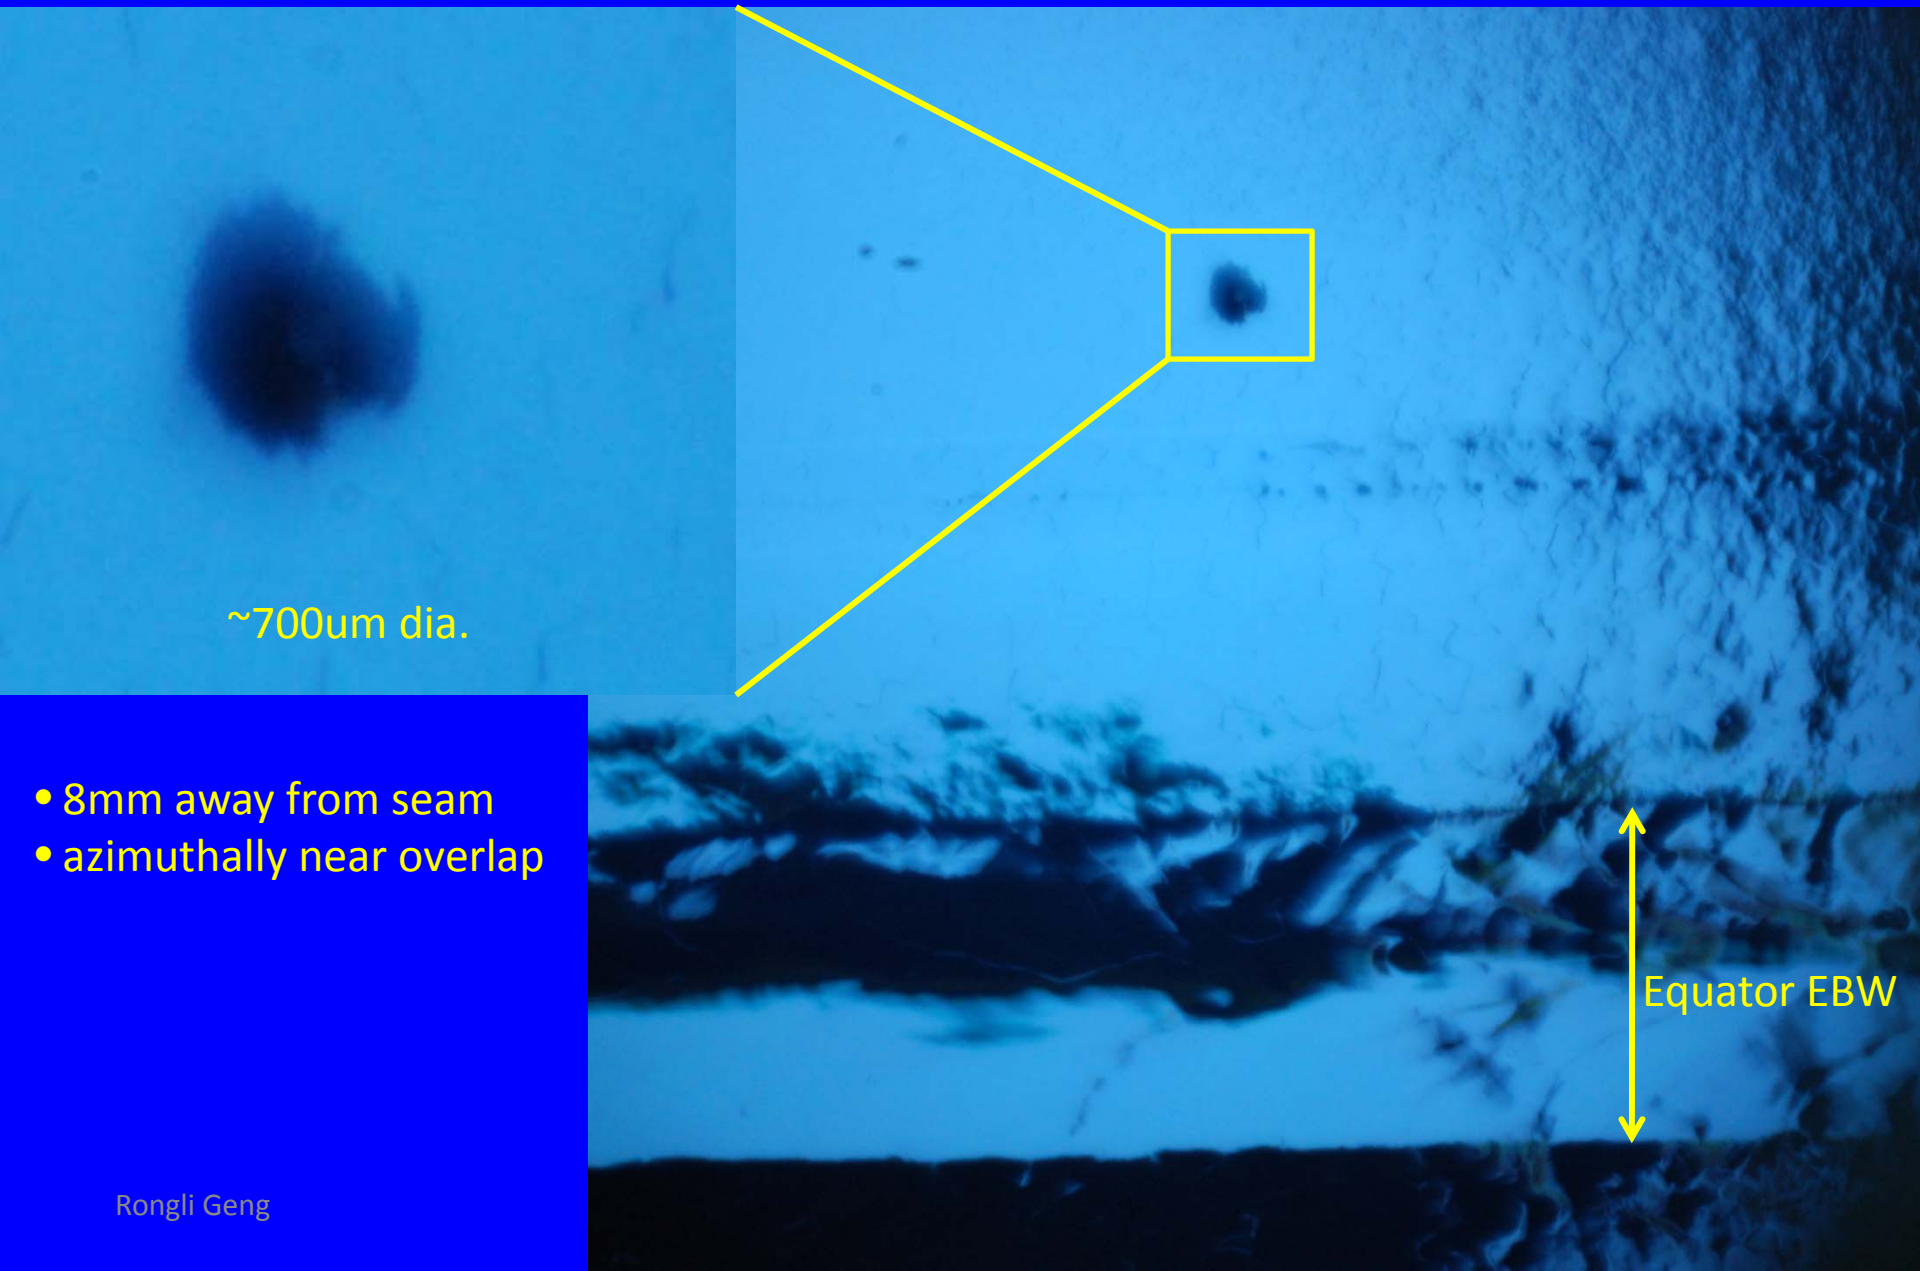
A 700 μm defect observed near T-map hot spots

~700 μm dia.

- 8mm away from seam
- azimuthally near overlap

Equator EBW

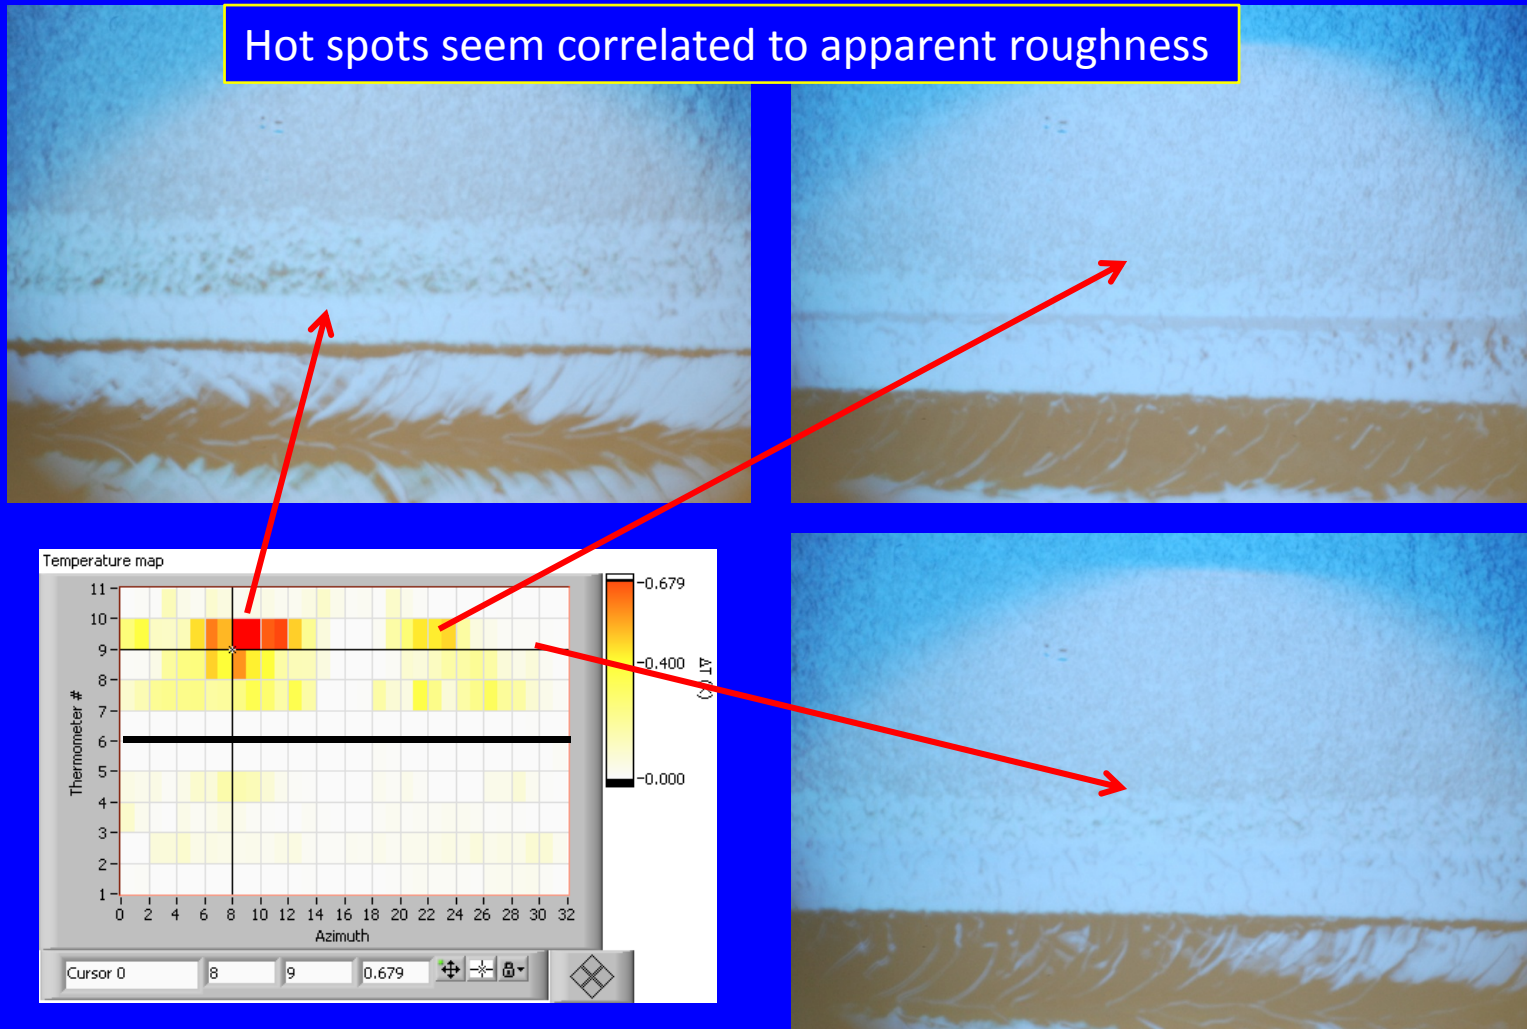
J2 (30 MV/m strong Q-drop) T-mapping and Inspection cell#1 from input coupler port, Equator weld & “hot” HAZ

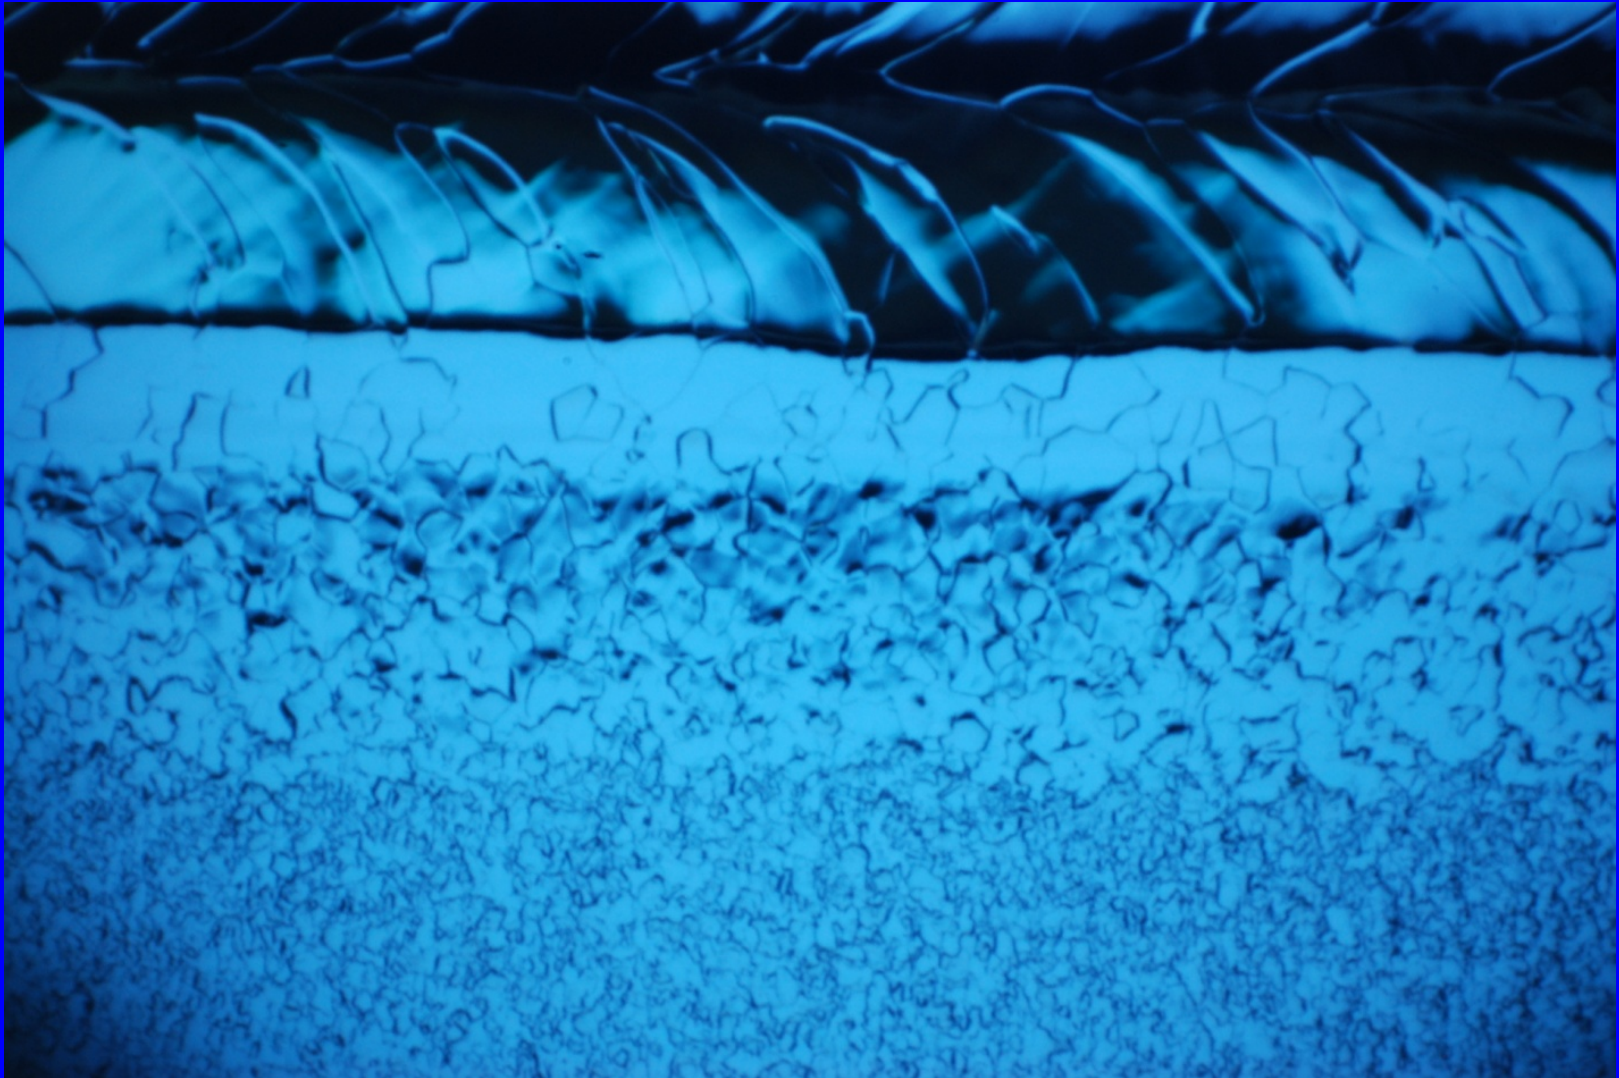
General appearance of HAZ of equator EBW in J2

apparent roughness likely caused by “bad” bulk EP which was done @ 3rd use of electrolyte
(and we now know it was due to water addition after first use of electrolyte – this problem is now fixed)

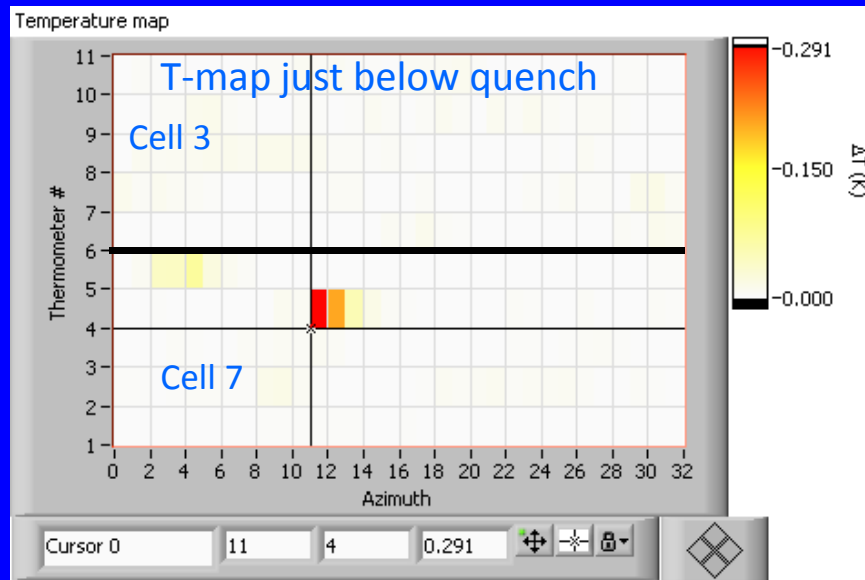
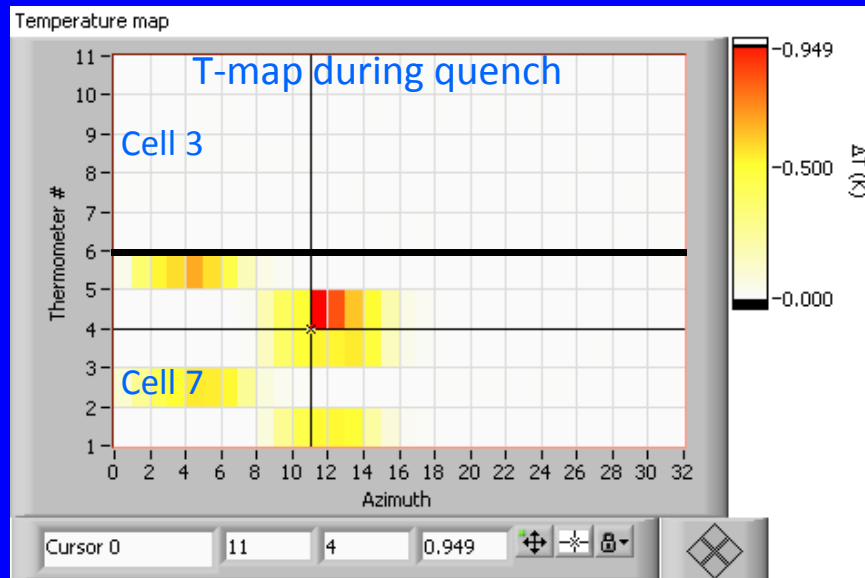
A12 (30 MV/m quench) T-mapping hot spots in Cell#7

No gross defect observed

Cell 7 equator EBW seam

Line inside box is weld prep machining line

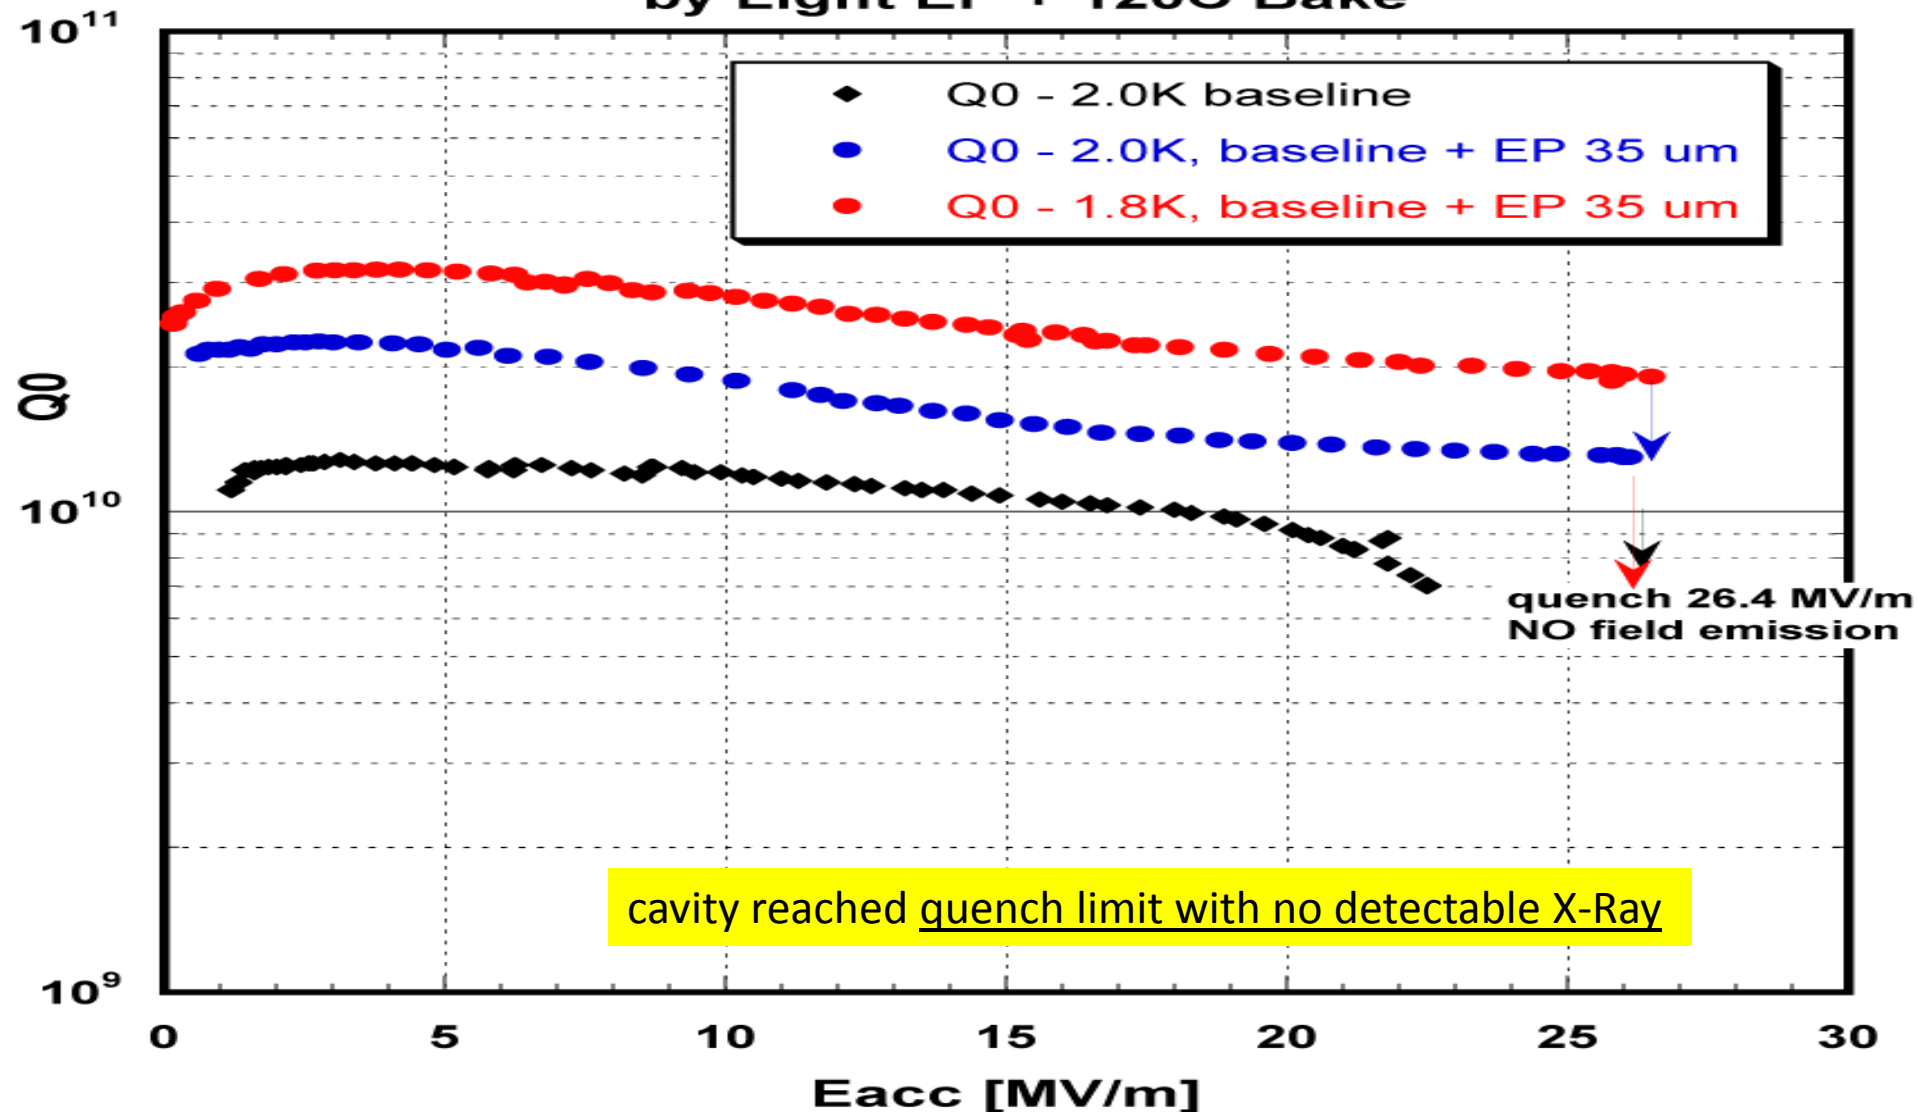
HG7 BCP+ EP, 26.5 MV/m quench no X-ray

- One example of documented natural EBW defect
- Cell #7 EBW overlap
- Pass-band indicates quench source in Cell 1/7
- Next step T-mapping suspected region
- Candidate cavity for countermeasure development

During weld of dumbbell 94-93 to the end group, the gun filament blew during the final weld. The weld dimpled but not hole. It was completed after the filament was replaced. The weld thins down some in the area of the dimple but is intact. Picture is attac
