Surface Analysis of the Quench Area Sample of Cavity Z111

W. Singer

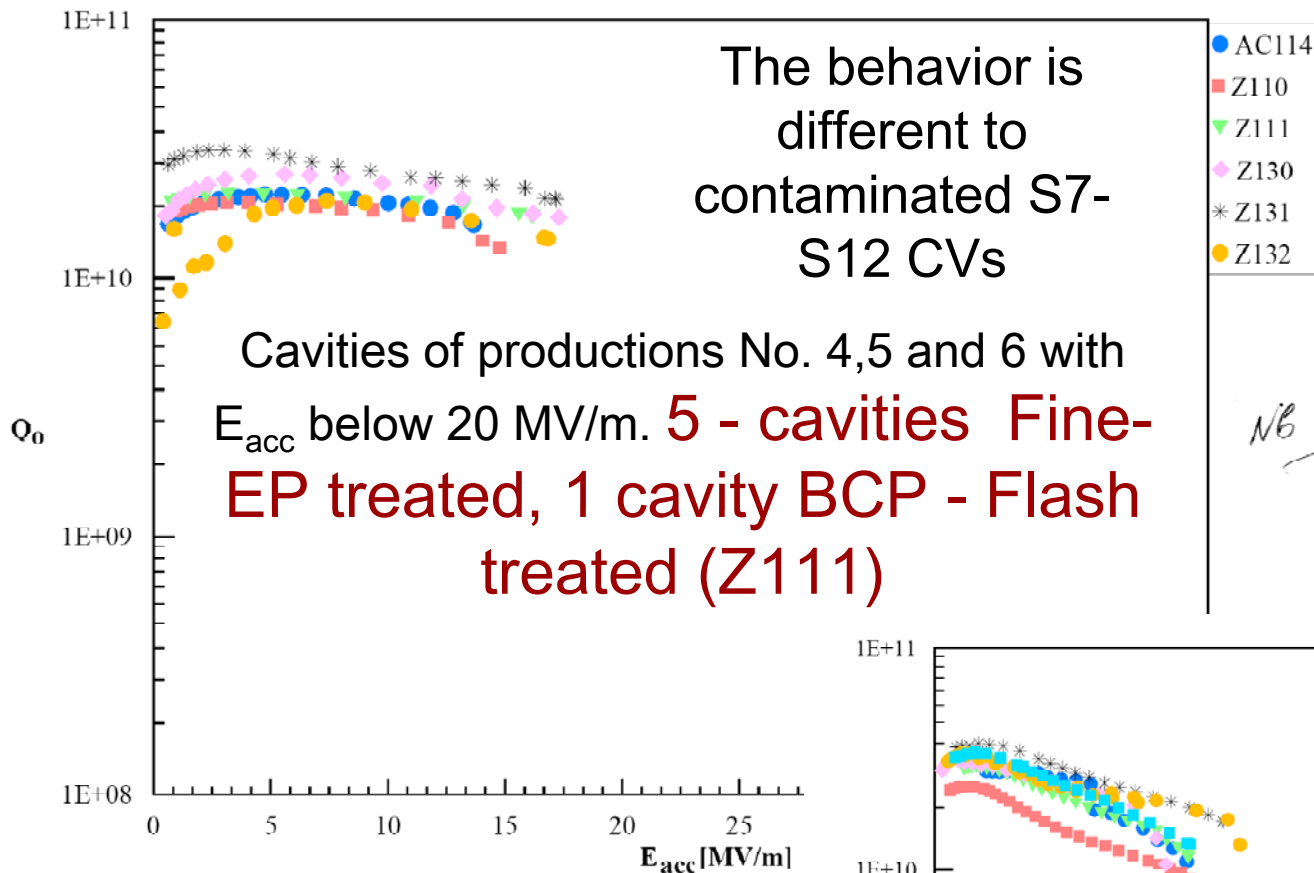
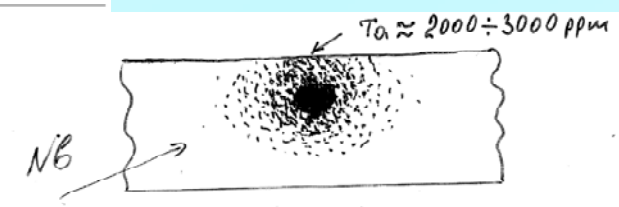
Ta inclusion in the cavity D6

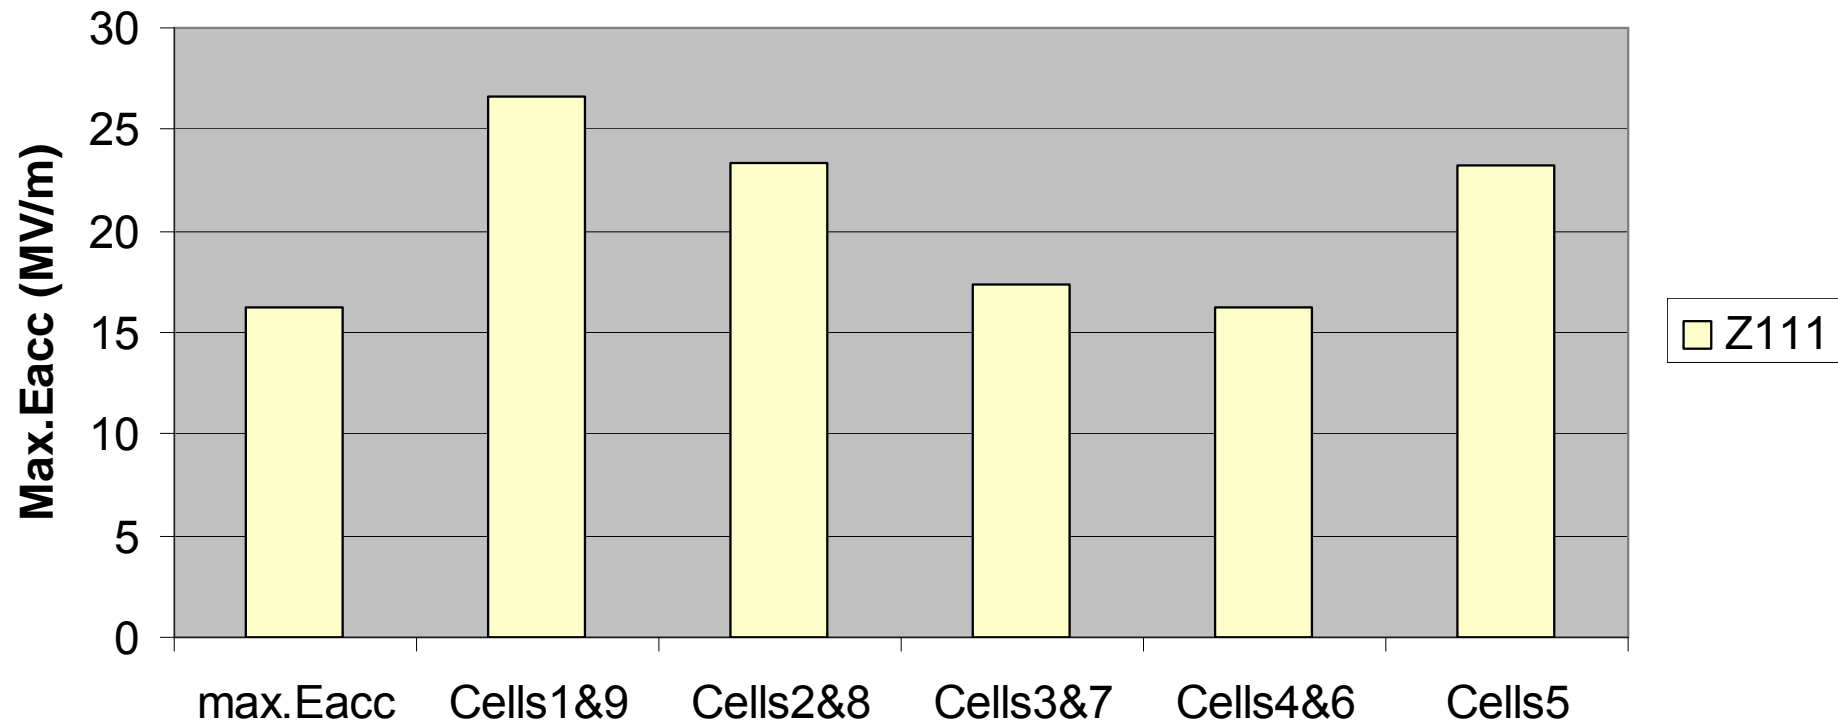
Best CW-Test

16.19	1.8E+10	2	bd			16.19	1.8E+10				
Aim: test of cavity first test										Result: not ok: LOw gradient without FE				Remark: No Q disease. Only 16.2 MV/m, Q=1.8E+10, limited by quench, without FE. Processing for 1.5 hour not effective. MM: all cells limited by quench, fields 16.2 (cells 4&6) to 26.6 MV/m (cells 1&9). Low x rays seen in modes 8/9 and 3/9 pi.

154.8	ep+	800	07.Dec.06	2	v1	16.03	1.6E+10	2	bd			16.03	1.6E+10				
Aim: test of cavity new test Rotating T mapping mounted										Result: ok				Remark: Cavity is limited by quench at 16.0 MV/m, Q=1.7E+9, without x rays., like in previous test. T mapping done showed that quench is in cell 6 (like one could expect from previous modes measurement) at equator area. New BCP or EP is proposed now for this cavity.

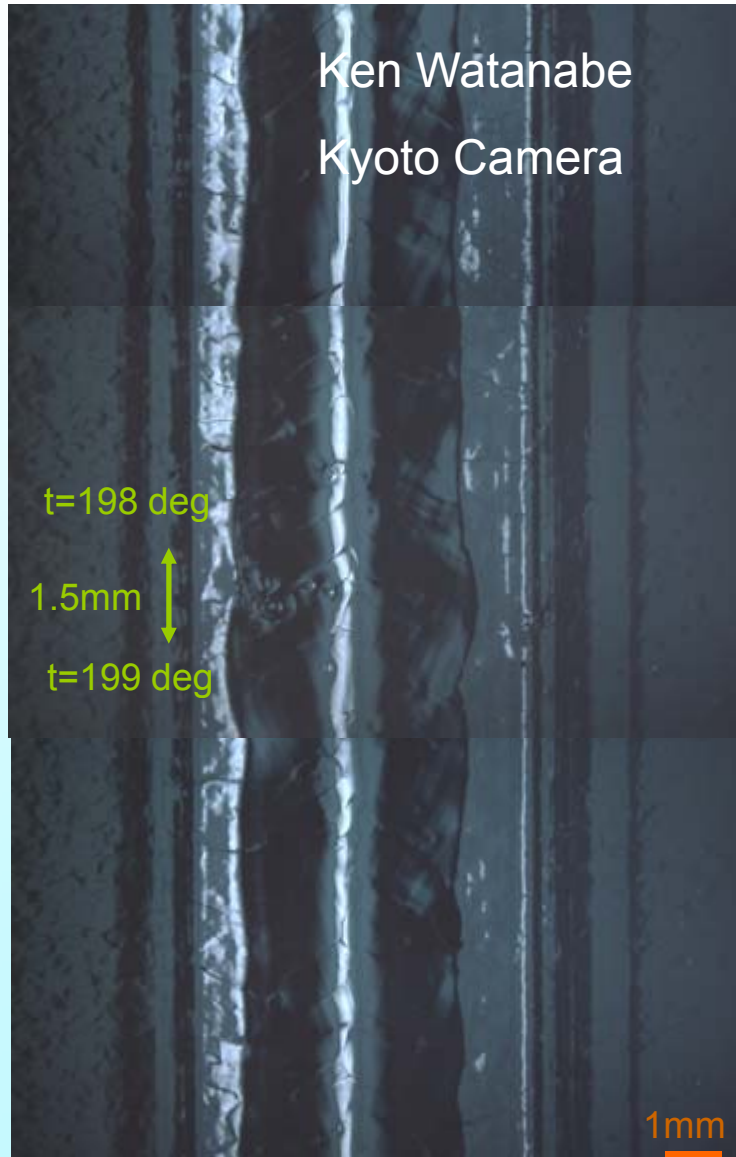
TESLA cavity Z111: #6 cell equator

#6 equator, $t=193 \sim 204$ deg

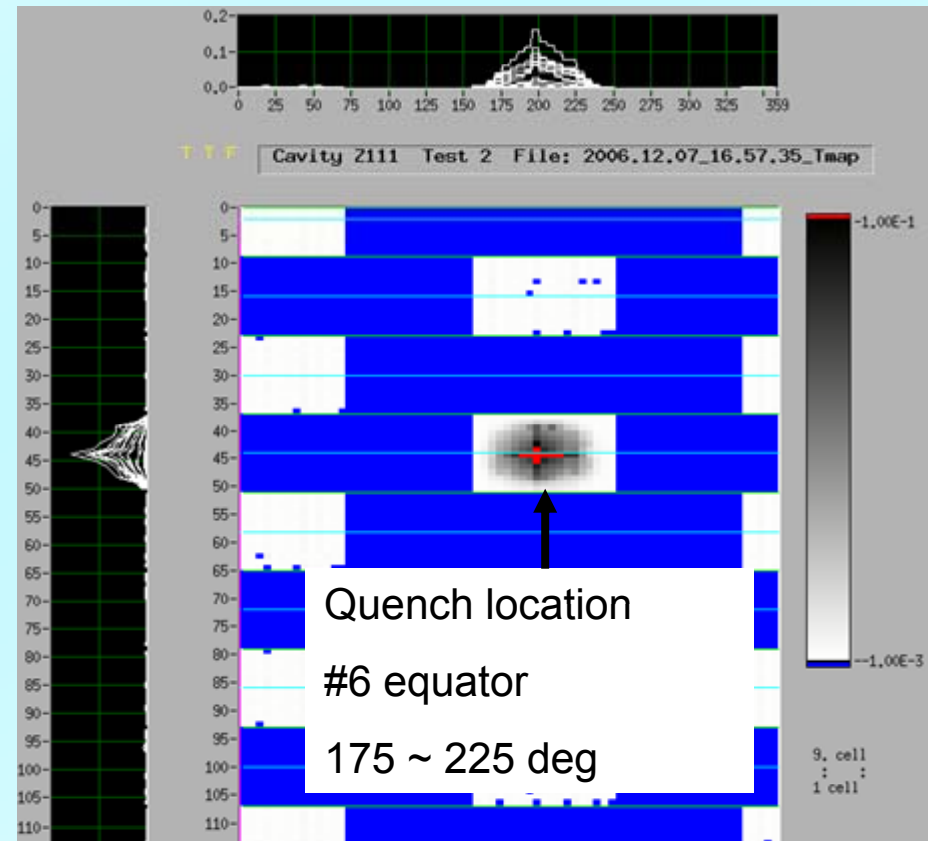
T-map data in test 2, 16.0 MV/m

group of beads(?) with 1.5mm wide were observed.

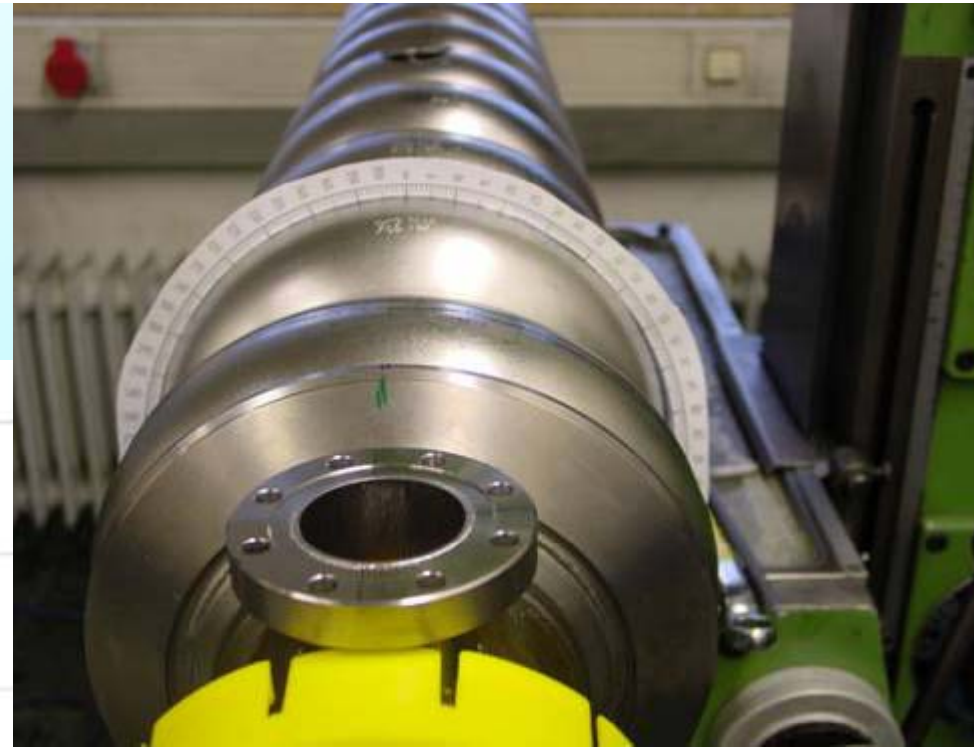
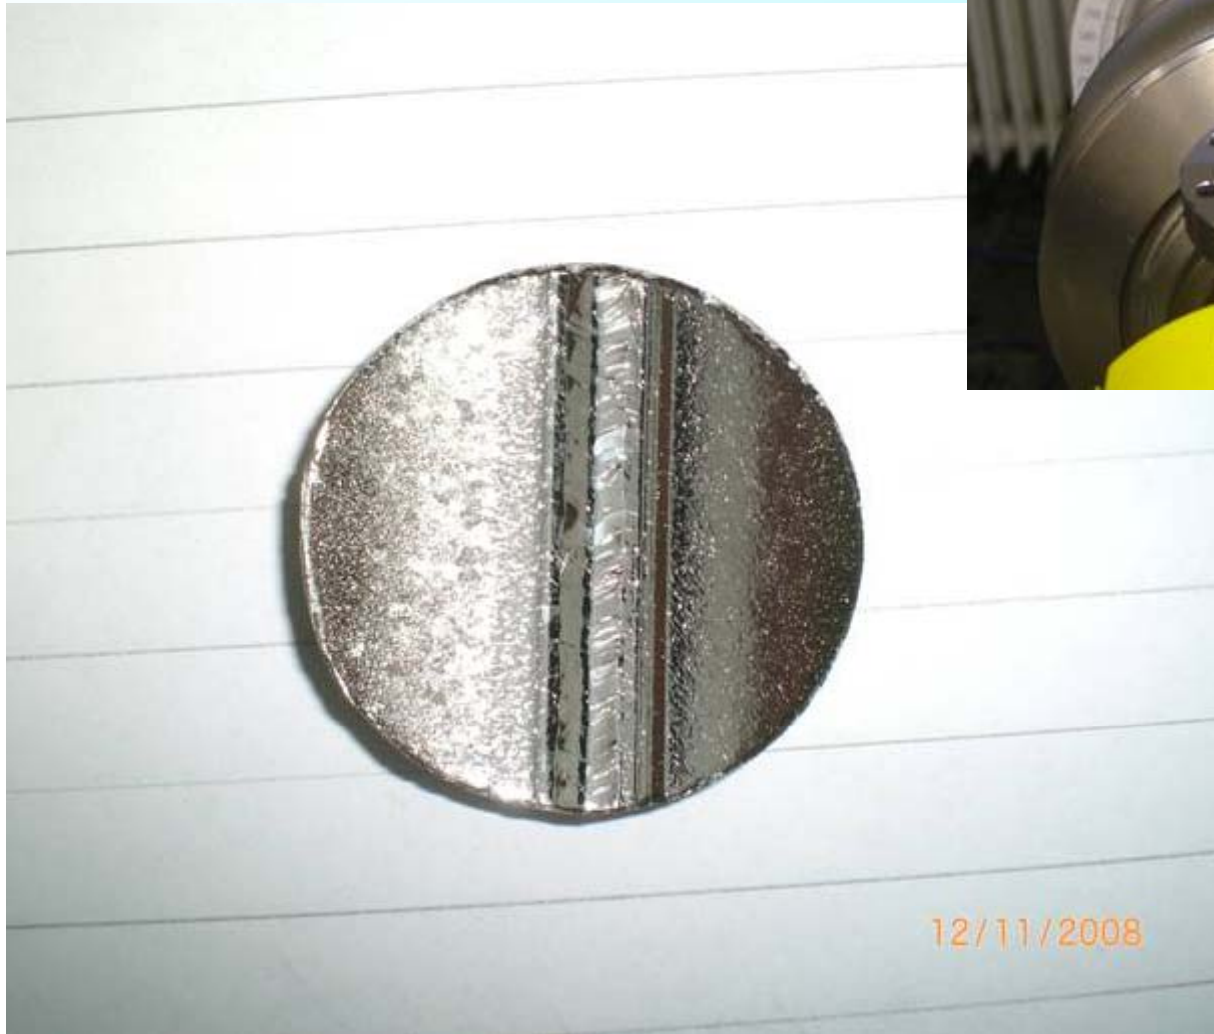
Z111, Cell 6, sample 1,
200°.

Quench location

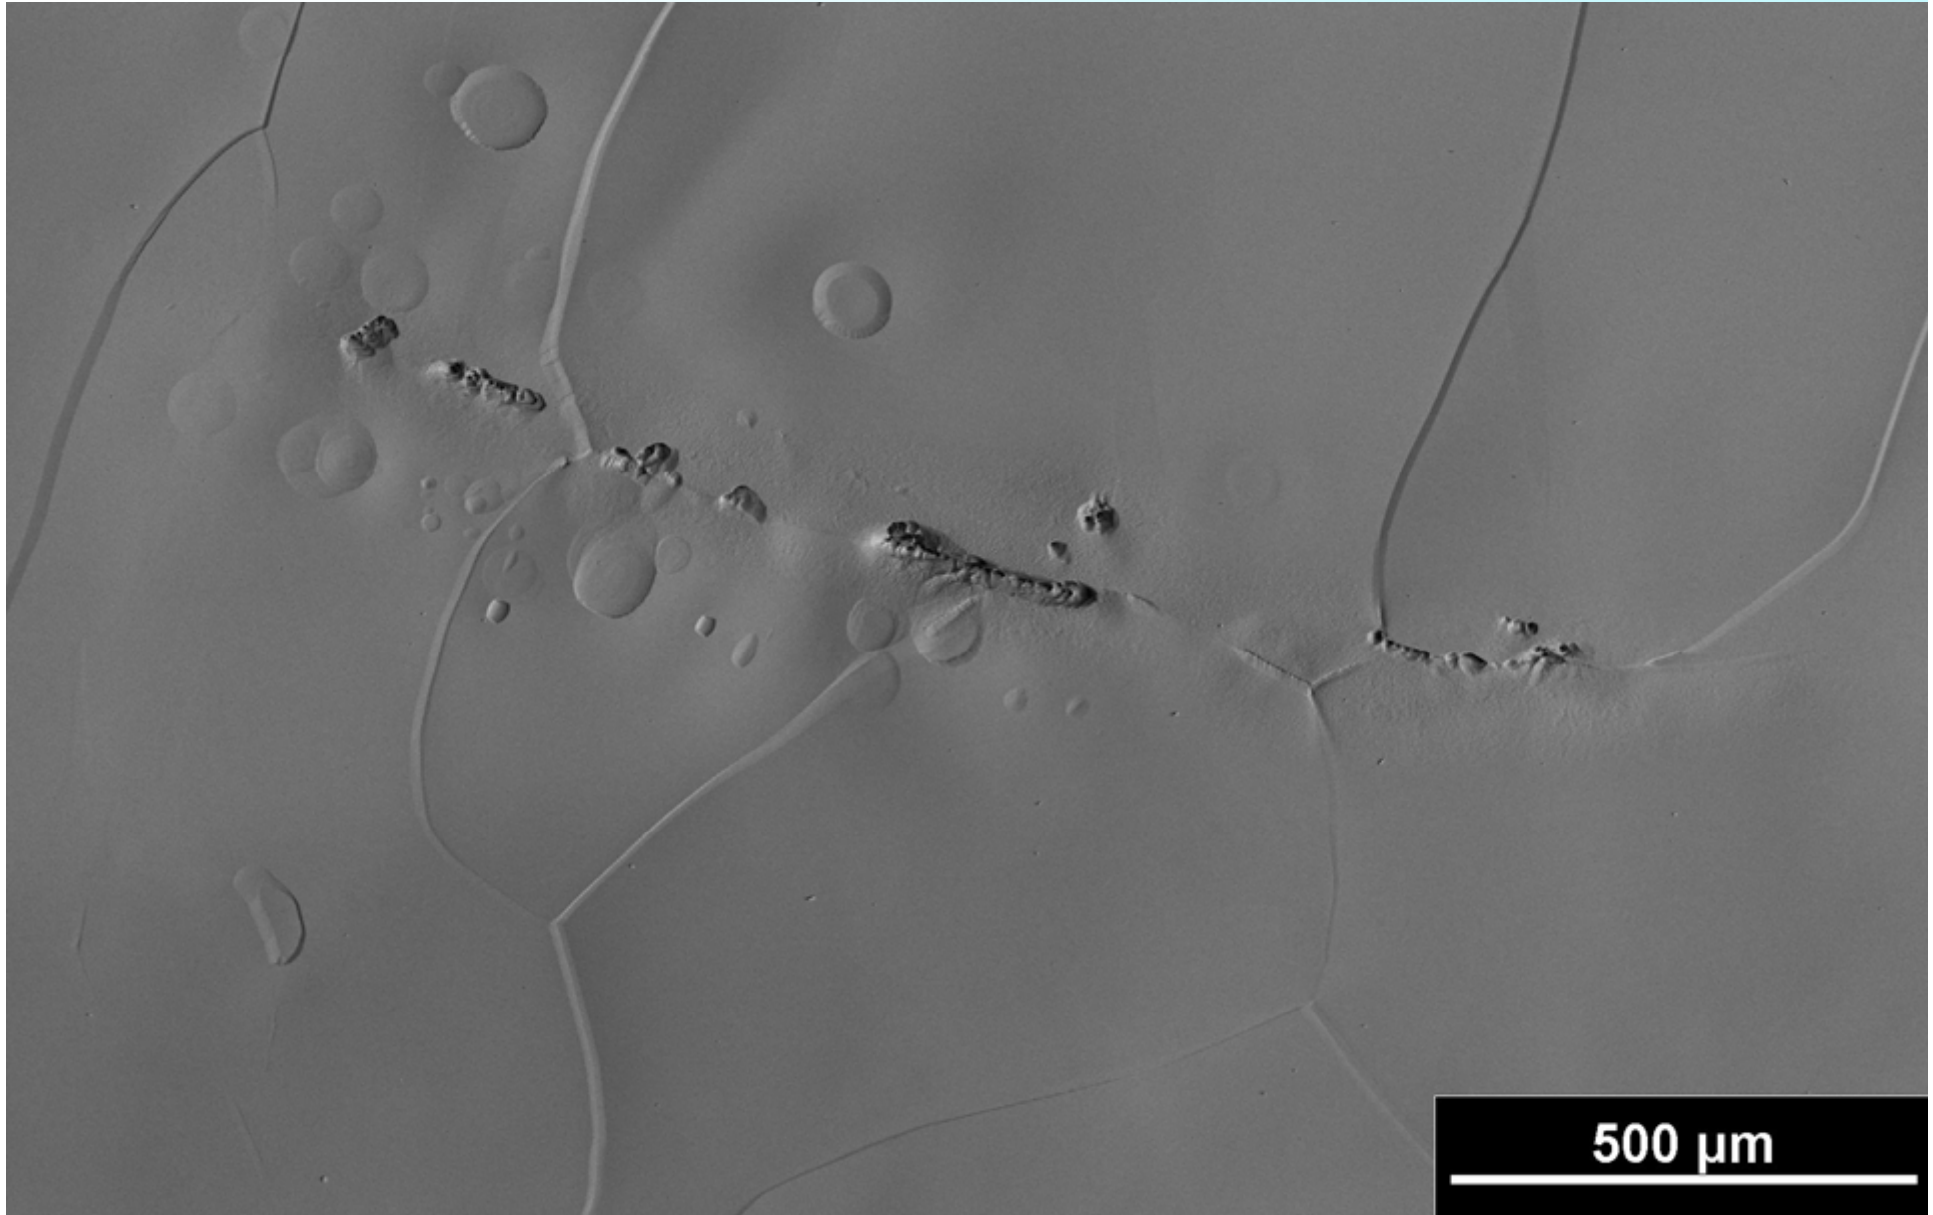
Light microscope. Quench location. Holes along grain boundaries. Cat's eyes.

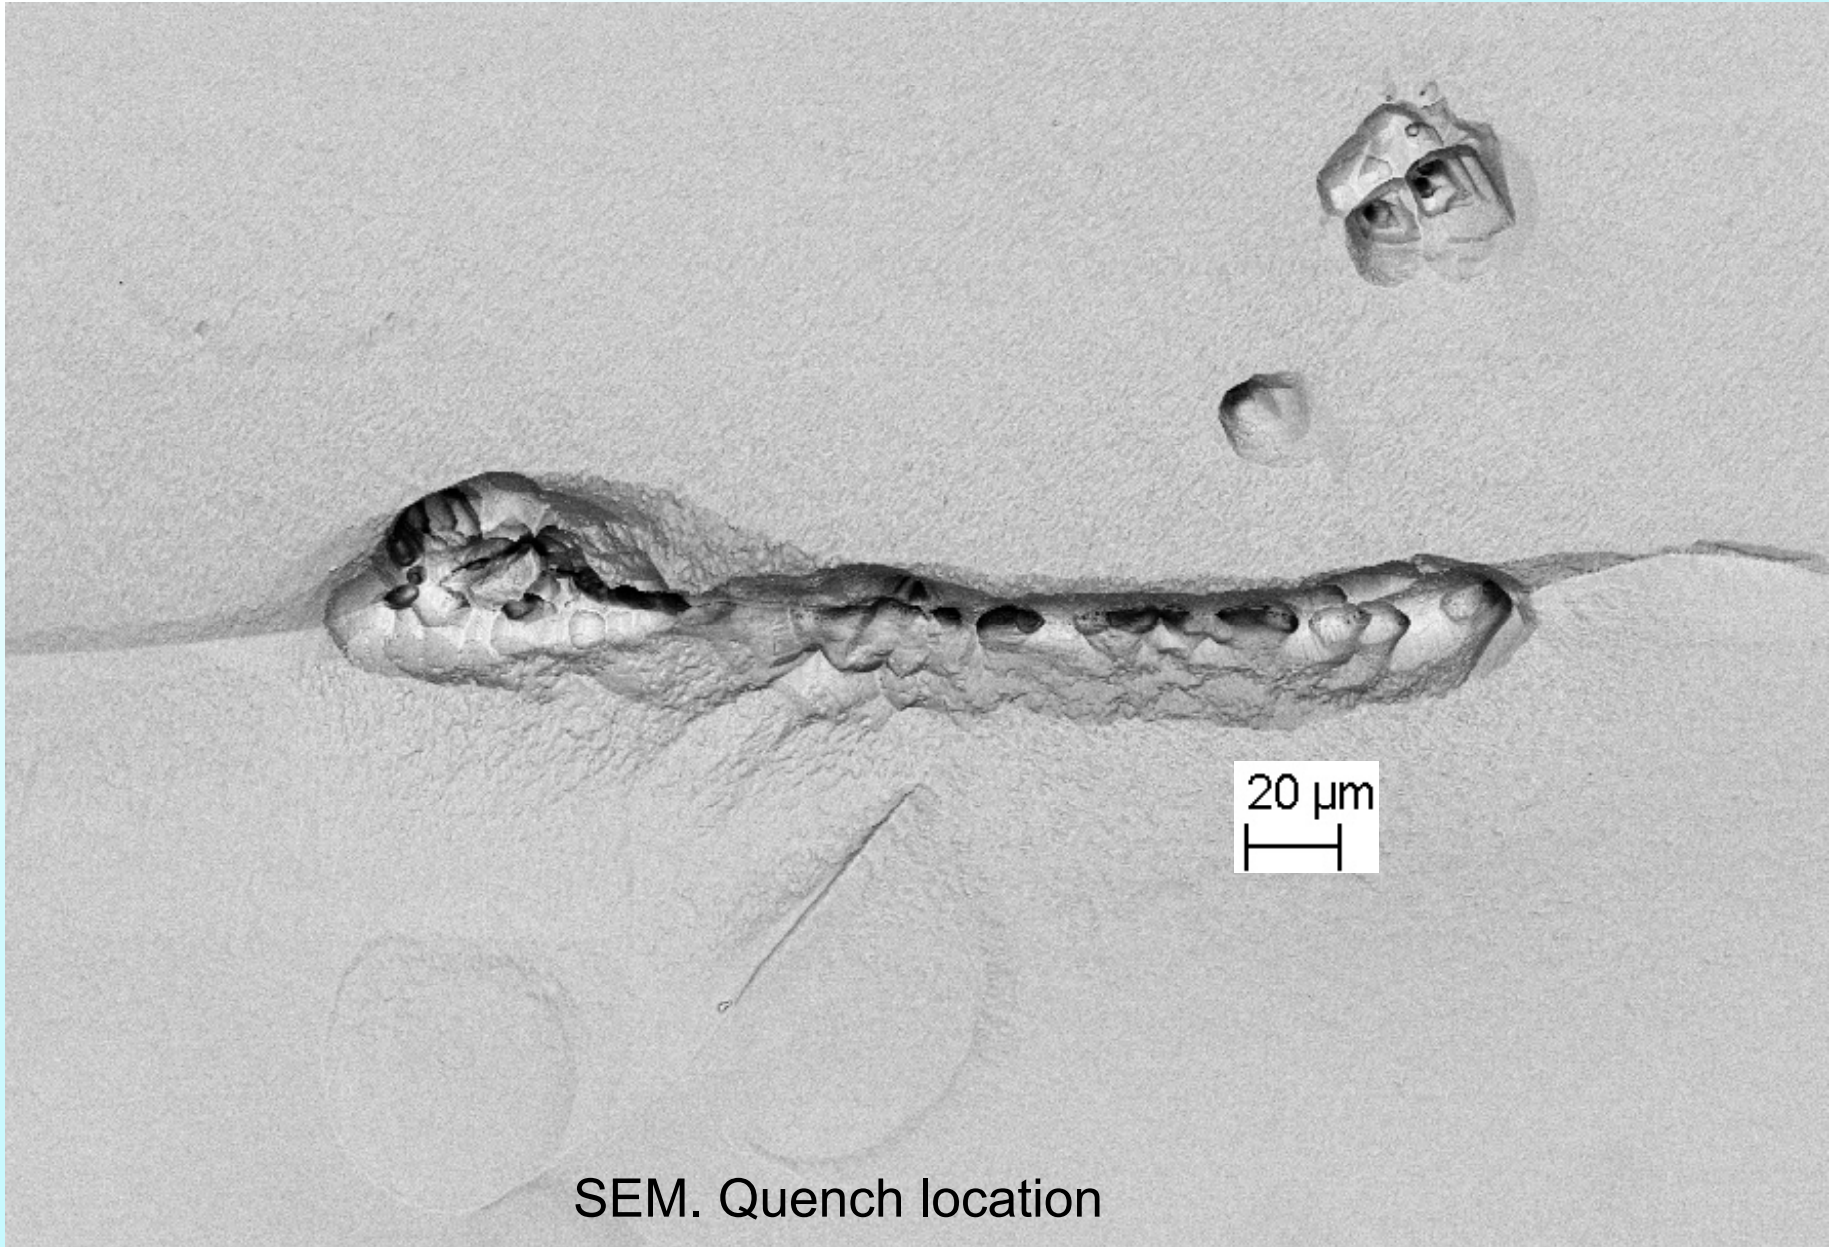
SEM. Quench location

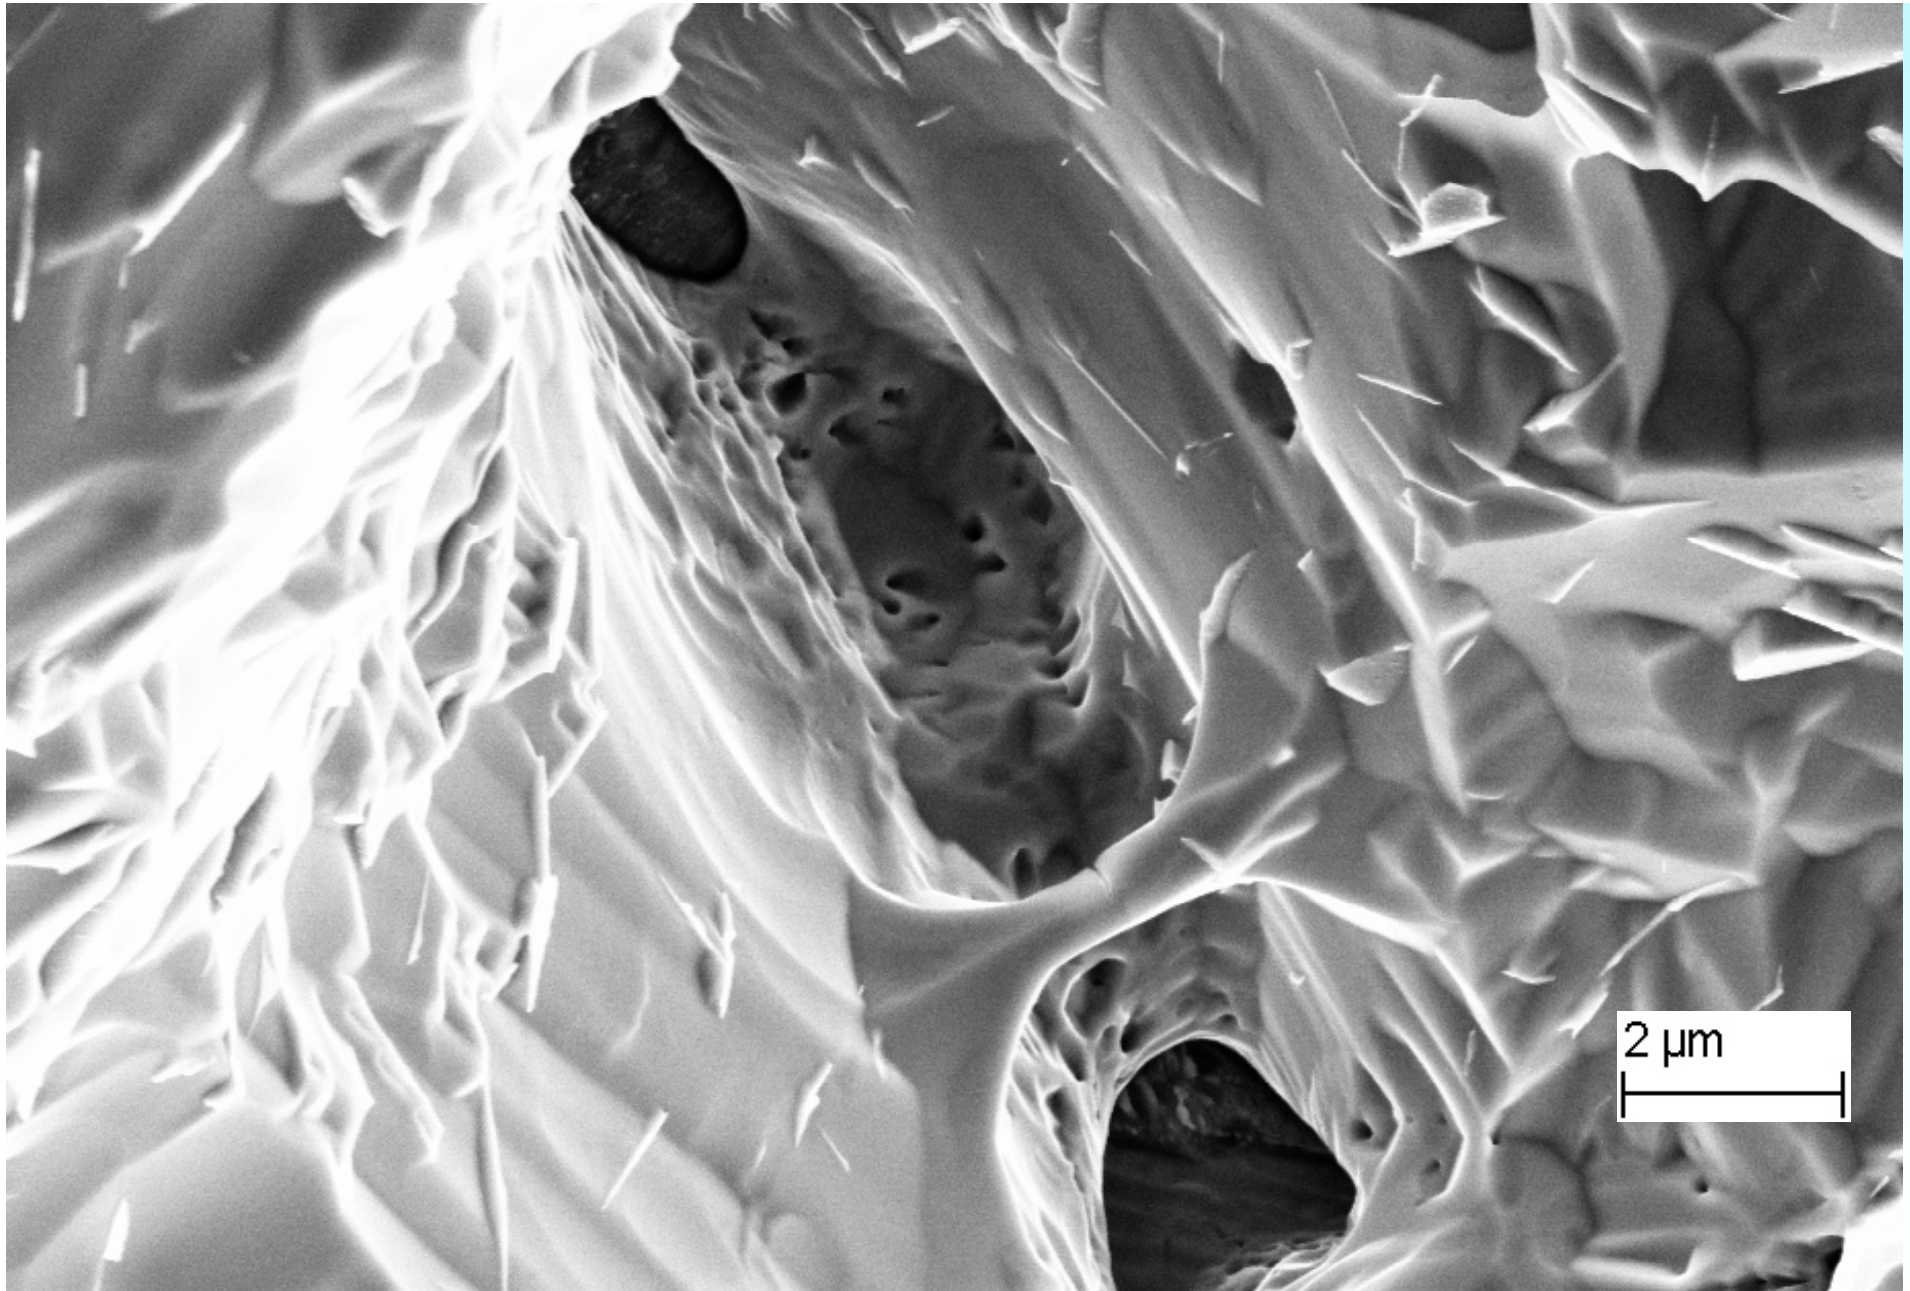
SEM. Quench location

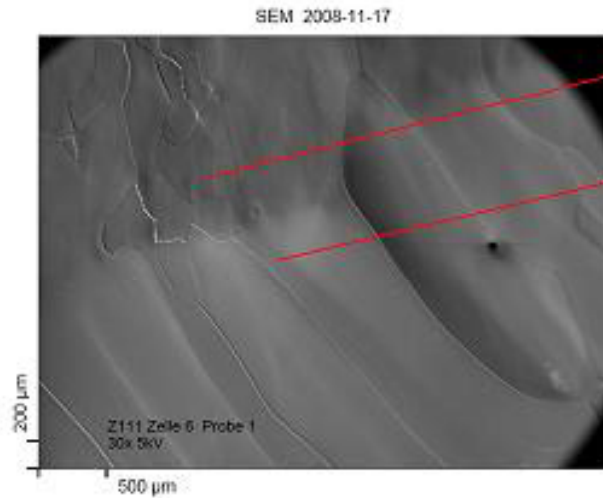
Auger analysis away from flaw areas

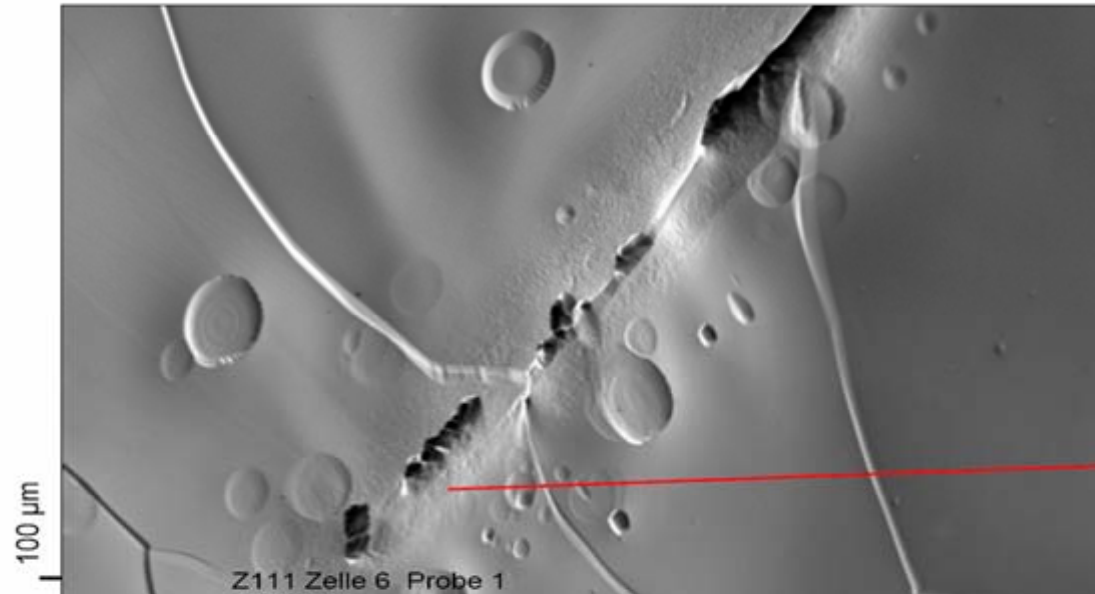
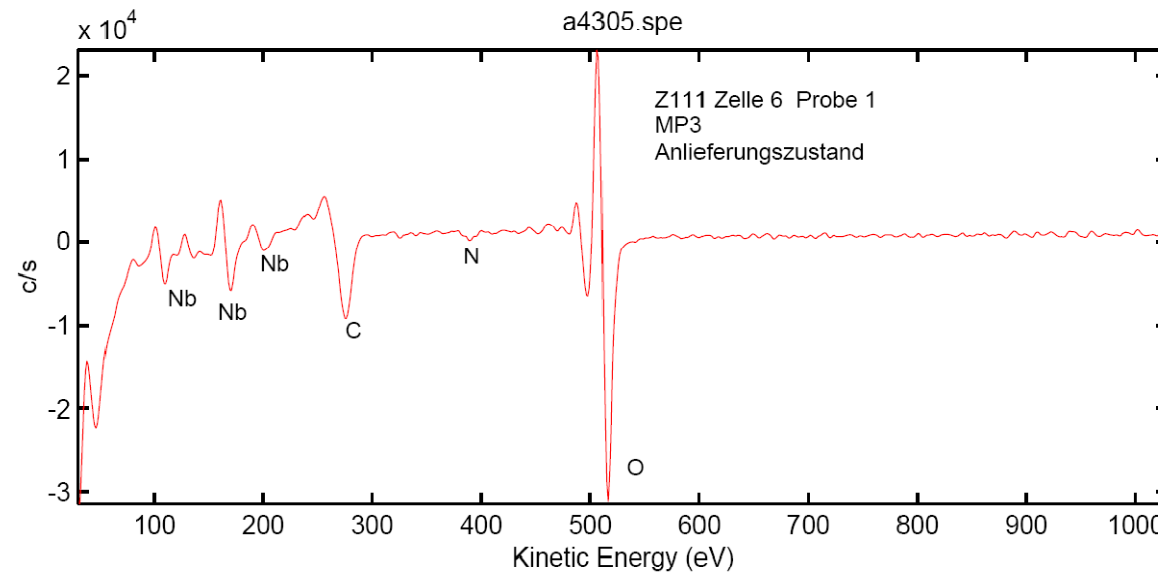
Auger analysis of the quench area (no foreign elements)

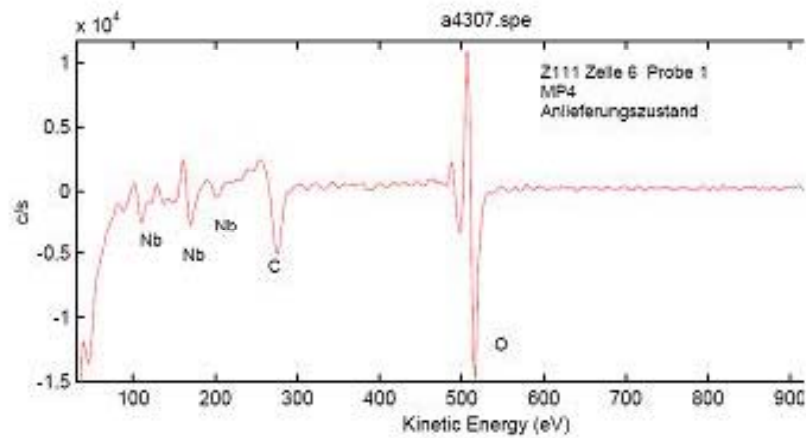
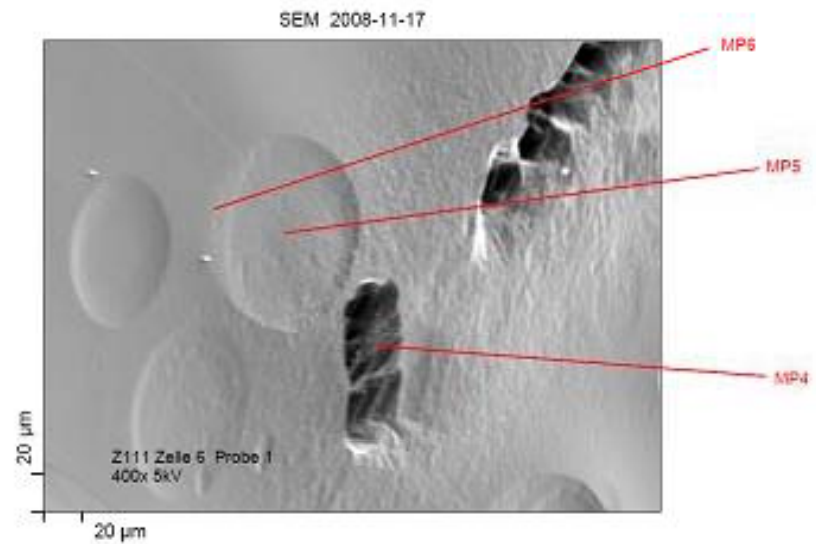
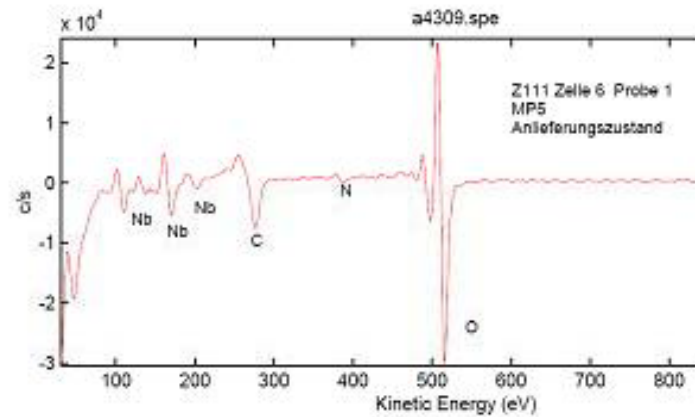
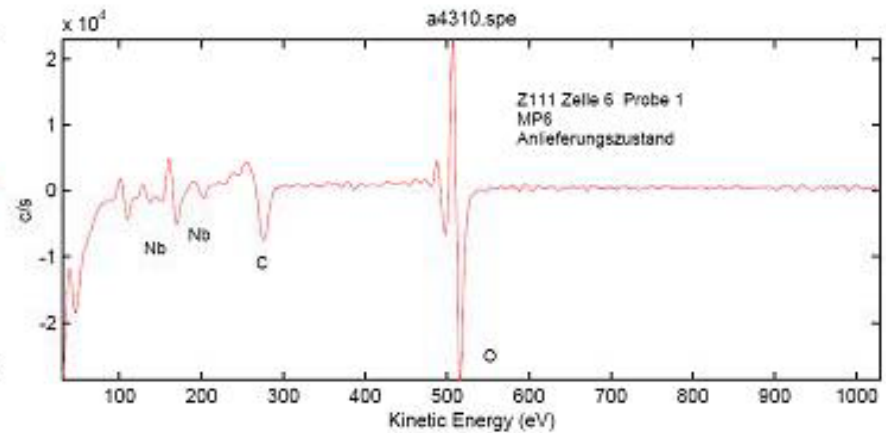
Auger analysis of the quench area (no foreign elements)

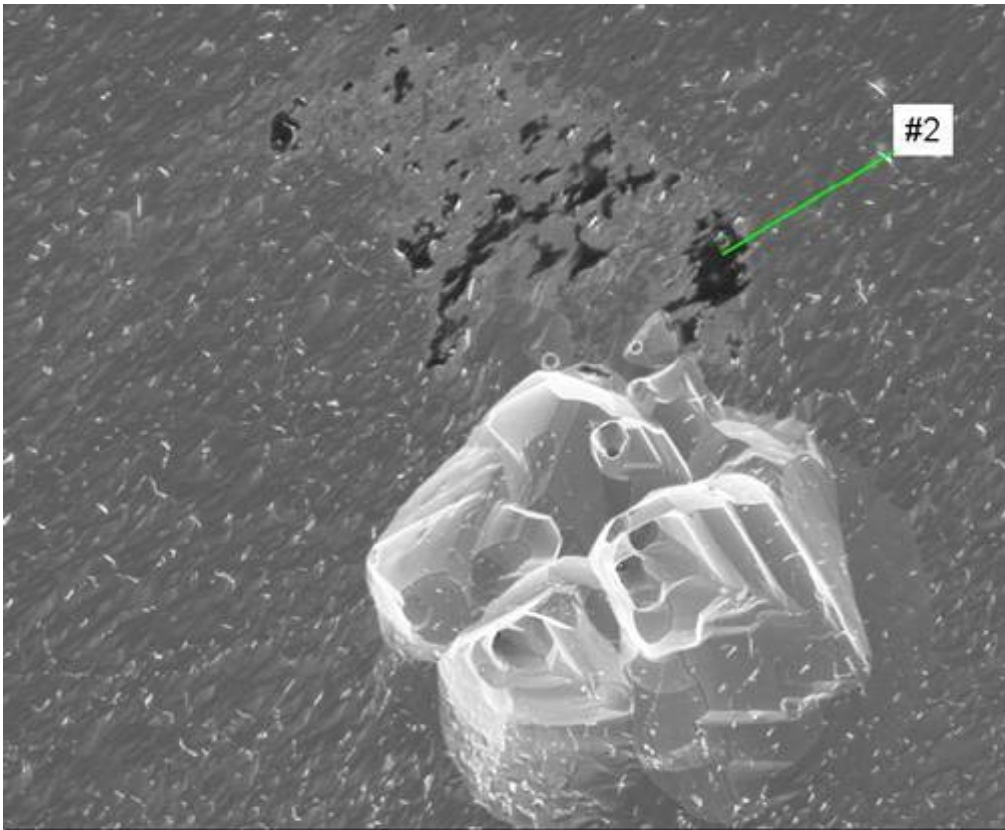
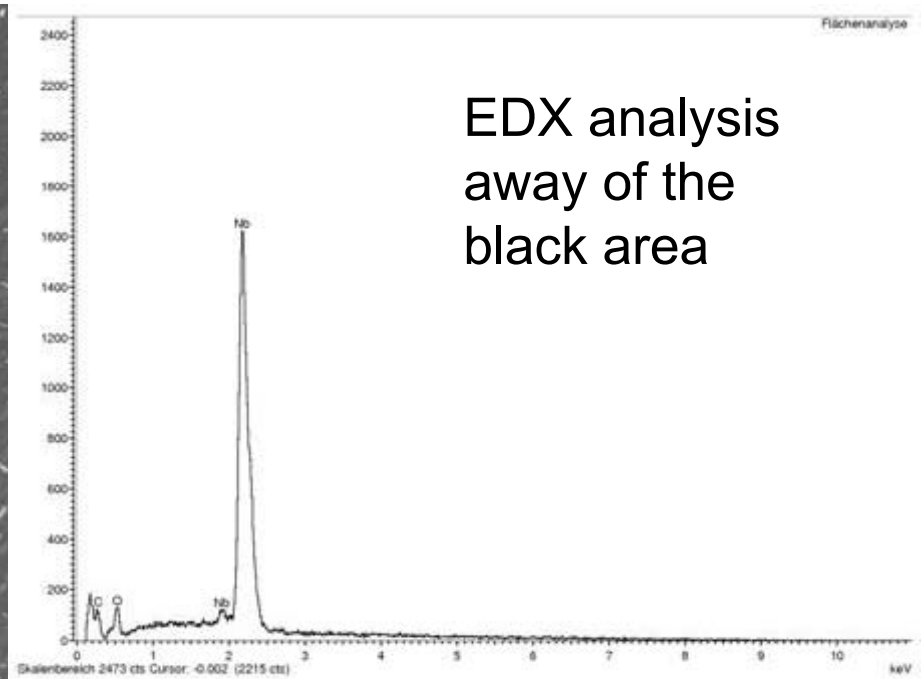
EDX –Analysis
on the black area
