What happen in GEM module ?

What we found through investigations

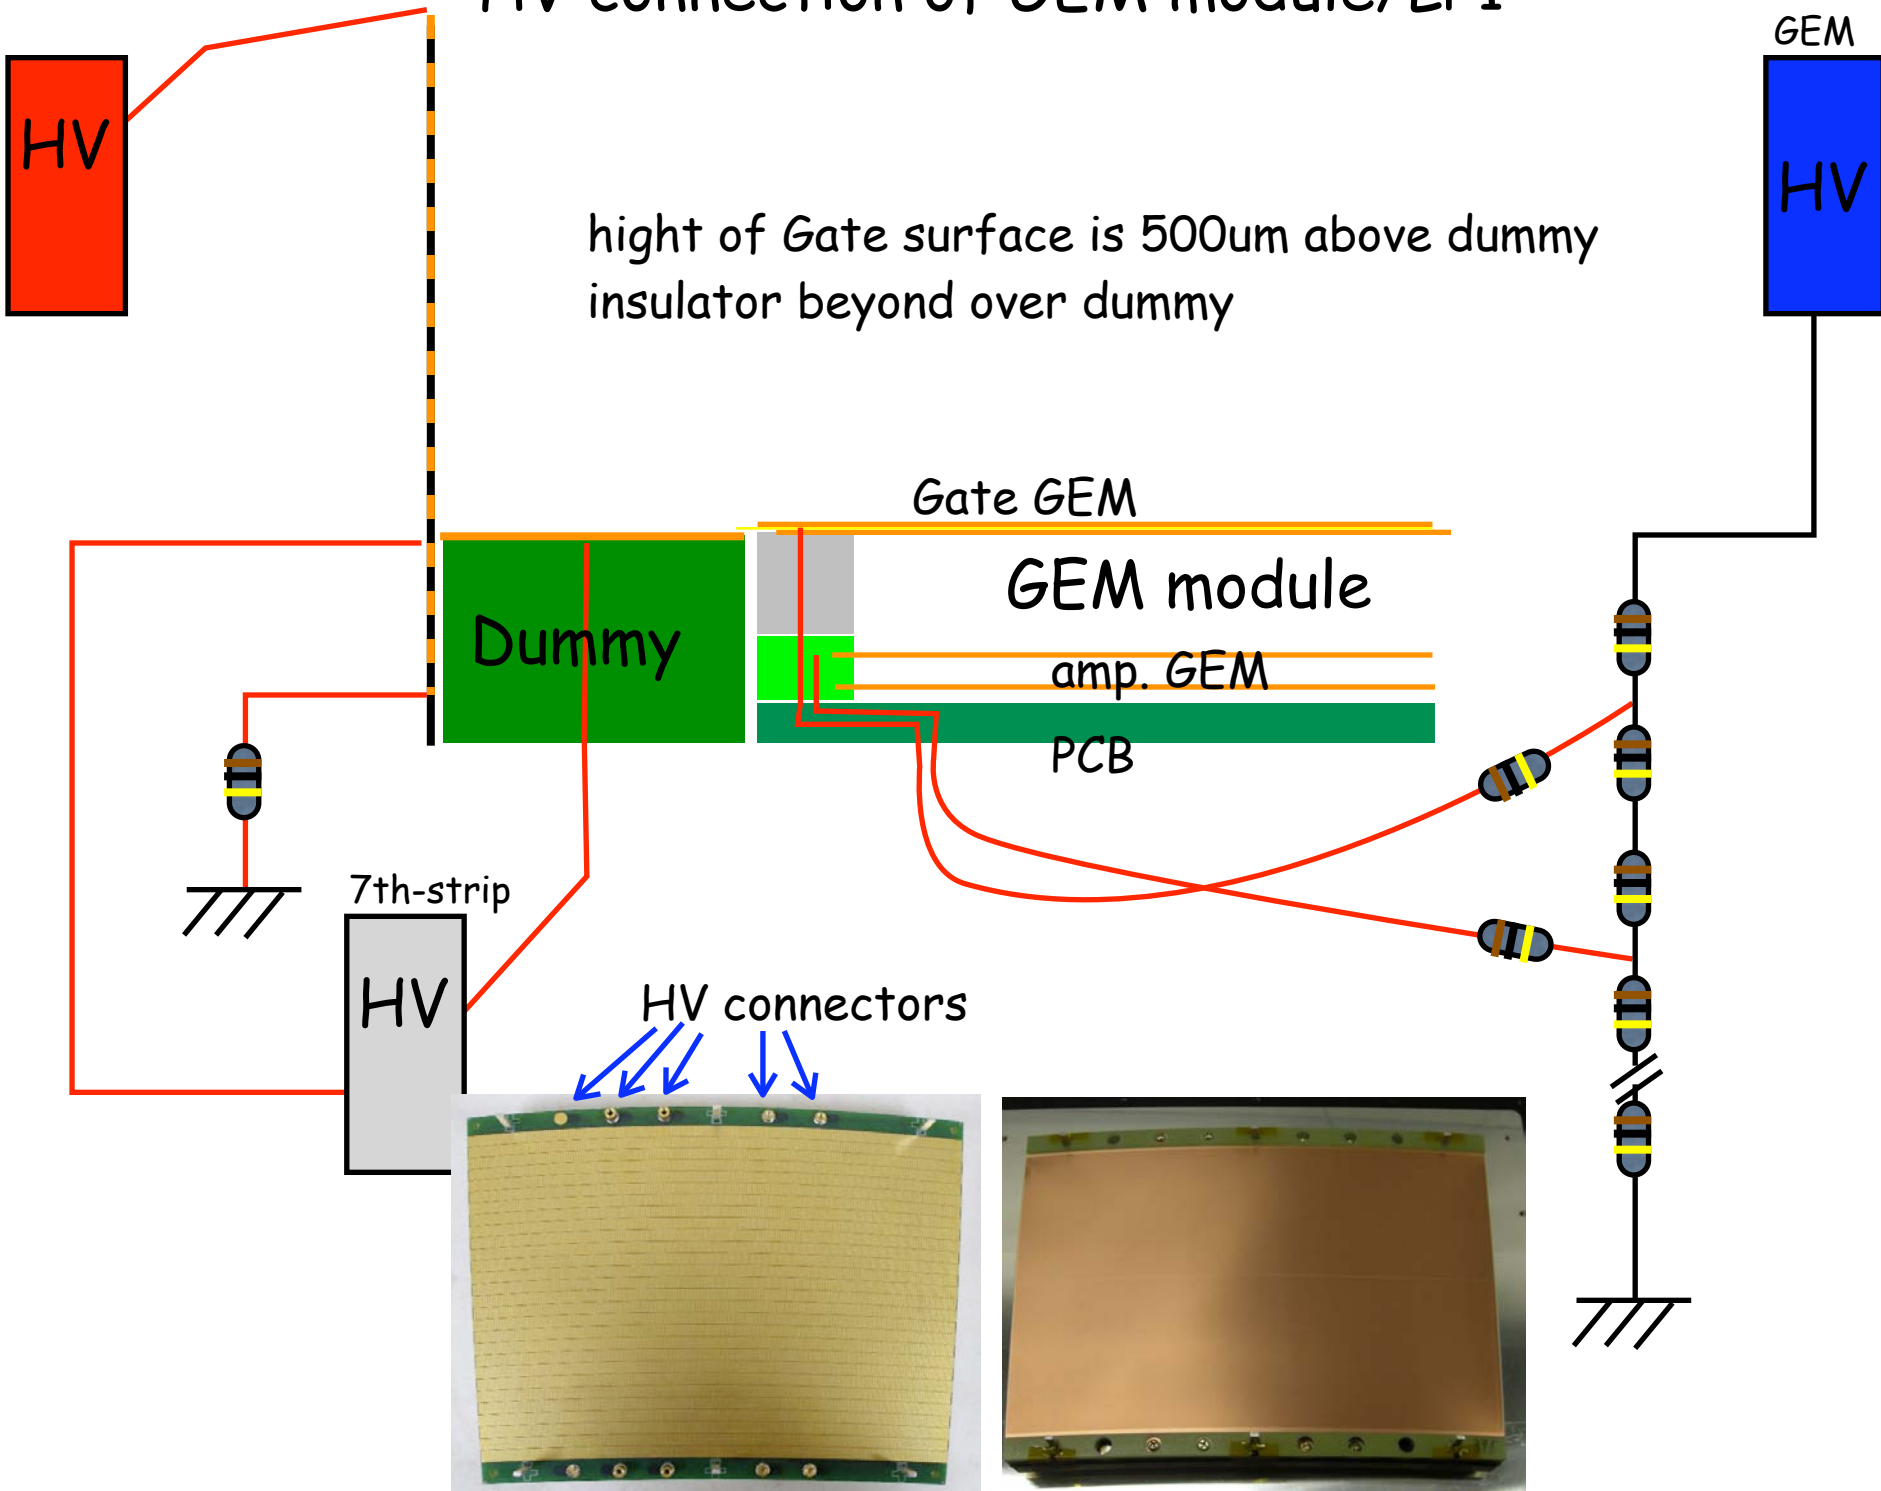
HV connection of GEM module/LP1

hight of Gate surface is 500um above dummy insulator beyond over dummy

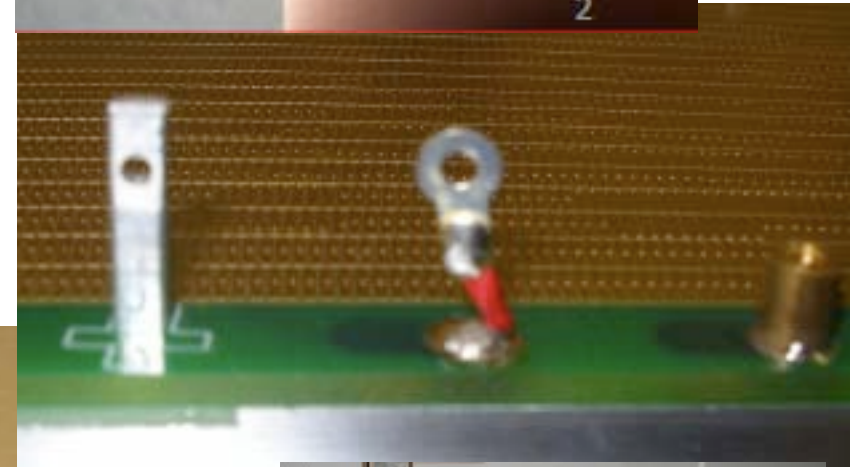
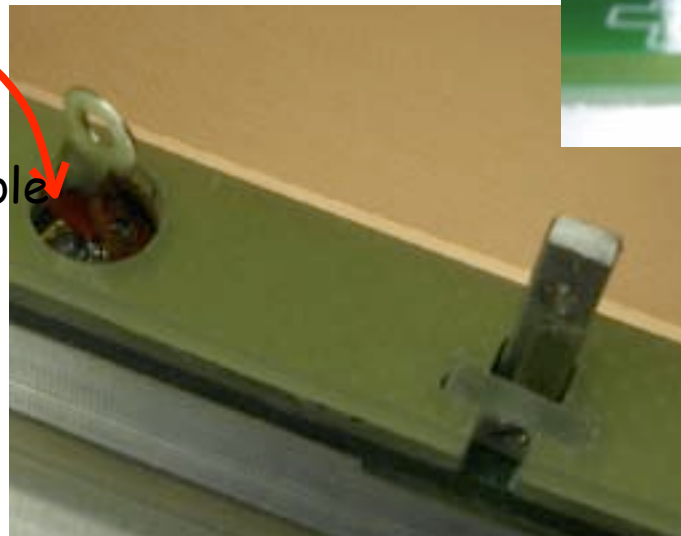
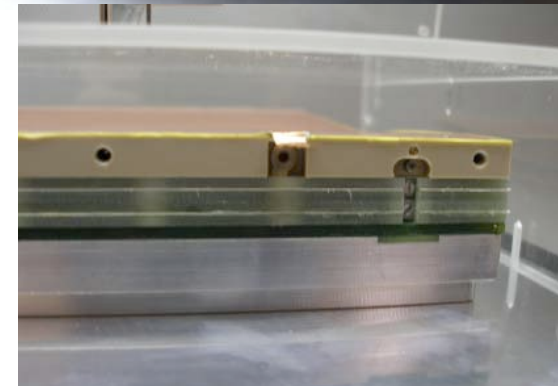
HV connection problem happen last time
solution => put Cu washer at HV - GEM connection

washer was found at Gate HV hole

Discharge trace is seen on corresponding PCB and GEM frame

At the initial HV test washer might be at the opposite position of pad plane.
After rotation of TPC, washer came to unlucky position and initiate discharge

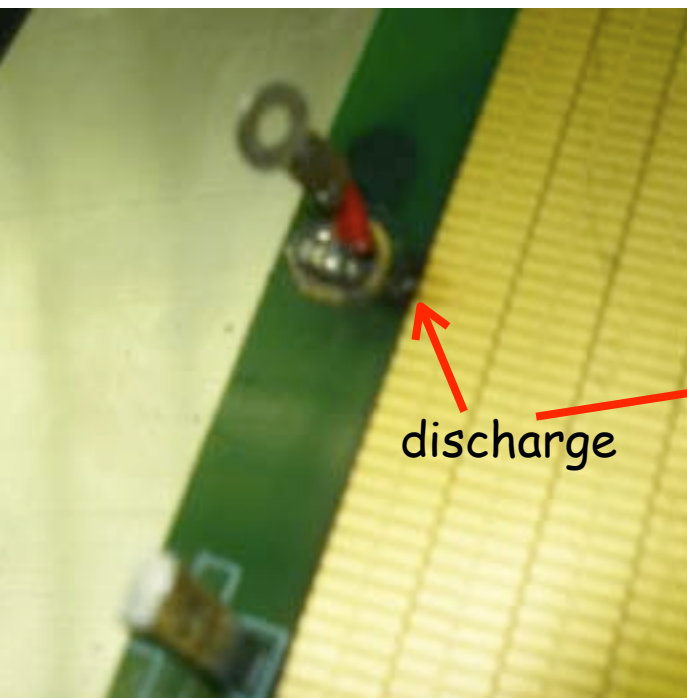
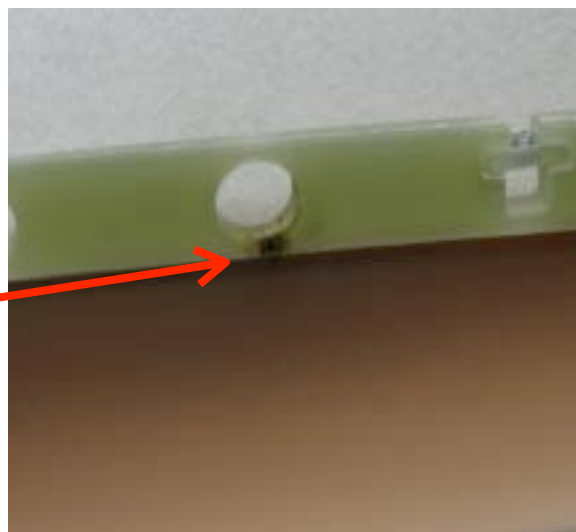
Corresponding Pad connector is D30
discharge seen on connector side between pad-GND

large discharge current may draw into D30,D31

W/o termination connector, pad is not GNDed
it makes situation complicated during investigation

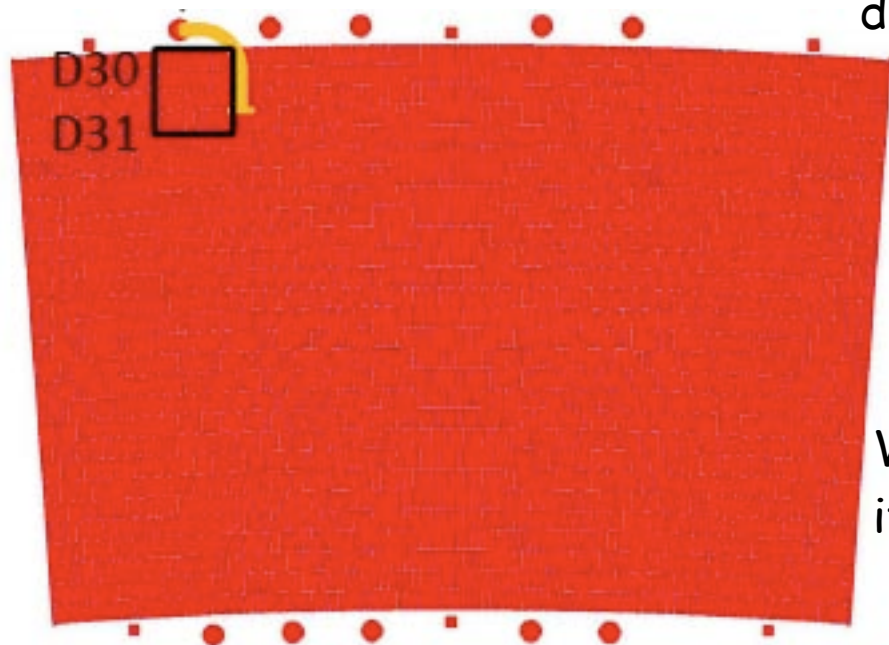
discharge at Gate surface

When HV trip, discharge may happen because Gate electrode is too close to Dummy surface over placed insulator help discharge

Chronological order is not proved

washer initiate discharge -> HV trip (Gate - GND term.)
HV trip -> discharge at Gate (Gate - Dummy)
more current from Dummy -> Gate -> PCB ?

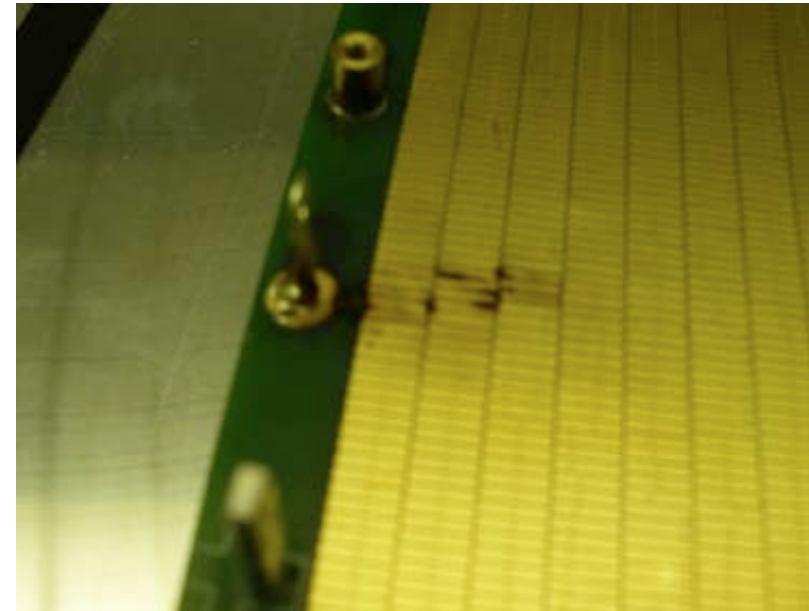
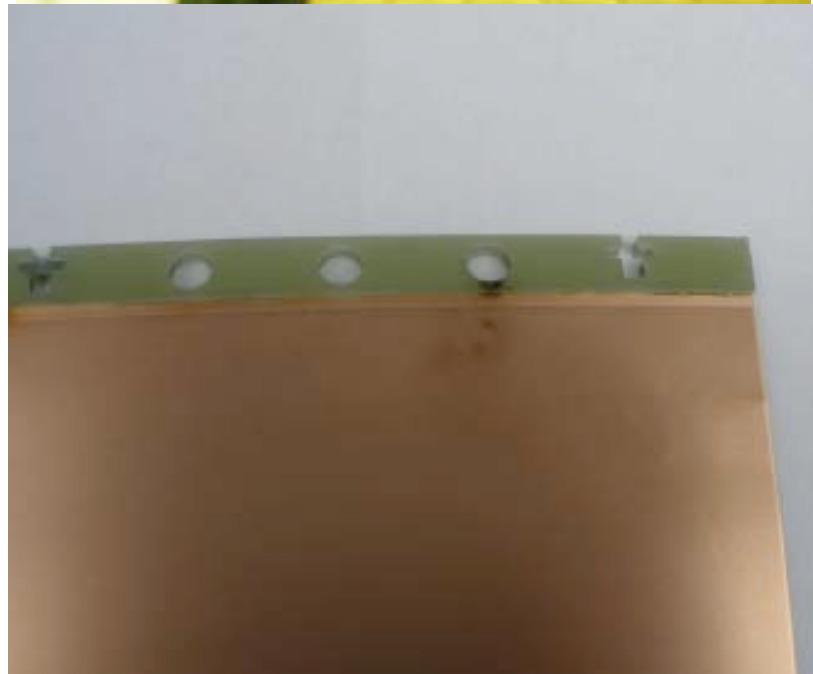
discharge at module 3

for module 0,
trace of discharge is concentrated at local

for module 3
trace is spread over wide area

we are not sure
why this happen on module 3
without initiator(like washer)

We don't understand this but
we are believing
this problem would not happen
without the initial problem.
