Replica and Local grinding

Repair for JLAB LG#1, AES-01, RI-026

K. Watanabe (KEK)

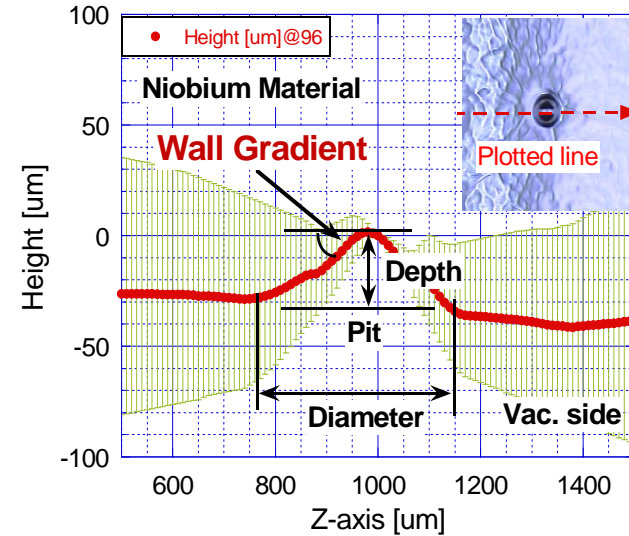
**STF Baseline cavity #4 : After Phase 1.0 project
#1-cell equator, t=087 degree**

Maximum measurable wall gradient by the Kyoto camera system at Equator is ± 22 degree. If the shape of defect is changing steeply, then the 2D-analysis for geometrical defect can not make by the Kyoto camera system.
To take a information for this defect, we need to use the replica method.

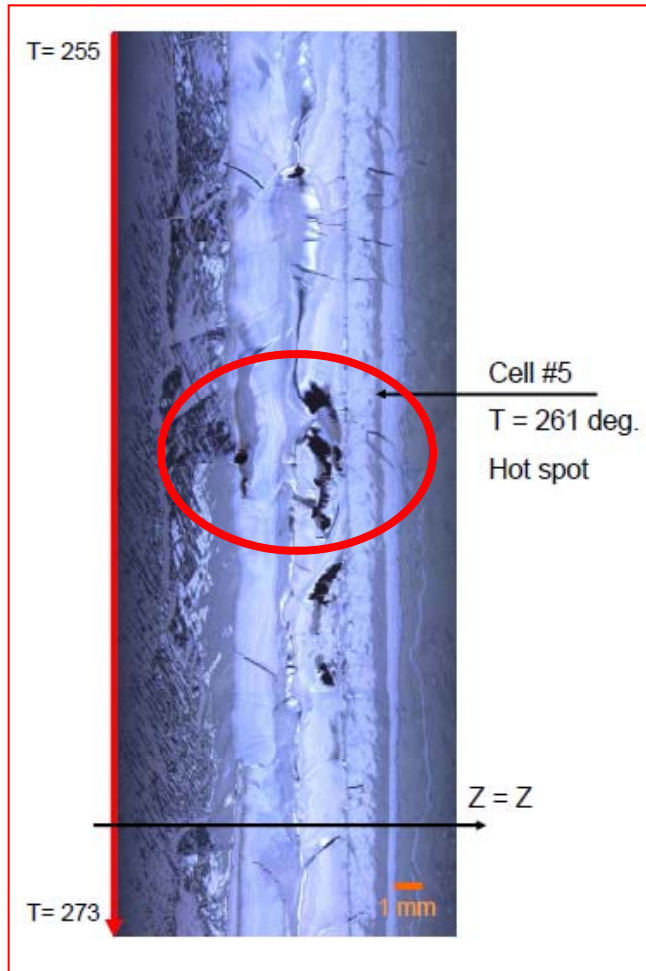
Initial: Pit-type defect (funk hole)

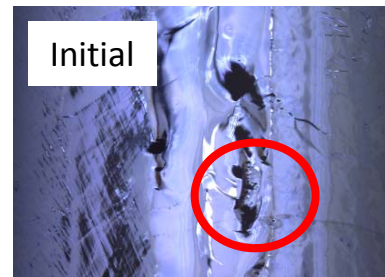
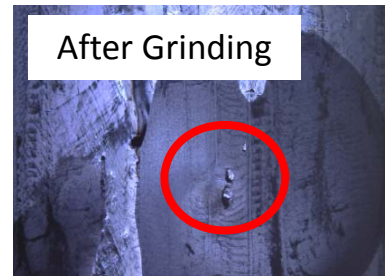
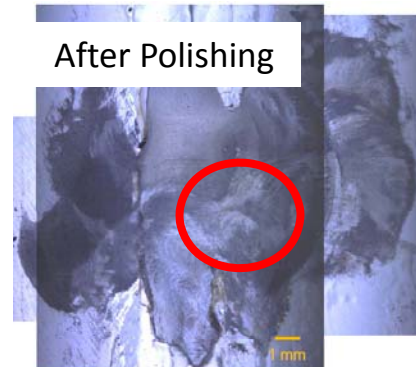
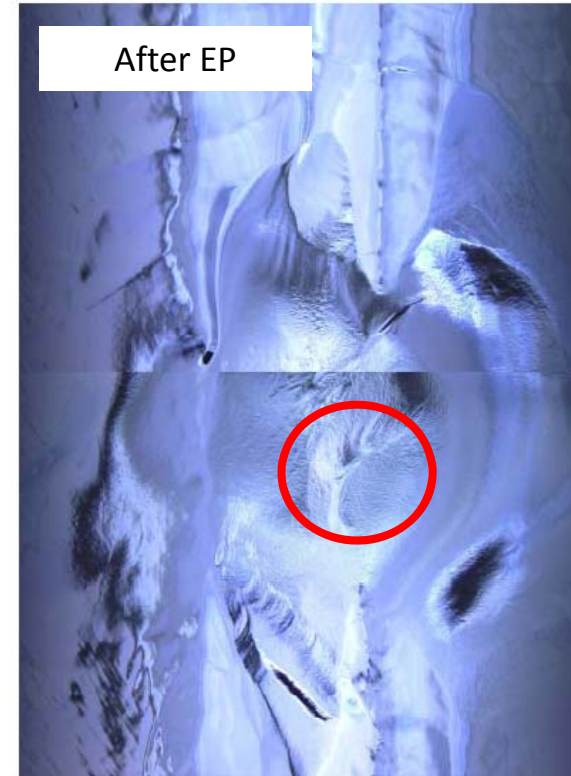
5-cell performance improved from 30 MV/m to 40 MV/m. However, the cavity performance was limited at 20 MV/m by quench at 6-cell.

After grinding and additional EP (85 um) at STF

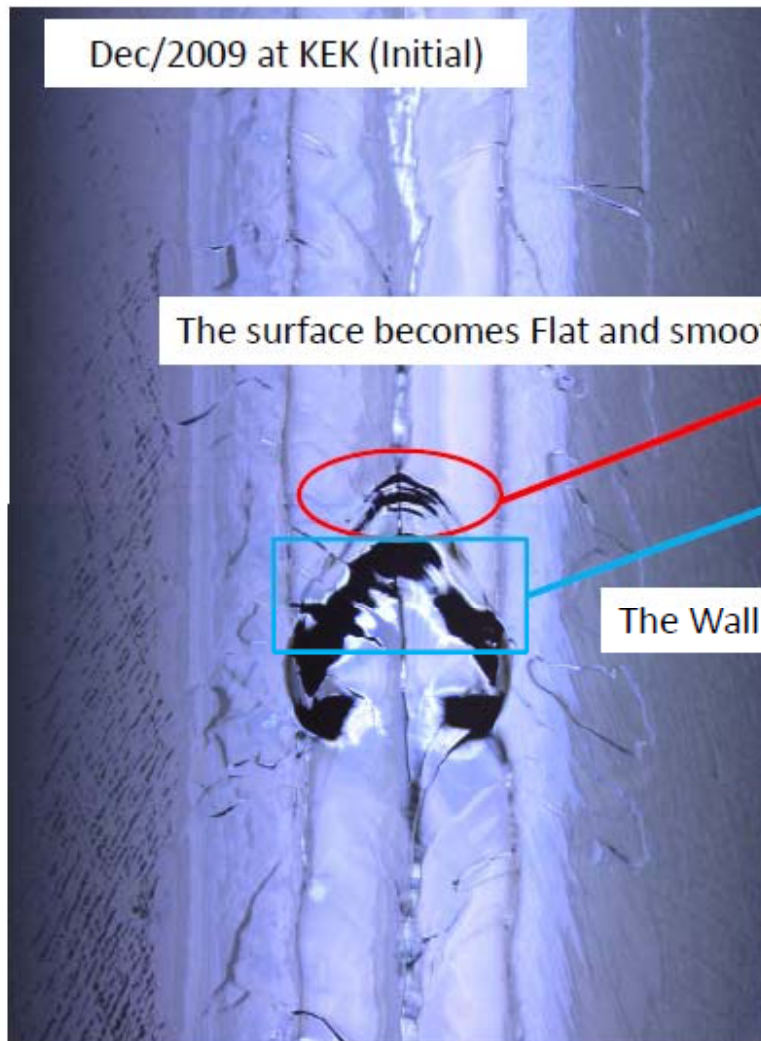
6-cell, $t=325\text{deg}$. Unstable EBW seam (Pit-type, funk hole)

Try again the local grinding for this defect until this summer.

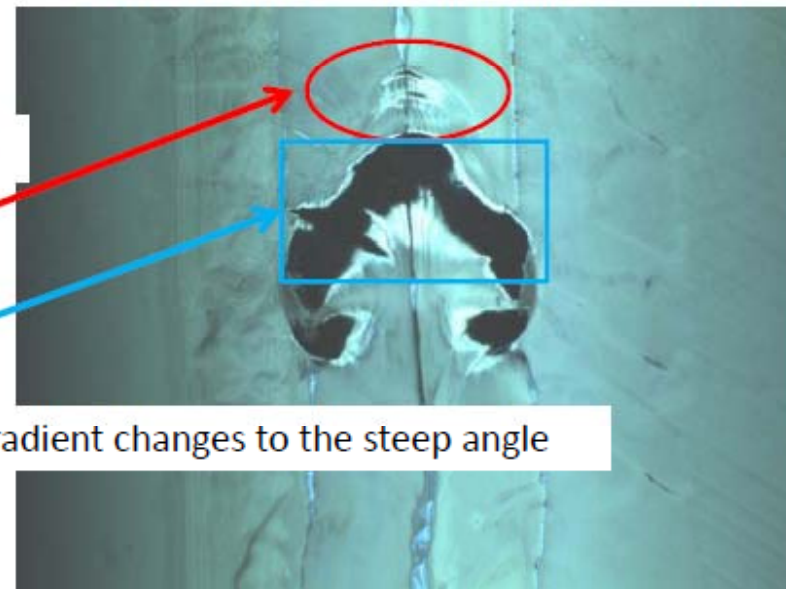
Feb/2011 at JLAB (Additional EP 85 um)

The dark zone grew by additional EP (85 um).

It is a possibility that the defect shape changes to a deeper pit, then the quench field also shifts to the low field. The edges also deformed to the sharp edges around dark zone of defect.

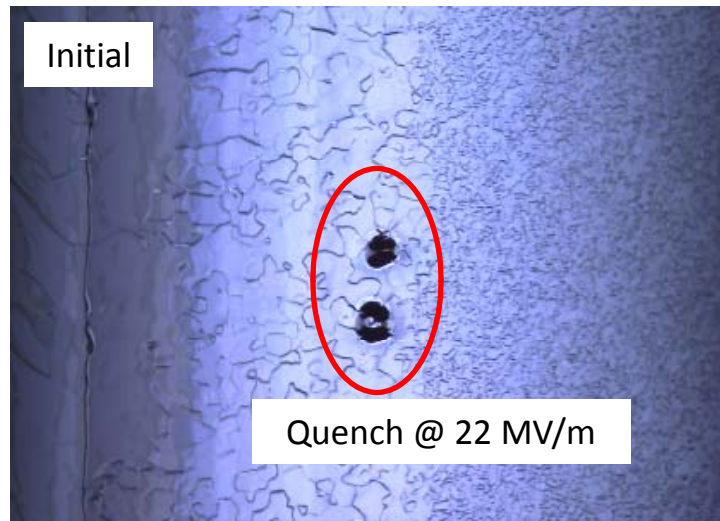
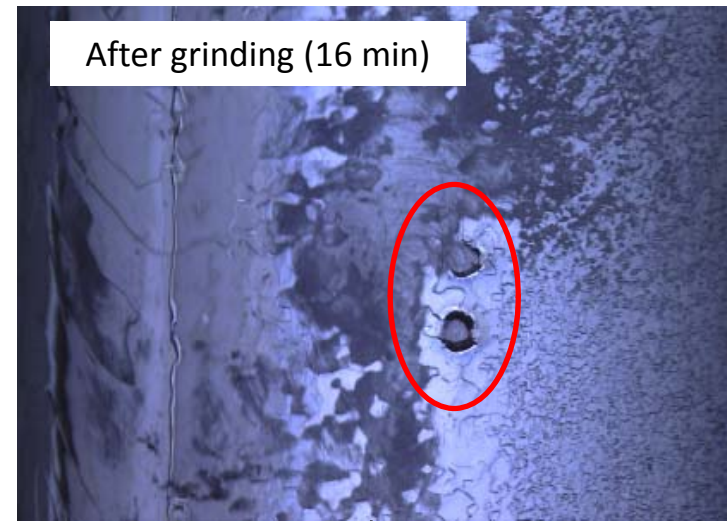
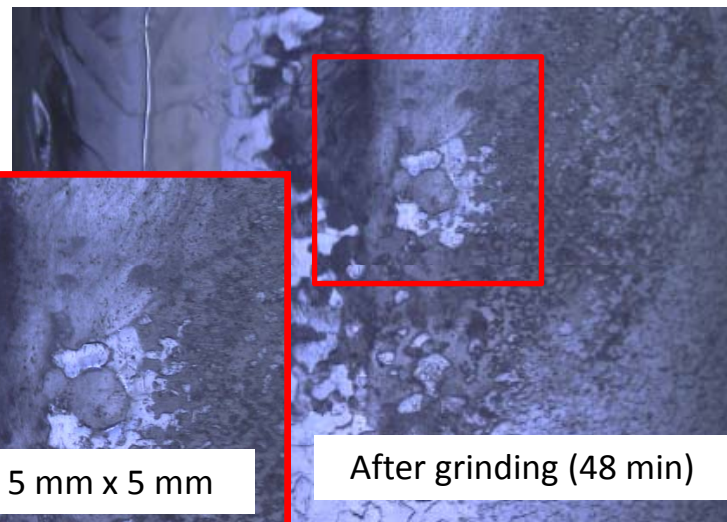
Cavity: AES-01 (Cause of limitation was Quench)

Defect: 3-cell equator, $t=169\text{deg}$. Bump-type

* Grinding time: 48 min (Diamond sheet #1000)

(include polishing)

* After mechanical grinding and polishing, the light EP (30 μm) was made at STF.

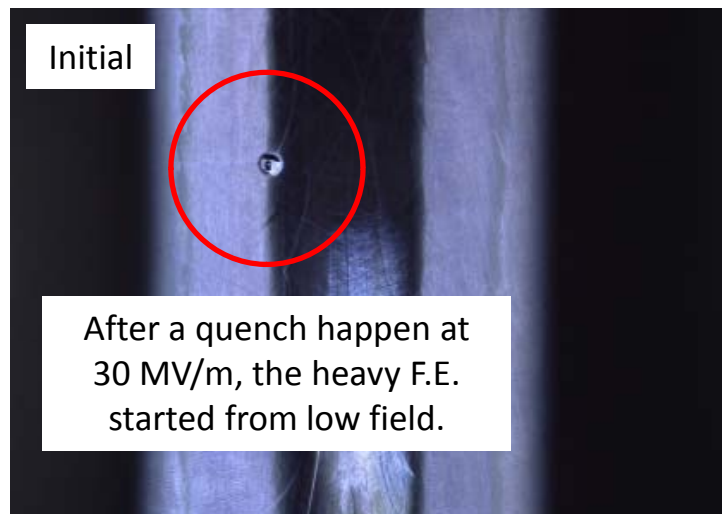
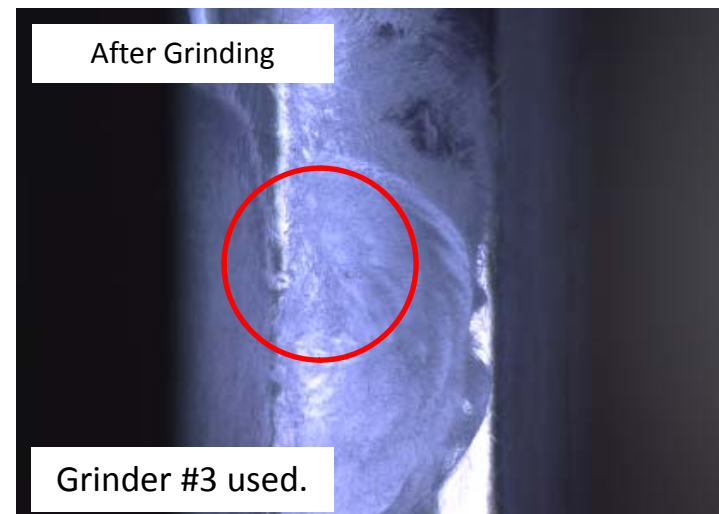
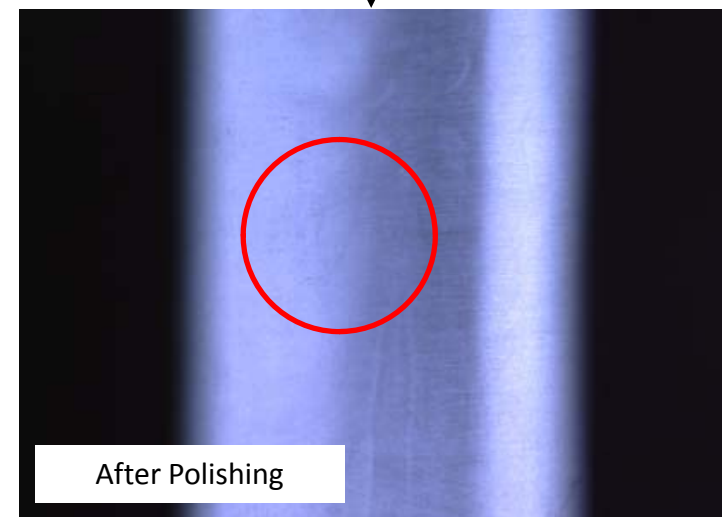
RI-026

Cavity: TB9RI-026 (Cause of limitation was F.E.)

Defect: 8-9 iris, t = 107 deg. Pit-type

*Grinding time: 115 min (Diamond Sheet #400)

Polishing by hand: 30 min (3M Micro fine)

*After mechanical grinding and polishing, the light EP (30 um) was made at STF.
