# Quality control of copper plating for coupler

LCWS13 at Tokyo, November 12, 2013

Nomura Plating Co., Ltd

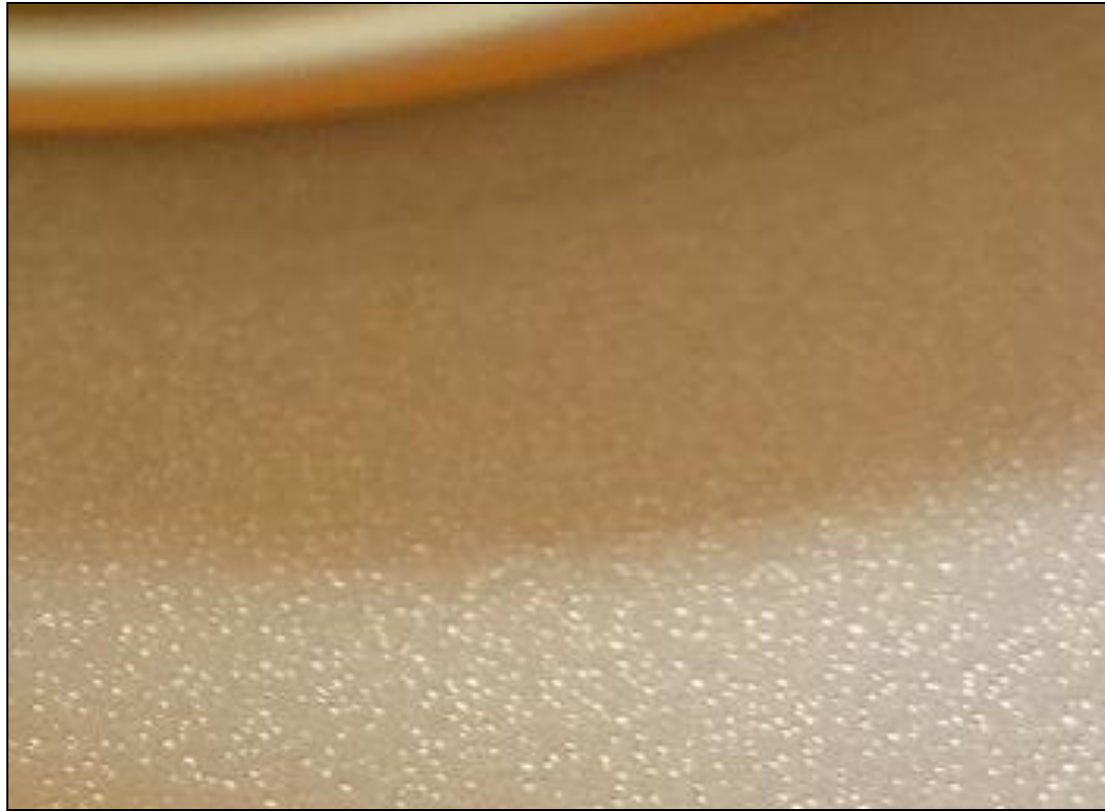
After the brazing process (conditions: hydrogen furnace, 800 °C), we found **micro-projections** on the surface of copper plated parts.

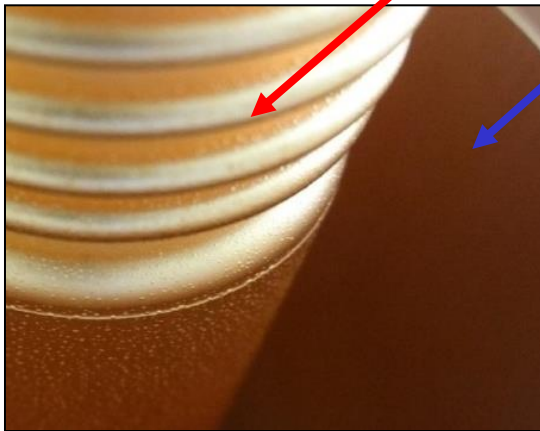
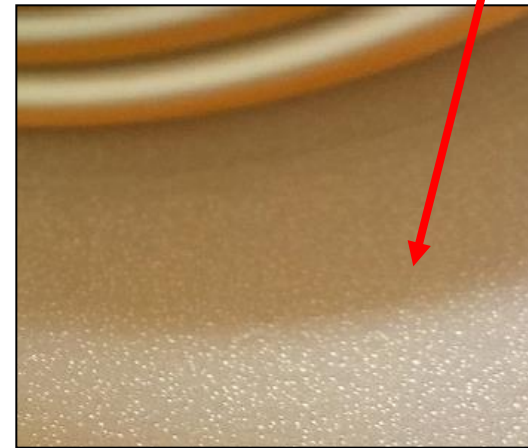
**Micro-projections** were created if using **nickel** for strike plating. On the other hand, smooth surface was obtained if using **gold** for strike plating.

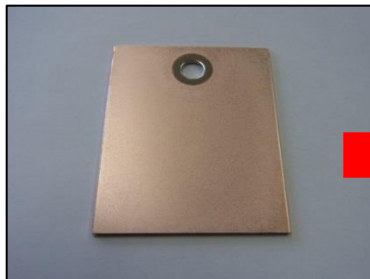
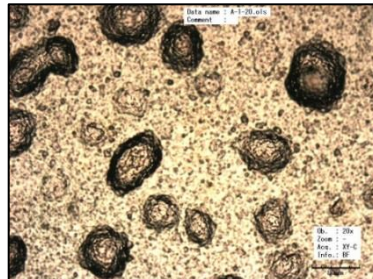
Test piece with micro-projections

We thought the reason why we had micro-projections on the copper plated surface might be the old solutions in the plating processes. So we performed **verification experiment** by old and new solutions in the plating processes.

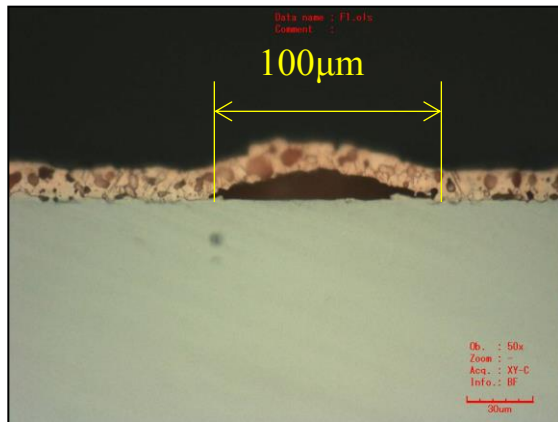
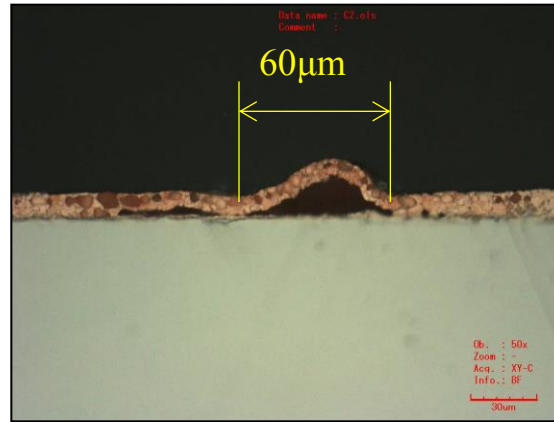
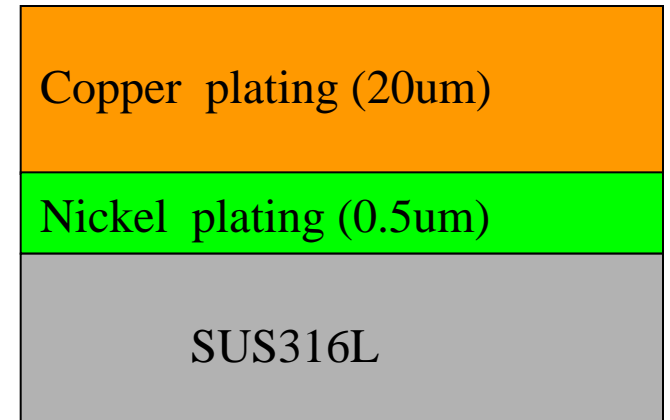
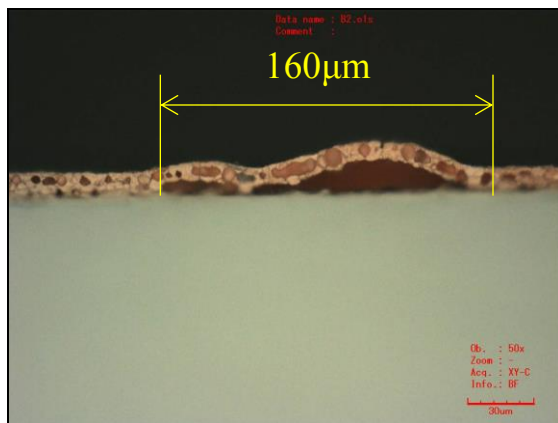
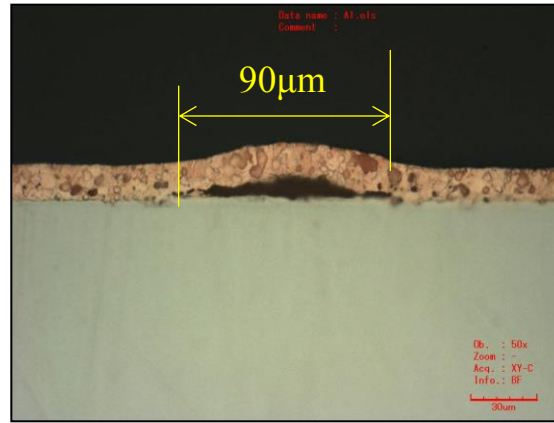
Detachment was found in between copper and nickel films. This means there might be a problem in the **solution of copper plating**.

We performed the analysis of Organic impurities (Total Organic Carbon = TOC). As the result, we found 100 times more organic carbon contamination in the old solution than new one.

- Organic impurities caused degradation of copper plating bath.
- We have solved this problem successfully with **new copper plating bath**, or by **gold strike plating**.

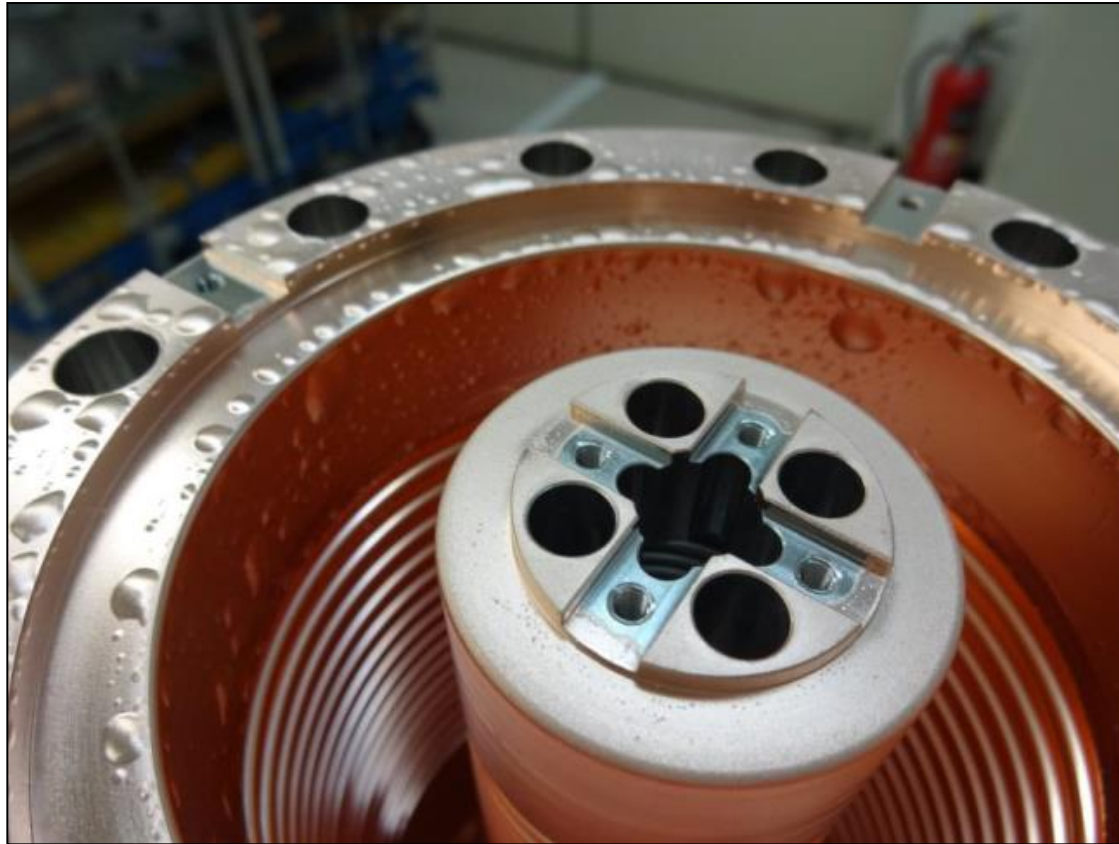
After the brazing process (conditions: hydrogen furnace, 800 °C), we found large size of swelling on the surface of copper plated parts.

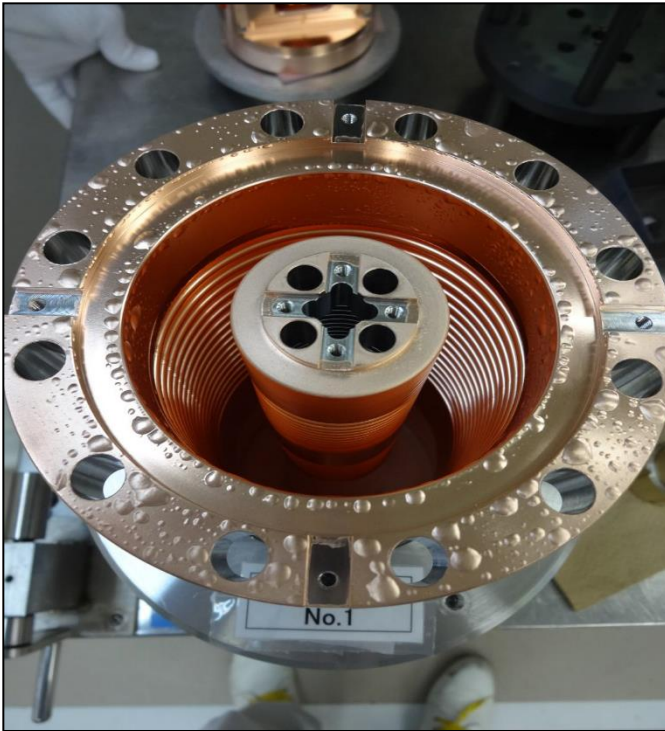
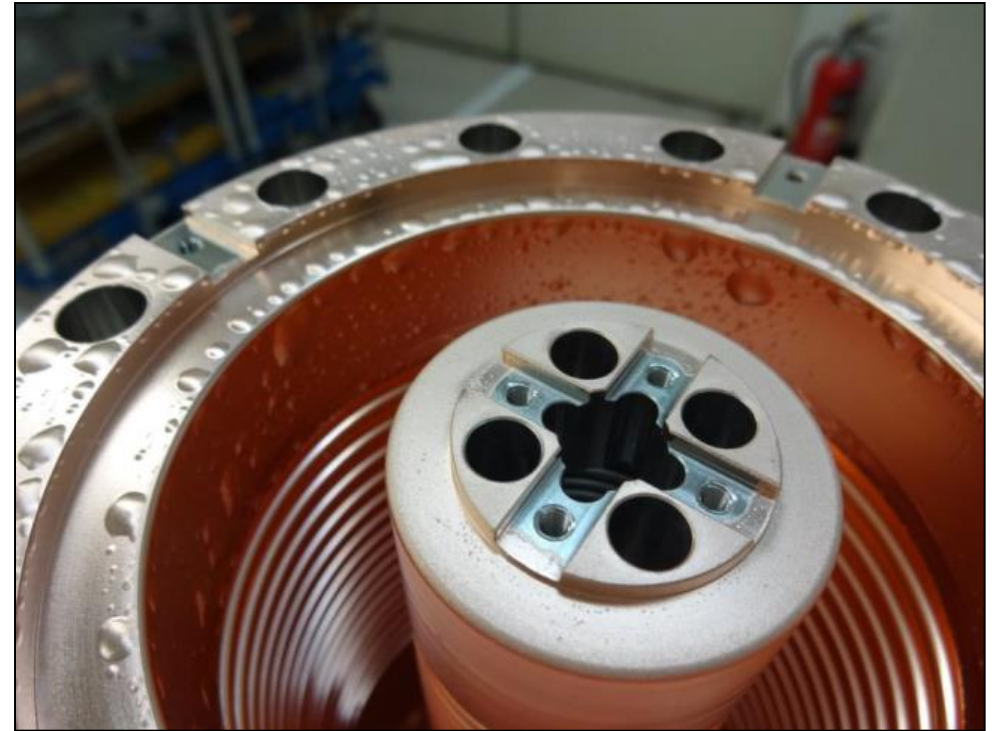
5 ~ 10mm $\phi$  swellings were created only if using gold for strike plating. Swellings were found mainly around the flange.

The part D has the **large plating area** and **large liquid load** in the plating process, and we used gold for strike plating to the part D.

We have solved this problem by applying the **nickel** strike plating only to part D.

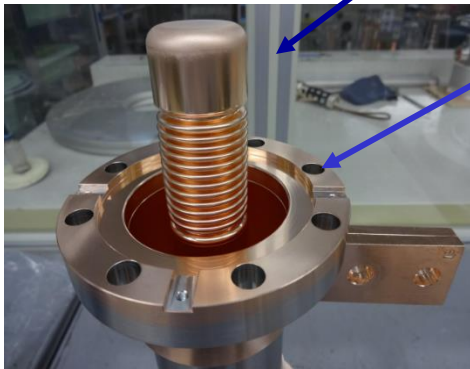
Parts A and B

smooth

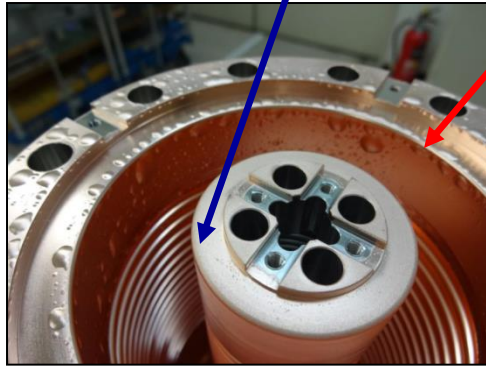
Parts C and D

swellings

Swellings were found only on the part D.
