Challenges and Status of XFEL

Attempted Outline

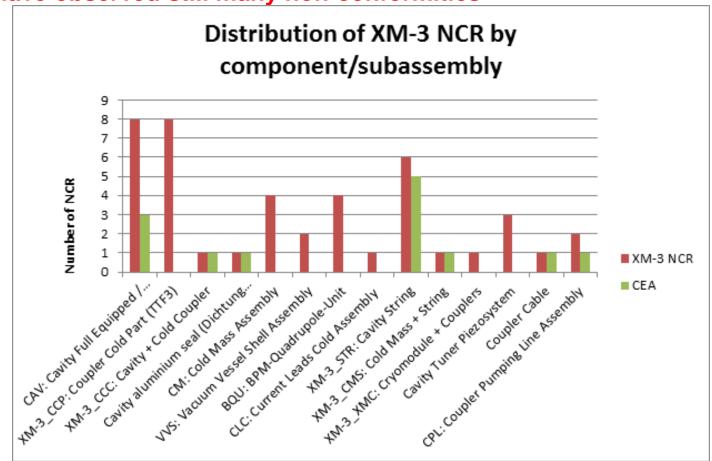
We have observed still many non-conformities

In total **43 Non-Conformance Reports** (NCR) were issued for XM-3, some global, about 13 NCR under the responsibility of CEA: one main reason for 7 months assembly.

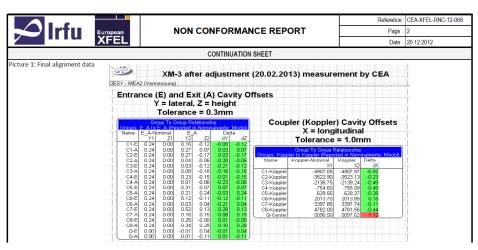
The Cavity Alignment Procedure had to be repeated 4 times, essentially due to mishandling by CEA and a technical problem on the needle bearings fixtures:

→ 1 month, instead of 3 days

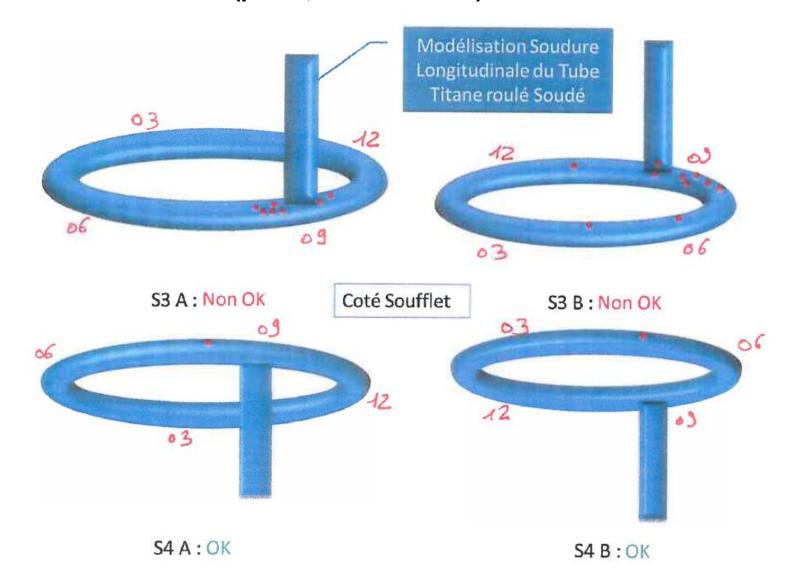
Welding Issue n°4

4 - Non-conform Welds (pores, or blow-holes) on XM-1

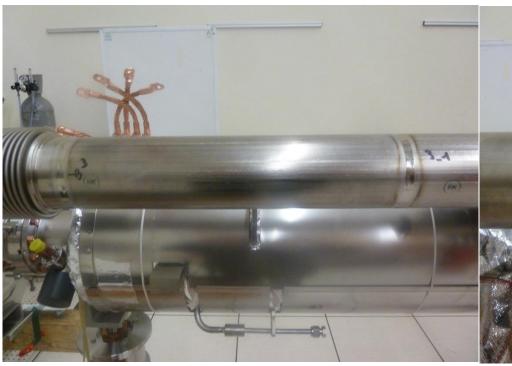
Reworking S3, S4 and S5 welds

Under the asumption that better procedures could be applied at Saclay, the decision was made to rework all the Titanium welds on 16-17 October by DESY welders: in practice only four welds could be reworked.

S3 and S3-1 are conform, no defect.

S4-1 and S5 are not conform, pores again!

- The project worked out some improvements of the procedures and tools. CEA will check purity of gas and presence of oxygen in the welding arm.
- A new welding and X-Ray campaign is planned next week, W47
