High pressure rinsing stand at DESY

HPR at DESY

actions on the system since installation

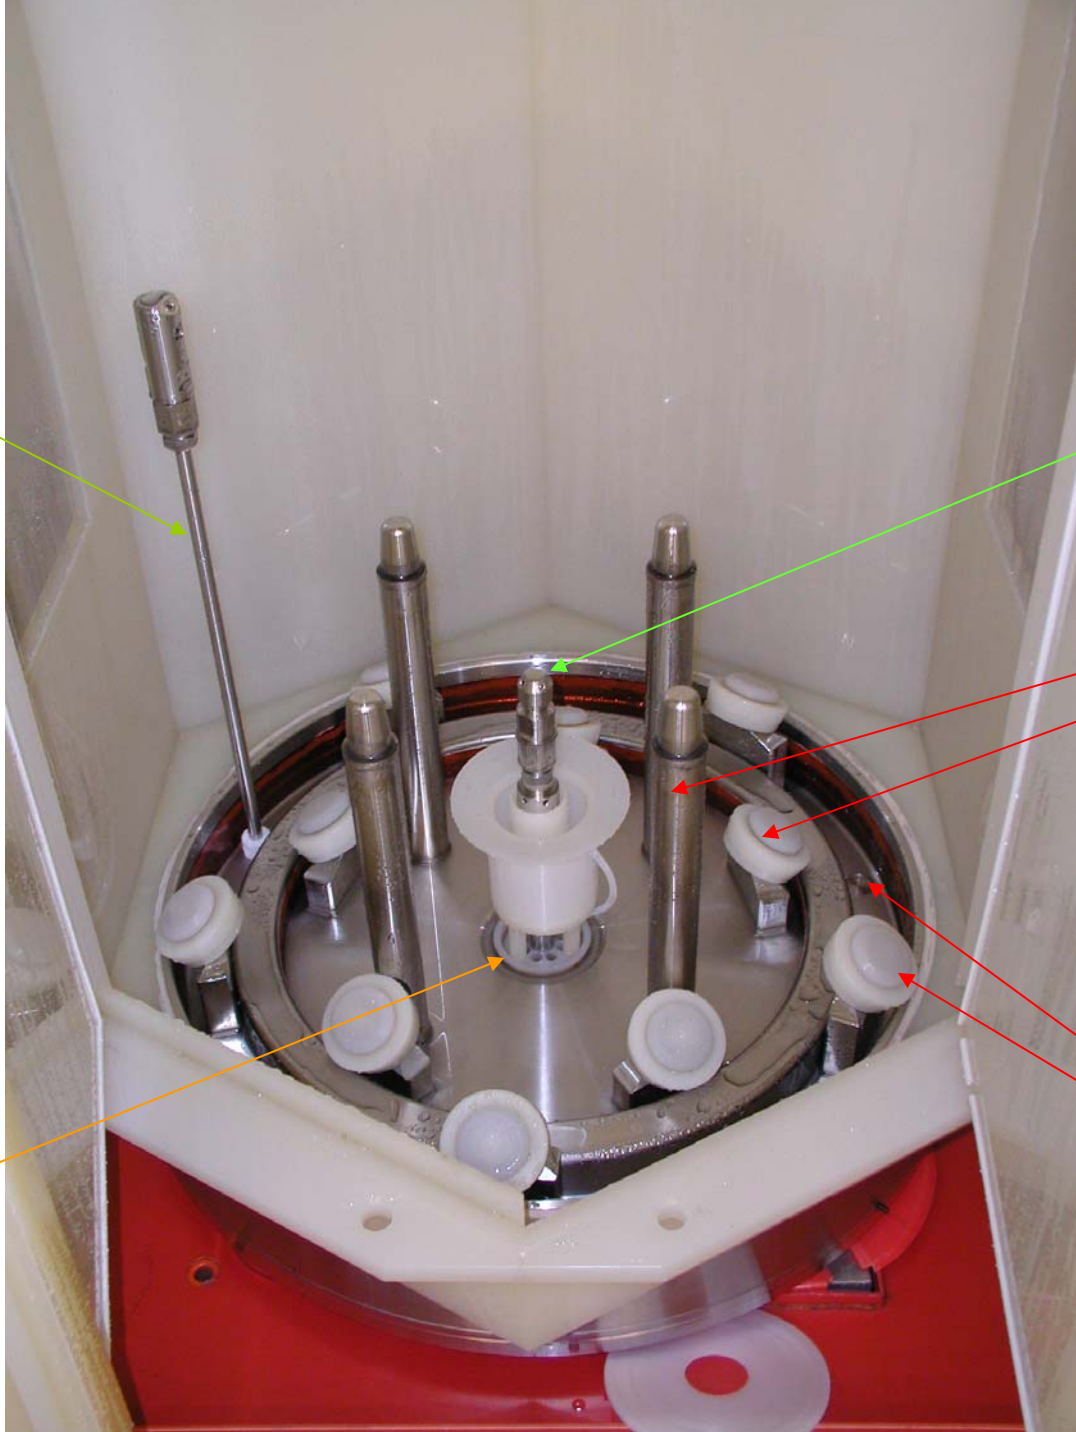
- **Bearings of cavity table and housing rusty**
(exchanged to stainless with sealed greasing area)
- **Housing ventilation installed** (measurements showed calls 10000 inside)
- **Chain and chain wheel Not lubricated** (particulates / renewing)

- **Rotational bearing Platform to cane crashed** (badly lubricated by water)
- Residues from PTFE / guidance on inner cane
- Sealing ring abrasive (particles on cane)

Cane outside
rinse

Cane inside
rinse

Cavity drive unit

Baring and
guidance for
cane

Housing drive unit

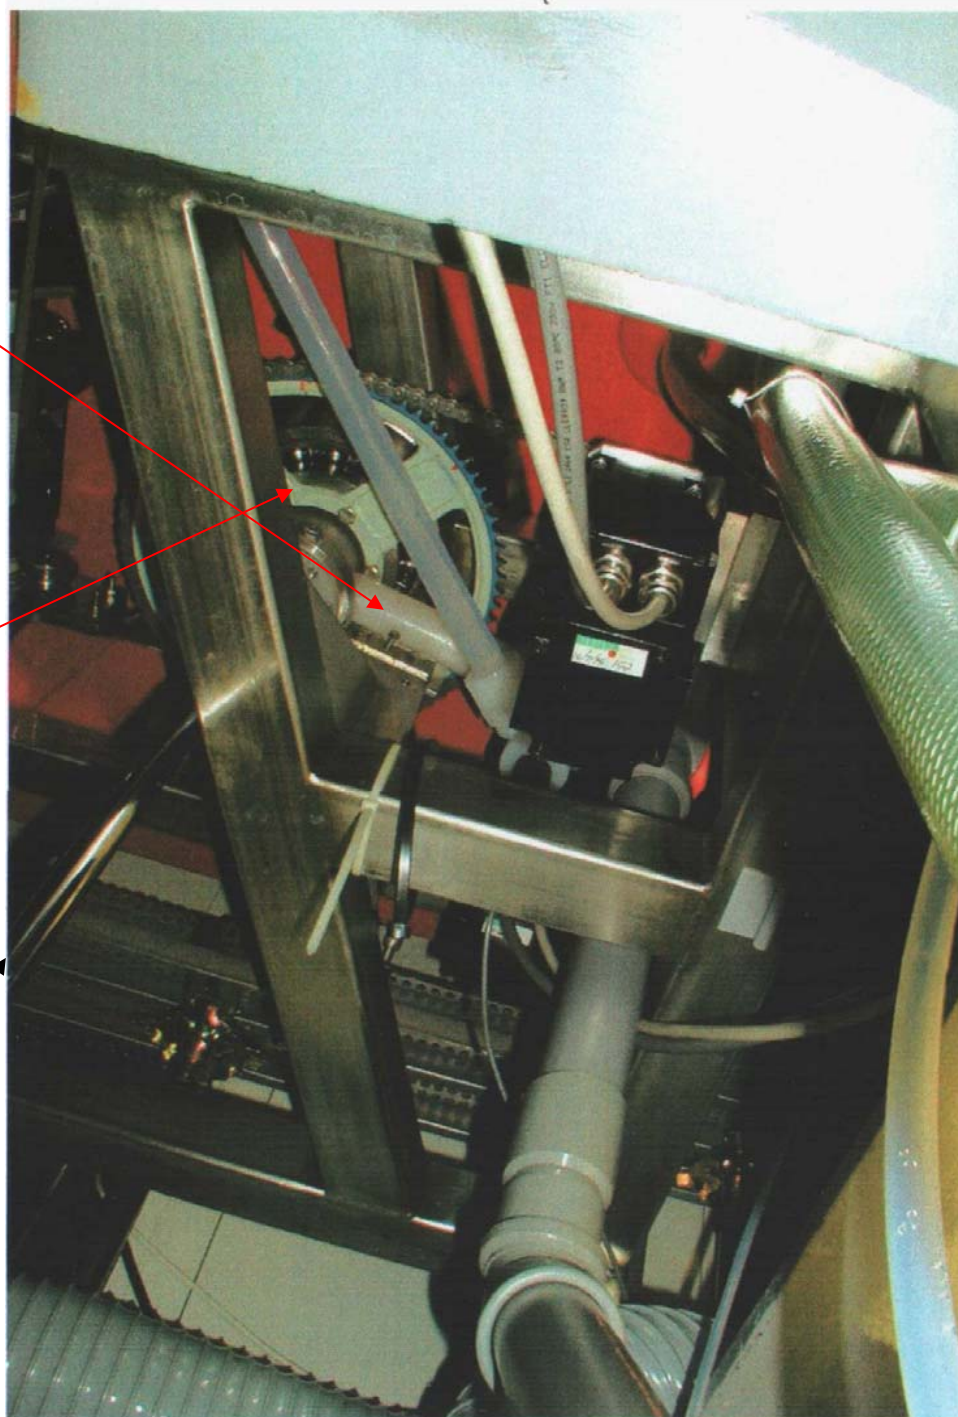
Drain and bearing unit

Drive for cavity platform

cane

- **Rotational bearing Platform to cane crashed** (badly lubricated by water)
- Residues from PTFE / guidance on inner cane
- Sealing ring abrasive (particles on cane)

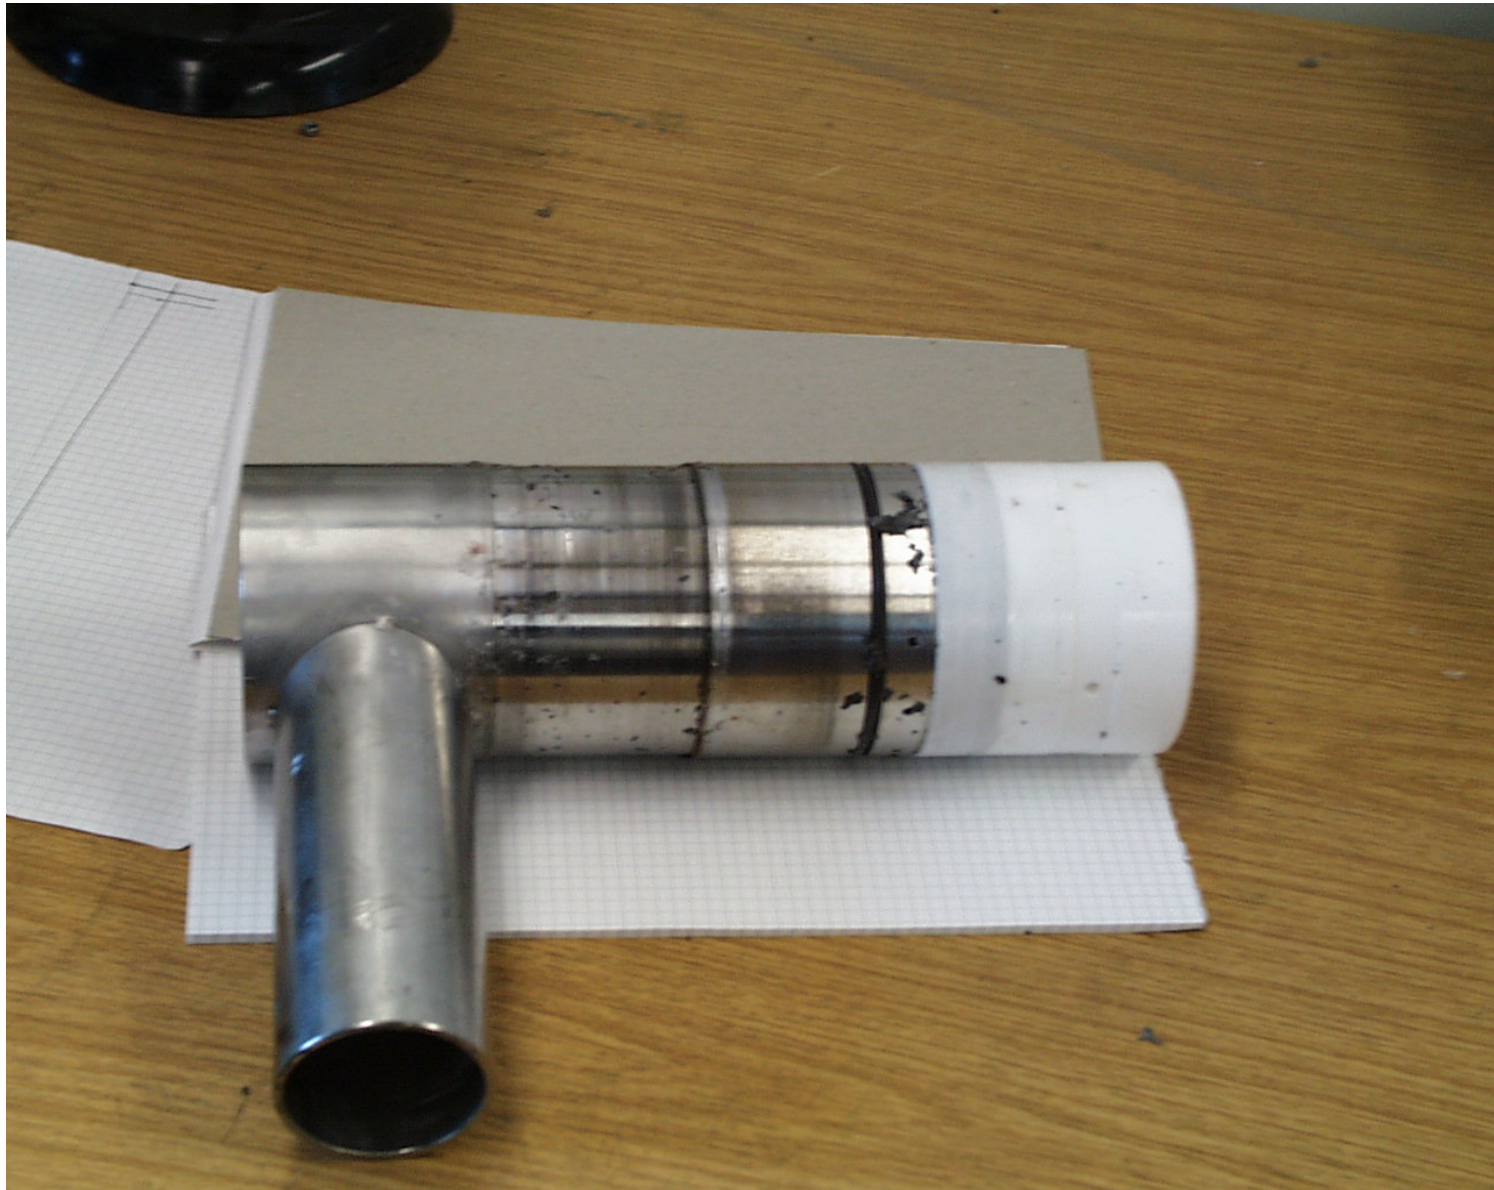
Main design draw back

- Cane rests in gray room interior (moves into cavity)
- Moving cane need seal (platform for filters; valve; mechanics and sensors in water)
- Bearing for cane and cavity table movement combined
- N2 filter unit installation filter lowest point in tube
- Water lines can not be drained Draining of tubing (inner cane has standing water
- Rust in 100 bar line elements / non lubricated parts cracked during disassembly
- Excess for maintenance
 - change cane seal means complete dismounting of rinsing unit!!
 - Rinsing for weeks to clean)
- insertion of cavity (abrasives form post and frame)
- Airflow inside HPR cabinet
- Alignment of cane (bottom platform underground cane top in class 10)

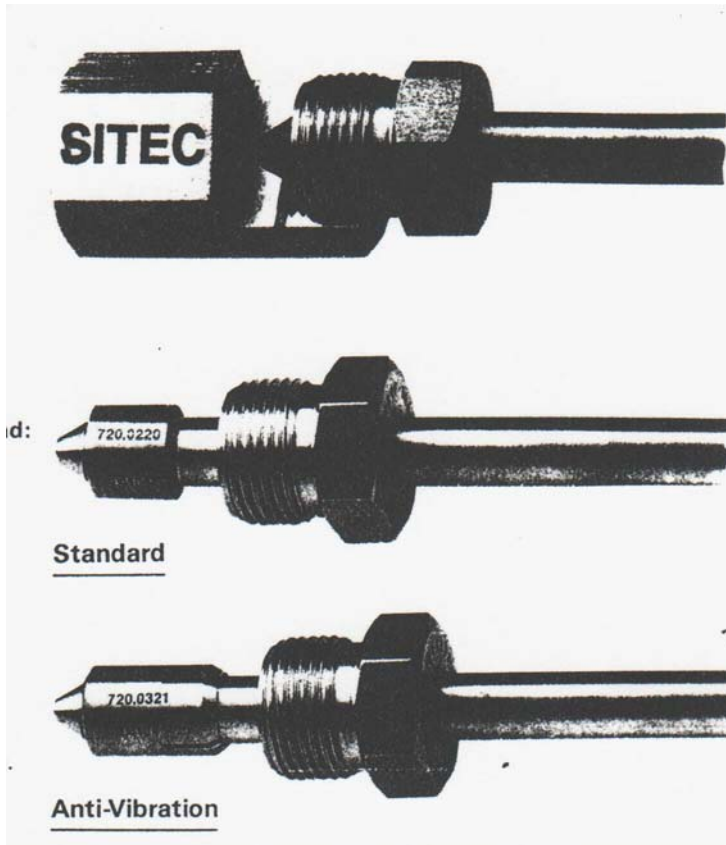
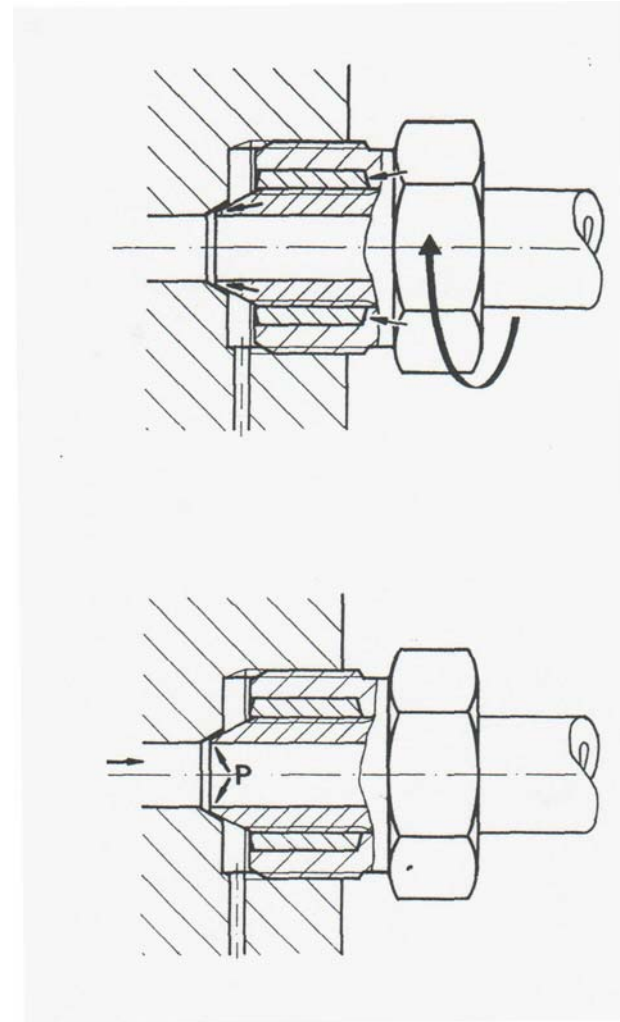
- Minimum death volume
- Cutting of cone on place
- Cutting of threads on place
- Alignment of elements critical
- Material combination stainless on stainless

General design problem.
