# Summary of understanding of quench limit in 9-cell cavities using T-mapping and optical inspection

LCWS10 & ILC10 @Beijing  
(28/Mar/2010)

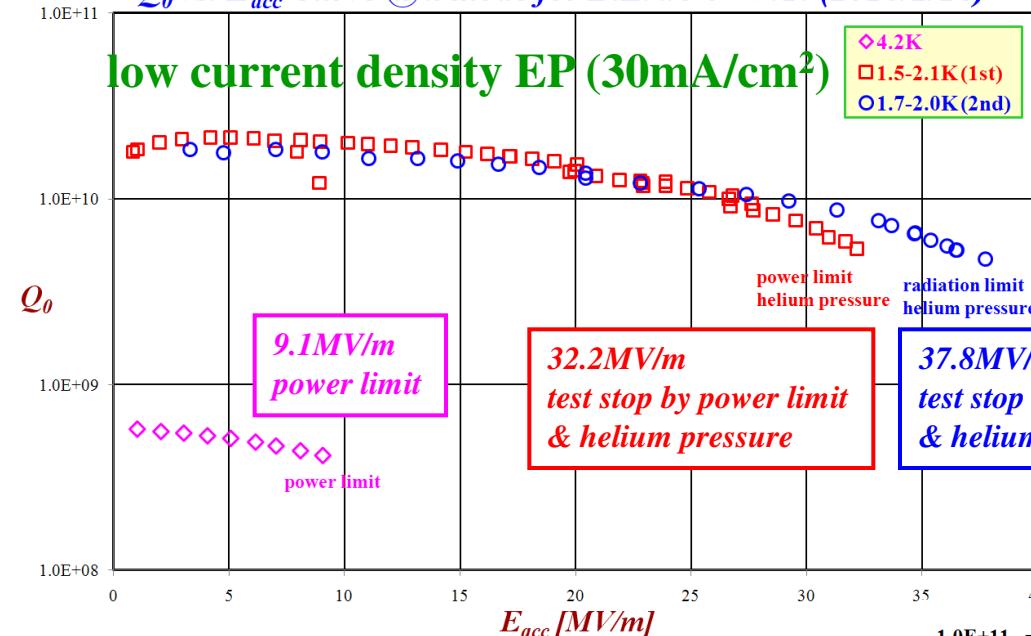
$Q_0$  vs.  $E_{acc}$  Curve @  $\pi$  mode for B.L. #8 4<sup>th</sup> V.T. (2010/2/18)

MHI#8 did not have any quench in pi-mode at 2K in 4<sup>th</sup> V.T.  
Limitation of RF test was the radiation level and helium pressure.

After the first V.T., local grinding was carried out and the pit at heating location was removed.  
After the second V.T., no grinding was done.

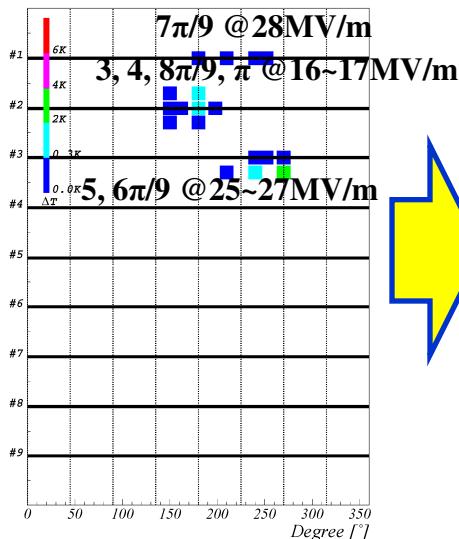
**1<sup>st</sup> V.T. @9/Jul/2009**

pre-EP : 5μm  
EP1 : 100μm  
EP2 : 20μm

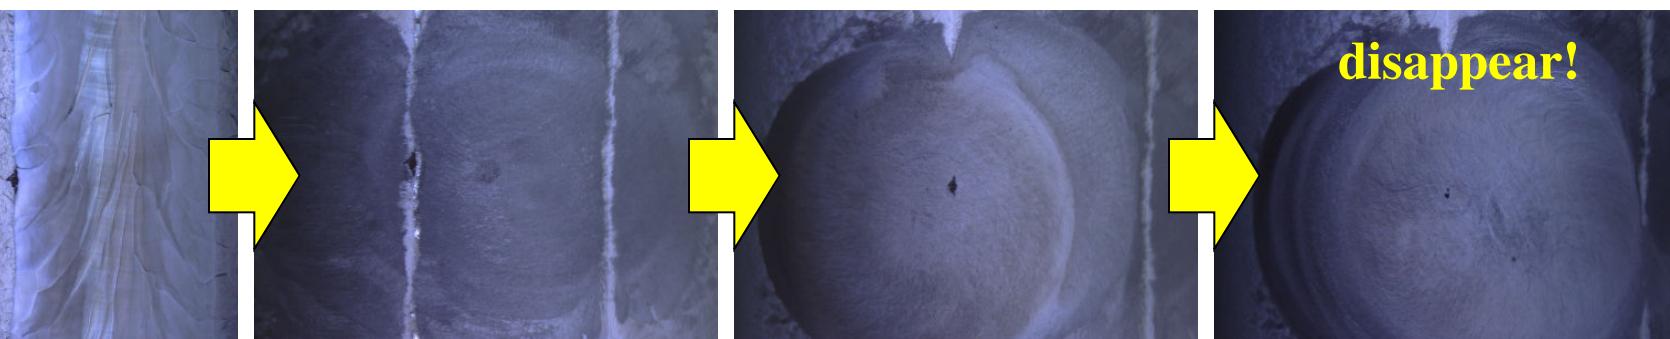
## cell #2, 172°@16.0MV/m (triangle pit)

disappear!

Local grinding was performed to remove it!  
(Ken will talk about it in detail.)

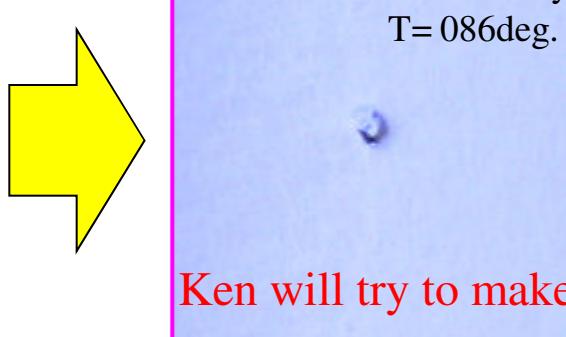
## cell #2, 86°@26.8MV/m (ellipse bump)

After 2<sup>nd</sup> V.T. 195 um removed

MHI-08, 2-cell equator, Outside weld area  
40mm away from joint point at equator  
T= 086deg. Upstream

2 mm x 2 mm

After 4<sup>th</sup> V.T. 235 um removed  
MHI-08, 2-cell equator, Outside weld area  
40mm away from joint point at equator  
T= 086deg. Upstream

Ken will try to make the replica of this bump!

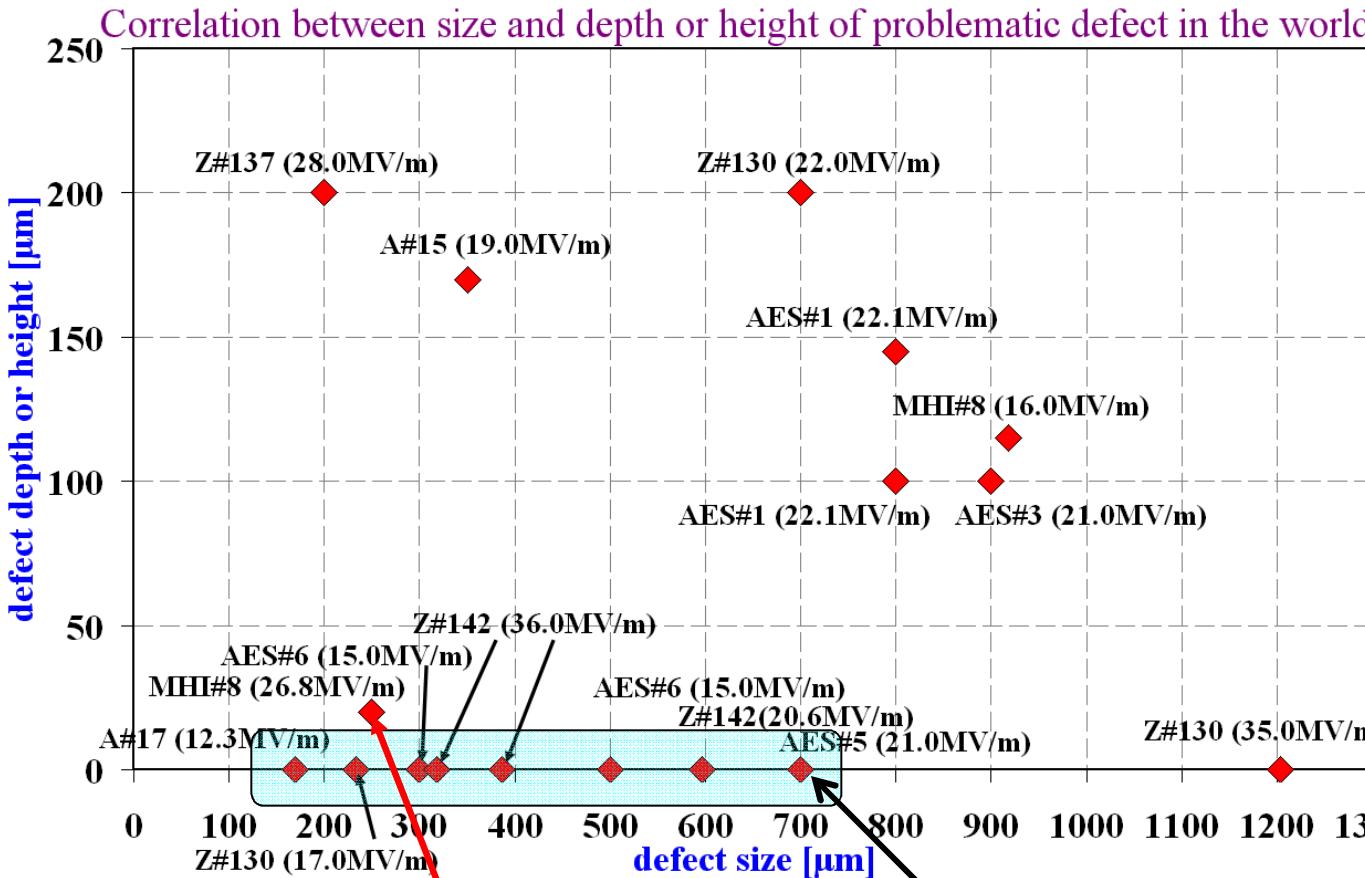
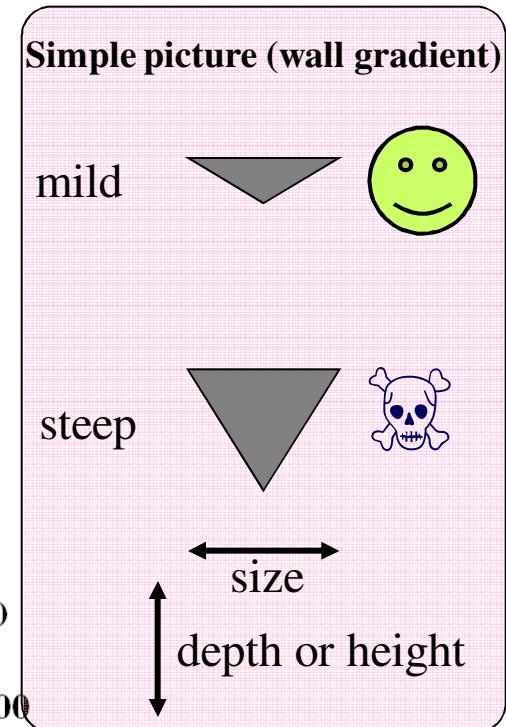
This graph shows the correlation between the size and the depth or height of problematic defects.

The profiles of these defects are unknown, and they should be observed clearly!

rare case?

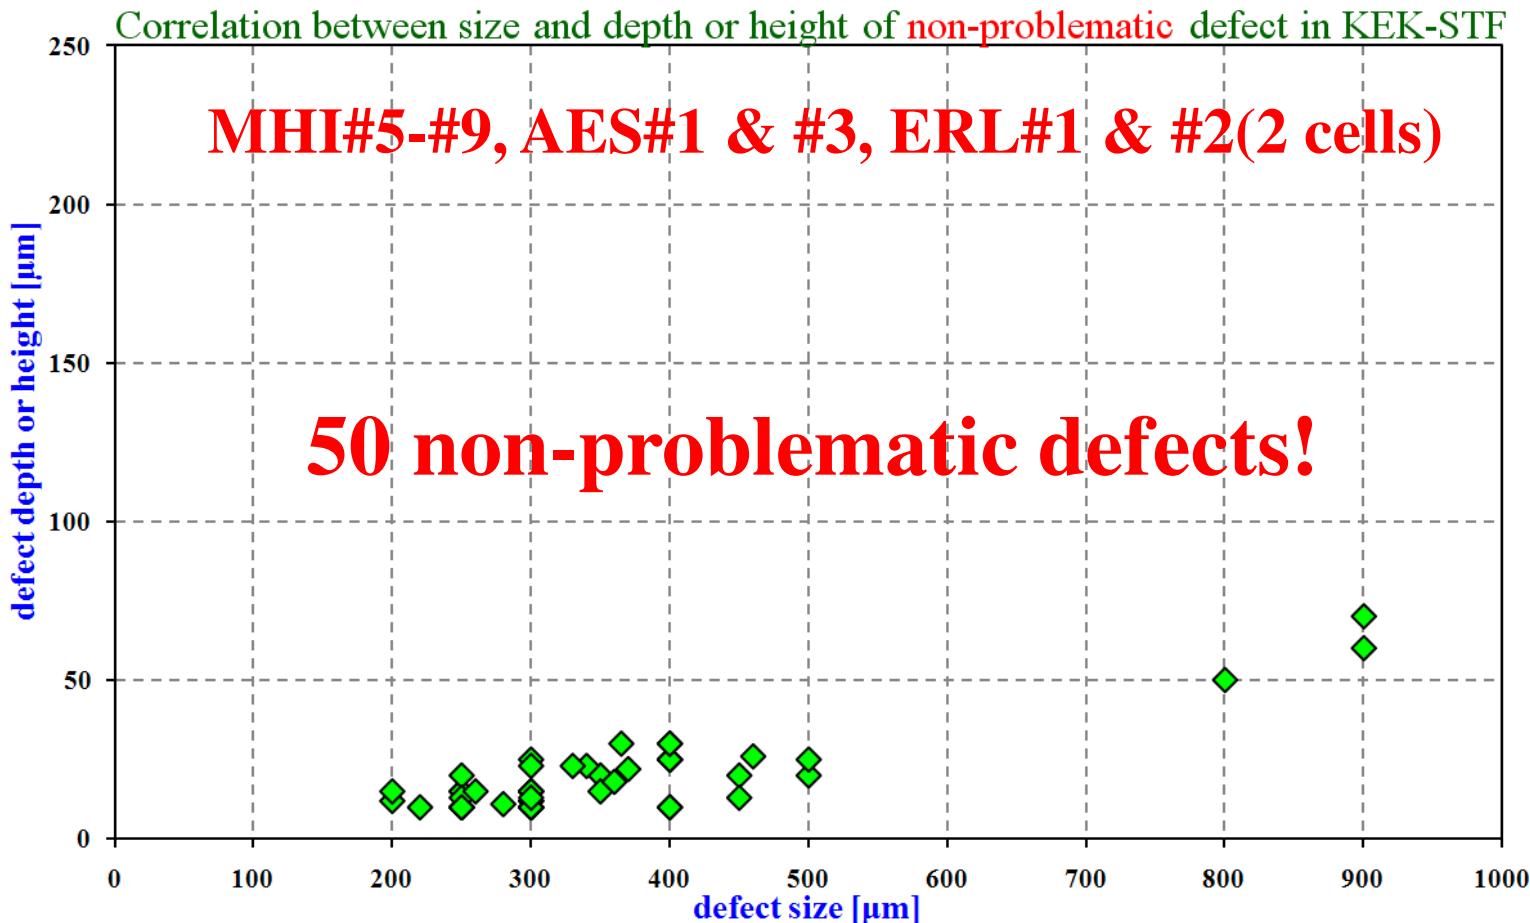
This graph shows the correlation between the size and the depth or height of non-problematic defects.

Generally, a smaller-size-and-depth defect is not problematic for heating.  
And, this is the common case for a defect in STF (at least)!

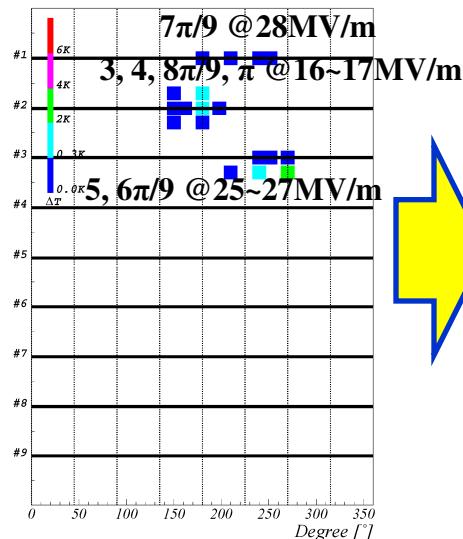
**1<sup>st</sup> V.T. @9/Jul/2009**

cell #2, 172°

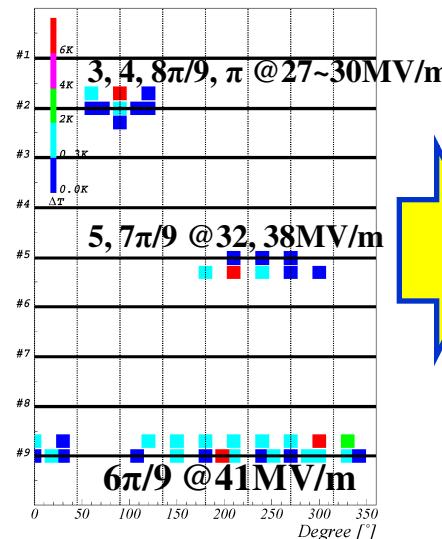
**2<sup>nd</sup> V.T. @29/Oct/2009**

cell #2, 86°
