Recent Surface Studies in KEK-STF

KEK, Tsukuba, Ibaraki, Japan

Studies on Nb surface contaminations in BCP, EP process

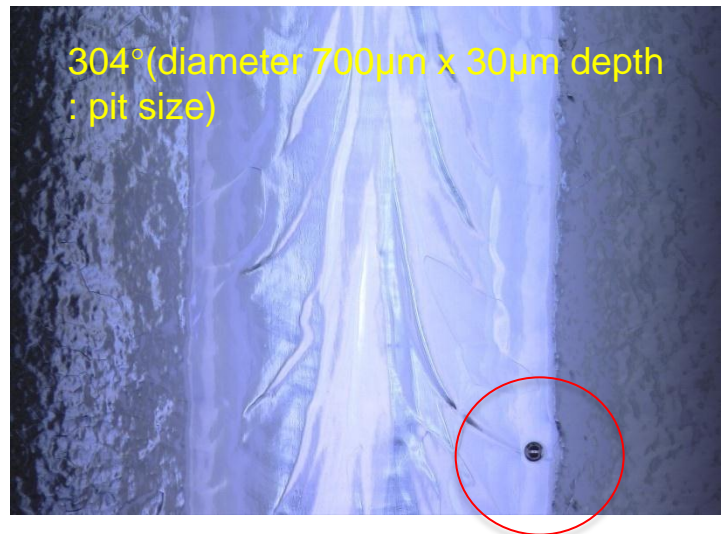
after 2nd V.T.

Local grinding example on cell#1

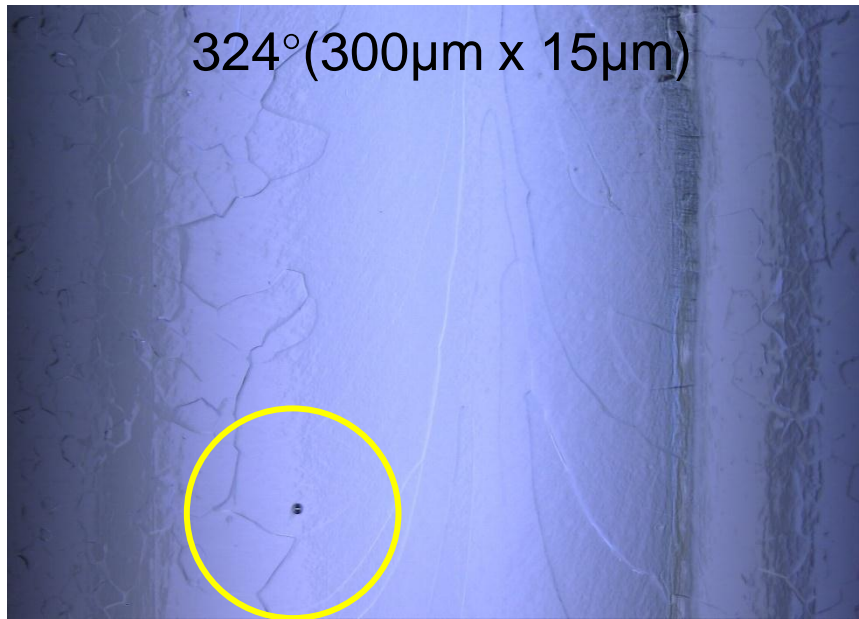
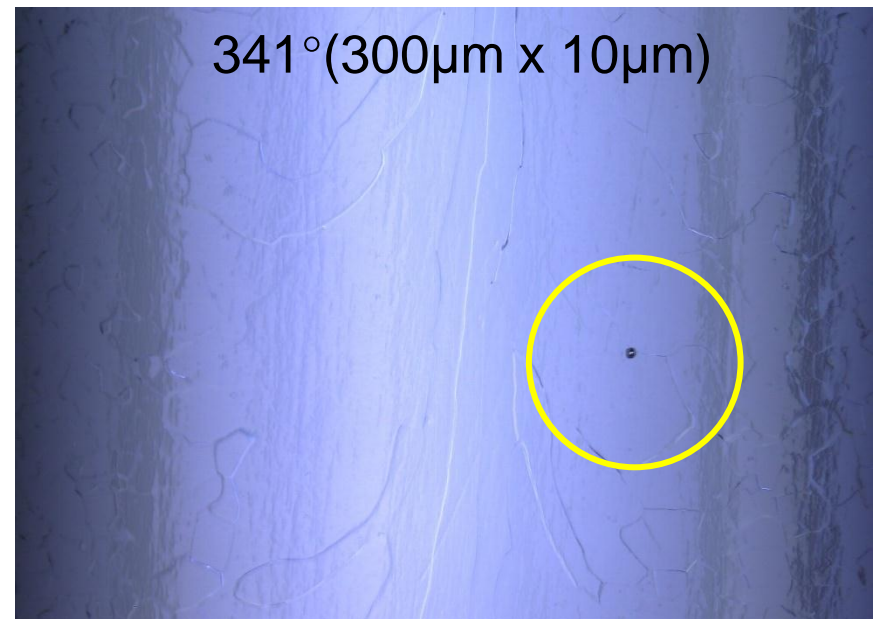
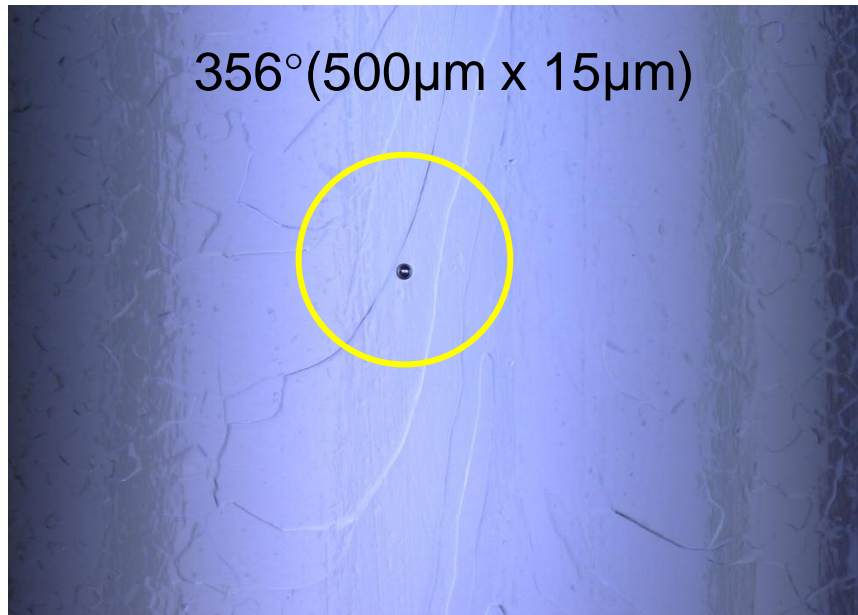
MHI-010

After local grinding and 100 μ m EP, new pits were appeared!

1st VT 23.8MV/m @ Q0=1.1E10 May 20,2010
2nd VT 25.7MV/m @Q0=8.1E9 June 17,2010

3rd VT 20MV/m @ Q0=1.1E10 Sep 02,2010

local grinding and 100 μ m EP

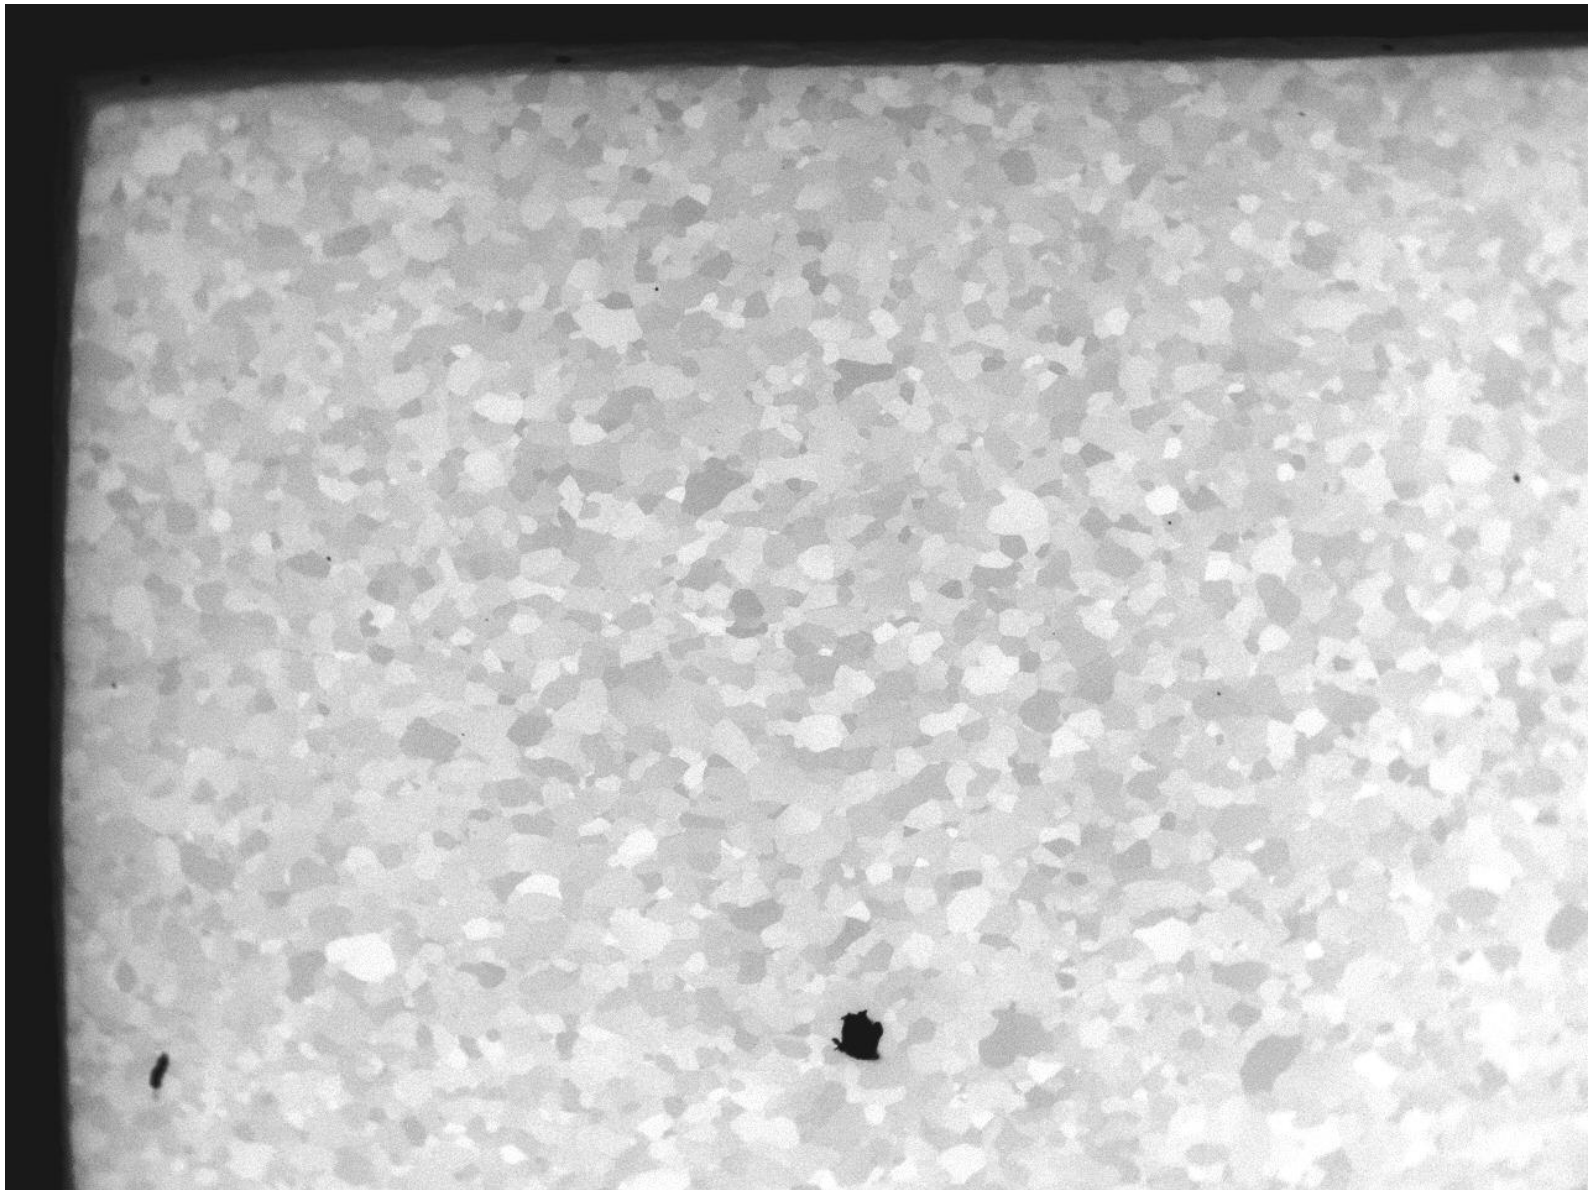
Found contamination on BCP treated Nb surface

Contamination appeared different place in every BCP treatment

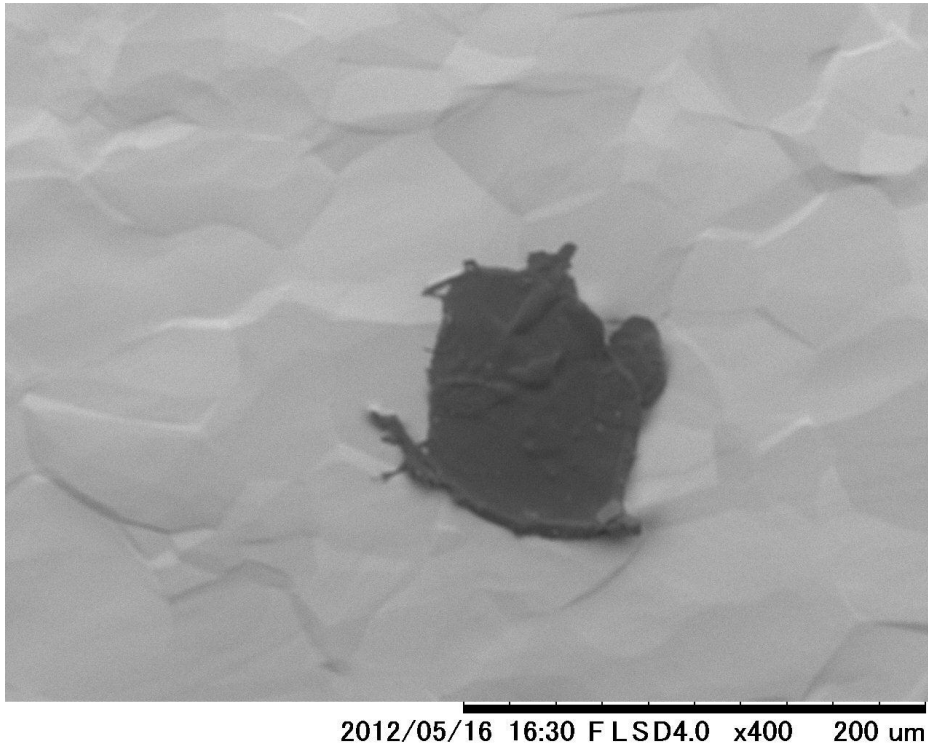
Found contamination on BCP treated Nb surface

SEM image
(black)

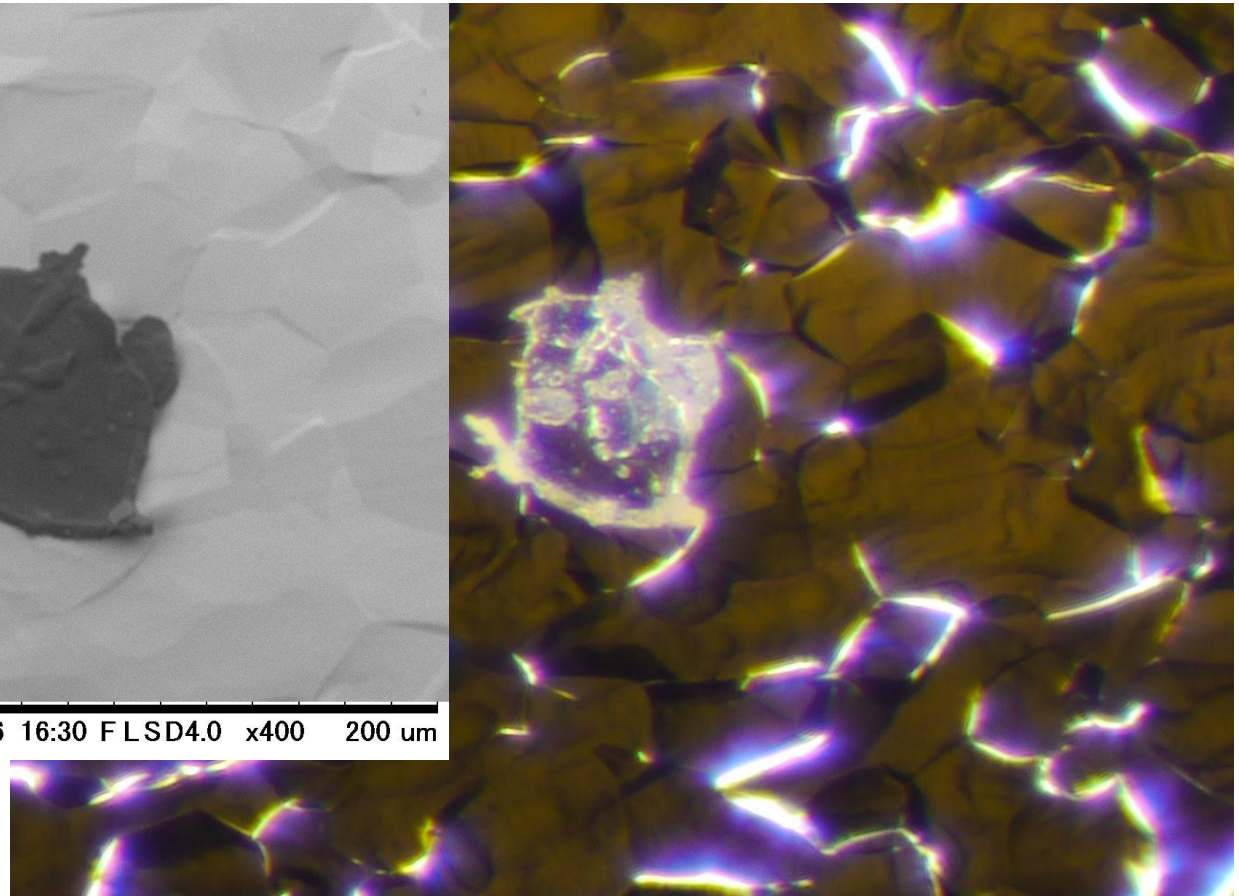
Optical Microscope image
(shiny)

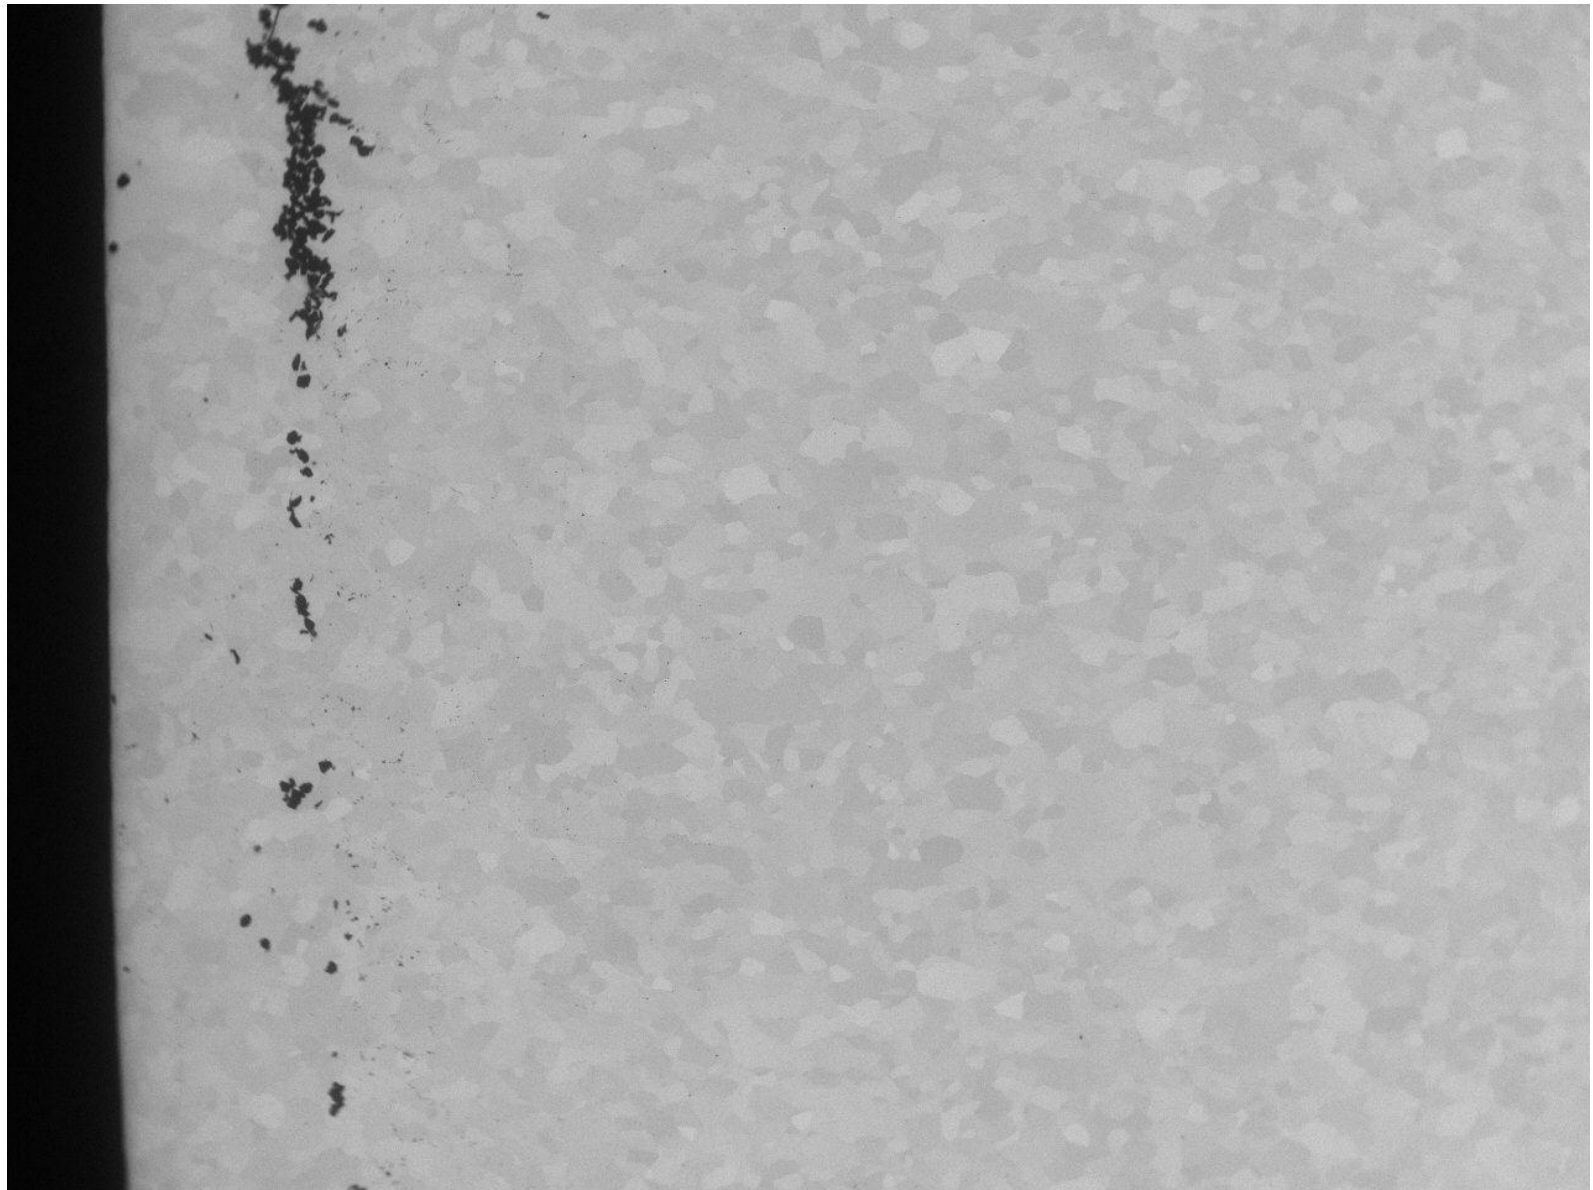
Found contamination on BCP treated Nb surface

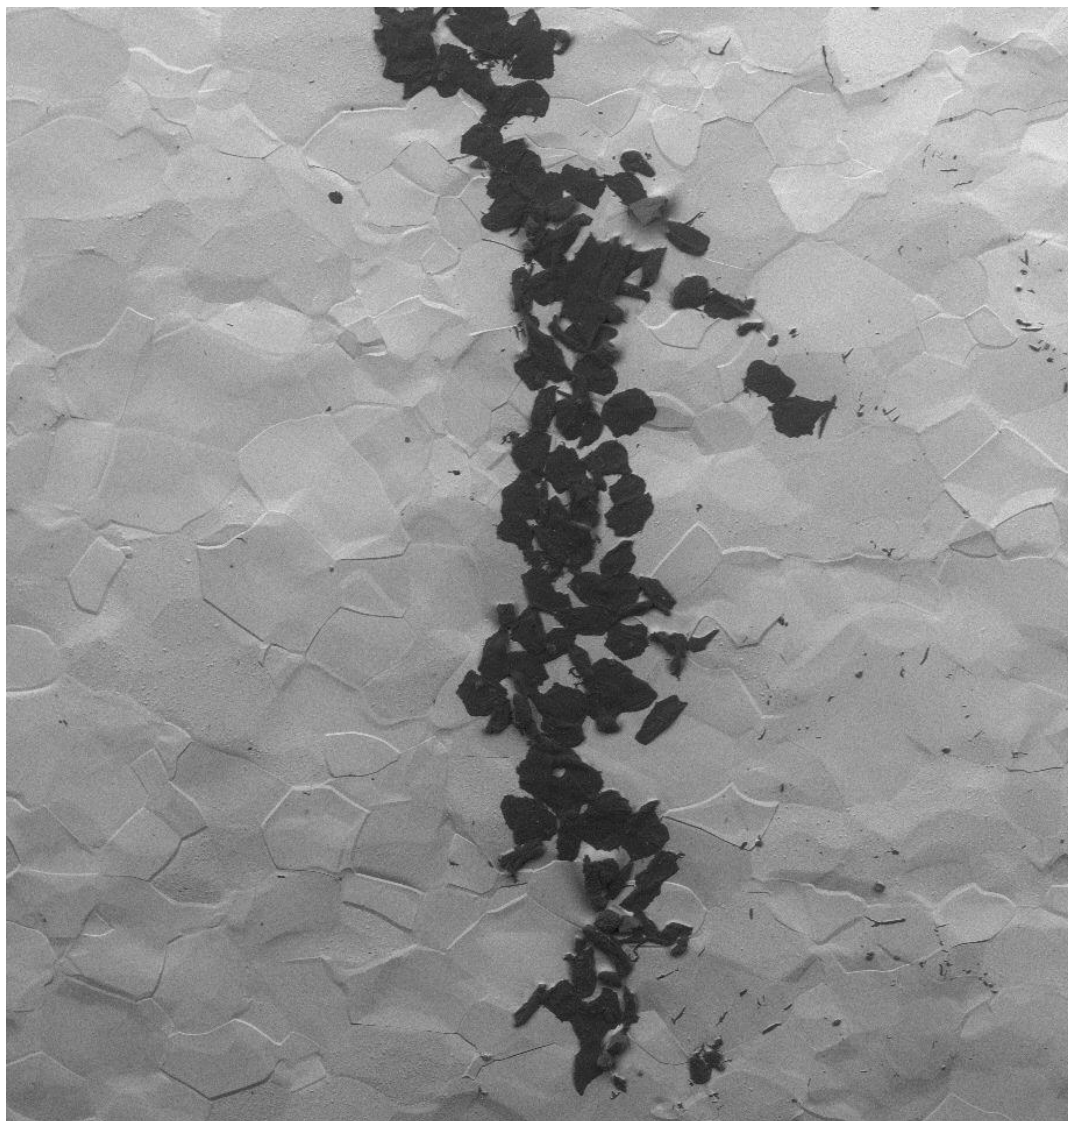
Found contamination on BCP treated Nb surface

SEM image

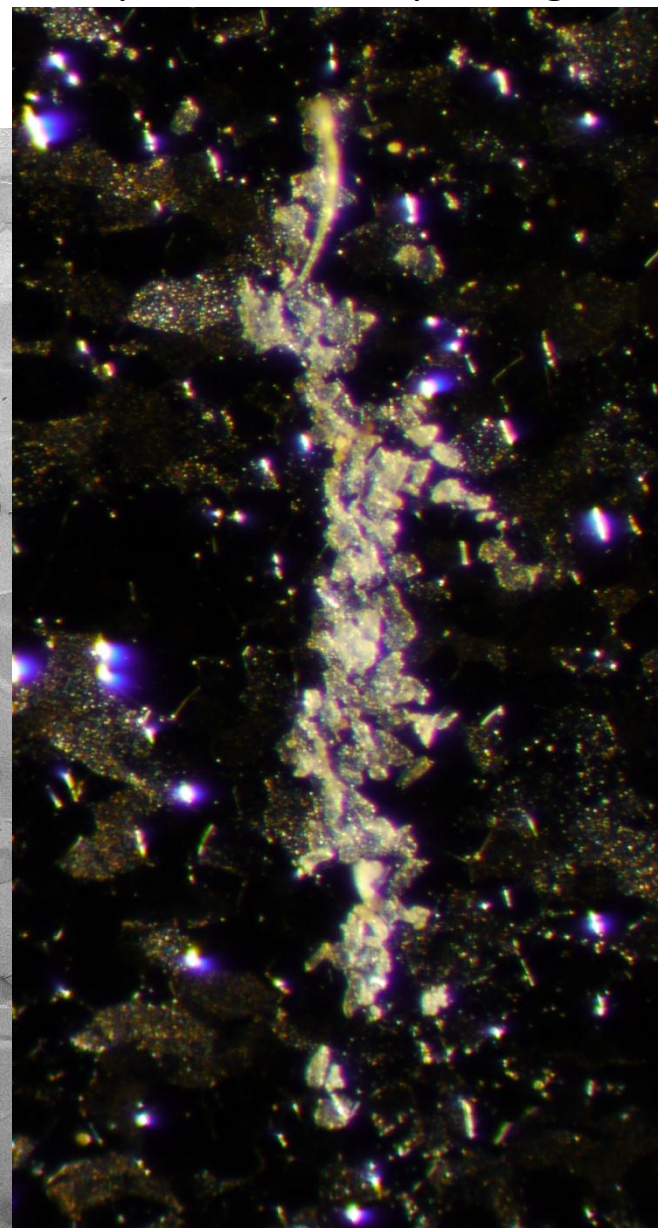
Optical Microscope image

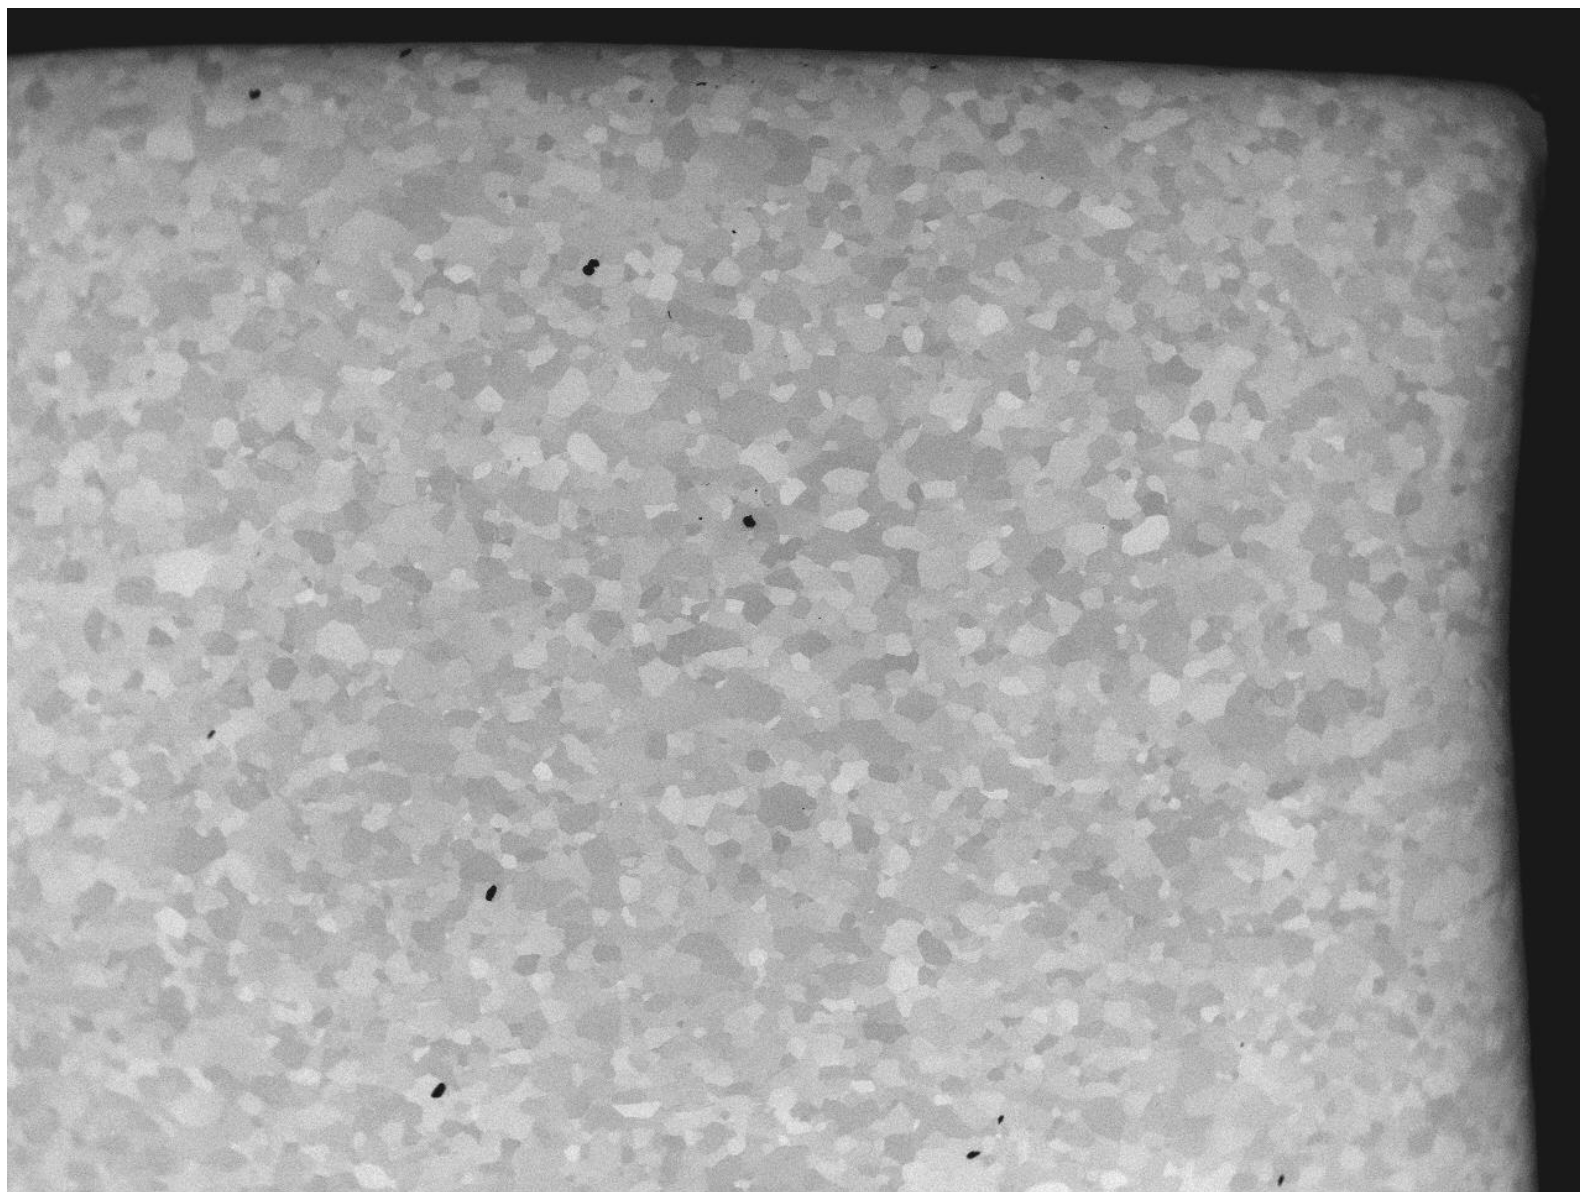
Found contamination on BCP treated Nb surface

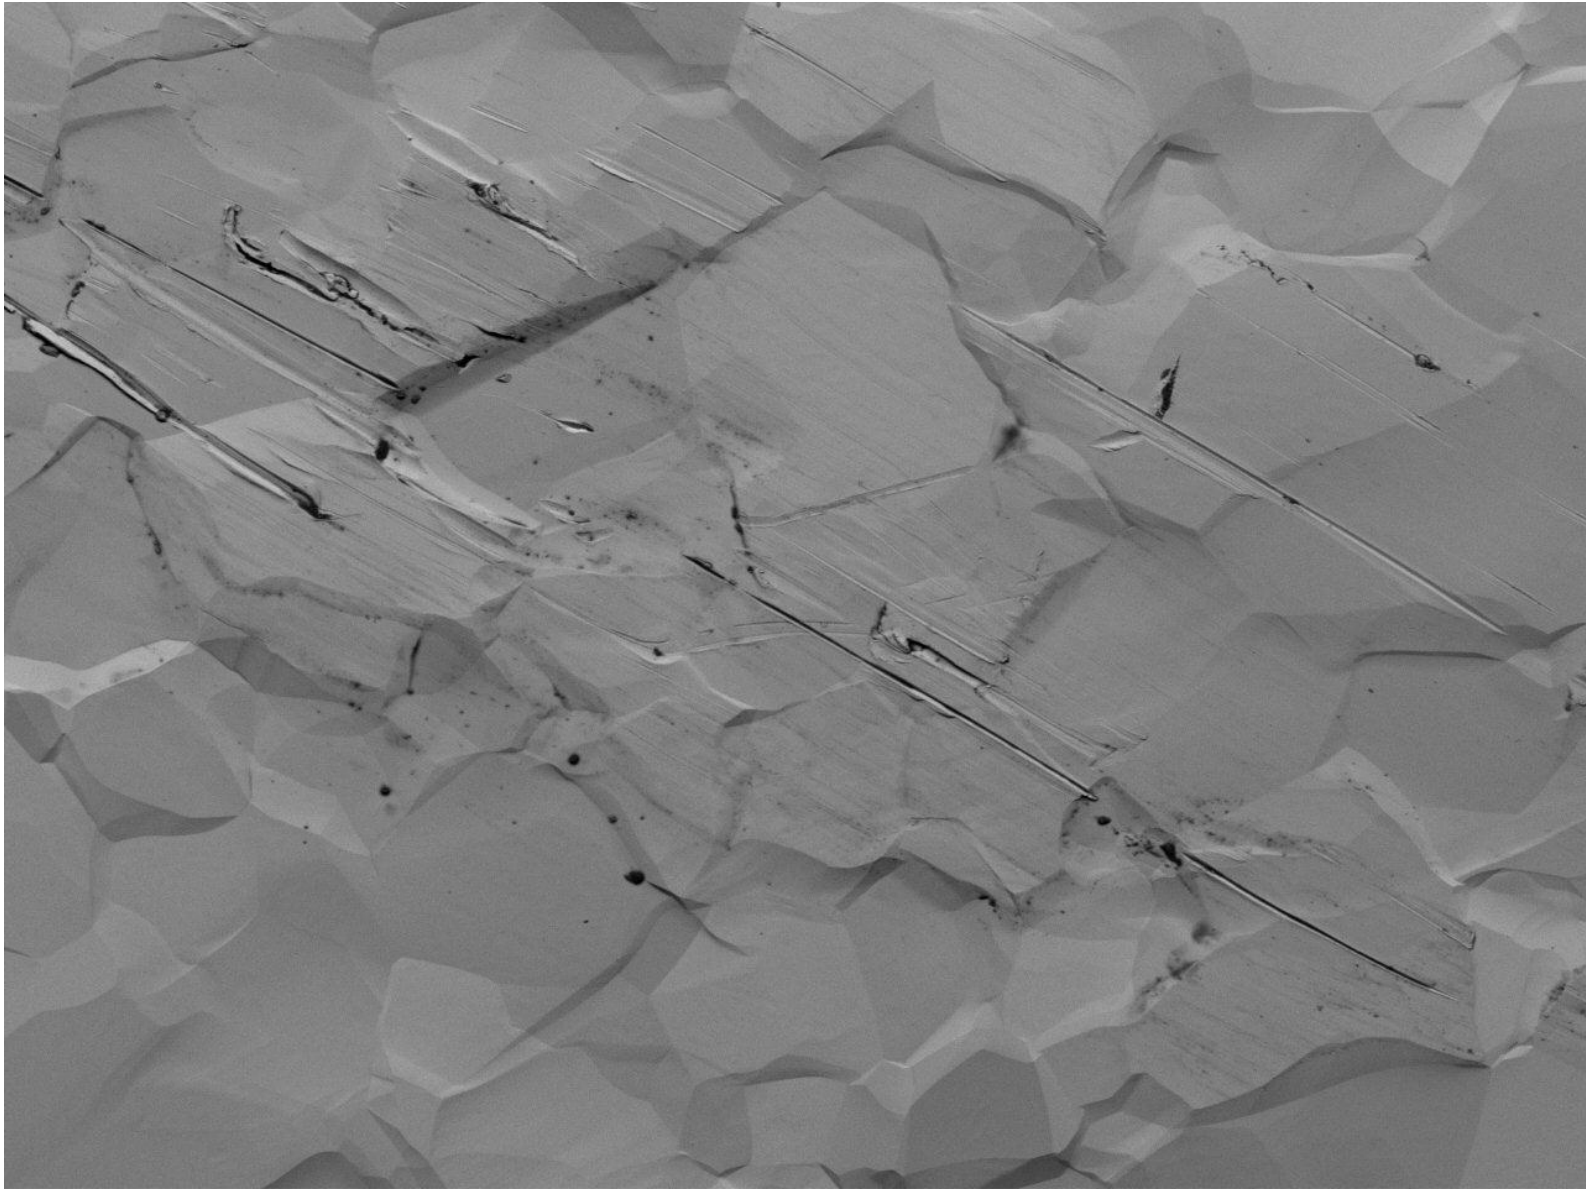
Found contamination on BCP treated Nb surface (easy to find on scratched place)

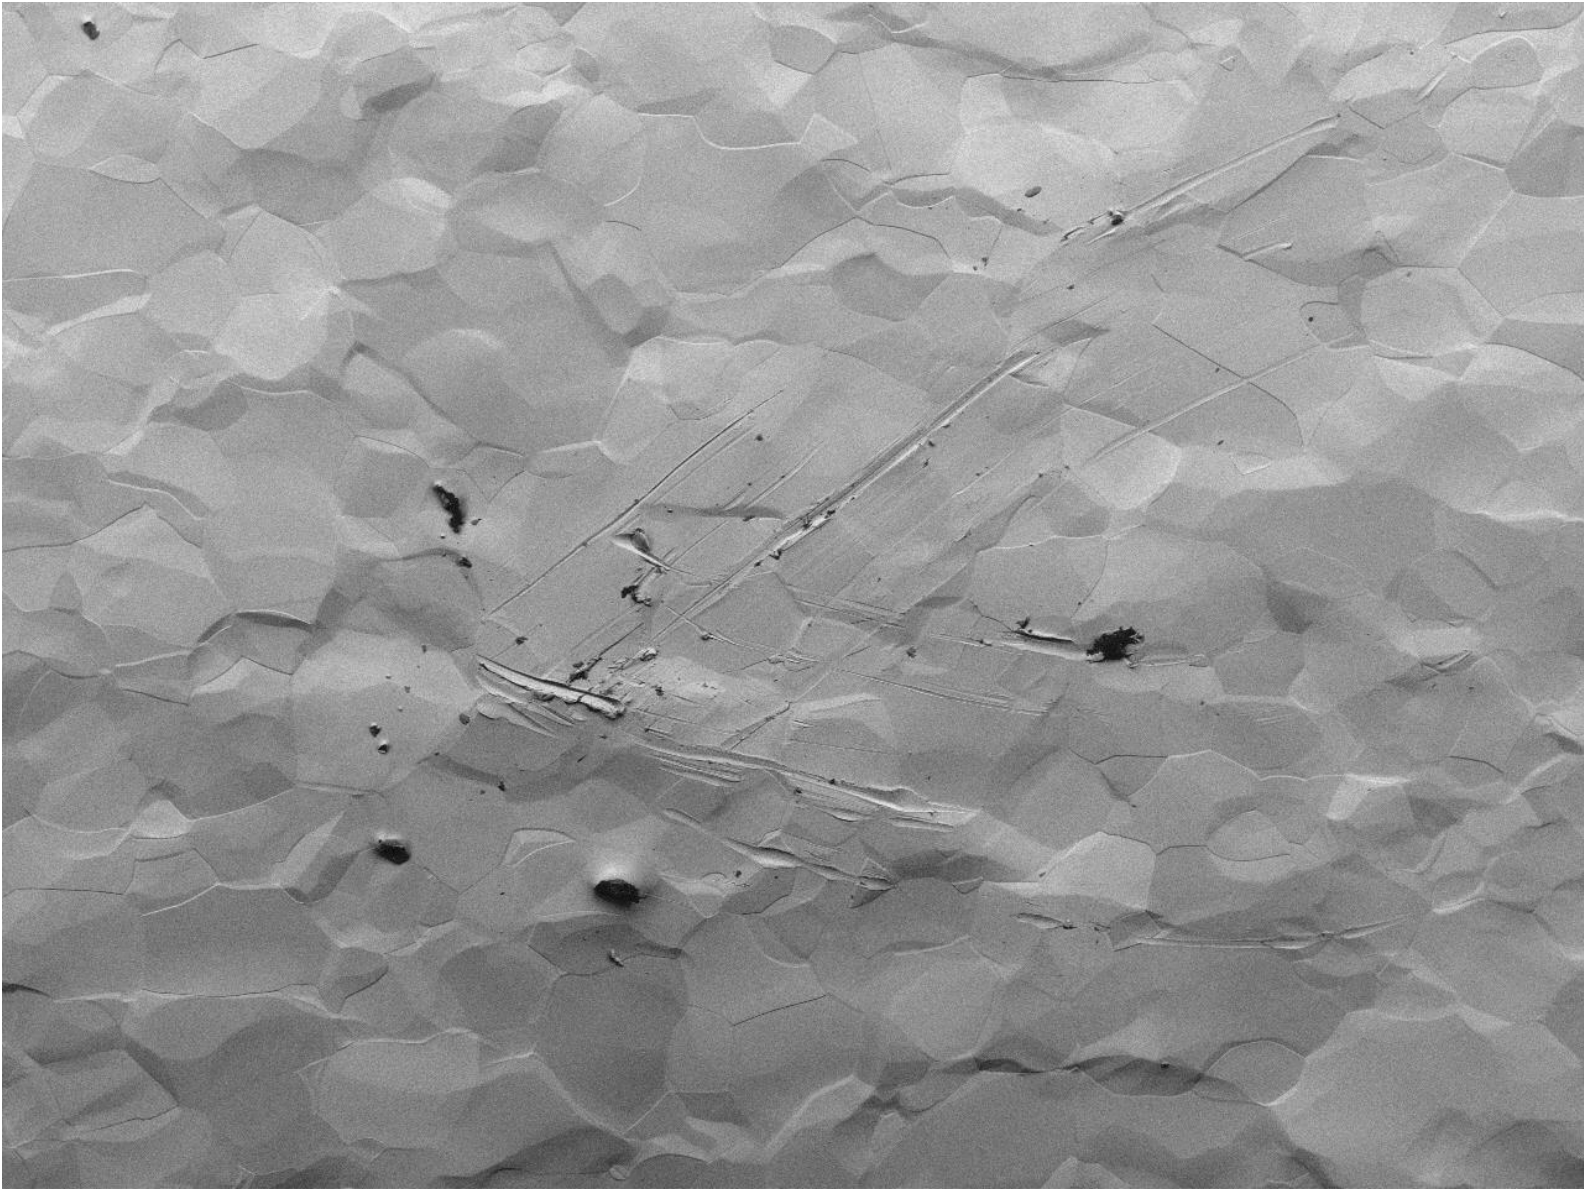
Found contamination on BCP treated Nb surface (easy to find on scratched place)

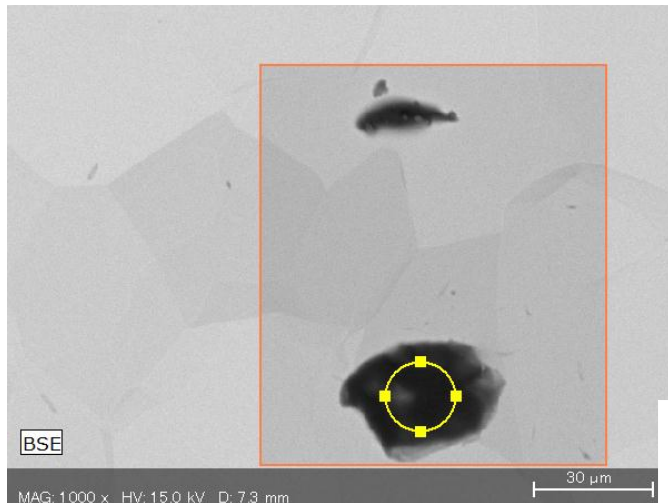
SEM image of the contamination

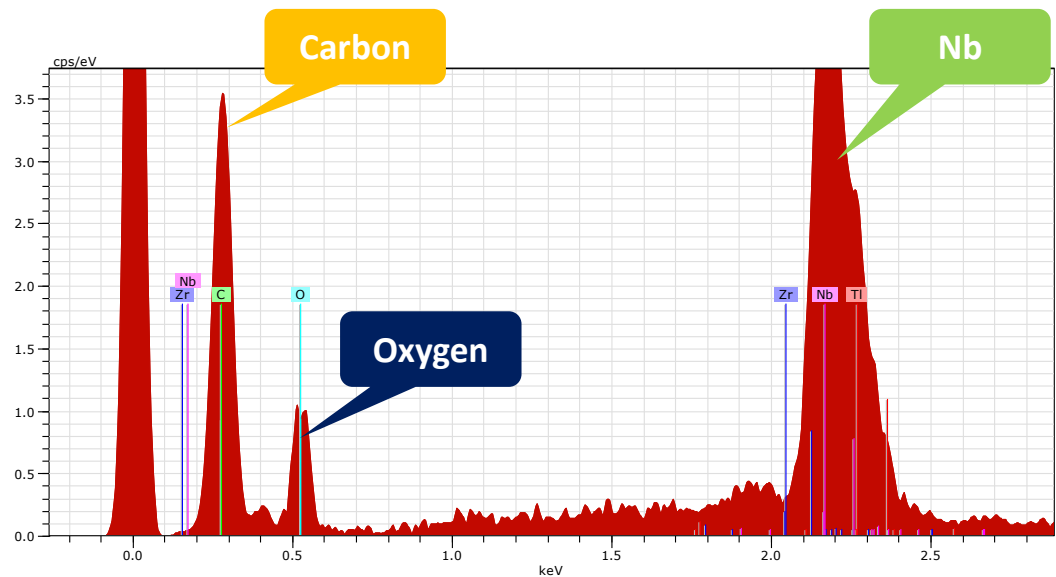
It's Carbon with oxygen!

EDX spectrum of the contamination

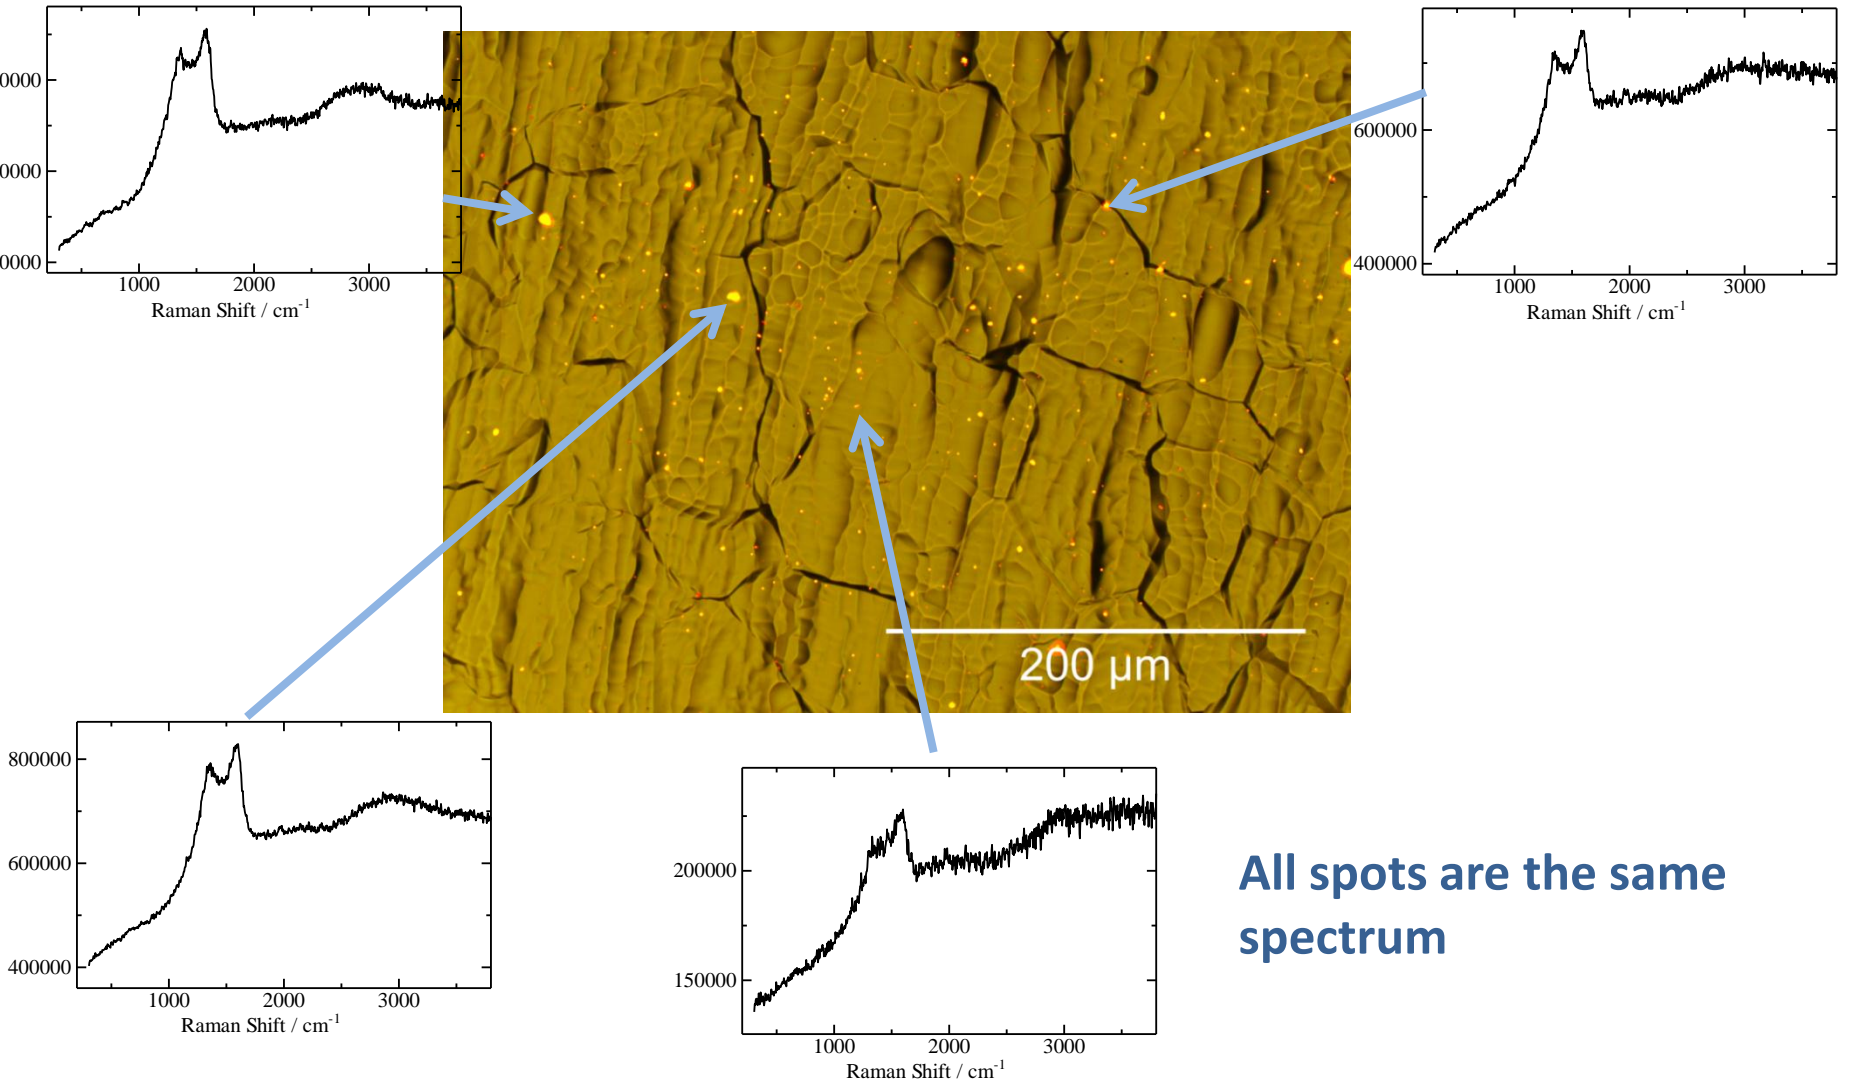
Raman image superimposed on SEM image of BCP Nb surface

Observed Raman spectrum of bright spots

All spots are the same spectrum

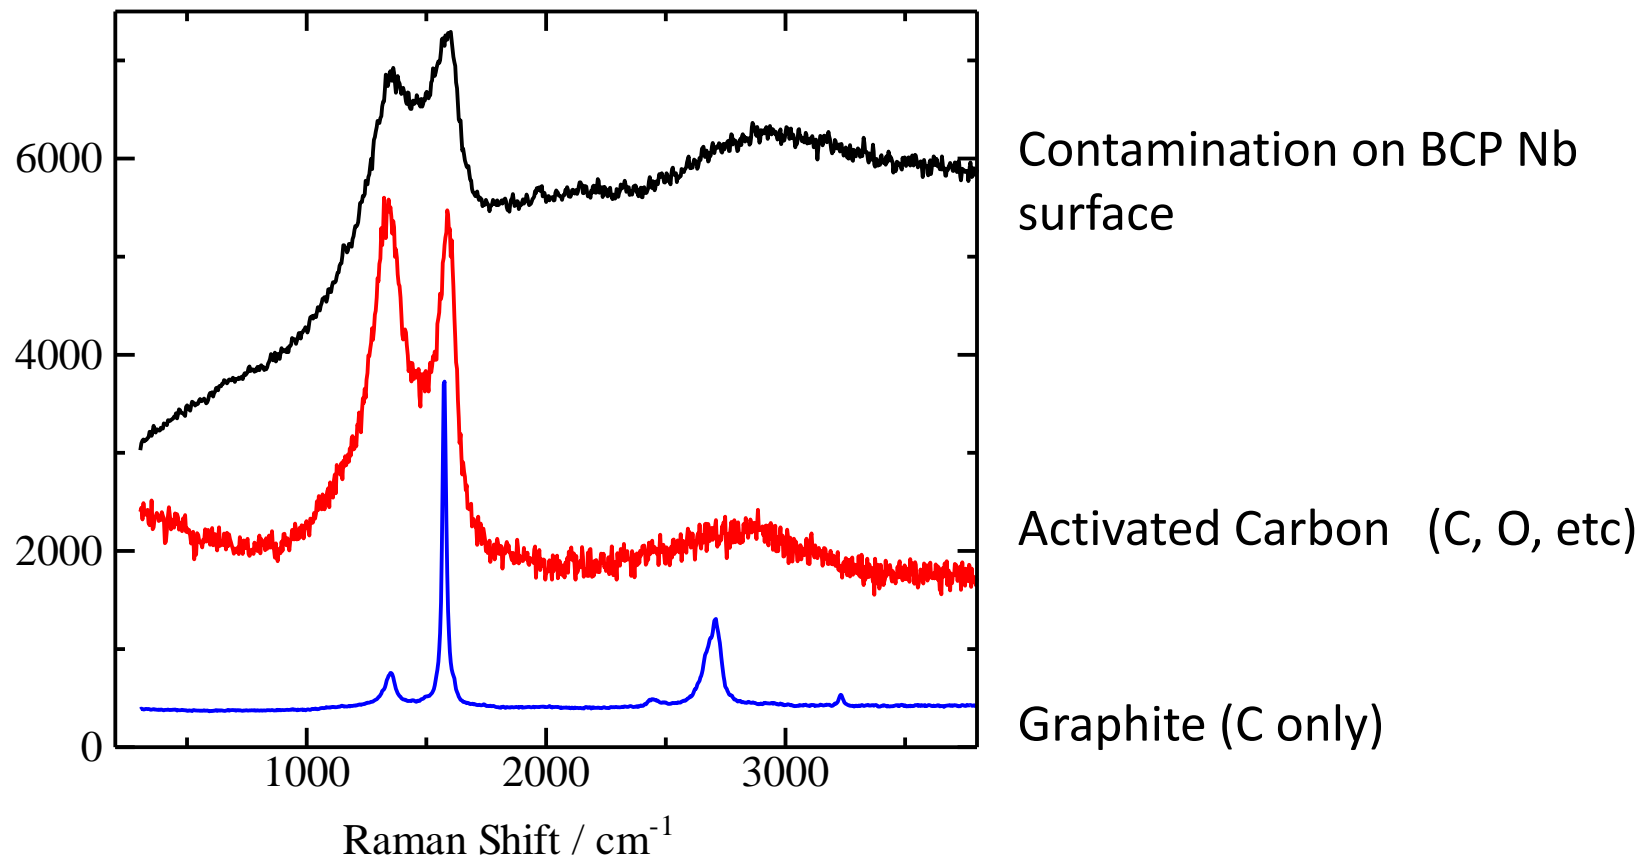
Comparison of Raman spectrum with Carbon

The contamination on BCP Nb surface is similar to activated Carbon!

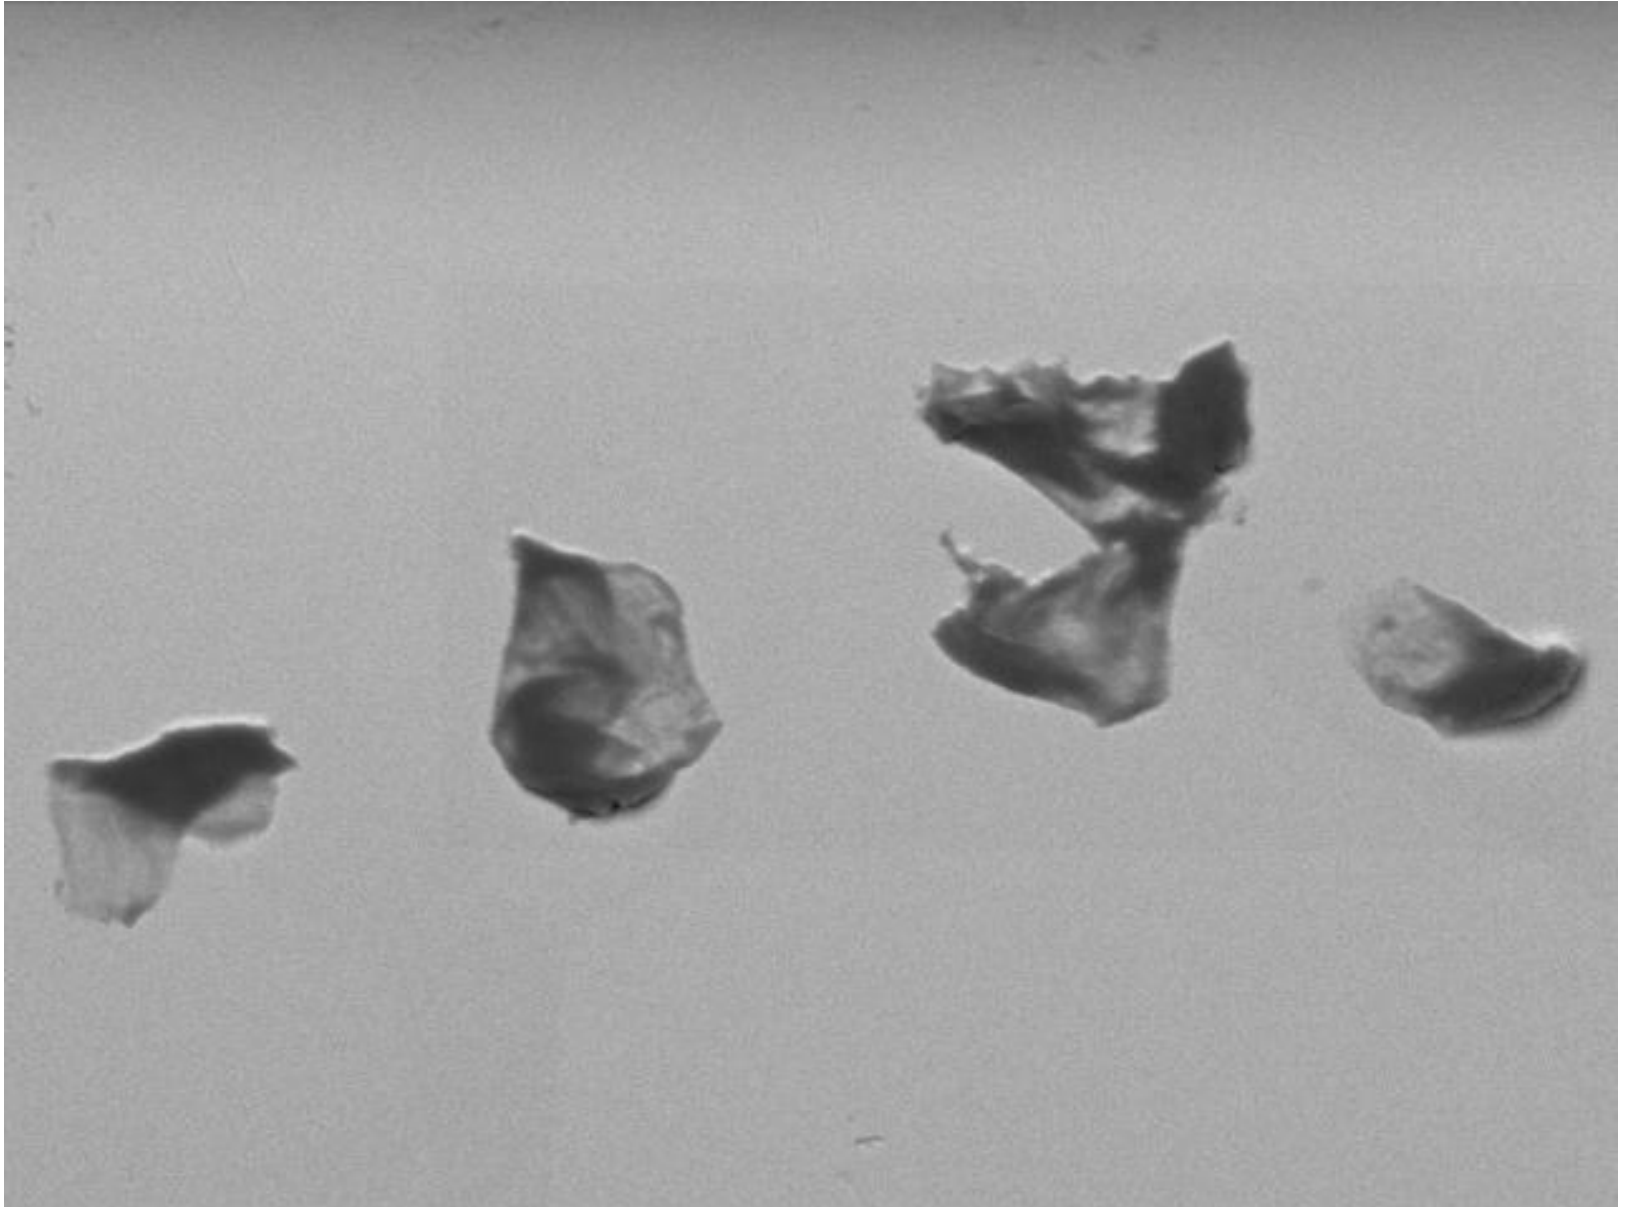
Found contamination on 100 μ m EP treated Nb surface
SEM image

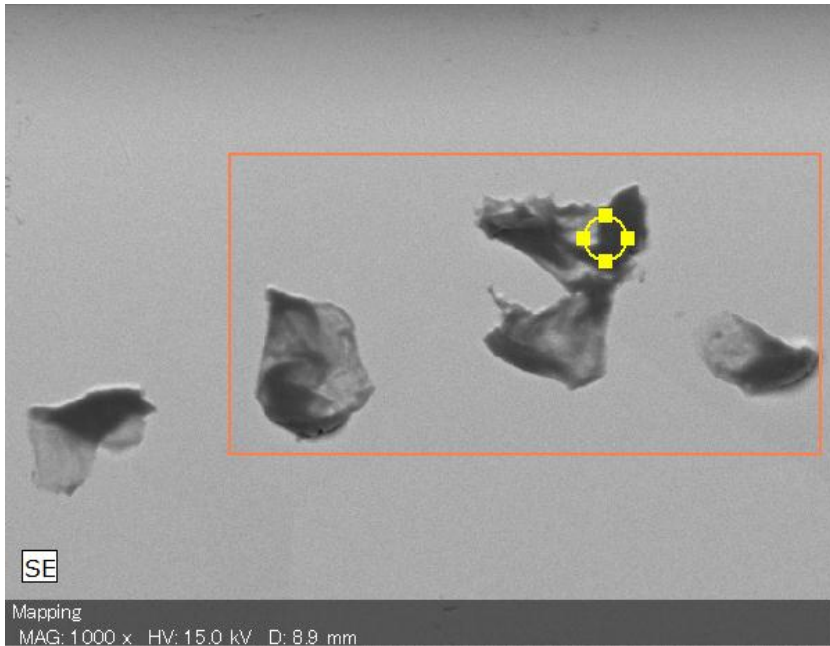
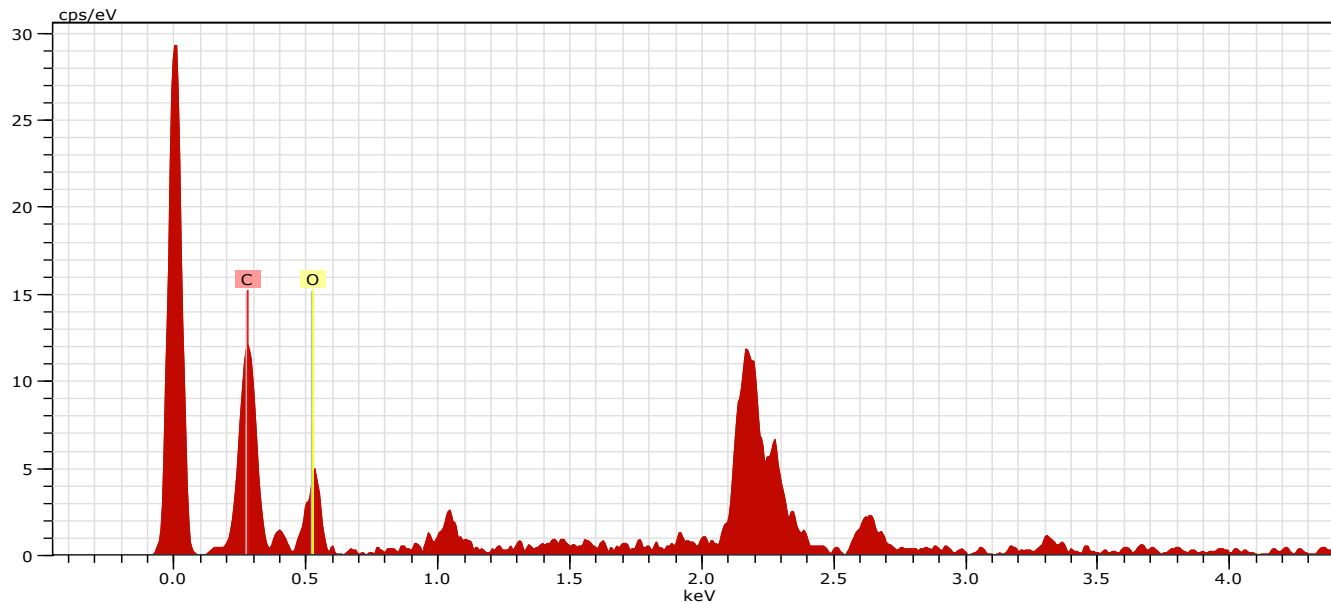
EDX Analysis

- Spectrum: Point
-
- Element AN Series norm. C Atom. C
- [wt.%] [at.%]
- -----
- Carbon 6 K-series 55.06 62.00
- Oxygen 8 K-series 44.94 38.00
- -----
- Total: 100.00 100.00
-
-
-
-

Again it's Carbon and oxygen!
