Explosive Events during V.T. in KEK

MHI-14

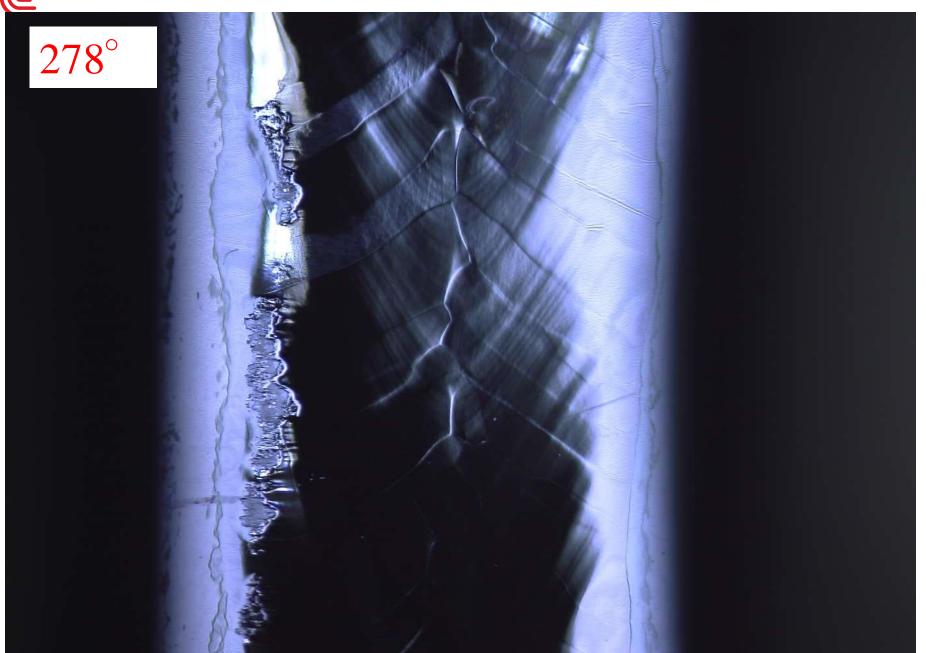
LINEAR COLLIDER COLLAB**LIFTIS** between Cell#8-#9

At this time, we didn't believe this defect was problematic. Then, we did the same surface treatment, not local grinding.

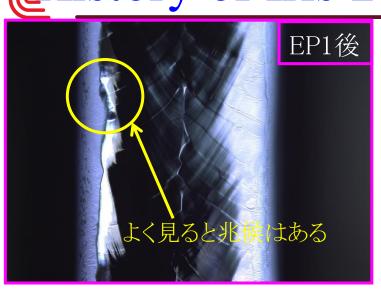
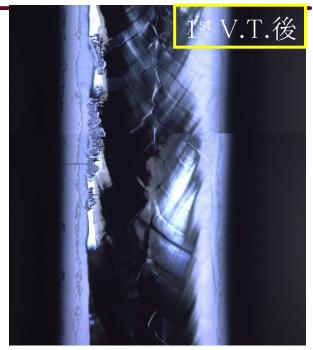
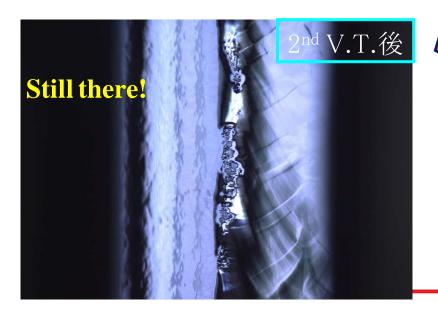
History of Iris 280° between Cell#8-#9

At this time, we **believe** this defect was problematic. Then, we did the local grinding for the removel.

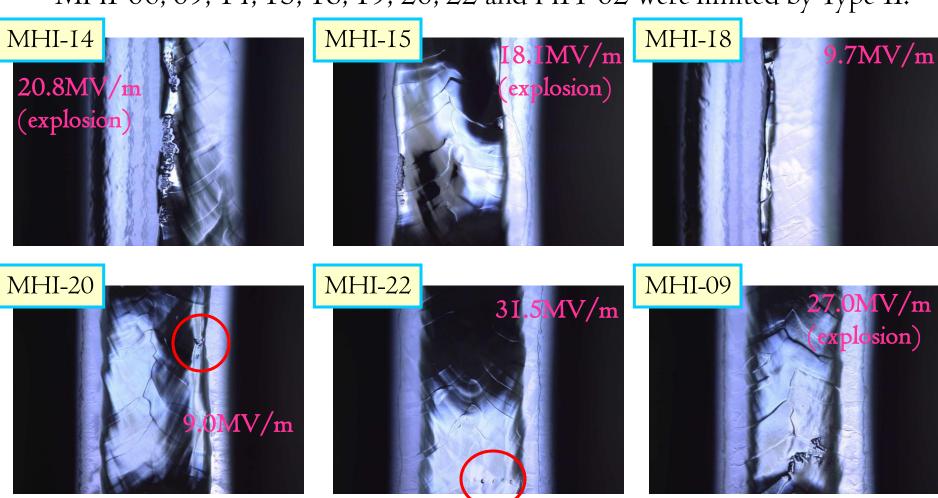
LINEAR COLLIDER COLLABORATION DE II: Defect on bead of Iris

MHI-06, 09, 14, 15, 18, 19, 20, 22 and HIT-02 were limited by Type II.

When a cavity has such a defect at iris region, the heavy field emission certainly occurs.
