IPBSM

- Stability of the laser system -

Nobuhiro Terunuma

Feb. 12th 2014, KEK, 17th ATF2 project meeting

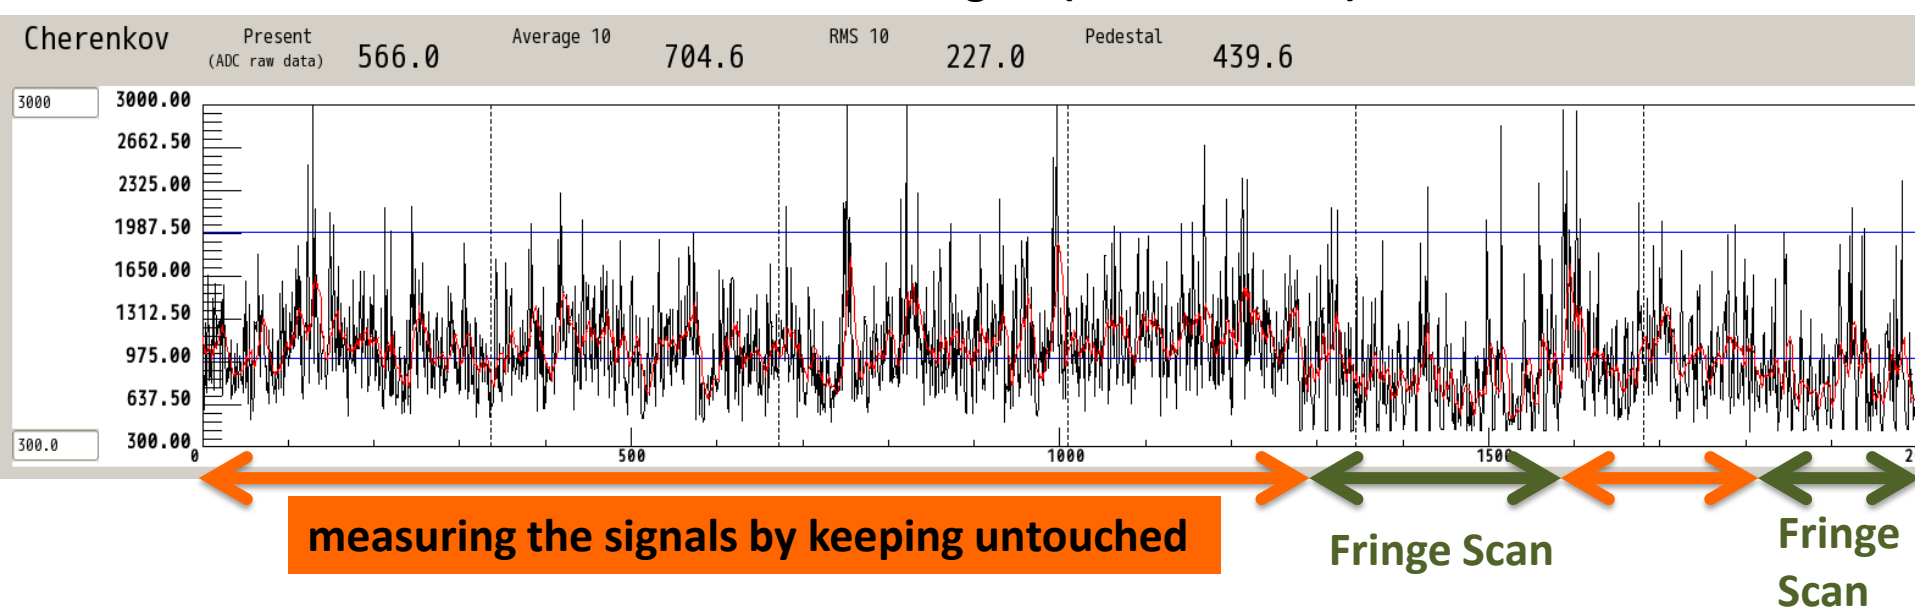
Cherenkov Signal (ADC raw data)

- In Jan/Feb runs, the beam size measurement by IPBSM was very difficult especially for the “fringe scans”.
- **We observed the unacceptable level of drift (50% or more) of the Compton signal. It destroyed the modulation profile.**
- Periodic drop about several tens of seconds was observed.
- In addition, the jitter was relatively bigger than before.

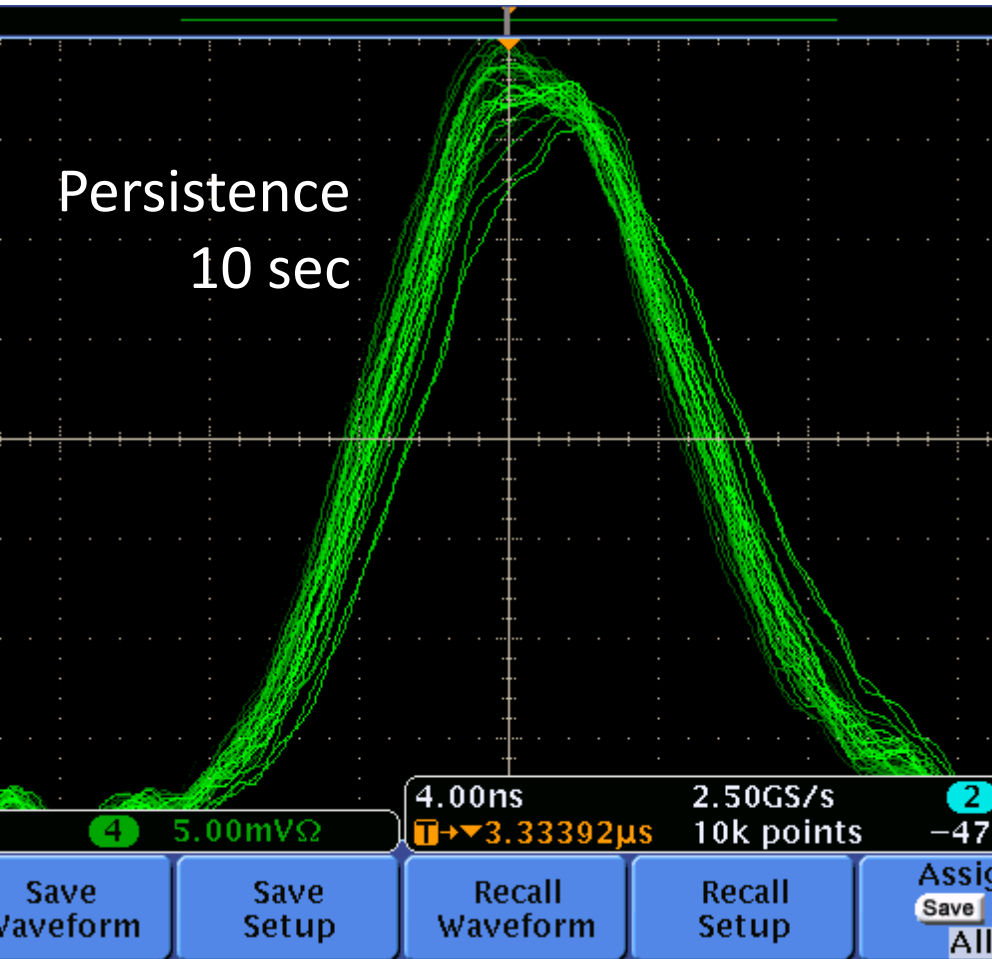
PIN Photo Diode located 0.5m from the exit of laser head

- **Timing jitter**
 - typically < 2 ns
 - sometimes < 4 ns
- **Power jitter**
 - resulting by the timing jitter
 - for beam (if sit on peak)
 - **typical** 0.5/8div ~ 6%
 - **sometime** 1.5/8div ~ 20%

The waveform drifts sometime but it is fast and small. It does not explain the amount of a drift measured on the Cherenkov signal.

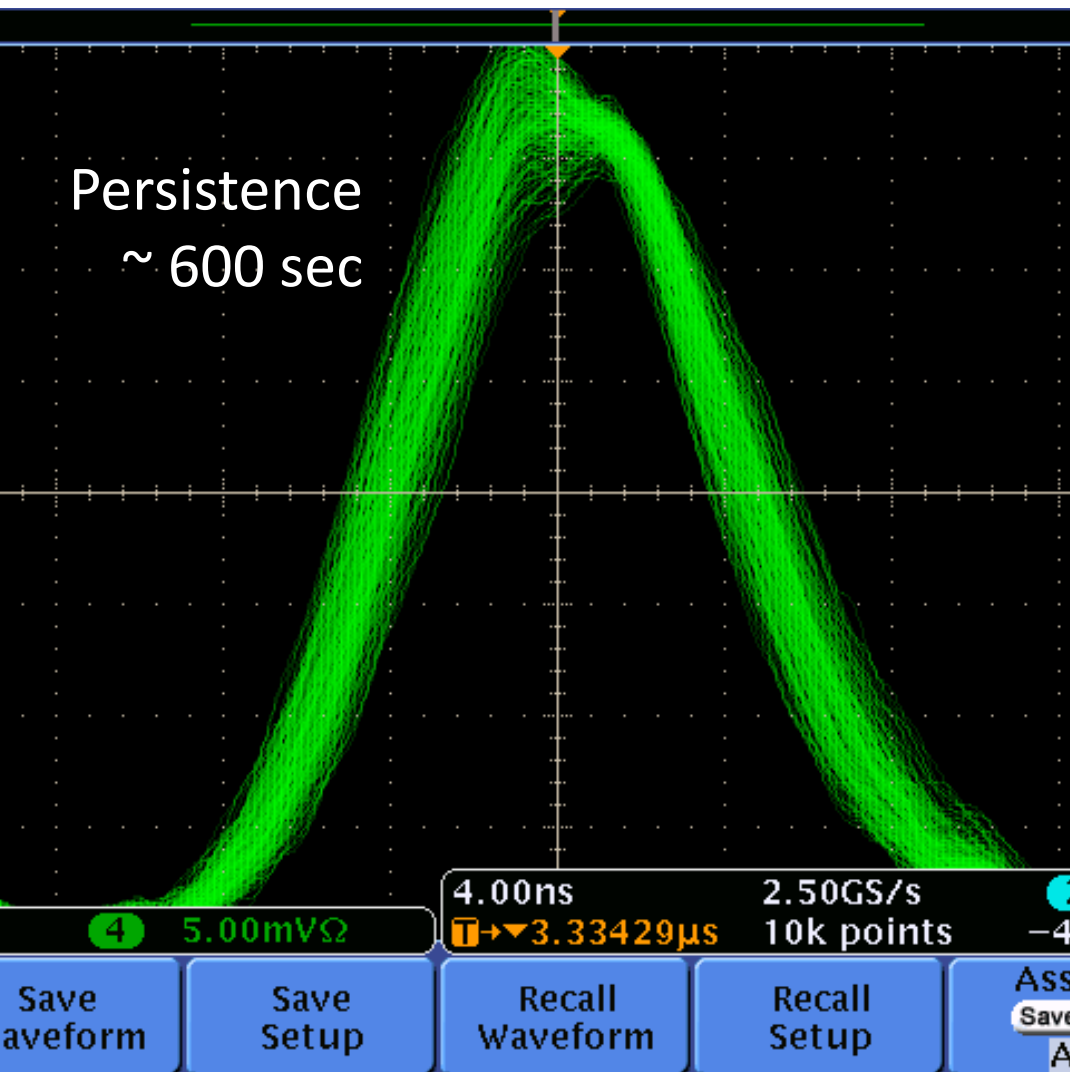
PIN Photo Diode 0.5 m from the exit of laser head

- No significant difference to the 10 sec measurement.
- It looks same as before; i.e. 65 nm measurement.
- → not sensitive to find the source of drift.
- Tuning of the laser oscillator improves/recovers the jitter level.

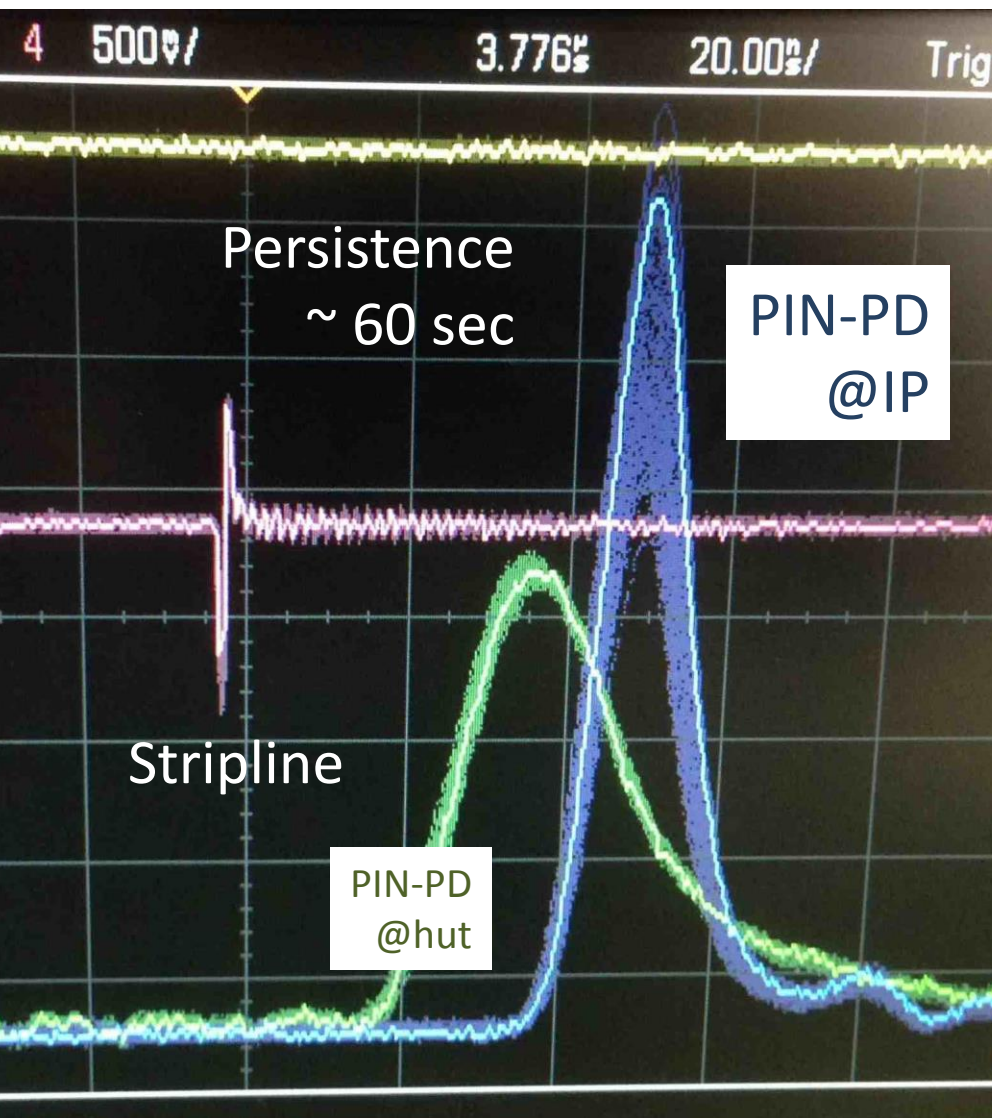
PIN Photo Diode 20 m from the exit of laser head

- Amplitude of PIN-PD signal jitters about 30% at IP but a few for @hut.

- It suggests the enhanced jitter after the transport.
 - **pointing jitter**
 - **laser profile jitter**

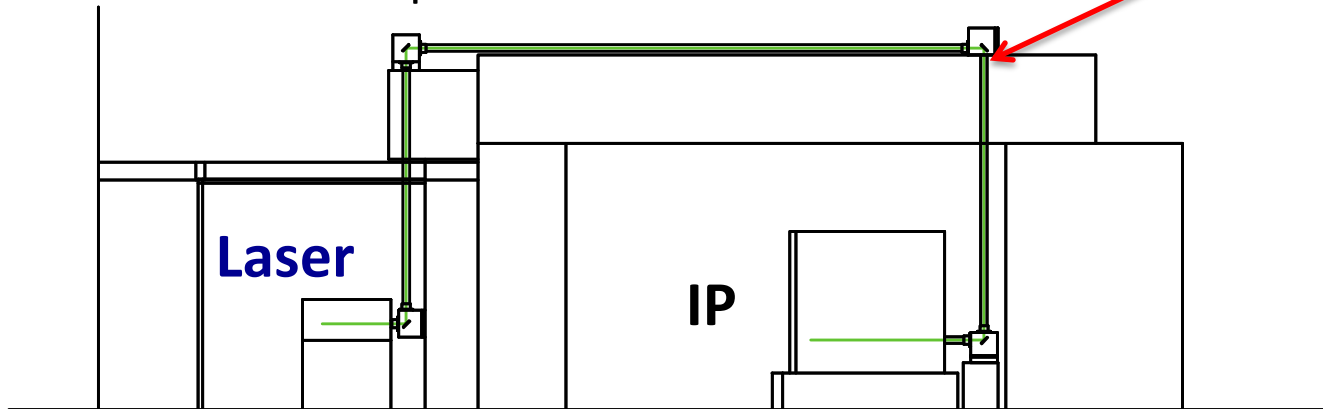
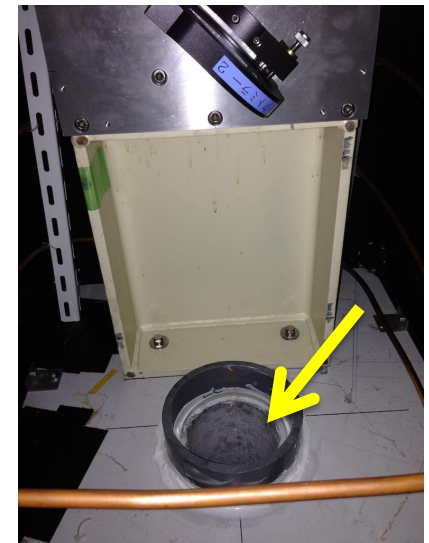
put an optical window on the hole

The laser transport is structured as a closed pipe and may act as a guide of air flow.

- Is there an air turbulence between the IP and the laser hut?
- Is it caused by the difference of pressure or temperature?
- Amount of flow may vary by the condition of IP room or laser hut.

I had put a optical-flat window (viewport for the previous IP chamber) to shut the possible air flow through a hole between the laser transport and the accelerator room.

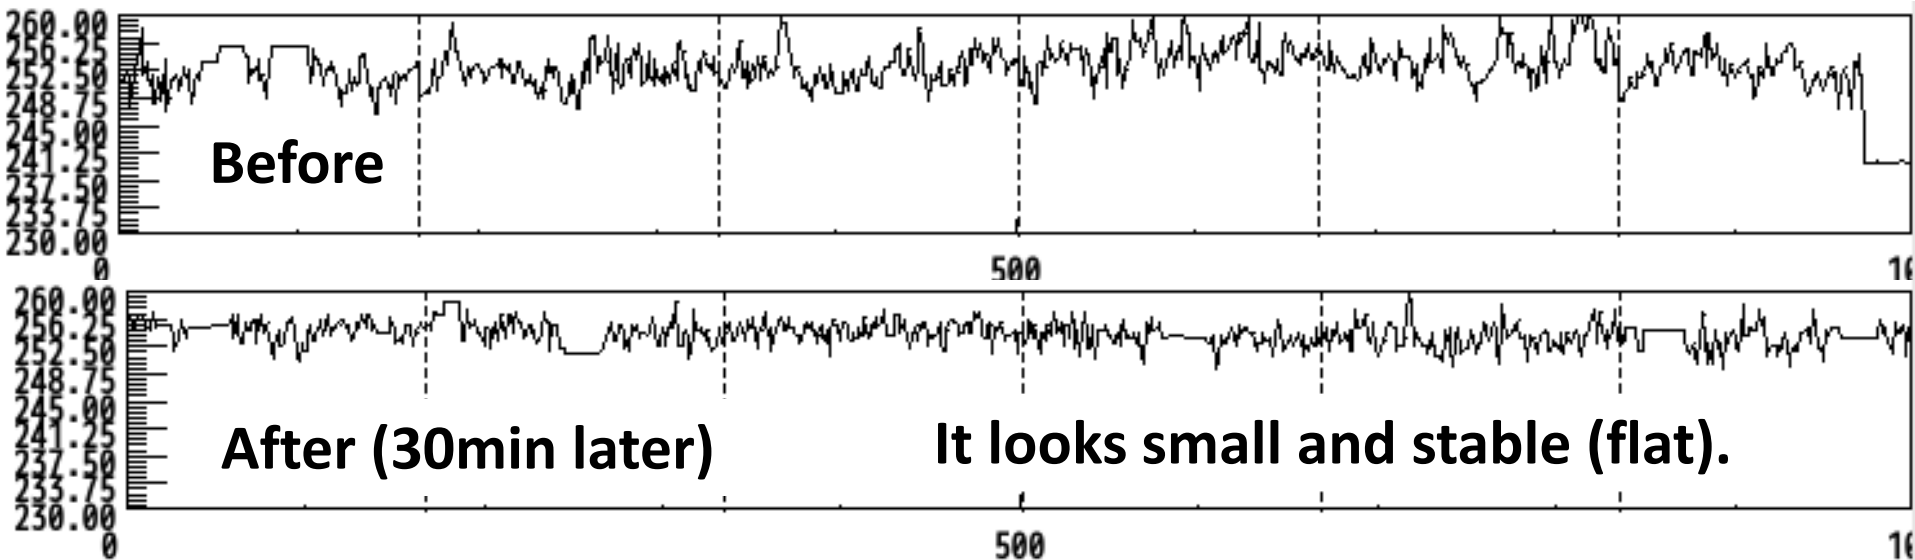
20 min History of the laser image center on the CCD (at vertical table)

- Just put a window on the hole to IP area on Feb.10th (Monday) evening.
- No tools to store the data was prepared at that time. **Monitoring only.**
- Comparing the displayed history, **It seems the CCD image was somewhat stabilized after putting a window.**
- **Try more, close other side to shut the air flow from the laser hut.**
