# Performance of the SiW ECAL prototype in the 2007 TB

Marcel Reinhard  
LLR – Ecole Polytechnique

CALICE days 11-13/09/07, Prague

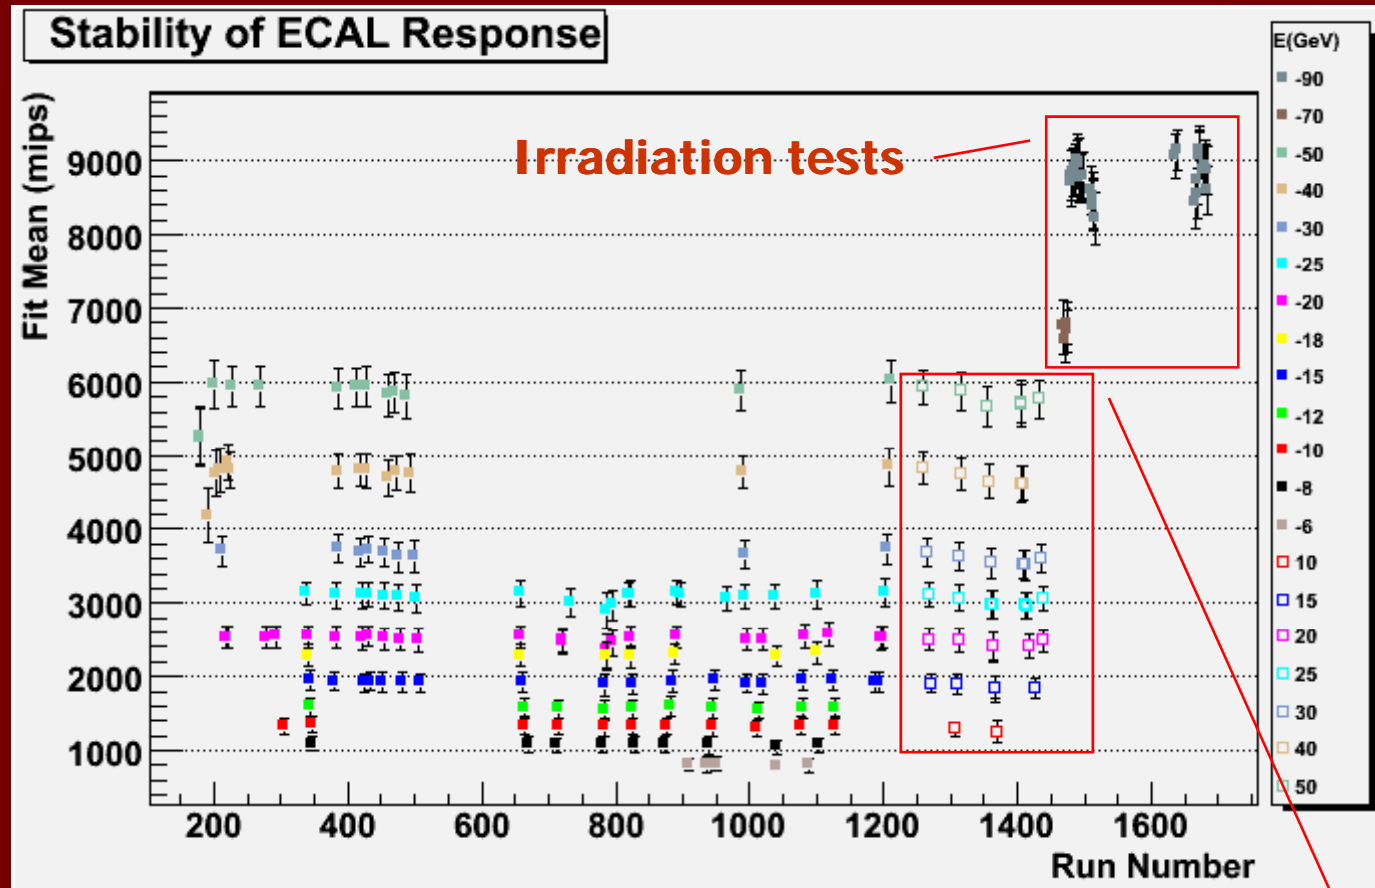
Dependent on beam quality,... ?

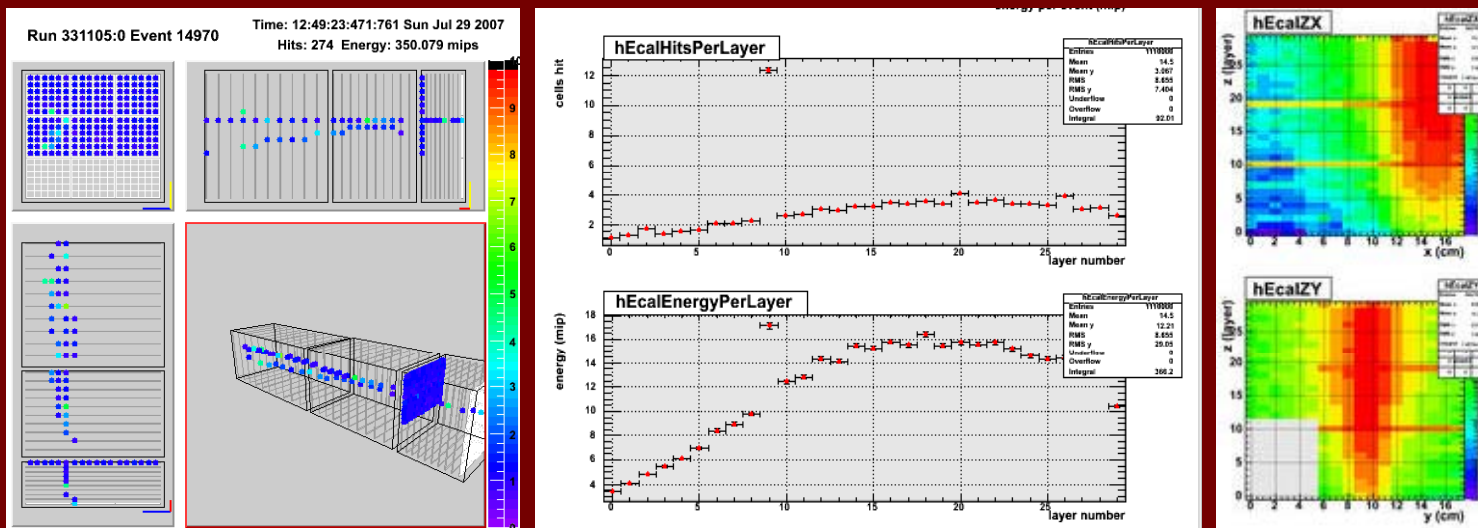
- Fake differential in chip PHY3 makes pedestals strongly depend on exterior effects
- Baseline of a whole PCB is changing dynamically
- Pedestal calculated in the pedestal events is no longer valid
- Calculation wrt to this pedestal may cause much too high values of energy deposit

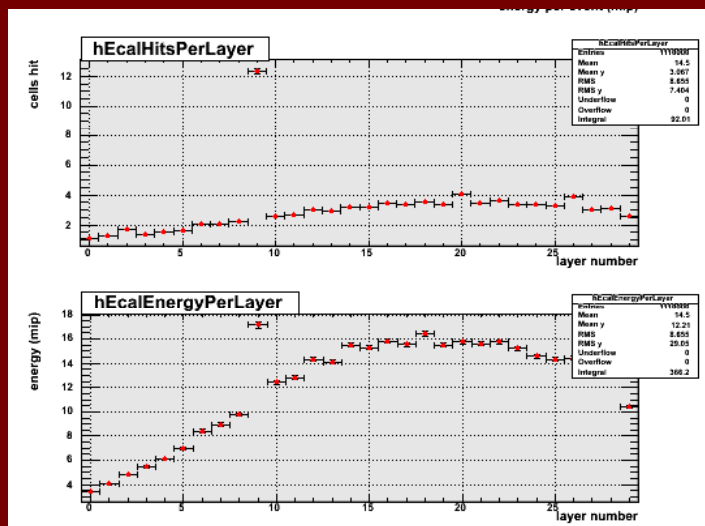
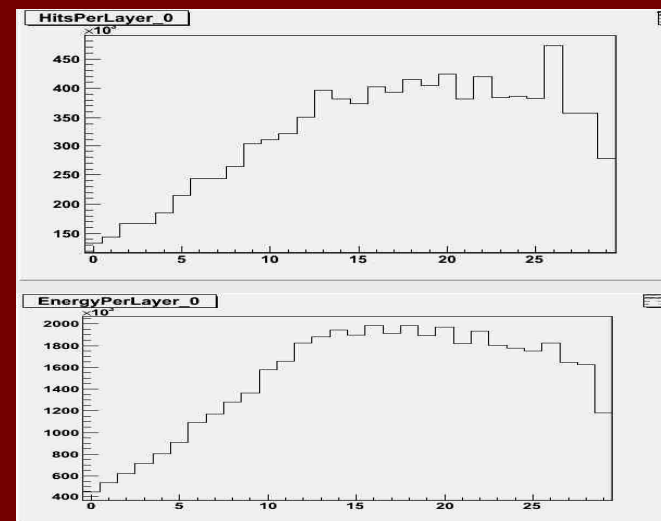
- Software solution: Correction in the reconstruction code calculating pedestal on event-by-event basis using non-hit wafers (becomes more difficult for high occupancies!, not complete correction in some cases)
- Hardware solution: Regulators; tests have been performed but without success (higher noise level)
- Seems to have distracted the shift crews a lot
- Include some correction in the Online Monitor ?

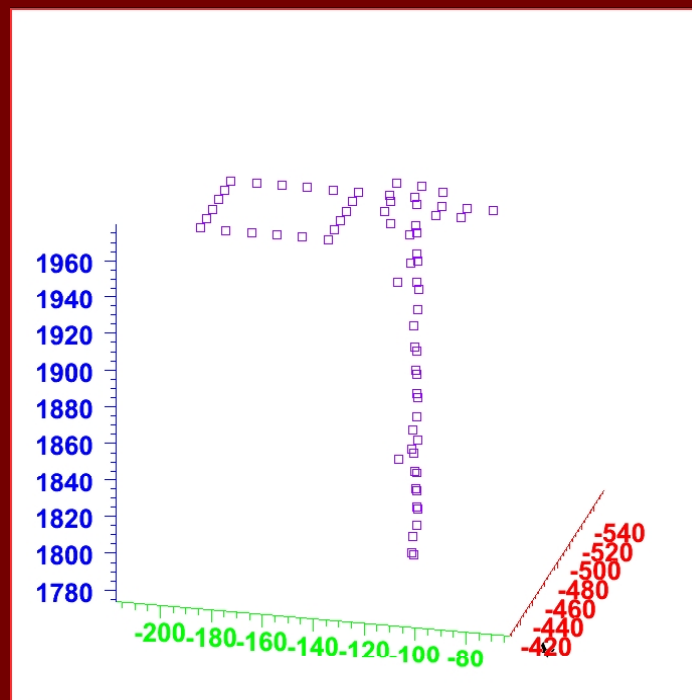
- Invoked by the guard rings around the wafers
- Energy deposit in this guardring induces a signal in the outermost cells of a wafer
- ... can definitely not be changed for the proto
- Corrections under study

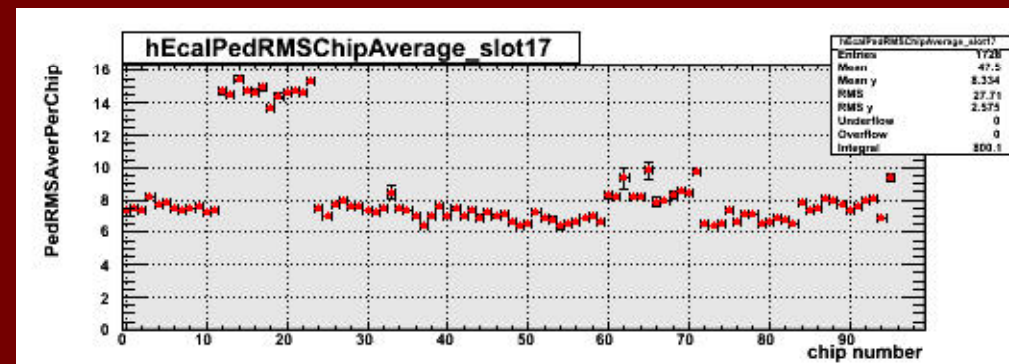
- All noise values for the cells on a PCB are too high
- Very sensitive to the delivered power, thus to the power supplies and/or the power cables
- Changing of power cable can solve the problem
- Several cables marked as „problematic“ – need replacements
- Access difficult in many cases (danger to do more harm than good)

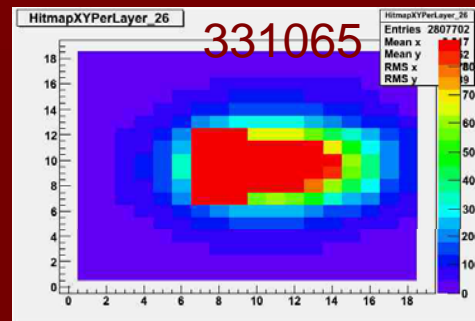
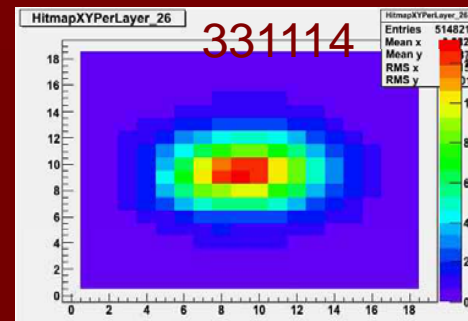
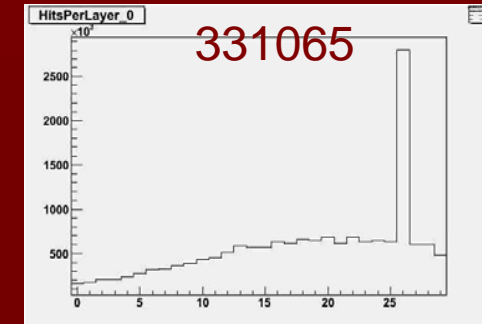
Layer 26

- Some chips can develop higher noise for a certain period in time

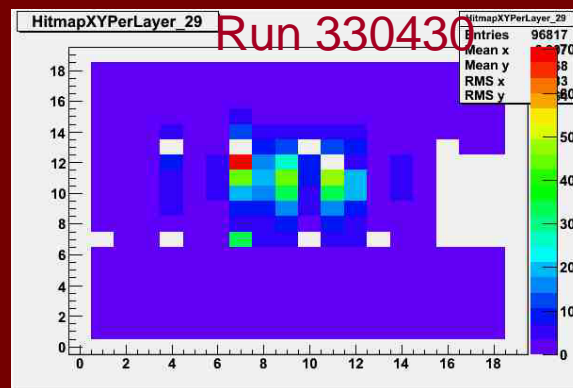
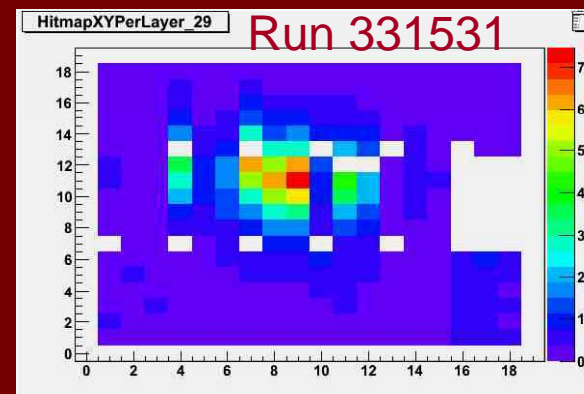
- Can cause noise in several cells
- Typical structure that one chip is not connected
- In some cases is the access impossible due to limited space
- No guarantee by de- and replugging
- Read-out problems (?)

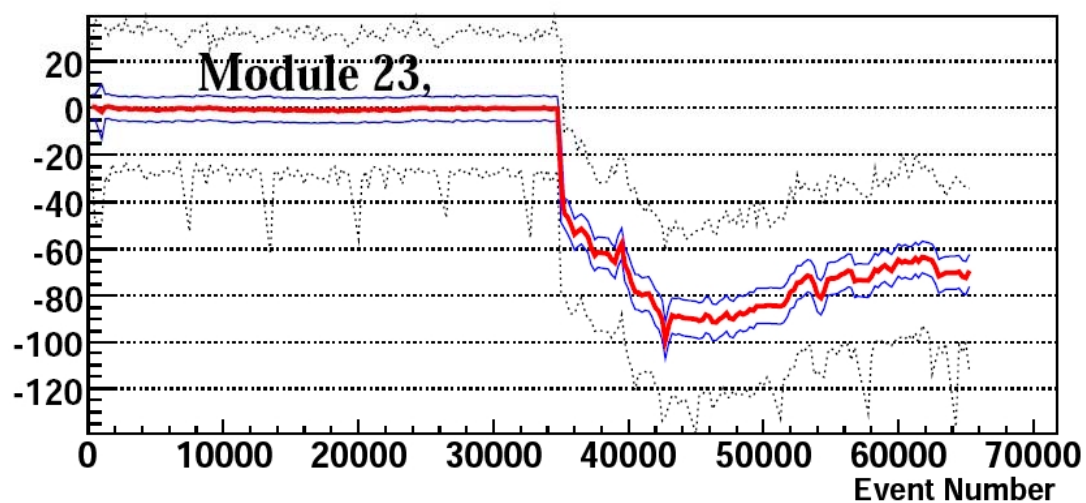
(A PCB with unstable pedestals)
