# Beam-induced EMI and detector electronics

Gary Bower, SLAC LaVonda Brown, Norfolk State University Nick Sinev, University of Oregon Yasuhiro Sugimoto, KEK

# **VXD electronics failures: observations**

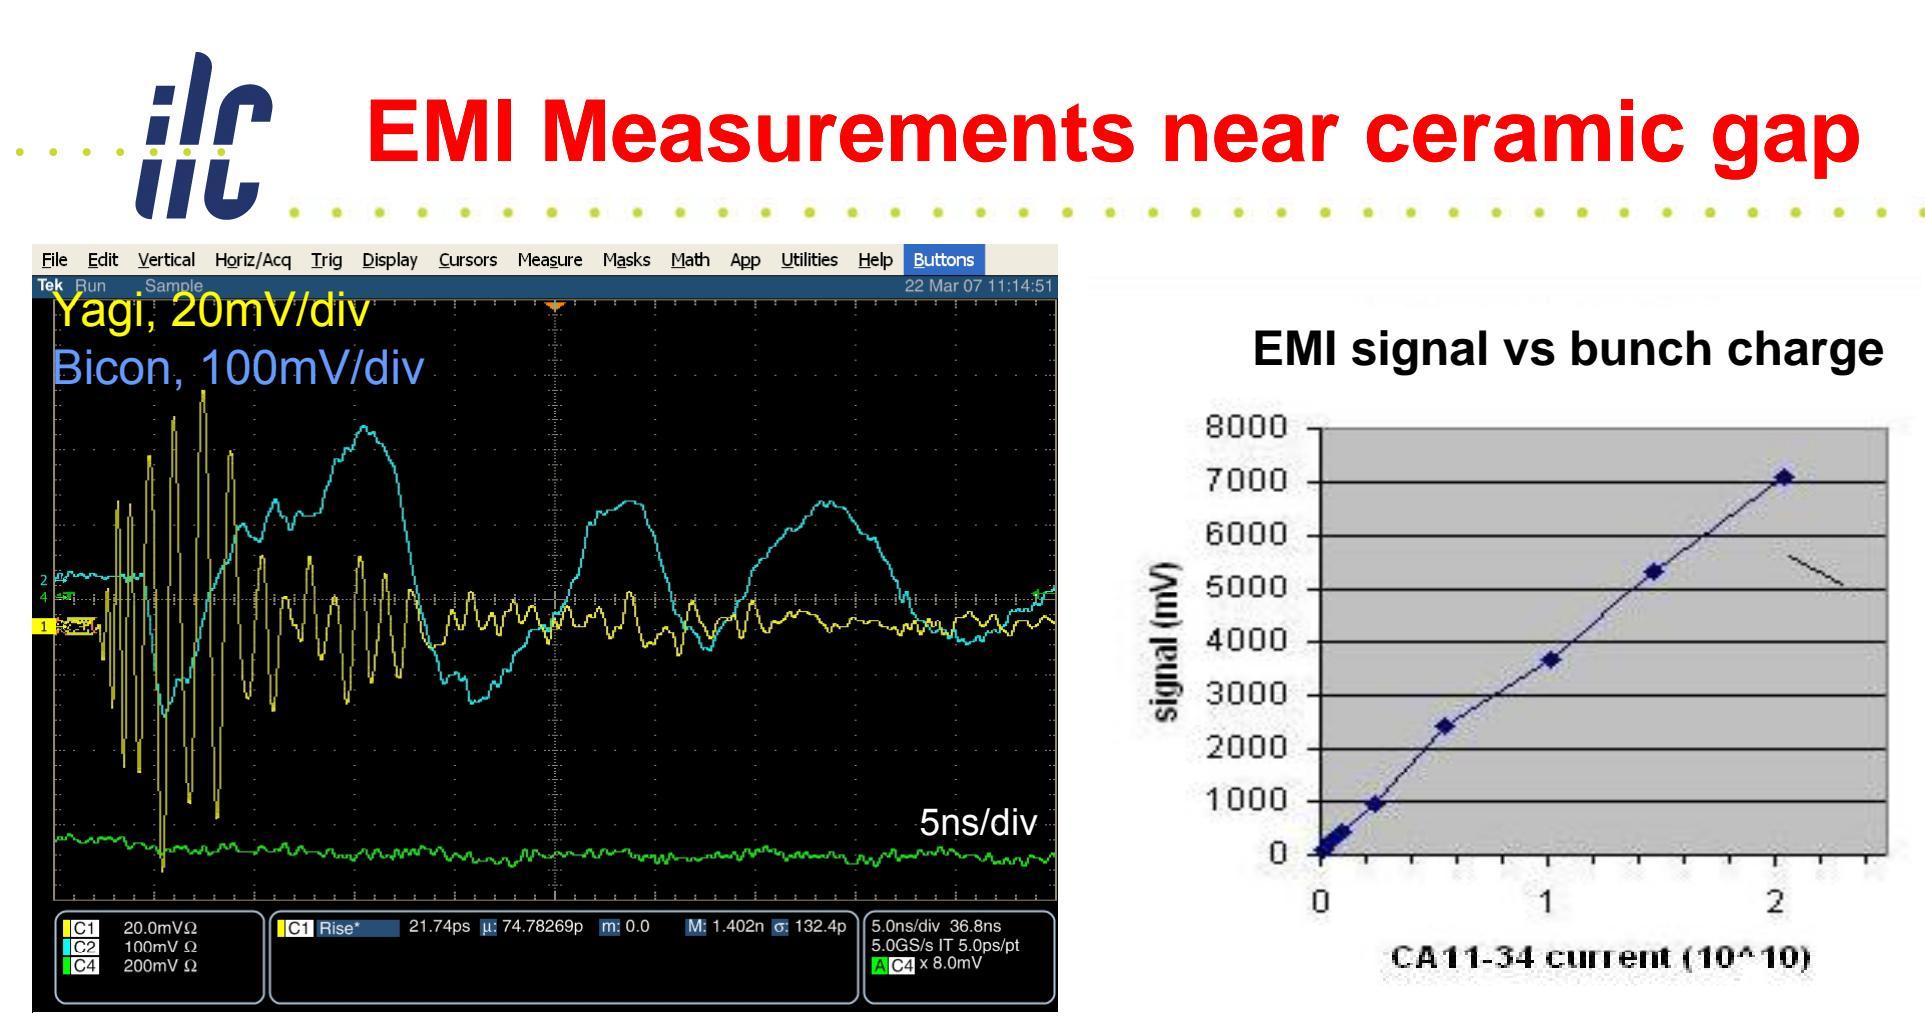
- Antennas placed near (~1 m) gaps observed EMI up to ~20 V/m.
- Pulse shapes are very stable over widely varying beam conditions, indicating they are determined by the geometry of beam line elements.
- Pulse amplitudes varied in proportion to the bunch charge but were independent of the bunch length. Observe ~1/r dependence on distance from gap.

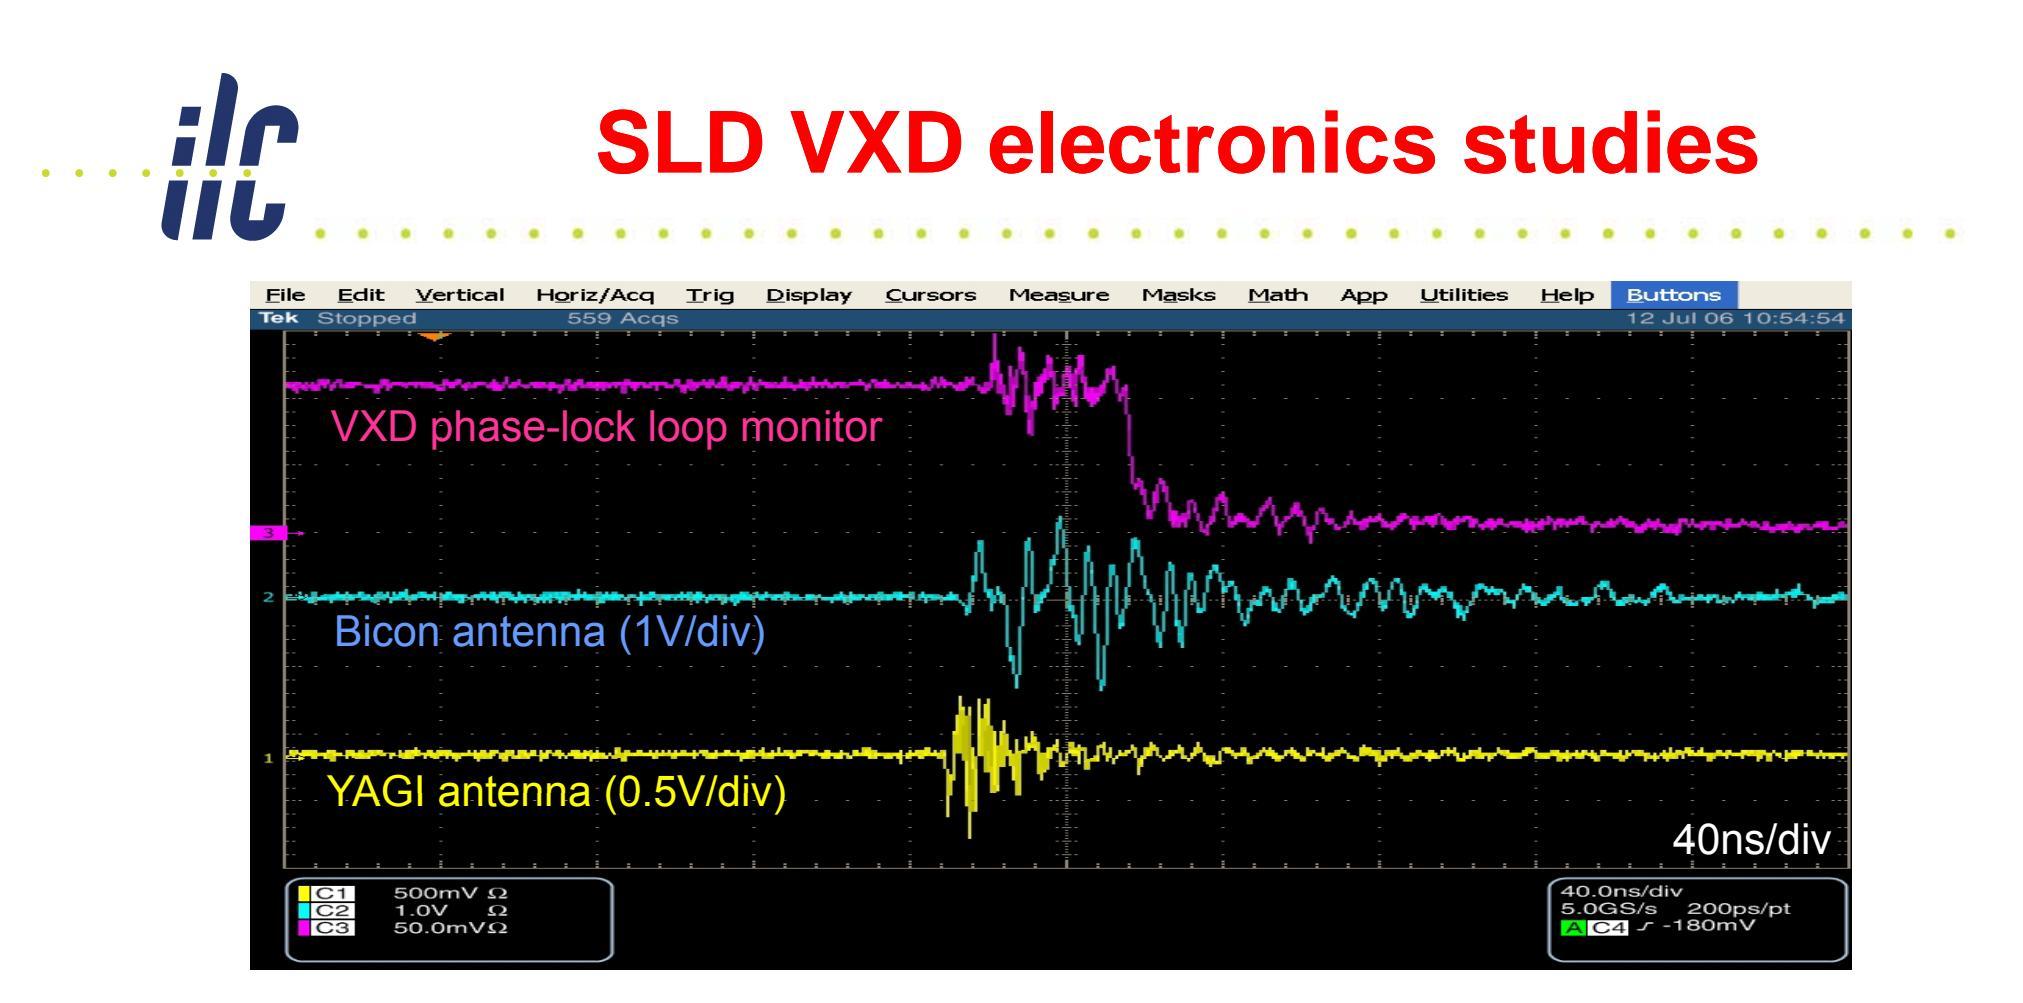
- → VXD front-end electronics placed near ceramic gap. When exposed to sufficient EMI the phase-lock loop monitor signal drops.
- Phase lock loop lost lock on about 85% of beam crossings when the module was at location where antenna observed ~20 V/m (YAGI measurement on 2.5GHz bandwidth scope)
- Phase lock loop lost lock failure rate drops to 5% at ~1 V/m signal from antenna.
   September 19, Nick Sinev
   IRENG, SLAC, September 17-21, 2007
   10

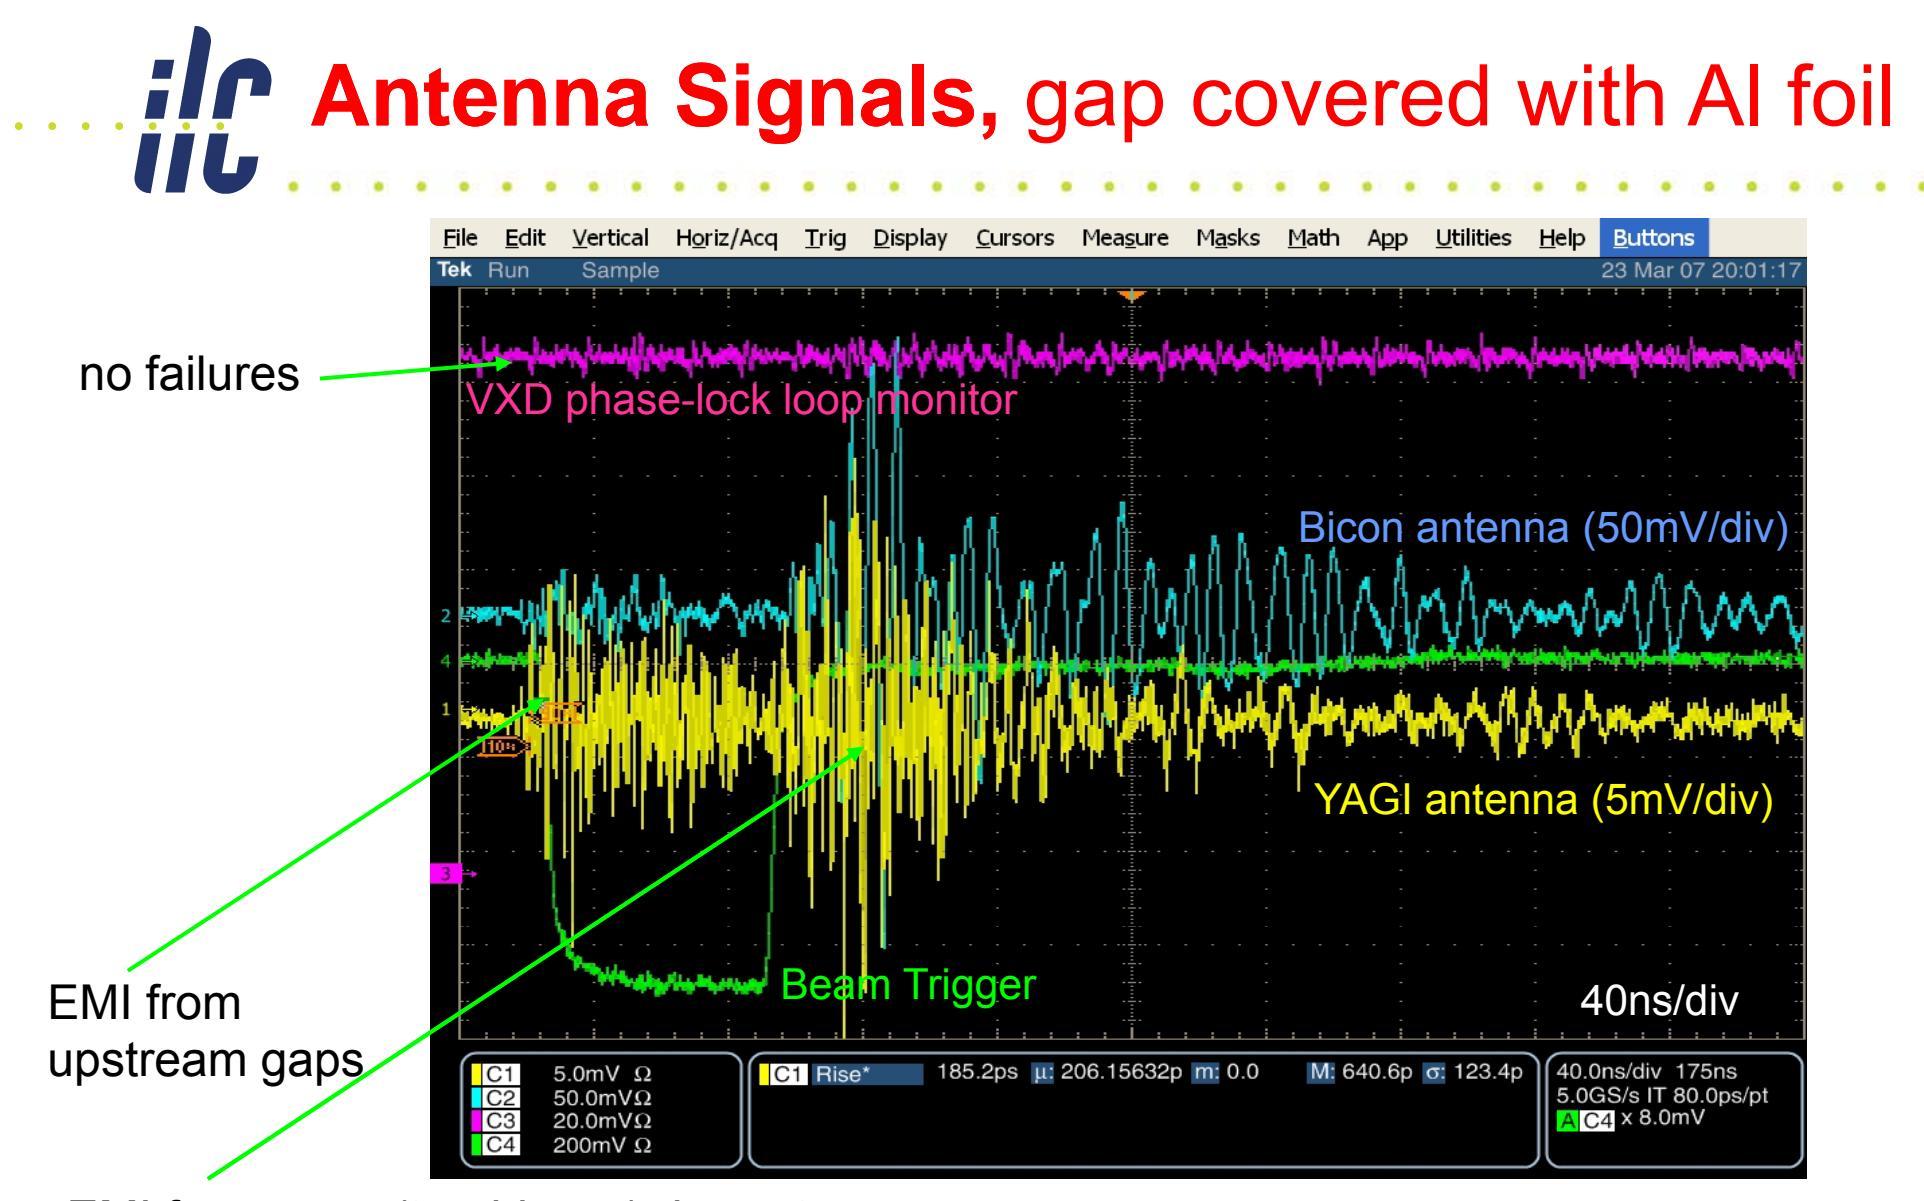
- A single layer of common 5mil aluminum foil was placed over the ceramic gap and clamped at both ends to provide an image current path.
- The antenna signal amplitude was reduced by >x10. (We could not say if it disappeared completely because of upstream signal pickup)
- The aluminum foil gap cover stopped VXD failures.
- A 1 cm x 1 cm hole in the gap foil cover emitted enough EMI to cause about 50% VXD failure rate at ~1m distance. (With no foil rate would be 100% at this distance.)
- There was no failure with a 0.6 cm x 0.6 cm hole.

EMI from gaps (toroids, ...) downstream

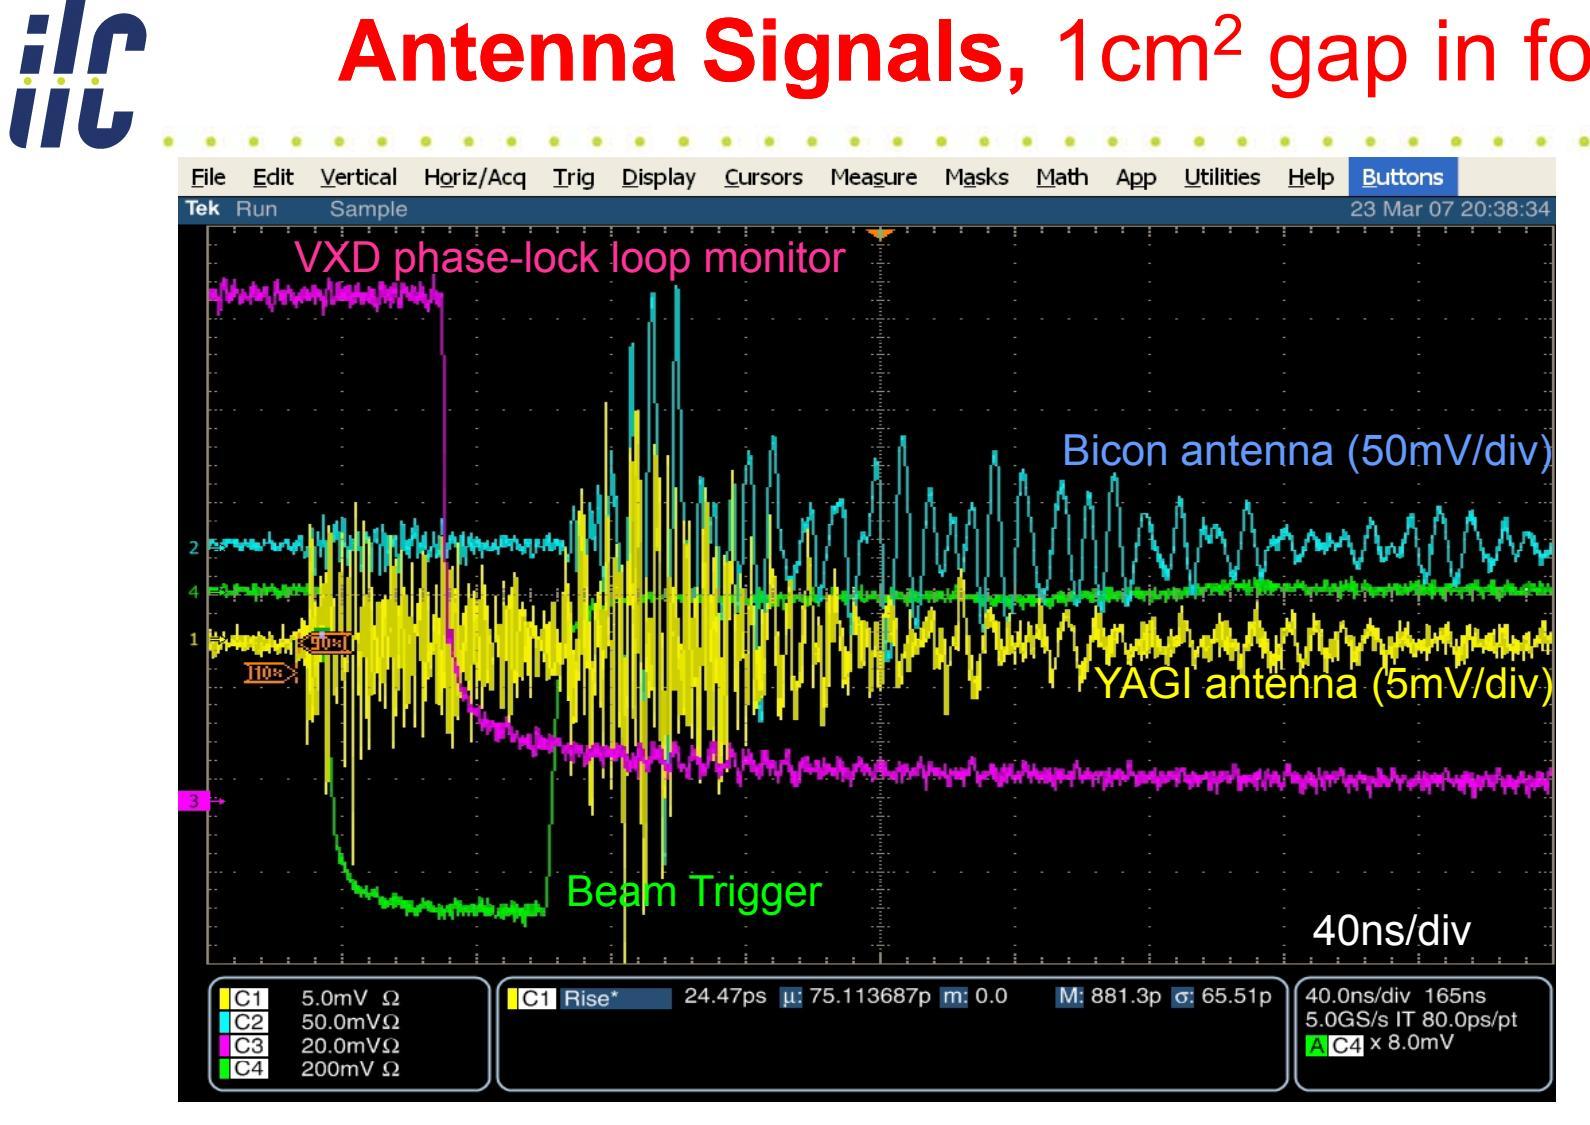
## Antenna Signals, 1cm<sup>2</sup> gap in foil

- $\rightarrow$  observe VXD electronics failure, but little change in antenna signals
- $\rightarrow$  indicates VXD electronics sensitive to EMI at higher frequencies than seen by YAGI; dimensions indicate sensitivity at ~30GHz

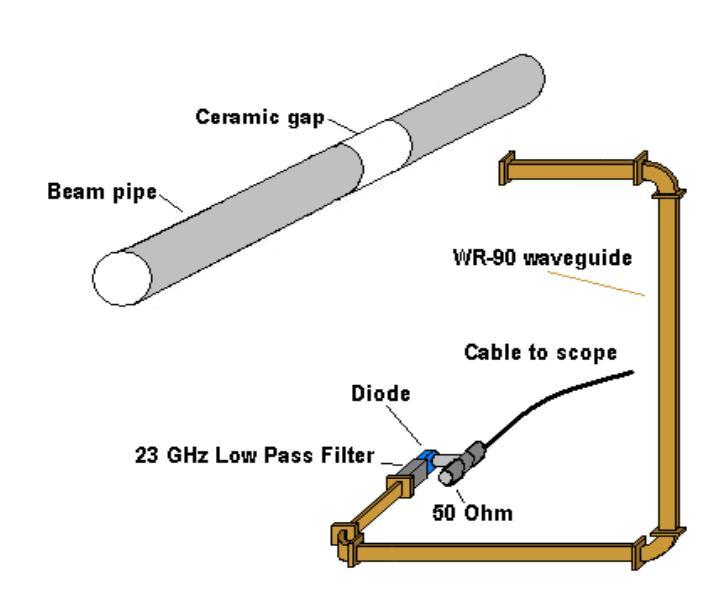
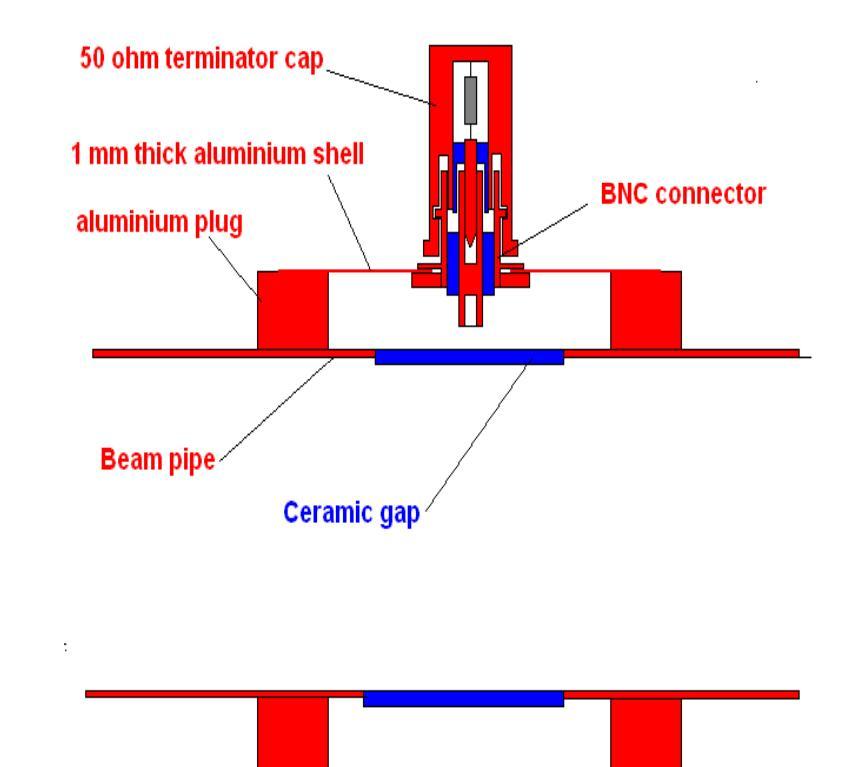
20 GHz diode setup for EMI measurements. The gap was either open, or covered with aluminum foil, or covered with "clamshell" shown on next picture

Cross section of beam pipe with gap covered with "clamshell" with BNC connector. Red color is metal, blue – insulator.

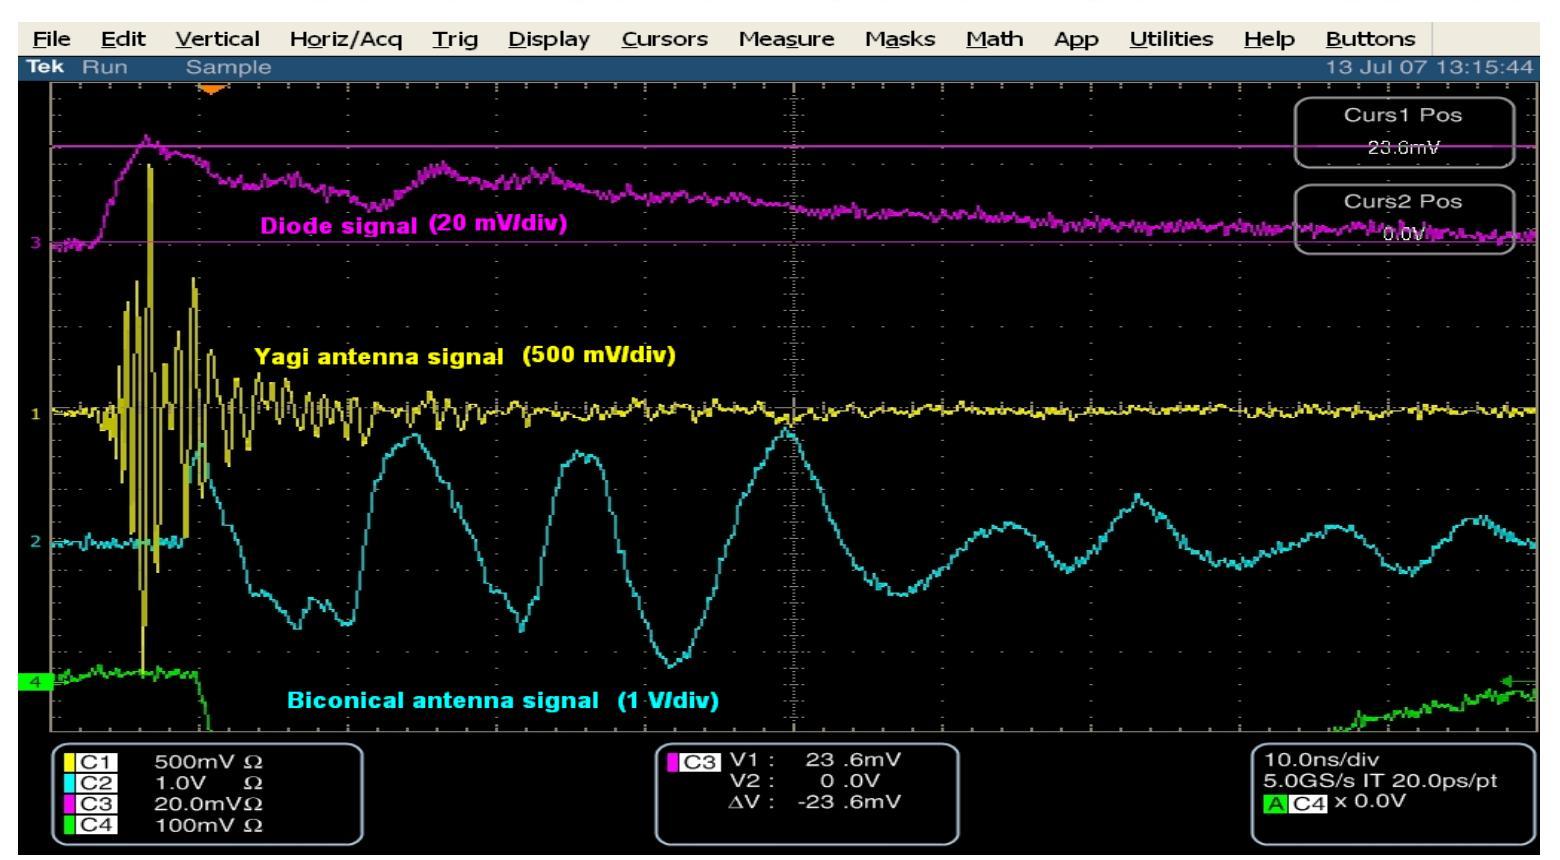
Here is the signal from diode (as well as from antennas) for uncovered ceramic gap. The diode signal from gap covered with aluminum foil with 1cm x 1cm hole was only 2 times smaller! The signal, leaking from BNC connector capped by 50 ohm terminator was about 1 mV.

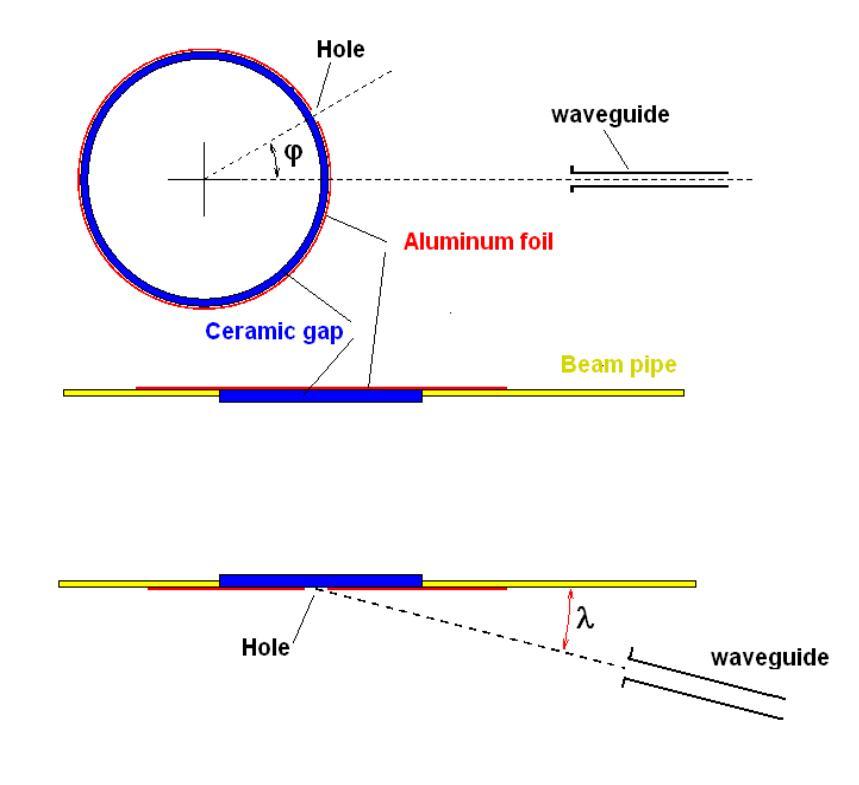
Angle dependence

- With uncovered ceramic gap we observed strong dependence of the diode signal on polar angle λ

at 30° signal was 6 time larger than at 90°.
- With gap covered with foil, having small (1cm x 1cm) hole, there was strong  $\varphi$  dependence – signal dropped almost to 0 at  $\varphi$ =90°, but very weak  $\lambda$ dependence – in fact, signal now had maximum at  $\lambda$ =90°.
