# Fast kicker Experiment at ATF

ATF2 - 40nm beam production, measurement

## *Fast kicker Experiment 2009*

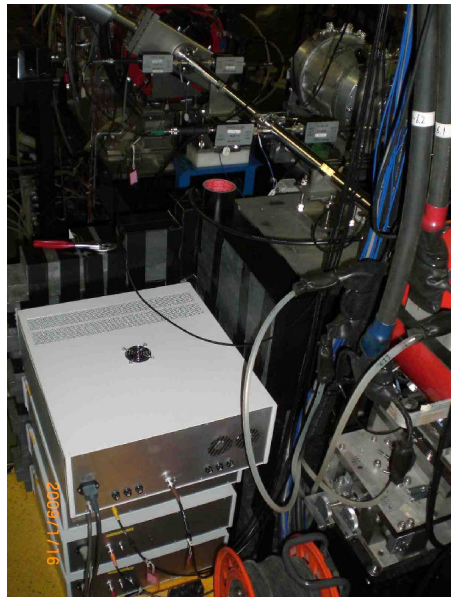
2009/12/15 *FDI pulser*

Two pulsers were broken by the radiation damage during only a few hours.

The radiation level at the location was  
>10msv/h(gamma) and  
100u sv/h(neutron).

*The location of the pulsers were located to the outside of the shielding.*

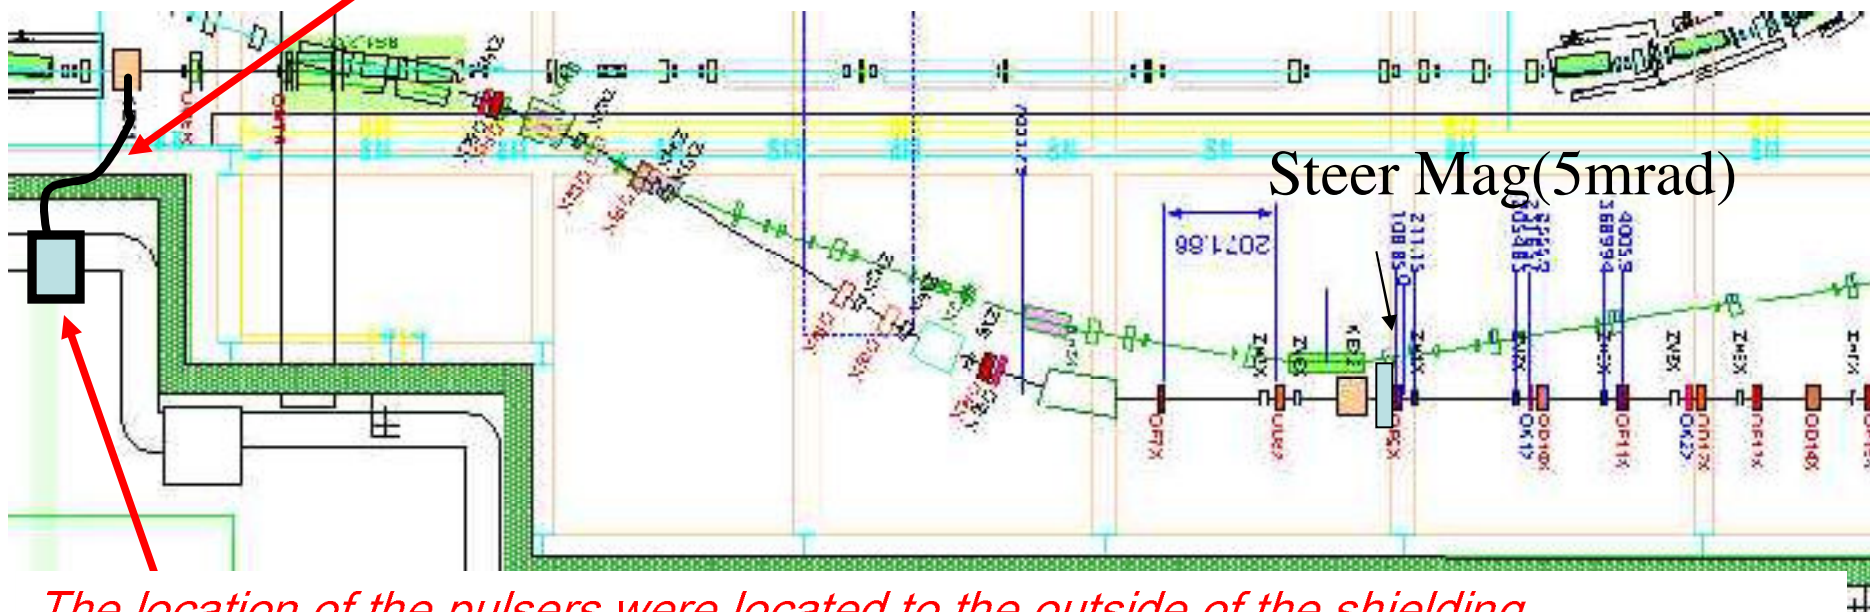
## *New location of the pulsers*

*6m cables*

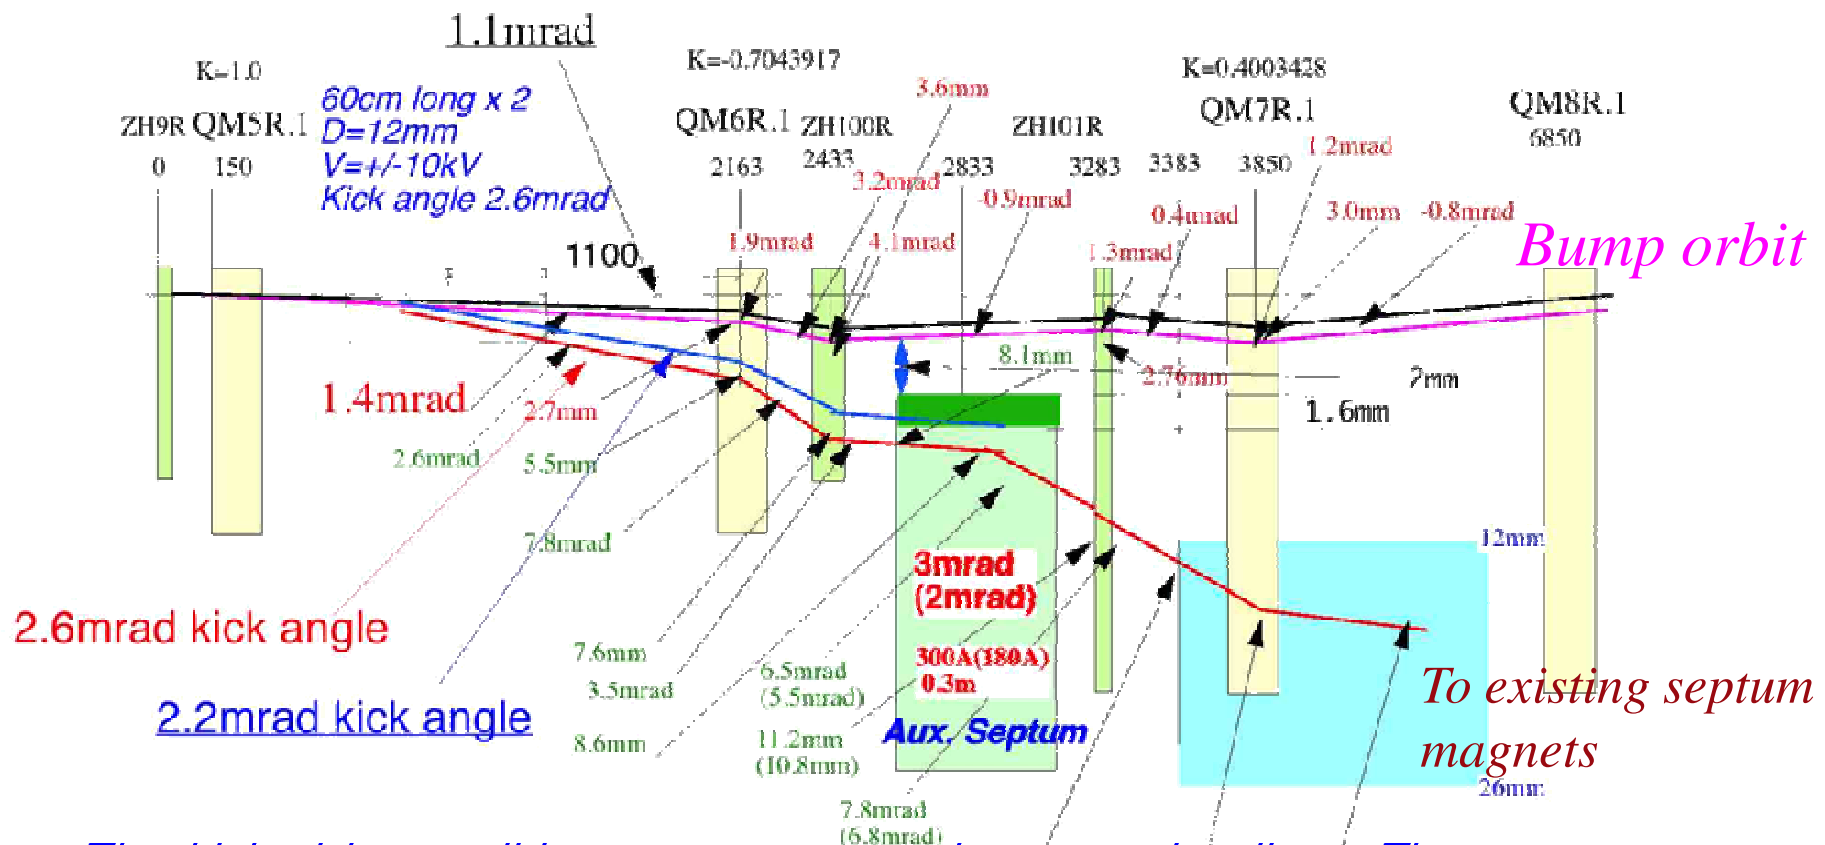
# Beam Extraction Orbit (2009June)

The kicked beam did not come out to the extraction line. There were two reasons. One is the lack of the kick angle due to the fabrication error of the strip line. The other is the lower local bump height at the auxiliary septum. The beam loss was happen before reach the design. The beam was disappear at the aux. septum.

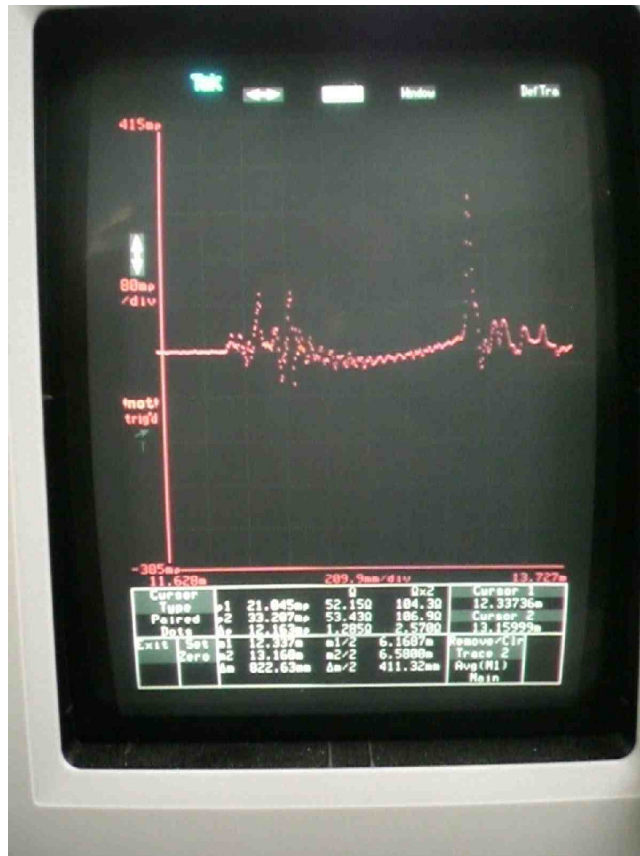
## 60cm Left side electrode

In 52.95Ω  
Out 52.95Ω  
Middle 48.9Ω

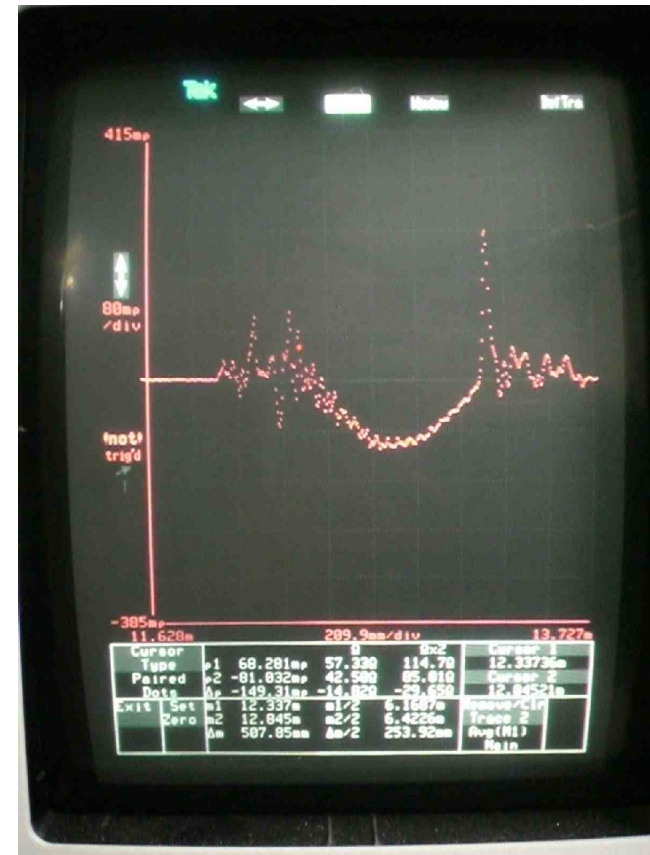
## 60cm Right side electrode

In 57.3Ω  
Out 50.16Ω  
Middle 41.9Ω

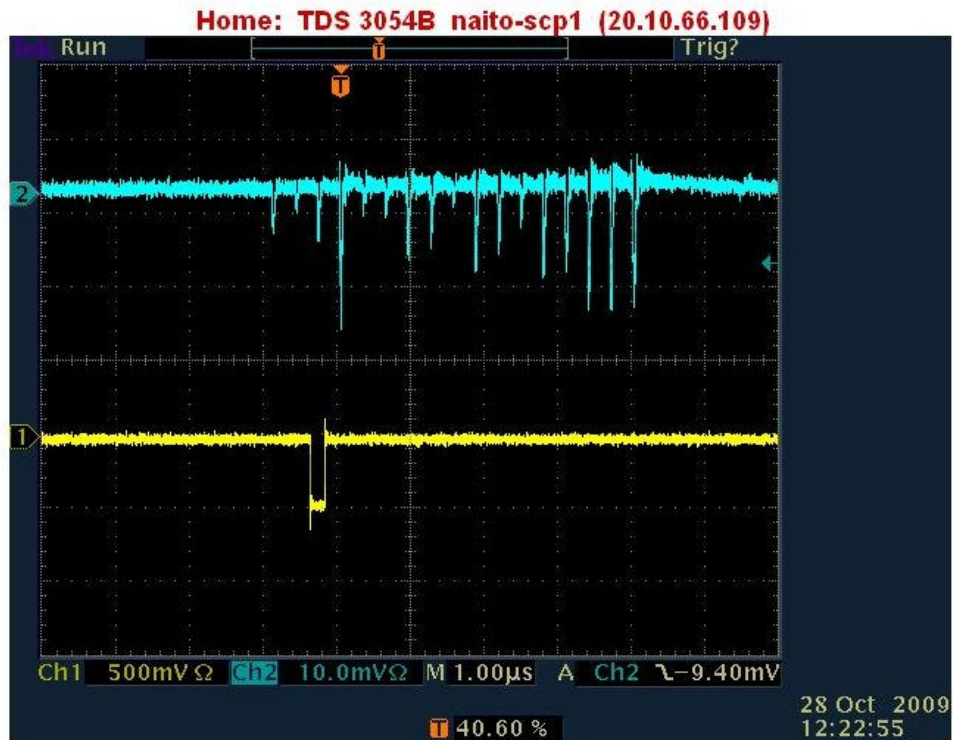
## Multi-bunch beam extraction by the Fast kicker(2)

Up to 17 bunches of the multi-bunch beam was extracted to the extraction line, however the bunch population of the extracted beam was not so flat. The timing system had a trouble at that time, which was caused by the unstable beam storage in the DR.

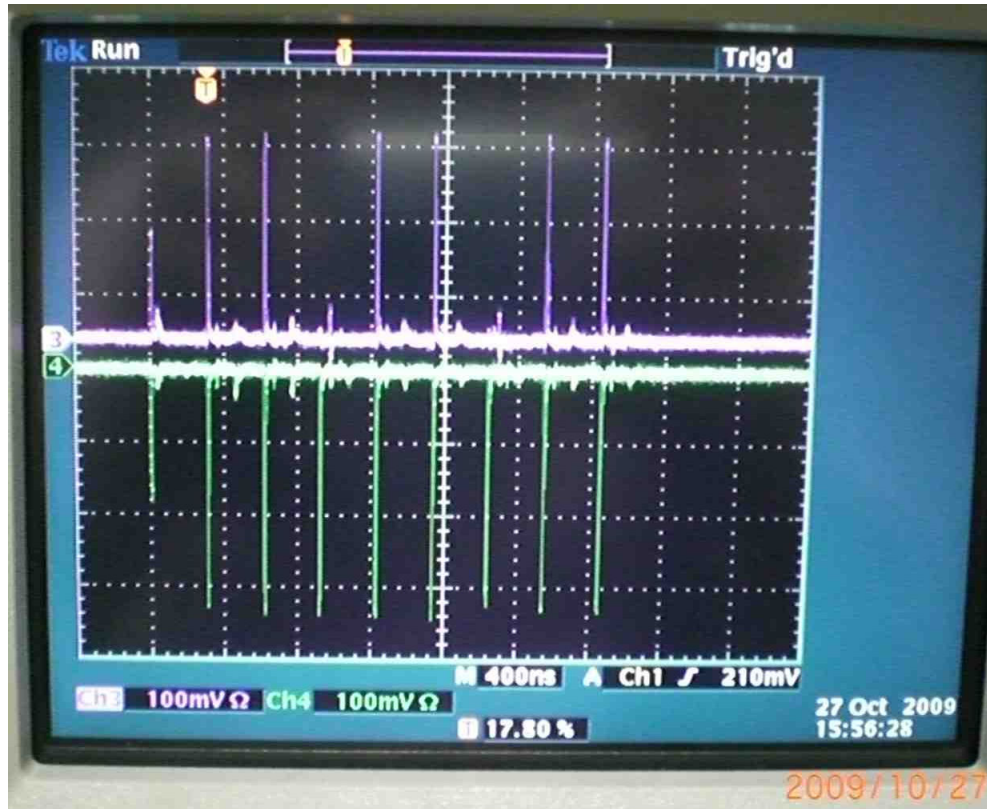
# Pulser trouble

*One of the pulsers did not output every third pulse. The every third pulse has different timing(302.4ns). The pulser was replaced to the 2ns pulser at the multi-bunch beam extraction.*

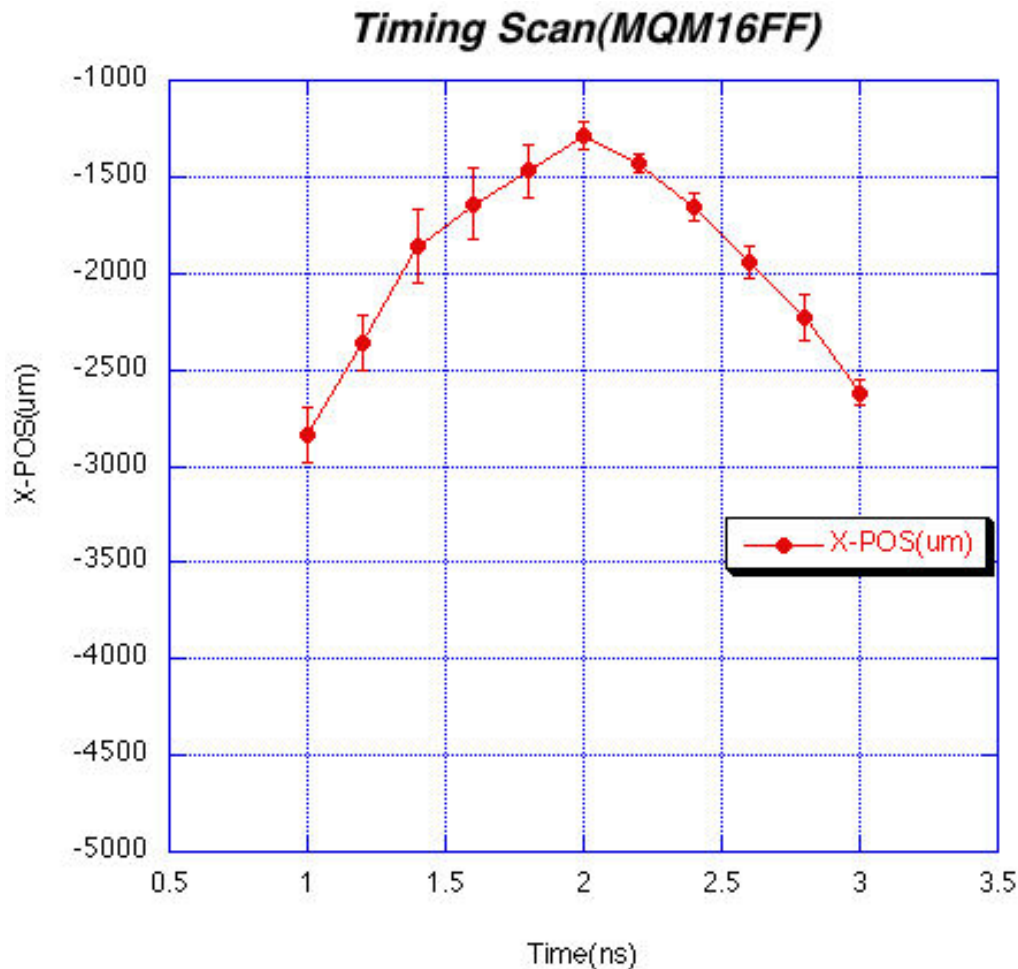
# Kick field profile and Timing jitter

The graph shows the measured horizontal beam position when the kicker pulse timing was scanned. The position displacement corresponds to the kick field difference. A cavity BPM(MQM16FF) at the ATF2 beam line was used for the measurement.

There is no flat-top for the kick field of the strip-line kicker. The estimated kick angle jitter is about  $2 \times 10^{-3}$ , when the designed R12 is used. We already found that the kick angle jitter come from the pulser. One of four pulses has a large timing jitter( $\sim 500$ ps). The kick angle jitter will be improved after treated the pulse power supply.

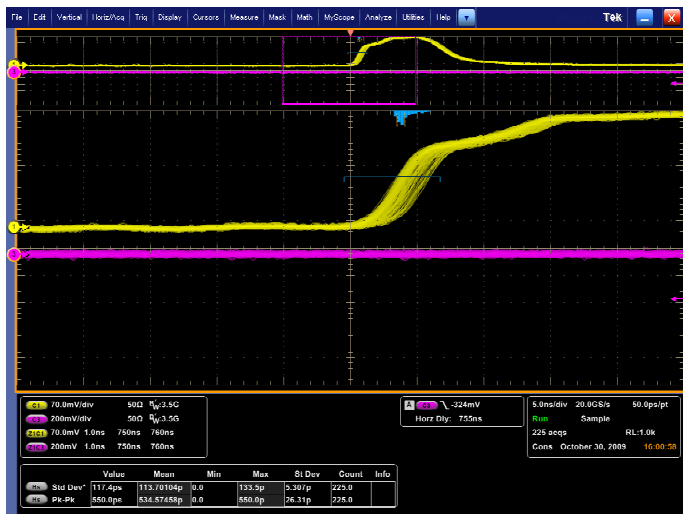
#1 pulser Jitter550ps(P-P)
