Sebastian Weber
University of Wuppertal

Status update of the Integrated LED Calibration System

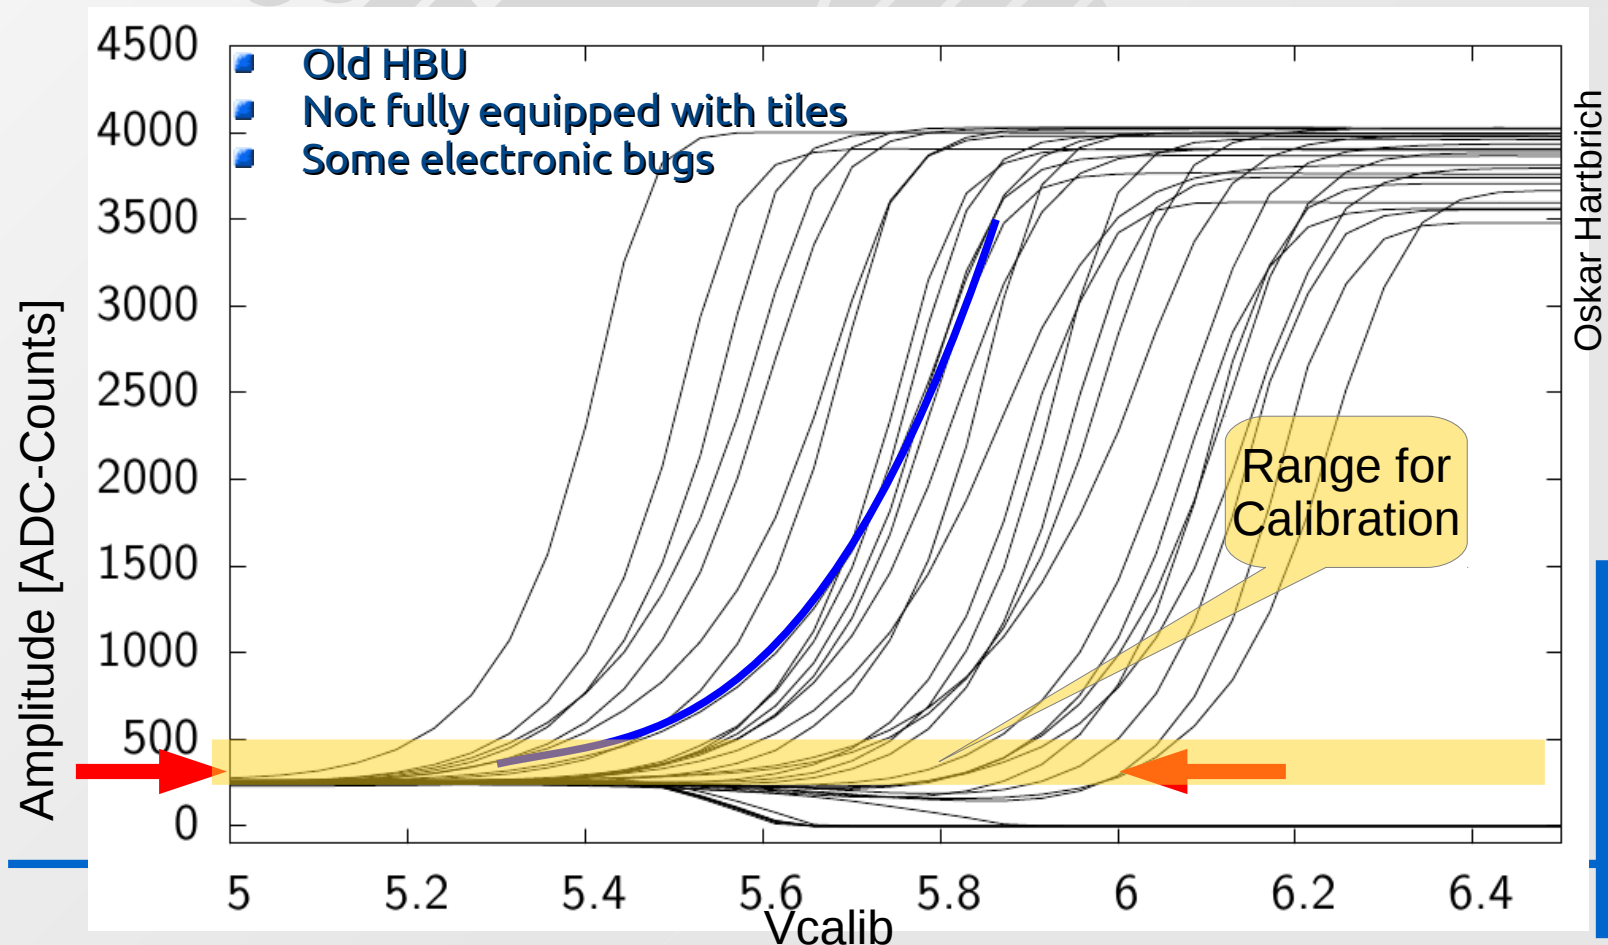
- Sweep Vcalib & measure SiPM-signal
- **Large spread in light yield** (light starts at 5 – 6V)
 - Too much to be compensated by tuning capacitors
- Sometimes lower **slope**

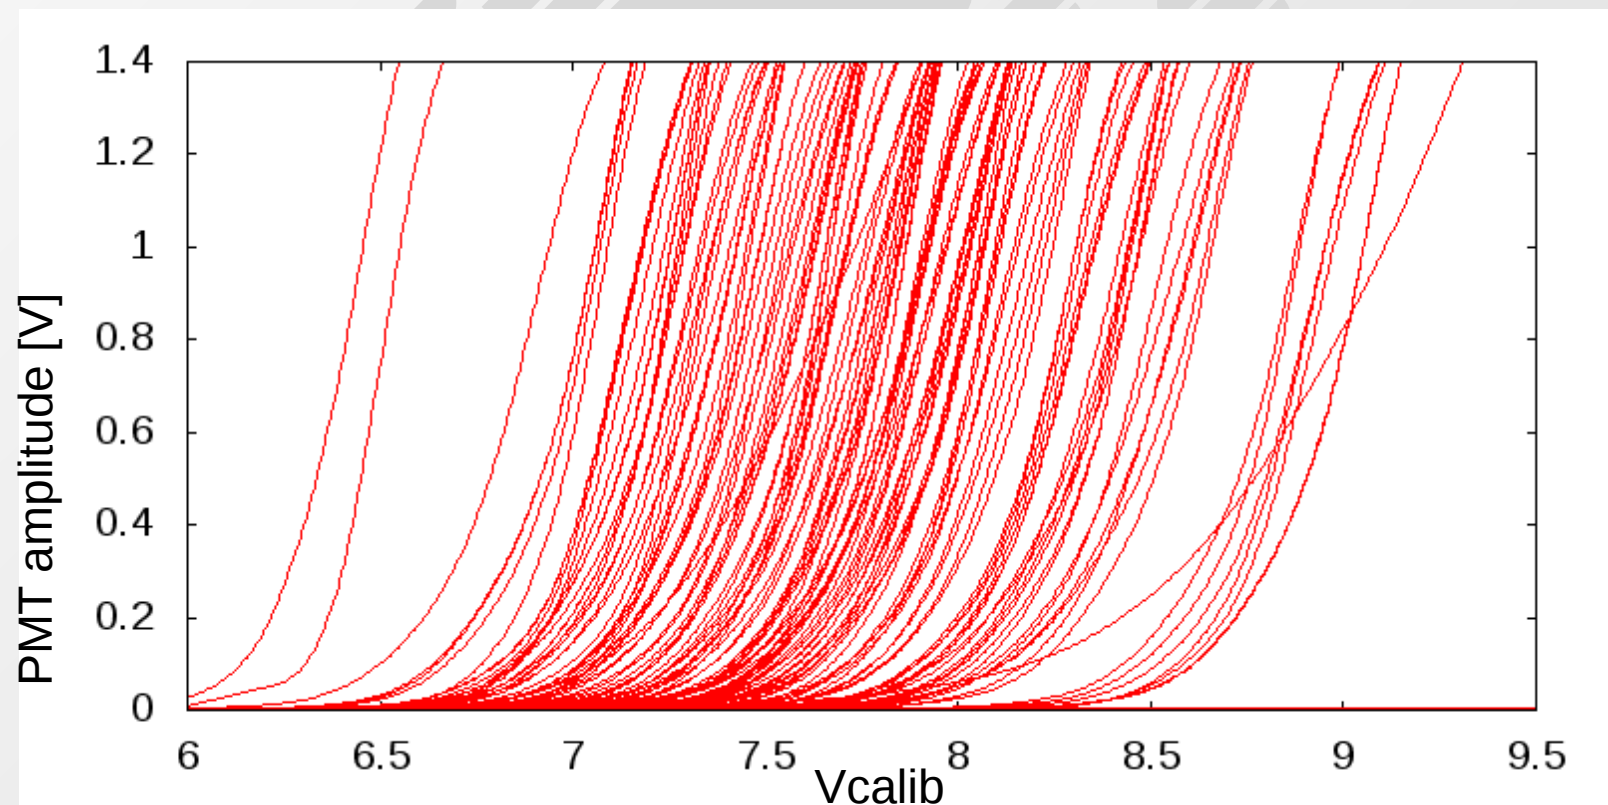
Vcalib scan with PMT

- 124 channels (20 not working due to technical reasons)
- Same effect, even worse observed
- → For SiPM calibration, several Vcalib settings needed!
- Is this part variance?

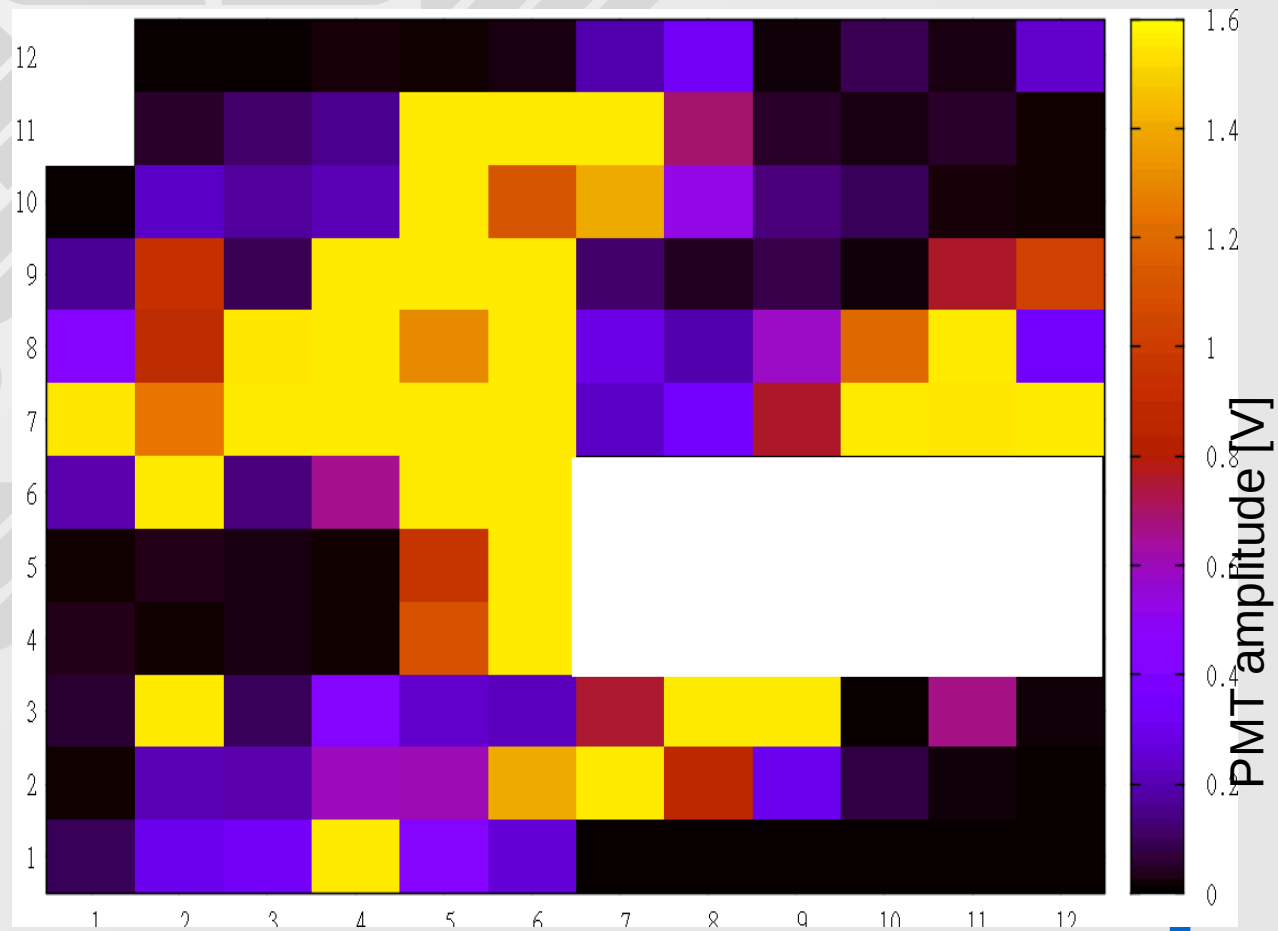
Vcalib scan with PMT

- Signal amplitude vs. LED position on HBU for one Vcalib
- Systematic, not random effect!
 - Not caused by part variance etc.
- Effect of trigger distribution

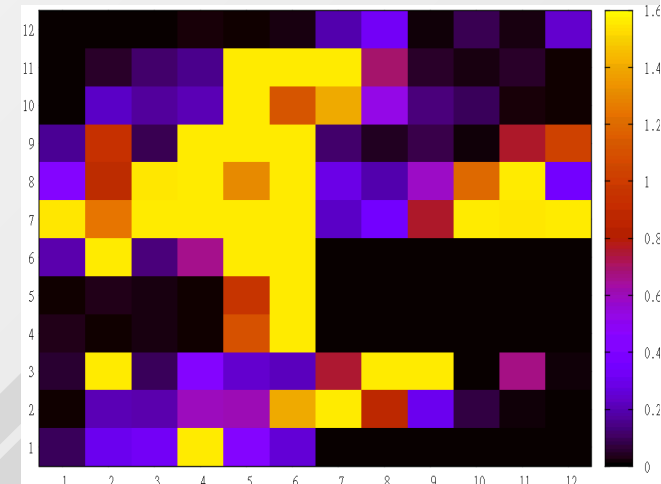
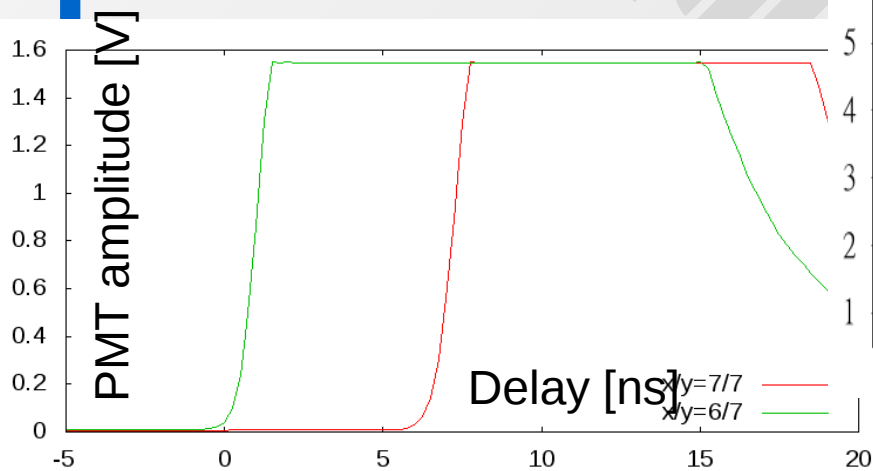
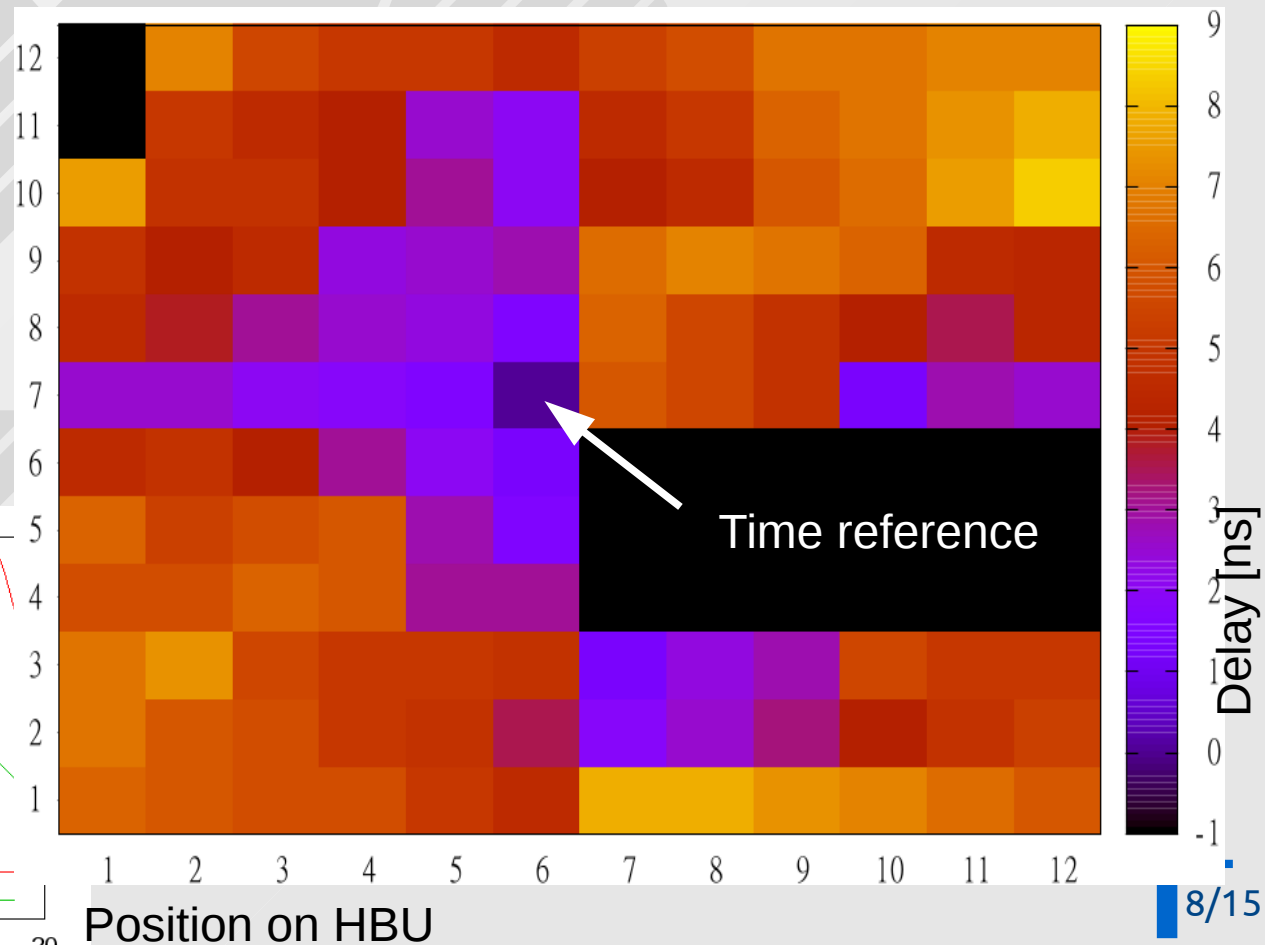
Timing

- LED system used for TDC measurements @DESY in past weeks
- Large delays between channels observed
 - Can not be PCB track length
- Confirmed by PMT measurement: delay up to 9ns
- Correlation with amplitude!

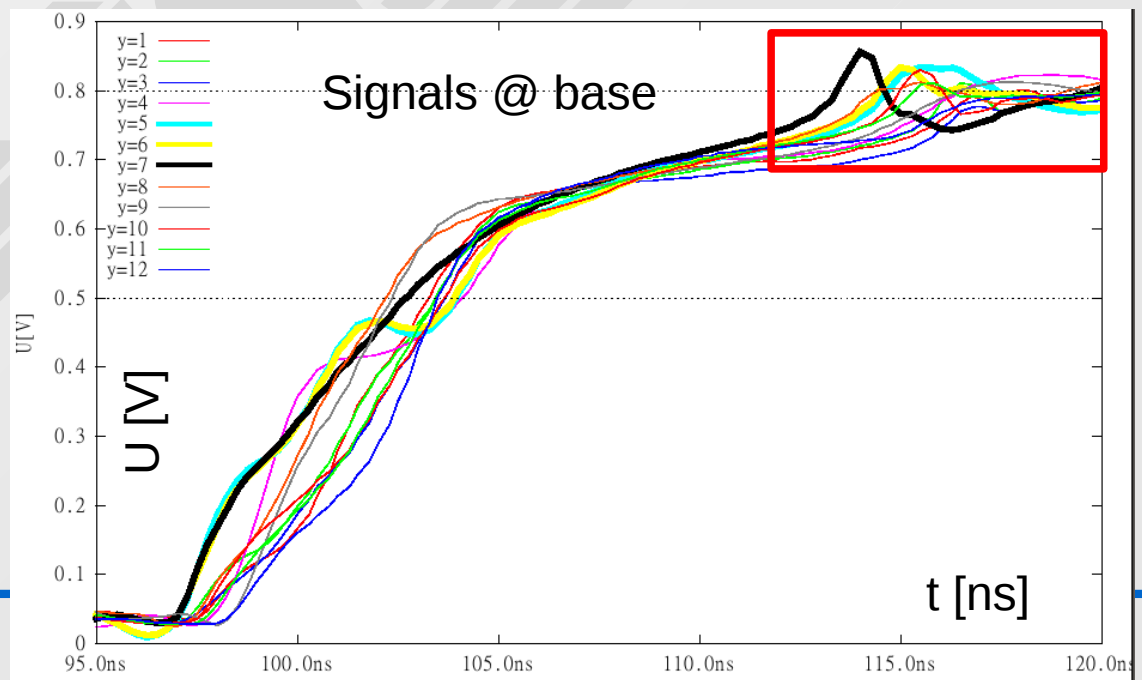
Timing & homogeneity

- LED-system was never intended for TDC measurements!
- Delay not important for SiPM calibration: $O(50\text{ns})$ integration time!
- However, correlation with homogeneity problem
- Problem tracked down to LED trigger distribution:
 - Track inductance & signal reflection
 - Weak drivers
- May/should be solved in future versions

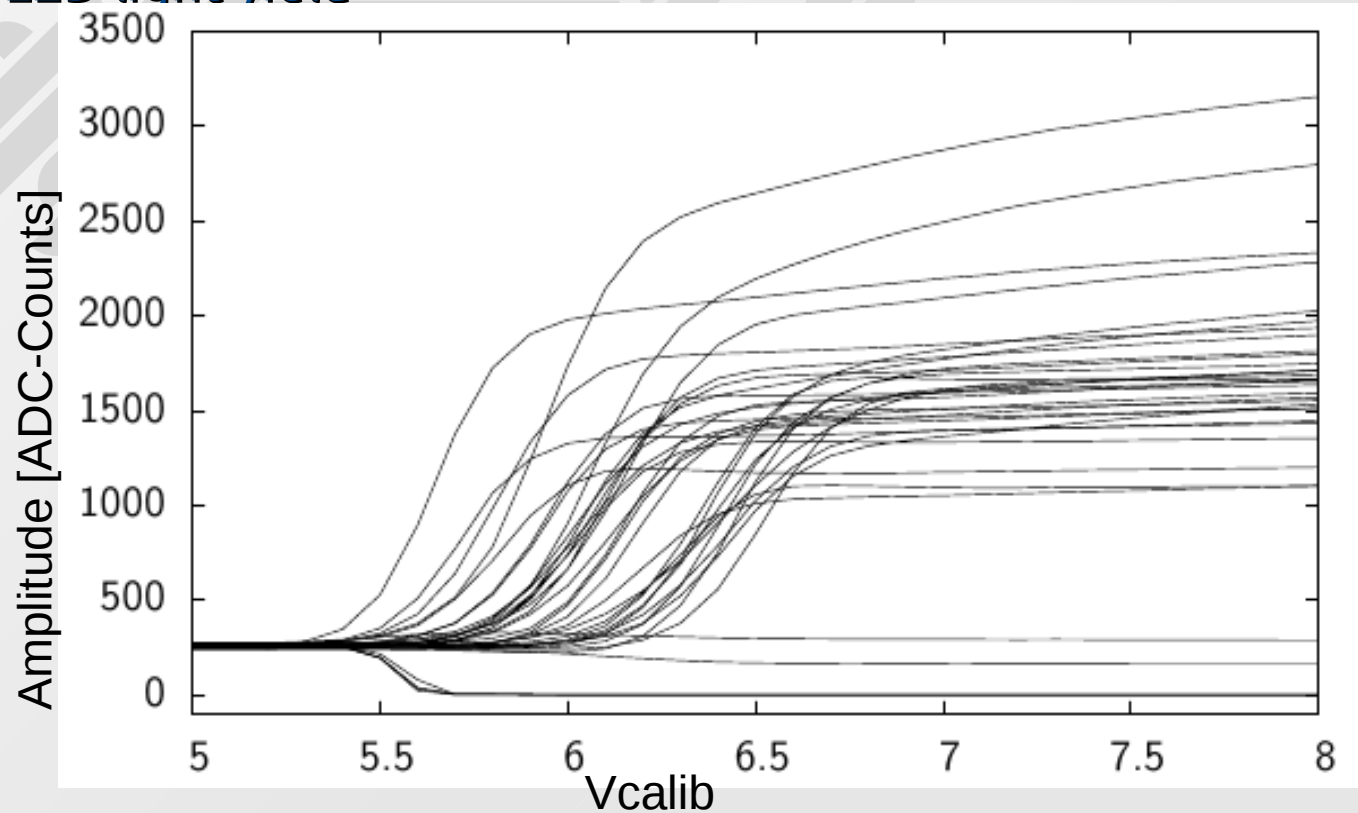
Saturation on HBU

- Saturation effect can also be observed with HBU
 - But no monitoring of LED light yield
- Various slopes at plateau
- different saturation levels
 - Signals not calibrated → electronic bugs
- Also spread in LED light yield
