Goal of this Enterprise ↓ Accelerator Module Assembly assembly of 103 accelerator modules with 1 per week throughput ! operated by an industrial contractor on the Saclay site and CEA infrastructures.

CEA Project Timeline

Assembly Industrialization

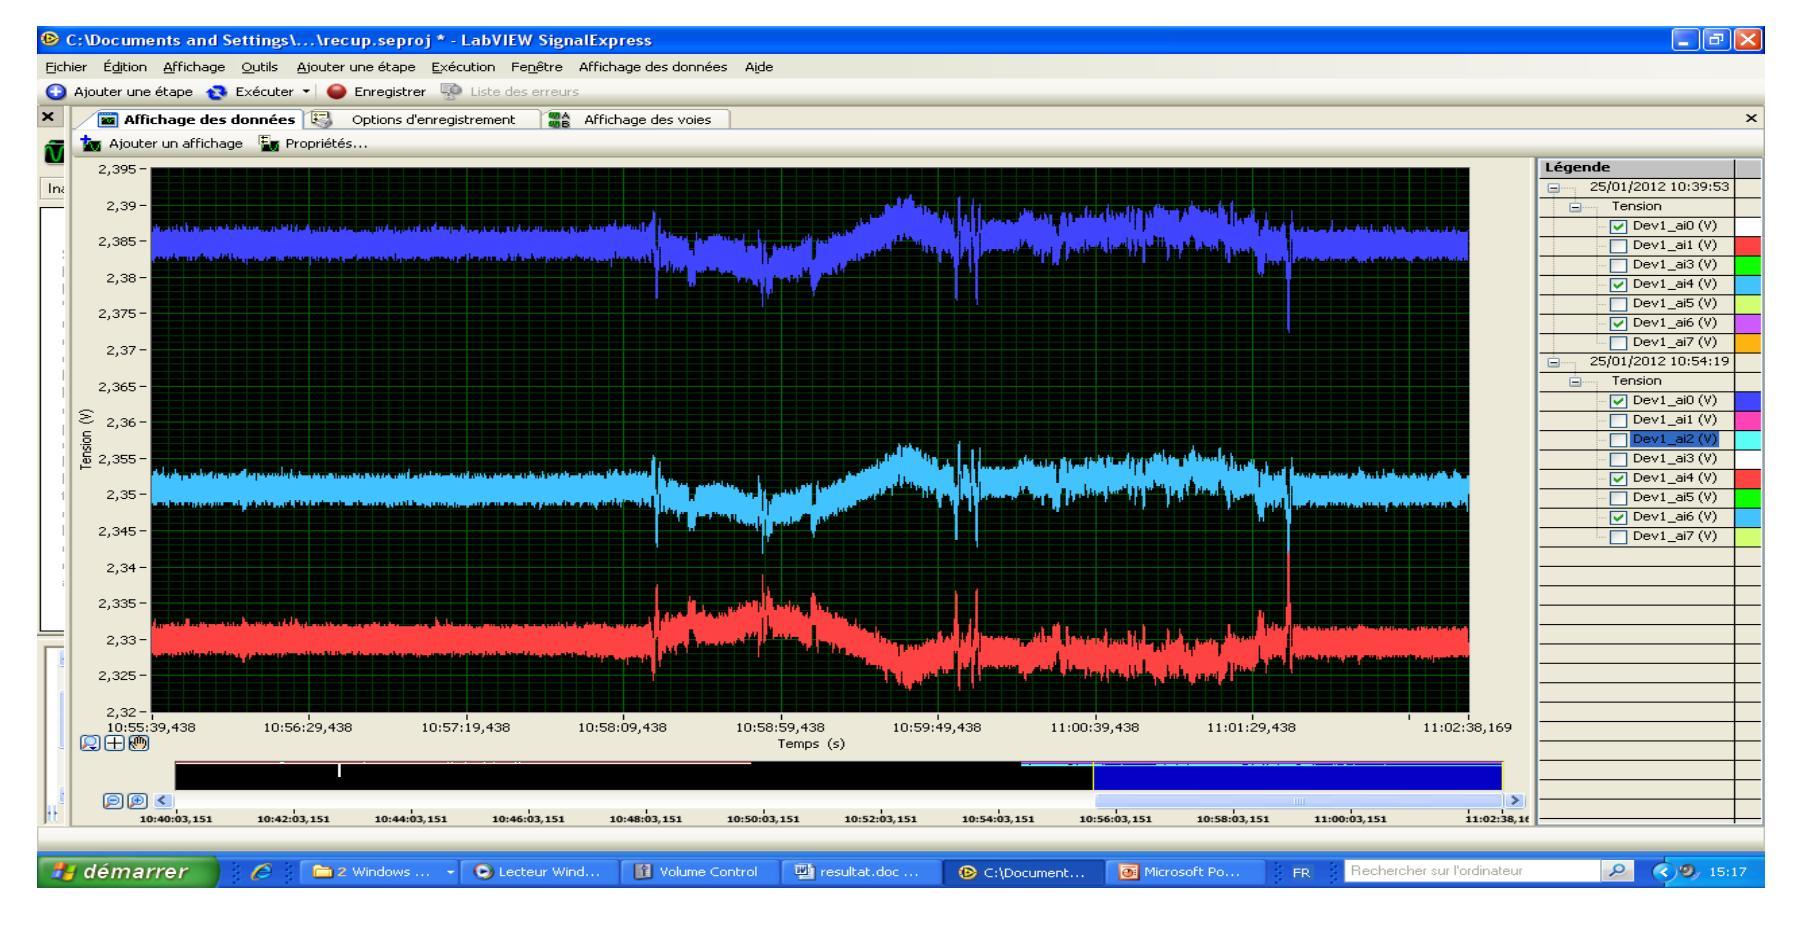
Exiting through the door from B126 to inner Yard

- Signal Amplitude = 10,4 mV. Sensitivity of accelerometers = 87mV/g.
- Acceleration is about 0,12 g along x-axis (transverse horizontal)

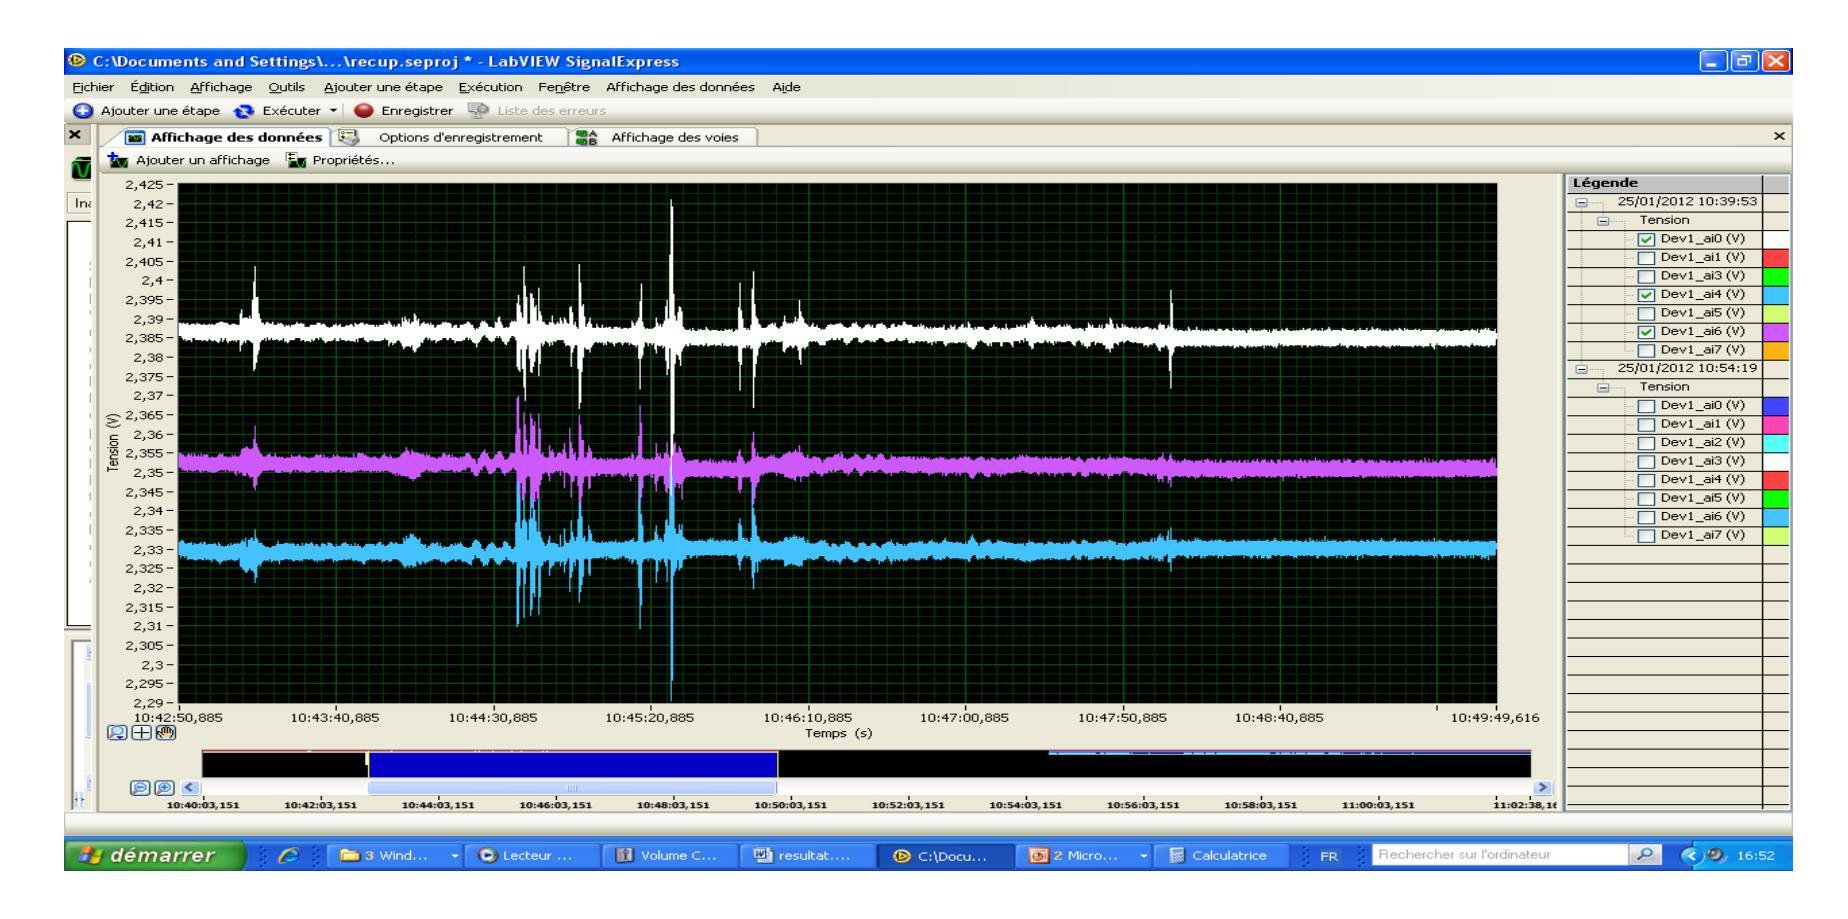
Transfer of the (empty) girder on the alignement pillars (b124)

x-axis (transverse horizontal)

- first (short) signal is girder take-off from the frame: 0,34 g at the center.
- second (long) signal is positioning on the pillars: 0,87g maximum

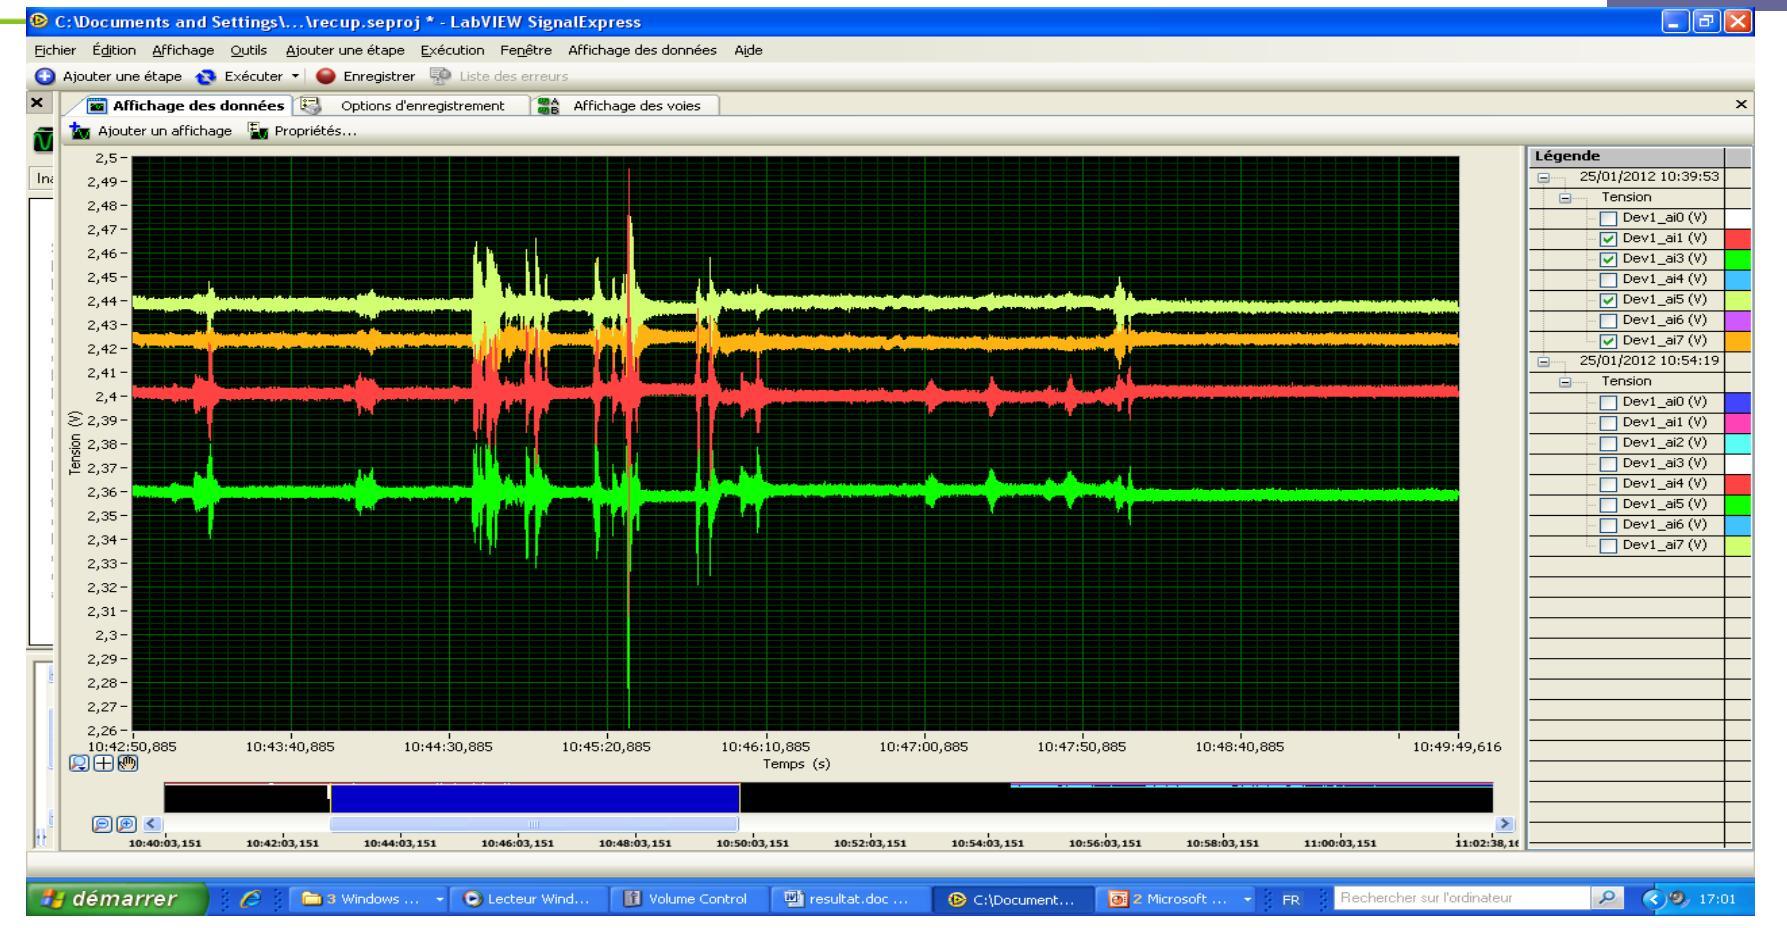
y-axis (longitudinal)

- first (short) signal is girder take-off from the frame: small
- second (long) signal is positioning on the pillars: 2,3 g (center) et 1,2g (upstream end)

- Vibrations are large, especially for the vented string, however PXFEL2_1 RF was not degraded.
- New measurement campaign with XM-2 transfer rom Roll-out till Warm Coupler workstations

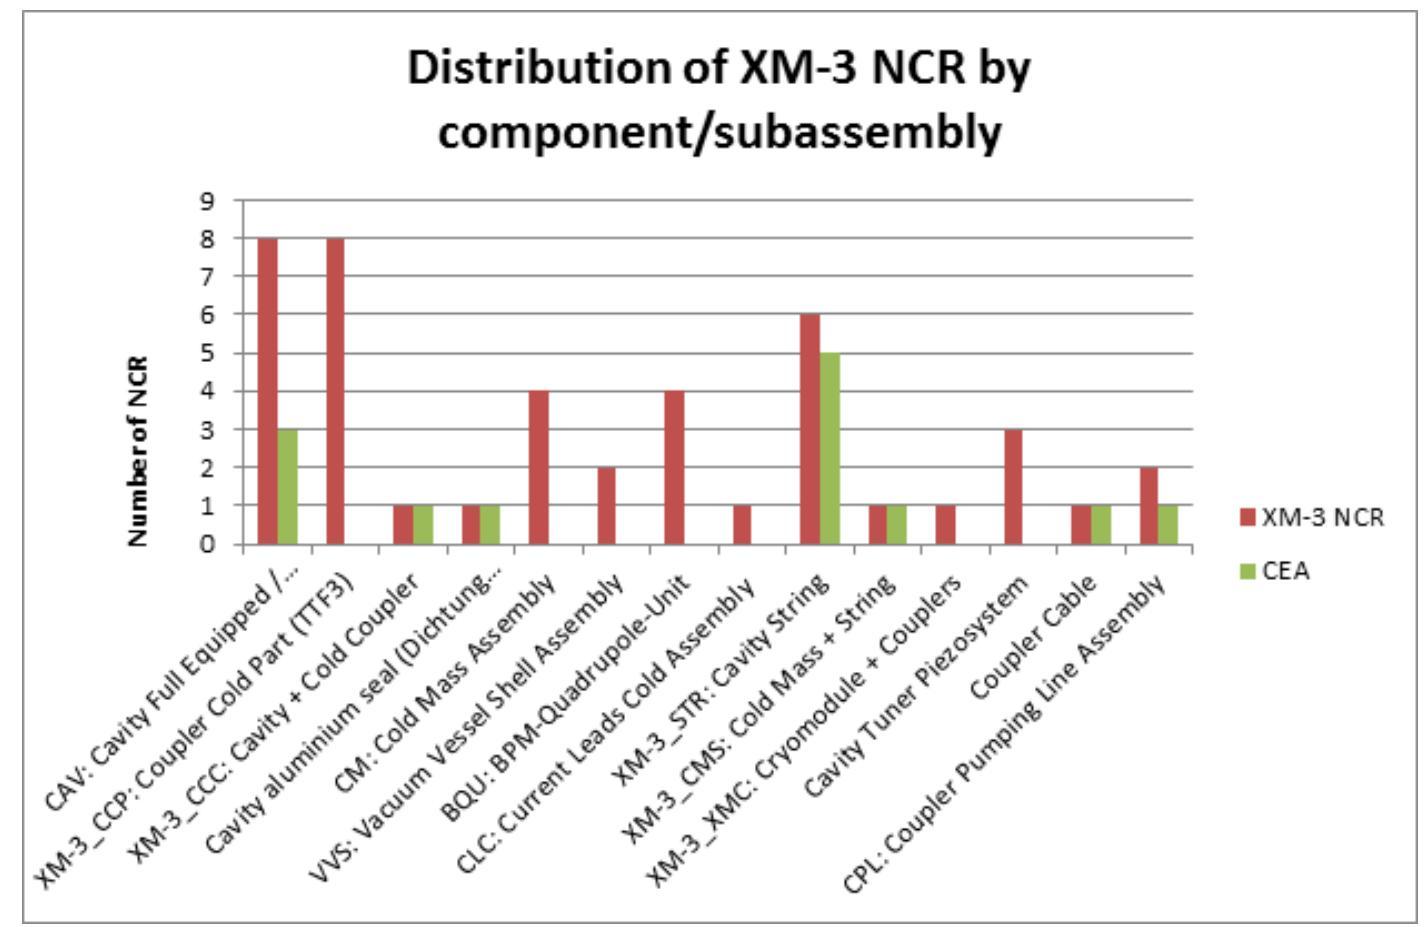
• We have observed still many non-conformities

In total 43 Non-Conformance Reports (NCR) were issued for XM-3, some global, about 13 NCR under the responsibility of CEA: one main reason for 7 month assembly.

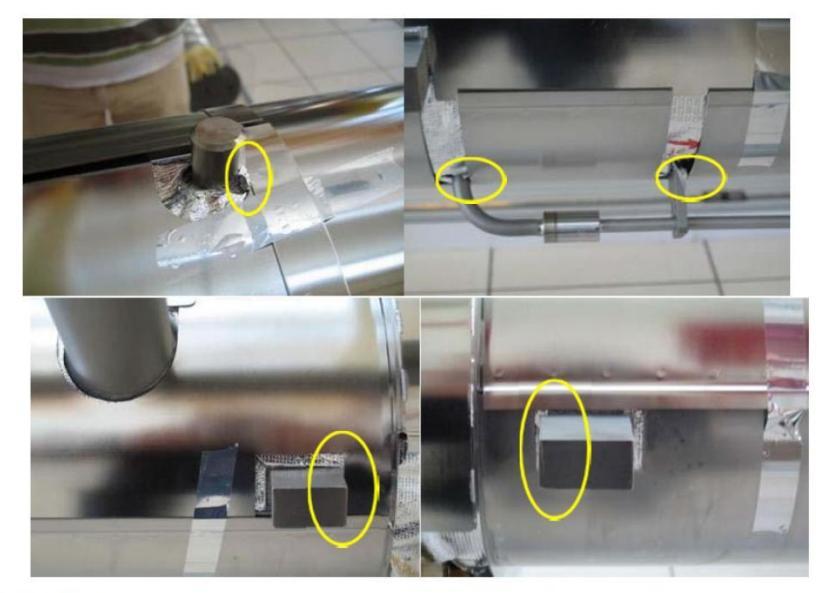
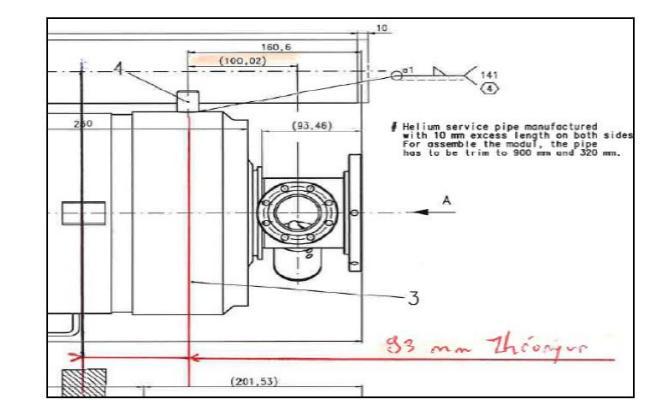
Assembly of the magnetic shield on the cavity AC158 :

| | | NON | CONFORMANCE REPO | RT | Reference | CEA-XFE |
|---|---|---|---|---|---|---|
| TITLE : | Deviation of the Pin | in the longitudinal posi | tion | | | |
| We observed on th | e cavity AC158 that t | he assembly of the new | vly produced magnetic s | hield was too tight | (cf. pictures | page 2). |
| AC15-103 mm in | stead of he nominal 9 | 3 mm +- 2 mm | | | | |
| This result was rep | roduced for all eight) | KM-3 cavities AC114, A | C146, AC151, AC152, A | AC154, AC156, AC | 157, AC158 | |
| On the cavity was i | measured a deviation | on the PIN (draw, 02) | pos 4) in the longitudin | al position: | | |
| The nominal distan | ice from the cavity bra | cke centert to the PIN | center is 93mm – measu | ured ~103mm | | |
| The nominal distan | ice from the coupler fl | ange center to the PIN | is (100,02mm) – measu | red ~96mm | | |

| The nominal distan | ice from the coupler fl | ange center to the PIN | is (100,02mm) – measu | red ~96mm | | |
| | - | | | | | |
| The connection of | the cavity string to the | cold mass will have to | be given a particular at | ention in view of | MINOR : | |
| the shrinkage of the | e cold mass during co | ool-down. | | | MAJOR : | |
| Check of the heliur | m tank dimensions for | the industrially produc | ed cavities. | | DOCUMENT/ | ATION |

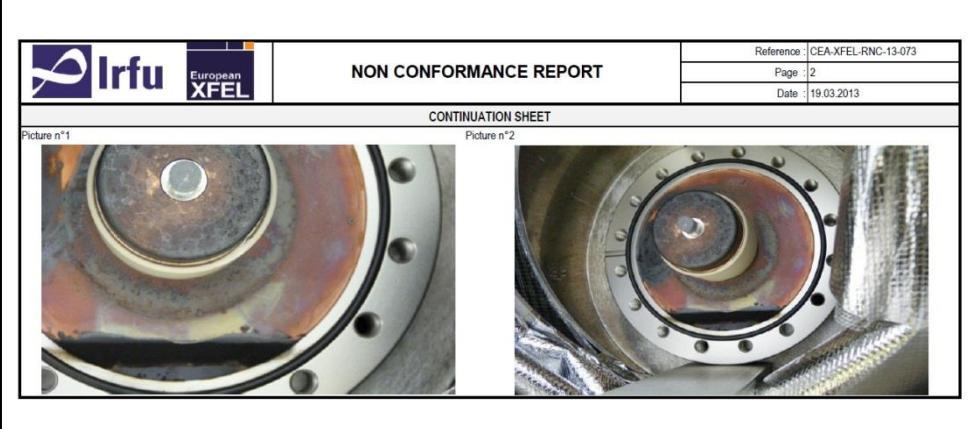
| | | | | Reference : | CEA-XFEL-RNC-13-073 | | | | | | |
|---|---|--|---|---|---|---|--|--|--|--|--|
| TITLE : | Water and broken ceramics in the | e cold part of the coupler | AC3C28 | | | | | | | | |

| | | | | Reference : | CEA-XFEL-RNC-13-073 | | | | | | |
|---|---|--|---|---|---|---|--|--|--|--|--|
| Water failing out of the cap, and indeed the copper coaling is oxidized (cf. pictures n°1 and n°2). Water may have entered the cap hough the valve during the washing of the coupler pair since one can see a trace of oxidation inside the cap in front of the valve hole (cf. picture n°3). The level of water straying in the cap for about 6 months, is indicated by the duriner hove rates on the picture. Ja broken commits (cf. pictures n°1 at 4h30 orientation, and n°4). One can see traces of broken ceramics on the cap (cf. picture n°5) and also on the tool (cf. picture n°6). Reference documents : | | | | | | | | | | | |
| loose. 2) We are investigating when the coupler pair, or when ope | n the breaking of the ceramics hap ening the ceramics cap. | pened: due to the presen | ice of water, it could have happe | ned only before the washing of | | | | | | | |

| | | | | Reference : | CEA-XFEL-RNC-13-073 | | | | | | |
|---|---|--|---|---|---|---|--|--|--|--|--|
| The oxidation of the coppe localy removed completely (c 2) The broken ceramics piece sharp edges. | er coating was removed by wiping sf. picture n°7) e was removed and the sharp bra | it with sullfamic acid and zing material layer (cf. pic | rinsing with ethanol. Unfortunate | ly, the copper coating has been is much as possible to prevent | S. Berry, F. Hoffmann | | | | | | |
| 1) Do not enter the cold coupler pairs in the ISO4 dean rothrough the washer-dryer until the origin of the water leak is found. 2) Preventive actions will be defined when the origin of the ceramics breaking is found. | | | | | | | | | | | |

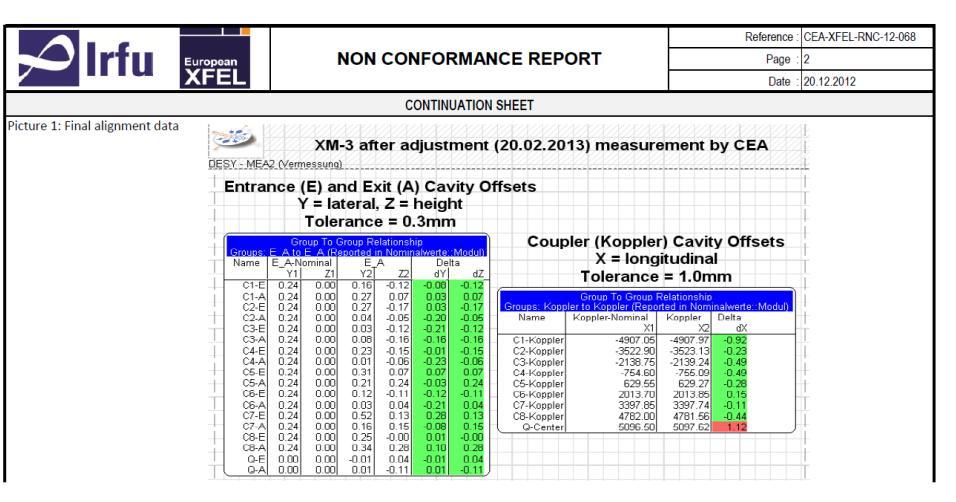
| | | | | | Reterence : | CEA-XFEL-RNC-12-068 | | | | | | |
|--|---|--|---|--|---|---|--|--|--|--|--|--|
| DESCRIPTION : | Problems during the cavity a | nd quadrupole alignment | | | | | | | | | | |

| | | | | | Reterence : | CEA-XFEL-RNC-12-068 | | | | | | |
|--|---|--|---|--|---|---|--|--|--|--|--|--|
| During the first attempt (23/01/13), cavities n°1 to n°5 were released by mistake from the invar rod, hence shifting significantly from their longitudinal position. JAffer the second attempt (23/01/13), alignment was off tolerances mainly due to a wrong definition of the reference frame. The proper definition was then instructed by DESY. JAfte third attempt (20/01/13), alignment was off tolerances mainly due to a wrong definition of the reference frame. The proper definition was then instructed by DESY. JAfte third attempt (20/01/13), alignment was off tolerances with good agreement between CEA and DESY data, but two needfle bearings were found lose (cavity n°3 and n°5, tbc). Aft the fourth attempt (20/02/13), the alignment was accepted by DESY, with a derogation for longitudinal position of the quadrupole (cf. Picture n°1). XM-3 assembly was continued. | | | | | | | | | | | | |
| was found 1.5 mm away fror expanded towards its upstre 3) the torques of the bush so torque of the bushes pushing | n its nominal position. By mis am end and cavity n°1 has b rews was checked systemati g the loose needles bearings | take, cavities n°1 to 5 were u een measured 14 mm off lon cally on the coupler side of th were not on specifications. | nfastenned from the Invar roo gitudinally. e cavity string (vertical and h | d: as a result, the string orizontal bushes). The | | | | | | | | |

The Cavity Alignment Procedure had to be repeated 4 times, essentially due to mishandling by CEA and a technical problem on the needle bearings fixtures: \rightarrow 1 calendar month, instead of 3 days.

| | | | | | Reterence : | CEA-XFEL-RNC-12-068 | | | | | | |
|--|---|--|---|--|---|---|--|--|--|--|--|--|
| DESY sent us the tools ne 2) CEA implemented the cor 3) The torque of the bushes attributed to their seizure sin the springs were not correct | eeded to displace the cavities rect reference frame in the pr was checked along the string ce the problem was fixed after y piled up. | longitudinally and the longitu st-processing of the raw data .The two bushes of cavity n° r manipulation of the bush by | dinal alignment of the string v a. Agreement was then reach 3 and n°5 were found incorre hand. Some bushes were di | vas corrected (25/01/13). ed with DESY. clty fastened. This is smounted and in one case | M. Fontaine, J-P. Charrier | | | | | | | |
| In order to prevent the sei In general, CEA will impleme | zure of the bushes, it is envis ent the practice where the sur | aged to use vacuum grease. veyor is not involved in the ca | also be checked operations. | K. Jensch, J-P. Charrier | | | | | | | | |
