# ILC Cryo-module studies

- Bellows and stability issues in interconnections
- St.steel/Ti transitions by explosion bonding: first results

CERN, AT/MCS C.Garion, V.Parma  
CERN, TS/MME G.Arnau, A.Gerardin, S.Sgobba,

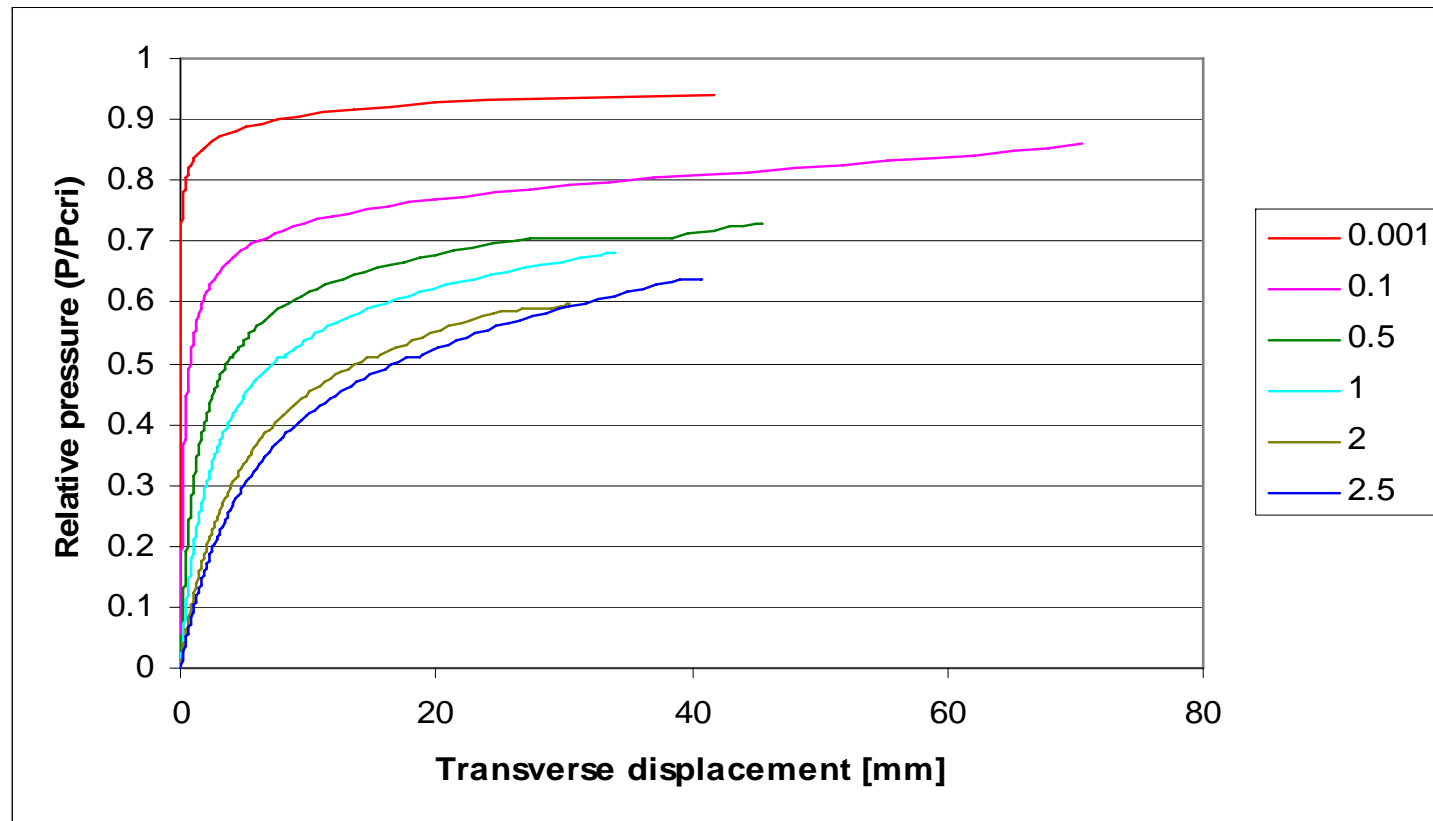
# Thermal shield stability: sensitivity to initial imperfection

Initial imperfection can lead to **large transverse displacements** at relatively low pressure:

- plastic deformation of bellows
- large transversal forces → cavity/quads alignment?
- interference with other equipment

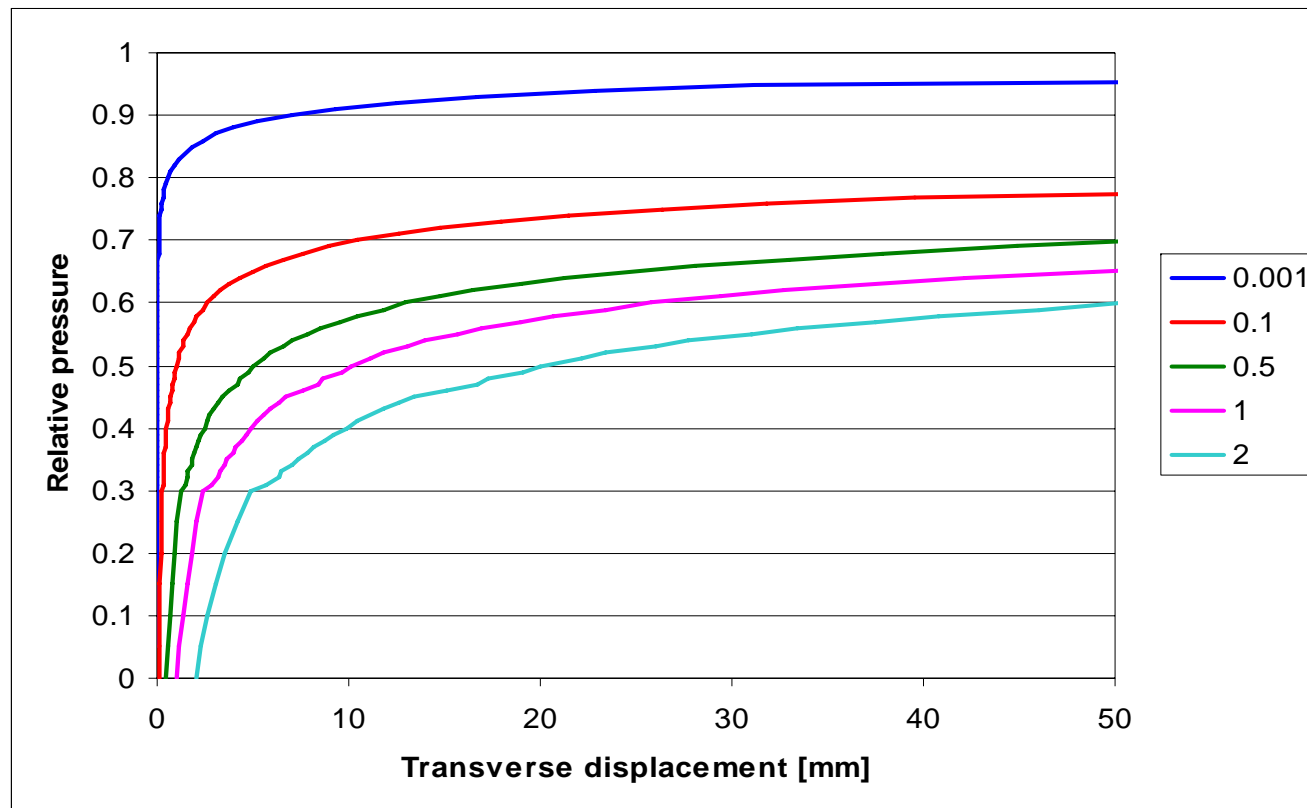
# Pumping line stability: sensitivity to initial imperfection

Hypothesis:

- Tube diameter: 300mm, tube thickness: 2 mm (instead of 3mm)!
- Bellows axial stiffness  $\sim 150\text{N/mm}$

(Critical pressure: 13.3 bars (need to be recalculated for a tube thickness of 3mm))

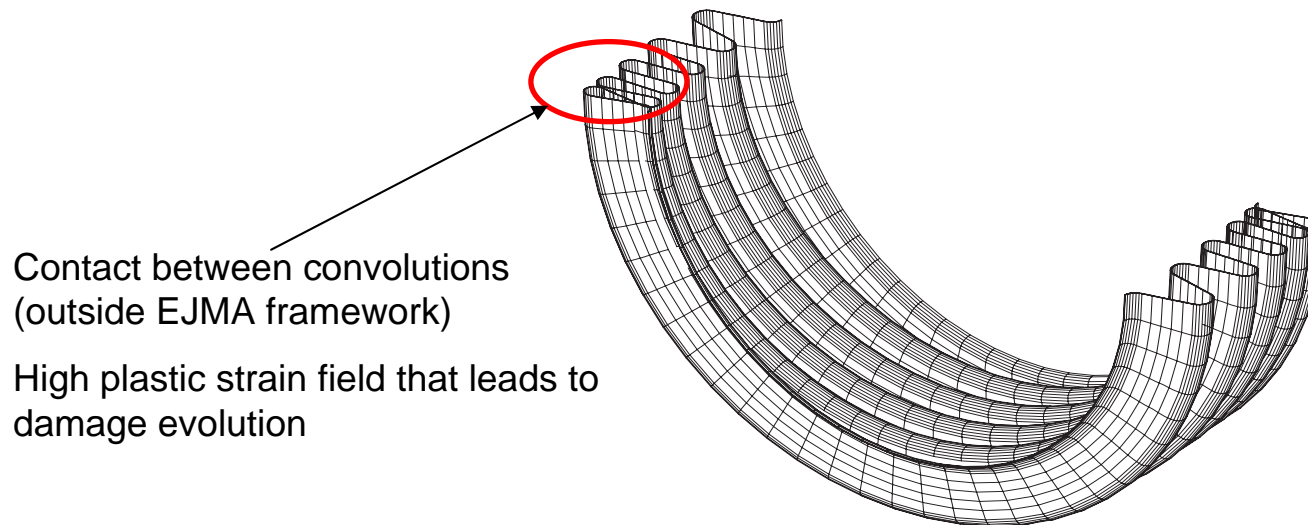
# Intercavity bellows

Preliminary study has been done for short version (5 convolutions):

- Under axial stroke (4mm), high cycle fatigue should occur ( $10^6$  cycles),
- Introduction of a lateral offset of 4mm leads to probably low cycle fatigue regime and local contact between convolutions,

- Global stability could be an issue
- More detailed study of thermal shield and puping line bellows can be done
- Model of the intercavity bellows has been done. Fatigue life can be estimated.

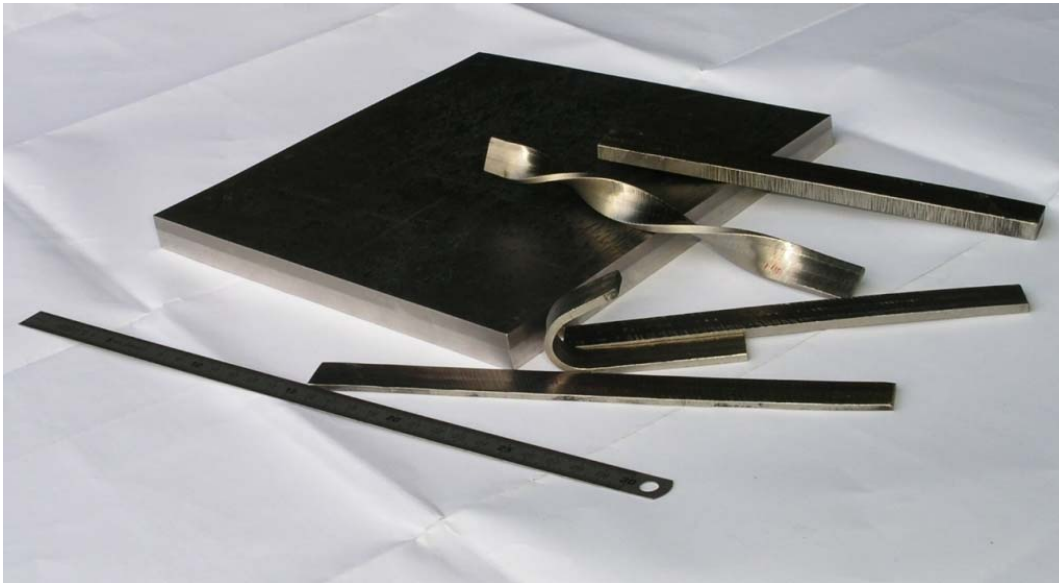
# Ti-316LN transitions by explosion bonding

- Prototype plate made for CERN by Powder Metallurgy Institute (PMI), in Minsk, Bielorrussia.
- Metallurgical characterization of samples.
- Pipe samples cut by electro-erosion:
  - 6 samples 42.8/48.2 (size of ILC connection pipe between He vessel and bi-phase pipe)
  - 4 samples 15.2/17.2
  - 3 samples 6/10 } Dimensions for which CERN has orbital welding machines

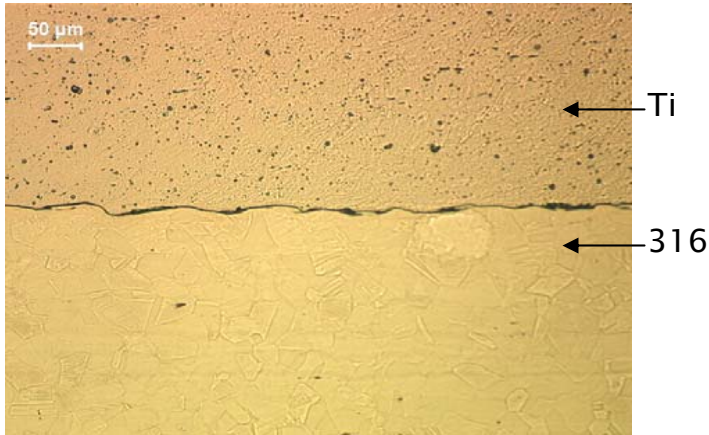
*Interface Ti/316 LN*

- No cracks detected
- Low 'wave' amplitude similar away and close to explosion location

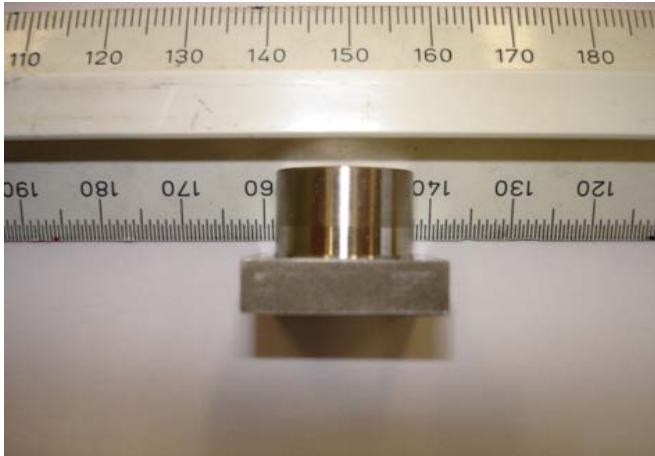
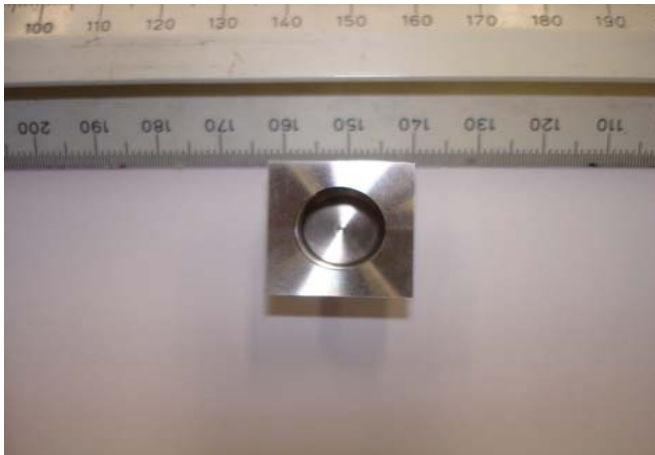
Samples

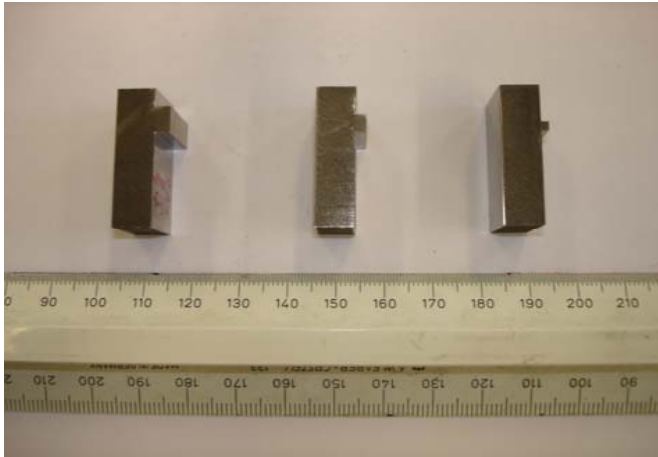
Samples

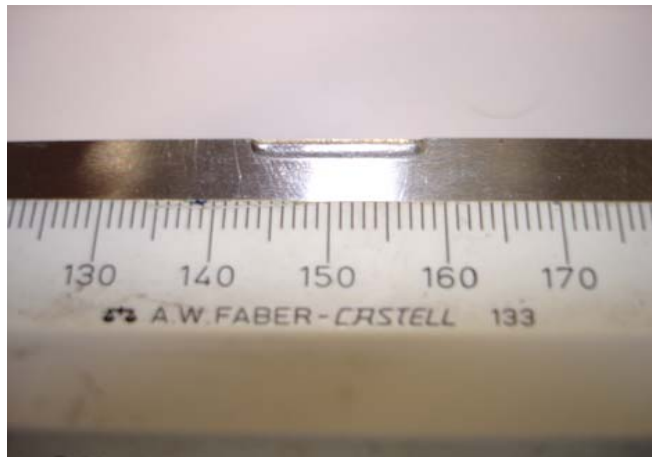
Distortion of the tooling before breakdown

- Maximum  $\tau$  measured  $\geq 360$  MPa , improved tooling will allow more accurate measurements
