Beam-induced EMI and detector electronics

Gary Bower, SLAC

EMI Studies at SLAC ESA

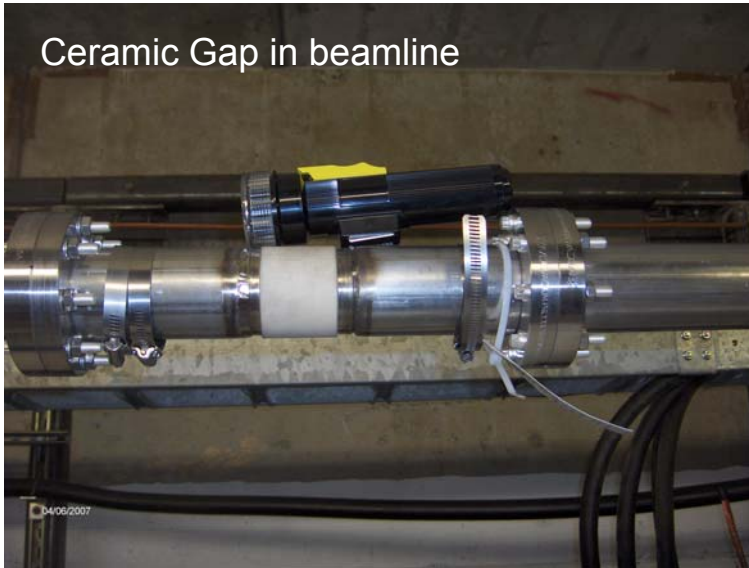
Ceramic Gap in beamline

- EM fields within the beam pipe are contained by the small skin depth.
- But dielectric gaps emit EM radiation out of the beam pipe.
- Common “gaps” are camera windows, BPM feedthroughs, toroid gaps, etc.

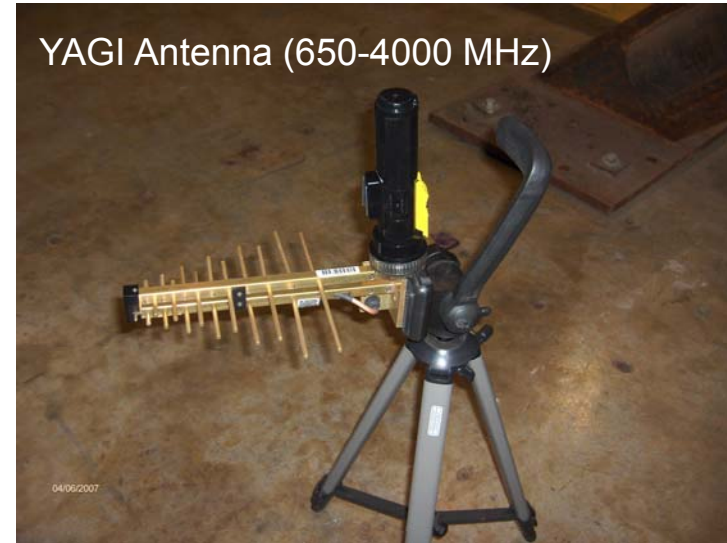
YAGI Antenna (650-4000 MHz)

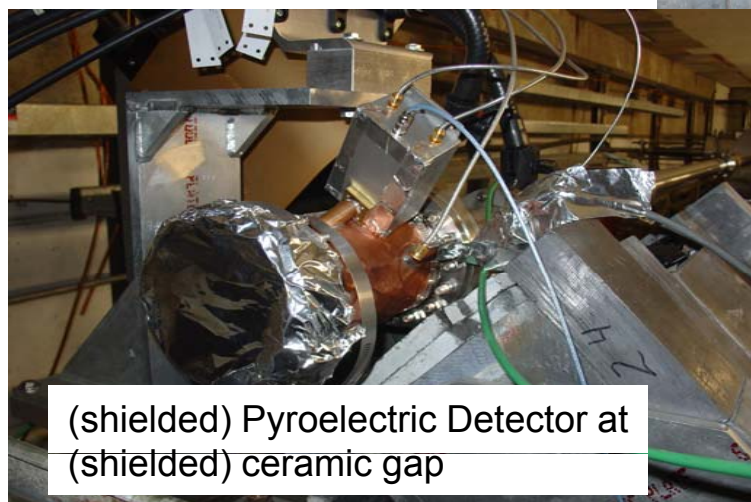
RF Bunch Length Detectors in ESA

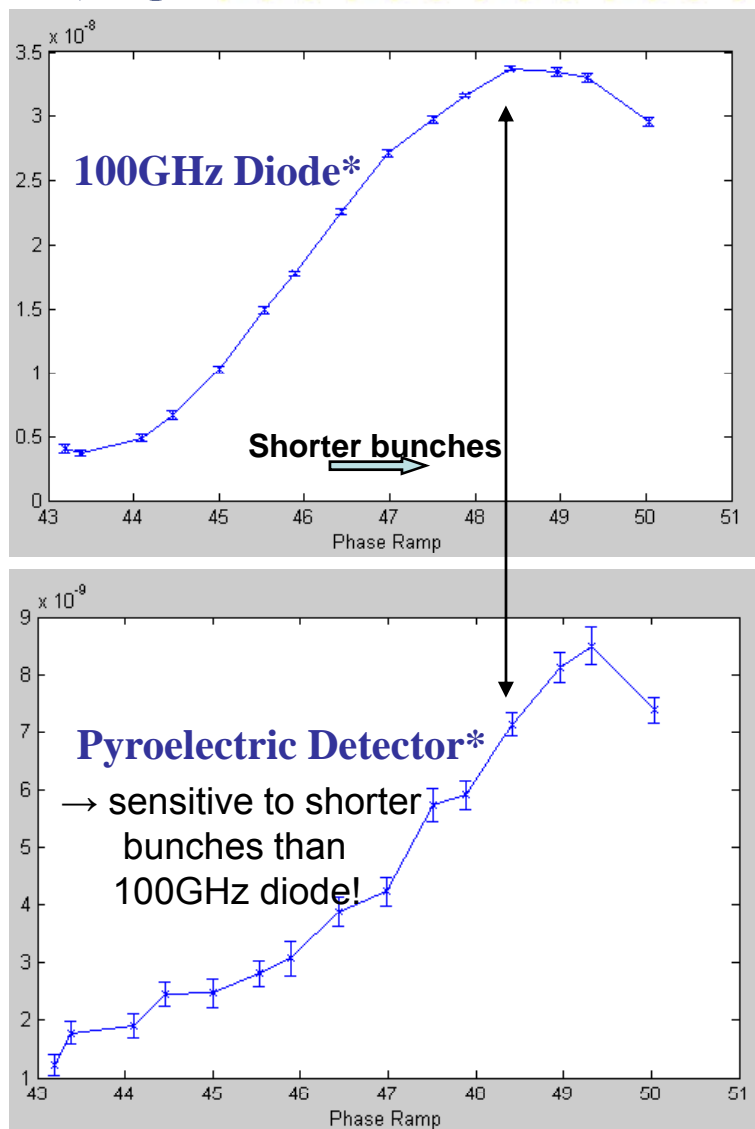
Bunch Length Measurements vs Linac rf Phase

(phase ramp determines relative timing of beam wrt accelerator rf)

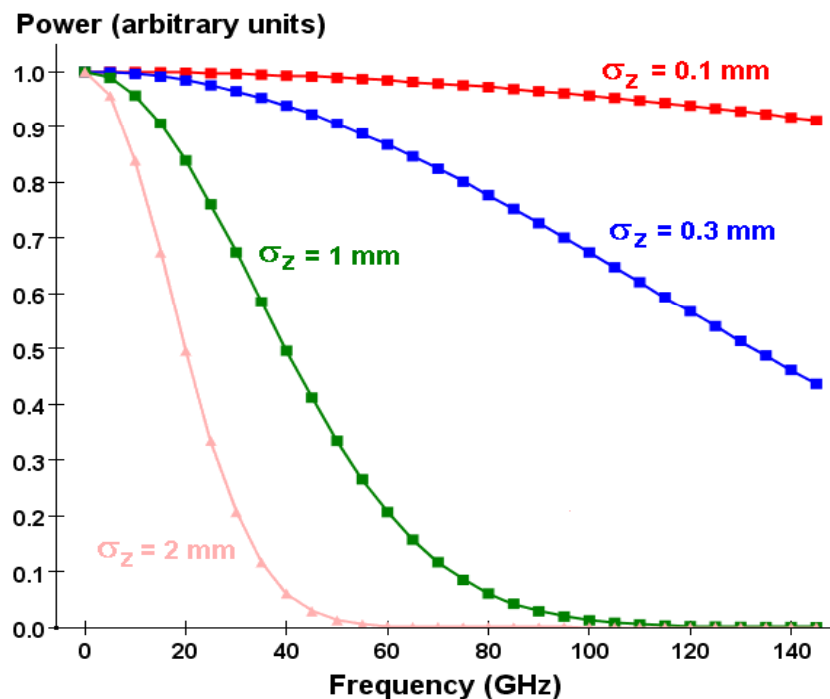
$$P(\omega) \propto Q^2 \cdot \exp\left(-\frac{\omega^2 \sigma_z^2}{c^2}\right)$$

Power vs frequency for different sigma z

23GHz Diode was insensitive to bunch length
