# Plans for inspection, diagnostics — Eddy Current Inspection, and T-Mapping —

Y. Iwashita and H. Hayano

# Eddy Current Test for Nb Plate

# T-mapping

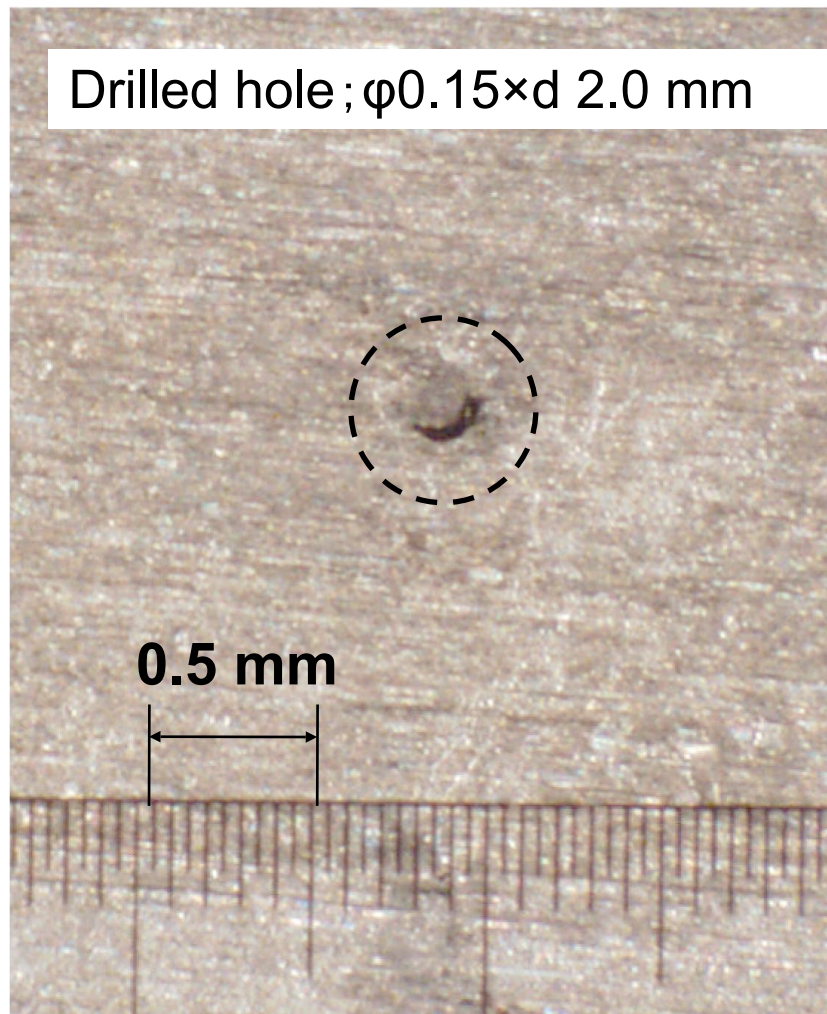
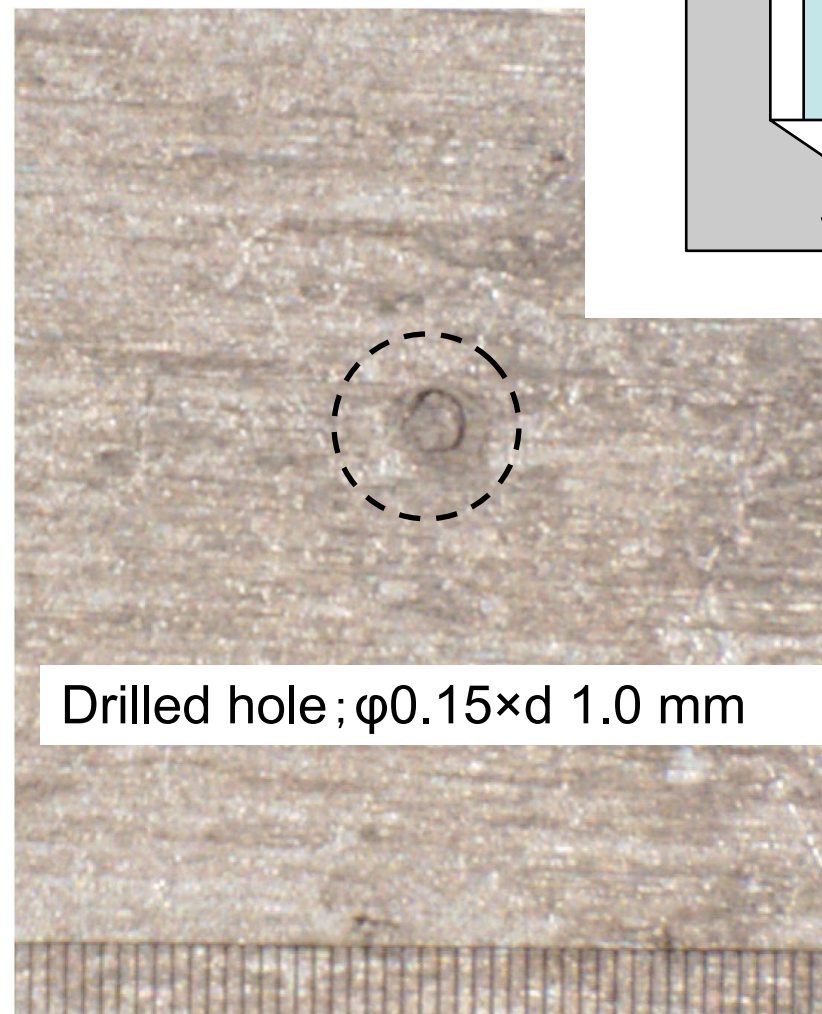
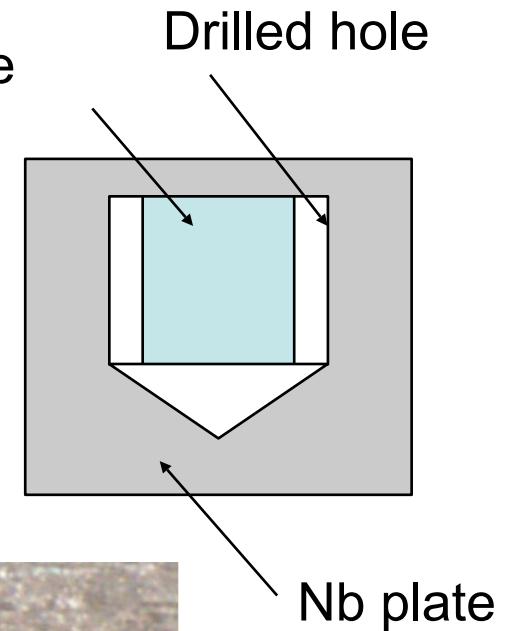
Photo. 1 Artificial Ta contamination

(b) Nb plate with artificial Ta contamination as shown in Photo.1

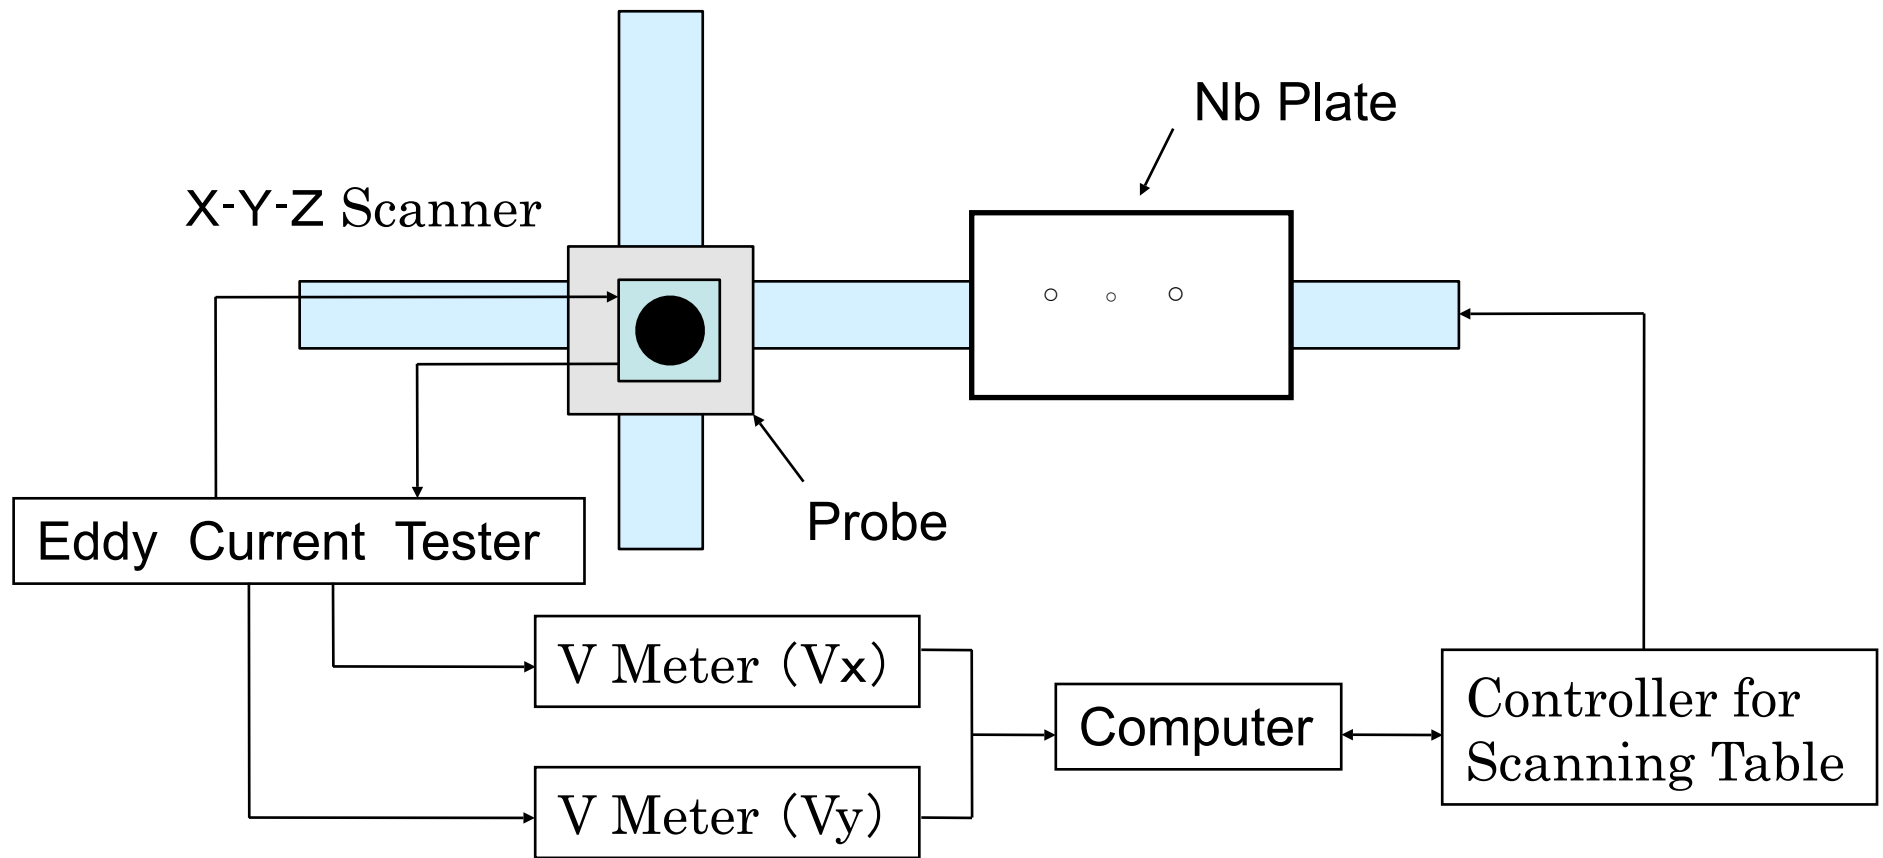
Fig. 2 Testing system for Nb Plate

Testing system is shown in Fig. 1 and is constructed by an eddy current tester that is specially designed by Hokuto Electronics, X-Y Scanner, digital volt meters and PC.

Figure 2 shows testing system .

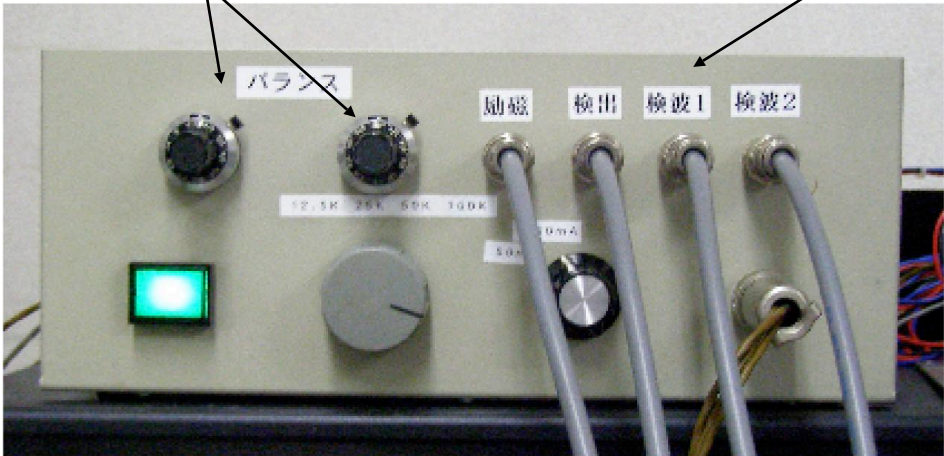
Photo. 3 Eddy Current Tester

Null adjuster

Monitoring terminals

- Exciting wave
- Detecting signal
- Demodulate signal (X,Y)

ET Probe

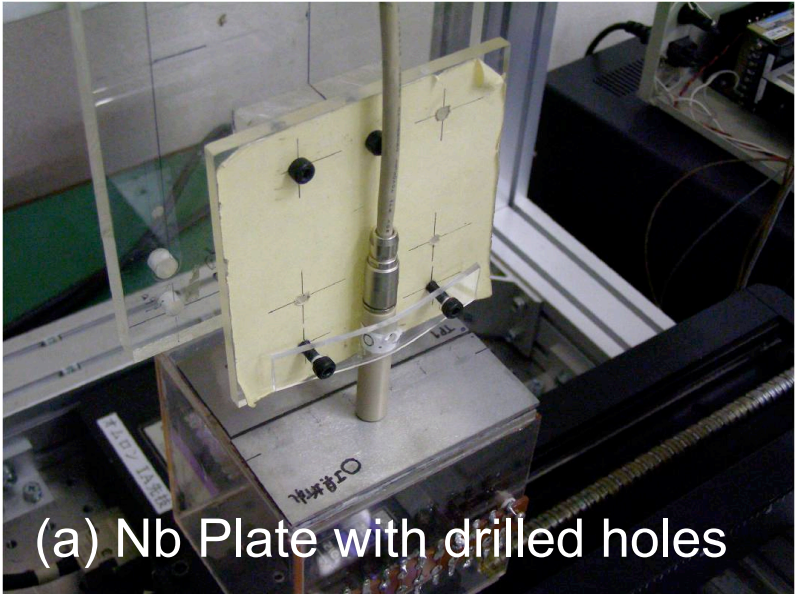
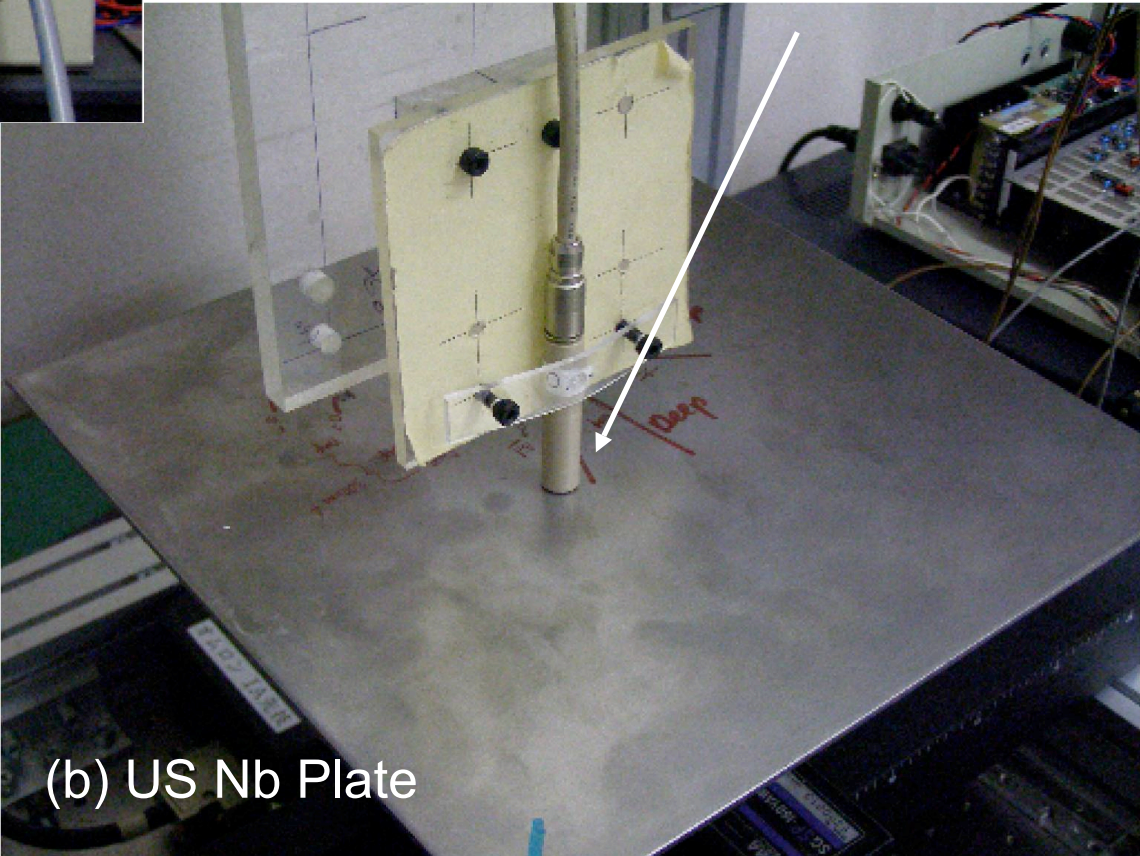
Photo. 2 Eddy Current Testing of Nb Plate

(a) Nb Plate with drilled holes

(b) US Nb Plate

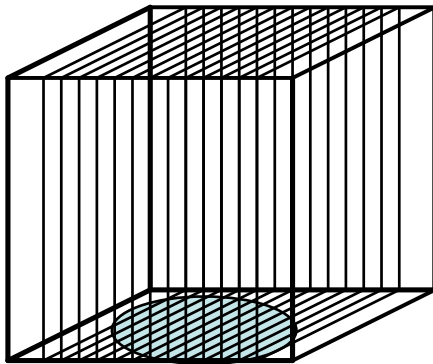
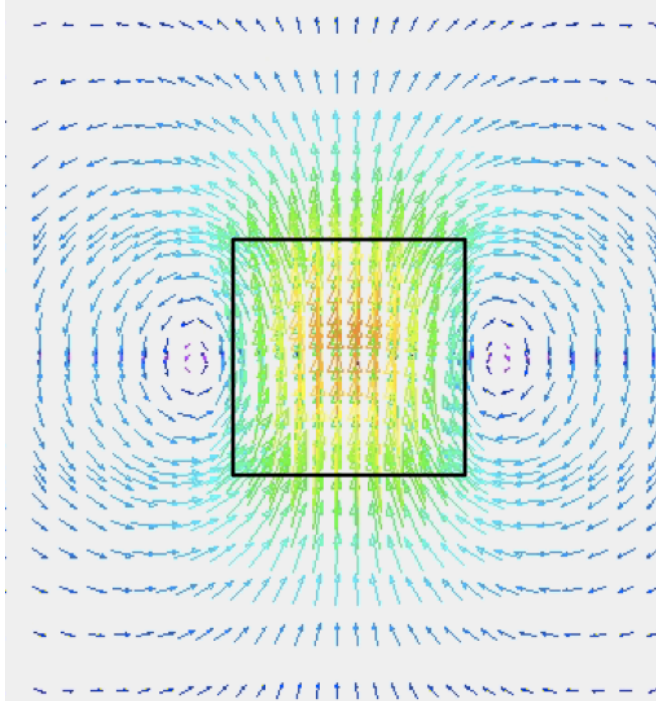
# Eddy Current Probe used for inspection of Nb plate

Flux sensing type probe

Exciting coil :Cubic type 5 × 5 mm

Detection coil : Thin film planer type

$\phi 5.0 \times t 0.1 \text{ mm}$ 、100T

Cubic exciting coil

Thin film planer coil

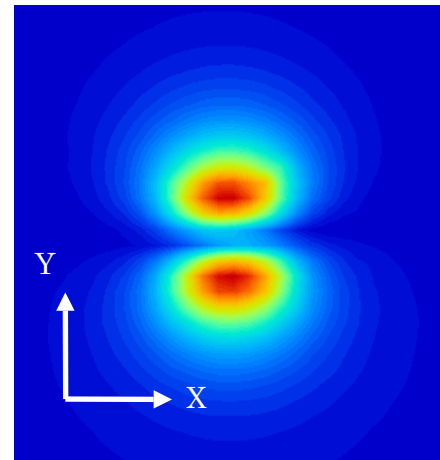
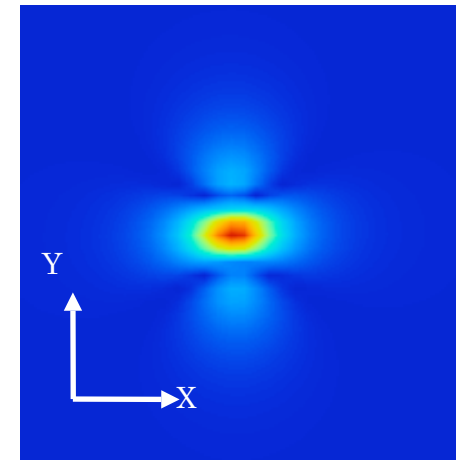
Profile of Exciting Magnetic Field (freq.:25 kHz)

(a) Vertical Component (b) Horizontal Component

Circular eddy current is observed in edge of exciting coil and eddy current is flowed straightly in central portion.

FEM simulation result

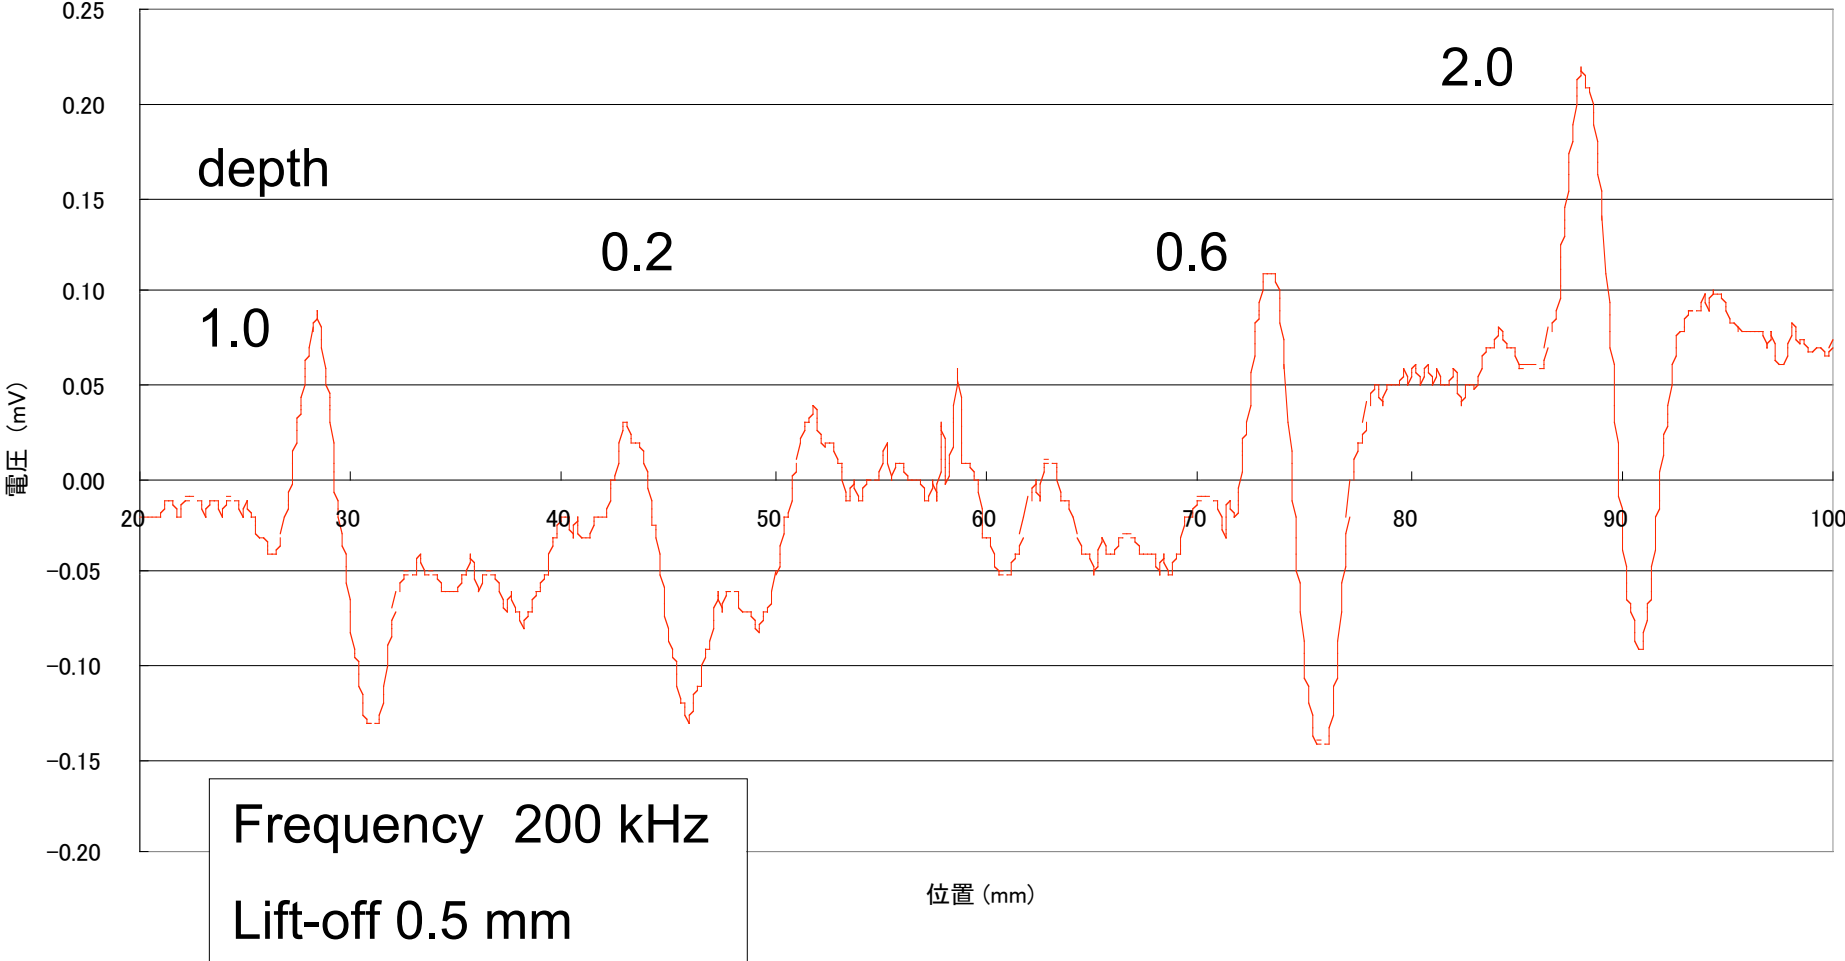
# Test Result 2 plate No.2

depth

diameter 0.15 mm

Frequency 200 kHz  
Lift-off 0.5 mm

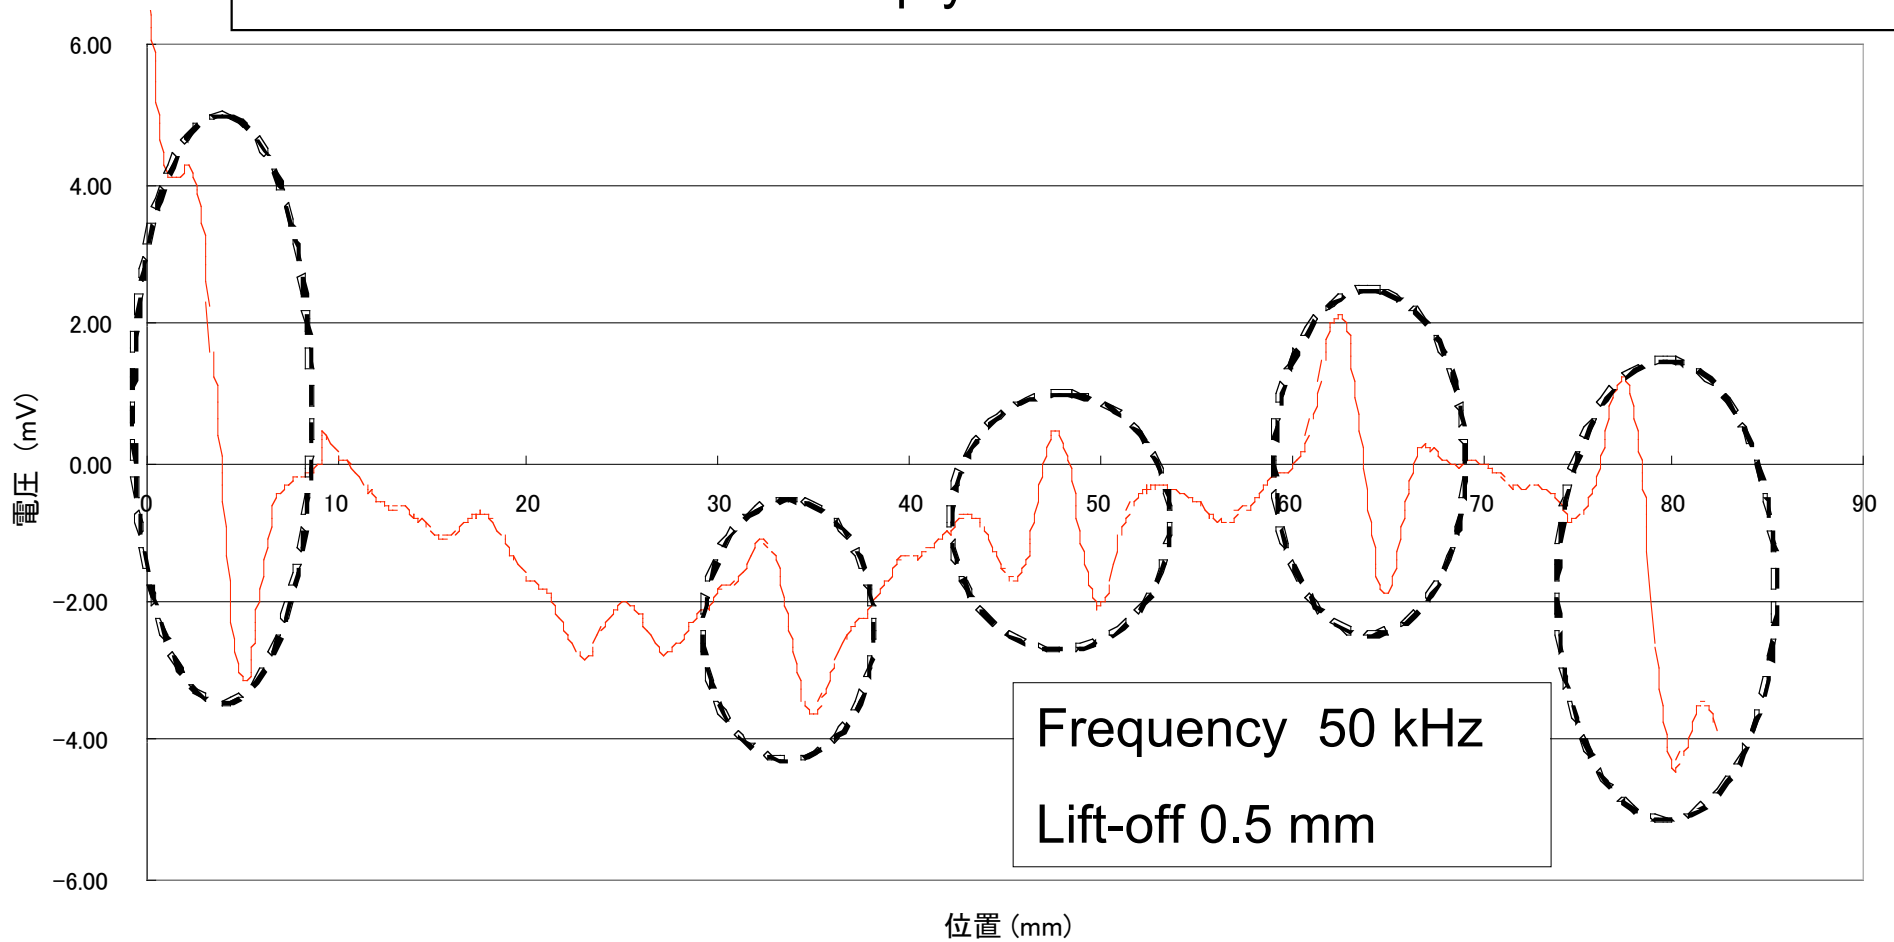
# Test Result 3 plate No.3

Ta contamination

$\phi 0.15$  mm empty holes

1. Drilled hole can be detected clearly by eddy current testing. Artificial Ta contamination can be also detected in spite of small conductivity difference between Nb and Ta.
2. Eddy current probe which has cubic exciting coils and thin film planer detecting coil can detect drilled hole of 0.15 mm in diameter and 0.6 mm in depth.
3. Higher detectability will be achieved by using more smaller detecting coil such as 1.5 mm in diameter.
4. Background signal caused by camber of plate will be decreased by differential signal conditioning.

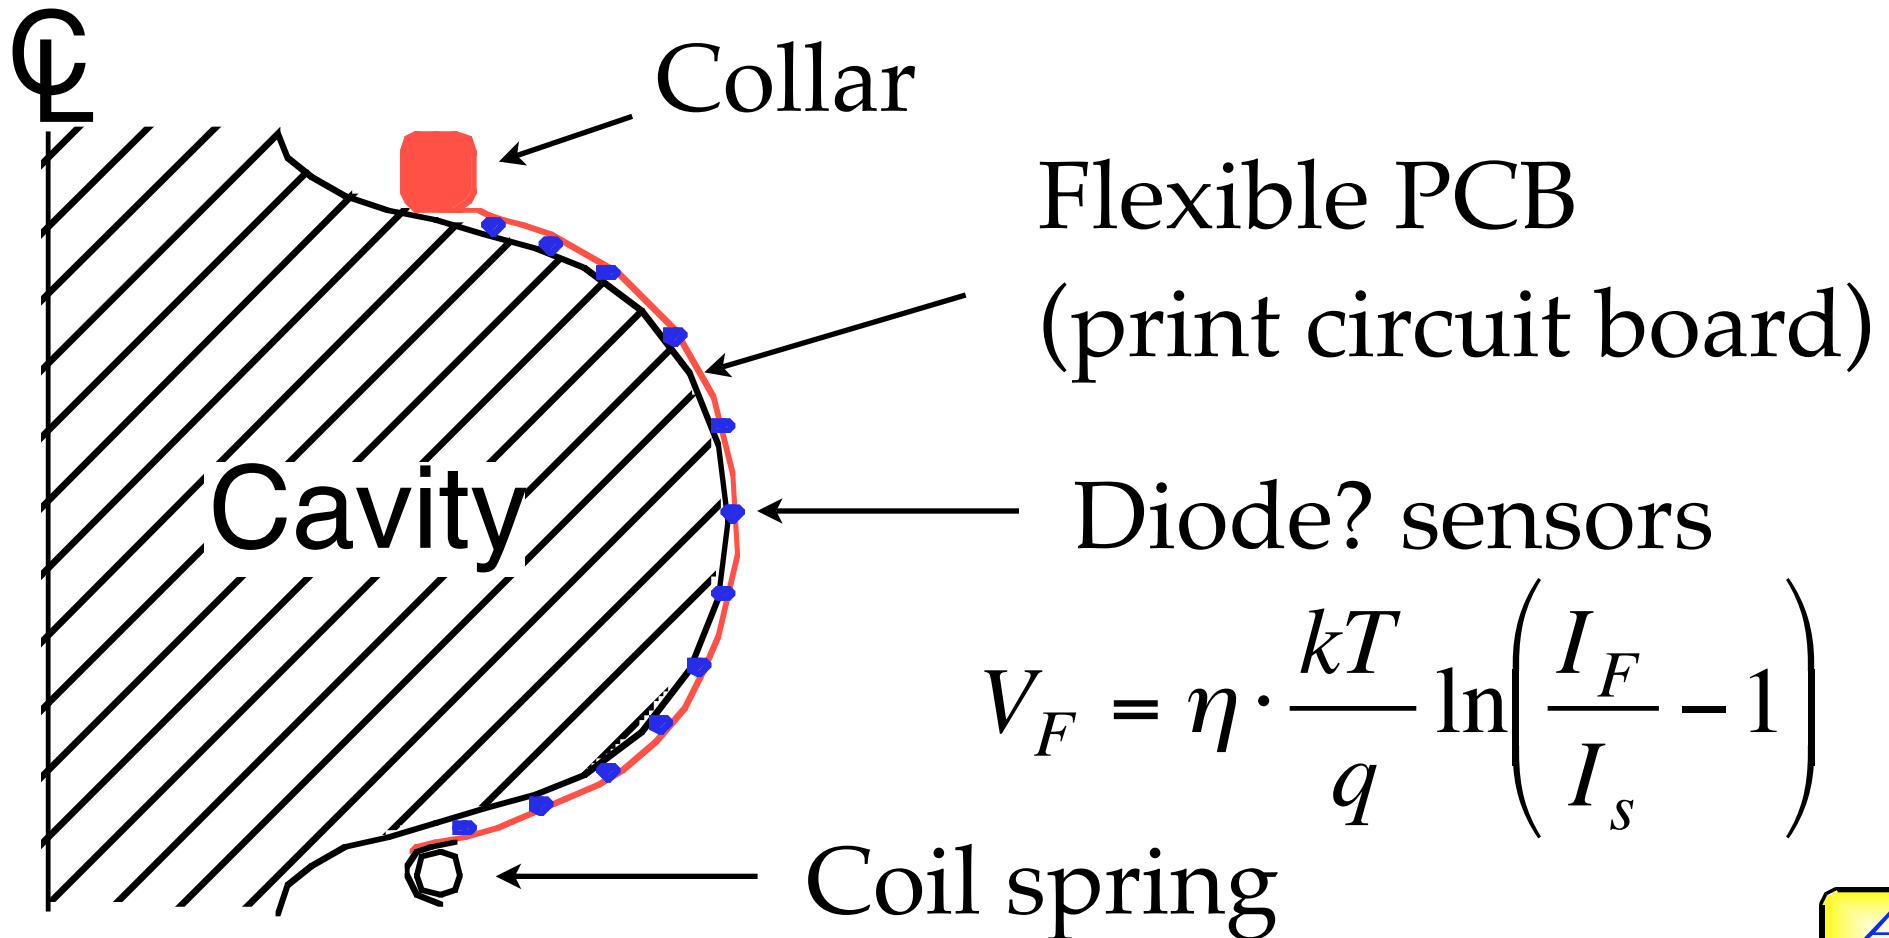
# Easy Installation

$$V_F = \eta \cdot \frac{kT}{q} \ln \left( \frac{I_F}{I_s} - 1 \right)$$

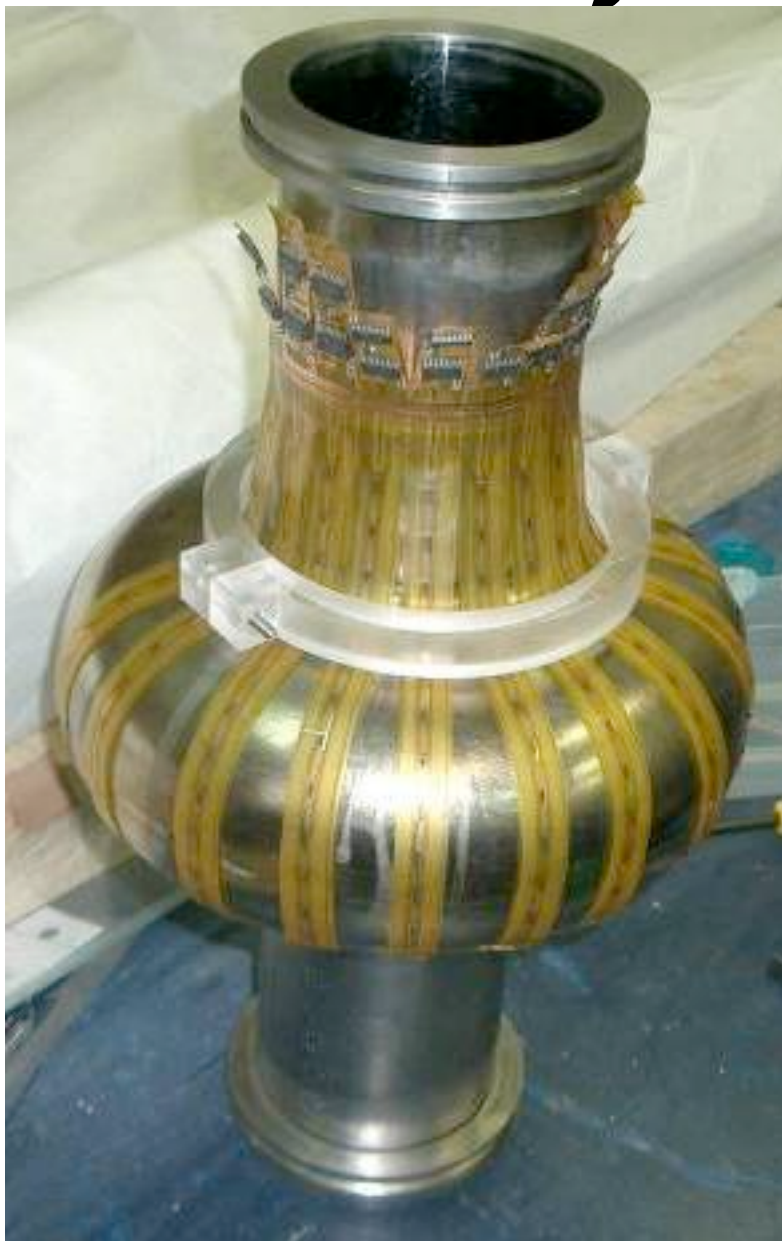
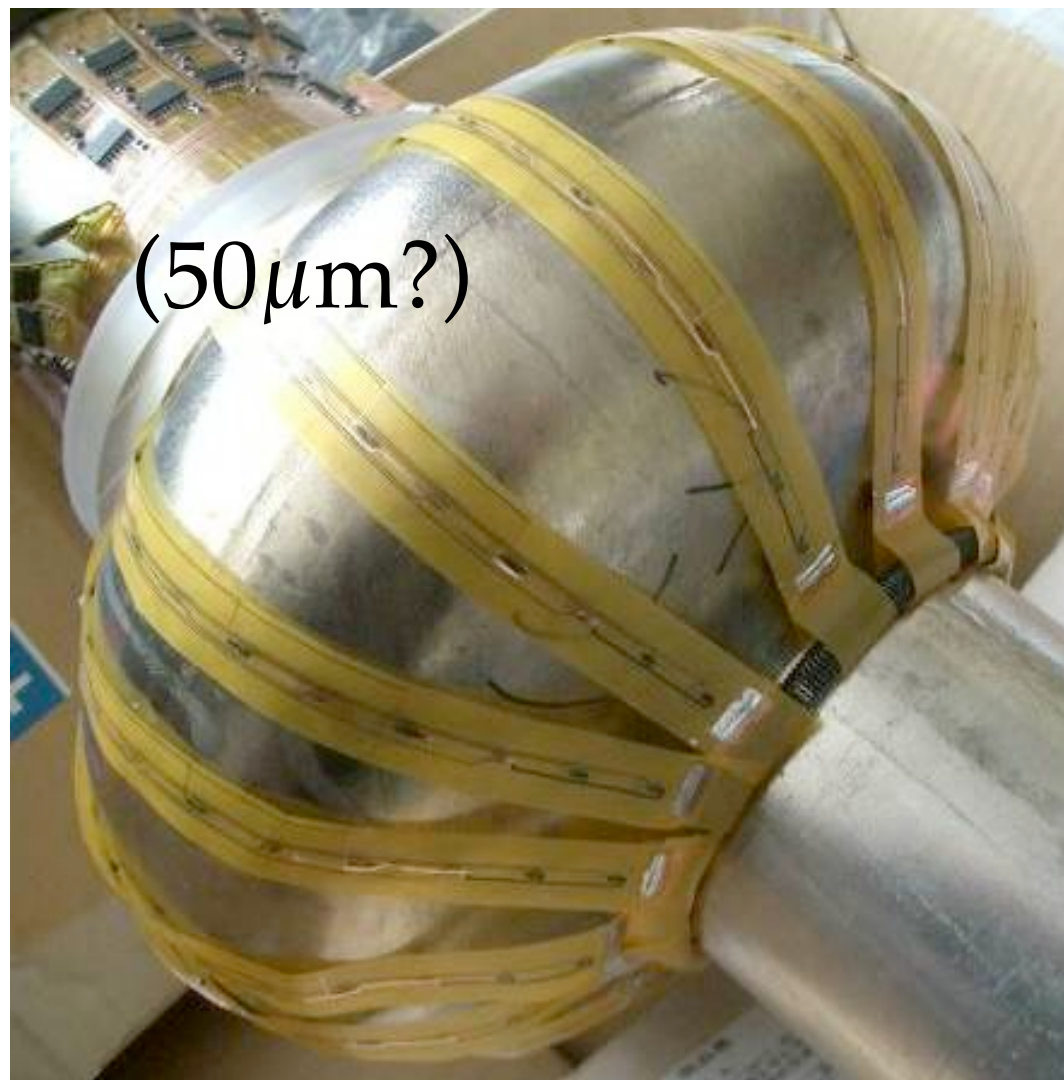
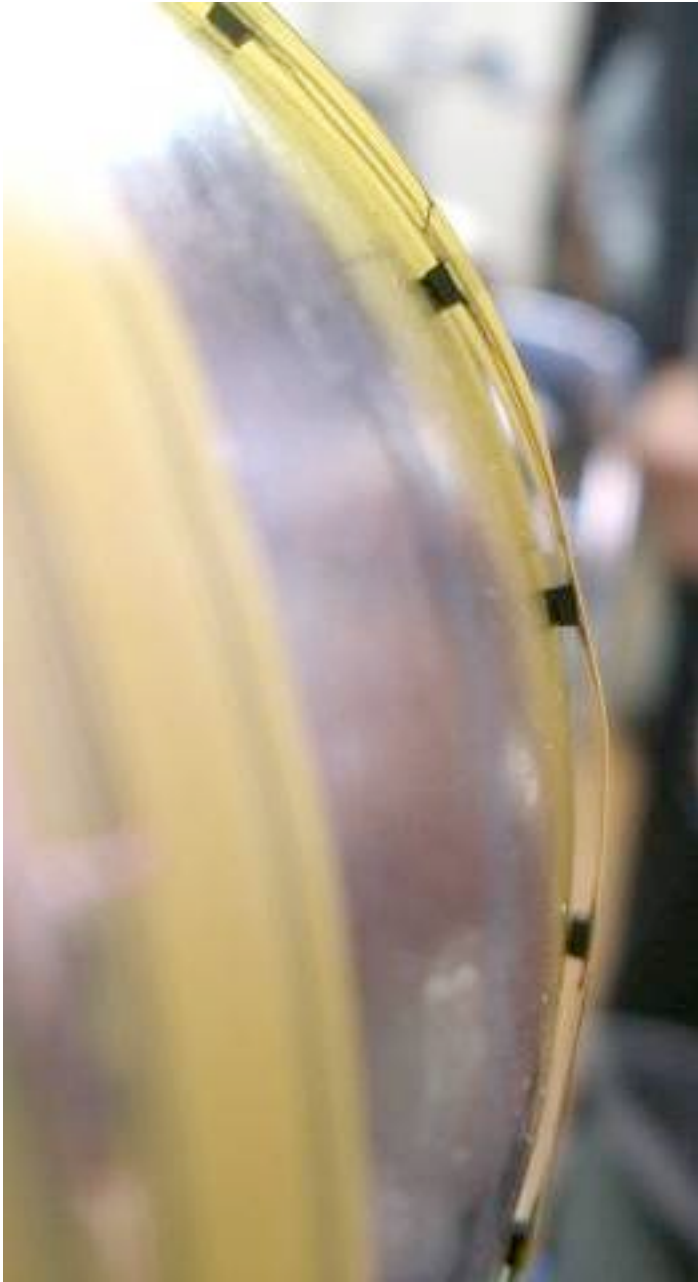
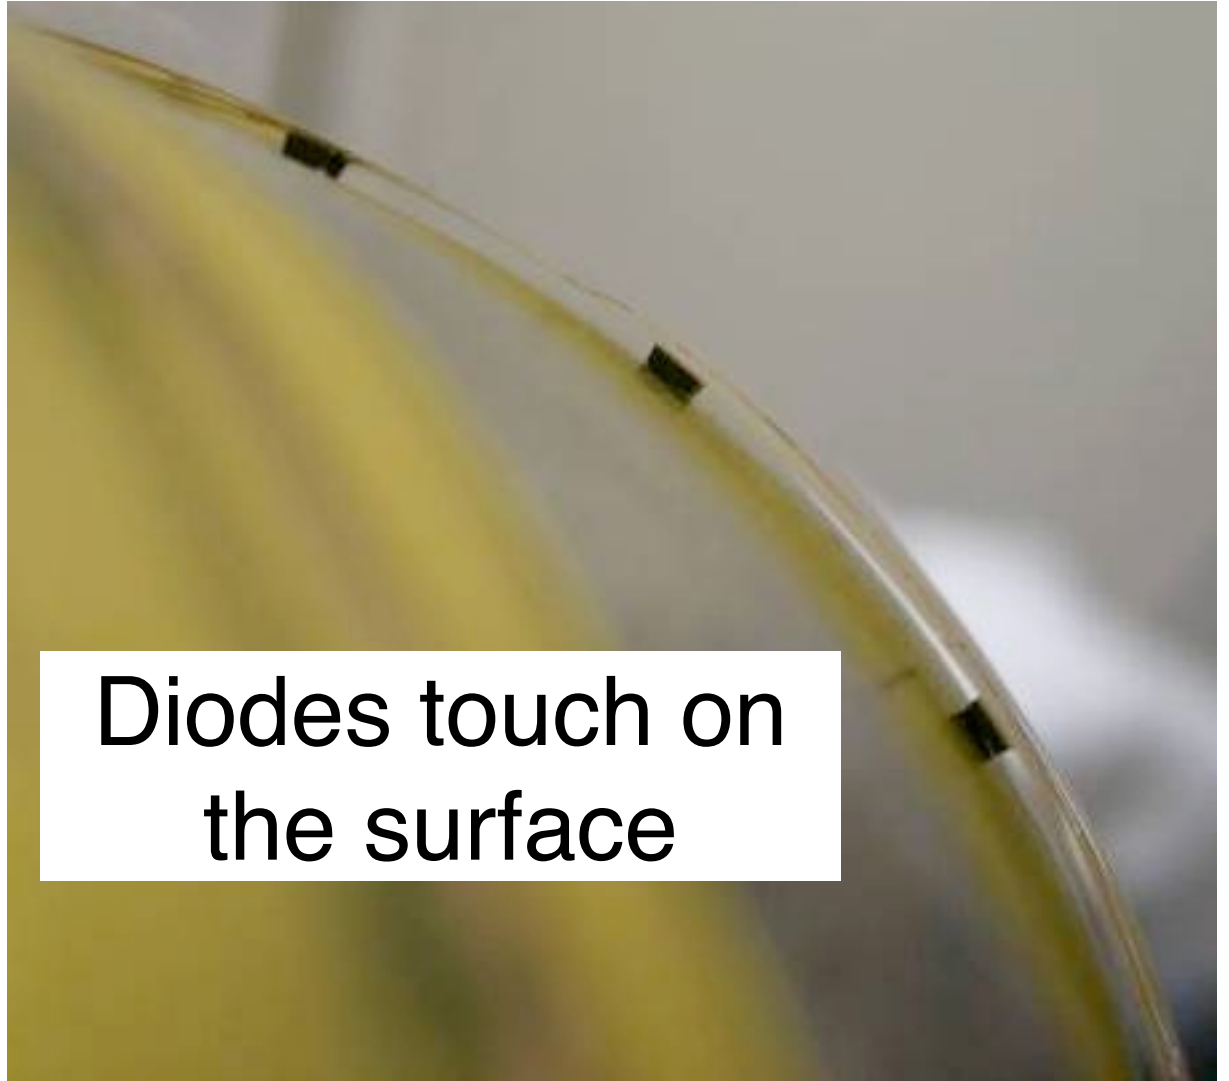
# Easy Installation

Diodes inner side

Coil spring to  
make tension

Diodes

Diodes touch on  
the surface

- I. Installation of the Multi-strip PCB seems OK.  
(need to fix the size)
- II. The flexible PCB did not lose flexibility at 77K.
- III. Analog MUX worked at 77K. — Need 2K test.
- IV. Combines sensor lines with A-MUX:  
8bit address lines combine up to 256 sensors.  
2 signal lines from each cell.  
 $= 8 + 2 \times 9 + 2$  (power for IC's) = 28 lines
- V. Serial ADC may work — Need check.

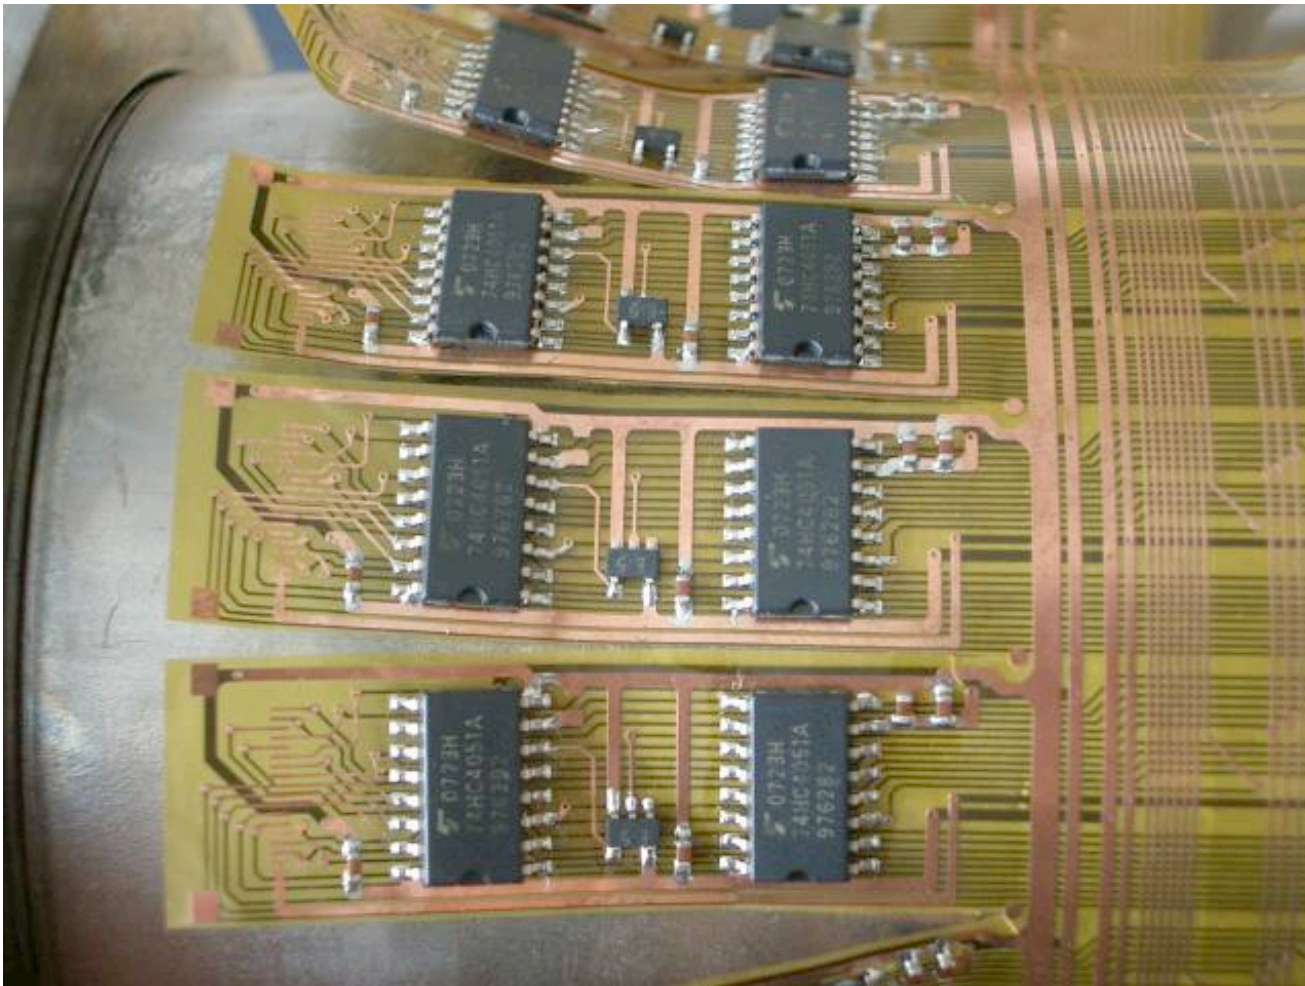
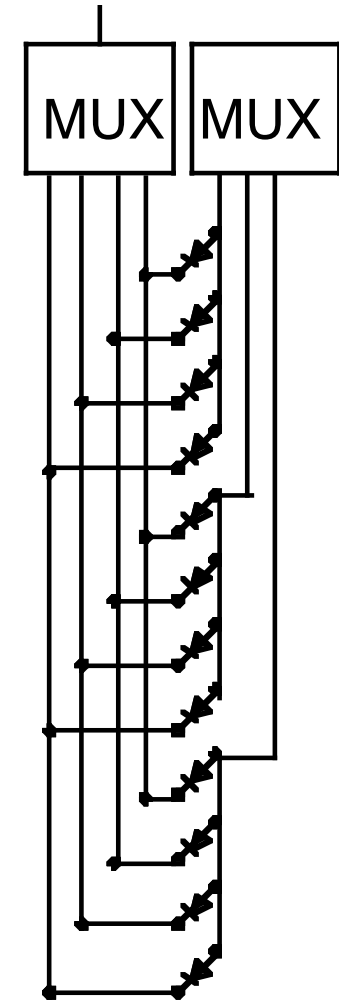
# Sensor lines are multiplexed by analog MUX (HC4051)

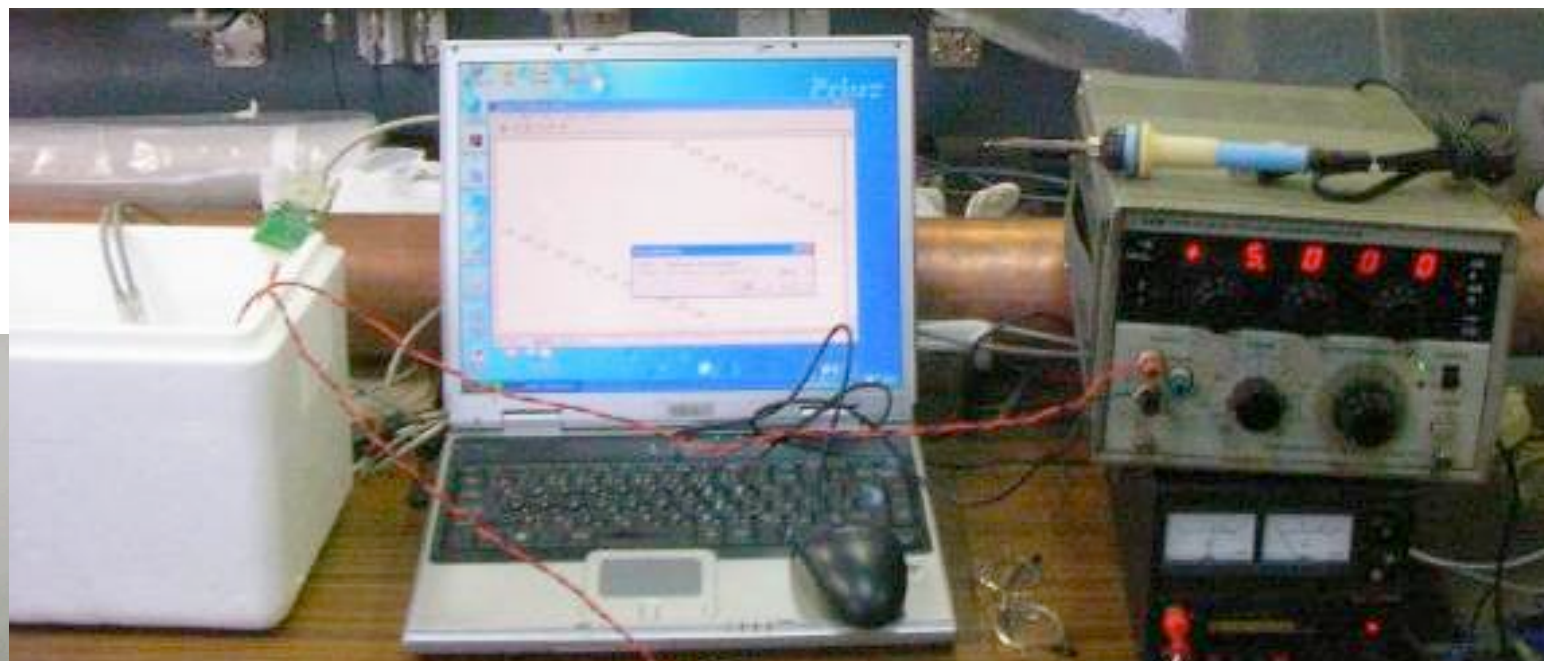
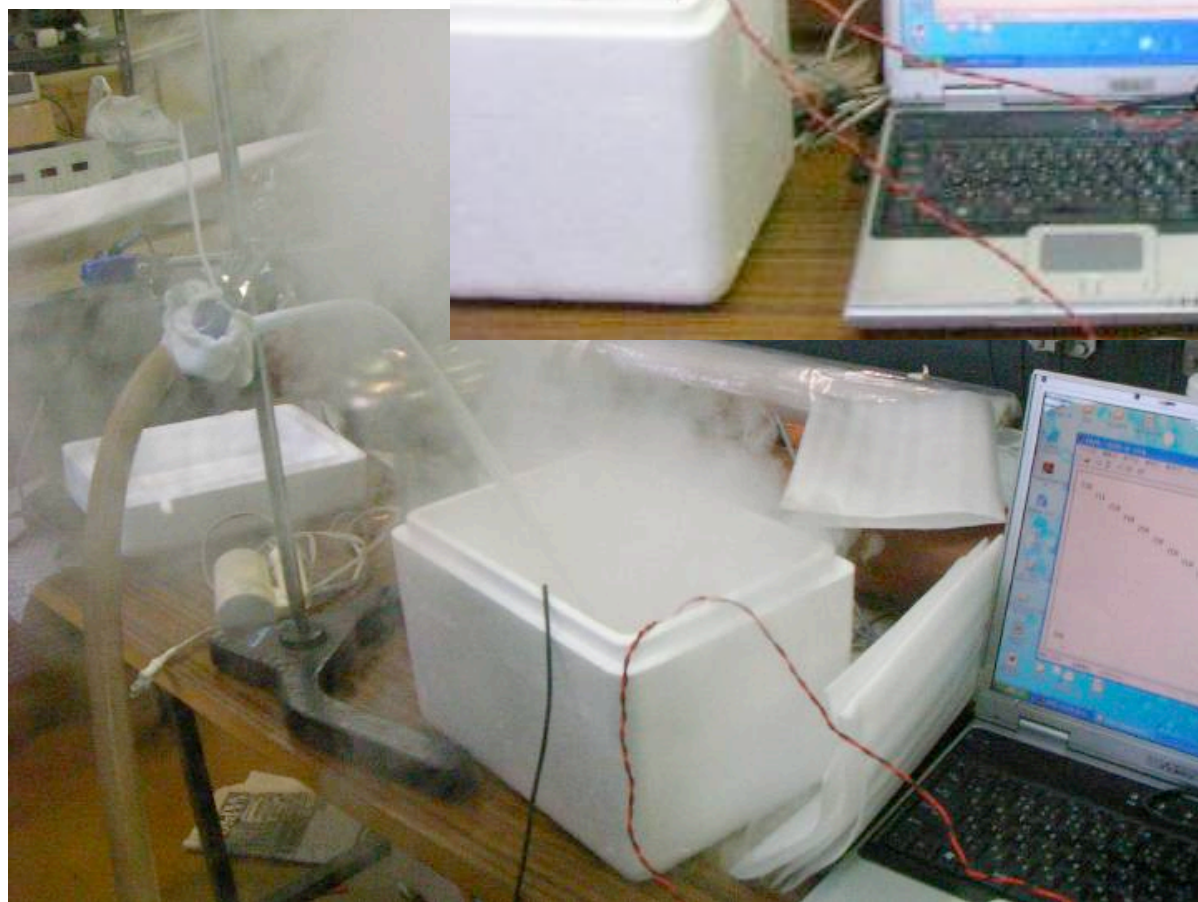
# Low Temp. Operation Test (LqN2)

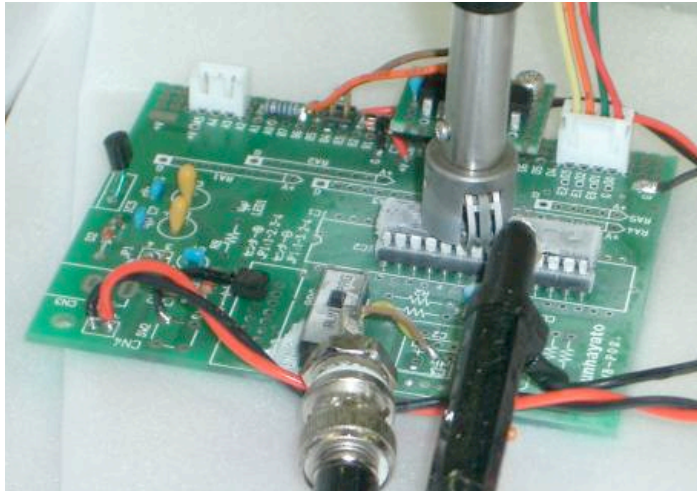
## PIC16F87x

- This board stops at  $-60^{\circ}\text{C}$
- TC74HC4066AP worked
- 74HC14P worked
