XFEL Accelerator Modules: Crash Test

L. Lilje

ILC Main Linac SCRF Meeting
FNAL
22.4.2008

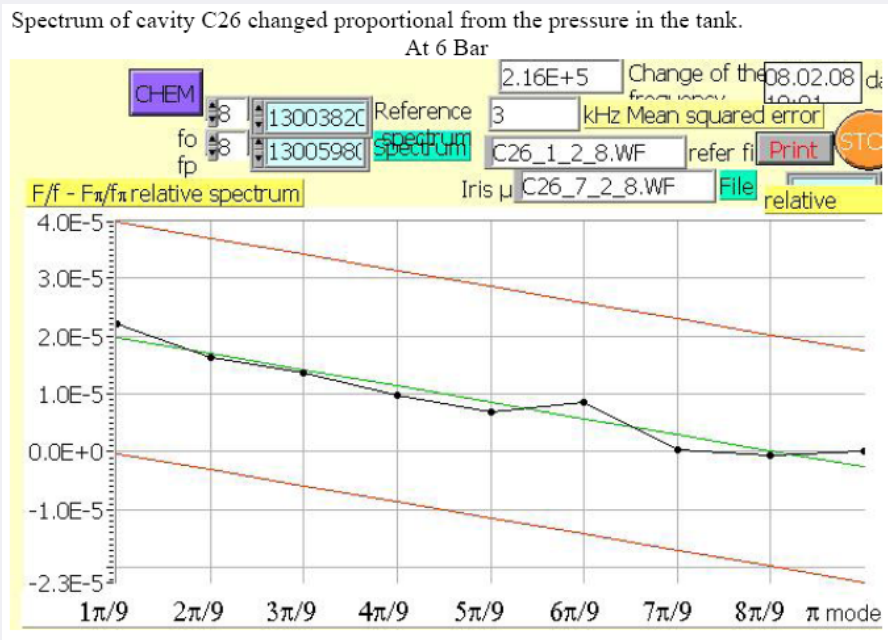
Cavity Spectrum under Overpressure – 2K

6bar at 2K

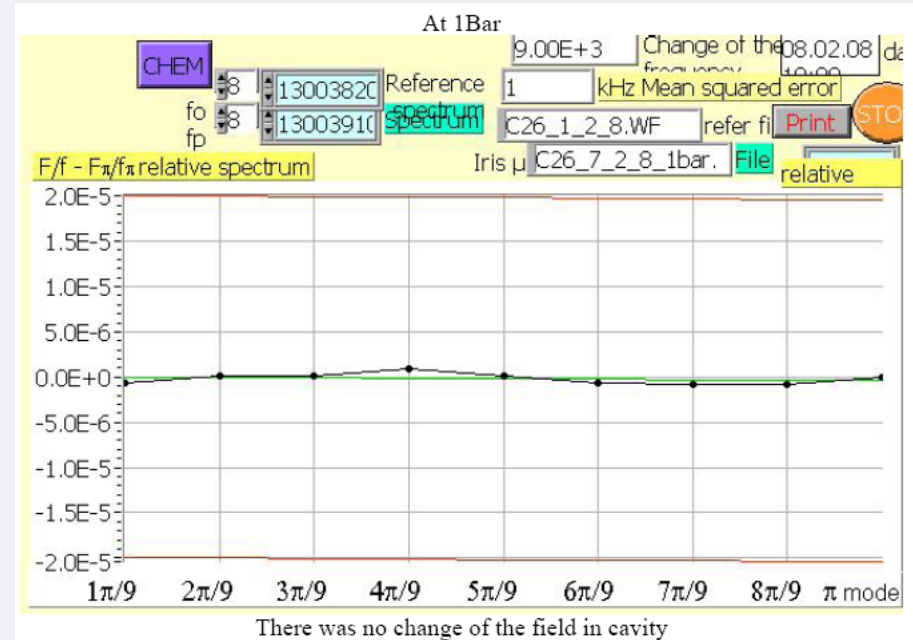
Return to 1bar at 2K

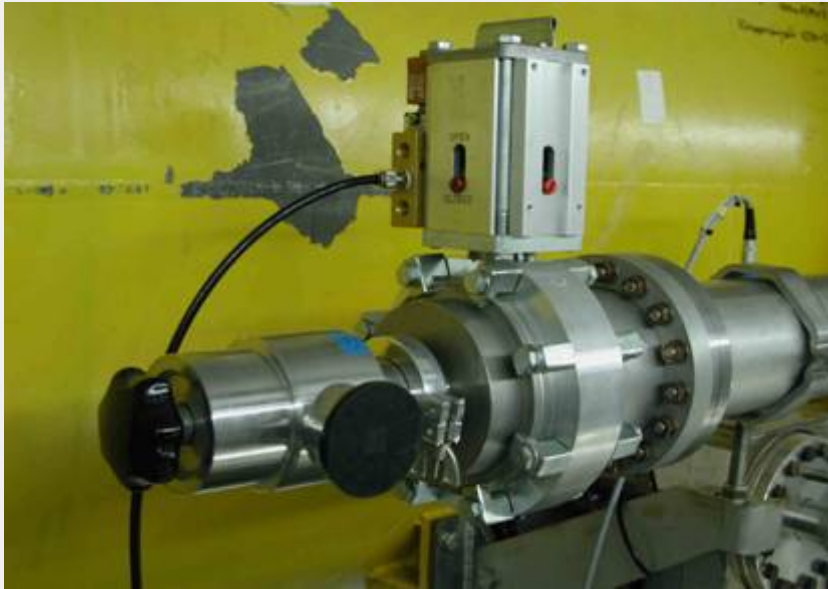
Venting system coupler-vacuum DN 100

Venting system beam-pipe-vacuum DN 100

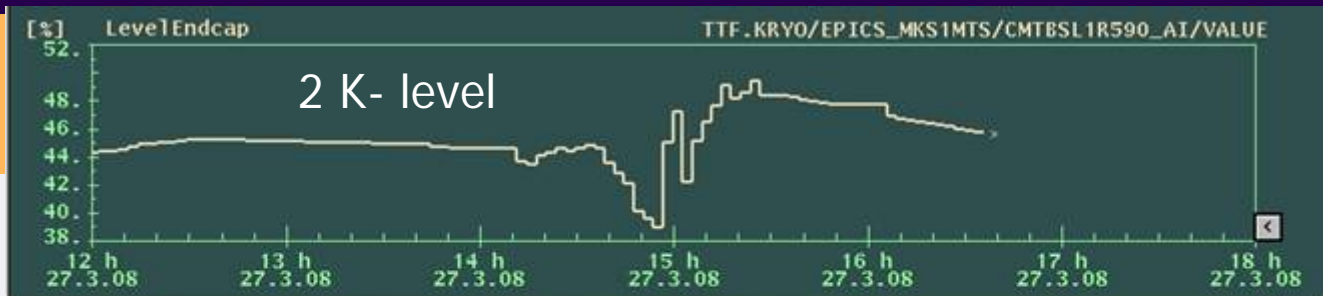
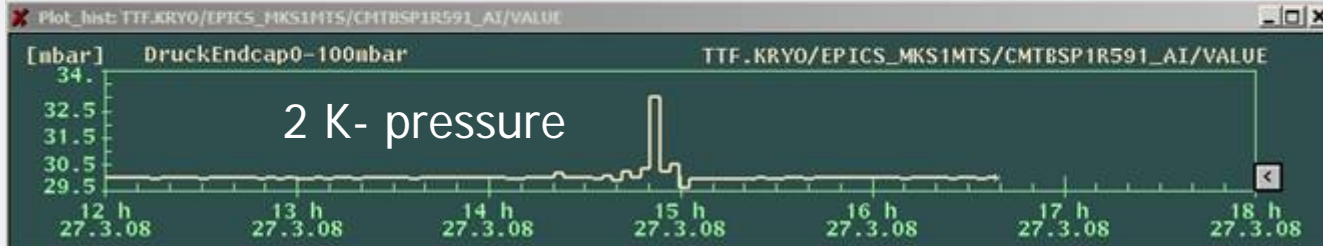
Slow venting beampipevac. with N2

- First step venting ca. 500 l with N₂ (27.03)
- Overnight-break:
 - measure kryo-losses
- Second step venting ca. 1600 l with N₂ (28.03)
- Warm up complete modul
- Check of safety valves beampipe

Steps	Pressure Beampipe Feedcap	He-Flow Vacuum-compressor	2K pressurse
Venting beampipe with ca. 500 l N2	$5,5 \cdot 10^{-7}$ mbar	Exept to 8 g/sec	max. 32,5 mbar
Overnight – break	$5,5 \cdot 10^{-7}$ mbar	Normal 1,15-1,2g/sec	30 mbar
Venting beampipe with ca. 1600 l N2	$5,5 \cdot 10^{-7}$ mbar	Exept to 12/sec	max. 40 mbar

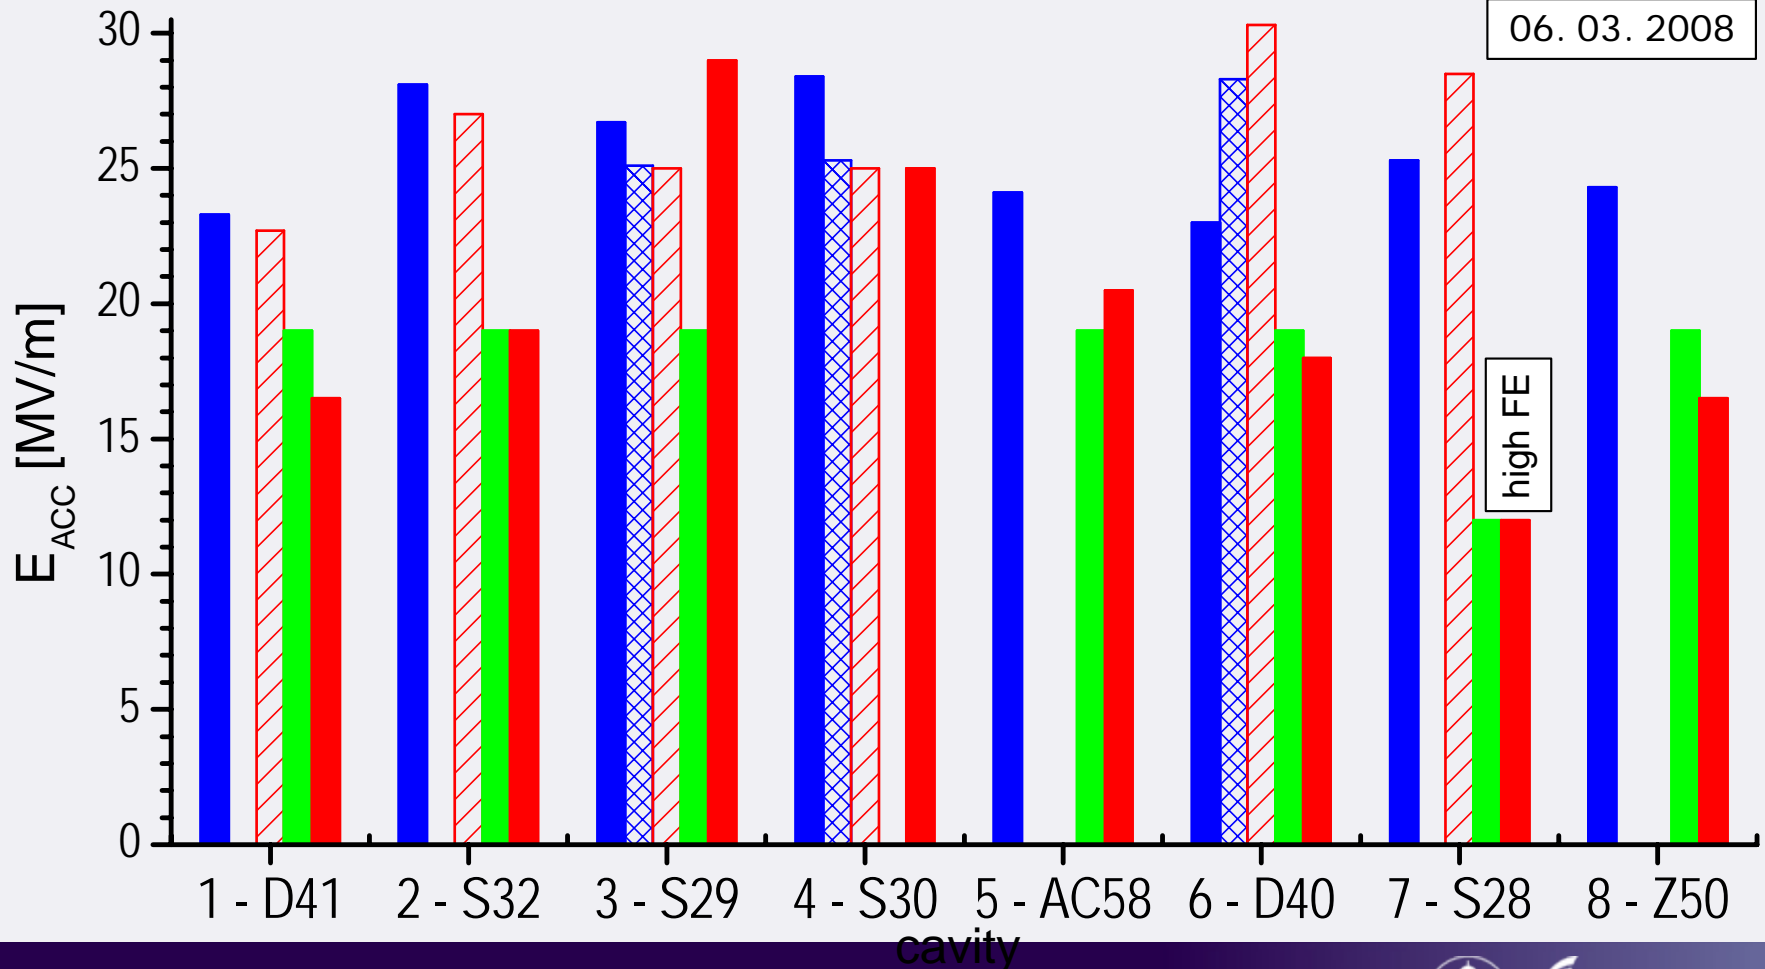
Module 3* Cavities tests:

- █ Vertical (CW)
- █ Horizontal (10Hz)
- █ Module 3 LINAC (10Hz)
- █ Module 3* LINAC (5Hz)
- █ Module 3* CMTB (2Hz)

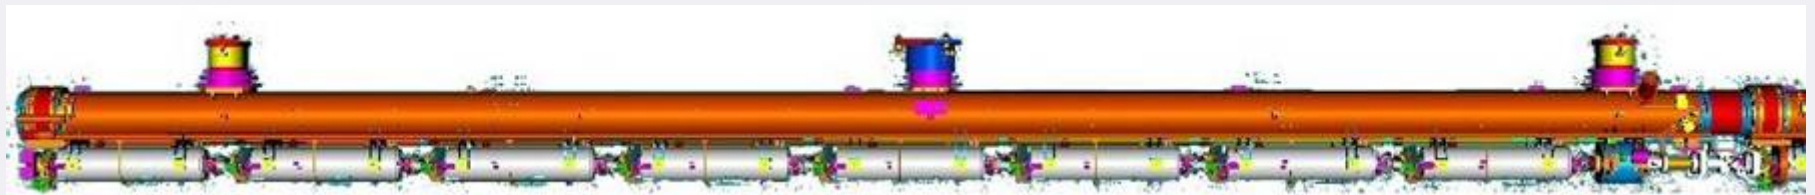
Cavities

Length quantized $n \cdot \lambda/2$ (possibility of ERL)
