# Status of Nb sample study

TILC09

on behalf of SRF surface analysis group at KEK

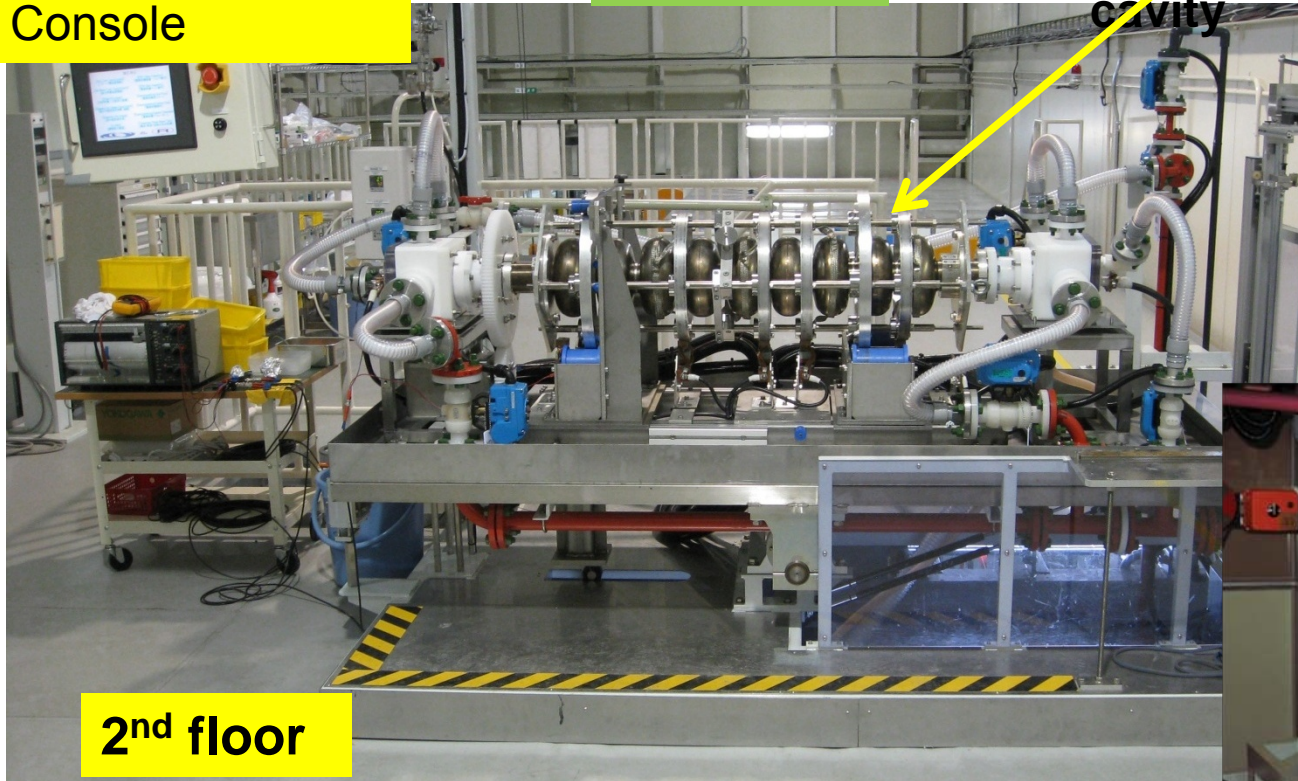
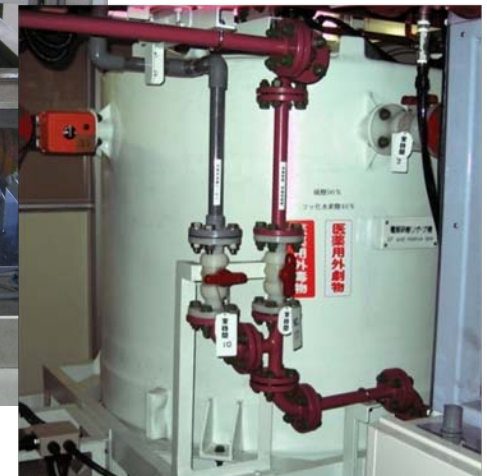
# EP facilities at STF/KEK

Automatic  
Operation  
Console

EP bed

9-cell  
cavity

2<sup>nd</sup> floor

1<sup>st</sup> floor

EP acid reservoir tank

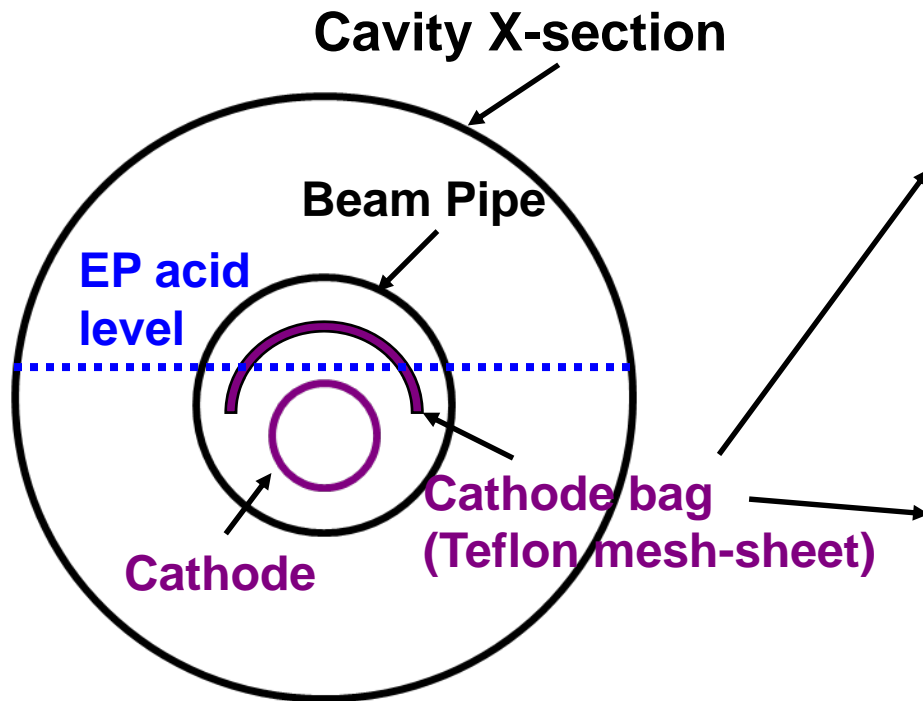
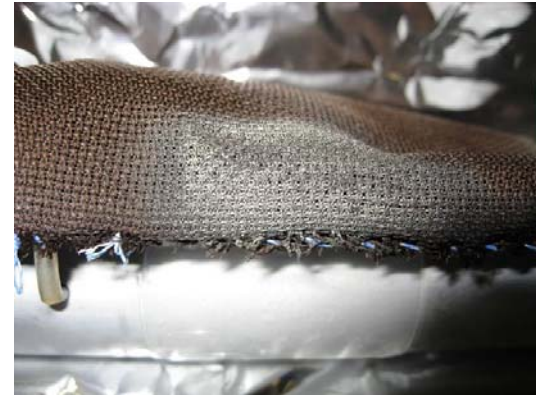
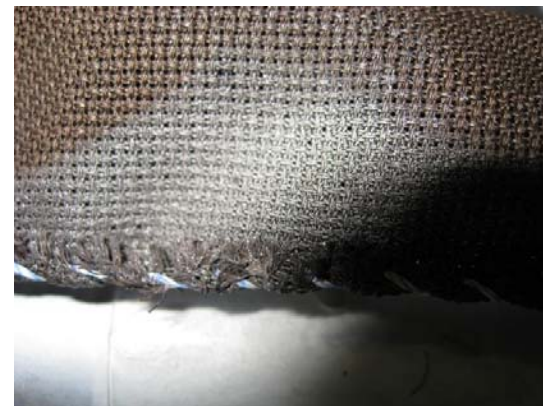
# Powder on cathode bag at STF/KEK

Commissioning run of  
STF EP facility  
30 June – 1 July 2008

Location:  
Iris Cell#4-cell#5, Iris cell#5-cell#6

- In the commissioning run of STF EP facility, we found white powder on the cathode bad.
- The components of white powder is found to be mainly sulfur by X-Ray Fluorescence analysis.

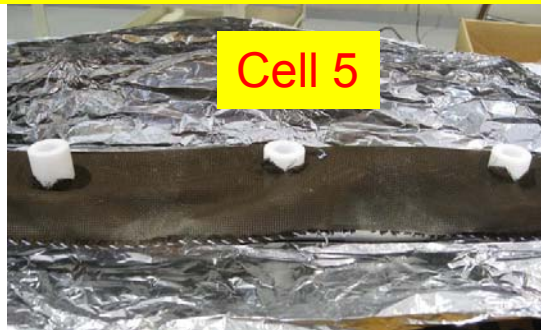
Ethanol rinse of cathode bag

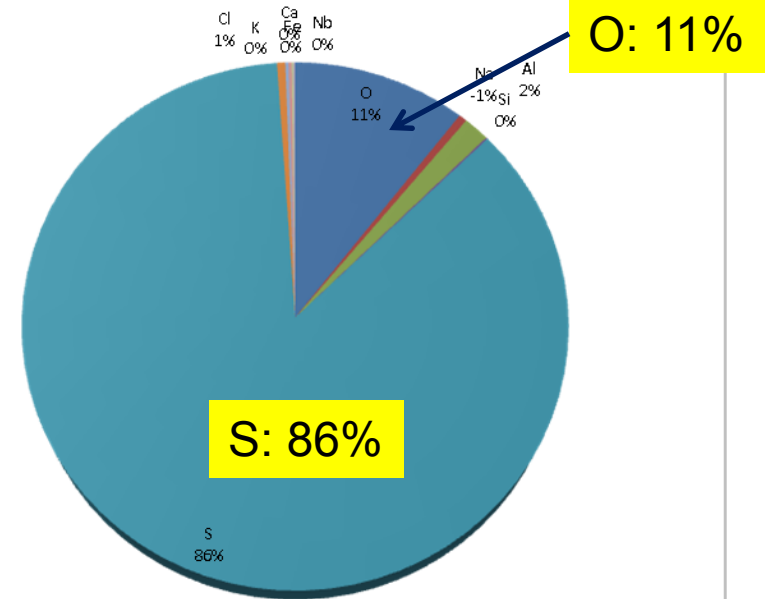
Results of analysis by XRF

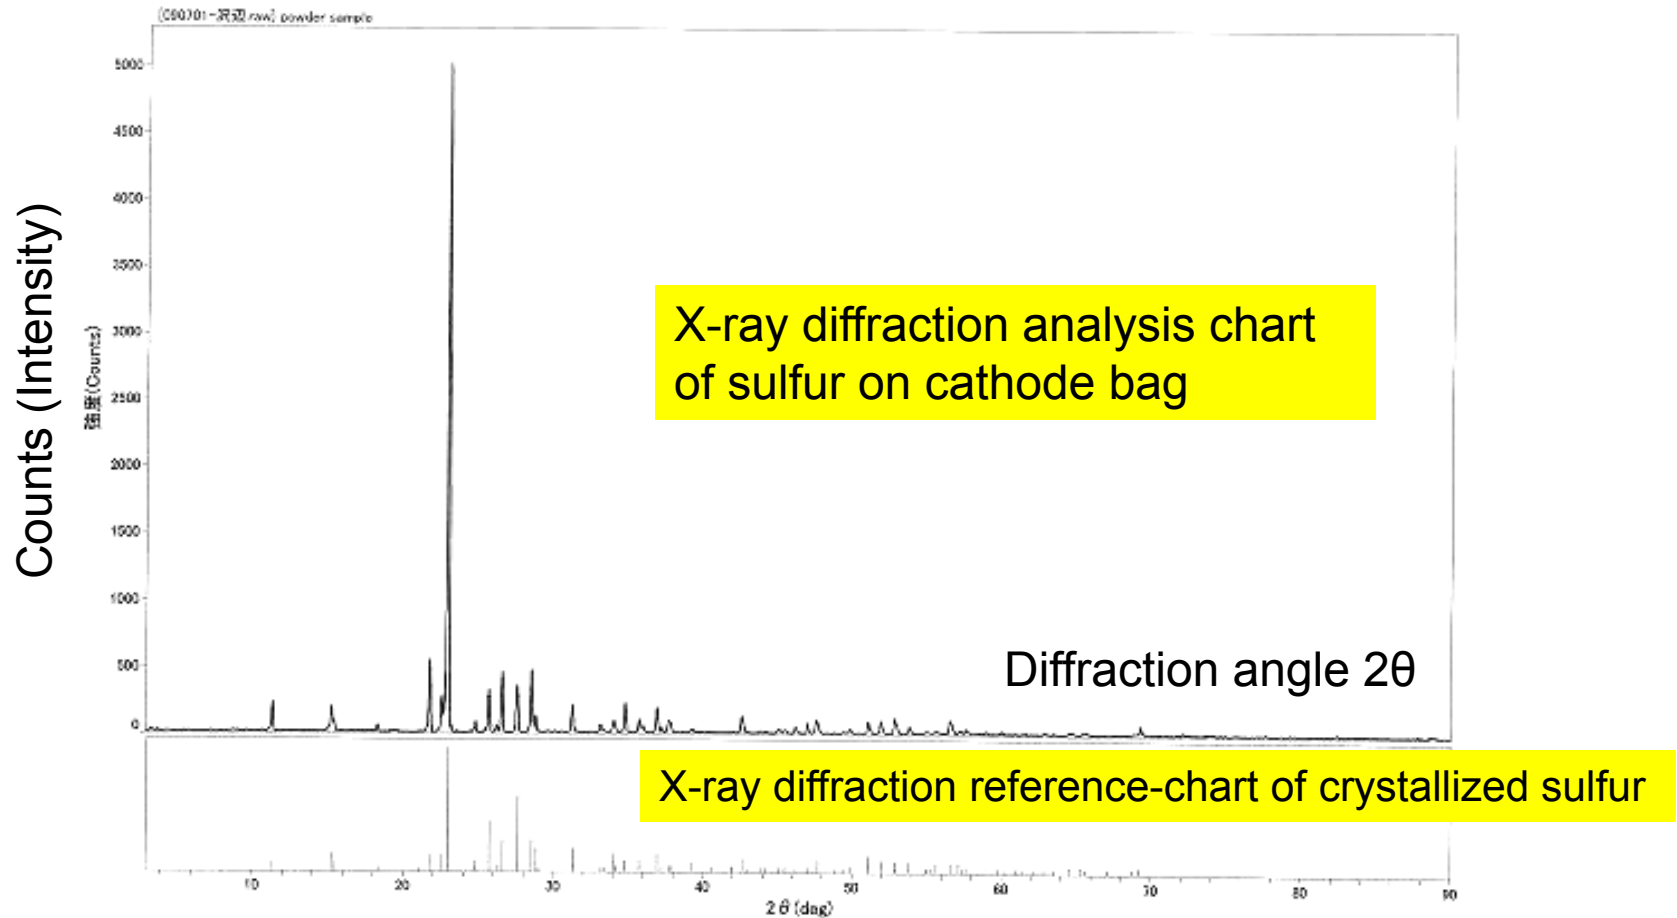
# X-ray diffraction analysis

The results shows that **sulfur is in a crystallized form**

- X-ray diffraction analysis showed that the sulfur powder is in crystallized form.
- We put detachable Teflon-mesh on the cathode bag in the real EP processes of 9-cell cavities to collect sulfur powder.

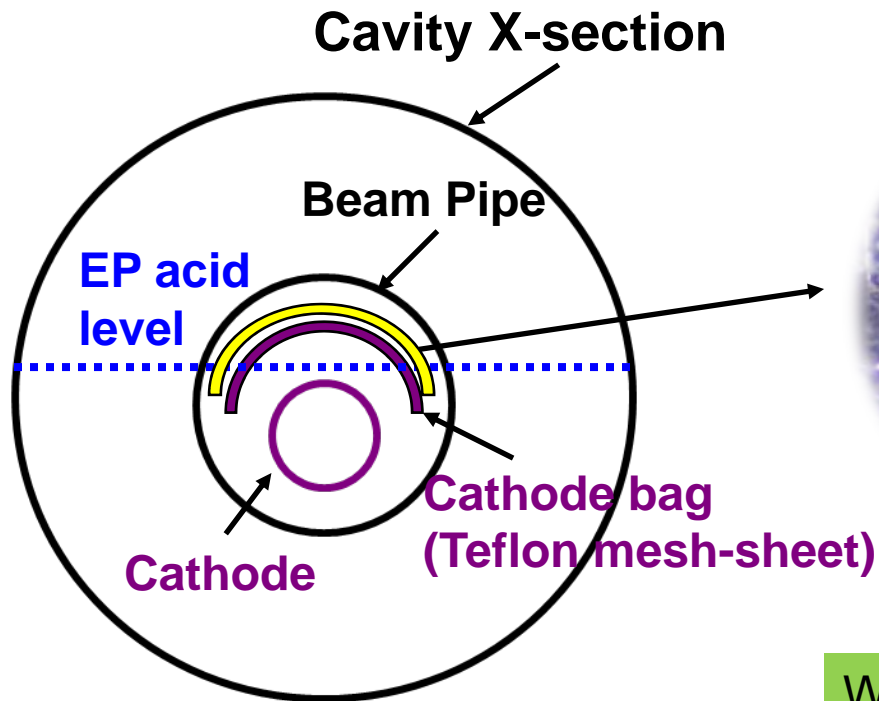
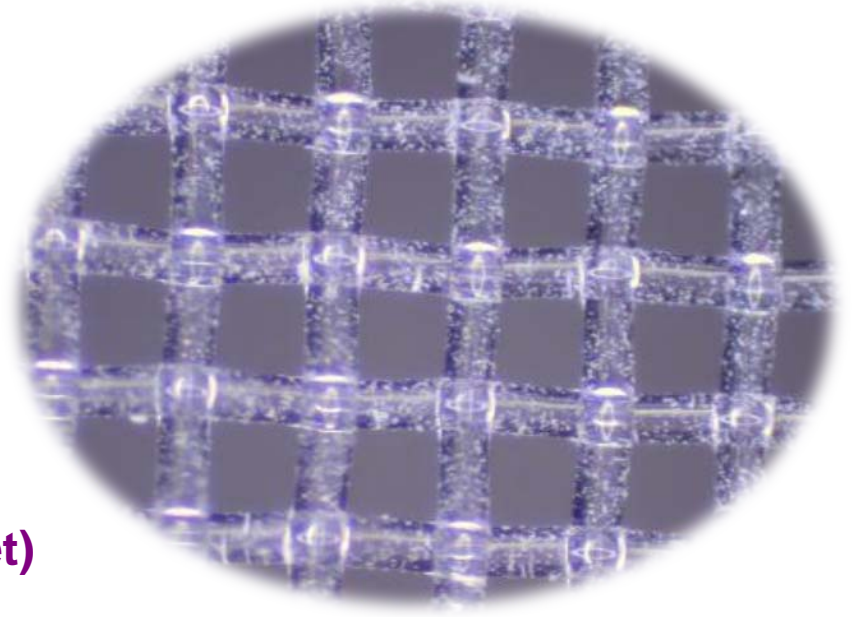
# Collection of sulfur powder on cathode bag

Location:  
Iris Cell#4-cell#5, Iris cell#5-cell#6

We added detachable piece of Teflon mesh-sheet over the cathode bag. The sheet collected sulfur powder in the EP acid during the real EP processes of 9-cell cavities at STF/KEK.

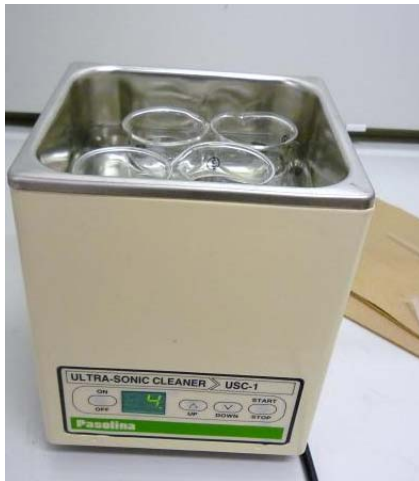
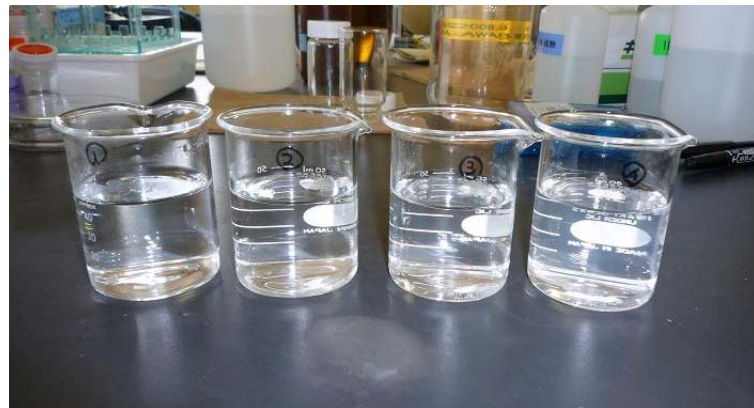
# Tests of rinsing effect for sulfur

- **Degreaser ( LION SUNWASH FM-550, FM-20 )**  
concentration = 0%, 2%, 5%, 10%, 20%  
50ml, T=50°C, 1 hour, Ultrasonic rinse
- **Ethanol**  
10ml, Room temp., 10min., Mechanical vibration (at a few Hz)  
50 ml, Room temp., 1 hour, Ultrasonic rinse
- **H<sub>2</sub>O<sub>2</sub>**  
50 ml, 10% H<sub>2</sub>O<sub>2</sub>, T=50 °C, 1 hour, Ultrasonic rinse

- Sulfur powder on the Teflon-mesh was observed by SEM and EDX.
- We tried to remove sulfur on the Teflon-mesh by various rinsing methods; detergent, ethanol and  $\text{H}_2\text{O}_2$ .

- We found that ethanol rinse with ultrasonic and detergent (FM-550 and FM-20) rinse with ultrasonic are effective to remove sulfur.
- We fabricated special single-cell cavity with holes in which we can set detachable Nb samples. The special single-cell cavity was EP'ed in the STF EP facility.

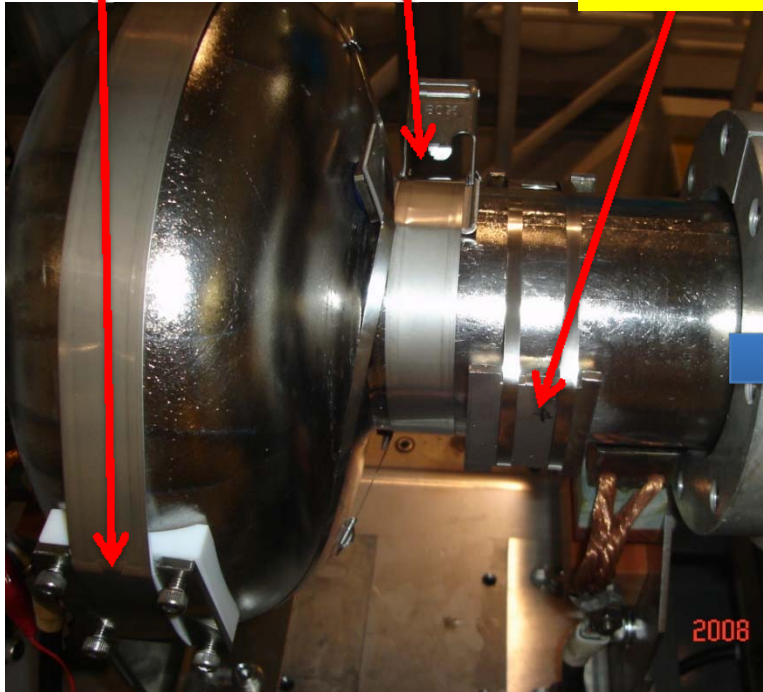
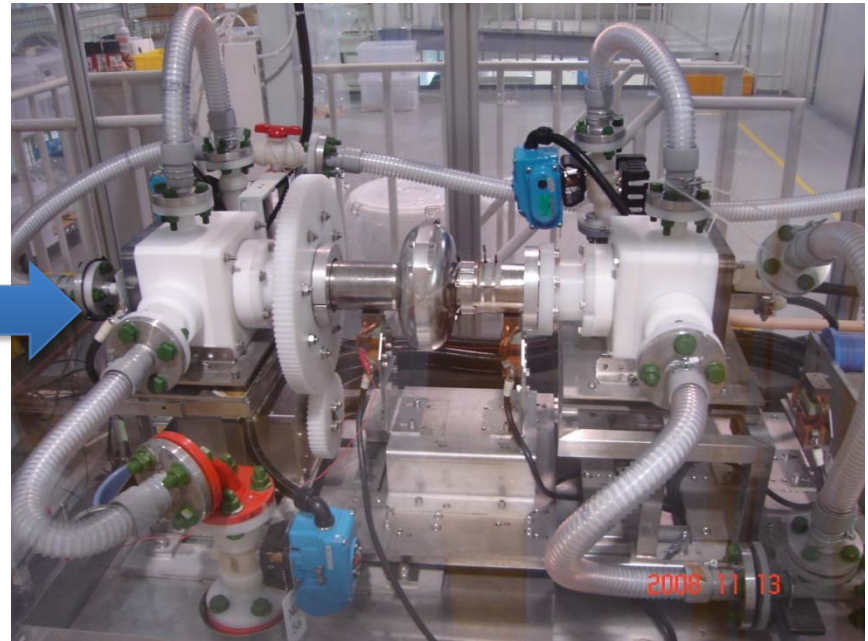
# Special single-cell cavity for sample-study

2 samples  
at equator

2 samples  
at iris

2 samples on  
a beam-pipe

6 Nb samples were dressed  
on the special cavity

EP 20  $\mu\text{m}$  + UPW rinse  
(No ultrasonic-rinse)

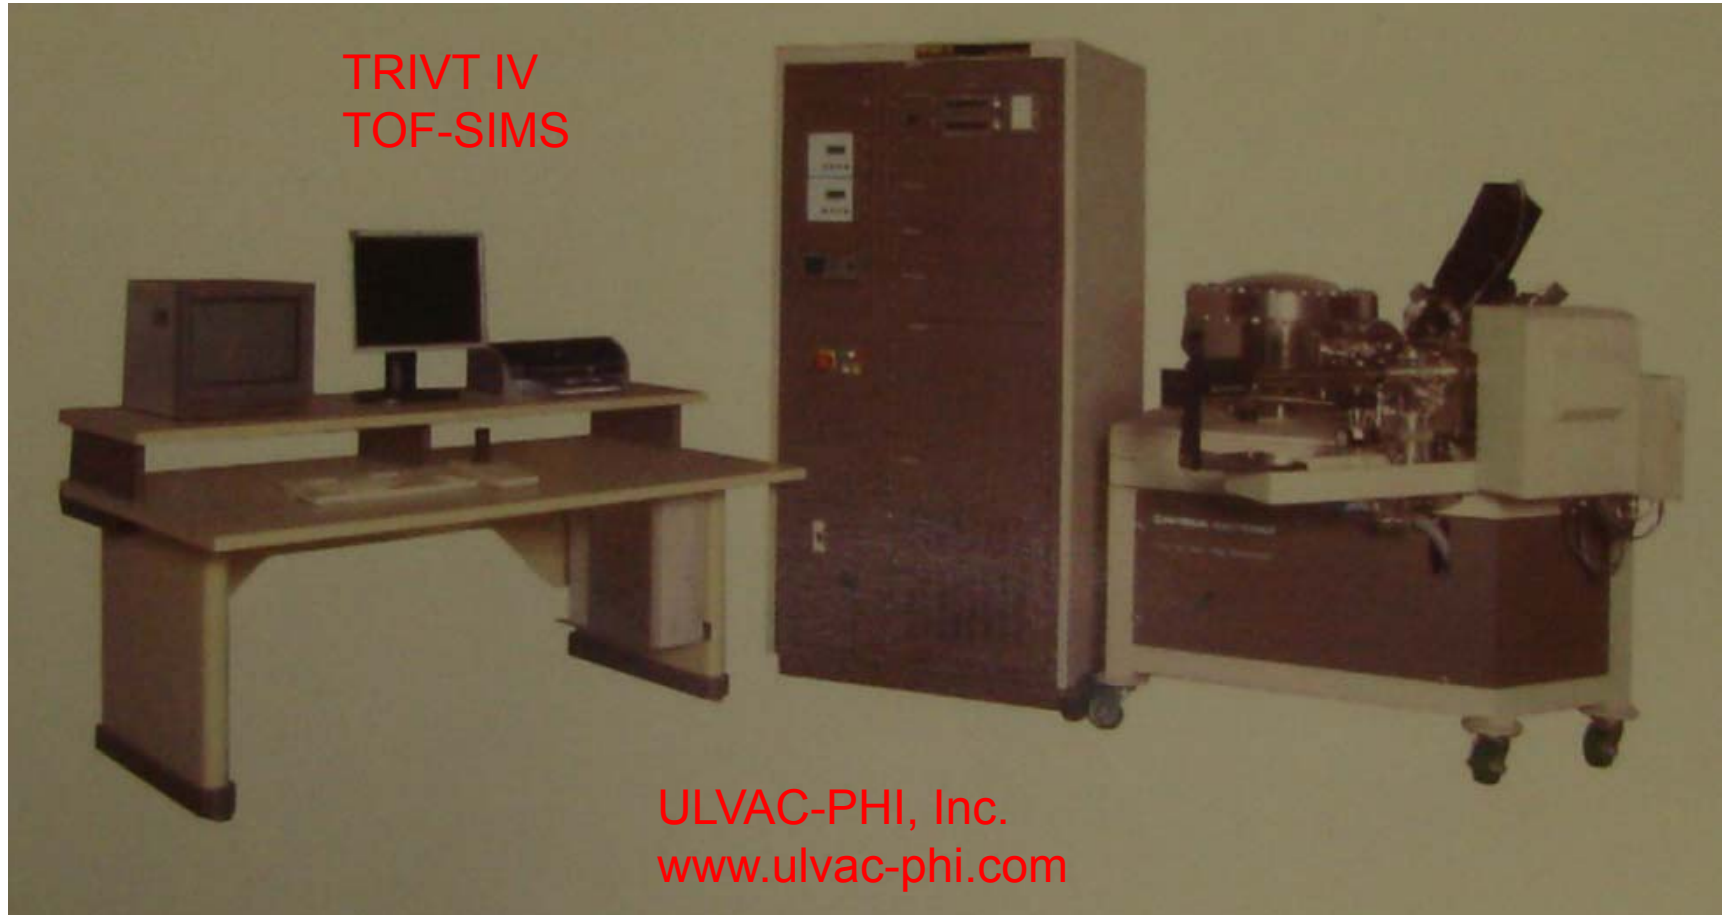
# Secondary Ion-Microprobe Spectroscopy (SIMS)

We ordered the surface analysis of EP'ed Nb sample by SIMS at a company.

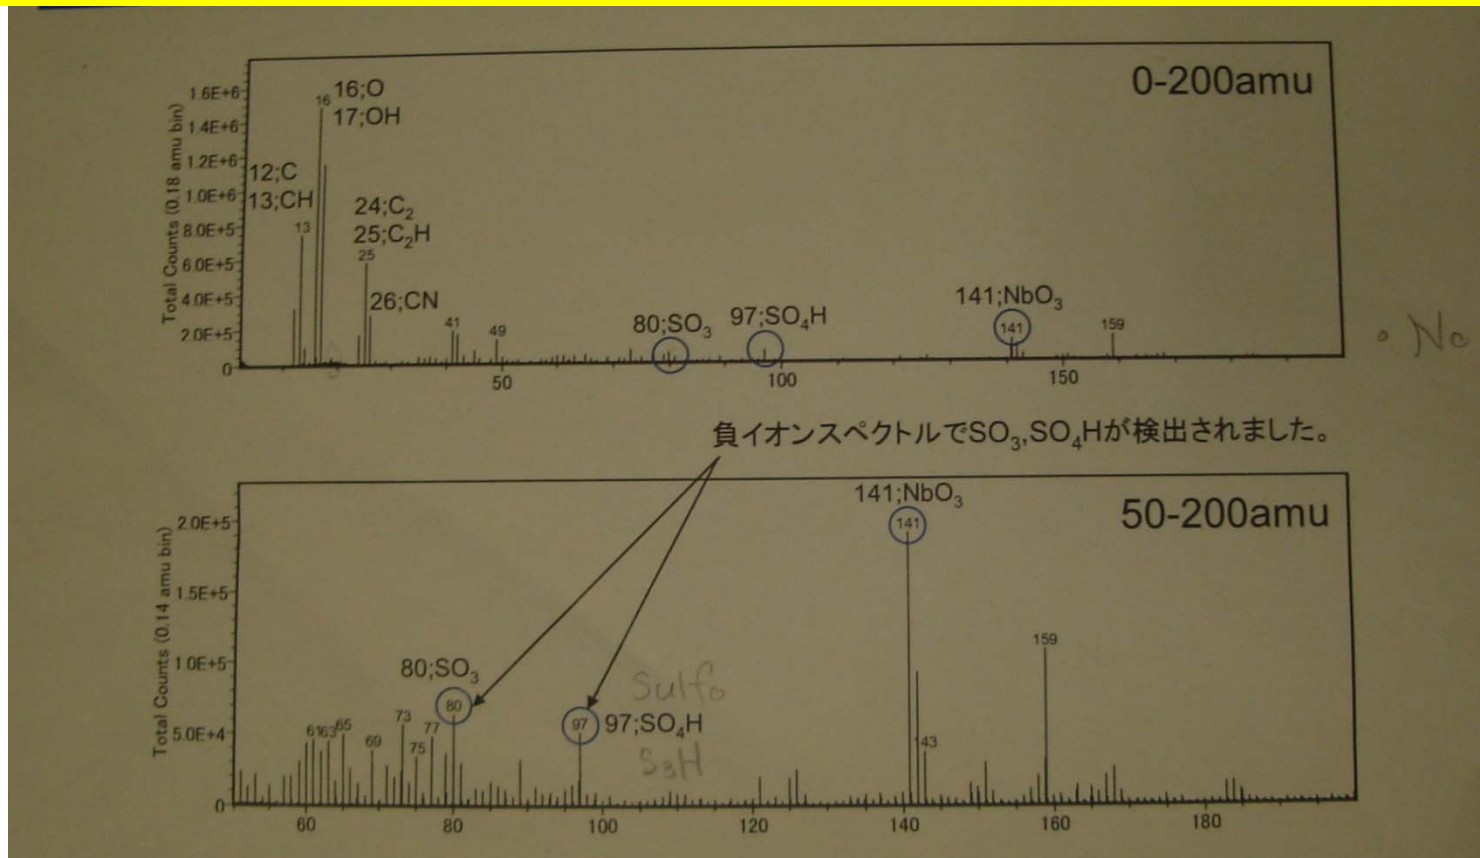
# Spectrum of Secondary Ion-Microprobe Spectroscopy (SIMS)

There are S signals in the spectrum which is the mean or integral of 600  $\mu\text{m}^2$  area. However, it is very difficult to say how much S is there, because generally the sensitivity coefficient of a component strongly depends on the neighboring components in SIMS analysis. Sometimes, it changes in the order of  $10^2 - 10^3$  depending on neighboring components.

- One of the EP'ed detachable Nb sample was analyzed by TOF-SIMS.
- We can say if there is some component there by TOF-SIMS, but quantitative analysis is very difficult.

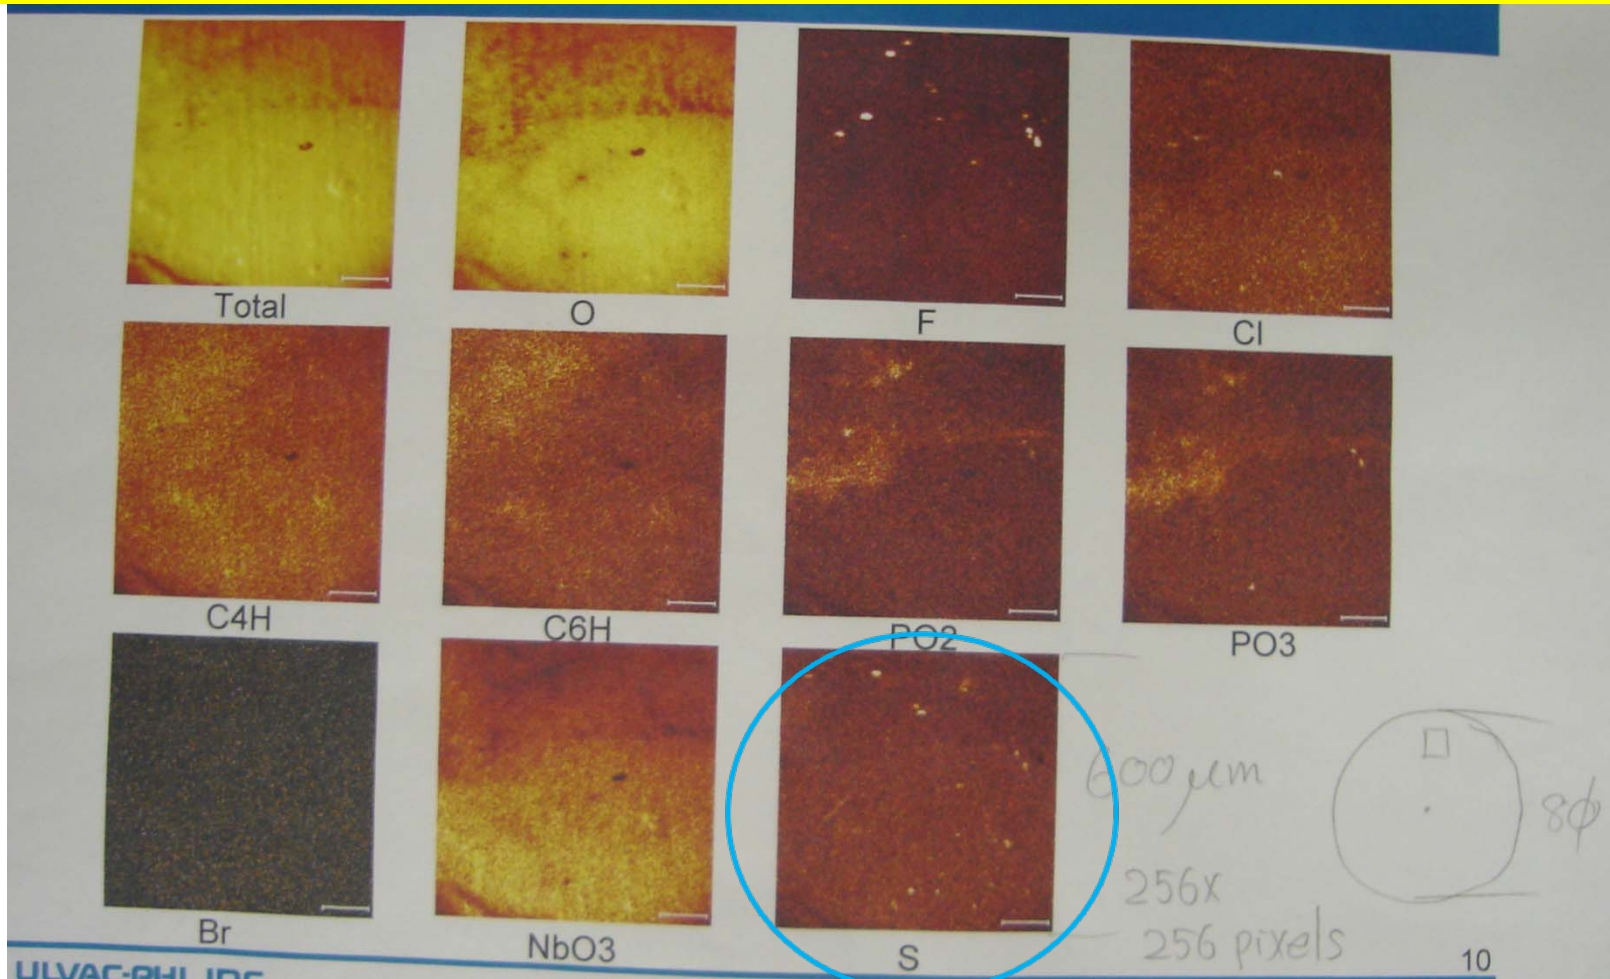
# Image of Secondary Ion-Microprobe Spectroscopy (SIMS)

Distribution of specific component is seen in an image of 600  $\mu\text{m}$ -square area by 256 x 256 pixels with the pixel size of  $\sim 2.3 \mu\text{m}$ .

There are spots of sulfur in the size of 10 – 20  $\mu\text{m}$ .

- We found sulfur on the detachable Nb sample in the measurement area of 600-um square by an imaging with 256 x 256 pixels.
