Helical undulator progress

TILC-09 18th April 2009

James Rochford
On behalf of the Helical collaboration

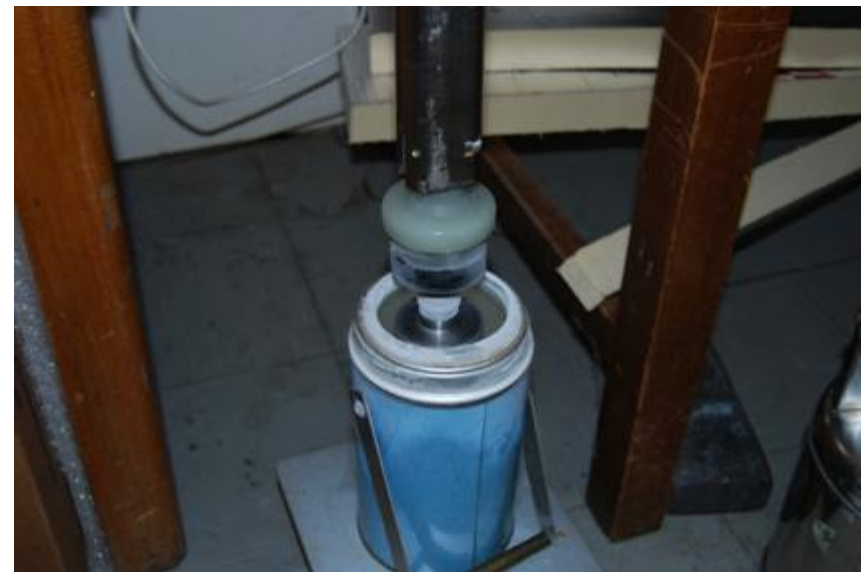
Leak fix

Most promising was a silver soldered copper-iron Bi metal ring

Soldered in position using cerobenze

The goal here is to minimise the thermal stress on the cerobenze joint by matching the thermal contractions of the different materials

Implemented this solution on some test pieces and it has survived 20 thermal cycles.

Finally remachined magnets and implemented on all magnet joints.

Each magnet joint then thermally cycled and tested 10+ times

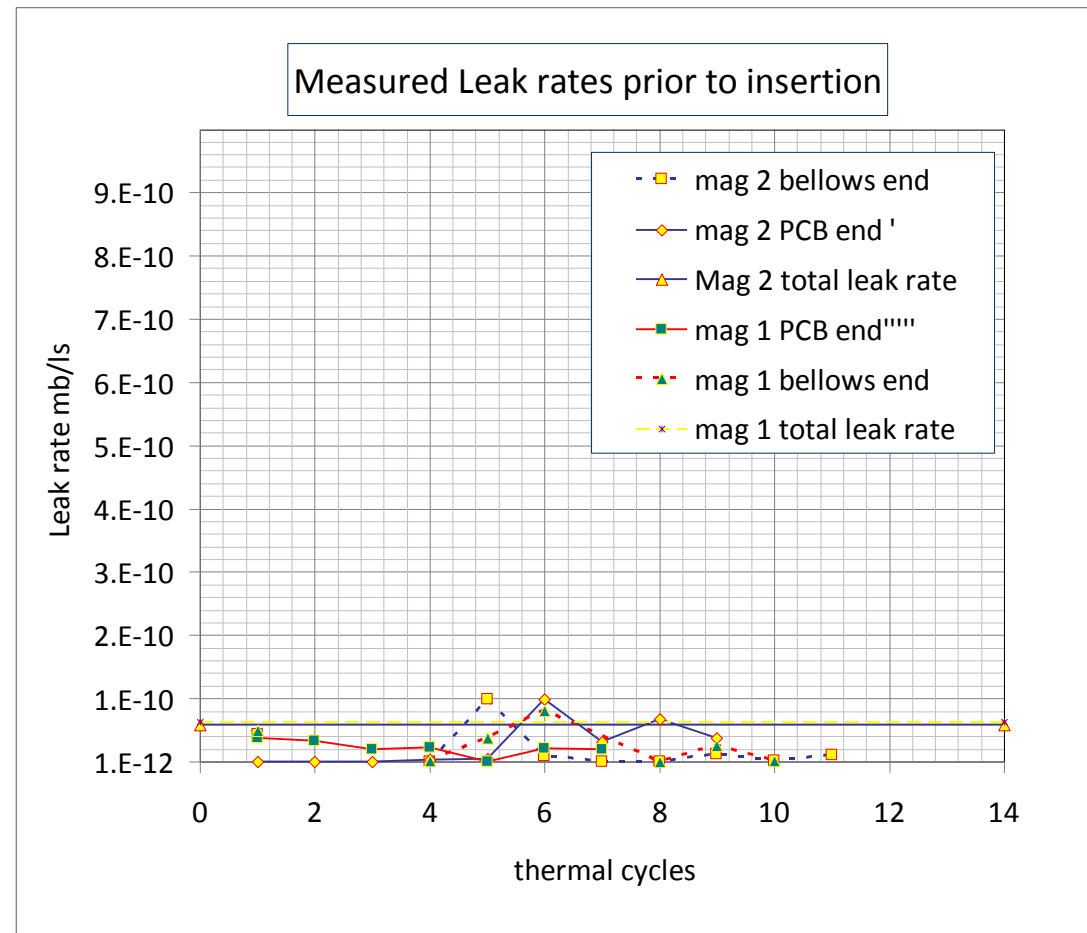
Re-testing magnets

The final leak check of the undulators inside the final vessel at temps $<77\text{K}$ is now complete. leak rate $<1\text{e-}12\text{mb/l/s}$ in the beam tube (leak checker limit).

The operational pressure for the ILC is expected to be $1.3\text{E-}13\text{mb}$.

A Starcell or triode pump with a capacity of 20l/s at the entry and exit to the module allows a leak rate $<1\text{e-}12$ to be accommodated.

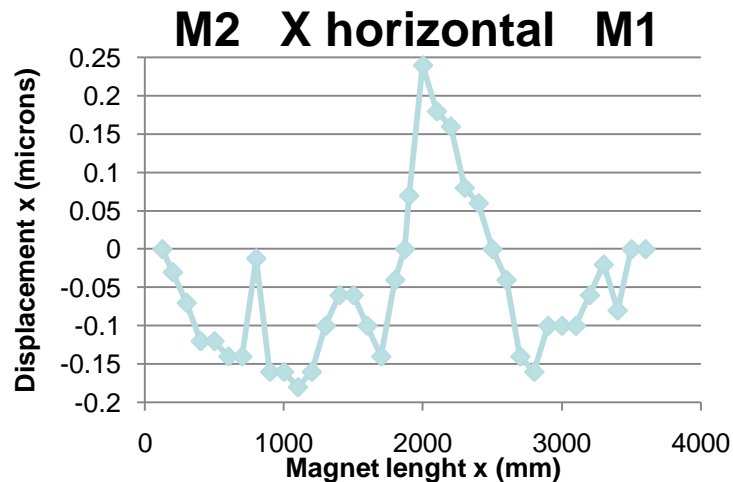
Alignment scope

Magnets inserted in helium vessel

Realigned magnet axes

– alignment not great! $\pm 250\mu\text{m}$ in X and $\pm 200\mu\text{m}$ in Y

Have developed an active alignment Yoke

Allows the straightness of the magnet to be aligned to better than $50\mu\text{m}$.

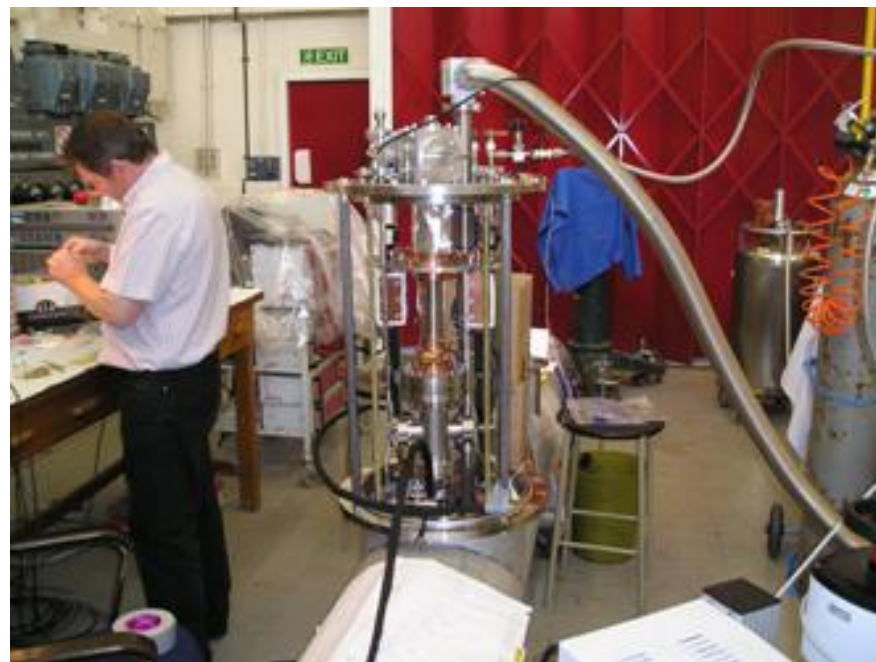
Final rebuild

End of March final system connections made.

Photos showing the turret rebuild

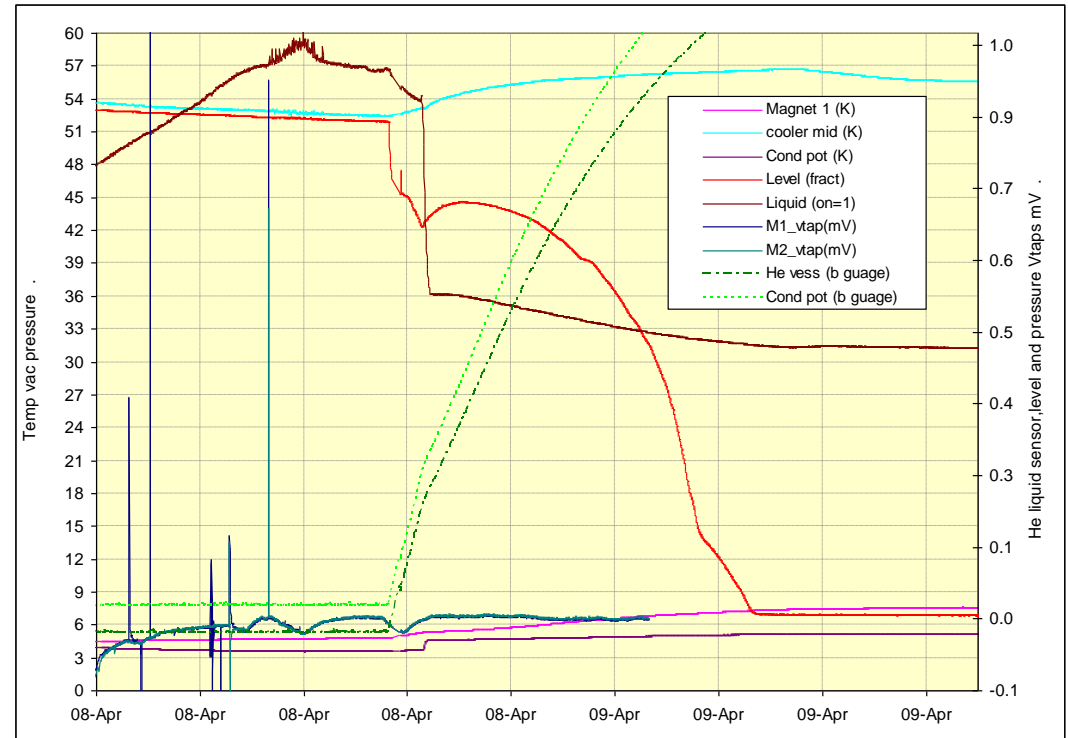
Thermal siphon

Issues with thermal siphon that

With vent valve closed

System pressurising rapidly

May have a convection problem in
vent line may need a baffle here

Generally heat load on 4k system
seems to be very small
