Status Optical Inspection at DESY

- Inspection of Z134, Z136, Z137 and Z142 before chemical treatment „as received“
- T-map of Z131 in all modes and optical inspection of the hotspots afterwards

ILC S0 Cavity Meeting S. Aderhold

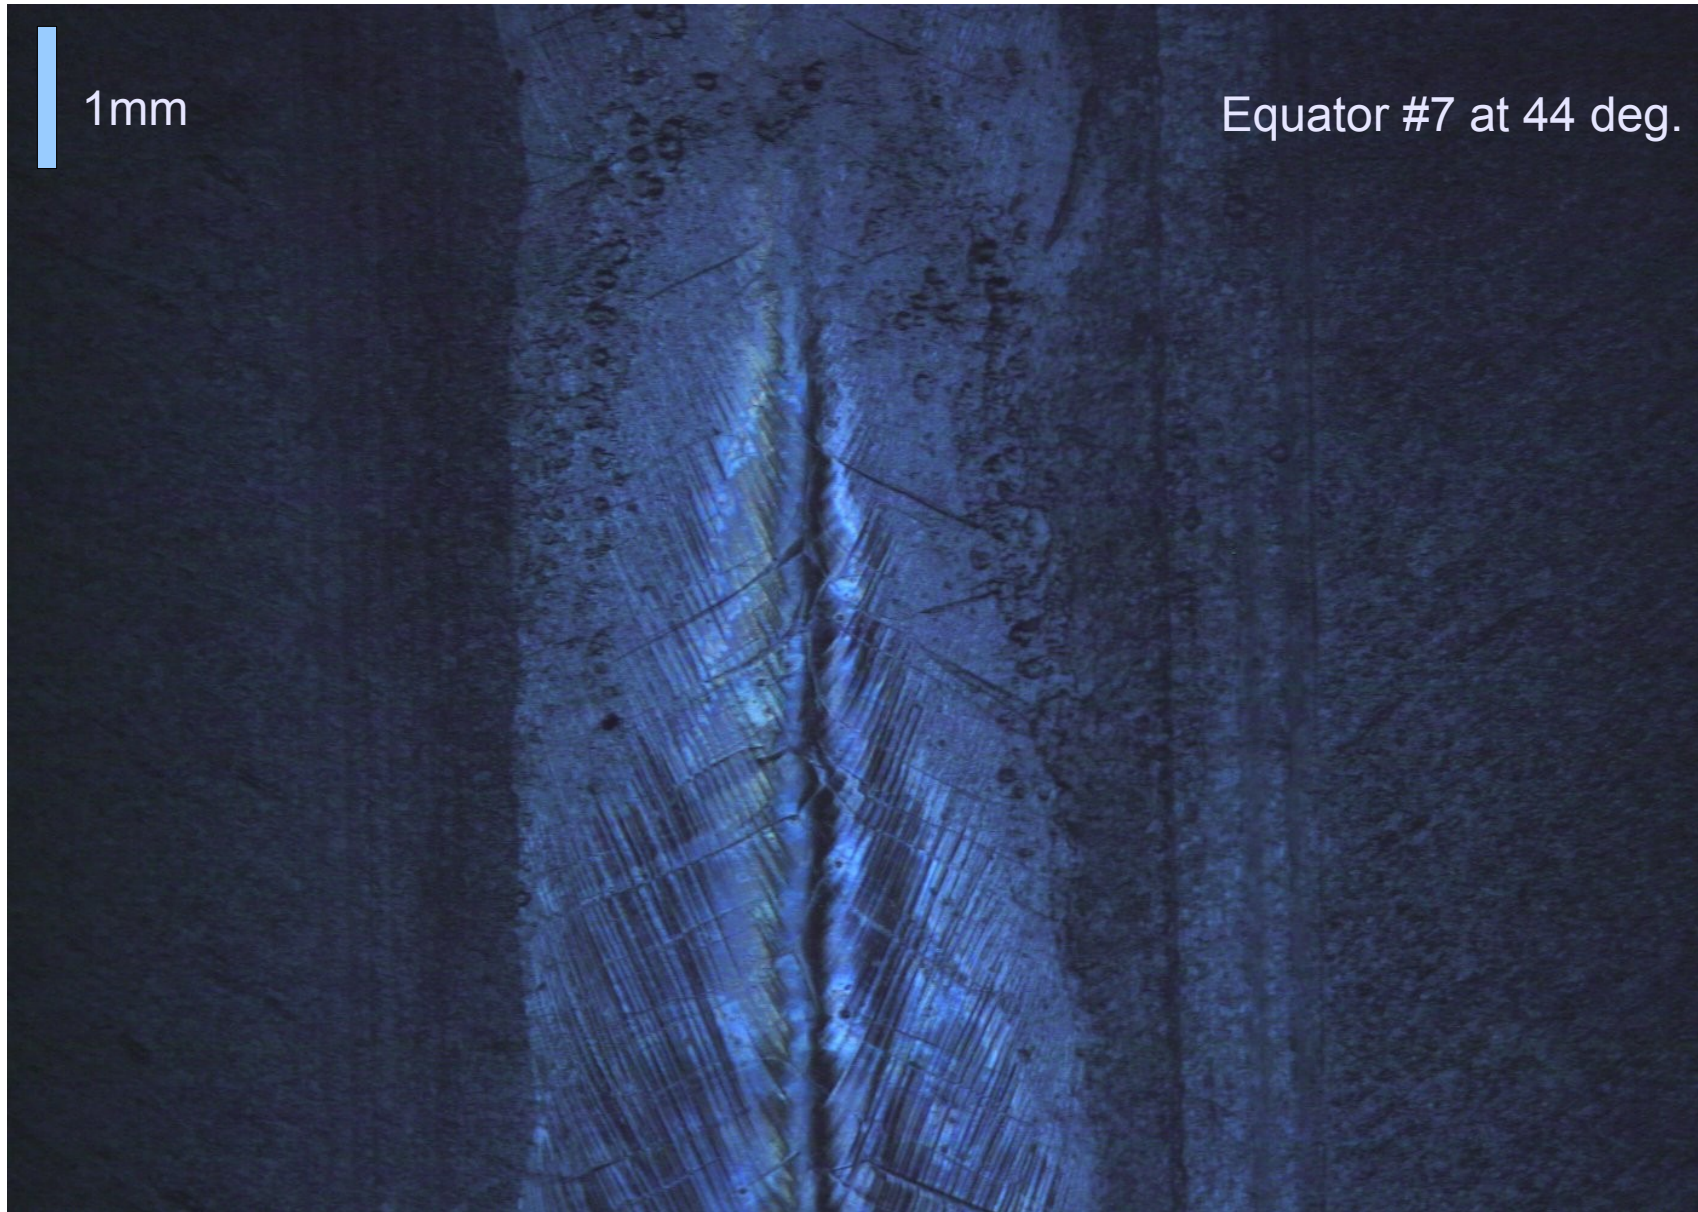
Z142

- Optical inspection before treatment shows some defects
- 3 of 4 are back from main EP
- Optical inspection after treatment will follow in 2009
