Update on S0 Work in the Americas Region

Mark Champion
27 January 2009

Argonne-Fermilab Cavity Processing Facility Status

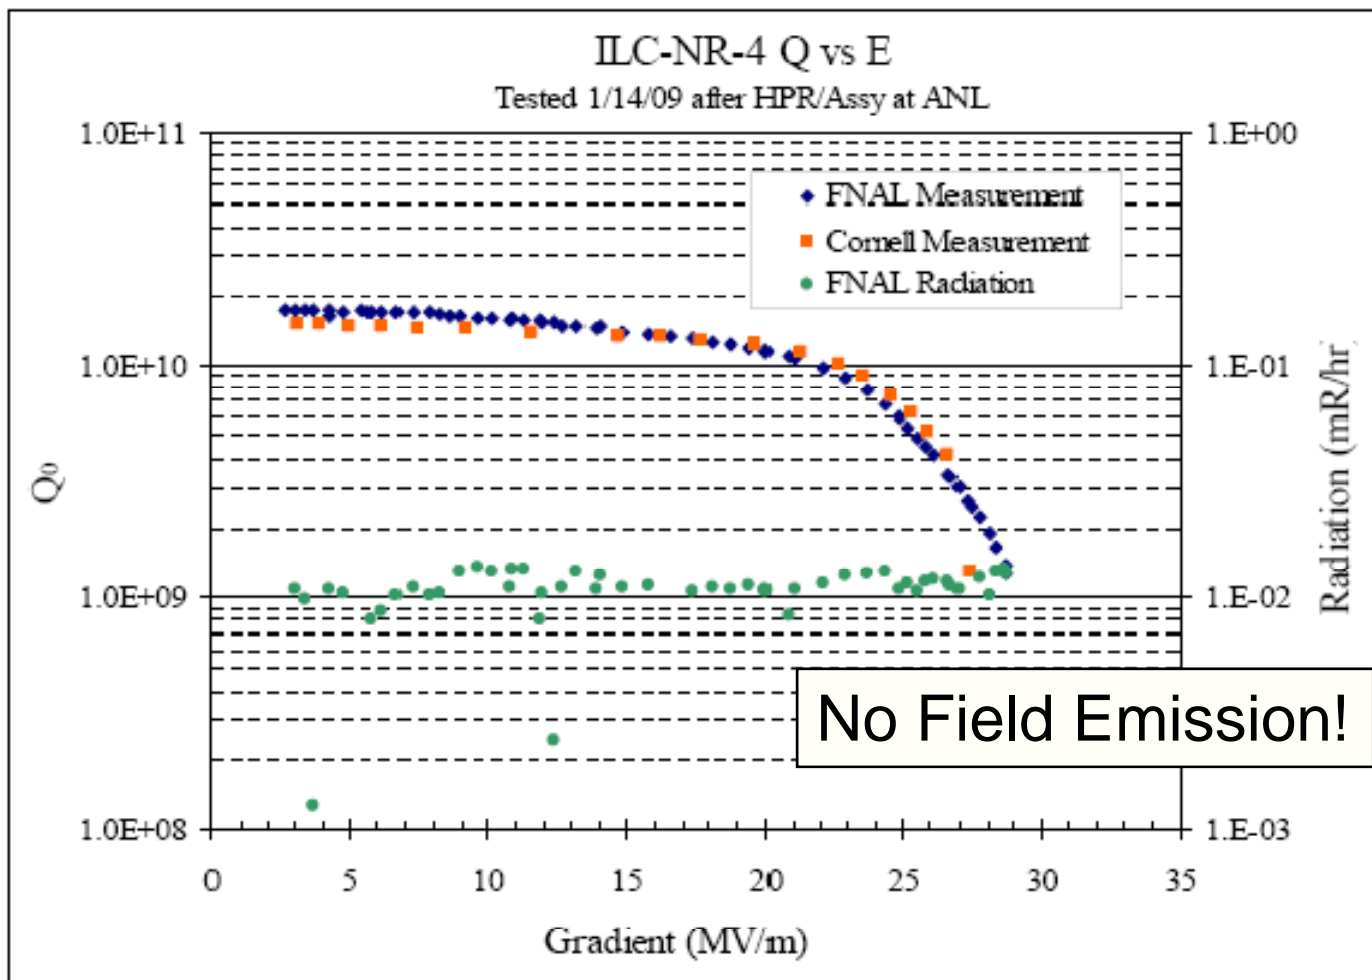
NR-4 single-cell cavity result after HPR and assembly at Argonne-Fermilab cavity processing facility

Figure 3.) Final Q_0 vs E run at 2K at FNAL, compared to Cornell data from 2008.

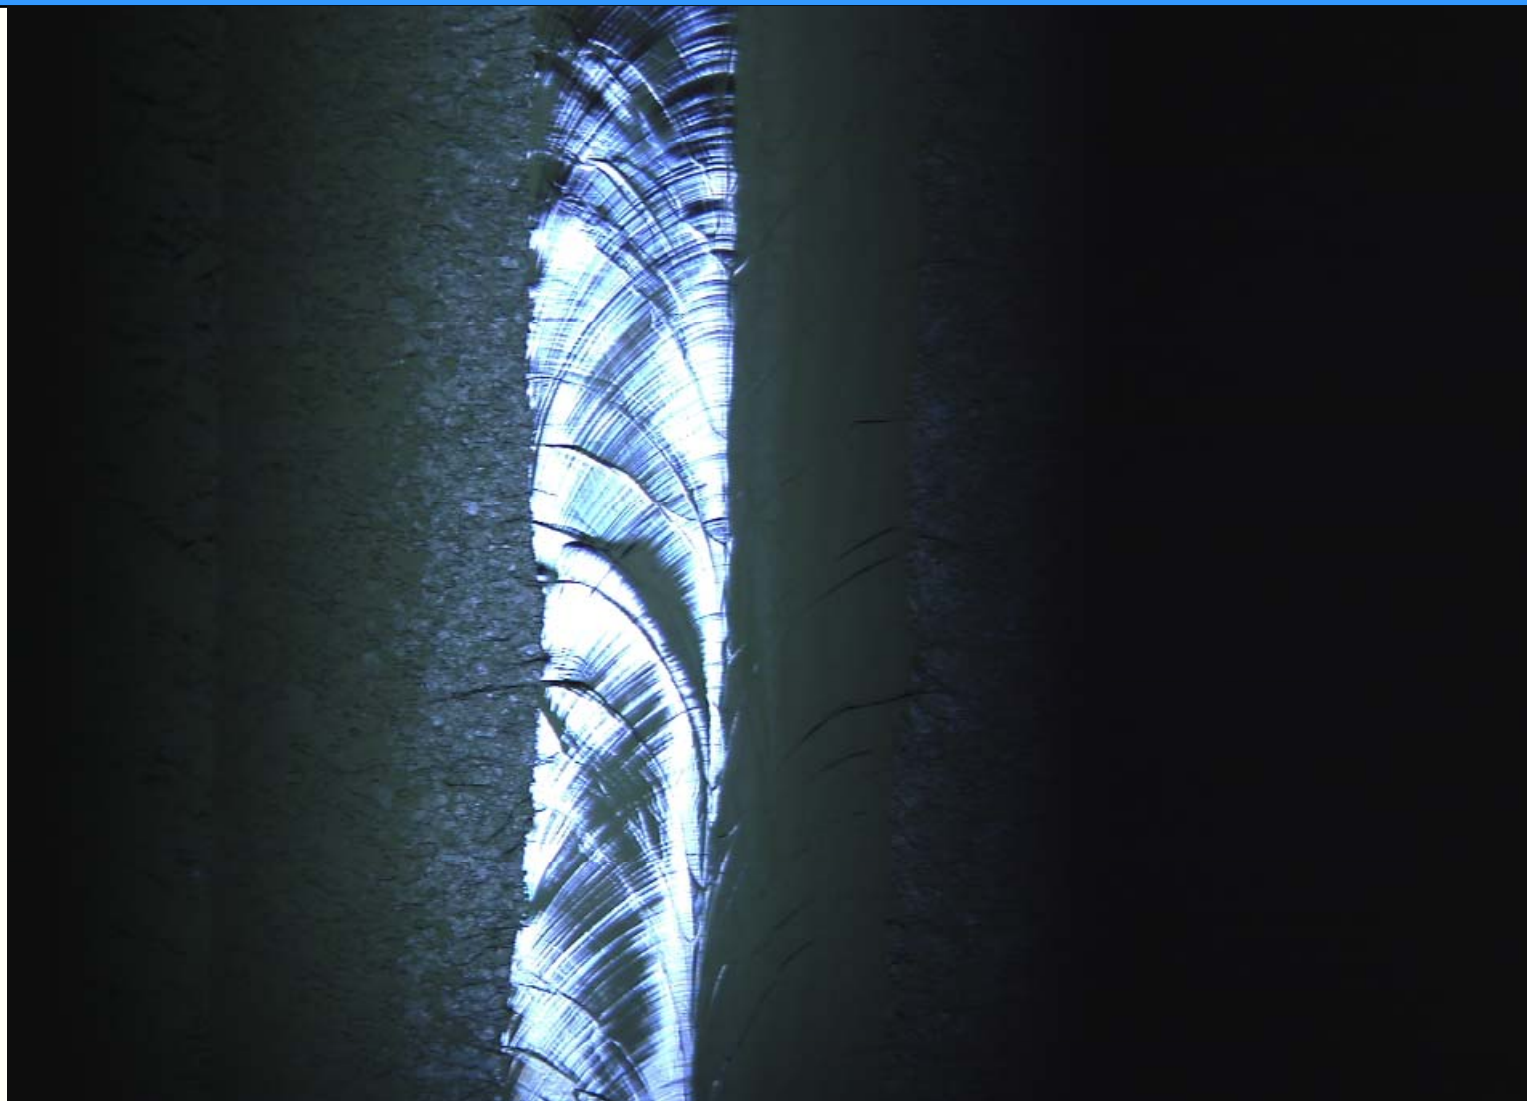
First image using optical inspection system at Fermilab, Jan 13

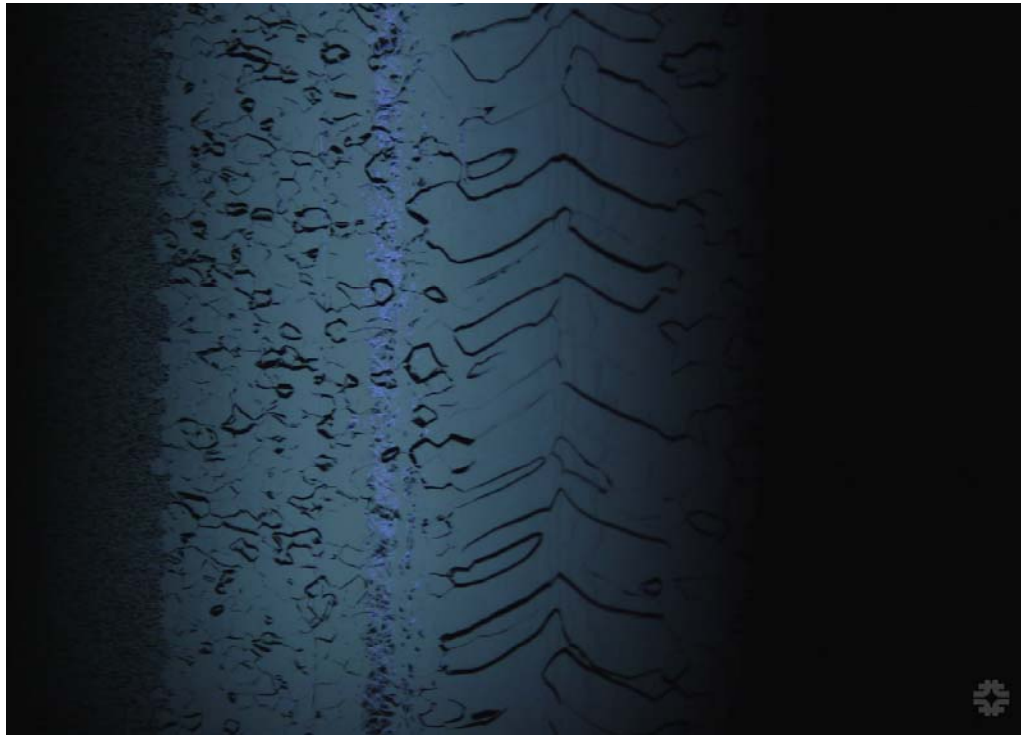
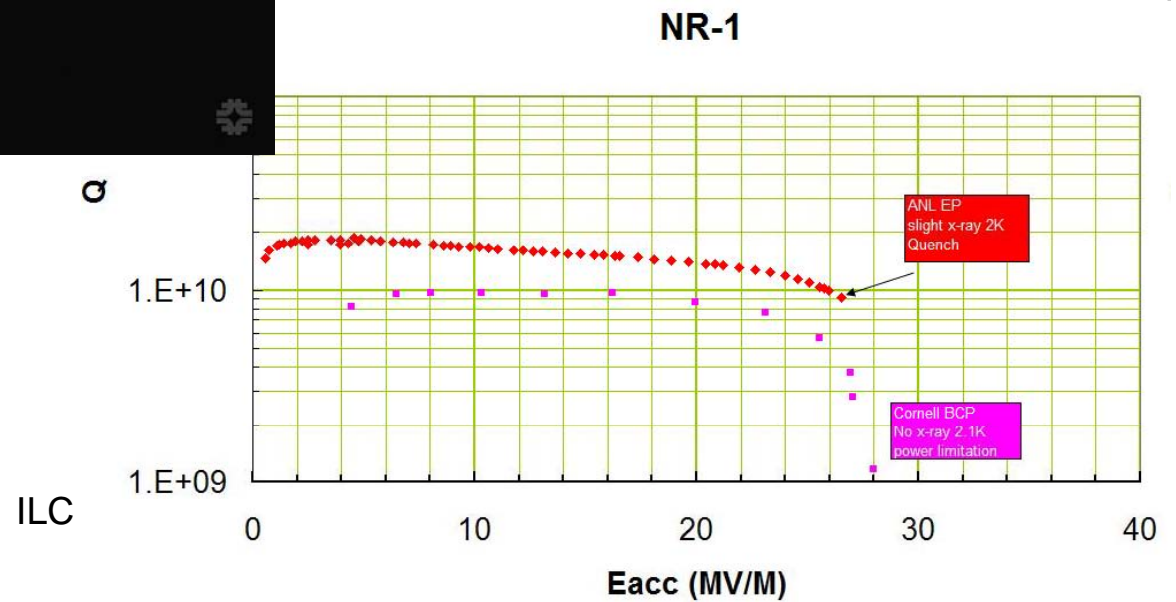
NR-1

Cavity history:

BCP 150 μm ,
EP 100 μm ,
No In-situ baking

26 MV/m, quench

Equator weld rough
despite 100 μm EP

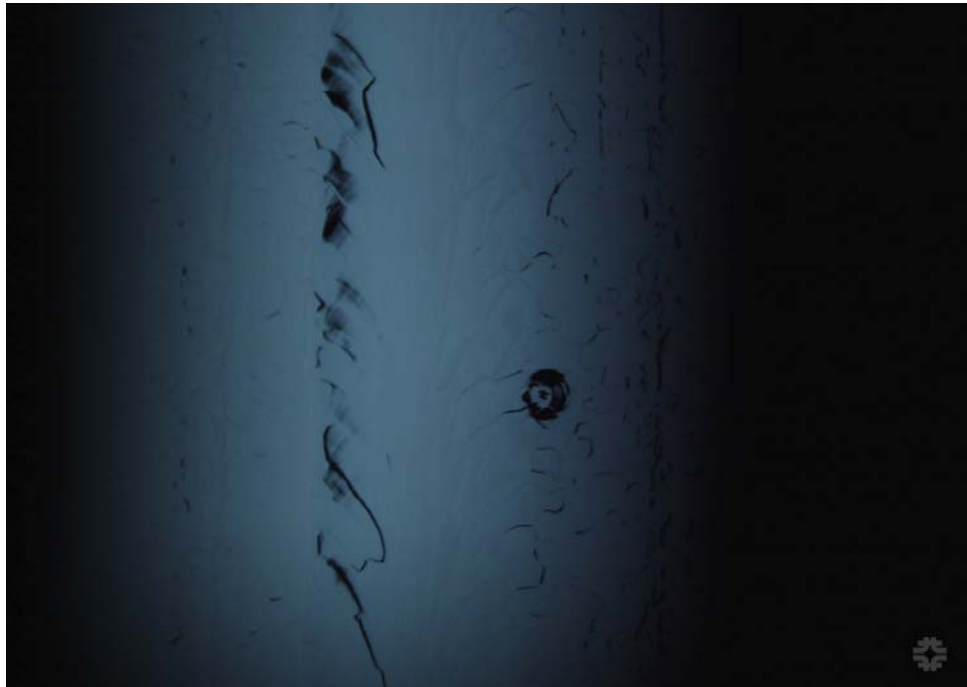
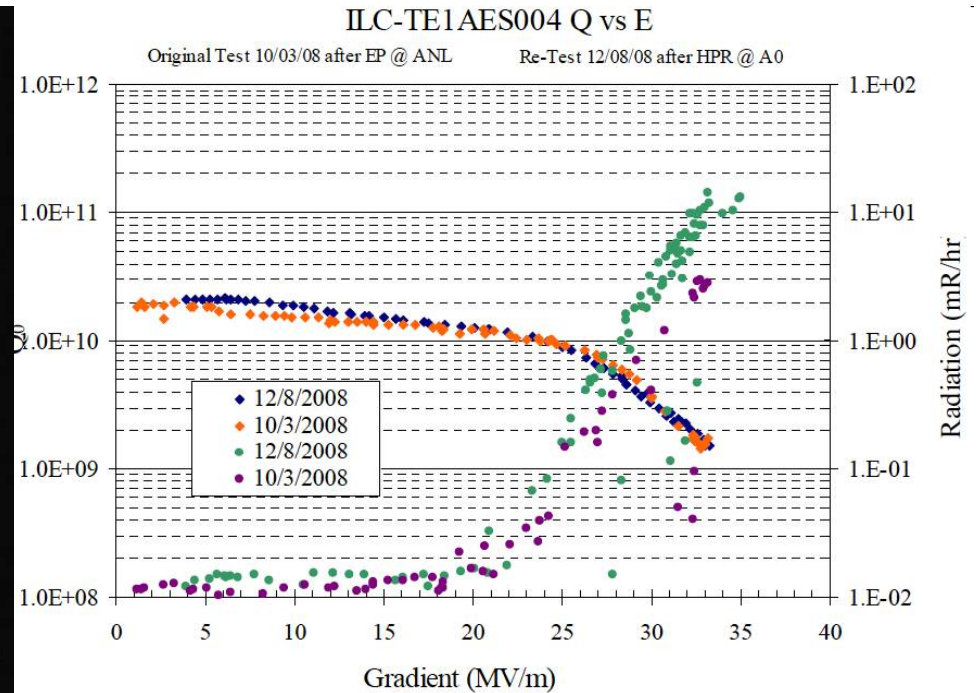
TE1AES004

Cavity history:

BCP 107 μm ,

EP 65 μm ,

In-situ baking 120°C

33 MV/m, No quench, limited by power

Pit 0.9 mm diameter, depth still being investigated

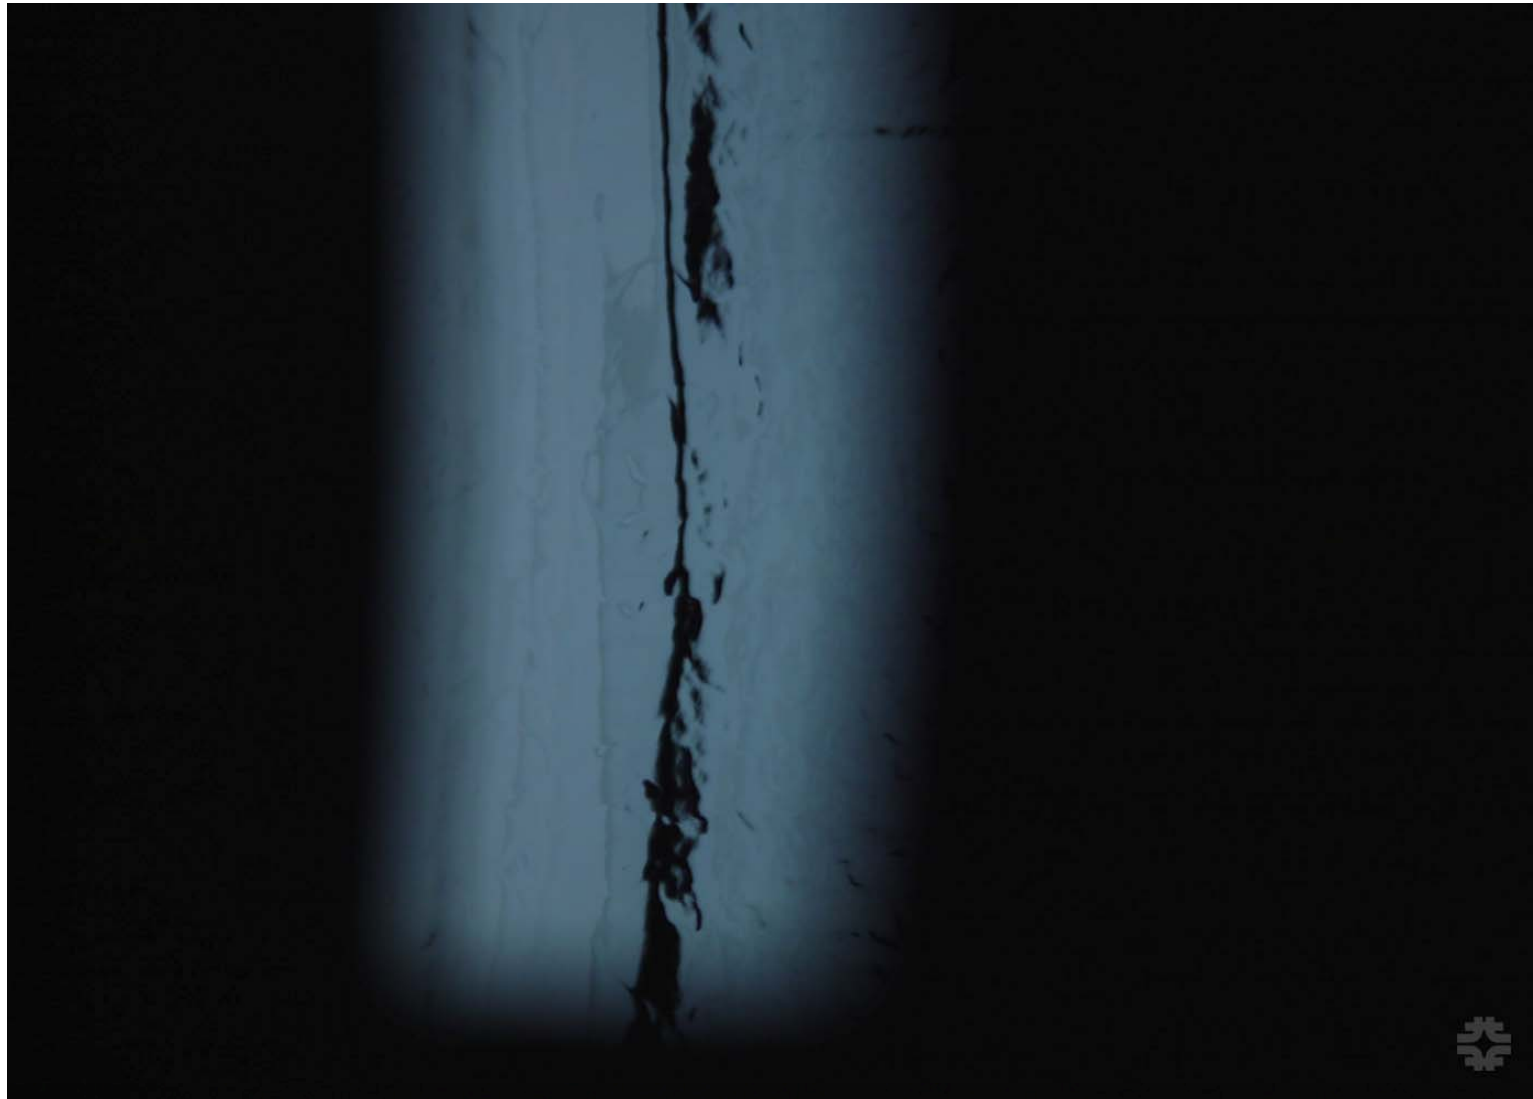
TE1AES004

Iris ridge evident, despite BCP and EP.
This may be cause of persistent FE.

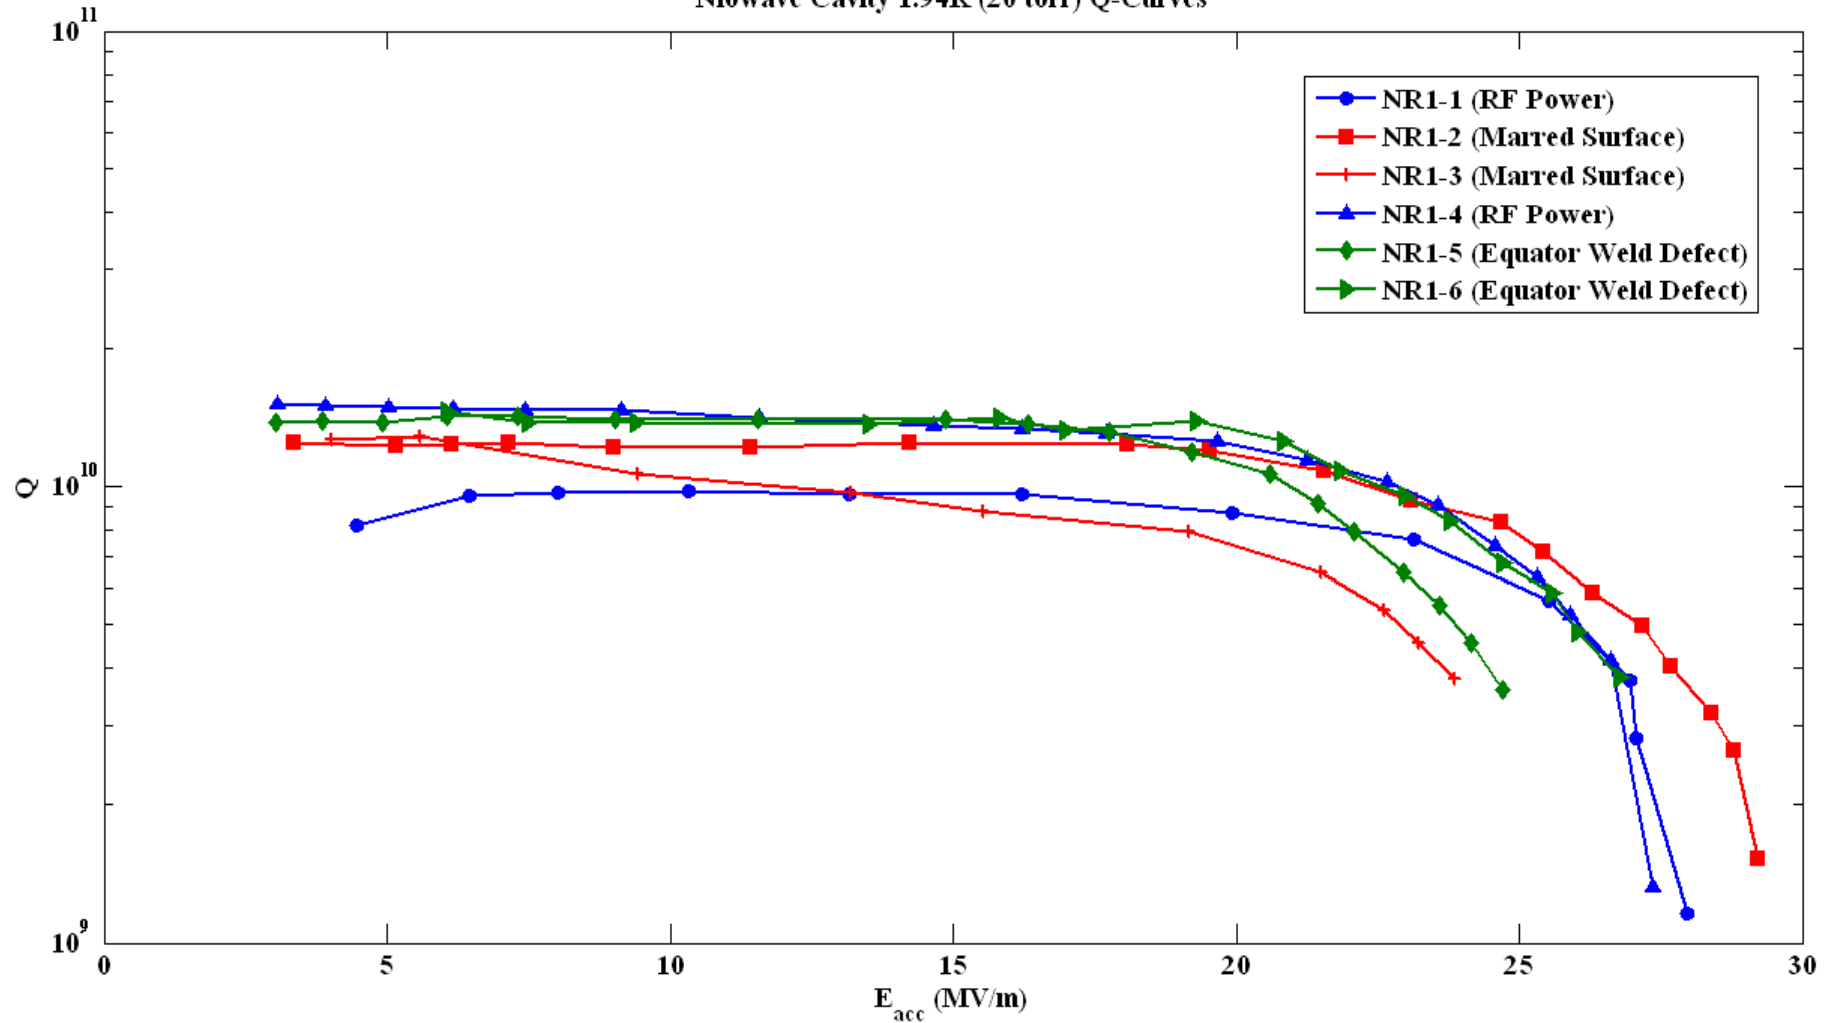
Niowave Cavity 1.94K (20 torr) Q-Curves

Niowave Cavity	BCP (1:1:2) Etch	Q_0 (1.94 K)	Peak E_{acc}	Q at Peak E_{acc}	Field Limit
NR1-1	85 μm	8.2 e 9	27.9 MV/m	1.2 e 9	RF Power
NR1-2	113 μm	1.2 e 10	29.2 MV/m	1.5 e 9	Marred Surface
NR1-3	60 μm	1.3 e 10	23.8 MV/m	3.8 e 9	Marred Surface
NR1-4	254 μm	1.5 e 10	27.4 MV/m	1.3 e 9	RF Power
NR1-5	184 μm	1.4 e 10	24.7 MV/m	3.6 e 9	Equator Weld Defect
NR1-6	205 μm	1.5 e 10	26.8 MV/m	3.8 e 9	Equator Weld Defect

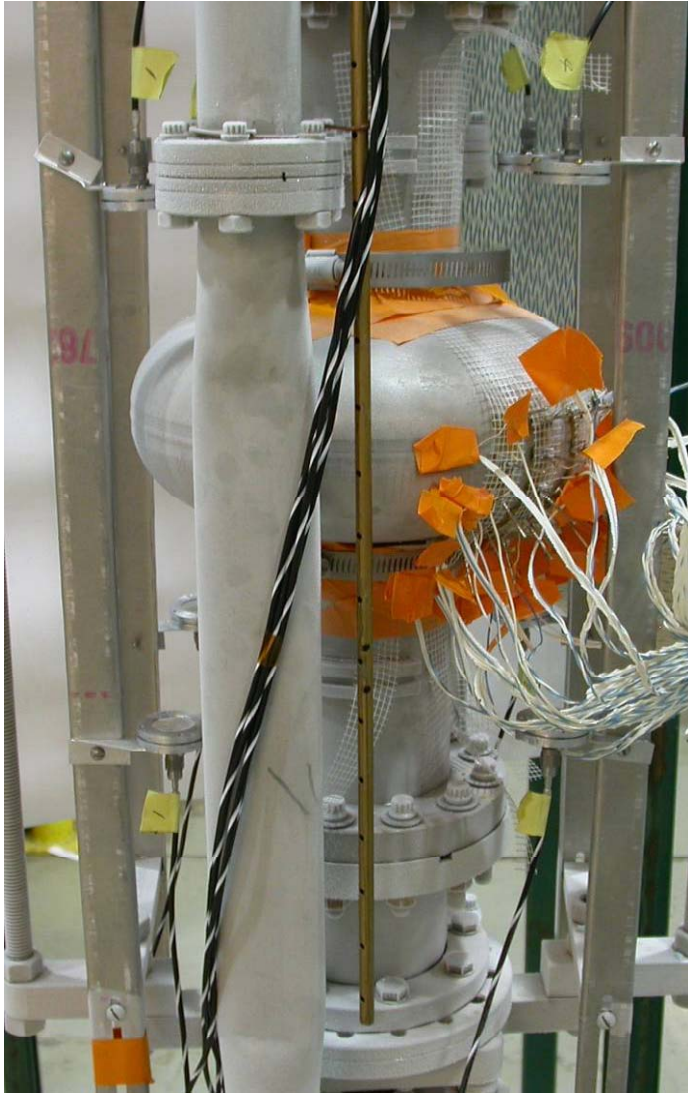
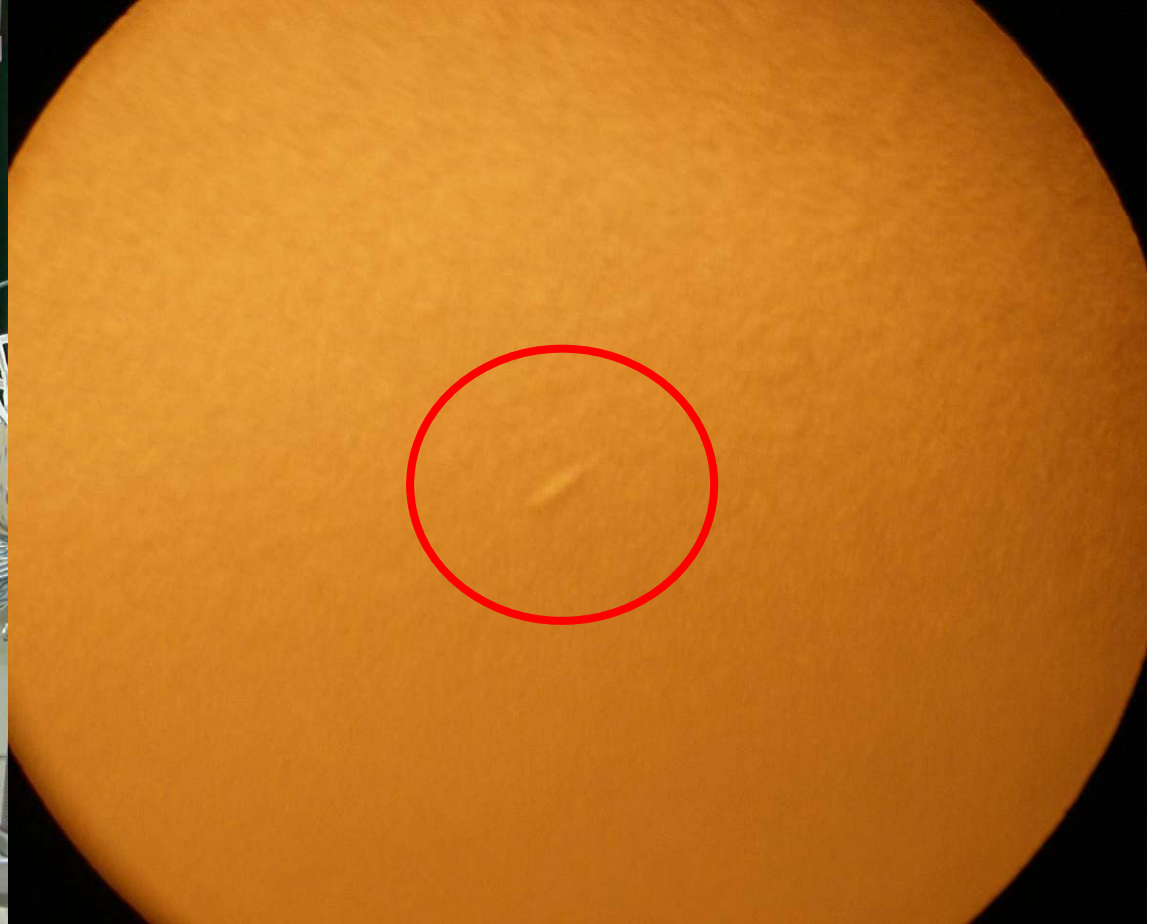
Niowave Single Cell NR-3

- The maximum field of 4 out of 6 Niowave cavities were limited by defects.
- The defects were located with a second sound time-of-flight measurement system.
- Niowave cavities 2 and 3 quenched at a surface defect caused by the die used to form the half cells.

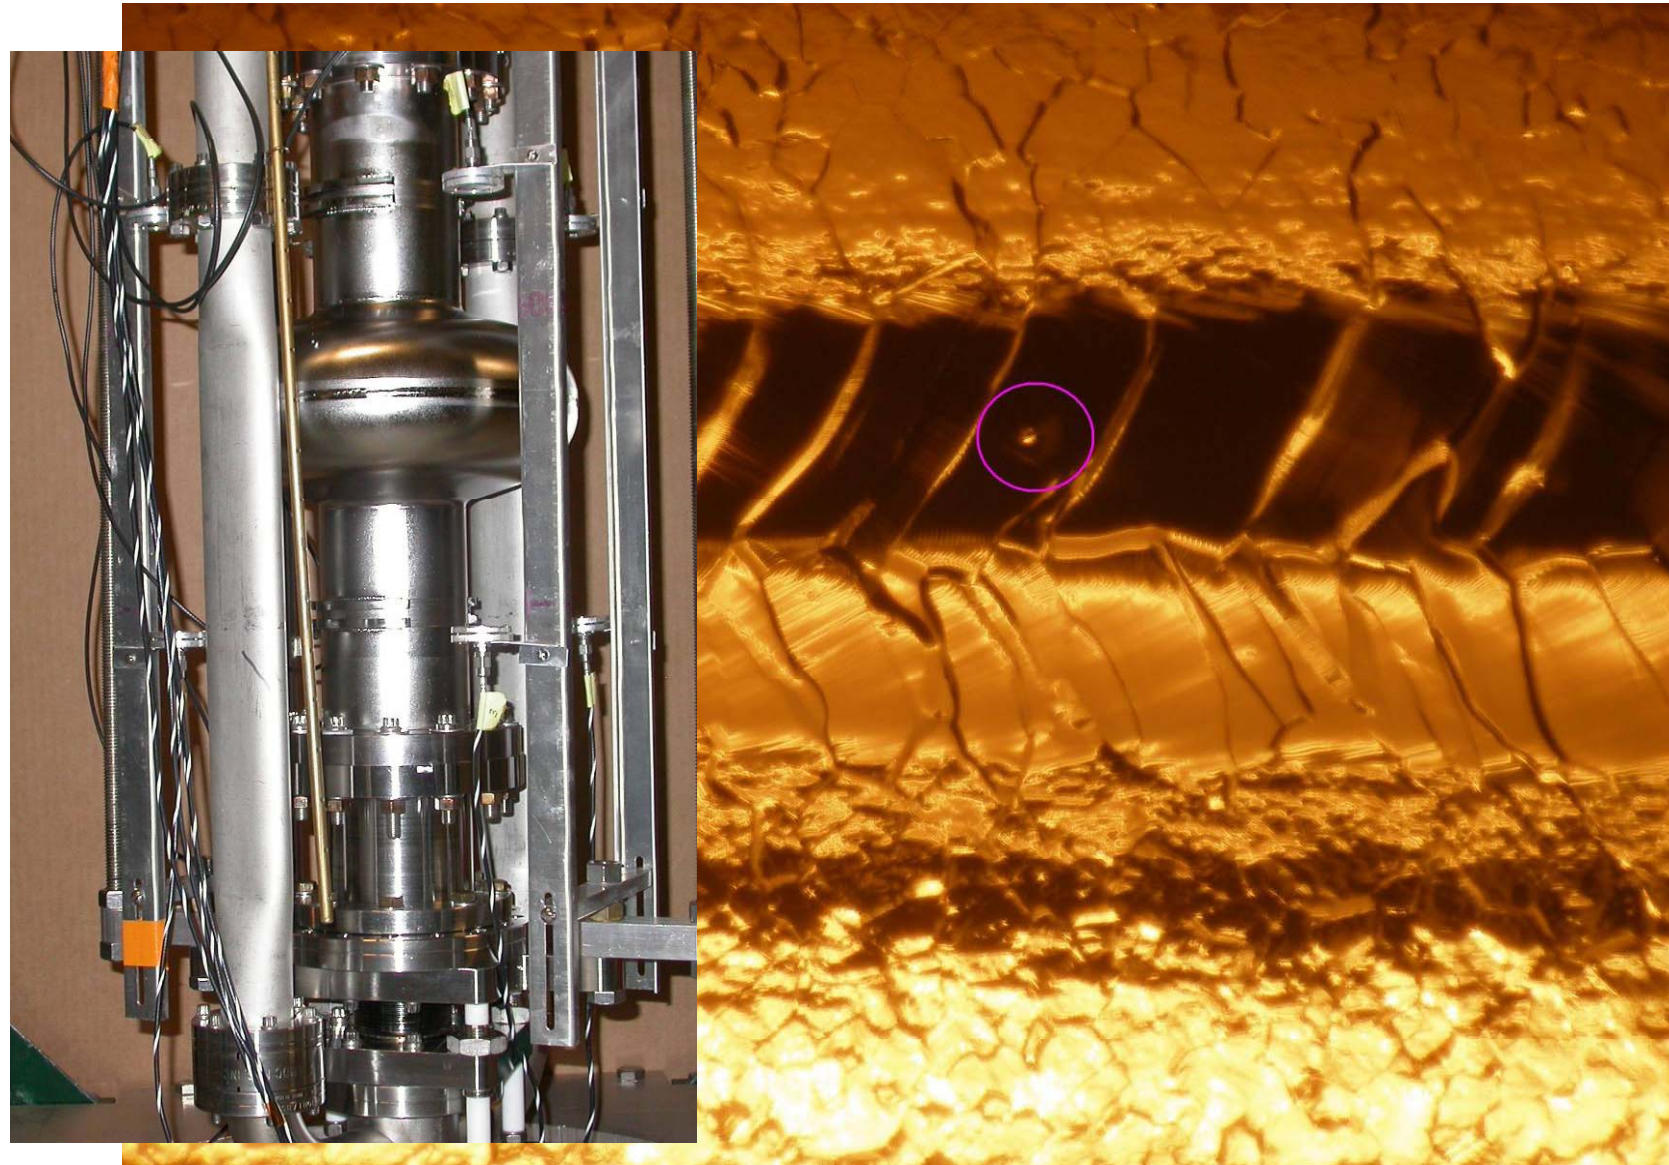
Niowave Single Cell NR-5

- Niowave cavities 4, 5, and 6 received extra BCP to remove the die caused surface defect.
- Cavities 5 and 6 quenched on the equator weld. Cavity 4 was limited by Q-slope.

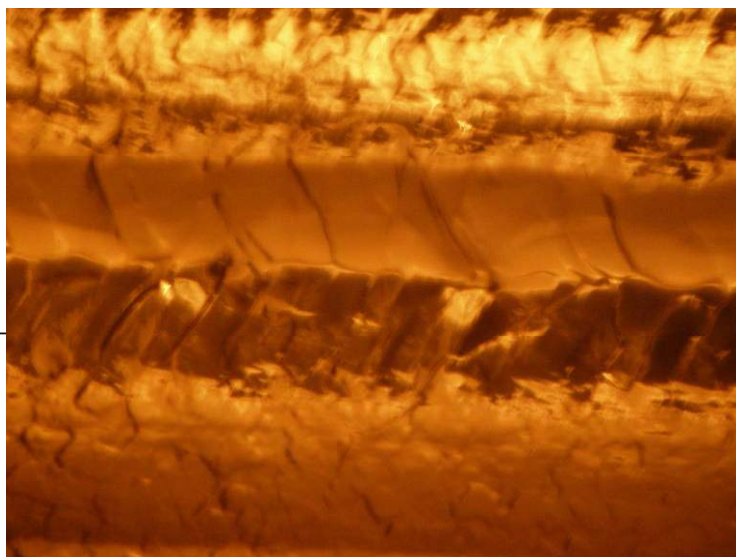
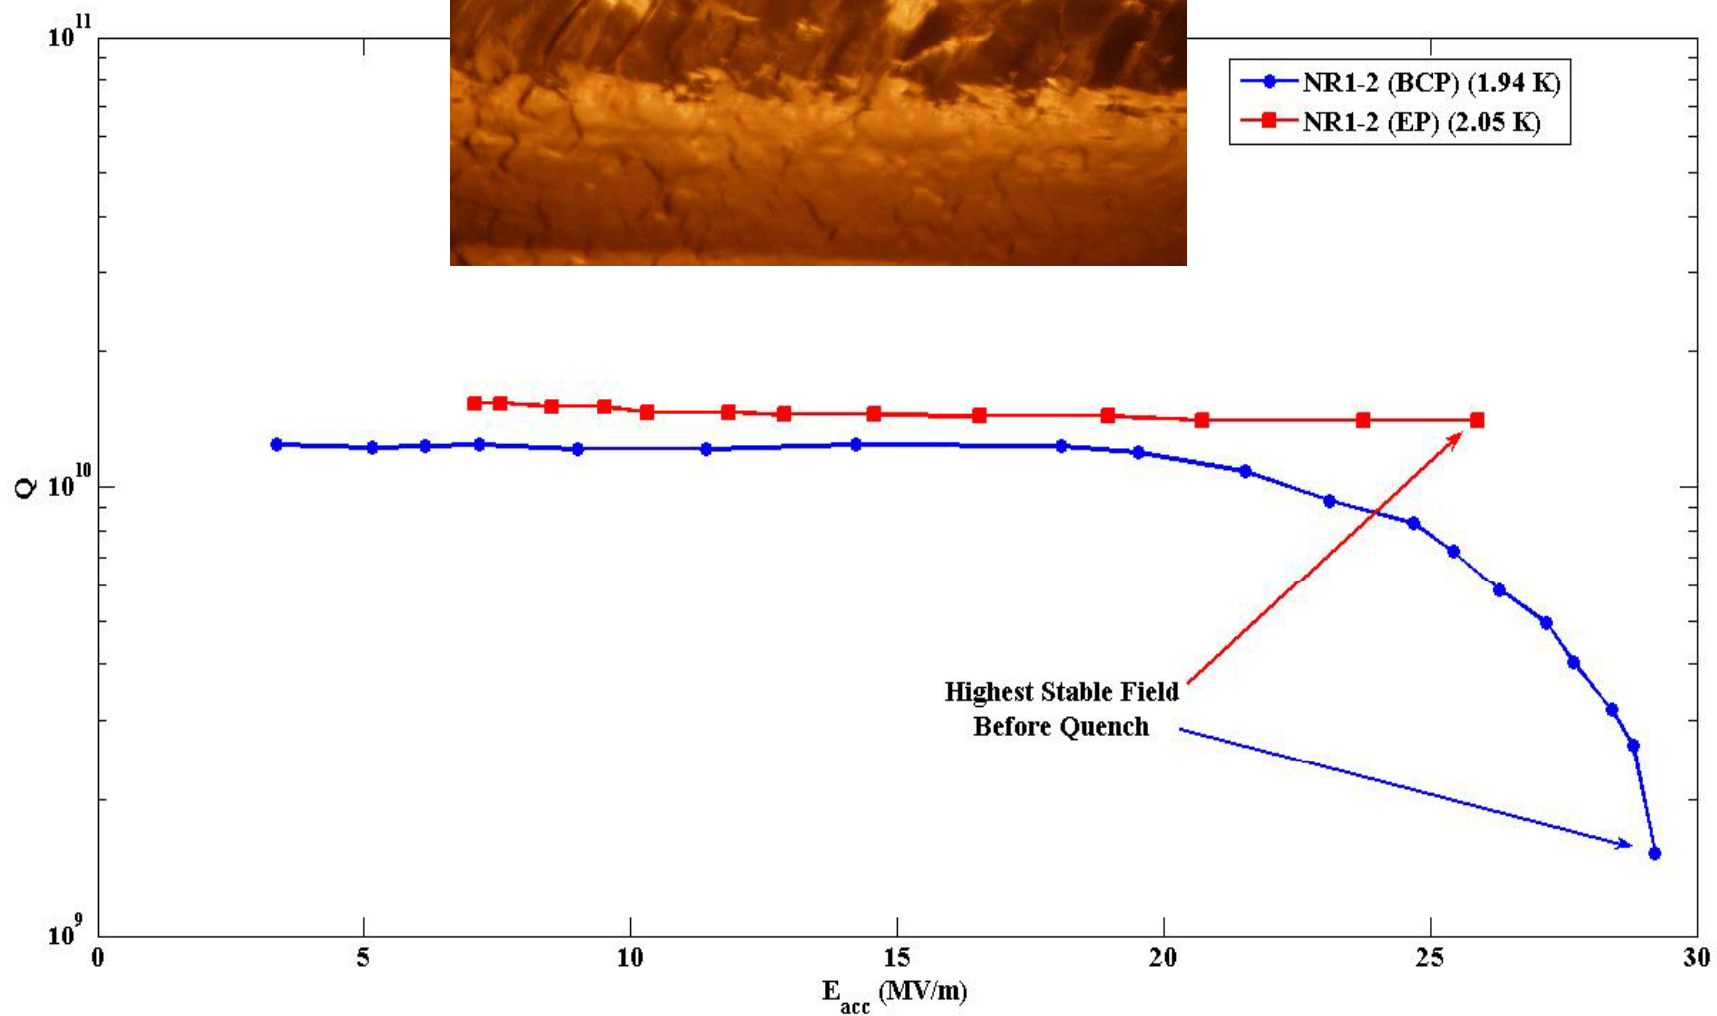
Niowave Cavity #2

- Following the BCP test, Niowave cavity #2 received a heavy VEP (200 μm), a 2 hour 800 C bake, and a 25 μm VEP.
- Test results are shown on the next slide.
- This cavity had a high Q and no Q-slope. This cavity quenched on the equator weld.
