DHCAL Meeting

20/01/09

GRPC development in Lyon

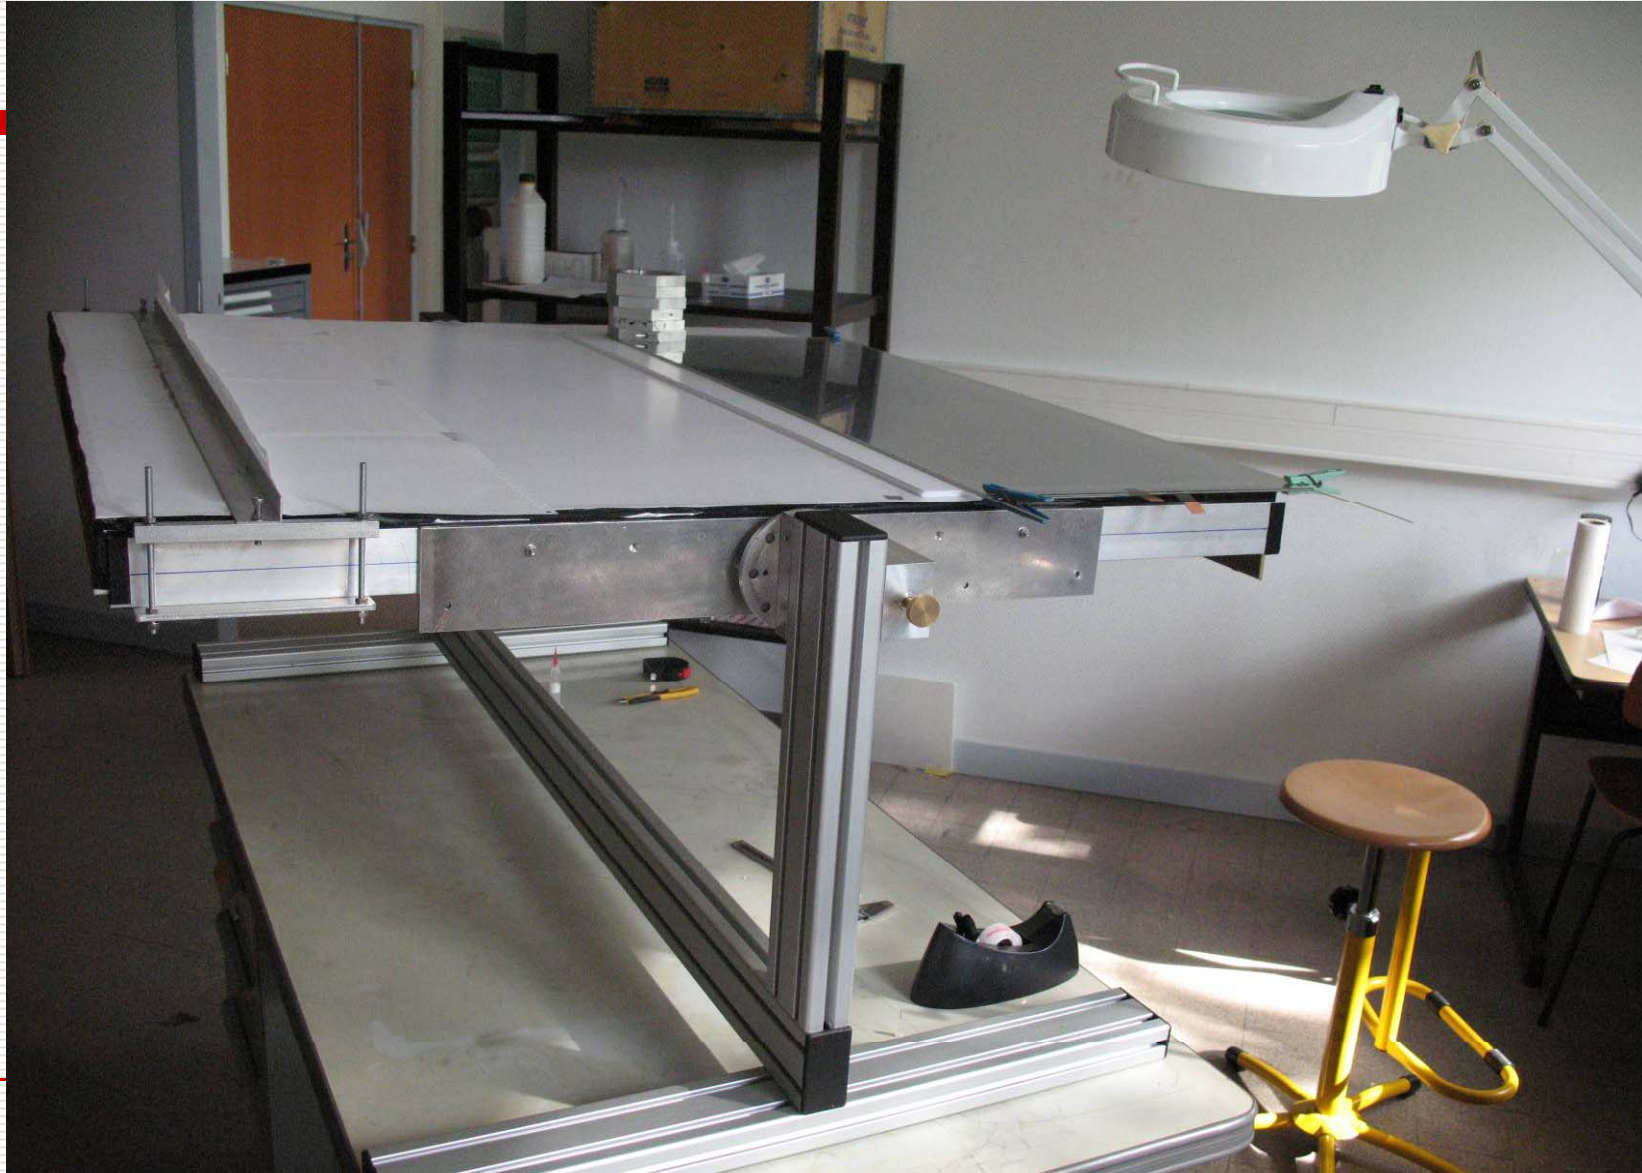
Gluing table

- Three chambers 1m x 1m produced:
 - 2 x "Licron" chambers
 - 1 x "Statguard" chamber
 - All with standard gas distribution
 - Construction steps:
 - Clean glass and cover with resistive coating
 - Glue micro-balls, frame, gas spacers and capillary tubes to cathode glass on gluing table
 - Add glue to upper surfaces of balls and gas spacers
 - Turn table to vertical position
 - Introduce anode glass
 - Turn table to horizontal position
 - Add weights to anode glass and wait for glue to dry
 - Deposit glue lines between glass and frame to make gas-tight
 - Glue 6mm gas connectors to capillaries and solder HV connectons
 - Transfer to honeycomb support
-

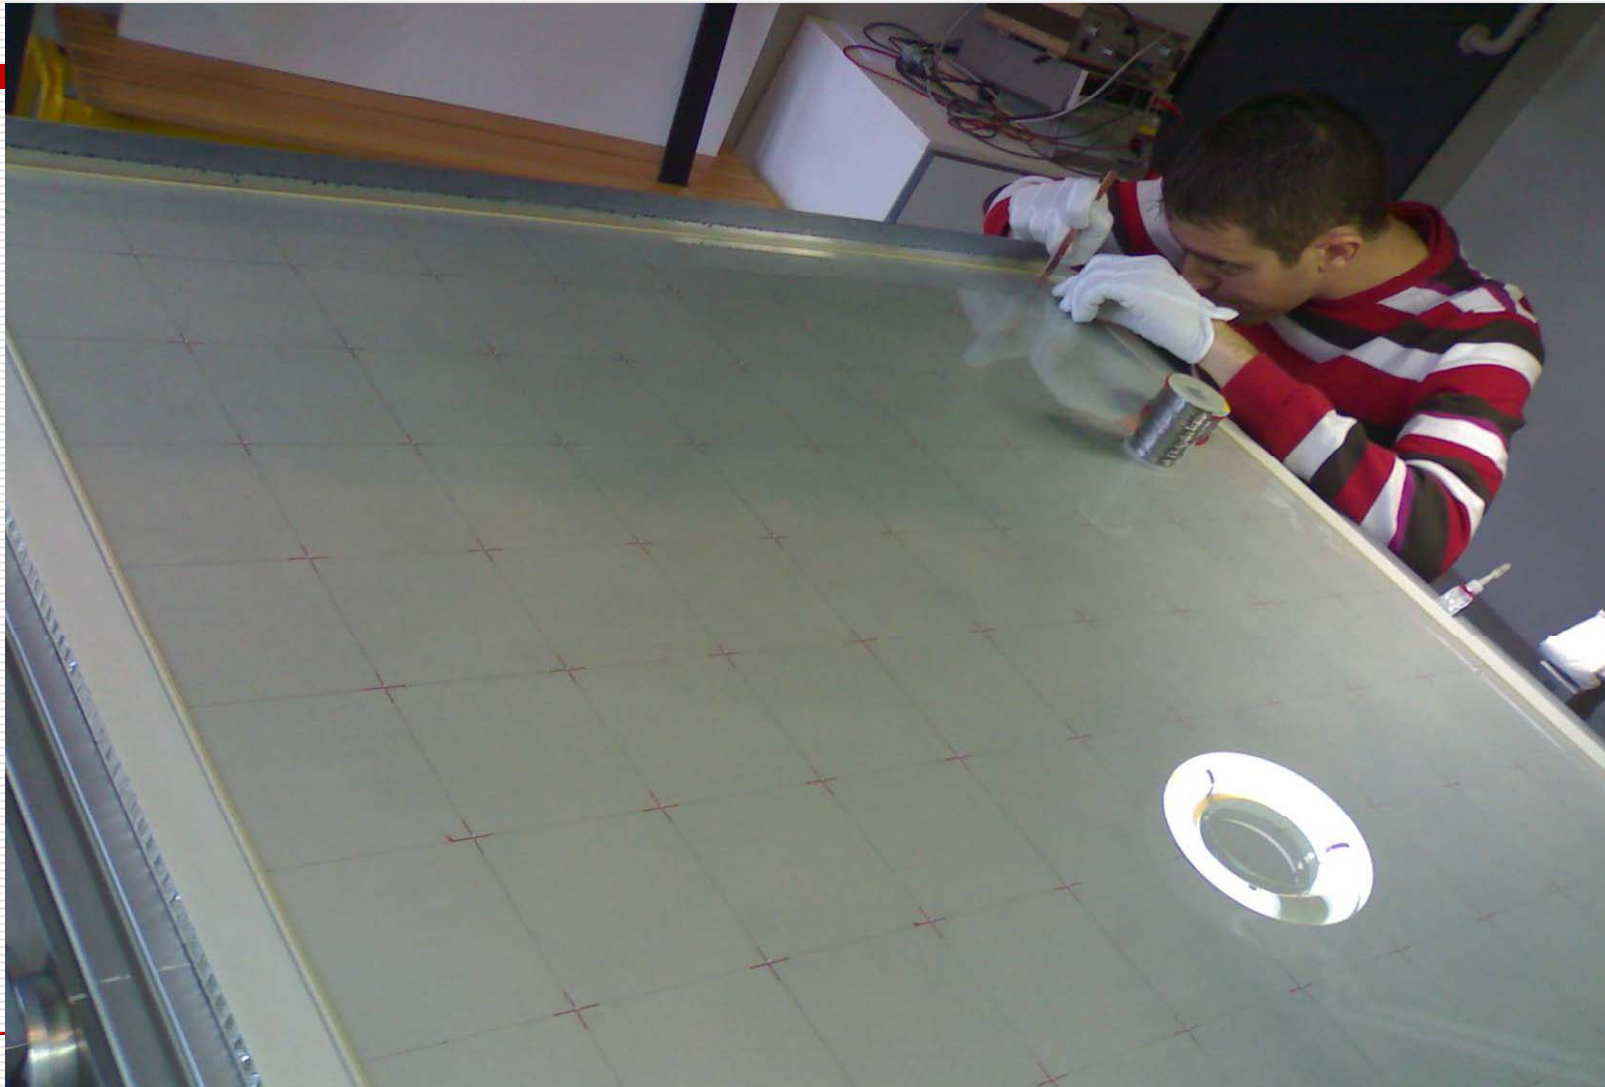
Gluing the gas channel spacers

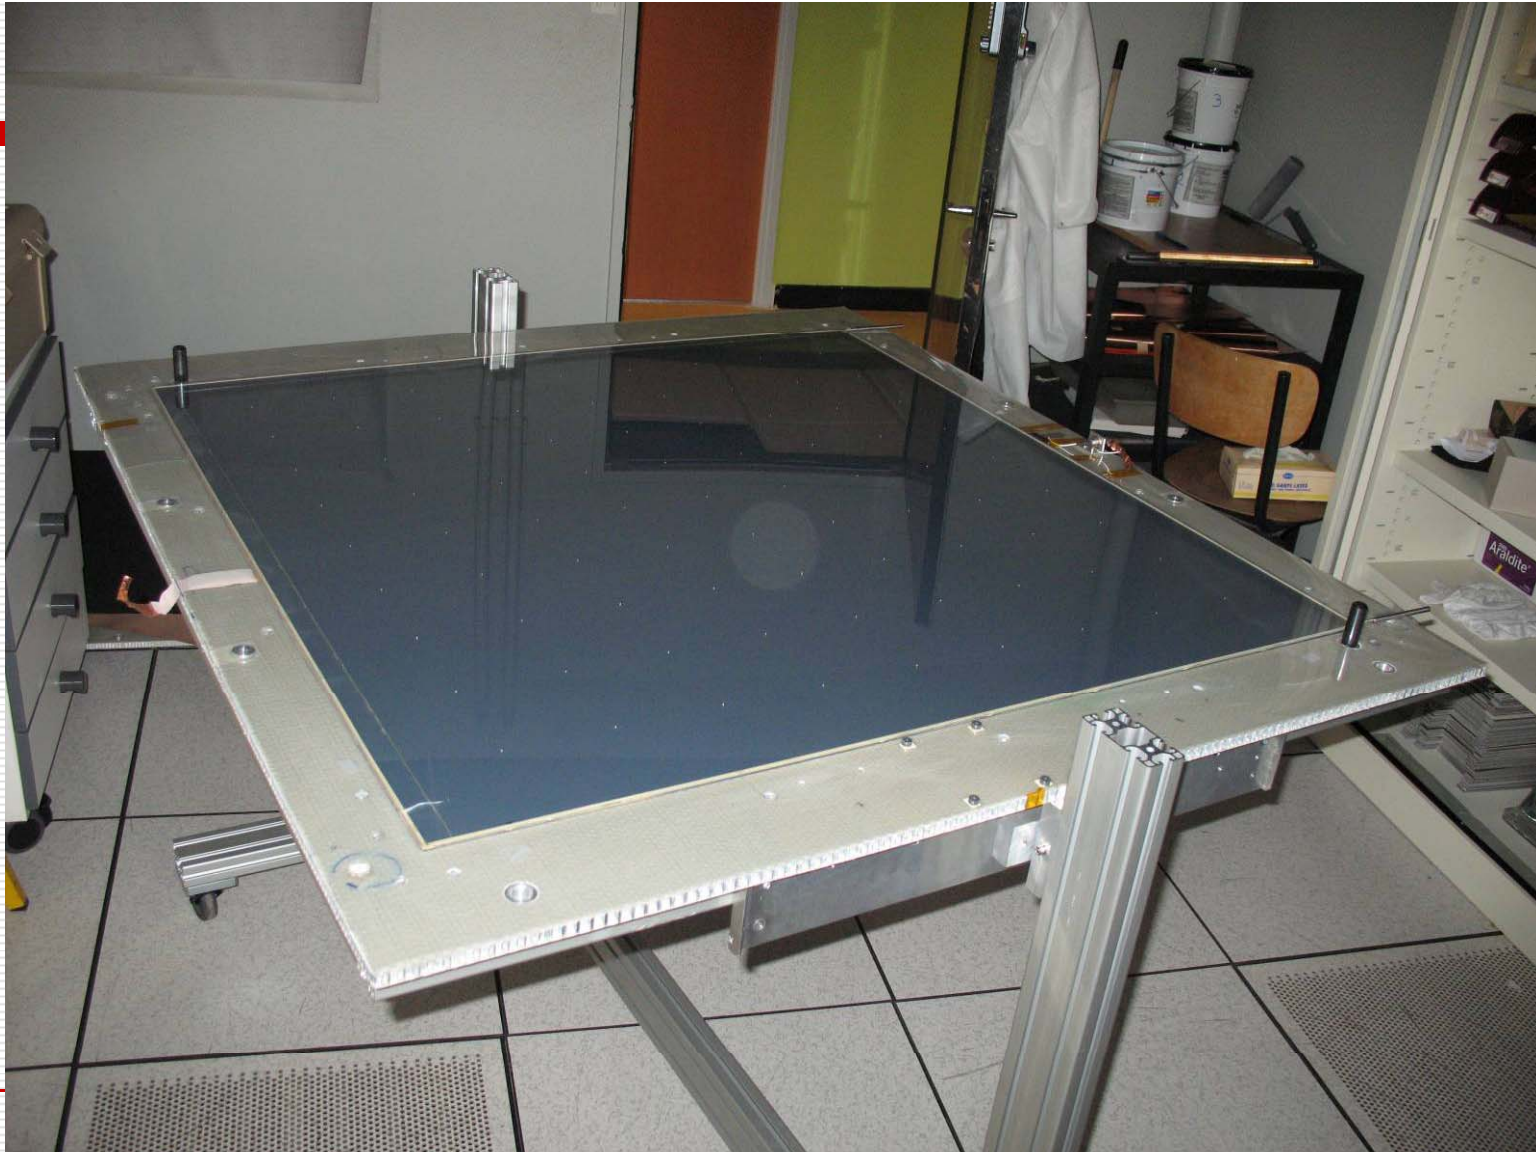
Statguard chamber + Honeycomb Support

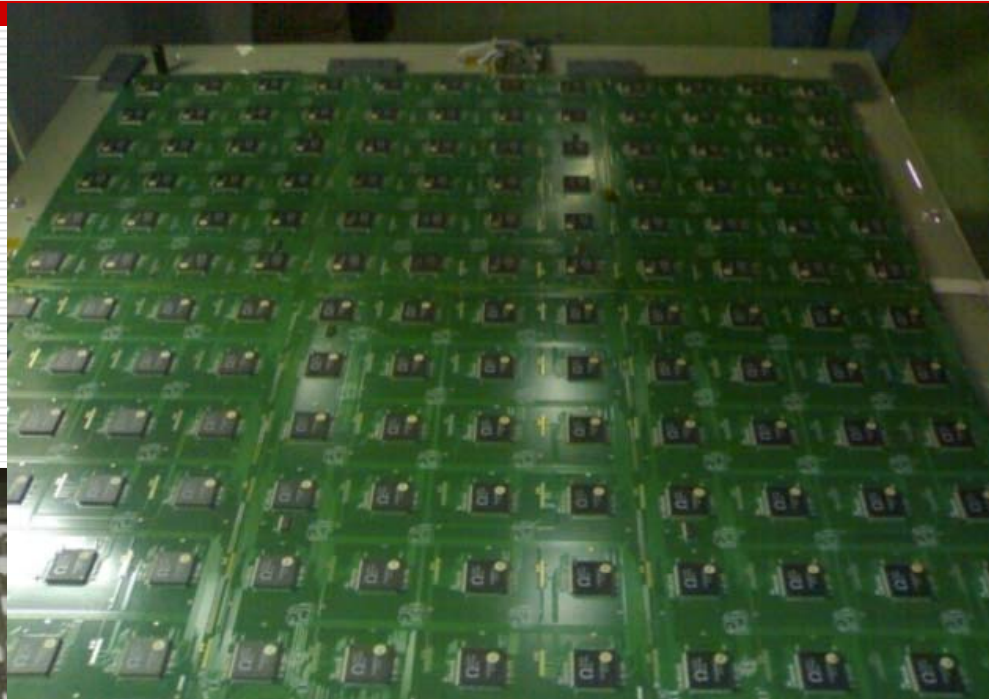
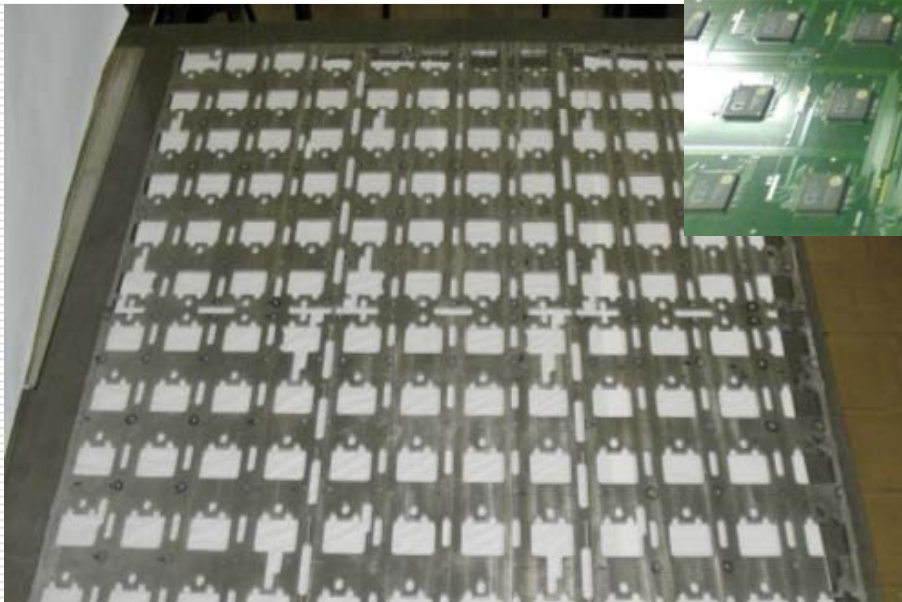
Large area read-out

144 ASICs/m² → 9472
channels/m²
(chamber is underneath!)

Stainless steel PCB support (CEIMAT)

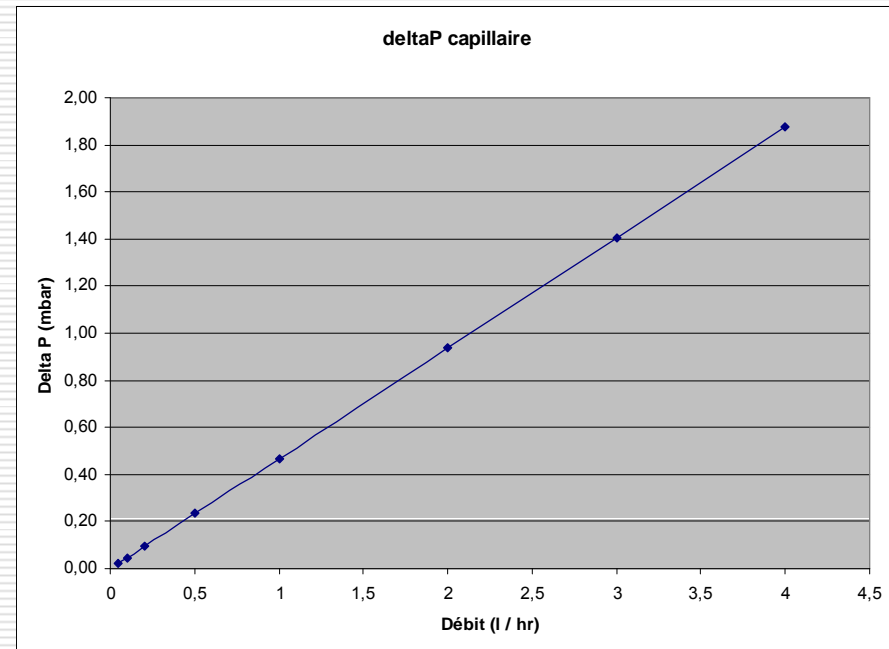
- ❑ First chambers inflated under gas pressure!
- ❑ Glue failure caused balls to become detached from upper glass
- ❑ Subsequent failure of glue around perimeter → gas leaks
- ❑ Over-pressure in chamber not excessive ($\Delta p_{\text{exit}} \sim 2.5 \text{ mbar} \equiv 250 \text{g / ball max.}$)
