Sample tests for stain problem at KEK

LCWA2009 at Albuquerque

Introduction: Stain problem at STF/KEK

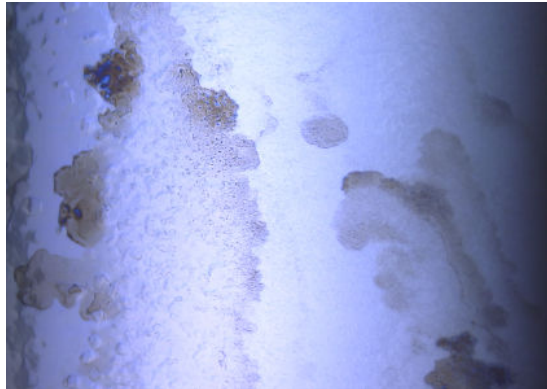
MHI#6 1-cell equator, t = 306 deg.
Downstream : Outside weld area

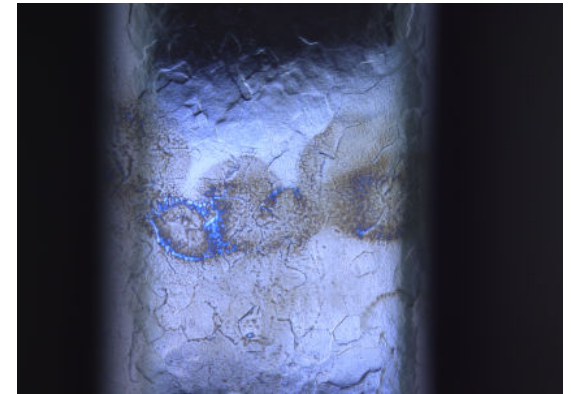
MHI#6 #9-BP, t = 241 deg. -2

Kyoto-camera pictures using new LED illumination

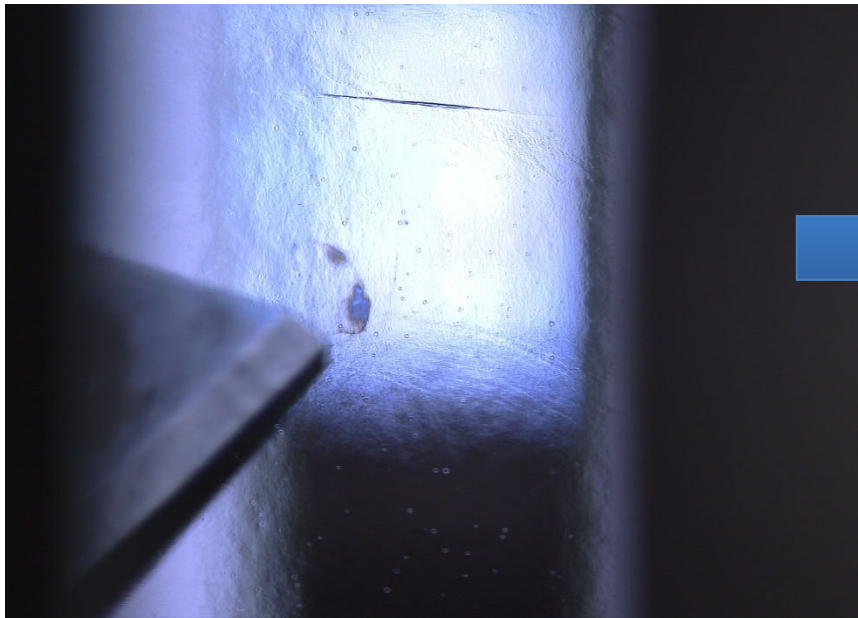
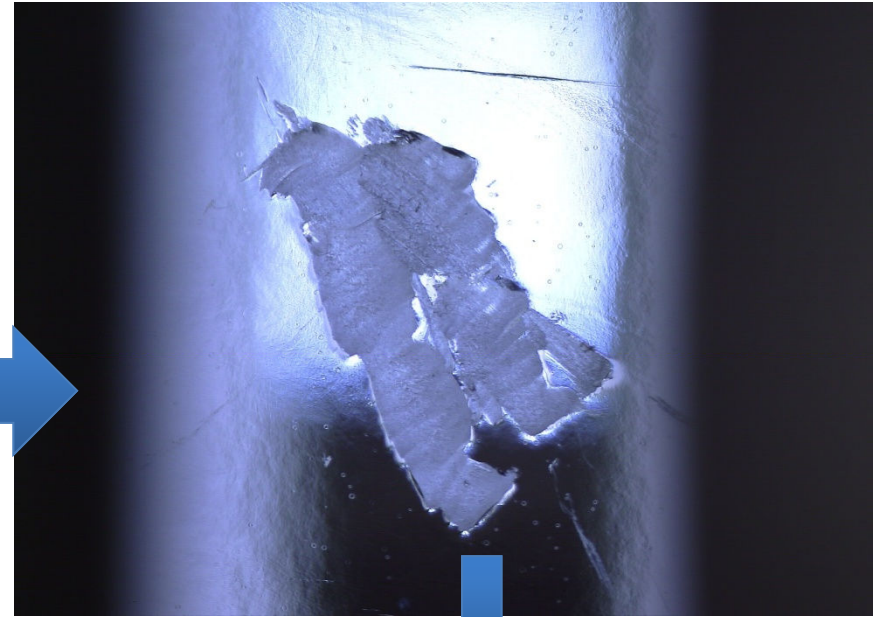
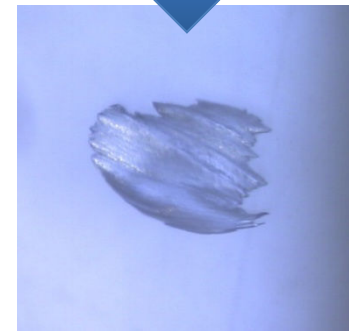
Scraped the brown spot by scraper.

An old MHI#0 9-cell cavity was EP'ed.

A brown spot was found inside the beam-pipe of old MHI#0 9-cell cavity after the EP.

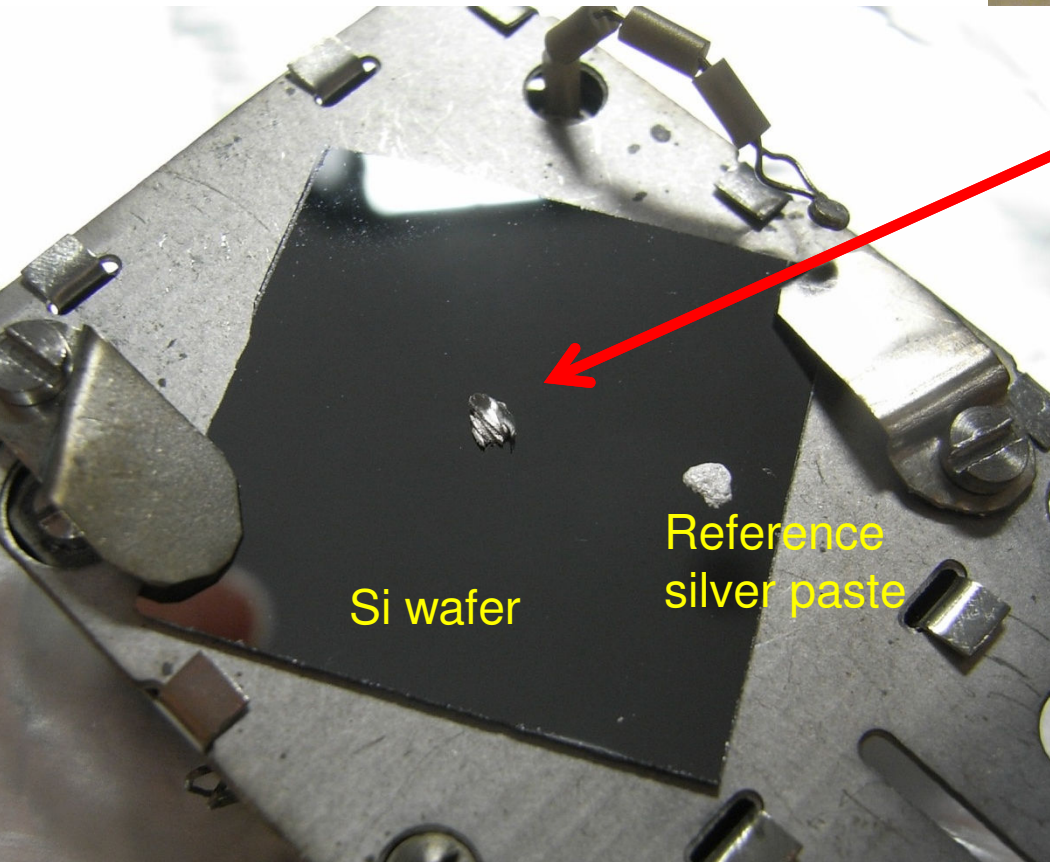
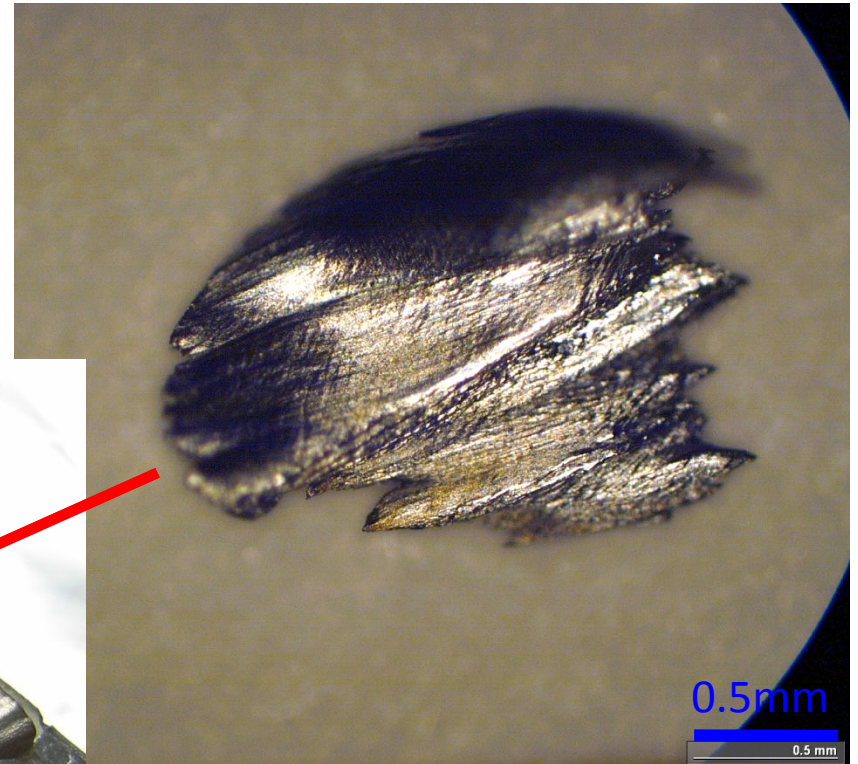
Sample was set on Si wafer by silver paste.

Scraped Nb sample

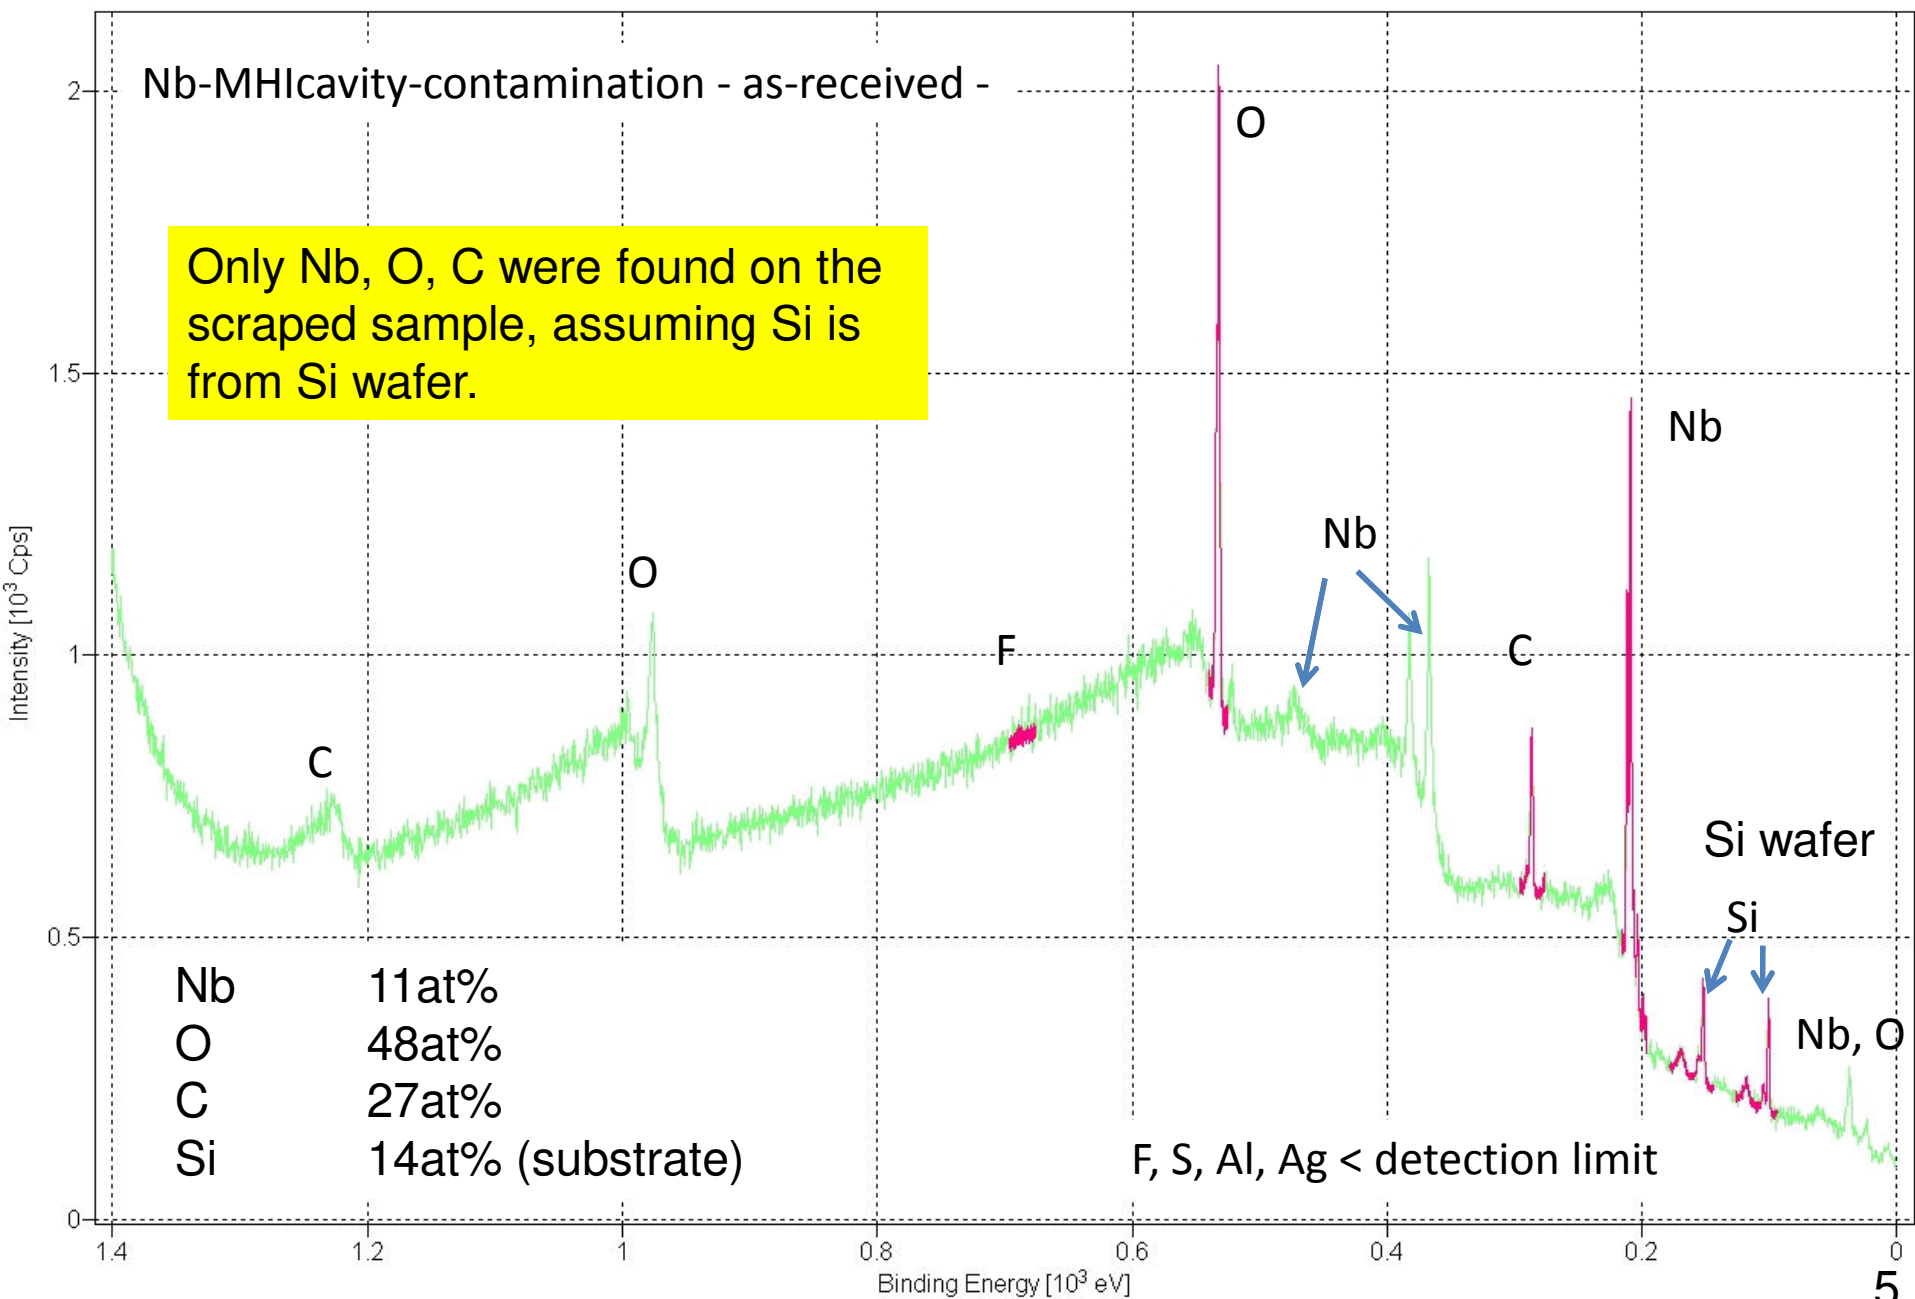
XPS analysis of scraped sample from old MHI 9-cell cavity

- After we replaced the EP acid tank with new one, we encountered stain problem with MHI#6, #7, and #8.
- Sample scraped from test cavity was analyzed with XPS. Only Nb and O components were found.
- Stains were created only on the sample labo-EP'ed with new EP acid, and just after being rinsed and exposed to the air.
- Rinse sequence was modified at STF/KEK and Eacc of MHI#9 reached 27 MV/m. But still some stains were found in the test cavity around the bottom cell. Rinse sequence need more modification.
- DESY uses aged EP acid for final EP. JLab uses new EP acid for final EP but different rinse sequence. Both laboratories have no stain problem.

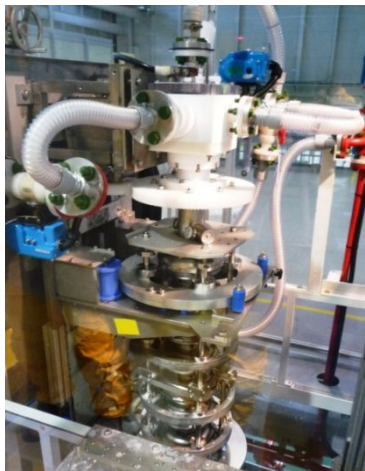
We are taking 30 min. to drain EP acid. This might be a reason for stain?

Drain EP acid for 15 min.

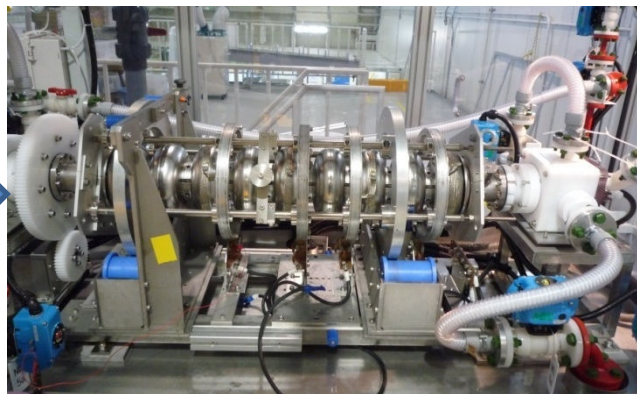
Horizontal for 5 min.

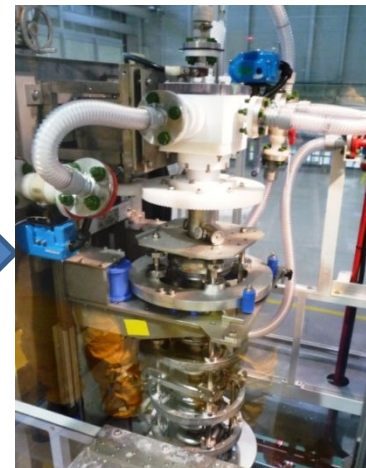
Drain EP acid for 10 min.
Then UPW rinse starts.

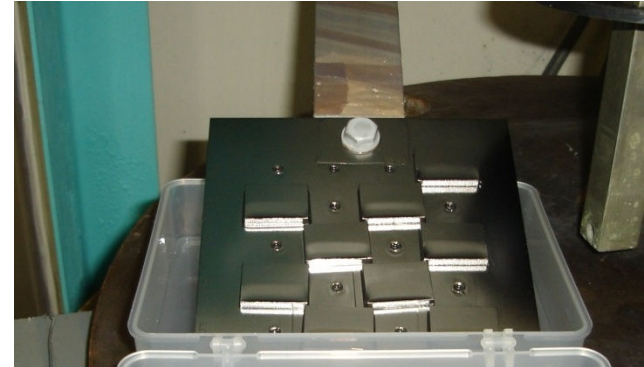
Labo-EP (20 μm) with **new EP acid** ($[\text{Nb}] = 0 \sim 0.4 \text{ g/L}$) at Nomura

Exposing the samples to the air for 70 min. w/o Pure-Water (P.W.) rinse. **No stain appeared.**

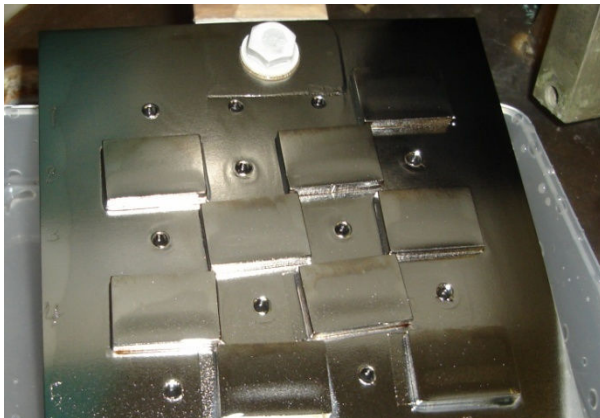
Stains appeared within a minute after exposing the samples to the air.

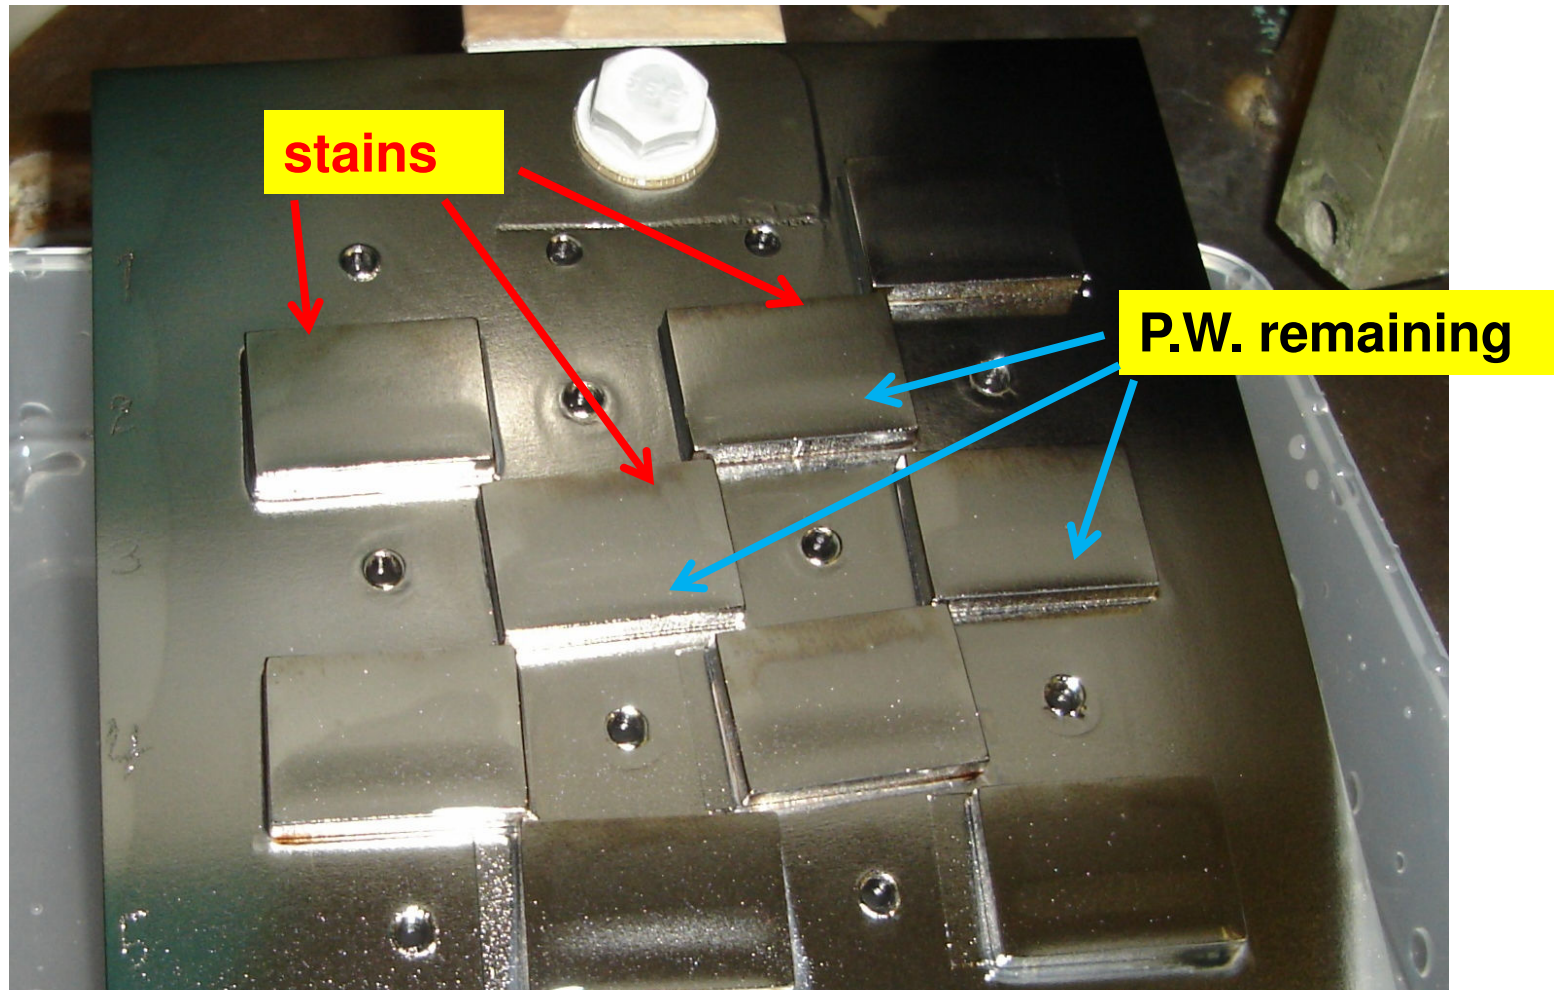
Exposing samples to the air after P.W. rinse

Stains appeared within a minute after exposing the samples to the air.
The stains appeared in the area where P.W. dried. (EP acid of [Nb] = 0.4 g/L)

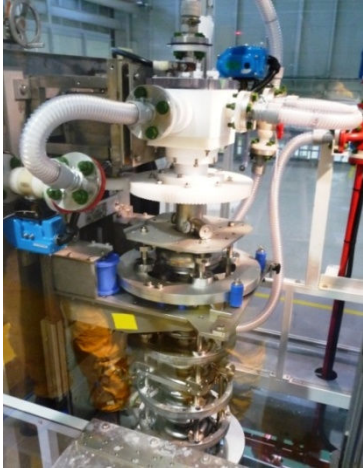
Drain EP acid for 15 min.

The first U.P.W. rinse was extended **with overflow** for **a longer time**.

Original sequence: [pouring U.P.W. for 7 min. + draining for 5 min.] x 5

Modified sequence: [pouring U.P.W. for 60 min. + draining for 10 min.] + [pouring U.P.W. for 20 min. + draining for 7 min.] x 3.

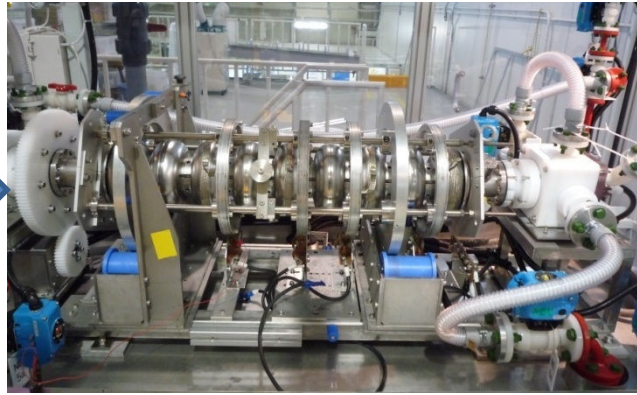
Horizontal for 5 min.

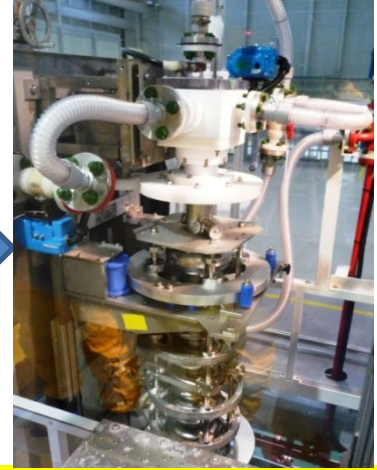
Drain EP acid for 10 min.
Then UPW rinse starts.

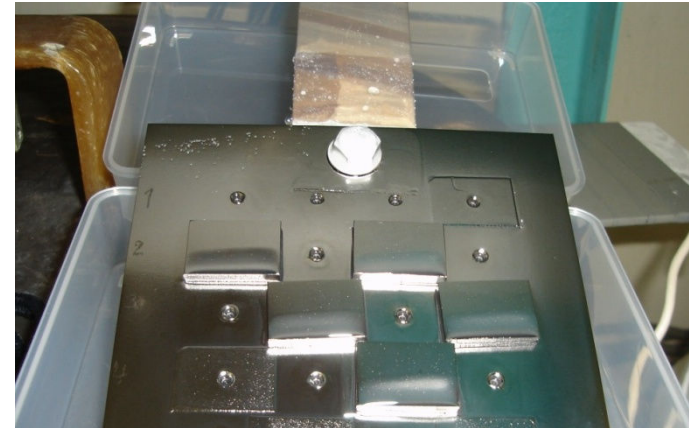
Labo-EP (20 μm) with **EP acid**
([Nb] = 4.4 ~ 4.8 g/L) at Nomura

Exposing the samples to the air for
30 min. w/o Pure-Water (P.W.) rinse.
No stain appeared.

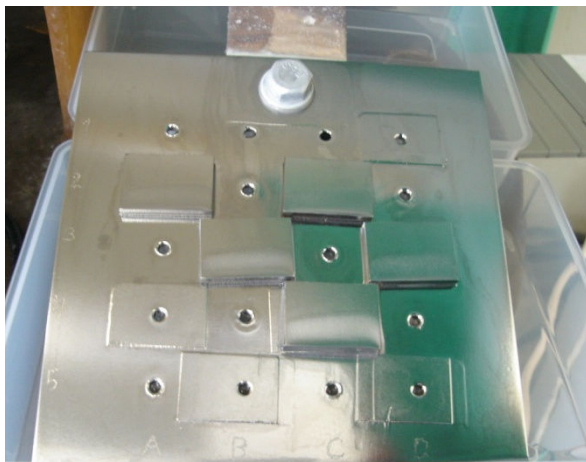
No stains appeared after exposing the
samples to the air.

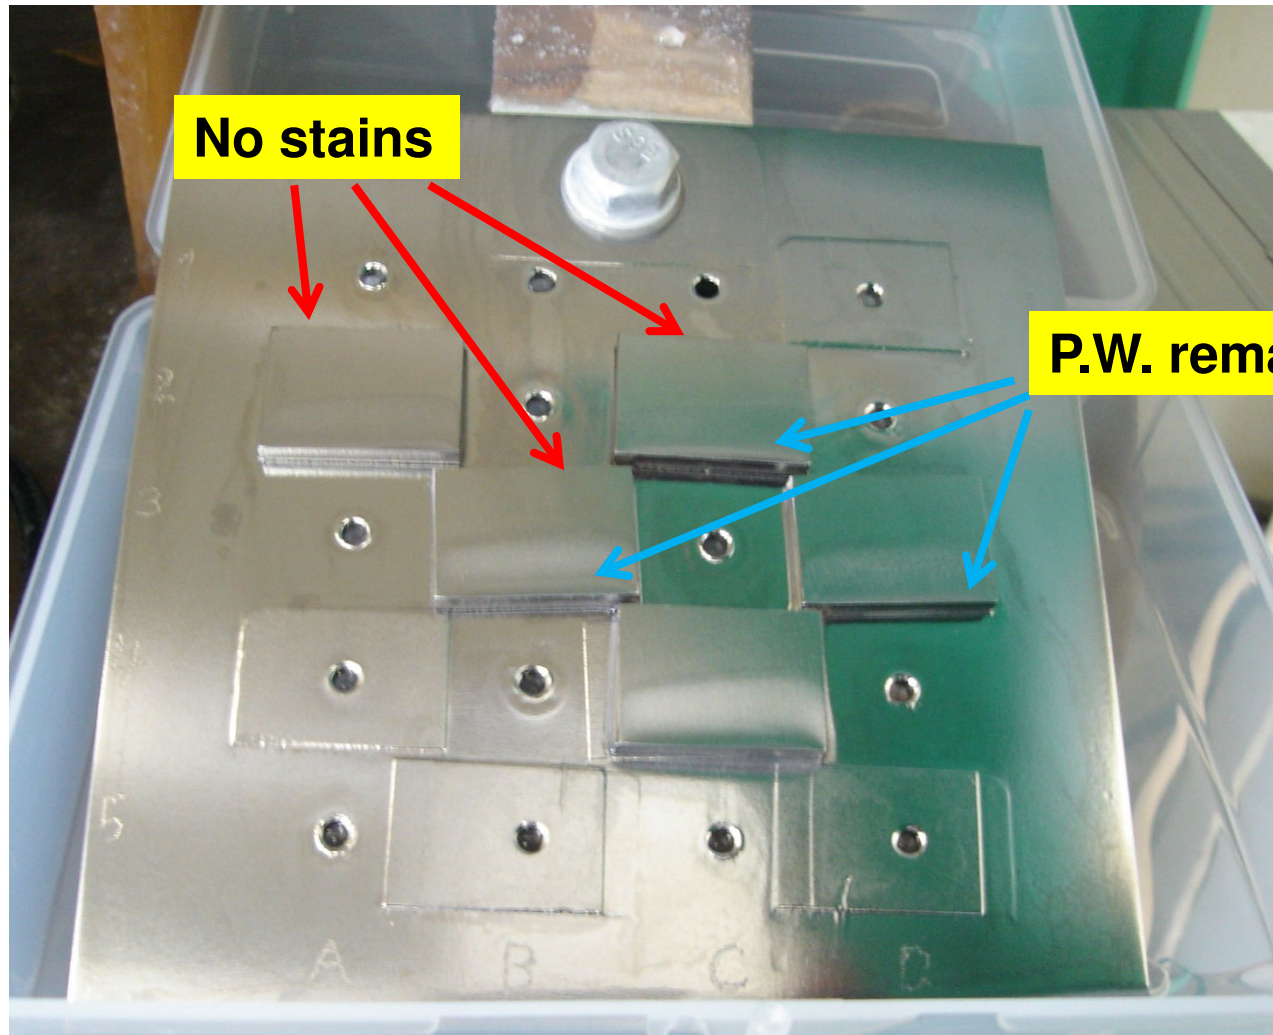
Exposing samples to the air after P.W. rinse

No stain appeared after exposing the samples to the air.
(EP acid of [Nb] = 4.8 g/L at the end)
