Sample tests for stain problem at KEK

LCWA2009 at Albuquerque

Introduction: Stain problem at STF/KEK

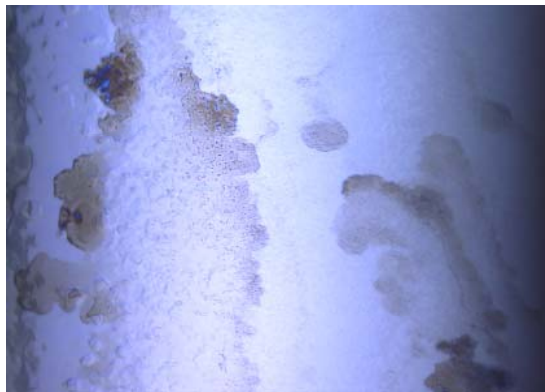
MHI#6 1-cell equator, t = 306 deg.
Downstream : Outside weld area

We observed brown spots and traces inside the 9-cell cavities (MHI#6, MHI#7, MHI#8);

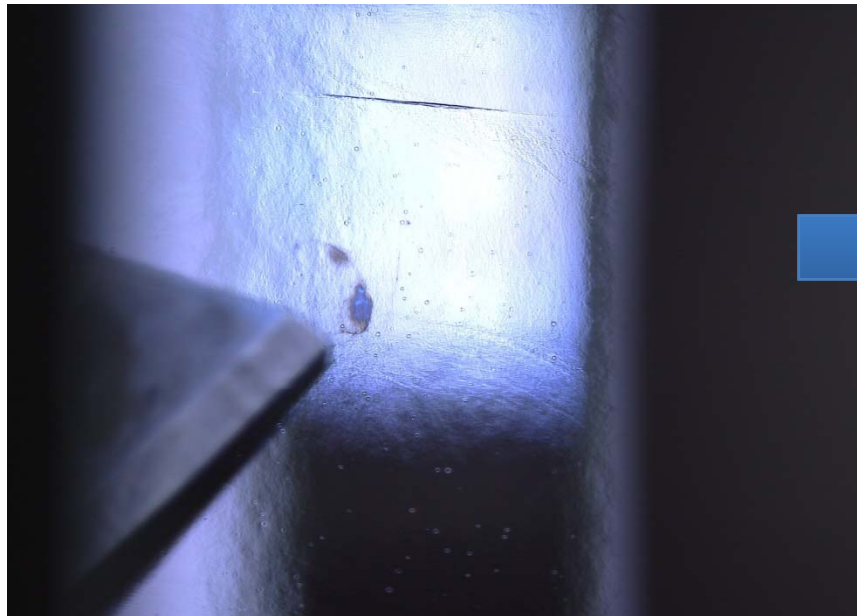
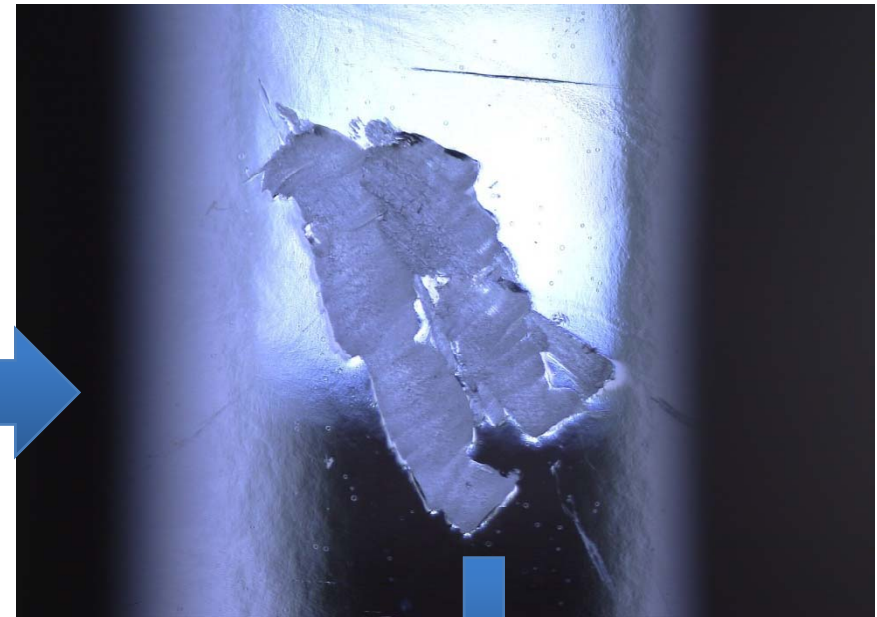
Scraped the brown spot by scraper.

An old MHI#0 9-cell cavity was EP'ed.

A brown spot was found inside the beam-pipe of old MHI#0 9-cell cavity after the EP.

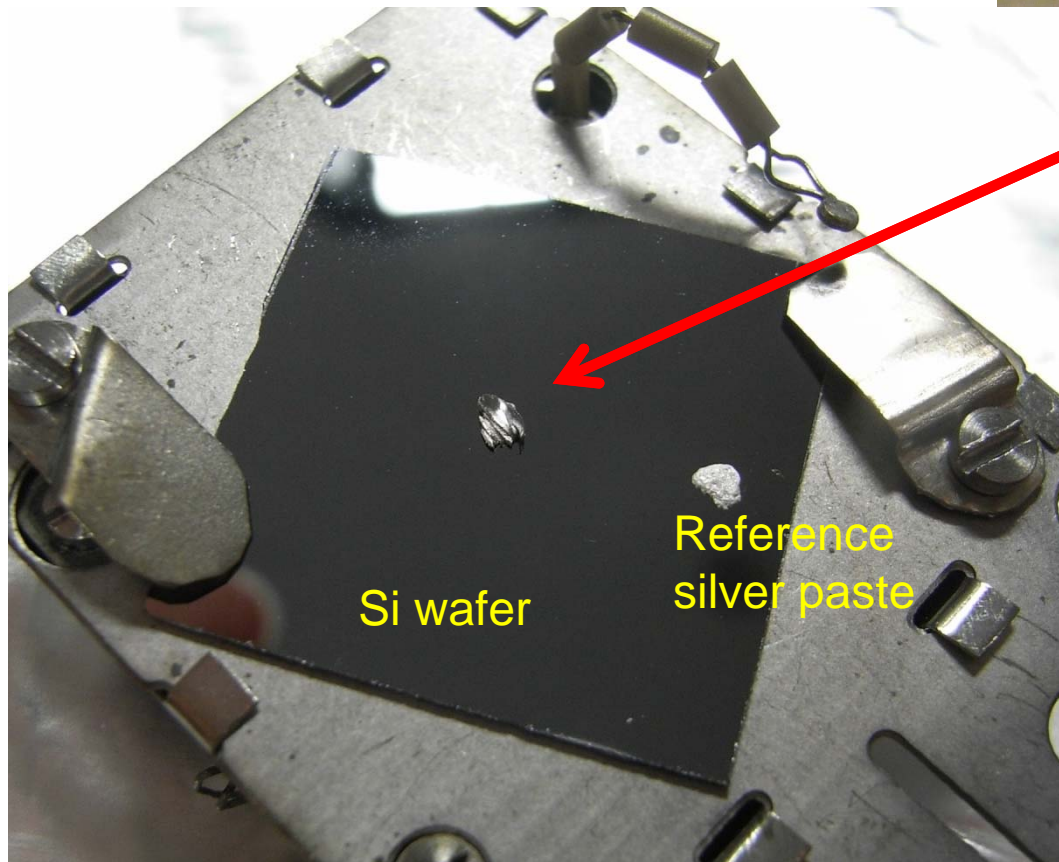
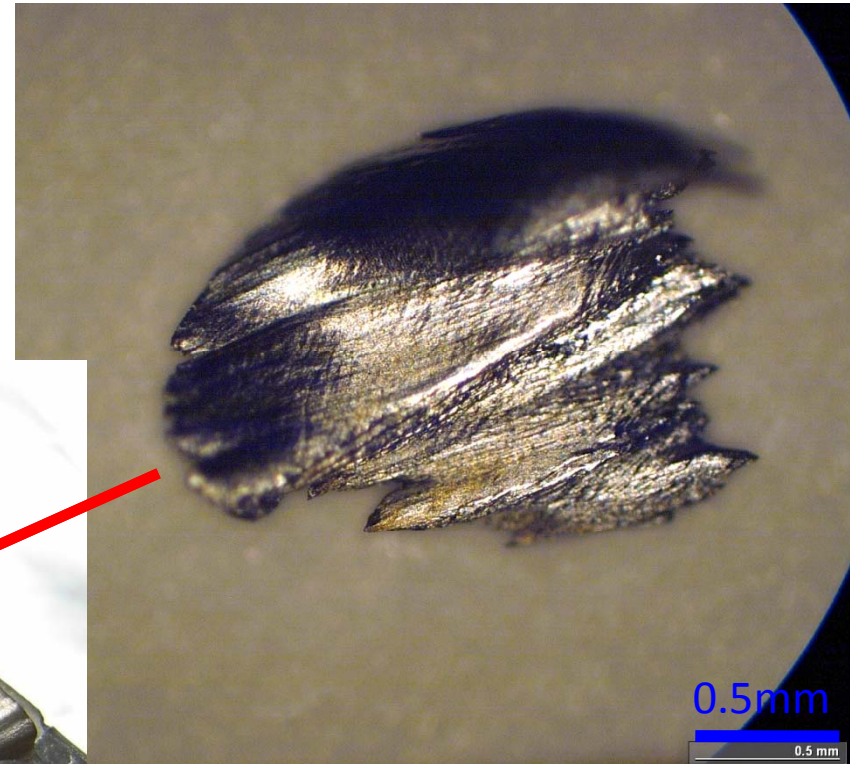
Sample preparation

Sample was set on Si wafer by silver paste.

Scraped Nb sample

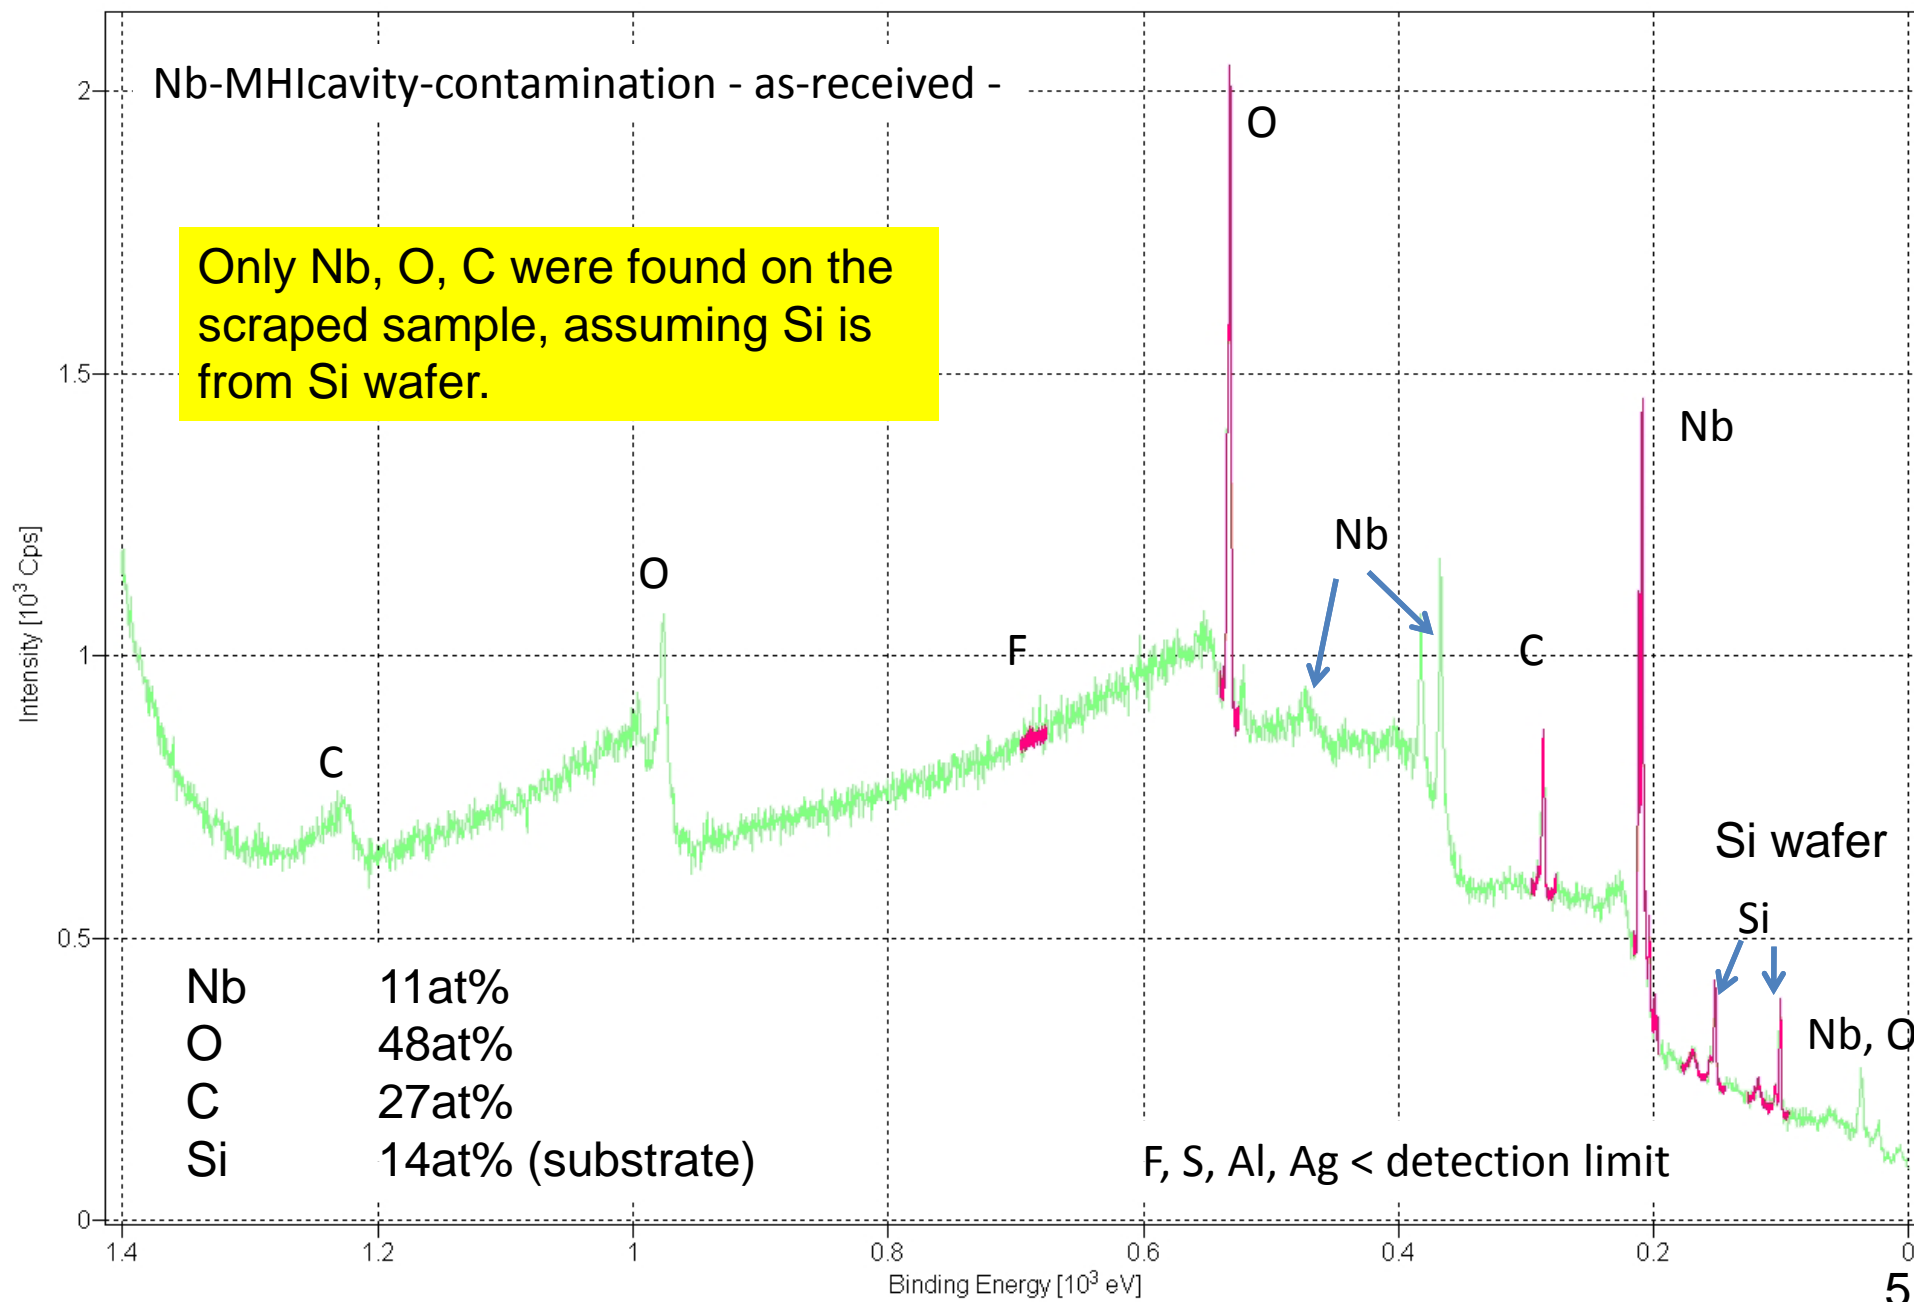
XPS analysis of scraped sample from old MHI 9-cell cavity

- After we replaced the EP acid tank with new one, we encountered stain problem with MHI#6, #7, and #8.
- Sample scraped from test cavity was analyzed with XPS. Only Nb and O components were found.
- Stains were created only on the sample labo-EP'ed with new EP acid, and just after being rinsed and exposed to the air.
- Rinse sequence was modified at STF/KEK and Eacc of MHI#9 reached 27 MV/m. But still some stains were found in the test cavity around the bottom cell. Rinse sequence need more modification.
- DESY uses aged EP acid for final EP. JLab uses new EP acid for final EP but different rinse sequence. Both laboratories have no stain problem.

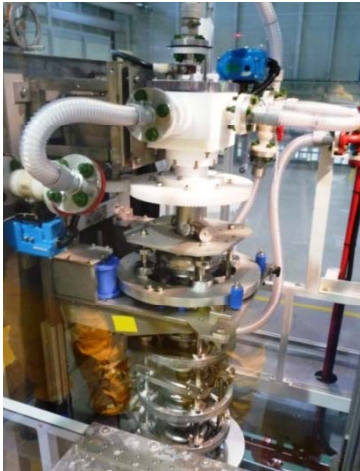
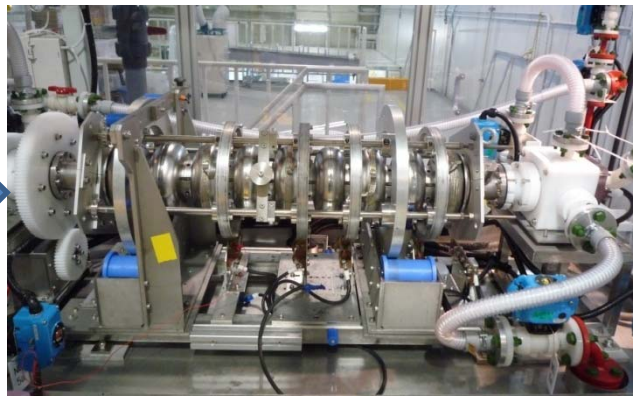
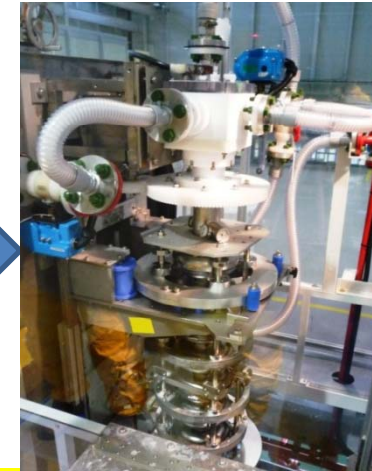
Draining process of EP acid

We are taking 30 min. to drain EP acid. This might be a reason for stain?

Drain EP acid for 15 min.

Horizontal for 5 min.

Drain EP acid for 10 min.
Then UPW rinse starts.

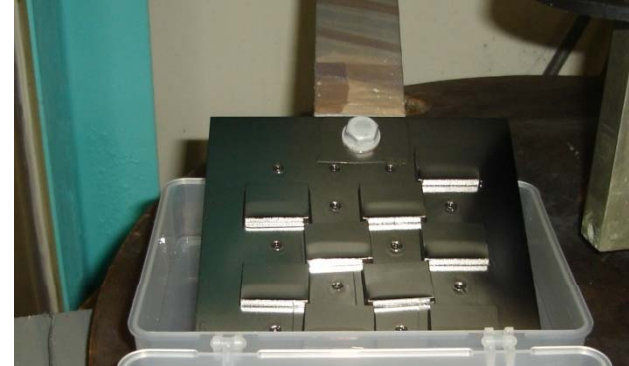
Labo-EP (20 μm) with **new EP acid** ($[\text{Nb}] = 0 \sim 0.4 \text{ g/L}$) at Nomura

Exposing the samples to the air for 70 min. w/o Pure-Water (P.W.) rinse. **No stain appeared.**

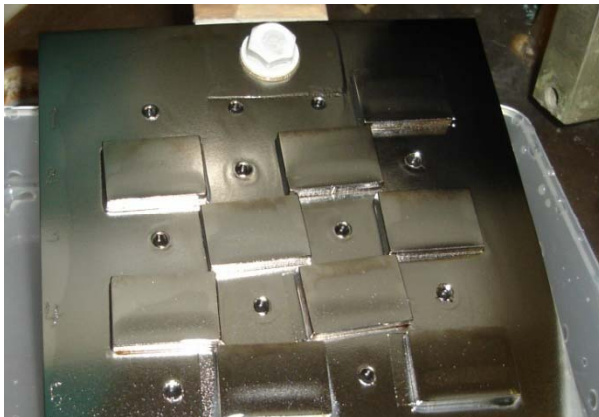
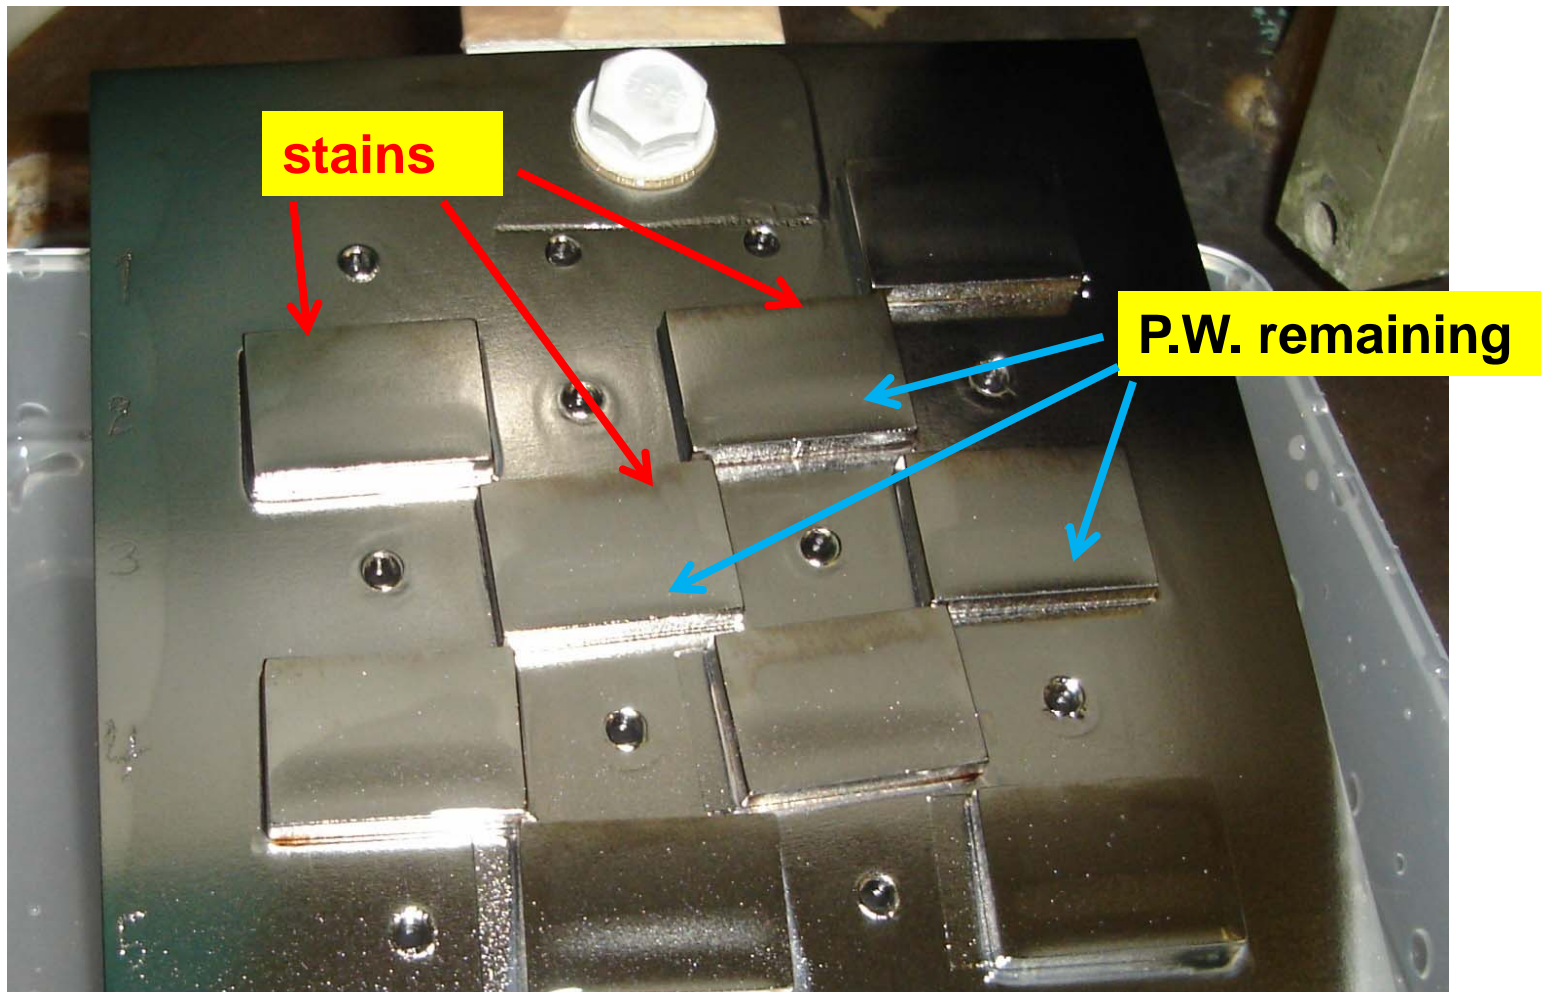
Exposing samples to the air after P.W. rinse

Light P.W. rinse for a few 10's seconds.

Stains appeared within a minute after exposing the samples to the air.

Stains appeared within a minute after exposing the samples to the air.
The stains appeared in the area where P.W. dried. (EP acid of [Nb] = 0.4 g/L)

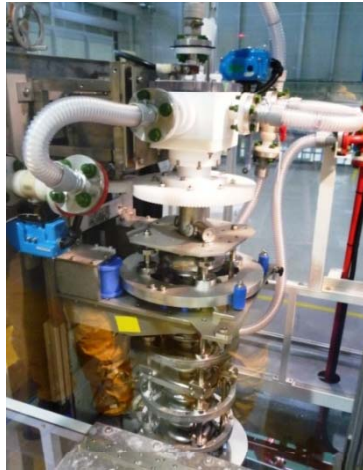
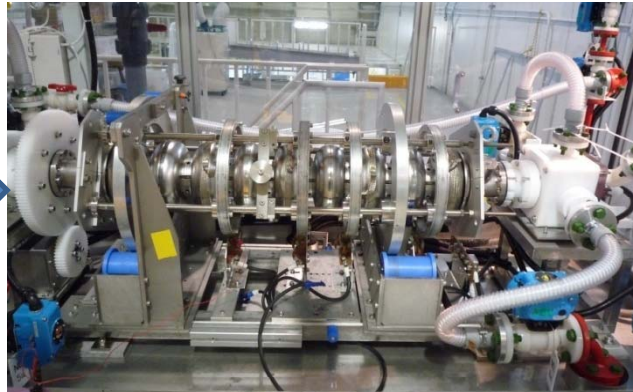
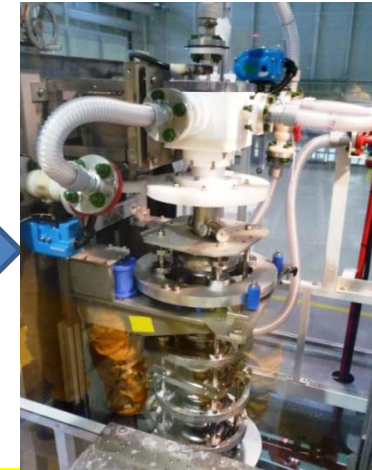
Modification of first U.P.W. rinse process

Drain EP acid for 15 min.

Horizontal for 5 min.

Drain EP acid for 10 min.
Then UPW rinse starts.

The first U.P.W. rinse was extended **with overflow** for **a longer time**.

Original sequence: [pouring U.P.W. for 7 min. + draining for 5 min.] x 5

Modified sequence: [pouring U.P.W. for 60 min. + draining for 10 min.] + [pouring U.P.W. for 20 min. + draining for 7 min.] x 3.

➔ MHI#9 (9-cell cavity) was processed with this modified sequence and reached Eacc – 27 MV/m at Q0 – 9×10^9 (quench), even with some field emission. More details about the results, see **"KEK cavity preparation for S1G" on 30th Sept. by E. Kako (KEK)**.

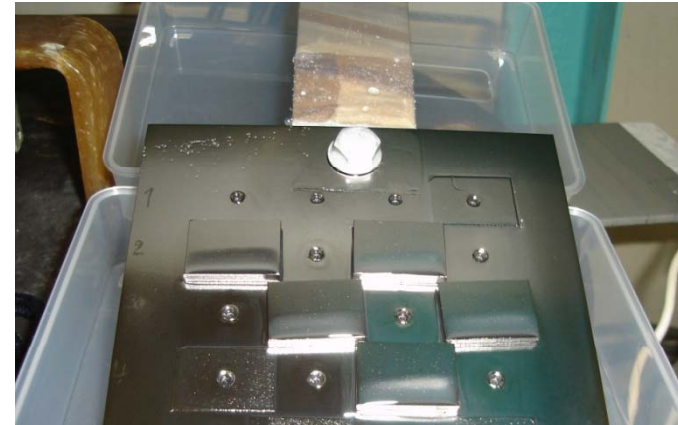
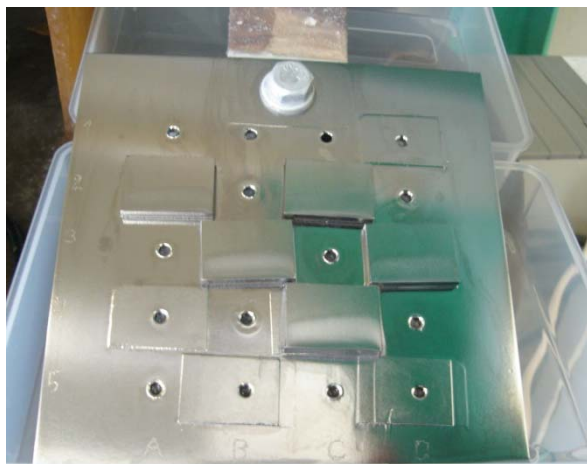
Labo-EP (20 μm) with **EP acid**
([Nb] = 4.4 ~ 4.8 g/L) at Nomura

Exposing the samples to the air for
30 min. w/o Pure-Water (P.W.) rinse.
No stain appeared.

No stains appeared after exposing the
samples to the air.

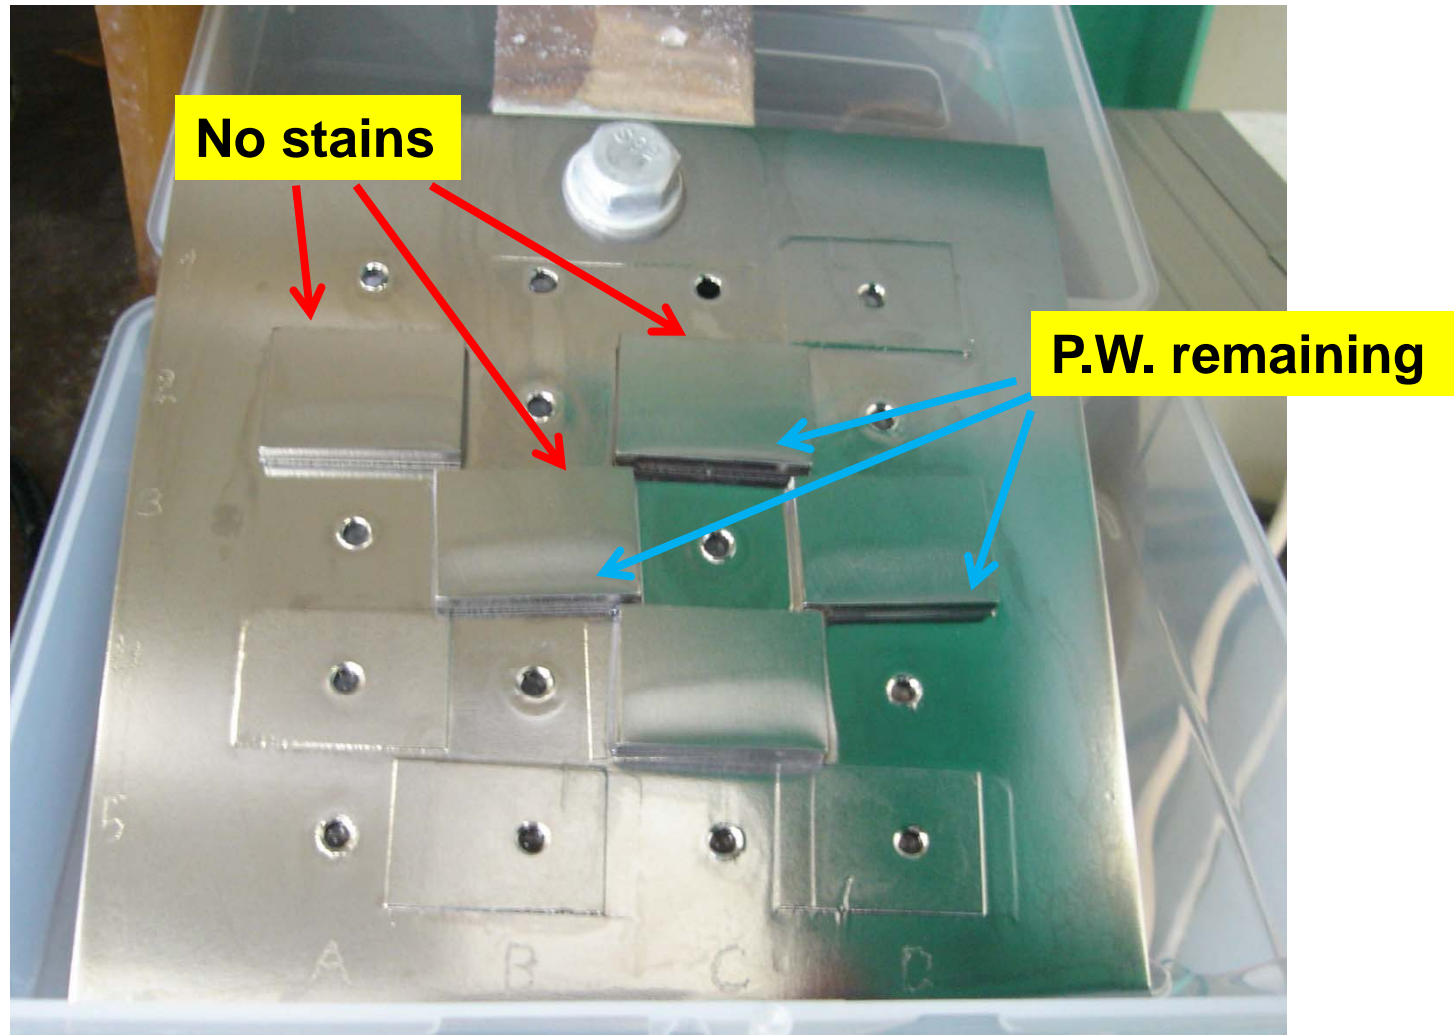
Exposing samples to the air after P.W. rinse

Light P.W. rinse for a few 10's seconds.

No stain appeared after exposing the samples to the air.
(EP acid of [Nb] = 4.8 g/L at the end)

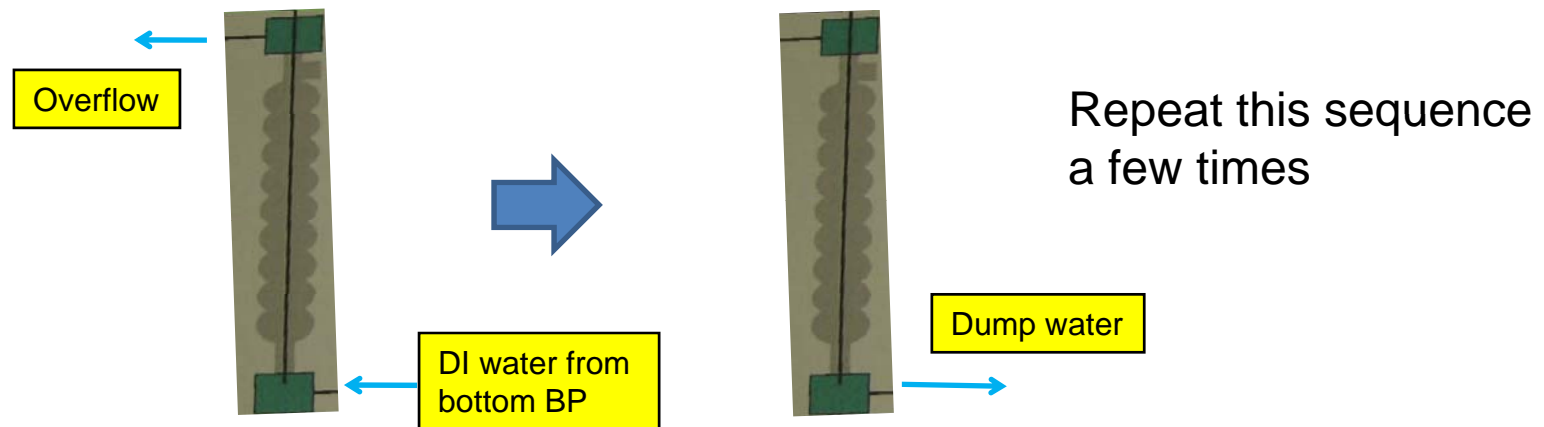
Comparison of EP process among laboratories

DESY and JLab have no stain problem.

- **DESY:** The final EP is done with the EP acid of [Nb] $\sim 10\text{g/L}$.
- **JLab:** New EP acid is used for the final (20 μm) EP 2 times, bulk ($>100\mu\text{m}$) EP, and then dumped. So new EP acid is used for the final EP is similar to KEK. But the rinse process is different from KEK.
