ANL/FNAL SCPF EP/HPR Processing Status and Plan

- HPR MIC Problem and Lessons Learned
- Cavity Handling at ANL/FNAL
- Current Status of One-cell Program & Results
- One-cell Program Plans
- Current Status of Nine-cell Program & Results
- Nine-cell Program Plans
- Summary

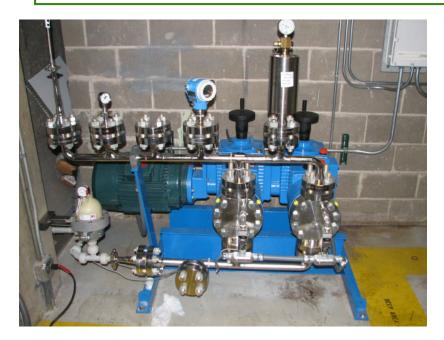
- Initially suspected LEWA pump failure. High carbon content in SEM analysis of seals.
- Removed heads and found bacterial nodules.

LEWA HPR pump and manifolds.

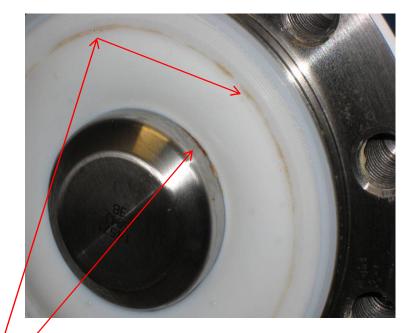
Bacterial Nodules

Teflon double diaphragm and bacterial nodules.

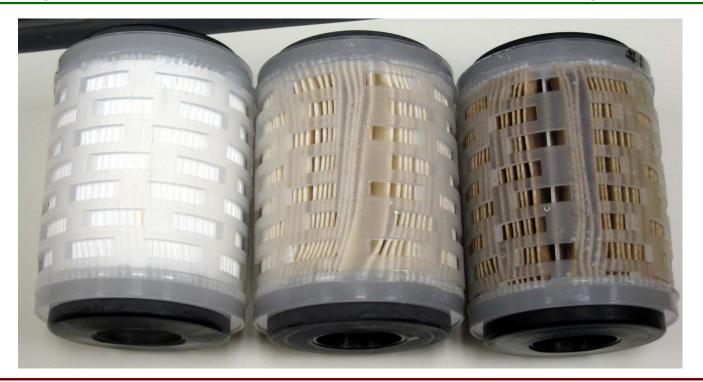
- Final Filters at HPR wand = 0.04 um polysulphone
- Left filter = new
- Middle filter = 12 hours HPR and 1600 gallons UPW
- Right filter = 100 hours HPR and 13,200 gal. UPW

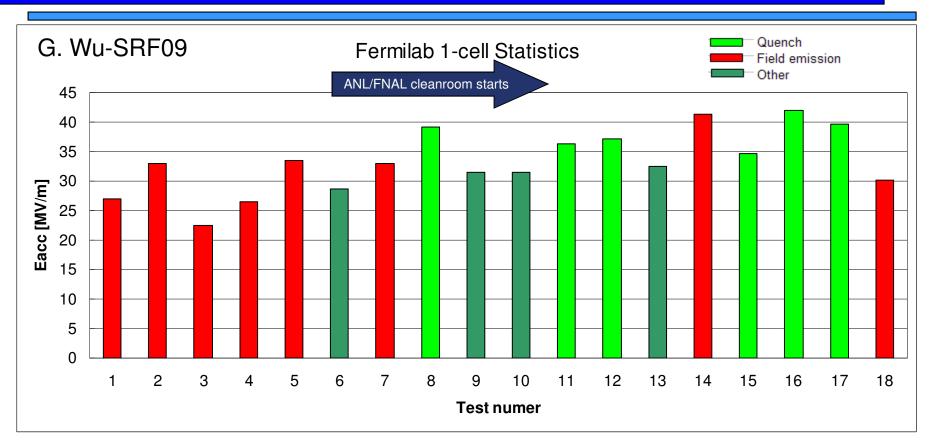
1.3 GHz One-Cell Program

Test 7 TE1ACC002 handled with new pumping station and poor evacuation control

Test 14 FE caused by poor vacuum connection before 120 C baking

Test 18 First ABLE immersion EP with poor evacuation control

1-cell Field Emission under control at ANL/FNAL

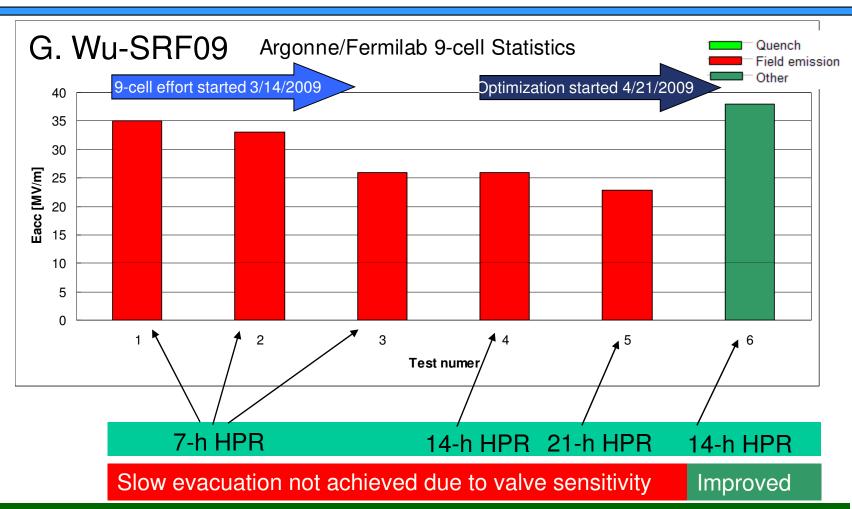
1.3 GHz 9-Cell Program

9-cell Preliminary: Field emission was mostly due to vacuum difficulties

New let-up/pump-down manifold in process!
