Material study for high pressure gas regulation (revised)

NAKAI Hirotaka
TERASHIMA Akio
(KEK)

Objectives of material tests

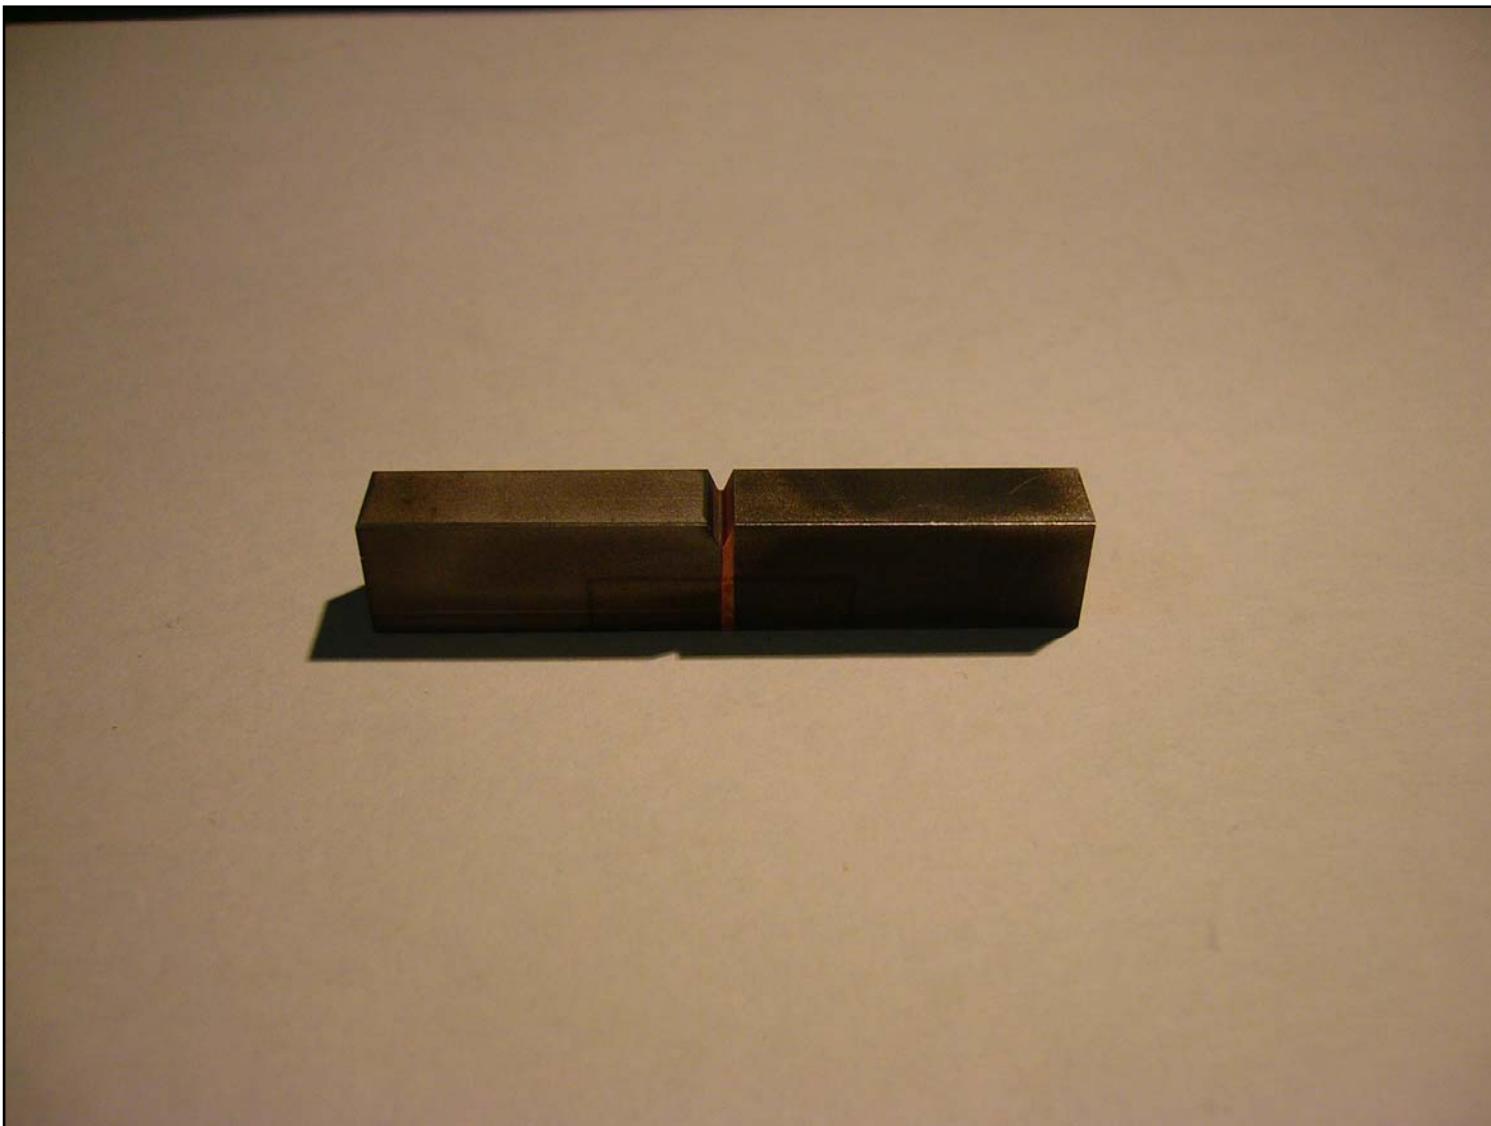
- HIP (Hot Isostatic Pressing) to join different metals
- Joint of niobium (cavity) and stainless steel 316L (helium vessel)
- Interlayer metal - copper
- Specimens from 2 companies to compare the difference, if any
 - Kuroki Composite (Kuroki)
 - Kinzoku-giken (Kinzoku)

Specimen (7.5 mm wide)

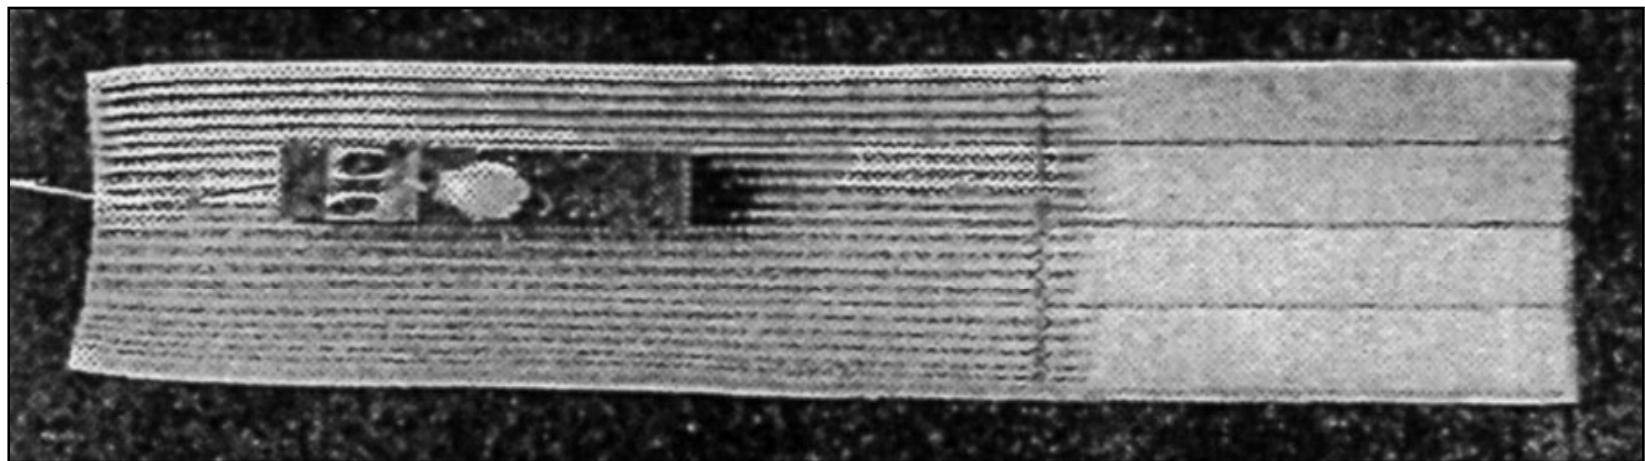
- Tests performed by a company
 - Kawaju Techno Service Corp., Kobe, Japan
- Specimens in insulation capsules made of “polyethylene foam”
- Energy absorbed by the capsule extracted in impact strength calculation
- Grooves on the insulation capsules for liquid helium flow cooling the specimens
- Specimen temperature monitored with AuFe-Chromel thermocouple

Specimen with insulation capsule

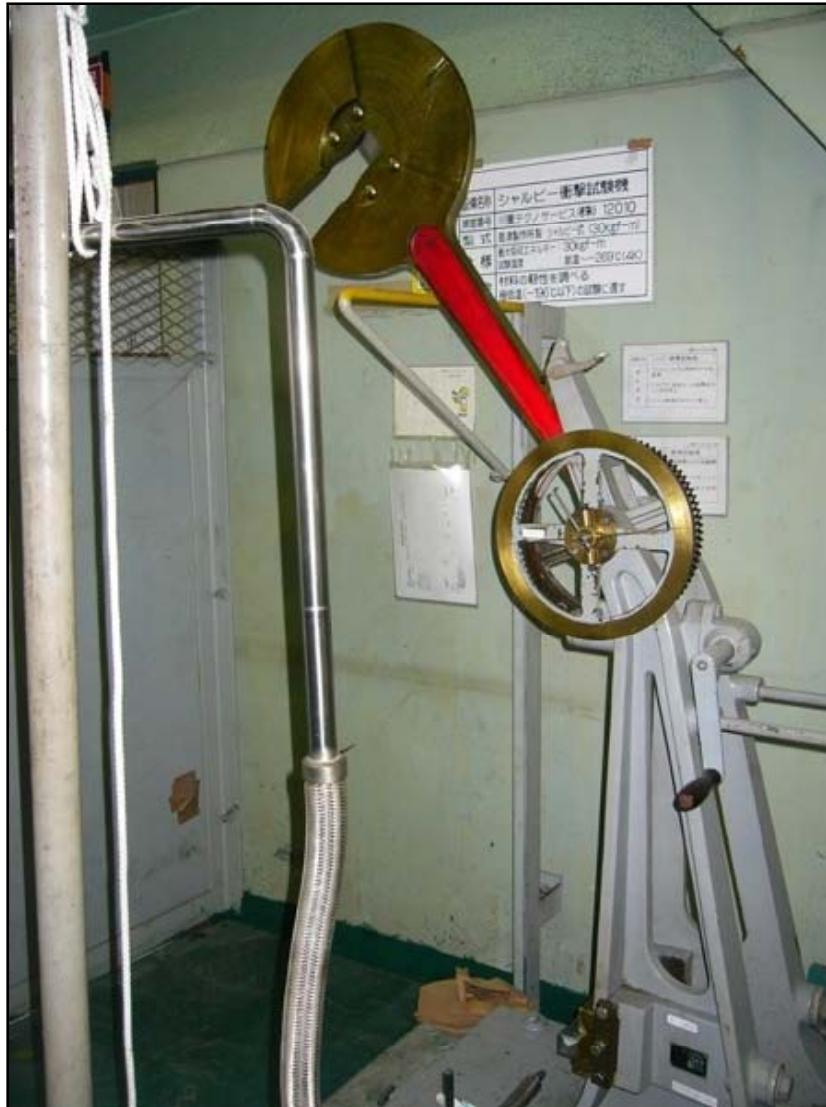
Charpy impact testing machine

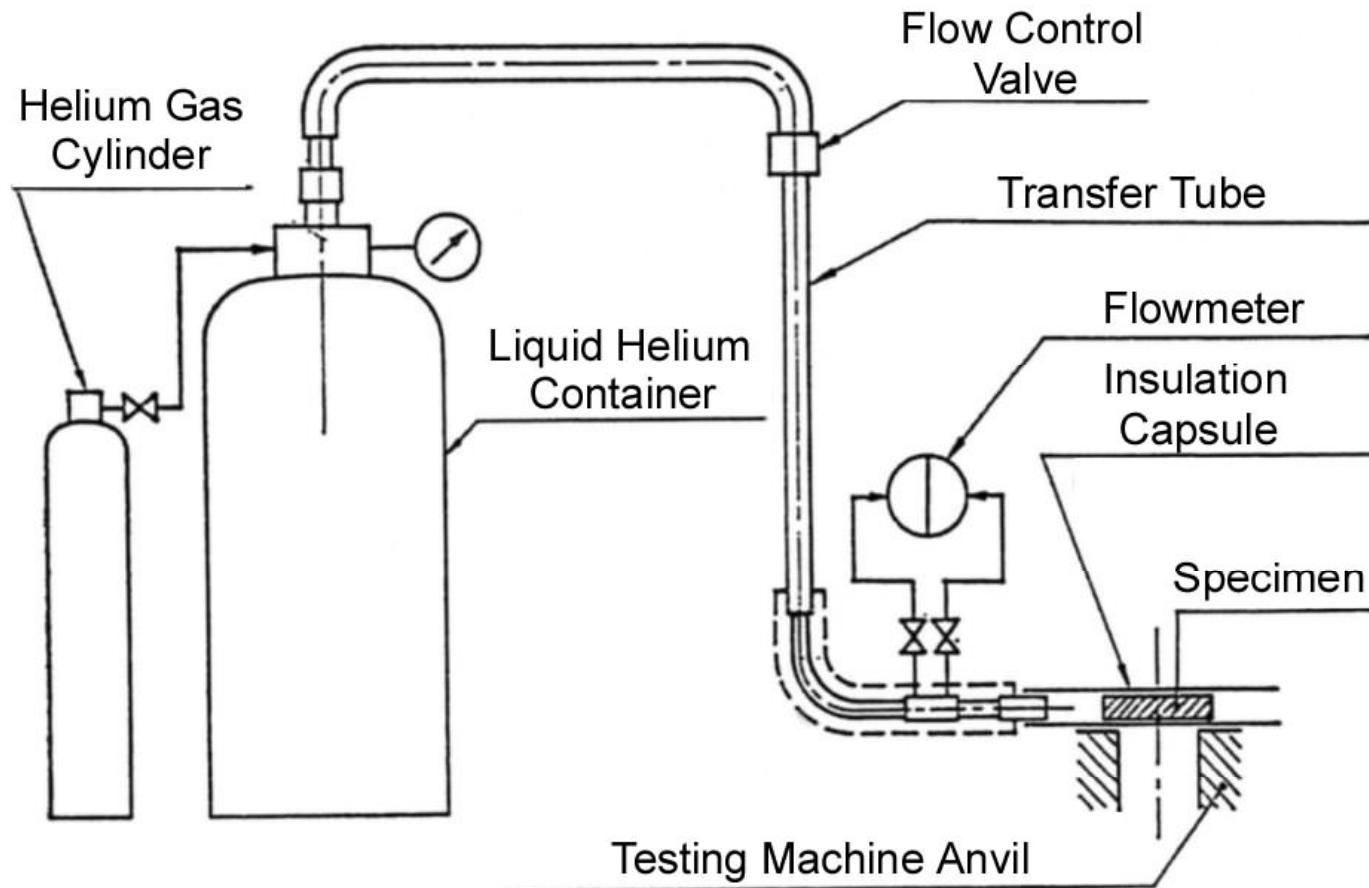
Test setup schematic

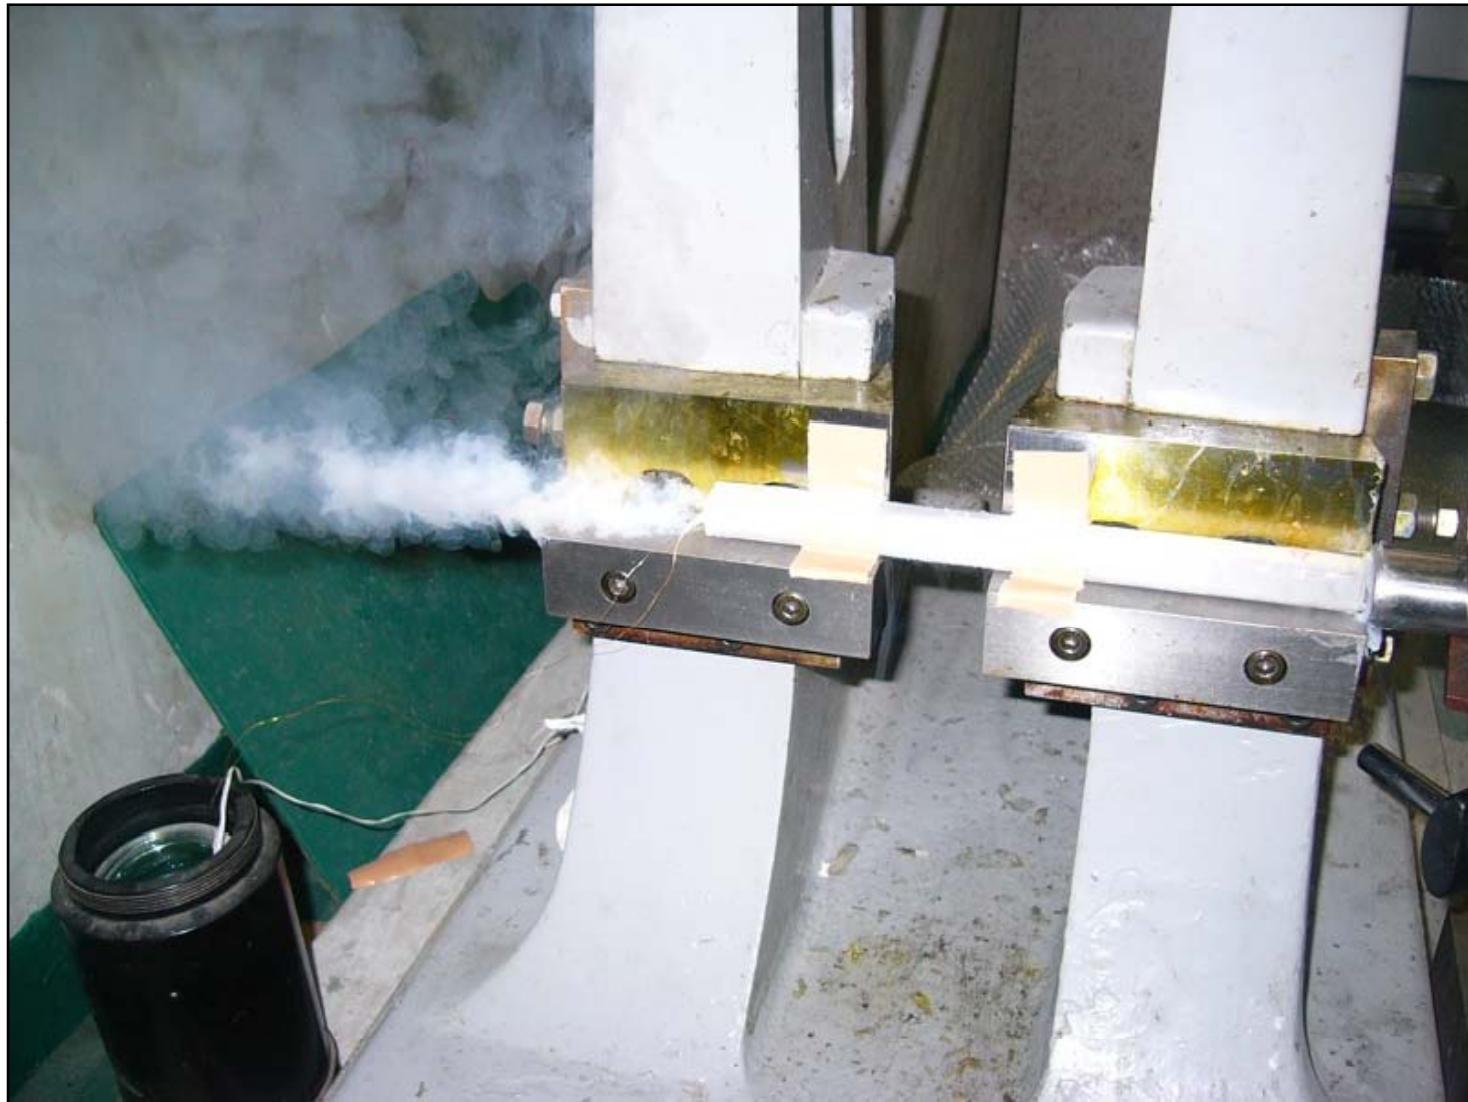
Specimen under test at LHe temp.

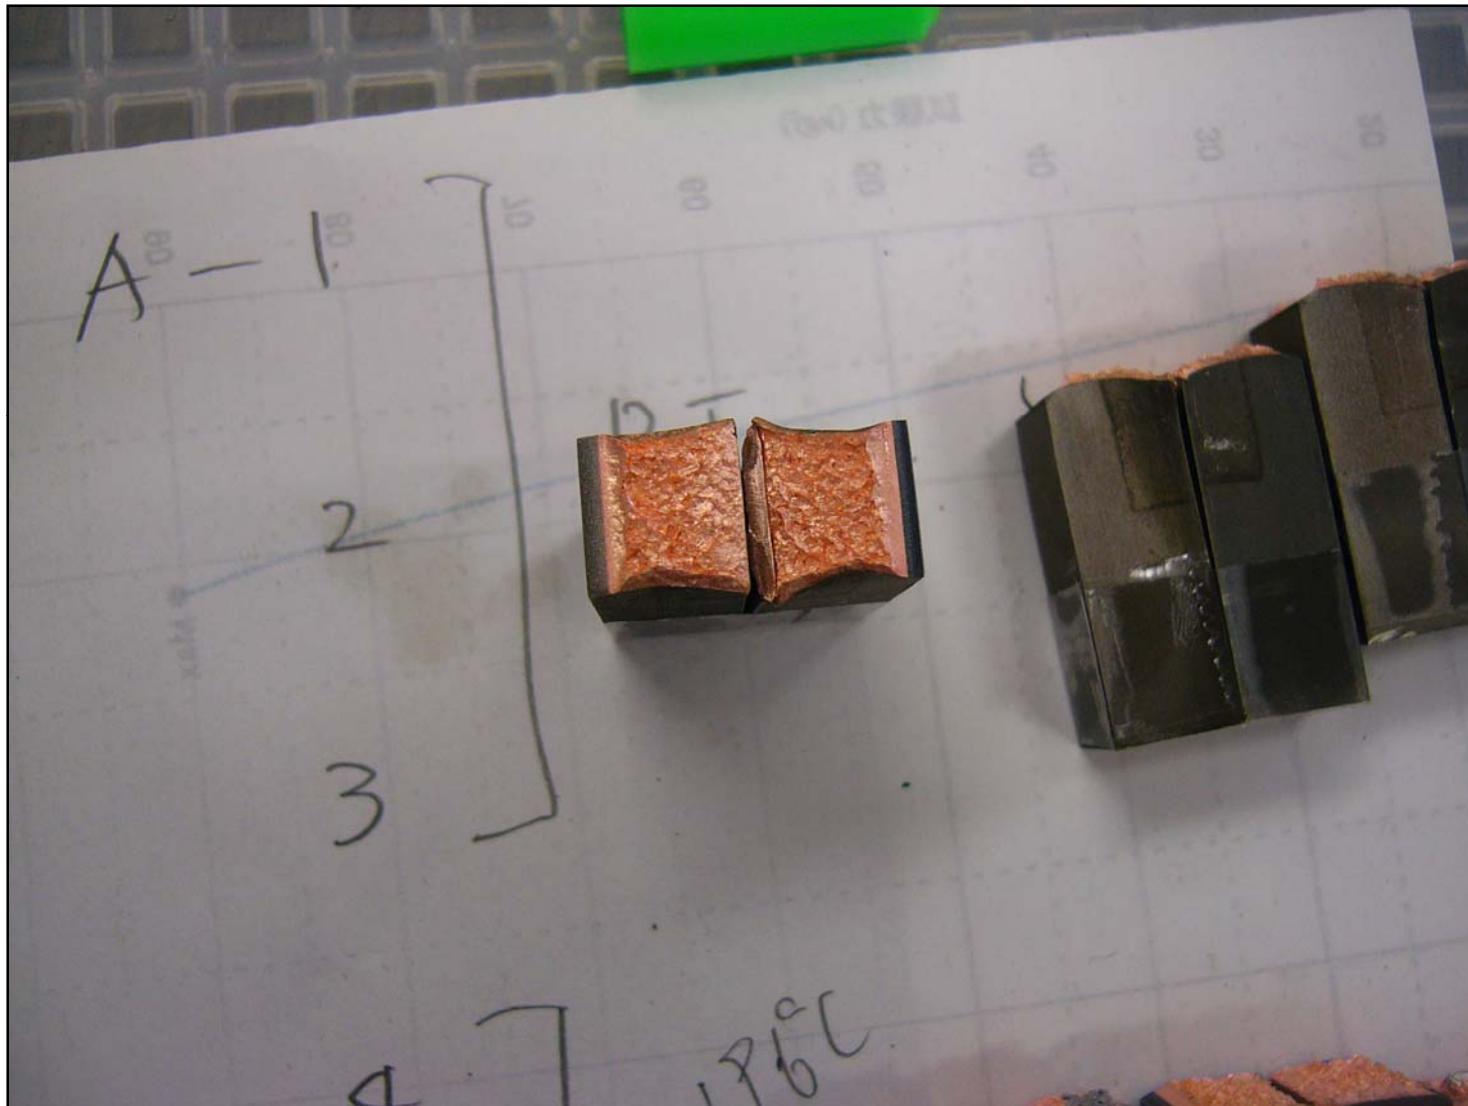
- Tensile Tests
 - All specimens cut in niobium part
- Impact Tests
 - Most specimens with notches in copper part (center of interlayer metal)
 - Some with notches in boundaries between niobium and copper, and between stainless steel and copper
 - All specimens cut at notch positions

HIP specimens broken at RT

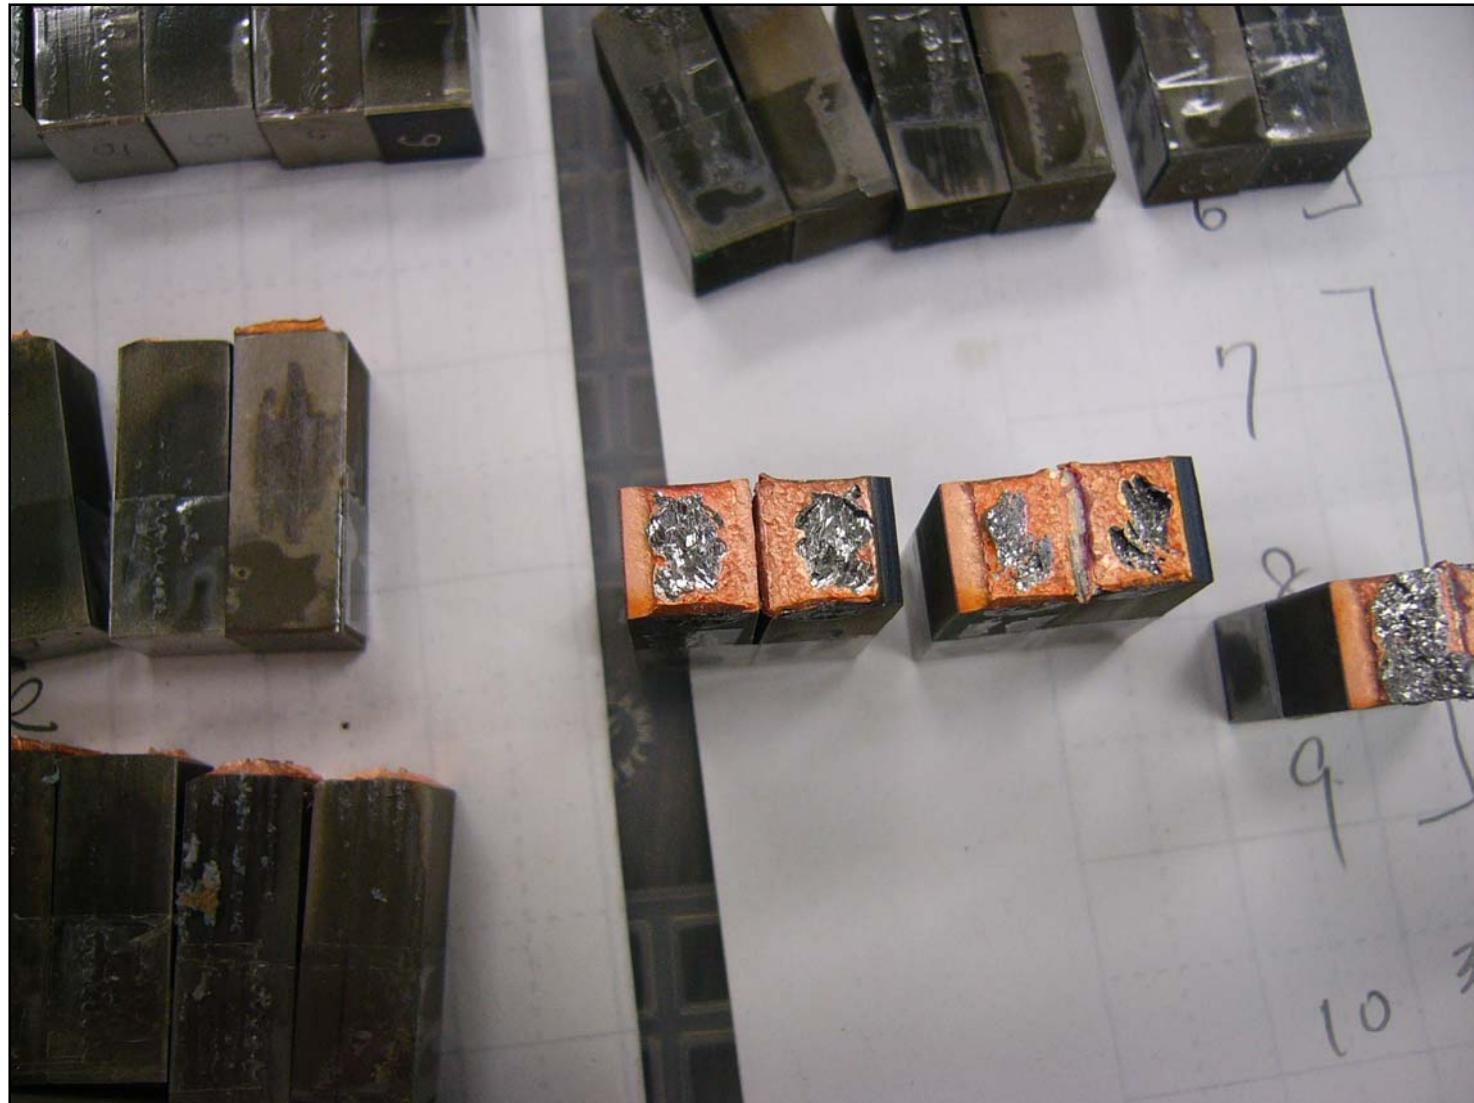
HIP specimen broken at LHe temp.

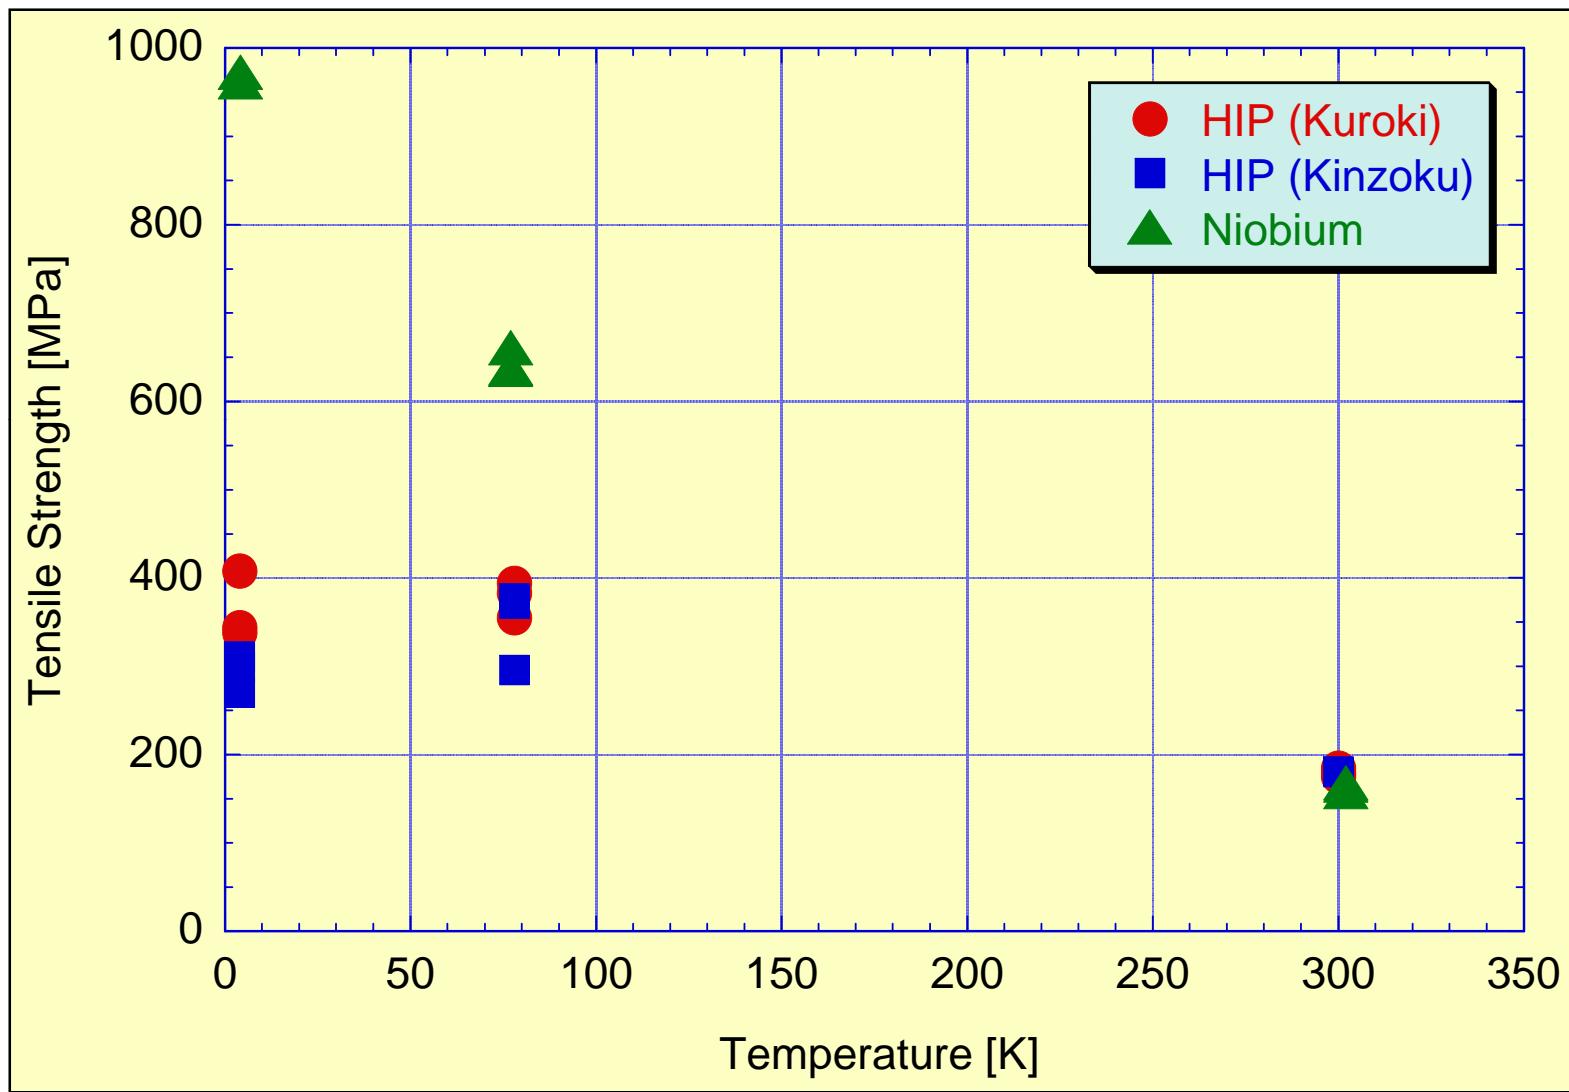
Tensile strength

- Tensile Tests
 - Unclear linear region in stress-strain relation
 - Yield strength and modulus of elasticity not well defined
 - Strength degraded at low temperatures
 - Elongation contains some gaps between broken parts
- Impact Tests
 - No difference of impact strength between the specimens from 2 companies
 - No clear difference of impact strength by notch positions
 - Impact strength (absorbed energy) degraded at low temperatures comparing with oxygen-free copper data

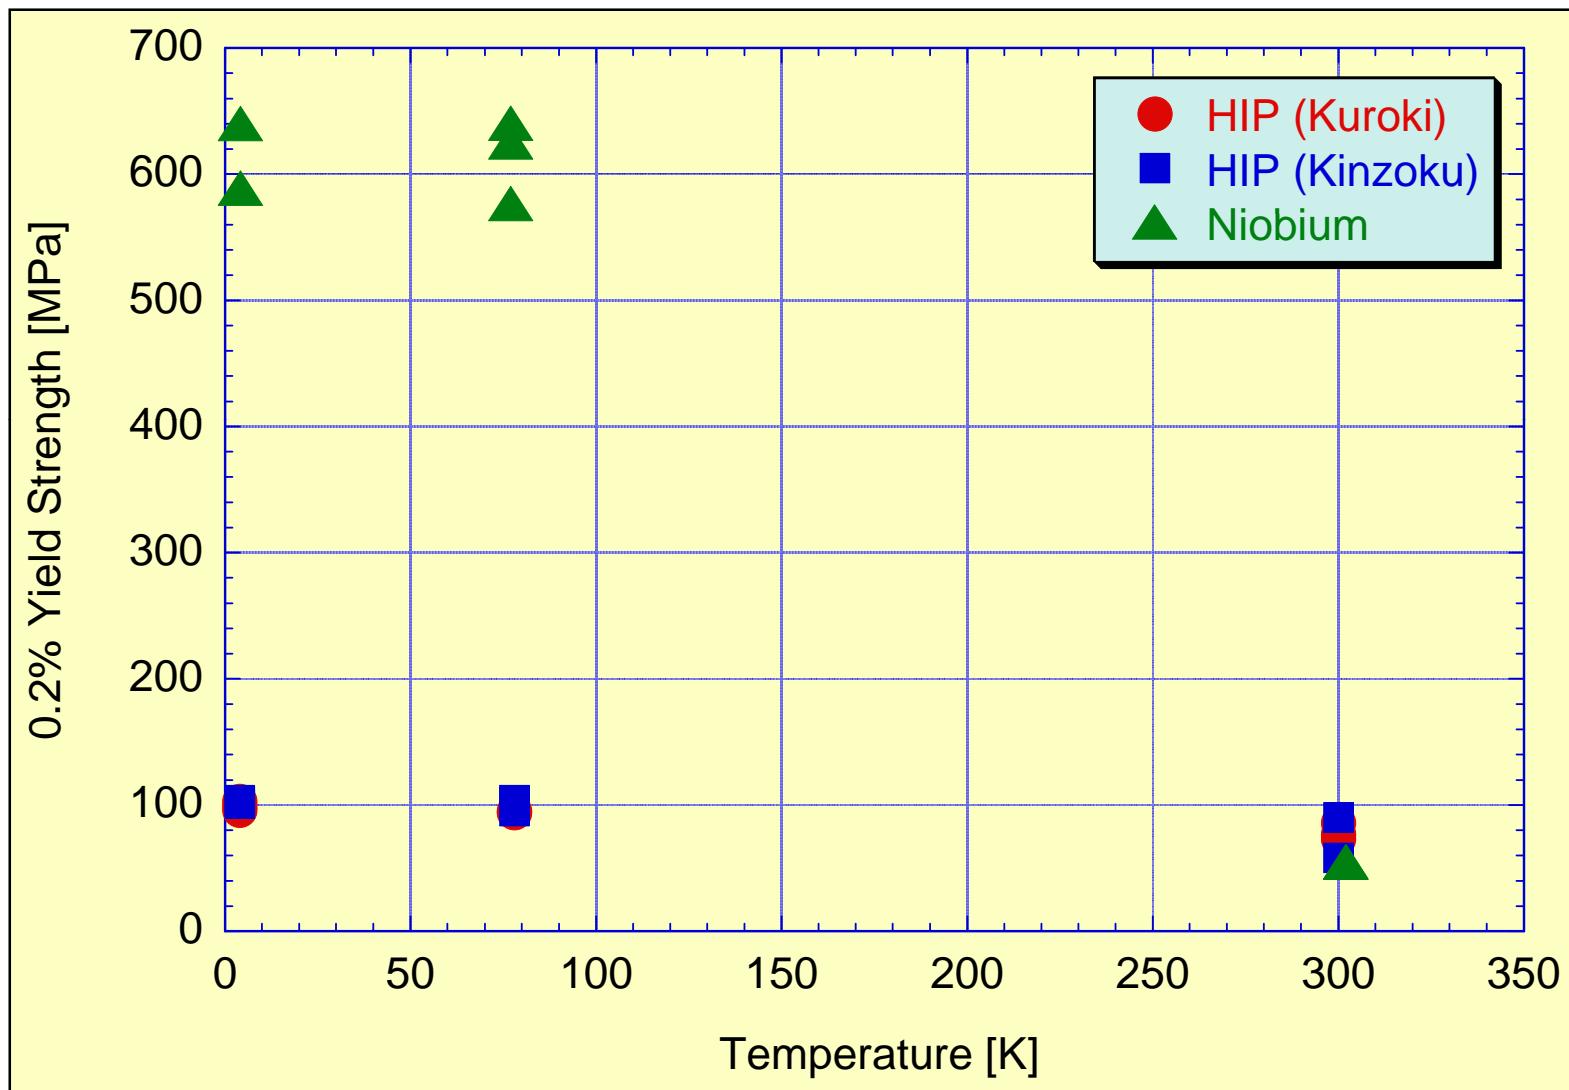
0.2% yield strength

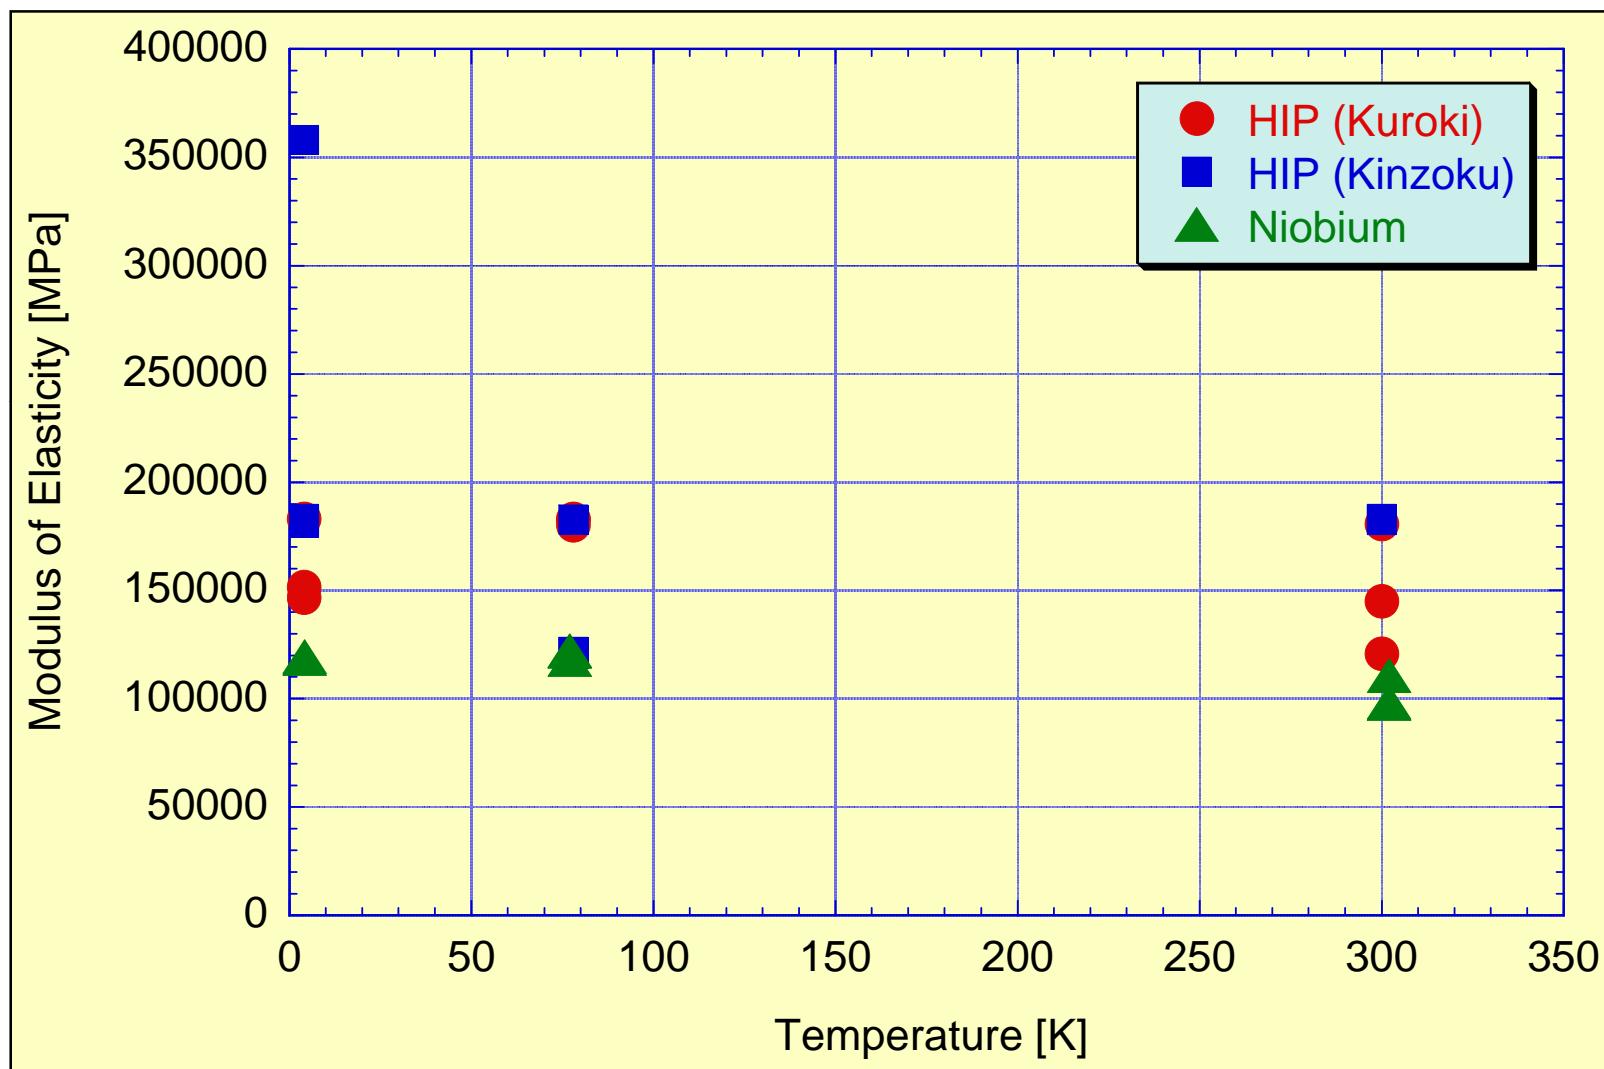
Modulus of elasticity

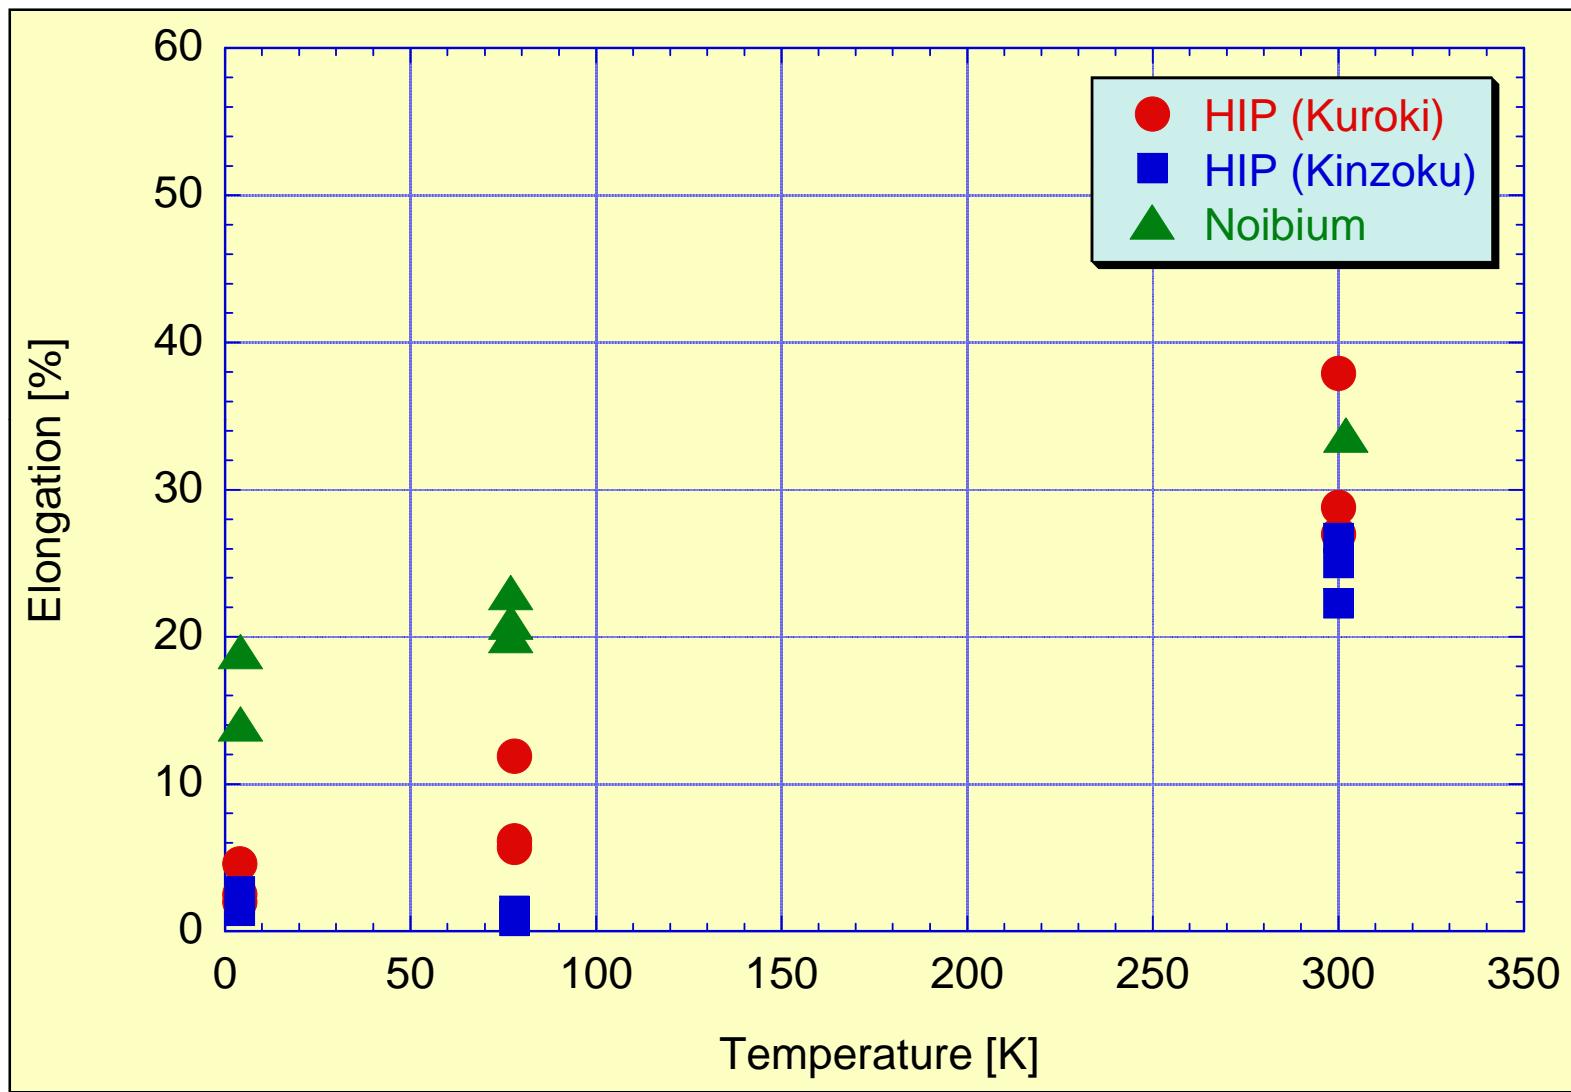
Elongation
