Progress of Shintake monitor work

KEK site meeting

2009/7/1

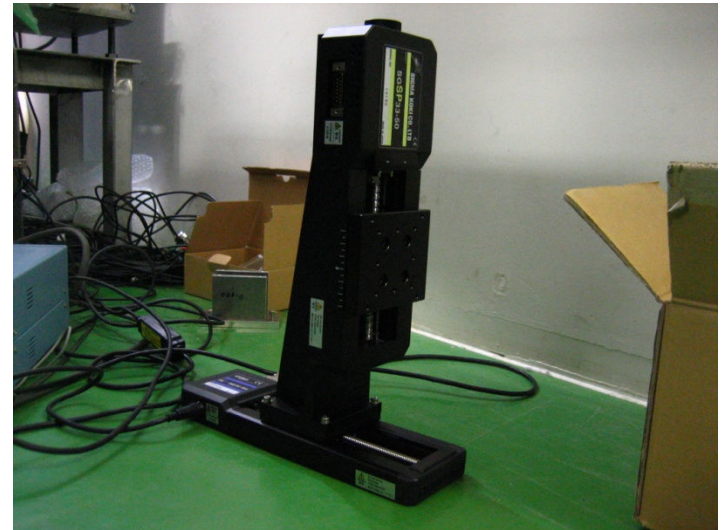
- Screen monitor & knife edge
 - waiting for the design from Seiwa Co. Ltd.
- Collimator scan stage
 - Stage was arrived
 - Remaining work
 - make lead block collimator

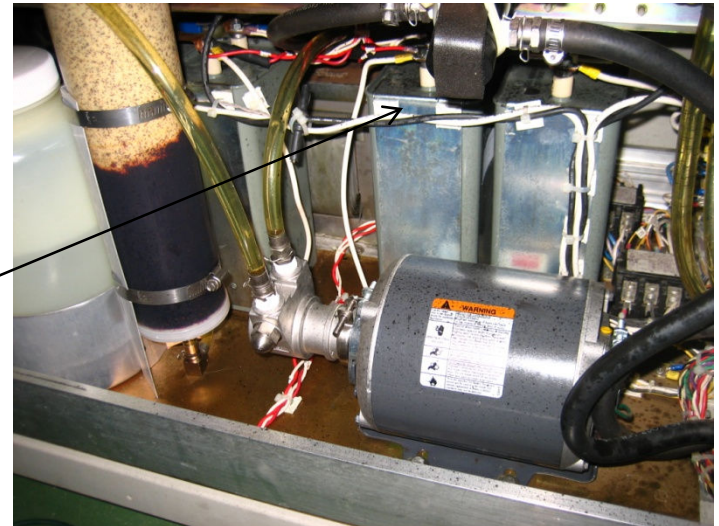
- During the laser operation spark was observed from laser power supply.
 - stopped the operation immediately
 - It was due to the leakage of oil from oil capacitors.
 - They are the replaced ones last year.

oil was leaked from this capacitor

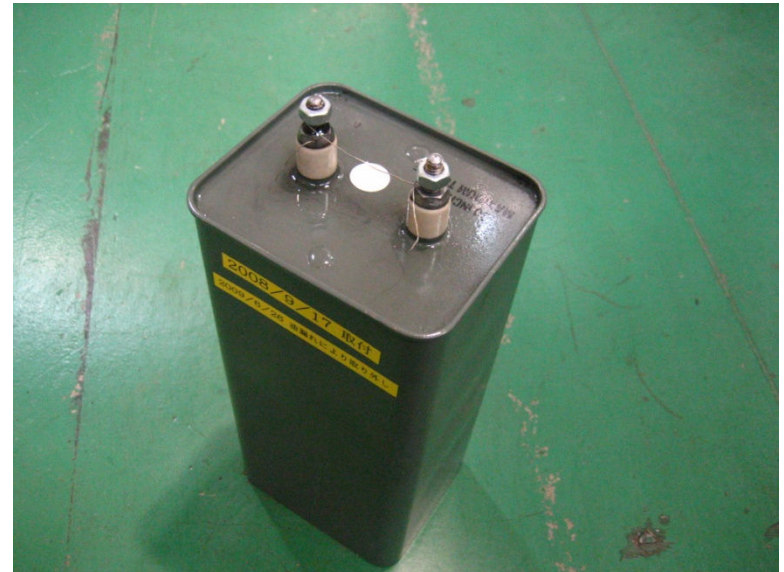
oil leaking capacitor
