Recent Status of ATF

N.Terunuma, KEK

- **R&D highlights**
 - **3.5 cells RF Gun**
 - **Upgrade of the DR BPM Readout**
 - **Fast Kicker**
 - **4-mirror Compton Generation**
- **Hardware maintenance issues**
- **Brief report on the fire accident and the earthquake**

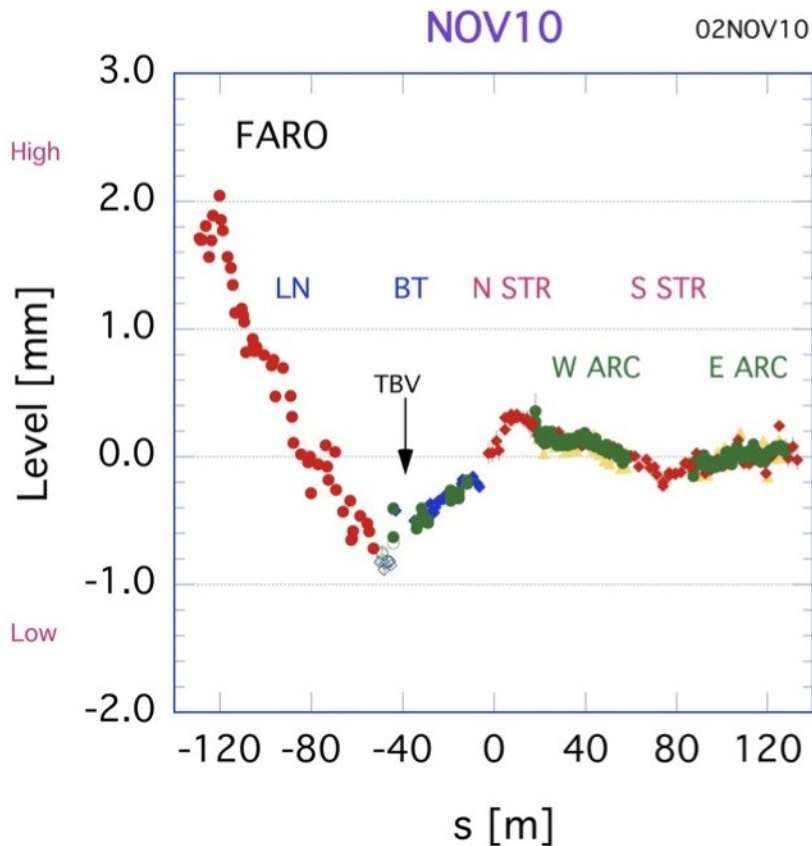
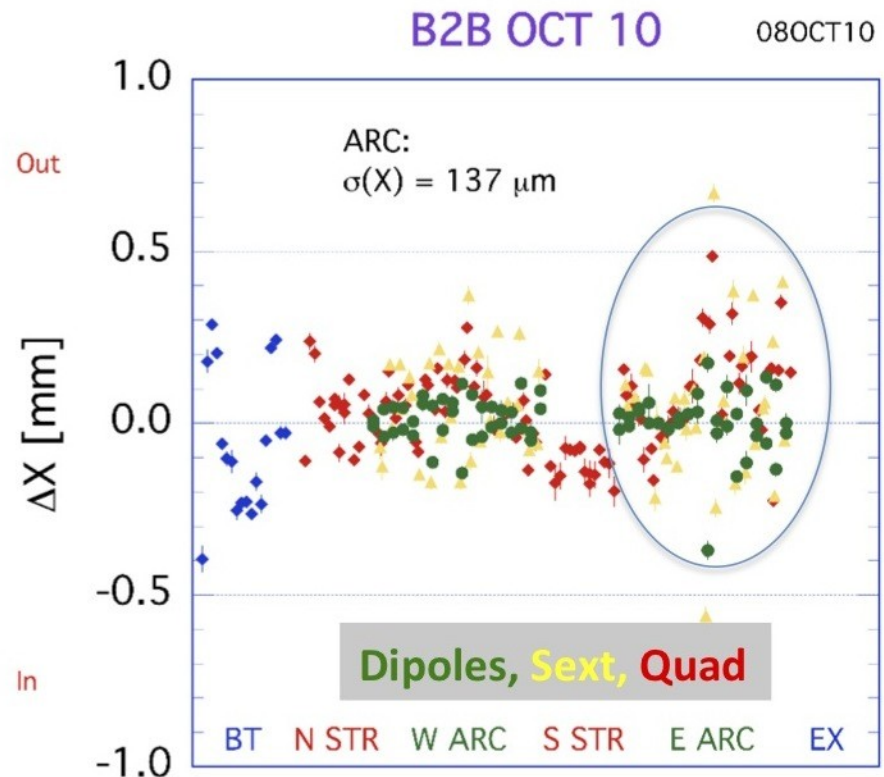
Alignment: Gun to DR

In the summer shutdown, we surveyed the magnet positions of whole ATF beam line.

We found the bigger rotation in some DR tables especially in the east arc.

East to north section was corrected in Jan. 2011

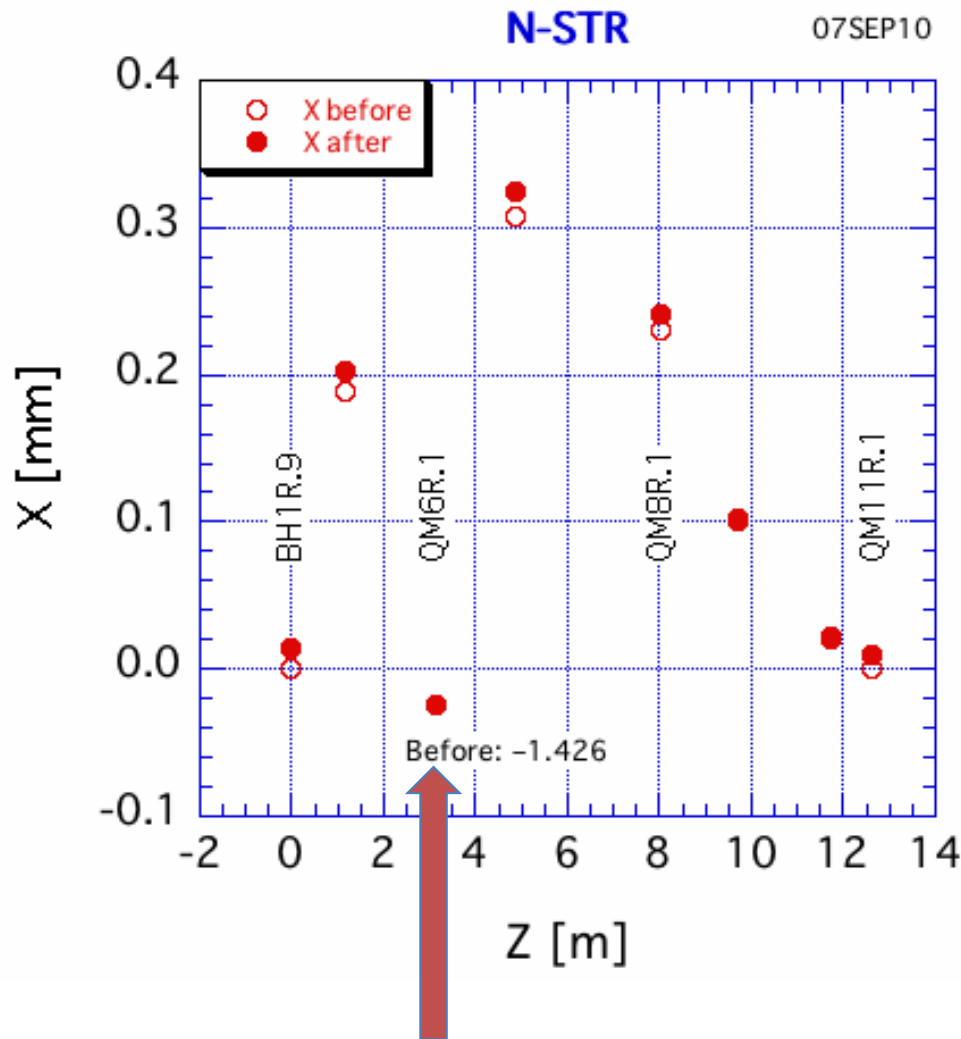
Alignment: DR North(Inj/ext)

During the survey of the magnet positions in summer, we found a huge position shift on QM6R.1 (just after the ext-kicker); $X \sim 1.4\text{mm}$, $Y \sim 0.25\text{mm}$.

We do not know when it happens.

- during the fast kicker installation in July??
- **Corrected in September.**

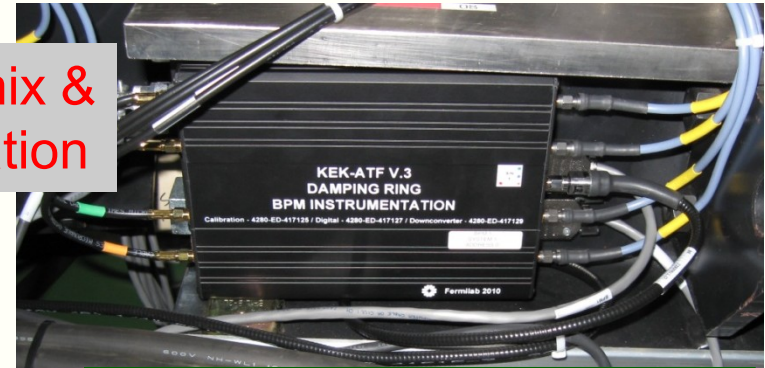
**Downmix &
Calibration**

**Analog downconverter
(located in the tunnel)**

**CAN-bus controls, IF filter,
remote diagnostics, etc.**

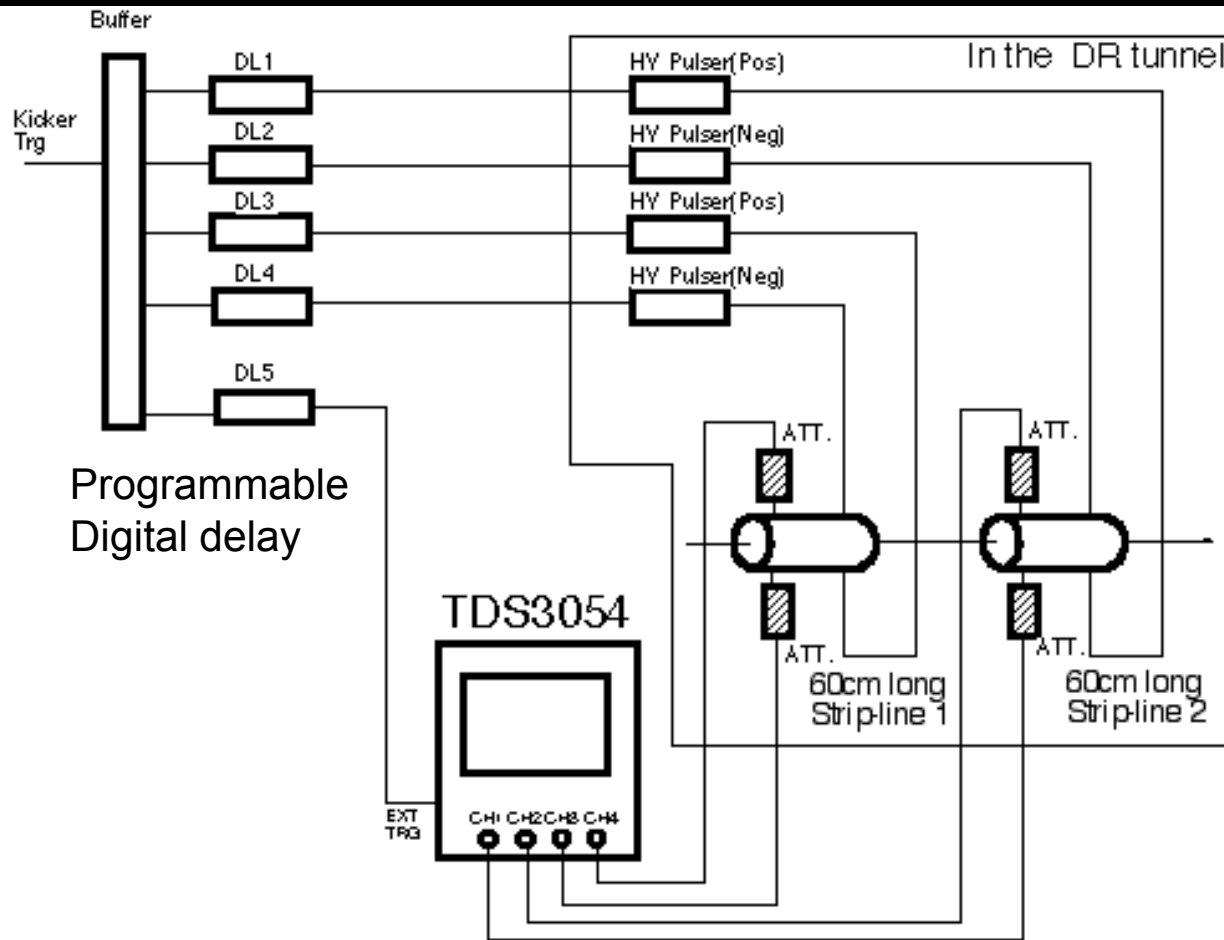
Trigger timing FB for Strip-line kicker

Precise triggers for each pulser and the timing control is required. The pulse measurement by the scope and the timing control by digital delays consist the trigger timing feedback. The step of the digital delay is 60ps. The trigger system could keep the pulse timing in the range of 200ps.

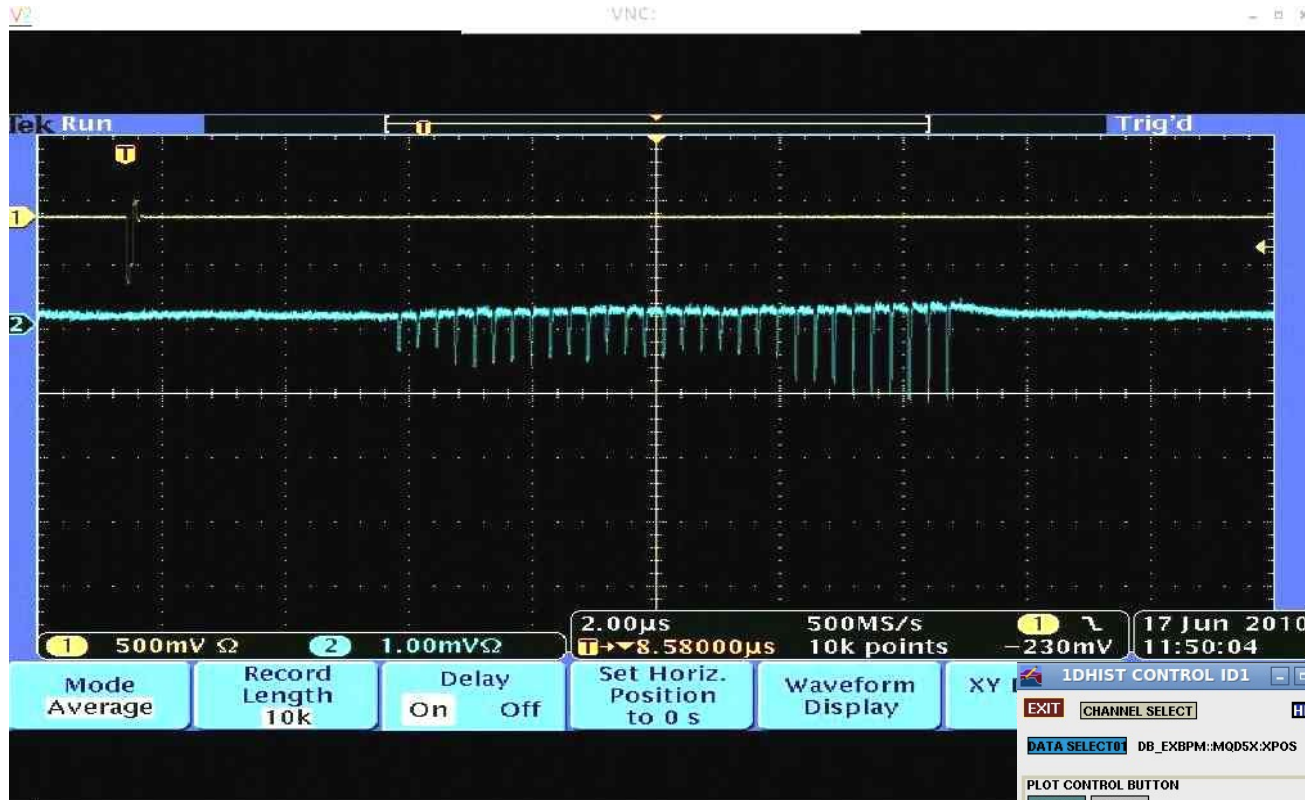
Multi-bunch extraction (30 bunches) with 308ns bunch spacing

The intensity of each bunch is not flat and unstable.
The horizontal beam position was distributed to two position.

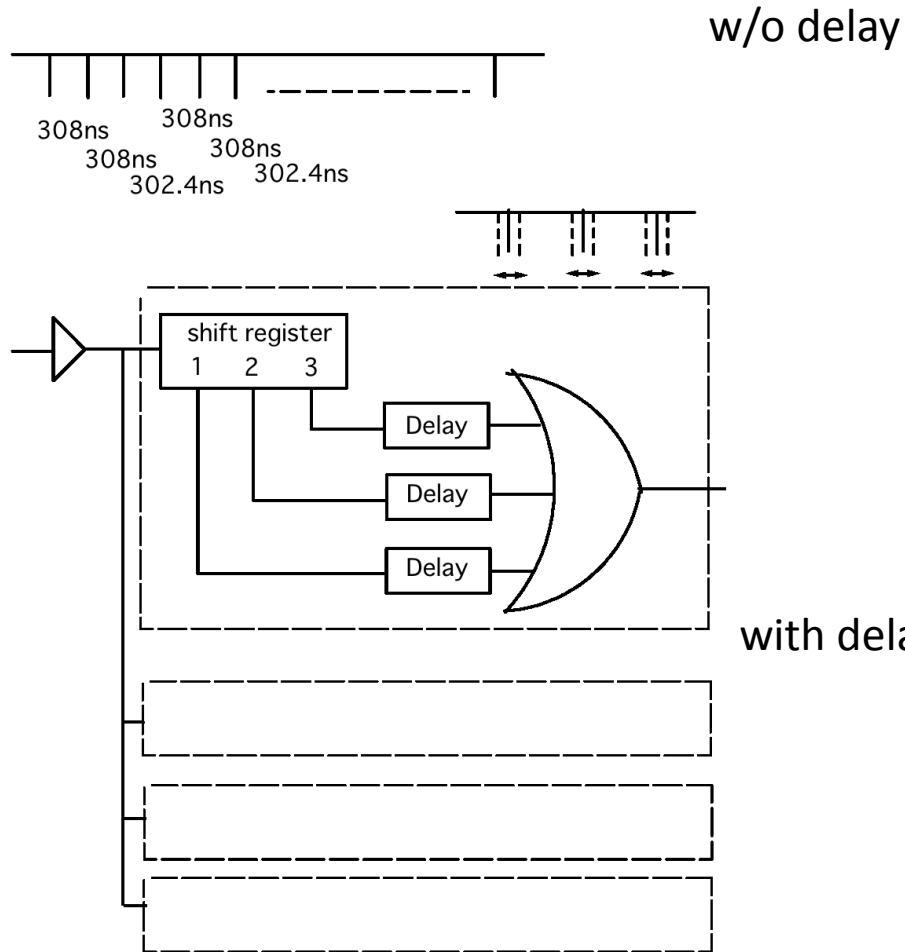
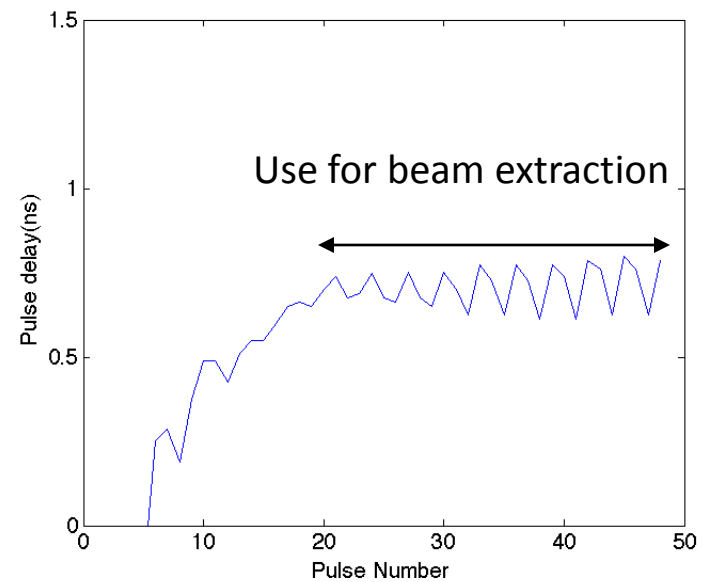
Pulse train delay adjustment circuit

30 bunches of the beam are stored to the DR, stably.

Stable beam extraction was confirmed at the extraction line. The beam reach to the beam dump without any beam loss.

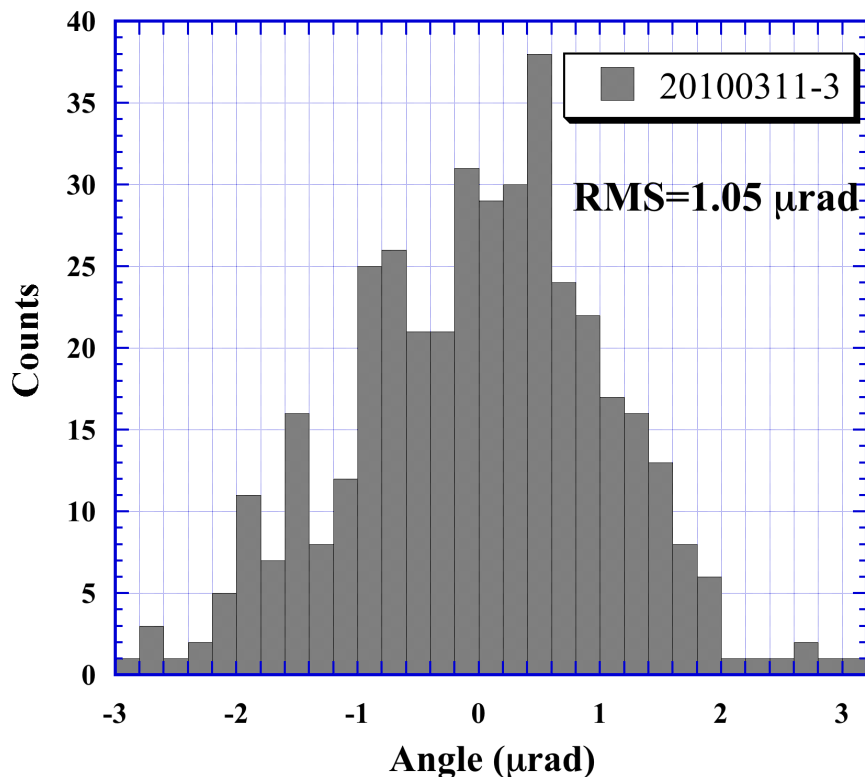
Kick Angle Stability

Kick angle stability was evaluated by the cavity BPMs at ATF2.

$$1.05 \mu\text{rad}/4.6 \text{ mrad} \\ = 3.5 \times 10^{-4}$$

It still has a jitter due to the timing jitter.

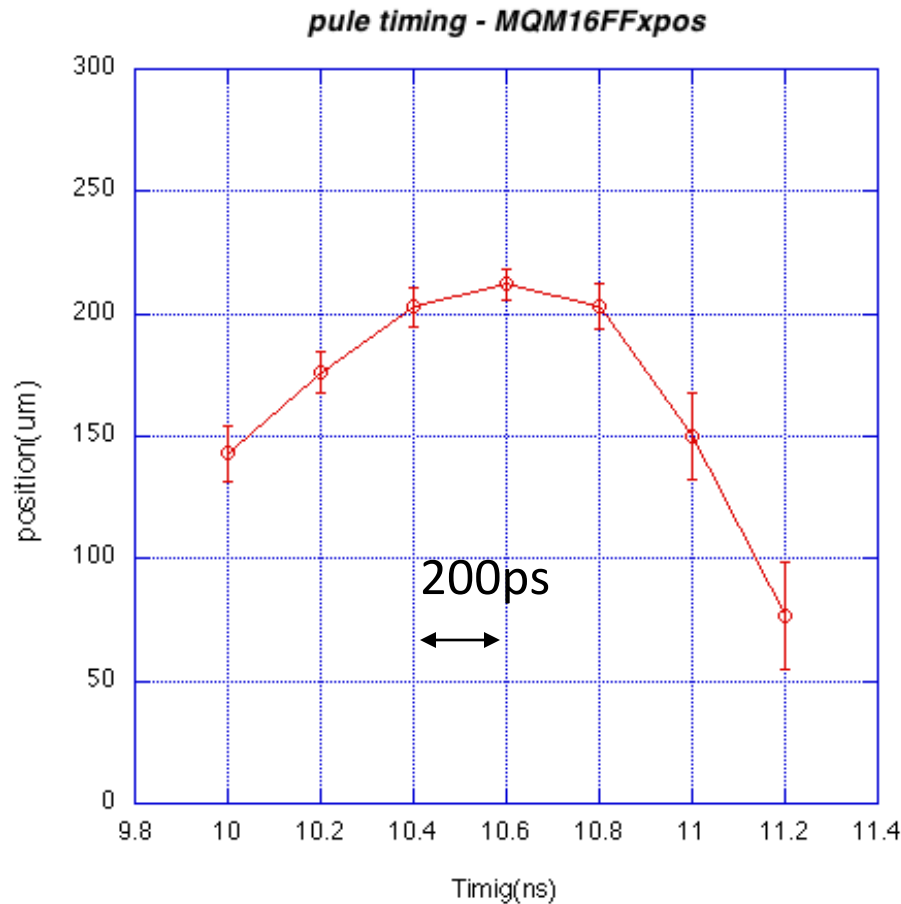
Profile of the kick field and the jitter

Plot shows the beam position at MQM16FF BPM, when scanned the kicker pulse timing. There is no flattop of the kick field and the jitter increased at the both side of the peak. **To make stable beam kick, careful timing adjustment of four pulses is needed.**

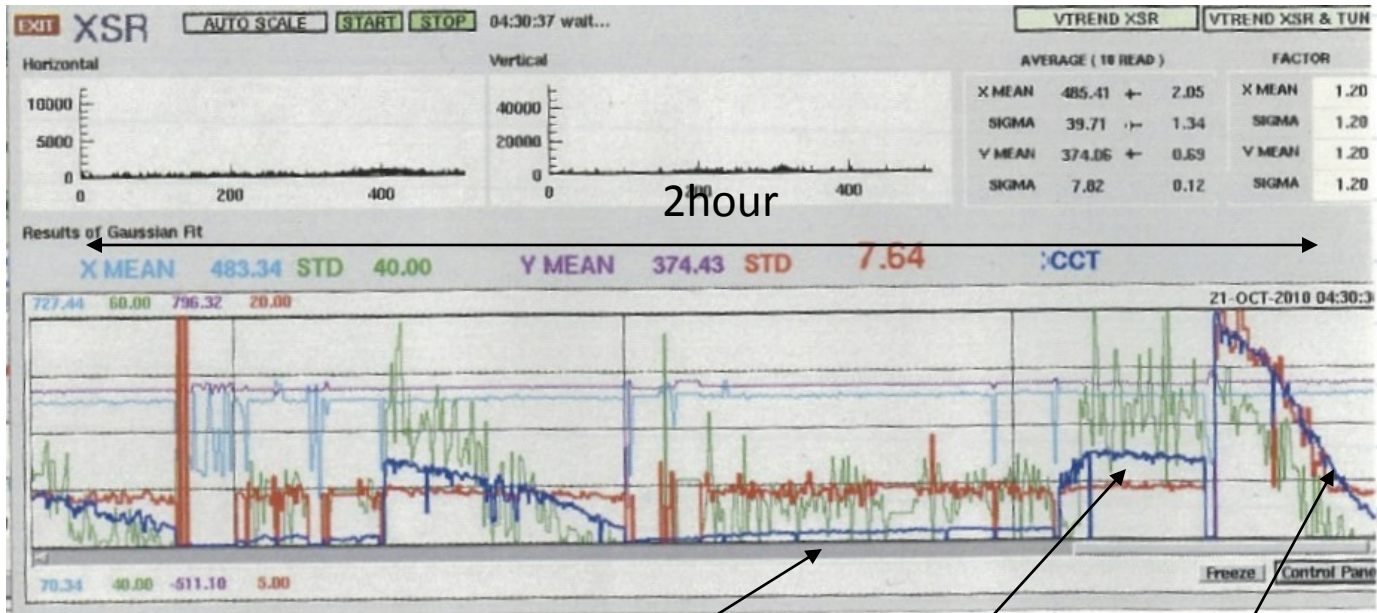
Problem: Stored beam intensity in DR

Blue line: current
Red line: v size (XSR)

The stored current decreased gradually when the multi-bunch operation. The current decrease depends on the stored current. Several minutes after the beam stop, the situation recovered. We suspect the heating of the strip-line electrode made such a happening.

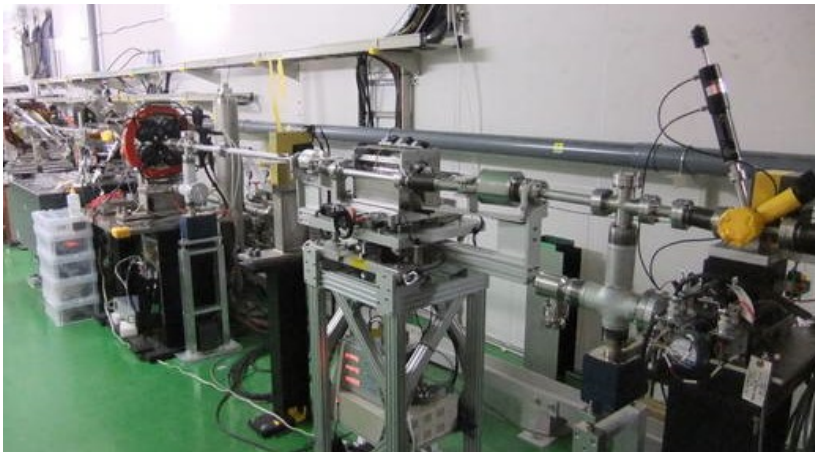
Permanent Magnet Final-Quad (Kyoto Univ.)

The magnet was assembled in Kyoto Univ in last fall.
It was delivered to KEK from Kyoto in the end of November.

- Field measurement by a rotating coil was done.
- It was temporarily installed in ATF2 line from Dec. 21st to 25th.
- Demonstration with beam was done on Dec. 23rd for the master thesis.
- Results should be reported in next meeting (ATF2 or TB).

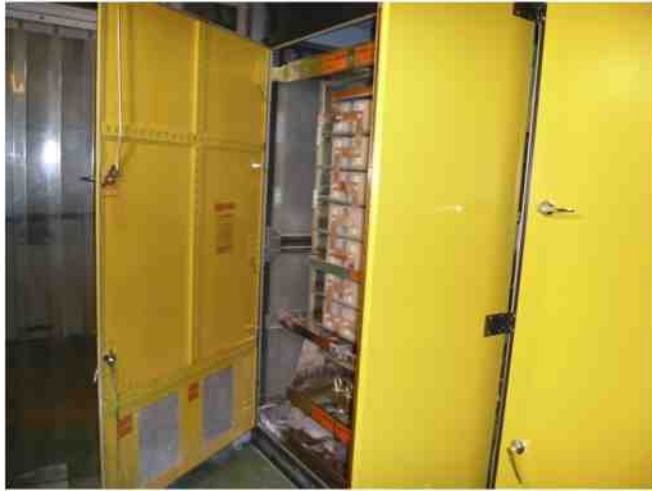
Fire Accident on the LINAC Klystron Modulator

A PFN capacitor of the renewed #0 modulator exploded and burned out on Feb. 16, 2011. (only ~1,200 hours operation)

- Exchanged the modulator #0 ← #10(ECS)
- Improved the failure sequence of the new modulators (i.e. for #8 operation).

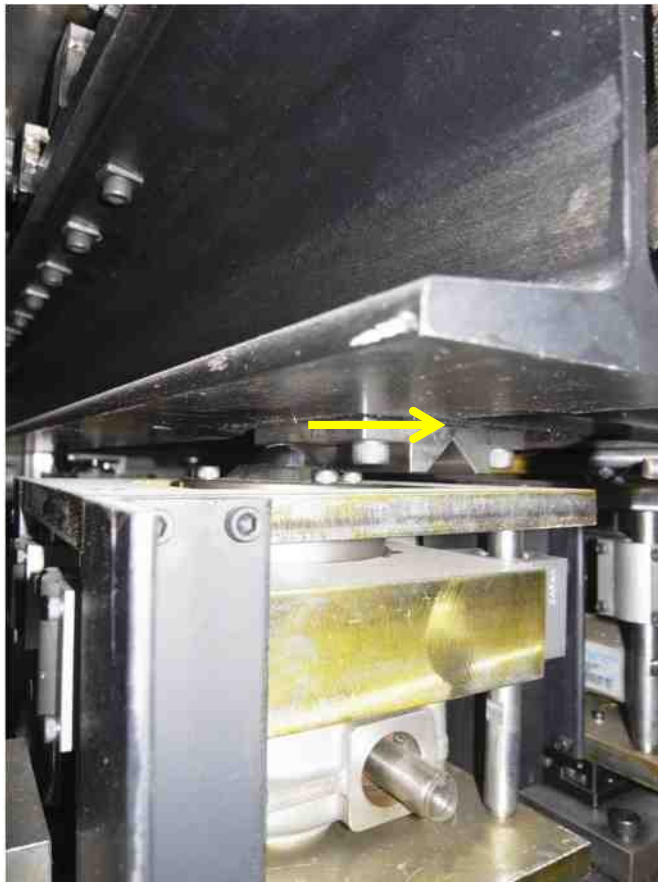
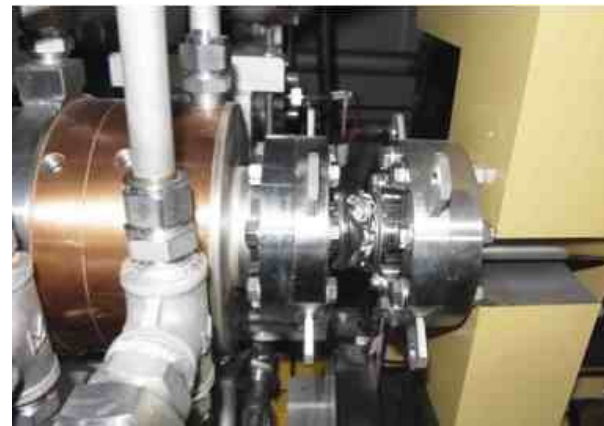
ATF LINAC

It looks **NO** severe physical damage except for the end section.

A small table moved then connections were broken. It seems easy to recover.

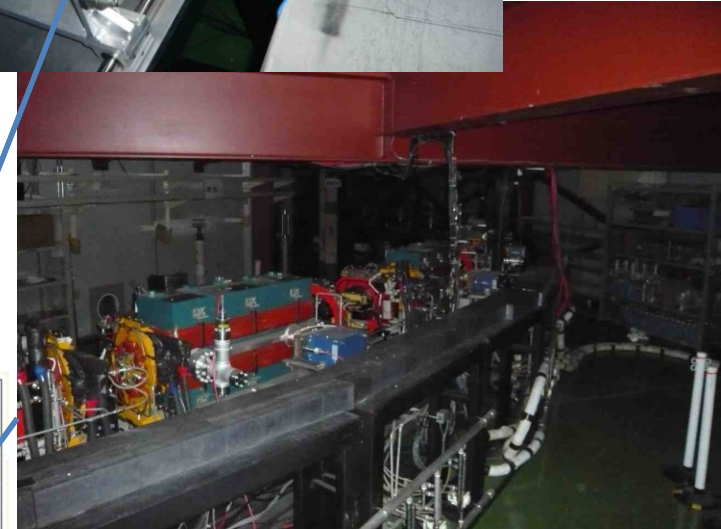
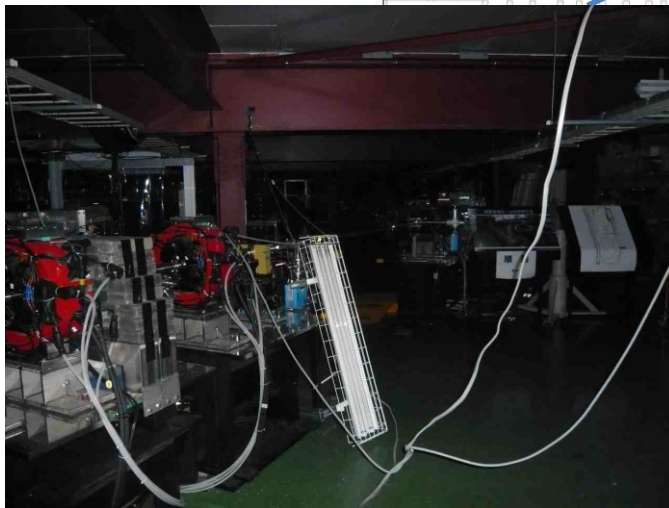
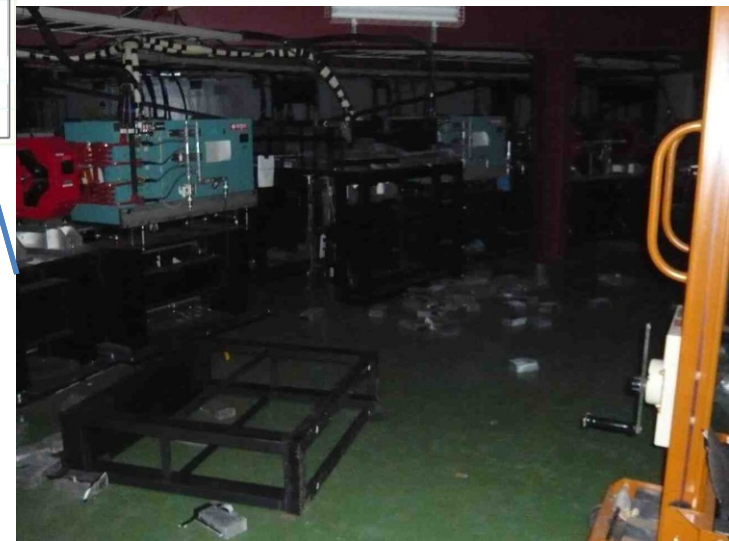
BT/DR(half)

Half of the DR, deep side, could not survey because of the safety.
It looks NO severe physical damage on the beam line.

Minor damages:

1. Expanded bellows of the ceramic chamber for SLAC kicker
2. Fallen Pb blocks and fluorescent lights

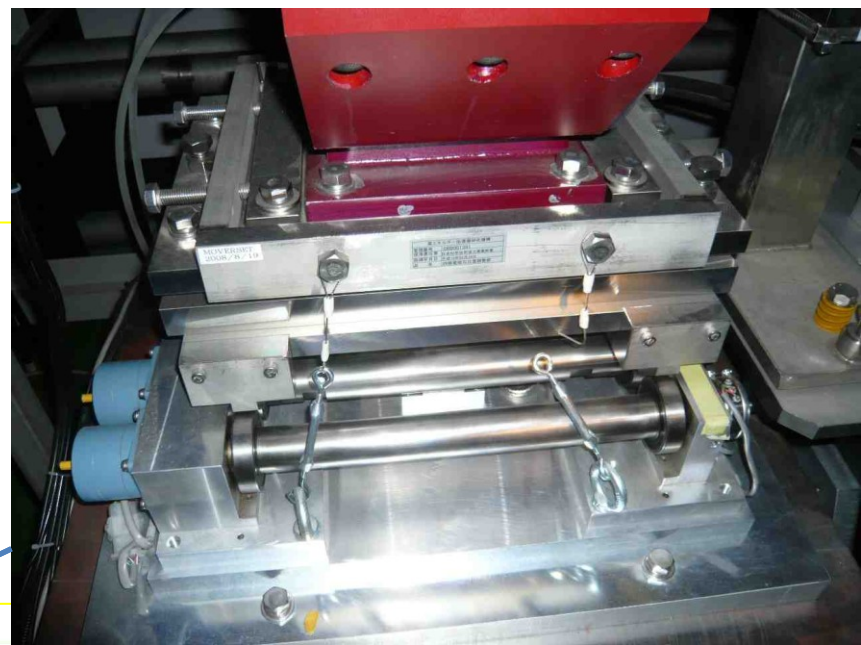
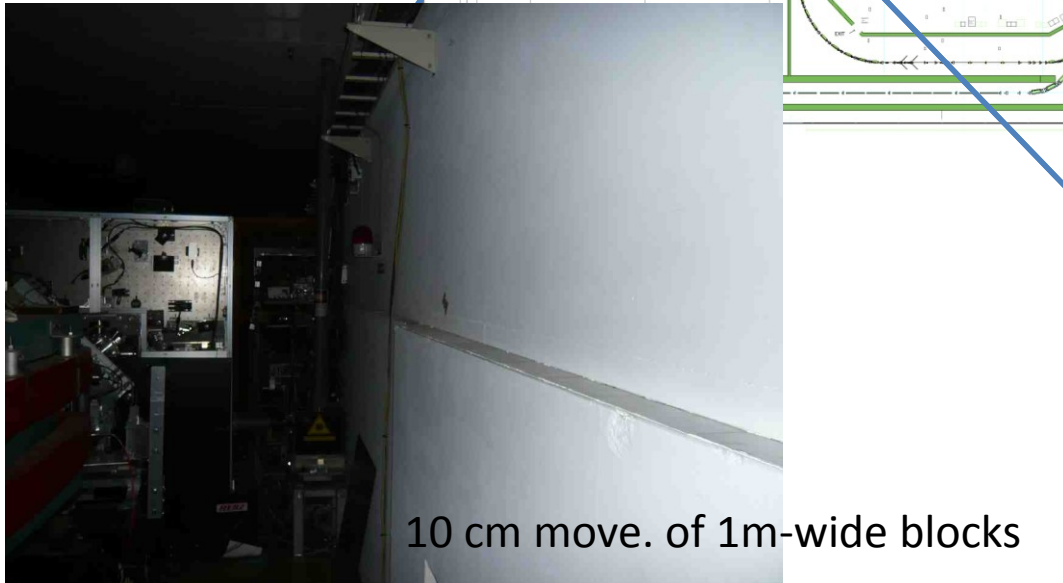
ATF2 beam line

It looks **NO** severe physical damage on the beam line.

Minor damages:

1. Some of the mount-safety wires for magnets were broken.
2. Side-shield blocks moved max.~10 cm.

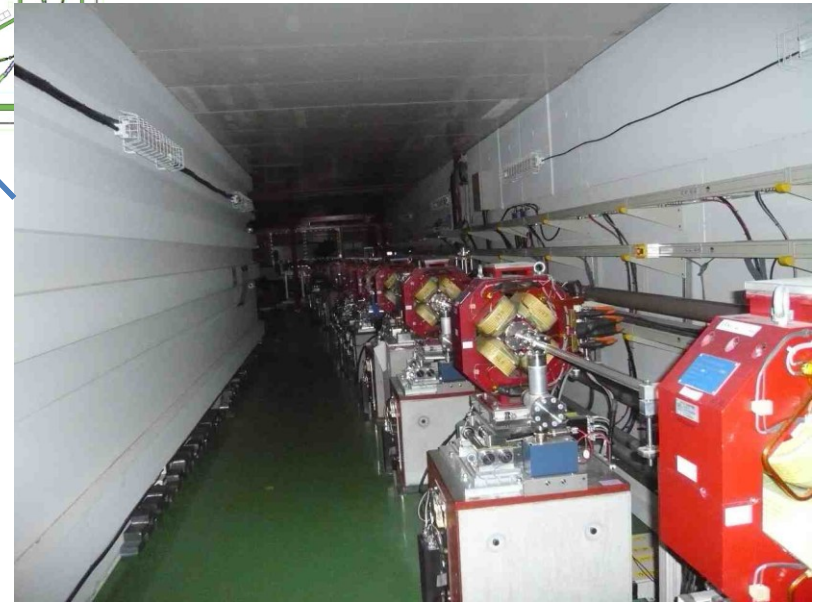
10 cm move. of 1m-wide blocks
