# **KEK cavity status, March 2011**

H. Hayano, 03202011

# STF Phase-2 Accelerator

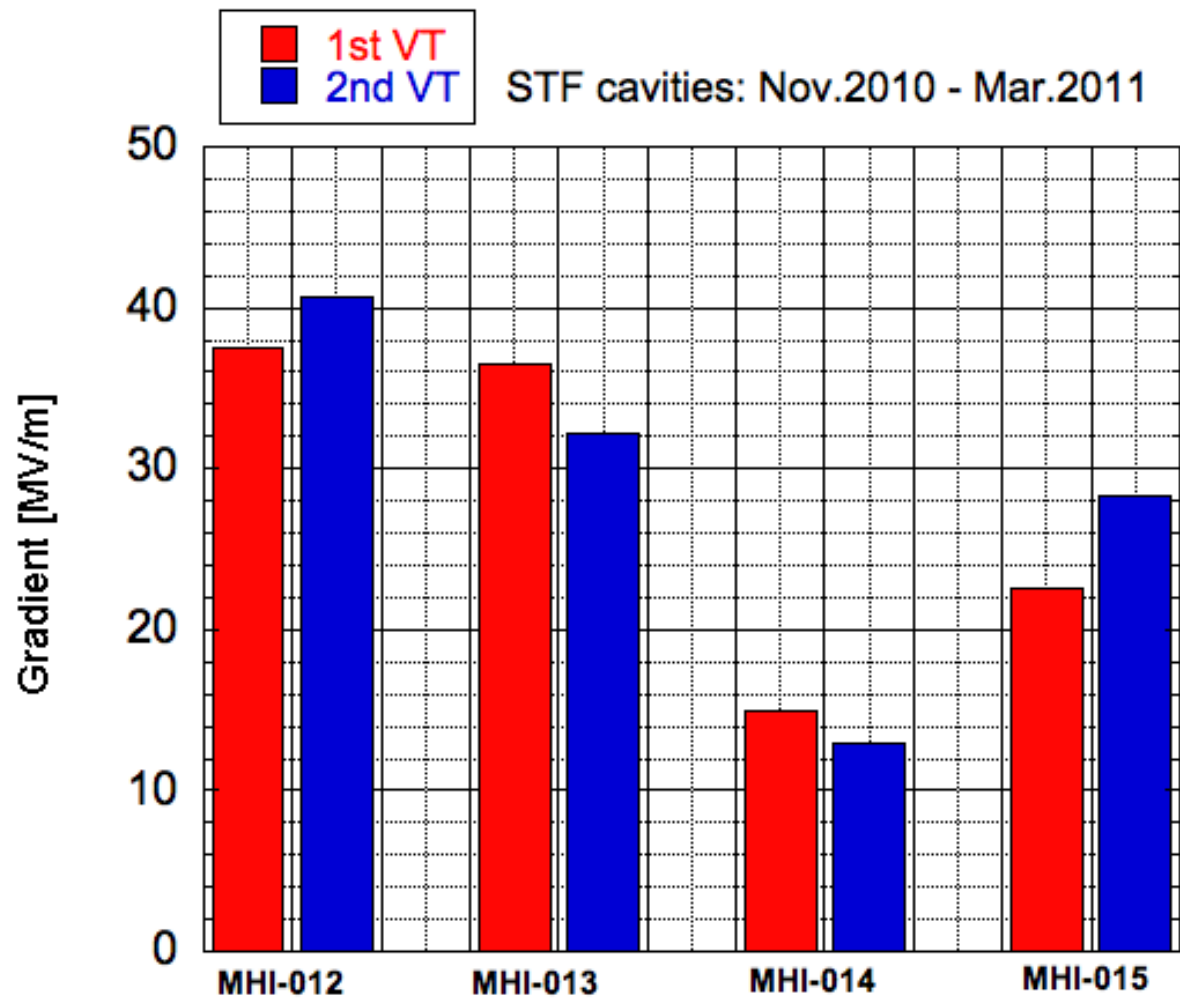
**Total 11 MHI cavities are planned. ( new production batch )**

\* These cavities are fabricated and inspected according to High-pressure-vessel code.

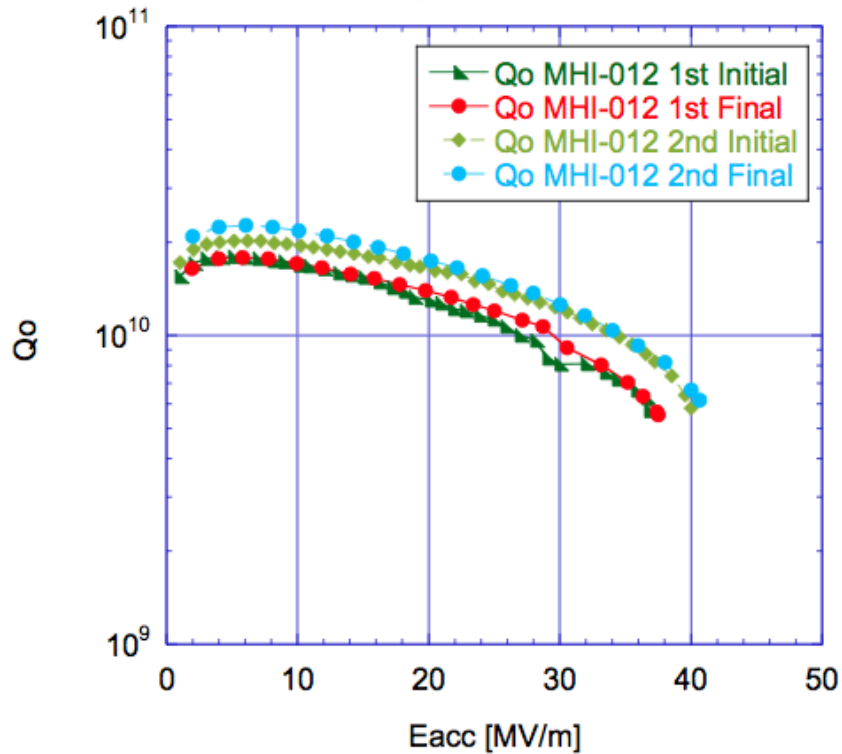
MHI-012 1st and 2nd

MHI-012: 1<sup>st</sup> VT 37.5MV/m @ Q0=5.5E09 Nov 11,2010

MHI-012: 2<sup>nd</sup> VT 40.7MV/m @ Q0=6.2E09 Dec 08,2010

# MHI-012 Eacc, X-ray

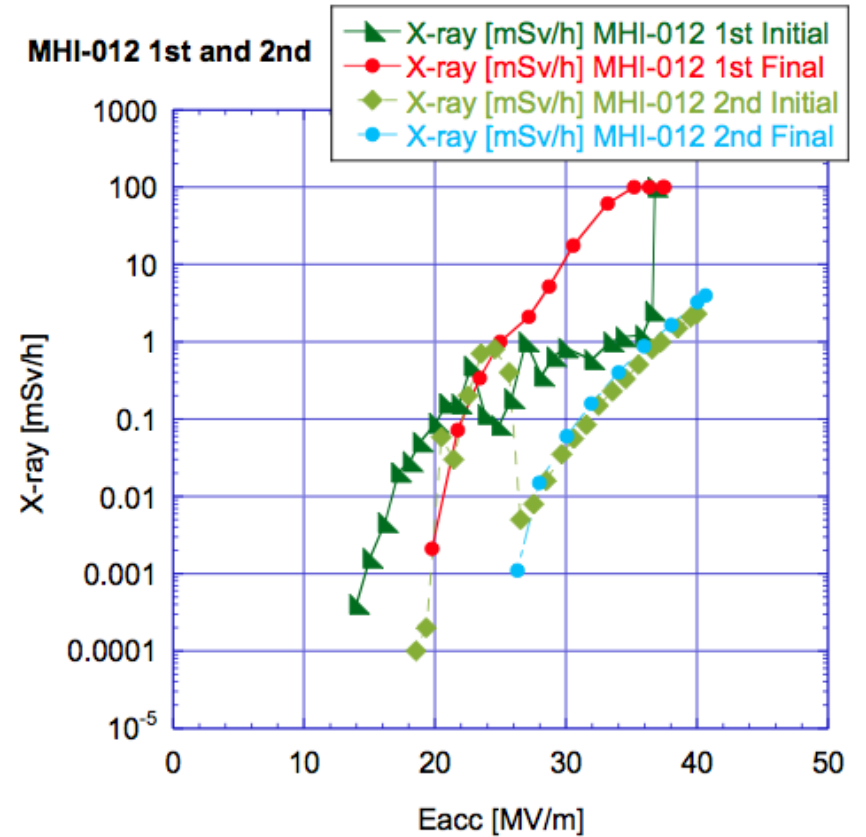
MHI-012 1st and 2nd

1 pit on cell #6 equator outside EBW seam

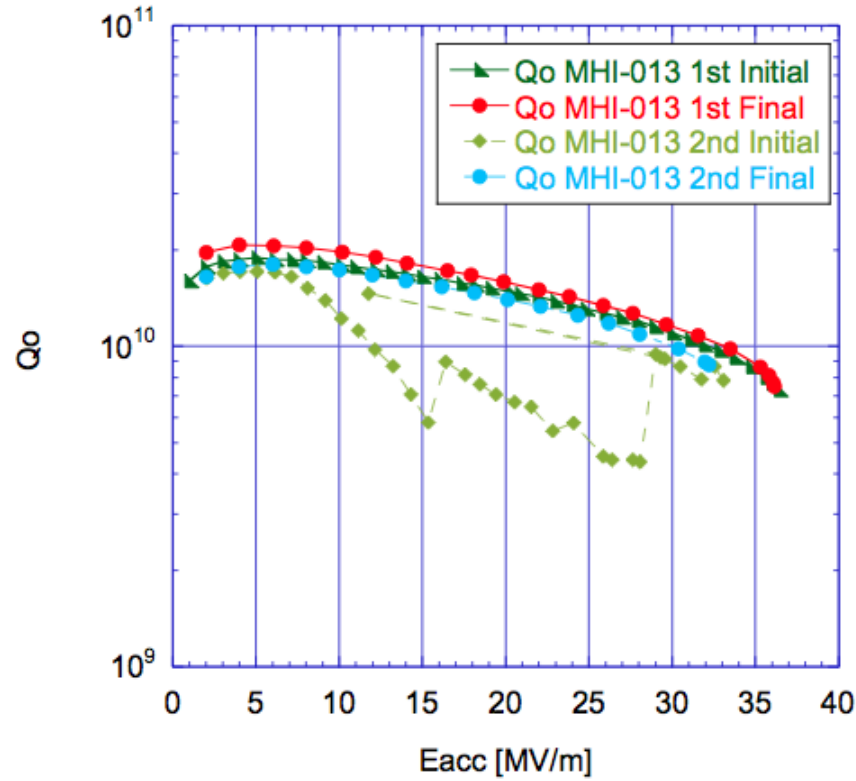
### MHI-013 1st and 2nd

MHI-013: 1<sup>st</sup> VT 36.5MV/m @ Q0=7.5E09 Nov 25,2010,

MHI-013: 2<sup>nd</sup> VT 32.2MV/m @ Q0=8.8E09 Dec 22,2010,

# MHI-013 Eacc, X-ray

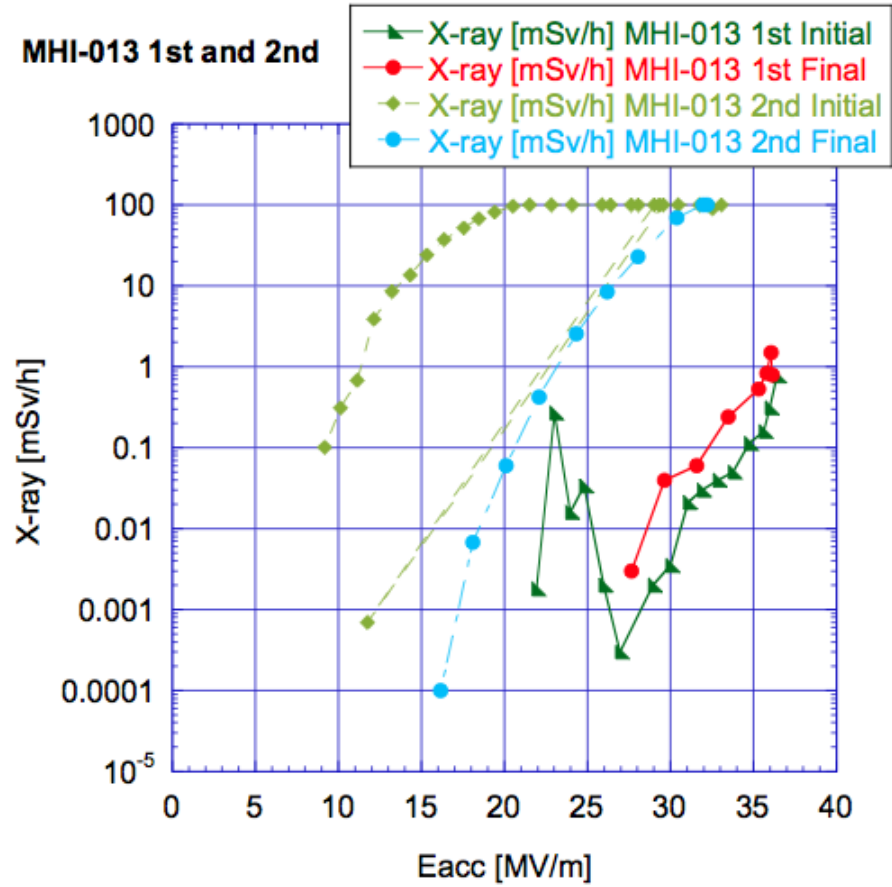
### MHI-013 1st and 2nd

3 pits on cell #2, #3, #5 equators  
outside EBW seam

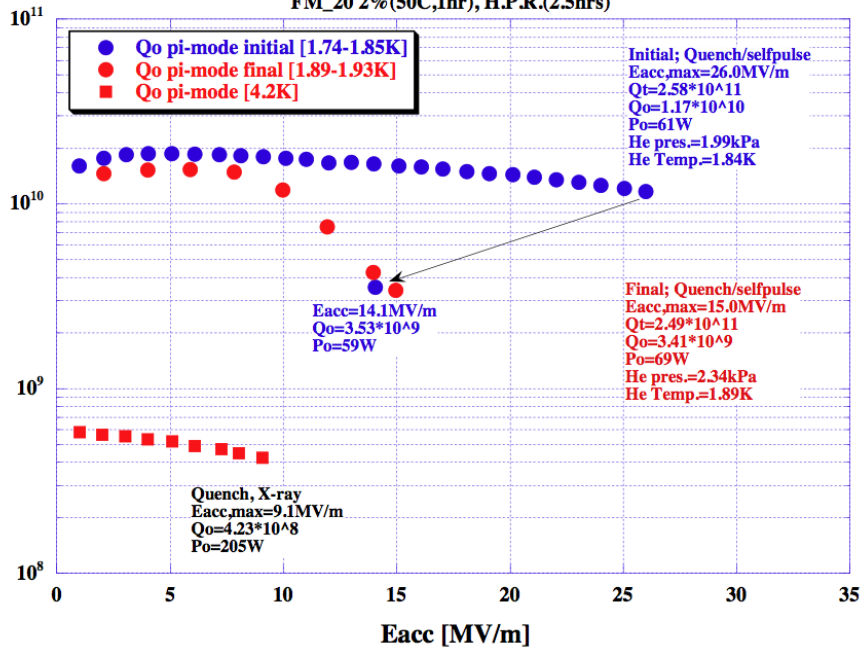
## 1st VT

MHI No.14 1st. Vertical Test 01/20/2011  
 EP-II(~37mA/cm<sup>2</sup>, 20μm), Improved Water flow(1.5hrs),  
 FM\_20 2%(50C,2hrs), H.P.R.(~9hrs), Vacuum Leak&Re-Assembly,  
 FM\_20 2%(50C,1hr), H.P.R.(2.5hrs)

Field emission turned on,  
 Heating at cell#8 120 degree,  
 X-ray onset = 5 MV/m

MHI-014: 1<sup>st</sup> VT 15.0MV/m @ Q0=3.4E09 Jan 20,2011

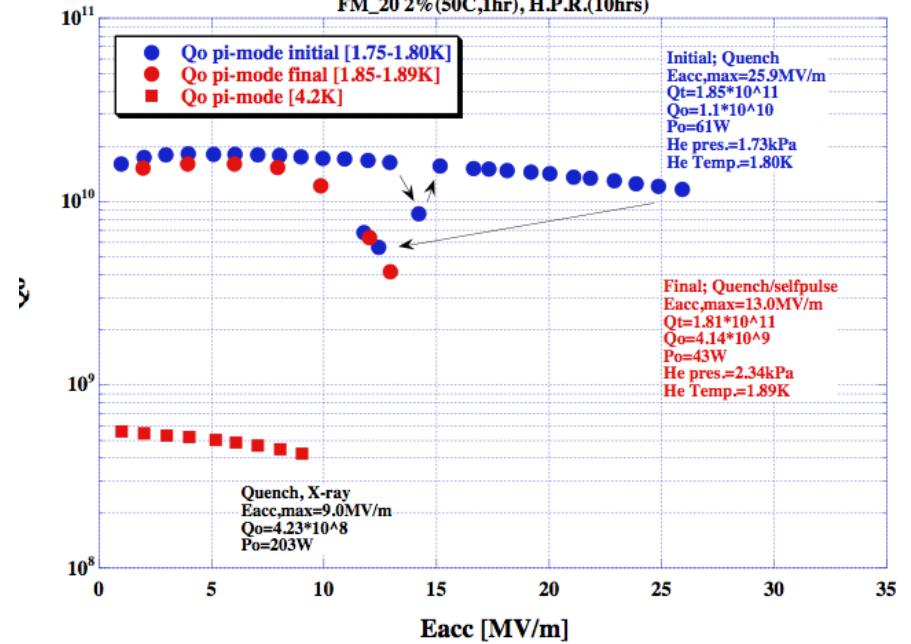
## 2nd VT

MHI No.14 2nd. Vertical Test 02/17/2011  
 EP-II(~37mA/cm<sup>2</sup>, 20μm), Improved Water flow(1.5hrs),  
 FM\_20 2%(50C,1hr), H.P.R.(10hrs)

Field emission turned on,  
 Heating at cell#8 90 degree,  
 X-ray onset = 5 MV/m

MHI-014: 2<sup>nd</sup> VT 13.0MV/m @ Q0=4.1E09 Feb 17,2011

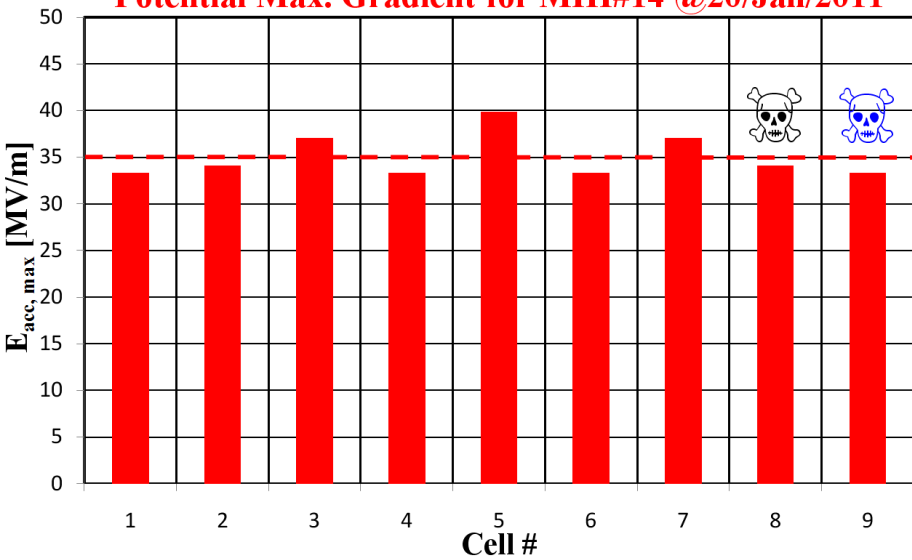
1st VT

Potential Max. Gradient for MHI#14 @20/Jan/2011

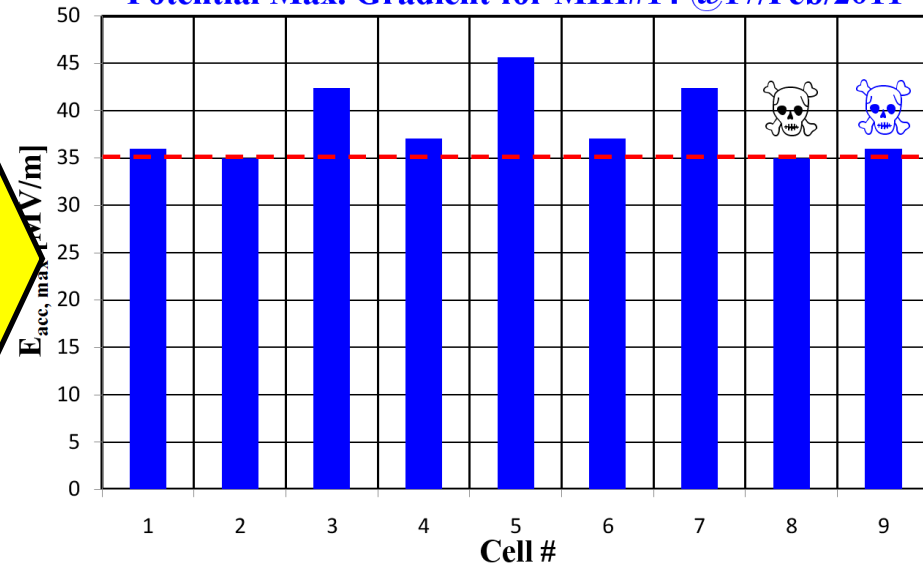
2nd VT

Potential Max. Gradient for MHI#14 @17/Feb/2011

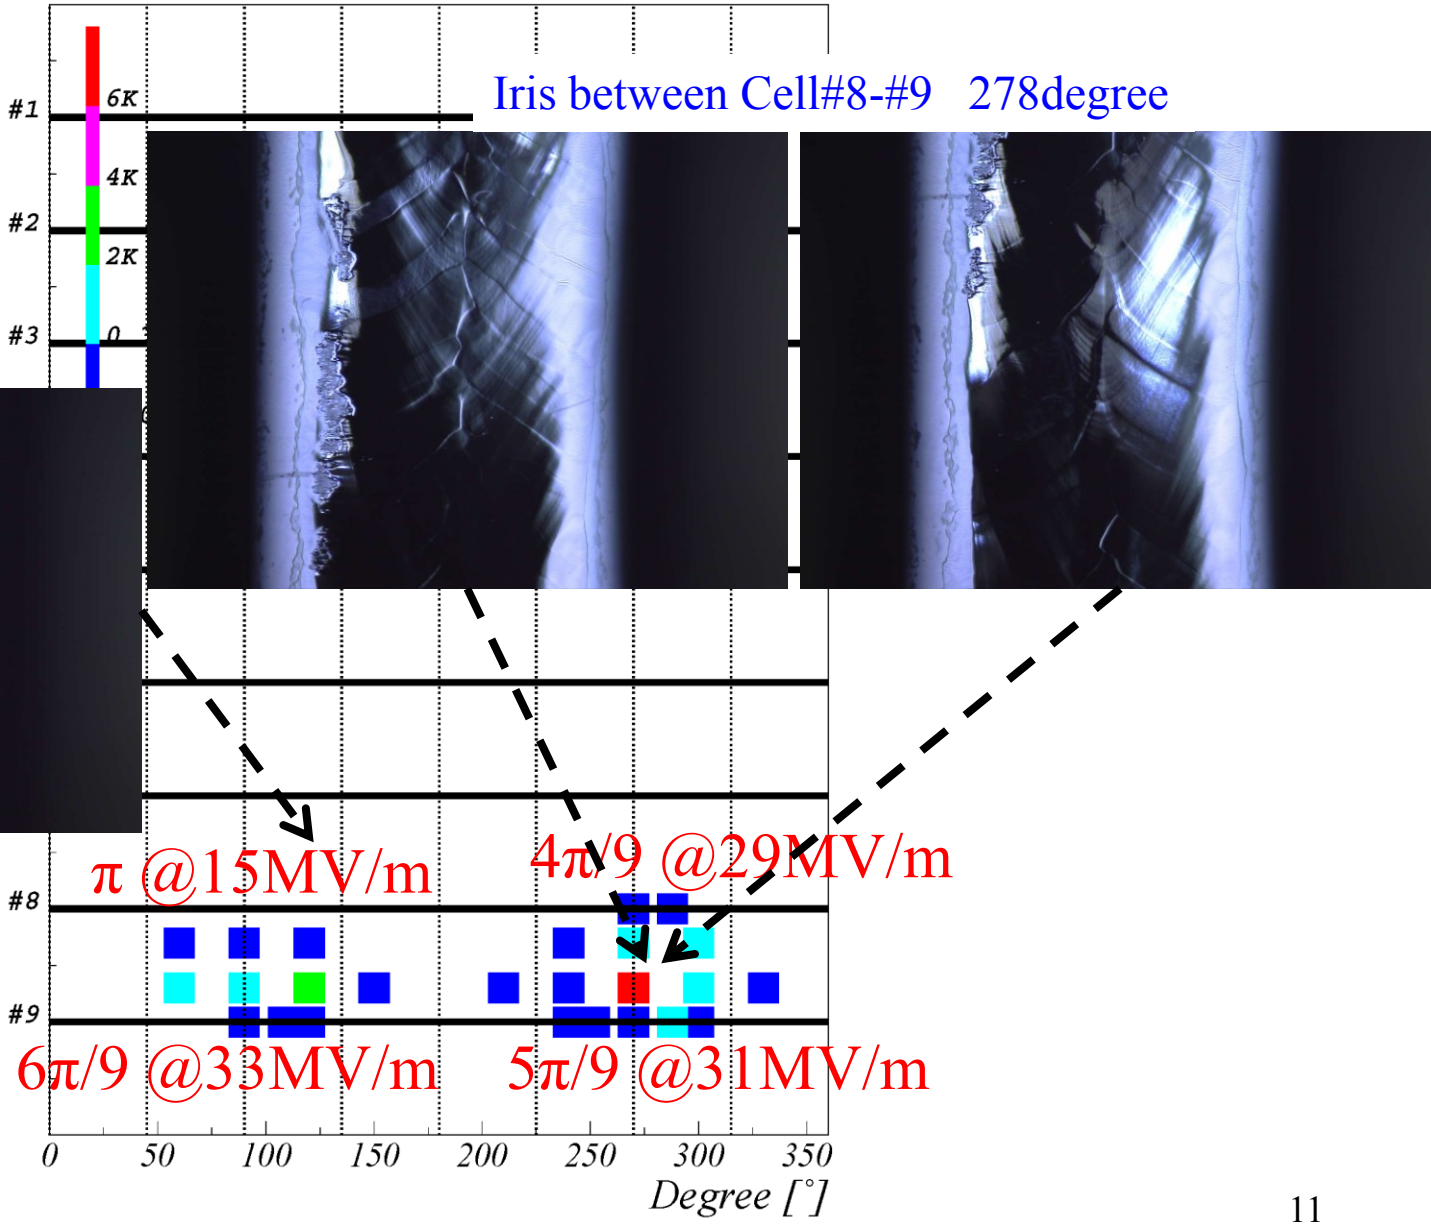
MHI-014  
after 1st VT

# Comparison of T-mapping and optical inspection

Iris between Cell#7-#8  
119degree

wide pits on Iris EBW seam between cell #8-#9 → Local grind in the next

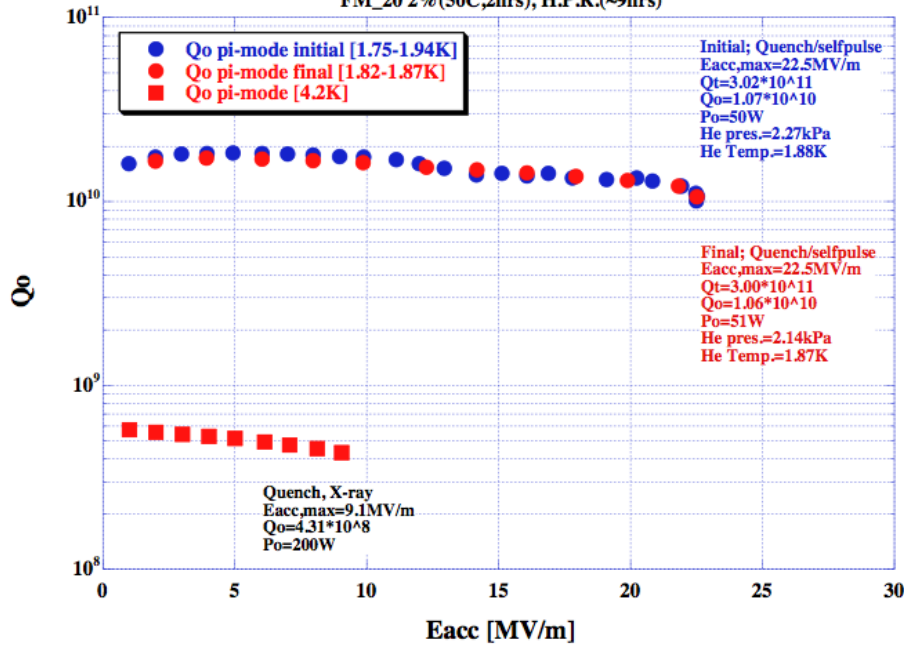
MHI No.15 1st. Vertical Test 02/03/2011  
EP-II(~37mA/cm2, 20μm), Improved Water flow(1.5hrs),  
FM\_20 2% (50C,2hrs), H.P.R.(~9hrs)

Quench at cell#2 60 degree,  
X-ray onset = 14MV/m

MHI-015: 1<sup>st</sup> VT 22.5MV/m @ Q0=1.0E10 Feb 03,2011,

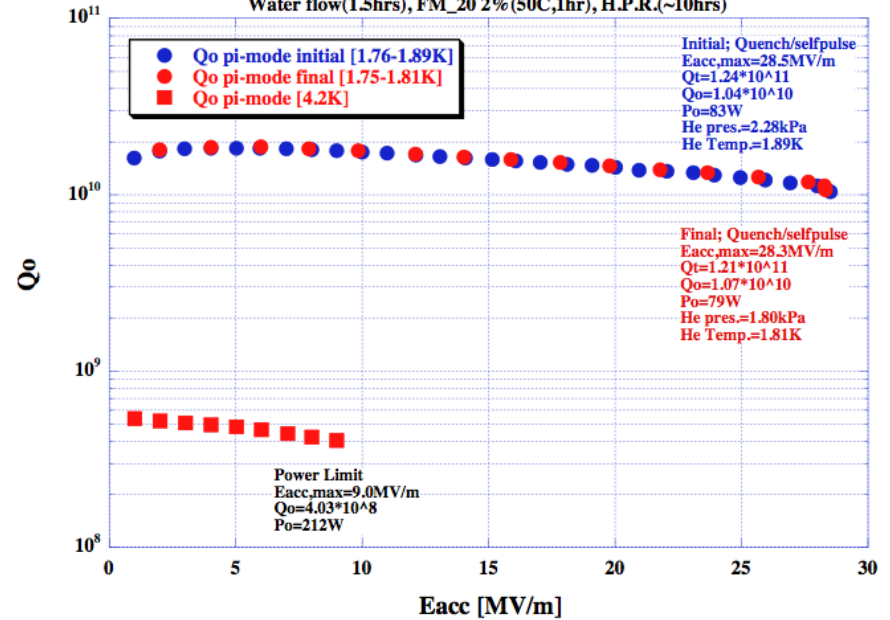
MHI No.15 2nd. Vertical Test 03/03/2011  
Local Grinding, EP-II(~37mA/cm2, 20μm),  
Water flow(1.5hrs), FM\_20 2% (50C,1hr), H.P.R.(~10hrs)

Quench at cell#9 0 degree,  
No X-ray up to 28MV/m

MHI-015: 2<sup>nd</sup> VT 28.3MV/m @ Q0=1.1E10 Mar 03,2011,

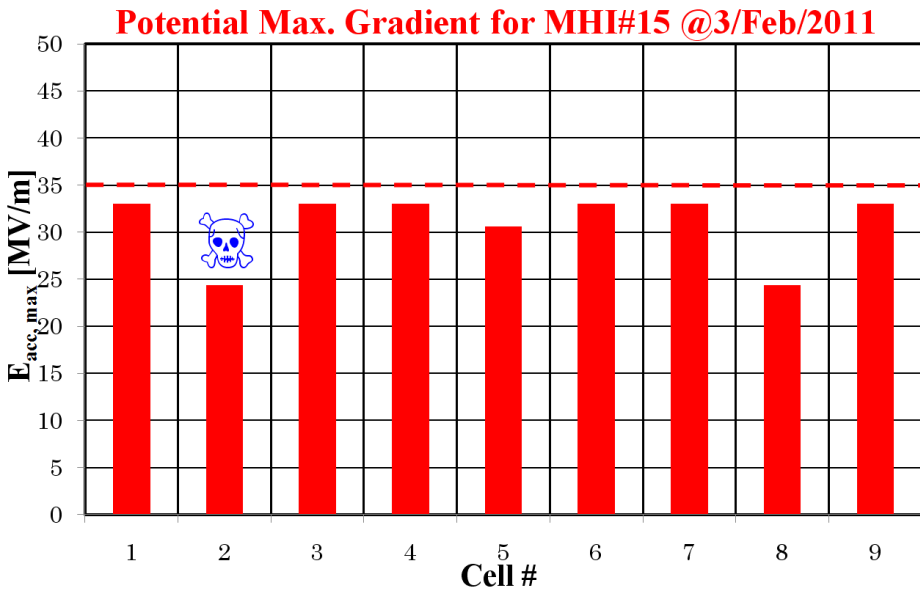
### 1st VT

## Pass-band mode excitation

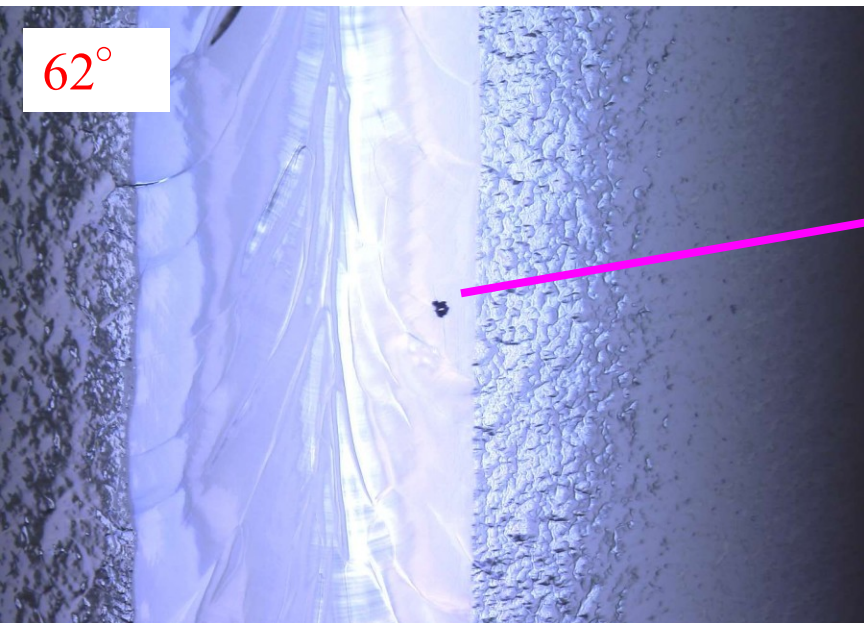
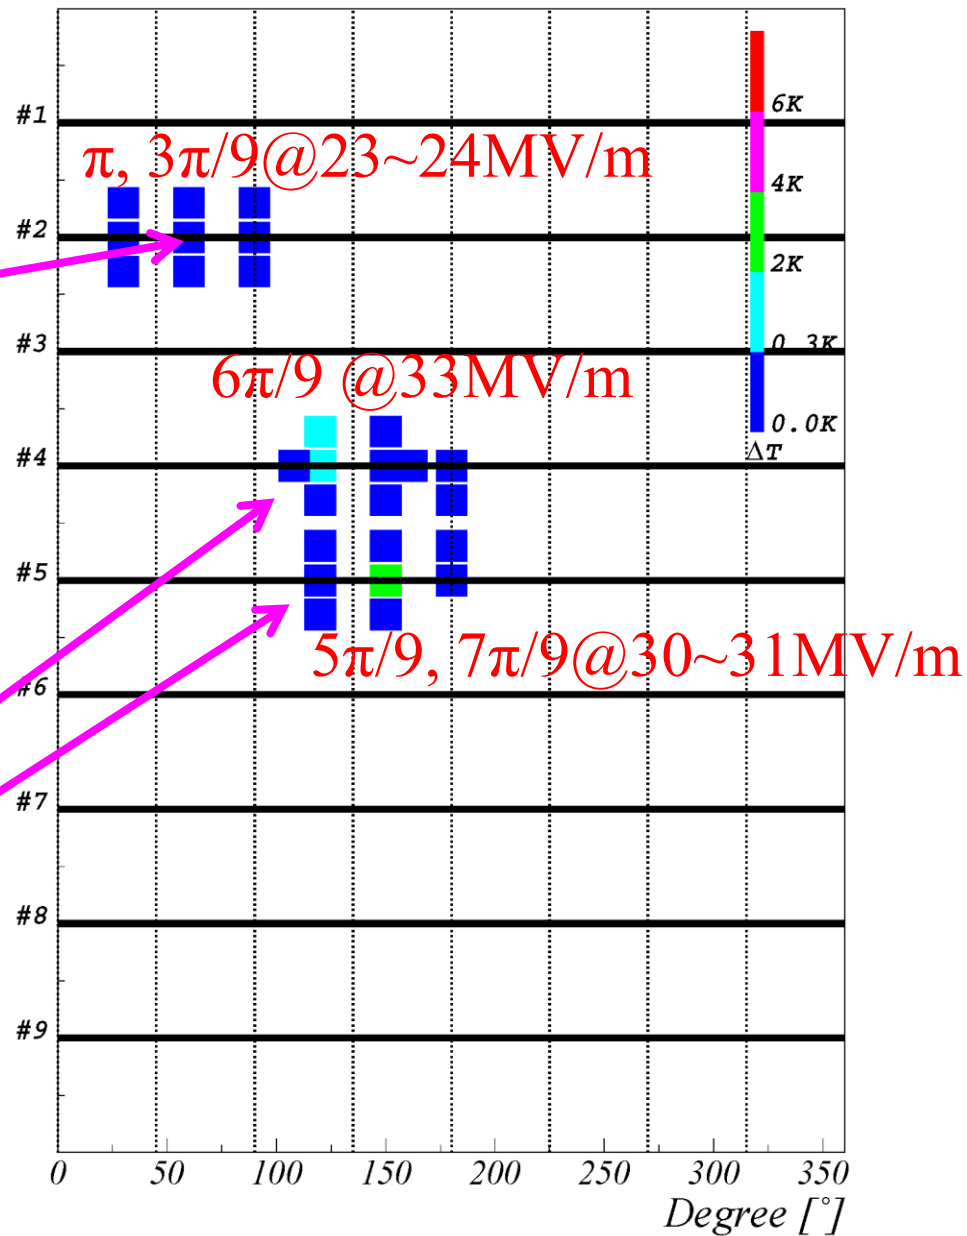
# Comparison of T-mapping and optical inspection

Nothing was found!

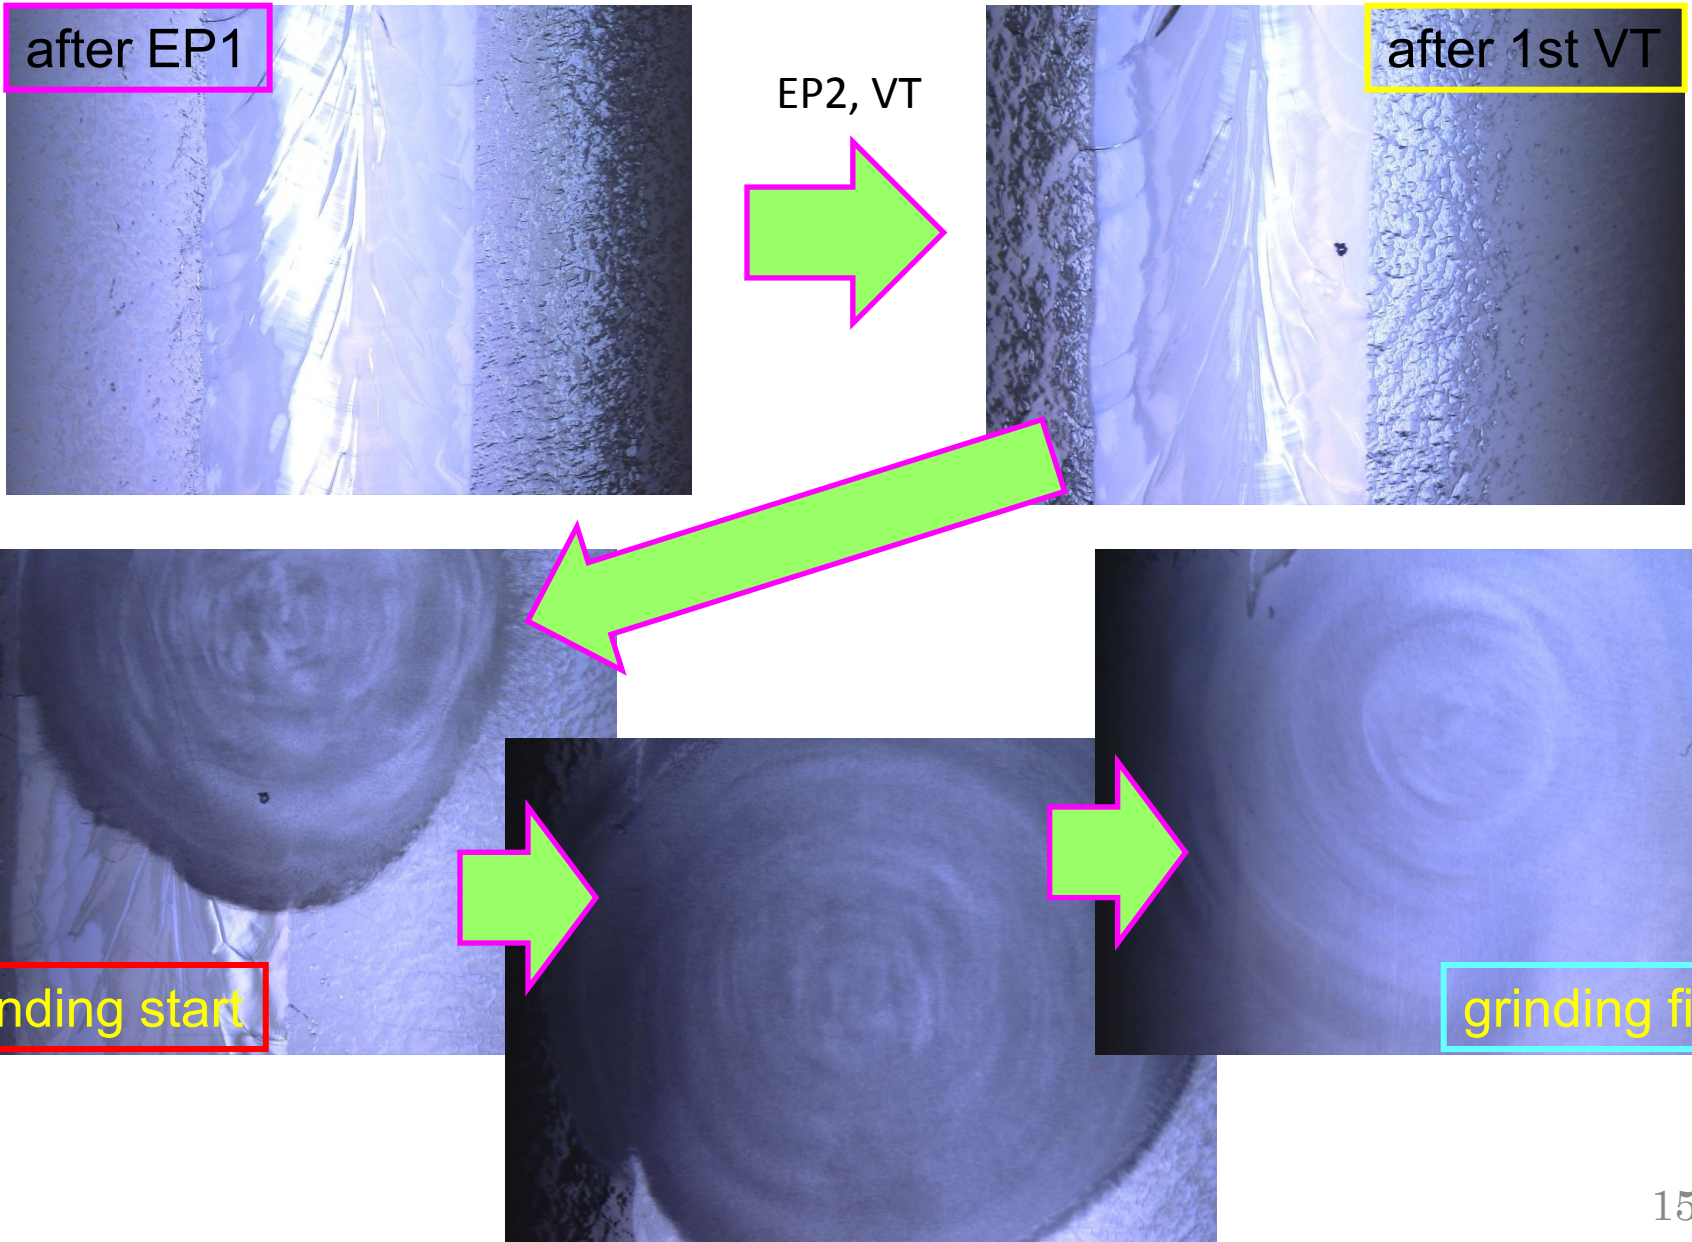
# Change of defect at Cell#2 equator

1 pit on cell #2 equator EBW seam → Local grind was done.

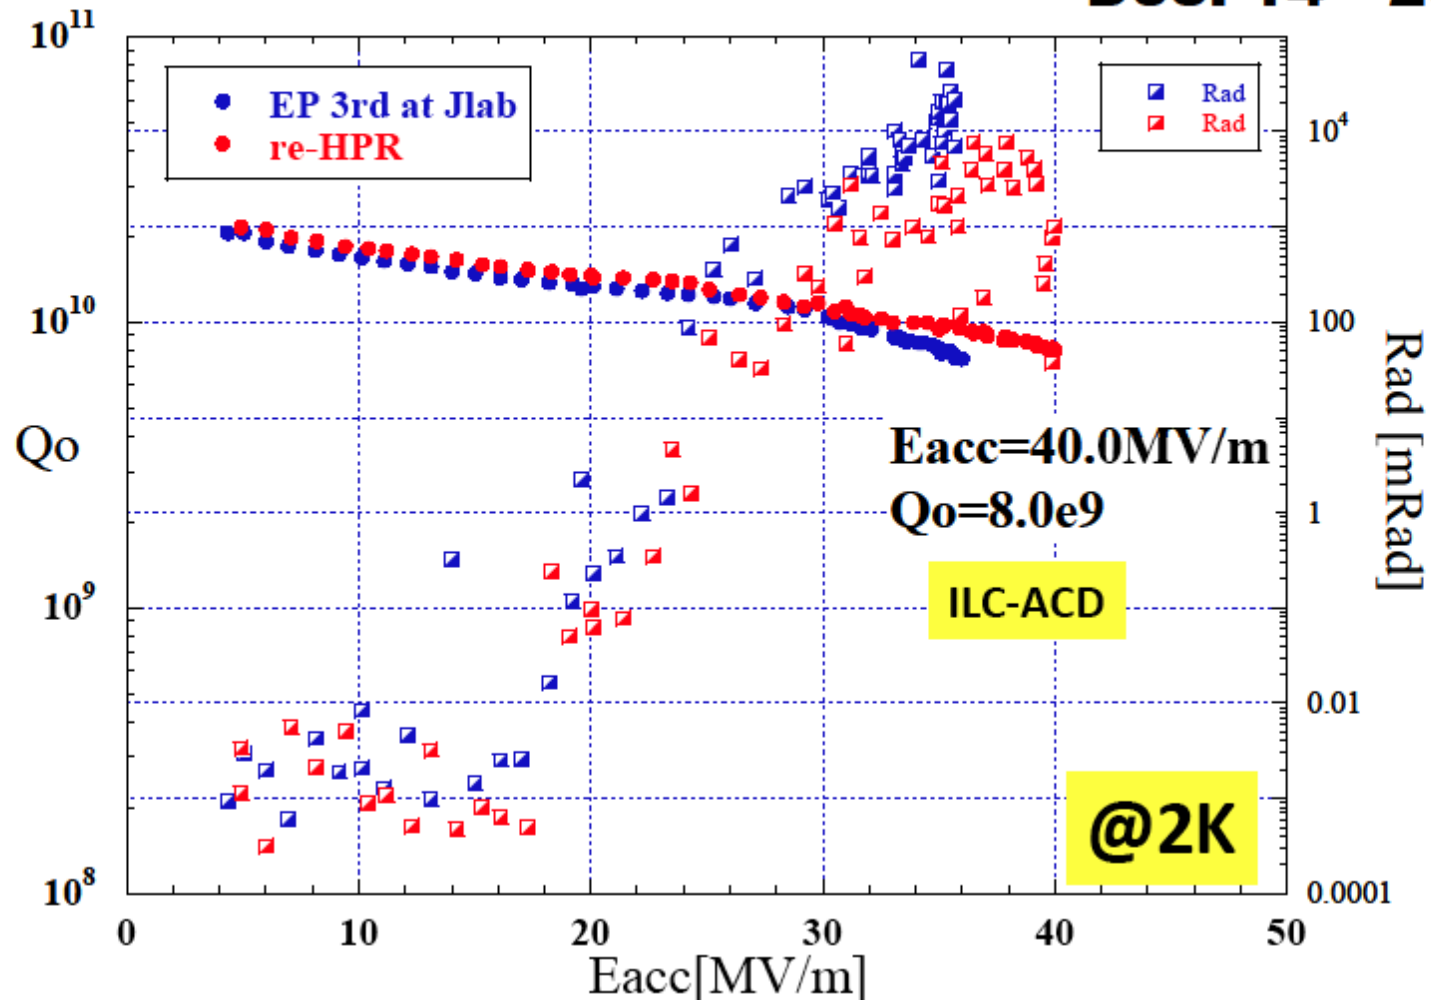
Dec. 14<sup>th</sup> 2010

# ICHIRO#7 VT after re-HPR at Jlab

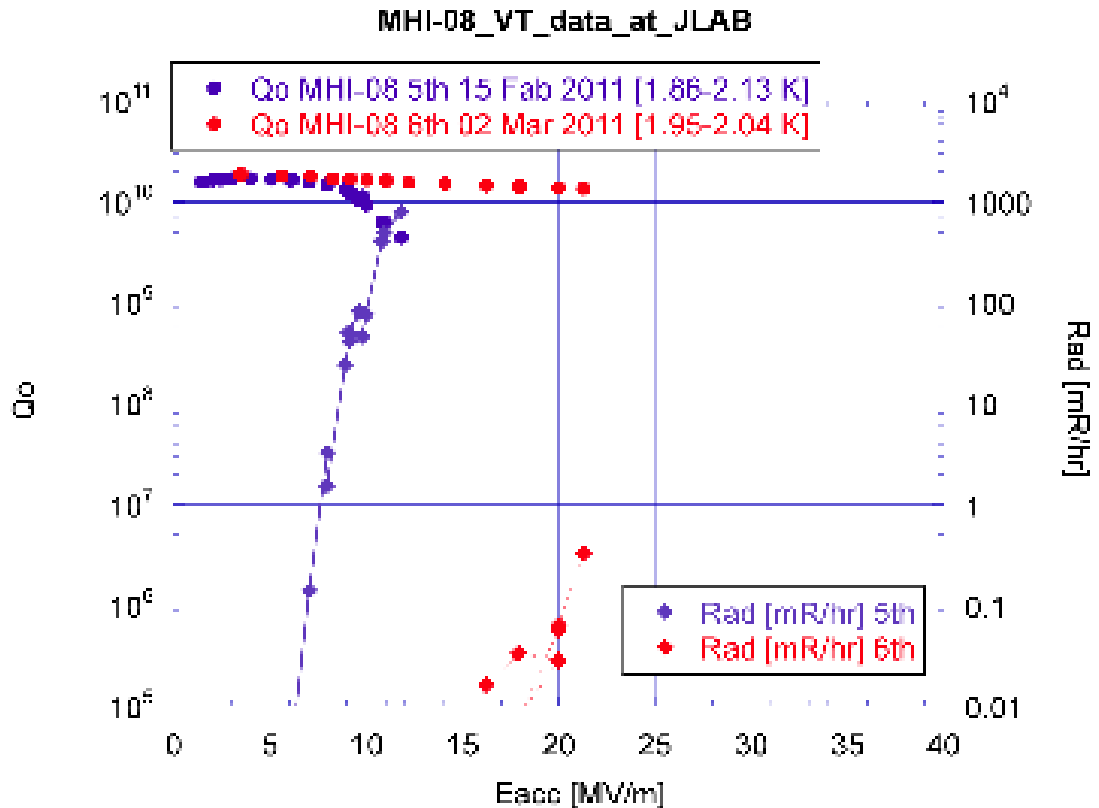
# MHI-08 at Jlab

**1st VT : 12MV/m Field emission  
(pump broken during baking)**

**2nd VT : 22MV/m quench  
at cell#1 or cell#9**

**(26-29MV/m at cell#4 or cell#6)**
