Curtis Crawford,
Georg H. Hoffstaetter
Cornell University

Laboratory for Elementary-Particle Physics

- Optimization of f 9-cell Vertical Electro Polishing (VEP)
- Study of alternative cell shapes:
re-entrant 9-cell
- 9-cell cavity repair by machine tumbling

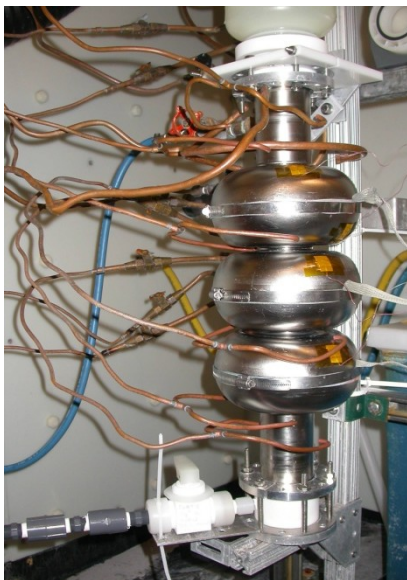
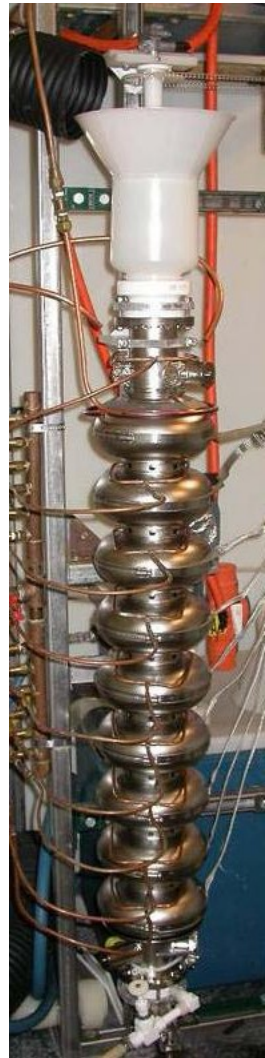
ILC cavity A9 has surpassed the 35MV/m ILC specification

- It has been repaired by tumbling a single damaged cell
- It had received bulk VEP (140 mm)
- Hydrogen degas (2h at 800C)
- 100nm oxypolish

ILC cavity A9 has surpassed the 35MV/m ILC specification

- It has been repaired by tumbling a single damaged cell
- It had received bulk VEP (140 mm)
- Hydrogen degas (2h at 800C)
- 100nm oxypolish

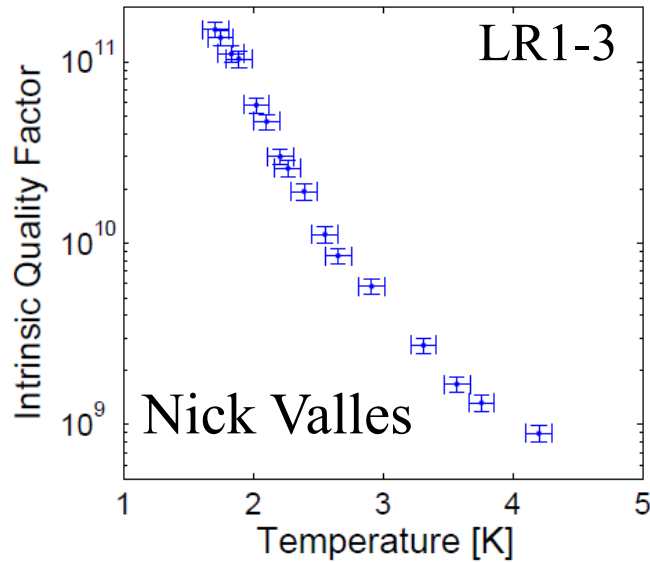
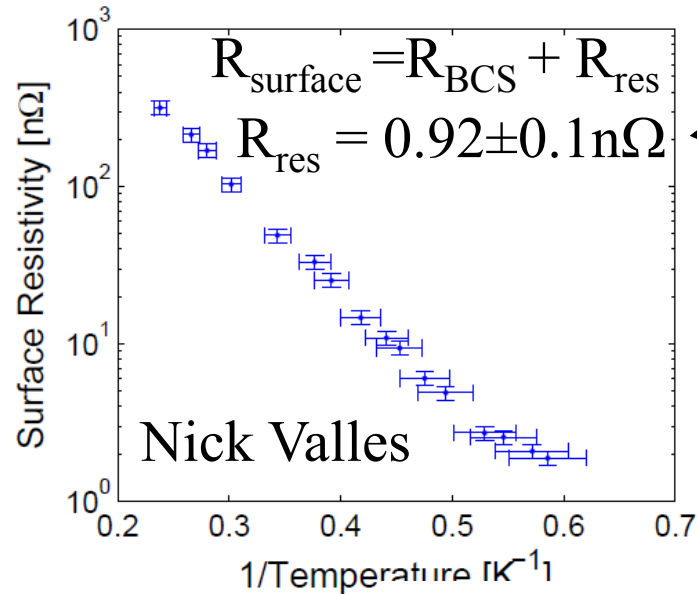
- Extremely low residual resistances
- CW field performance approaches theoretical limit

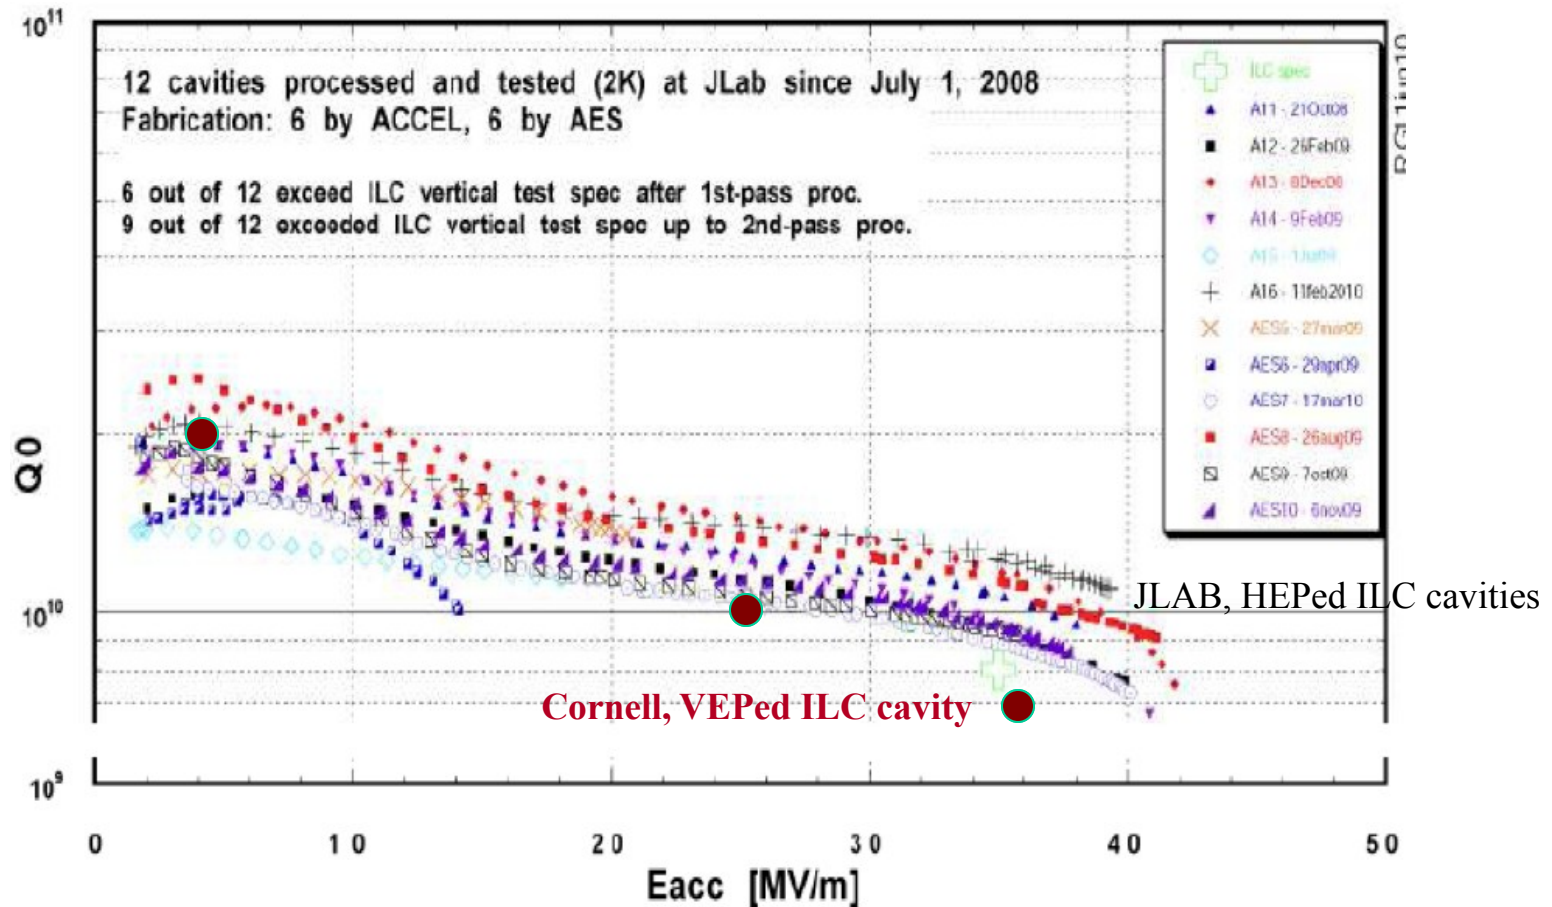
- ILC cavity A9 has achieved 36MV/m
- It had received bulk VEP (140 mm)
- Hydrogen degas (2h at 800C)
- 100nm oxypolish

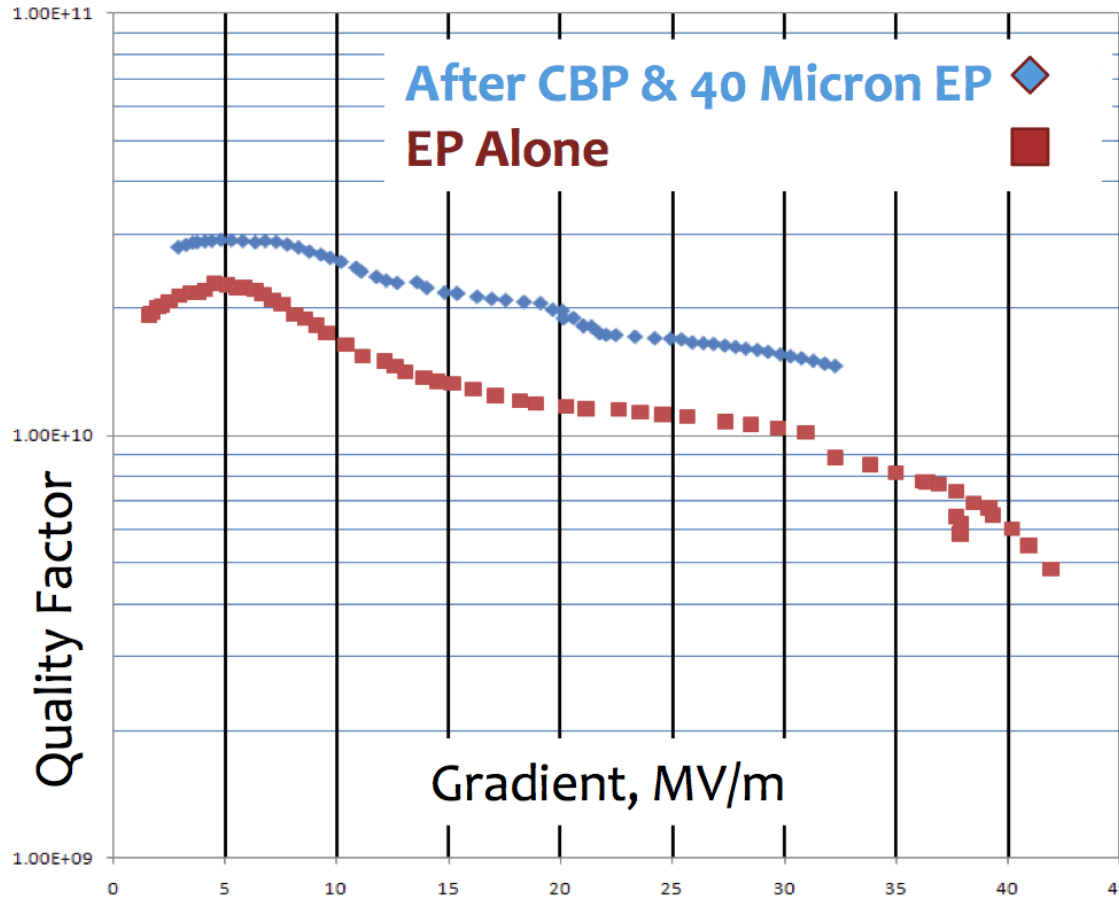
From TTC March 2011
presentation of Charlie Cooper

- Centrifugal Barrel Polishing (CBP) and EP have shown to increase Q0 in ILC cavity ACC001 at FNAL.
- Cornell has the same CBP machine as FNAL.
- VEP and CBP should bring cavities beyond the ILC specification for Q0

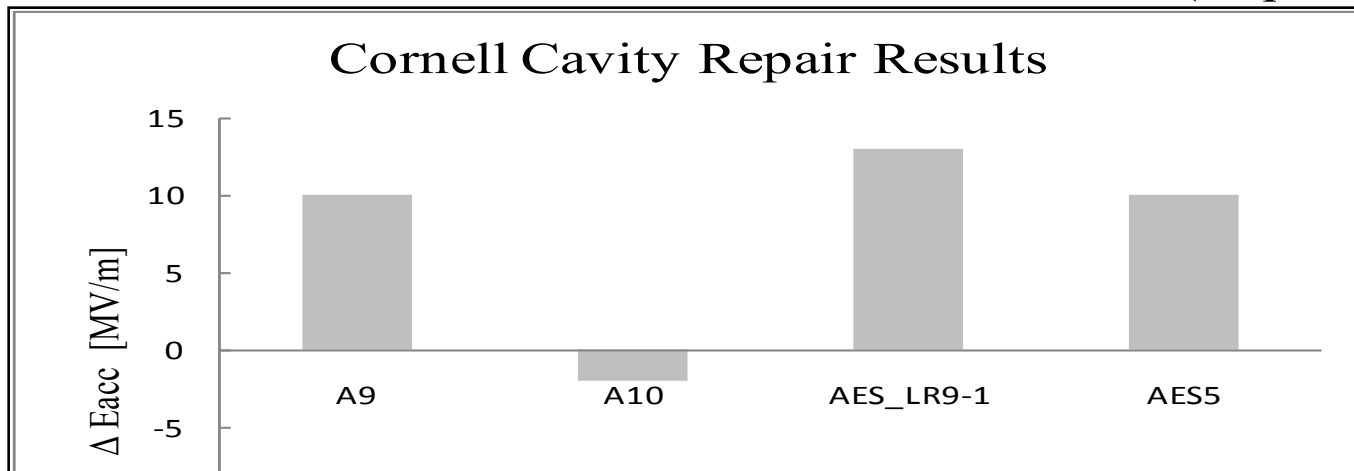
Cornell cavity repair: Tumbling and CBP

Original Limit	After Tumbling	Process
AES_LR9-1	15 MV/m	28 MV/m	all cells (pit removal)
AES5	21 MV/m	31 MV/m	1-cell (pit removal)
A9	26 MV/m	36 MV/m	1-cell (no pit visible)
A10	27 MV/m	25 MV/m	all cells (no pit visible)

Tumbling a cell that has a clear indication of a quench, while leaving other cells undisturbed, is a viable way of increasing cavity performance. This technique can be applied to both tumbling and centrifugal barrel polishing.
