S1-G Modules assembly status : Cryostat (20100518)

(Norihito Ohuchi)

S1-G Module assembly status

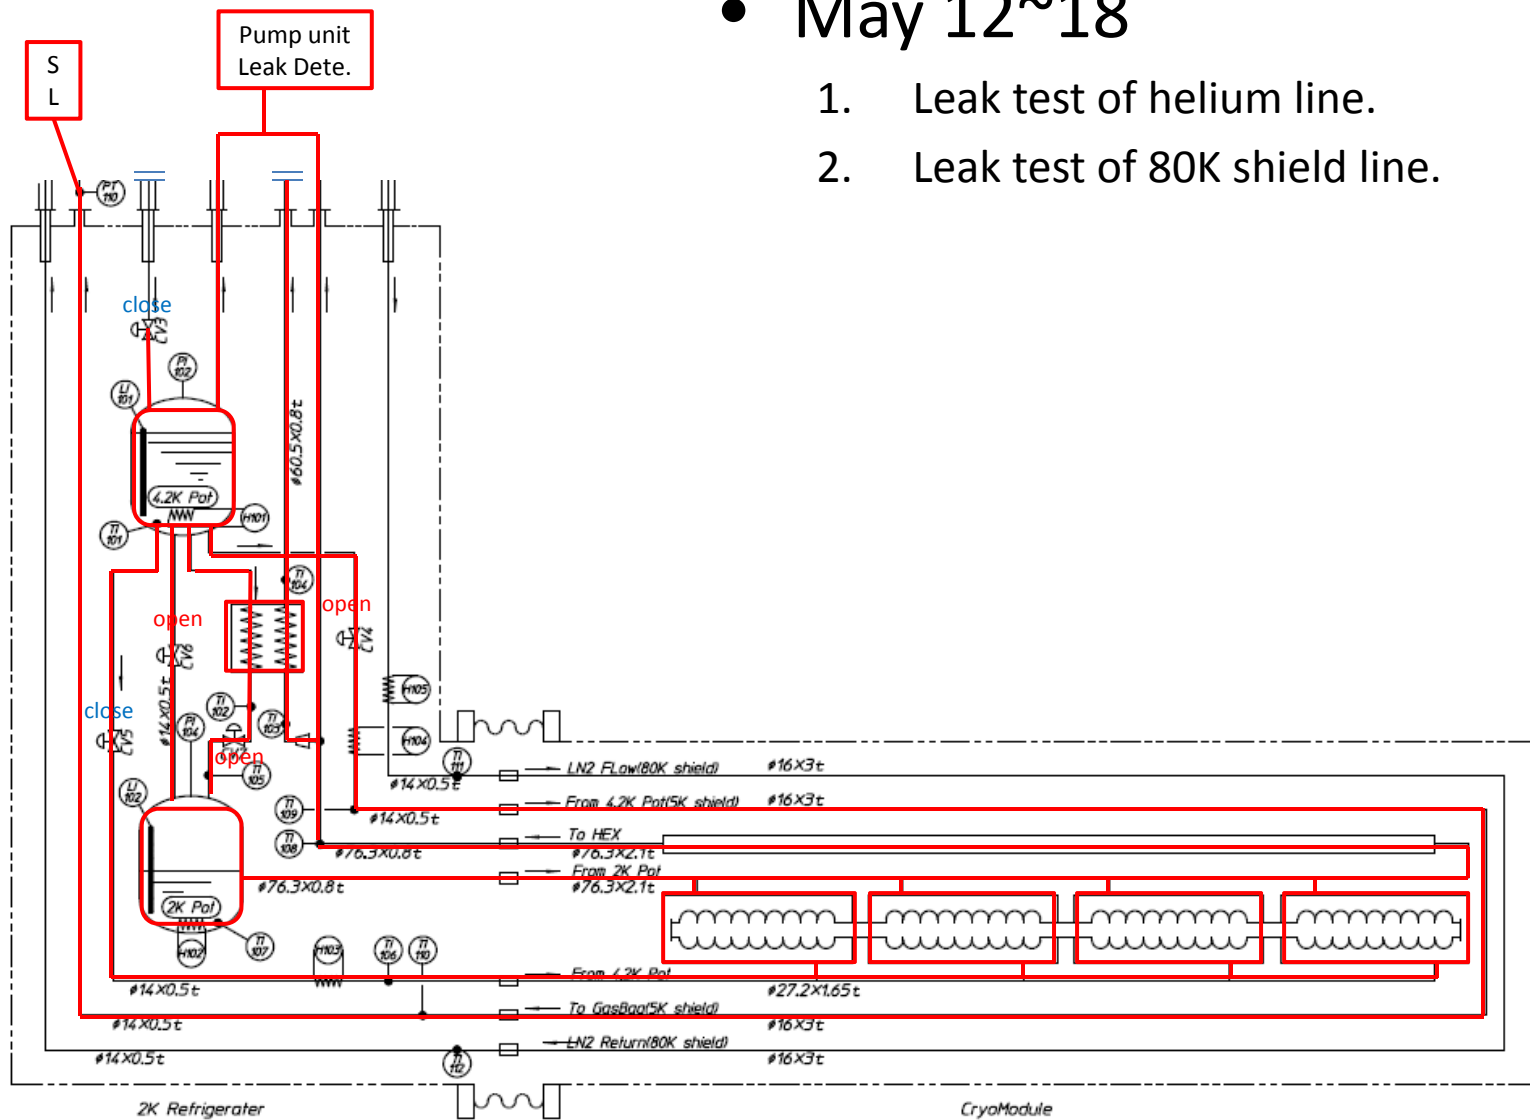
1. Leak test of helium line.
2. Leak test of 80K shield line.

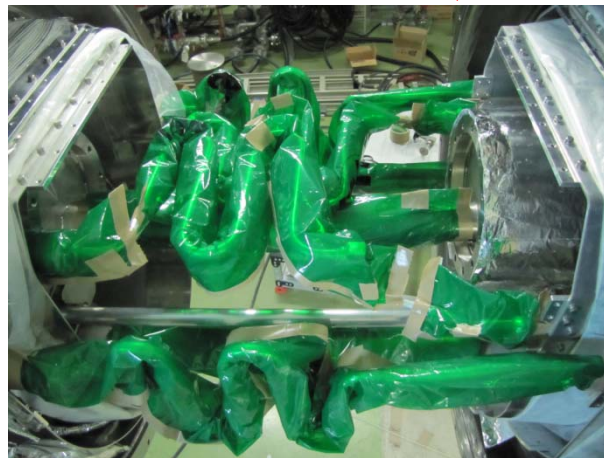
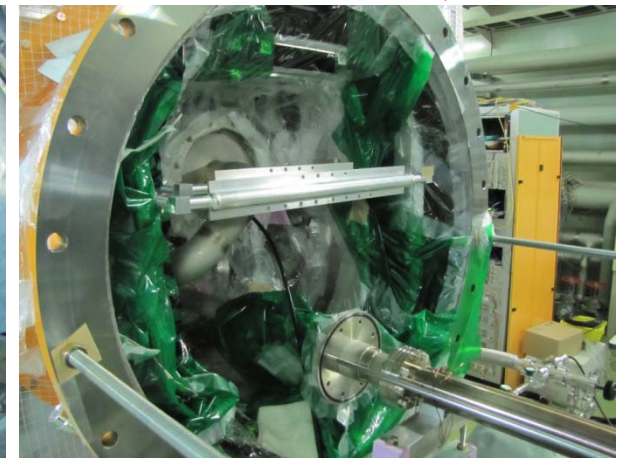
Welding positions

Helium line=24 positions

Nitrogen line=10 positions

Module-C

Module-A

Welding positions were covered with plastic bags.

- Gas in the helium lines was exchanged with N₂ gas 5 times.
- The helium lines were evacuated with turbo-molecular pump.
- The leak rate was confirmed with a standard leak, and the level of 10⁻¹¹ Pa · m³/s was confirmed.
- The allowable leak rate of the test was 1.3×10⁻¹⁰ Pa · m³/s.
- Helium gas was inserted into the gas bags.
- Holding the conditions for 30 minutes to check helium leak into the pipes.

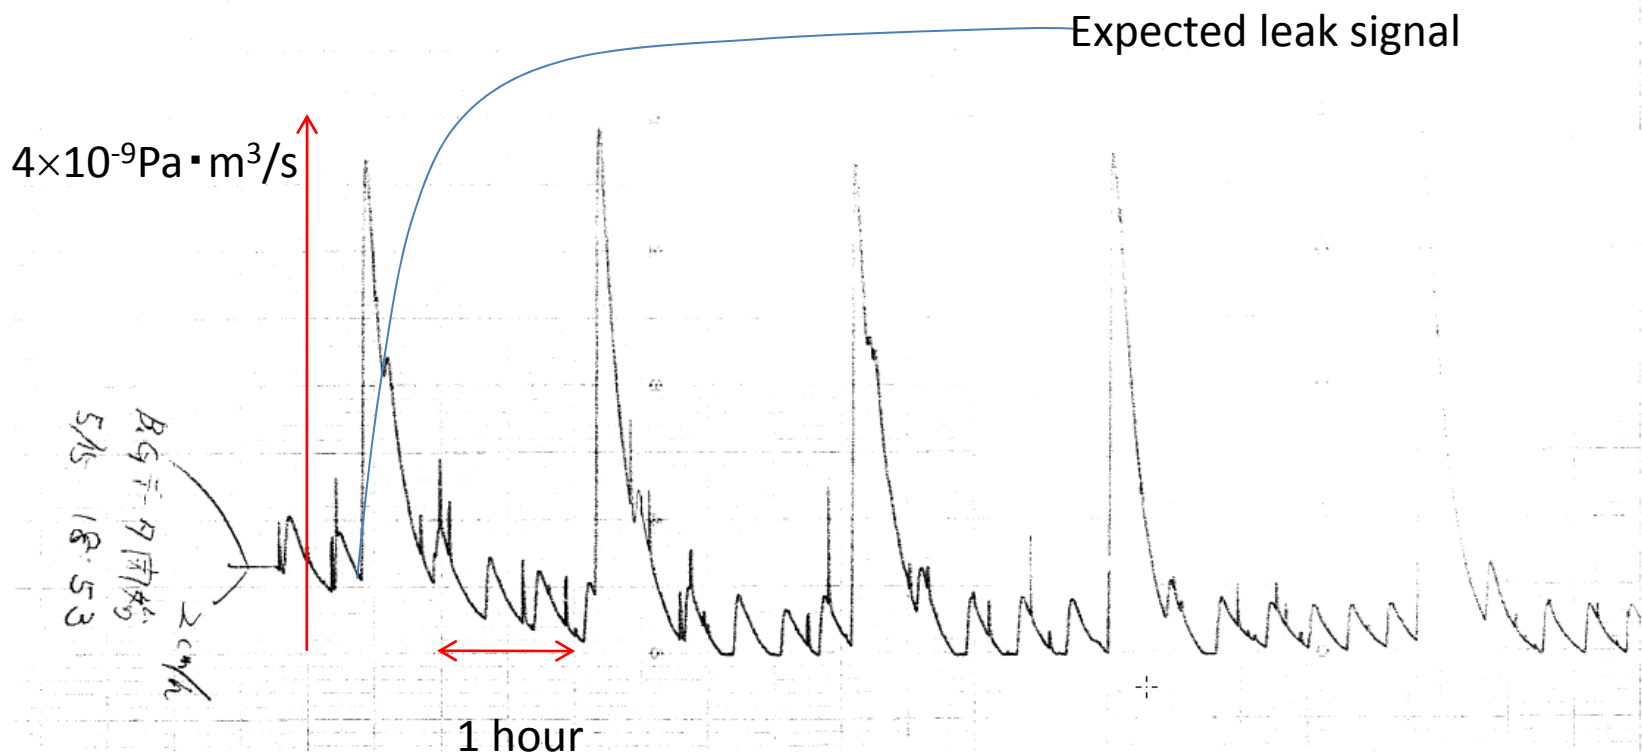
- During the leak tests, we measured periodic leak signal of $4 \times 10^{-9} \text{ Pa} \cdot \text{m}^3/\text{s}$. This signal was decreased spontaneously.
- The signals were observed without helium gas in the plastic bags.
- In the final leak test, we kept helium gas in the all plastic bags for 30 minutes. And we confirmed that there was no signal which continuously increased.
 - We judged that there is no external leak of the welded parts.
