New progress on BESIII-type RPC aging study

Changguo Lu
Princeton University

SiD Workshop, Oregon, 11/15-17, 2010

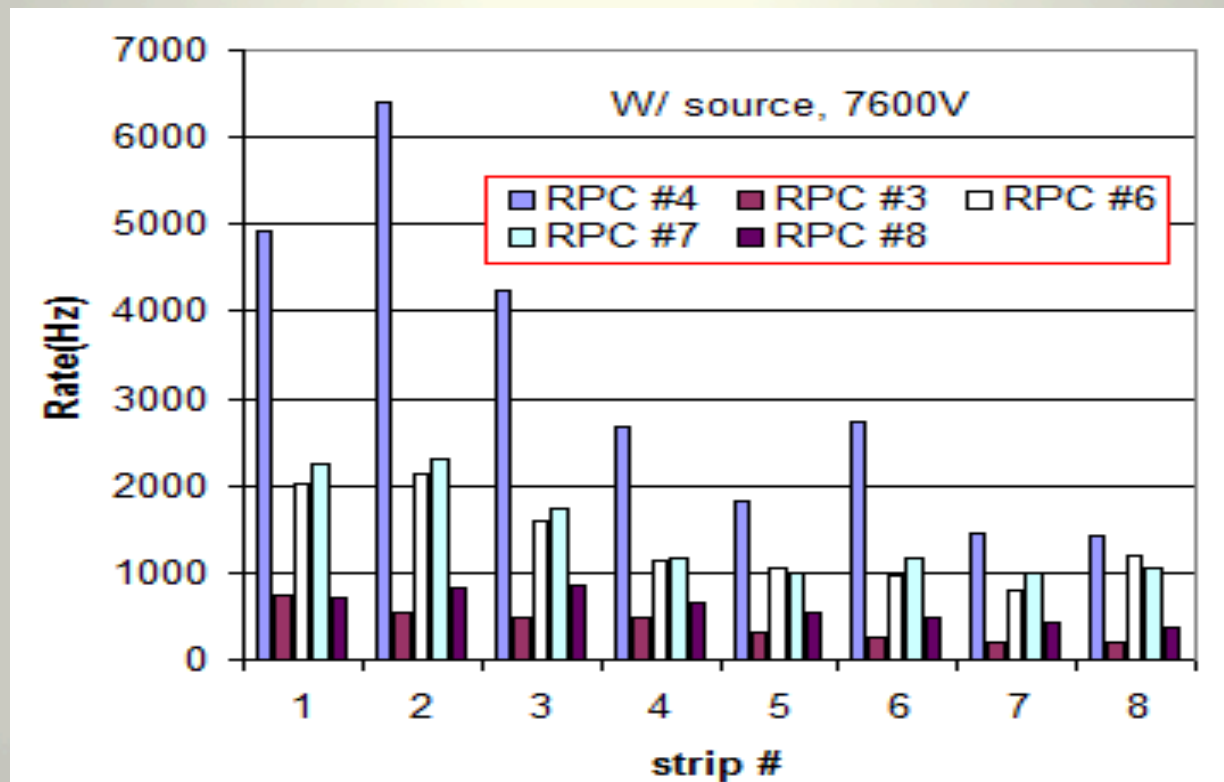
Aging test: Single's rate

Singles' rates w/ source are quite different for RPCs. RPC #4 is the noisiest, ~6kHz for strip #2. RPC #8 is the quietest, ~0.8kHz for strip #2.

Aging dose per day is different among these RPCs, their ratio is (#8): (#6, #7): (#4) ~ 1: 2.5: 7.5.

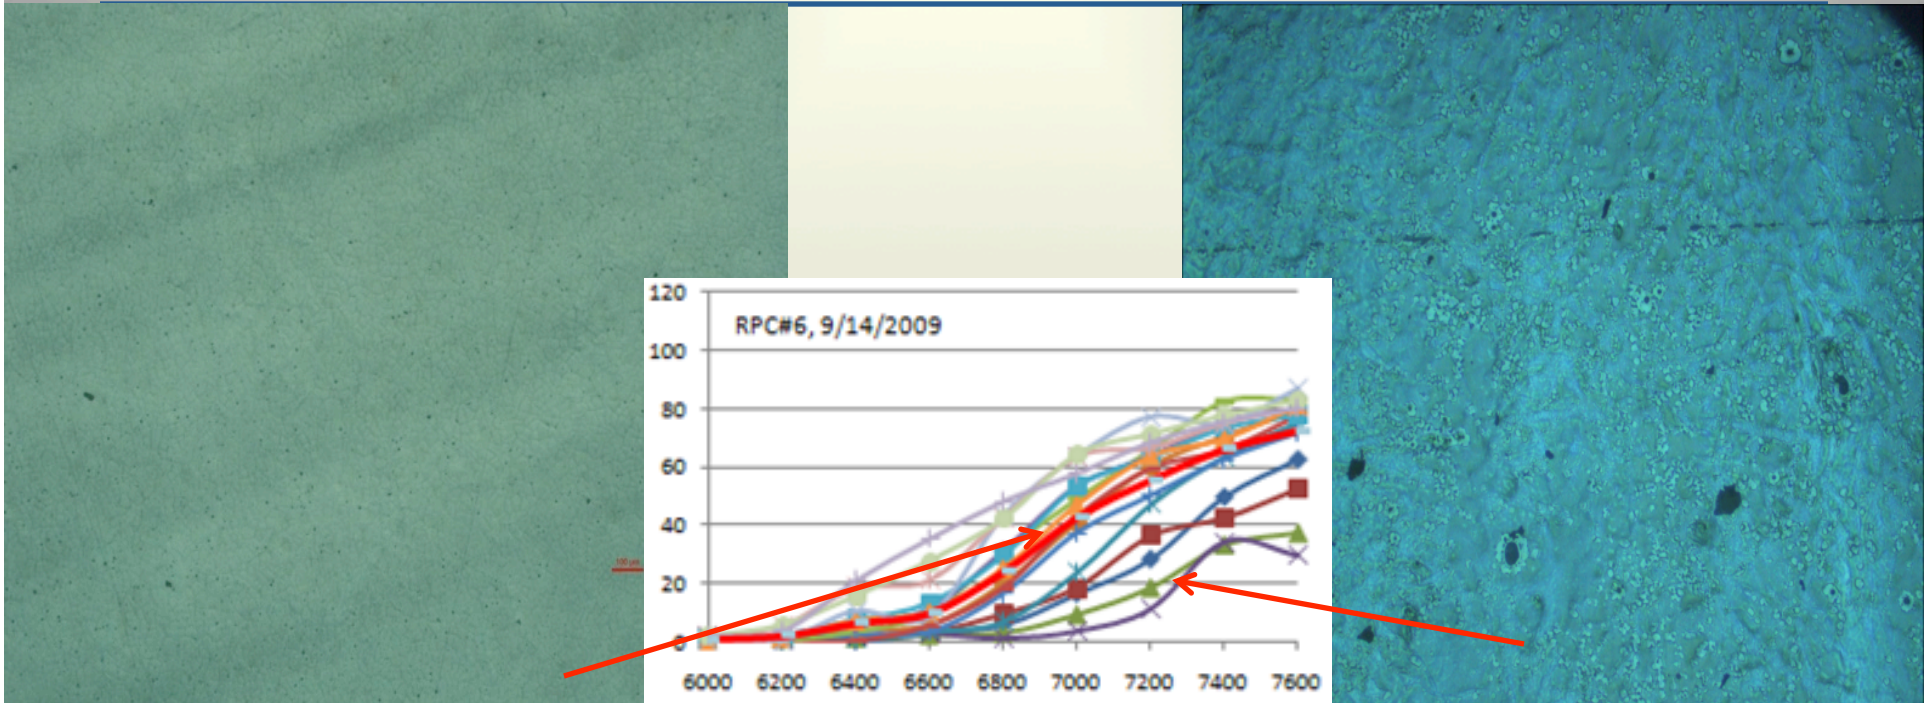
Two different areas in same aged RPC

RPC #6, area #8, less aged area.

RPC #6, area #4, severely aged area.

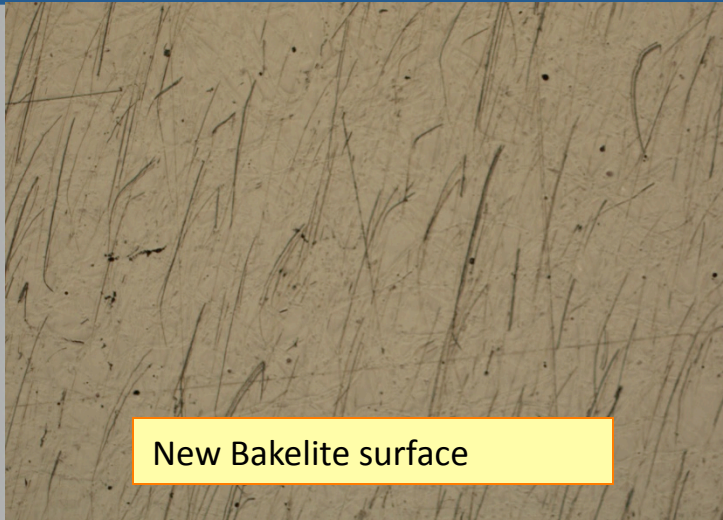
Microscopic images of the BaBar samples

Highly discolored area sample

Surface with the Linseed oil coating, the sample is from high intensity area, the Bakelite is highly discolored.

Compare two images we can clearly see the damage on Linseed oil coating. Actually the Bakelite substrate has not been etched by HF.

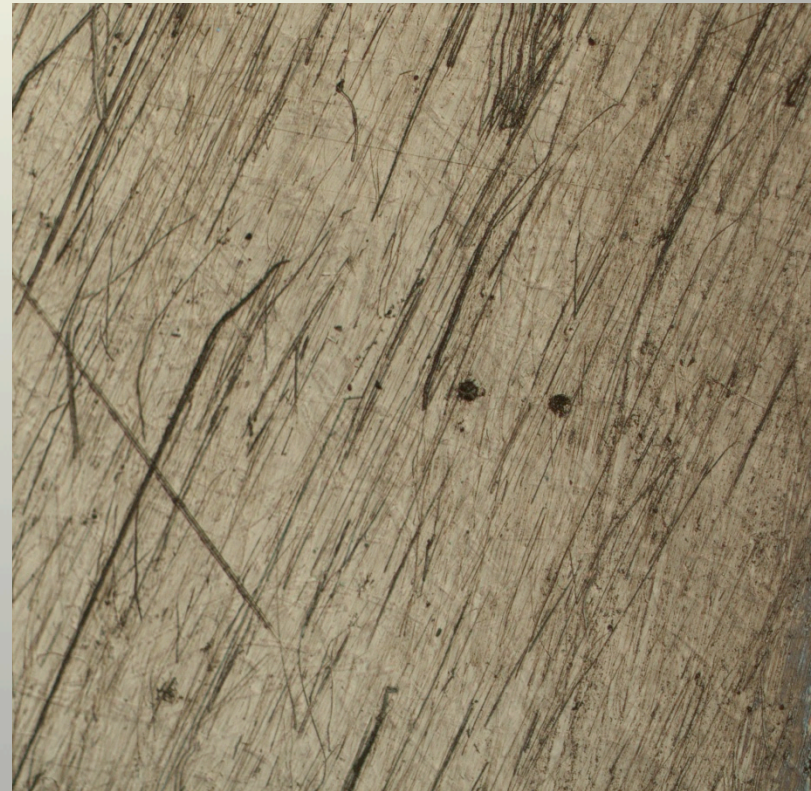
Same area, use ethanol wipe out the surface oil coating. The Bakelite substrate looks no damage.

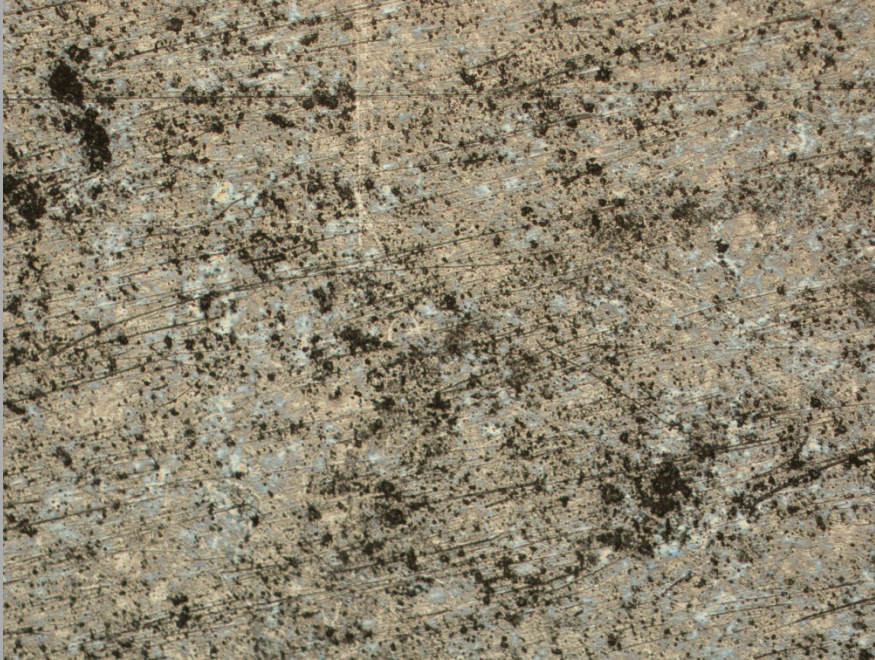
Surface with Linseed oil coating.

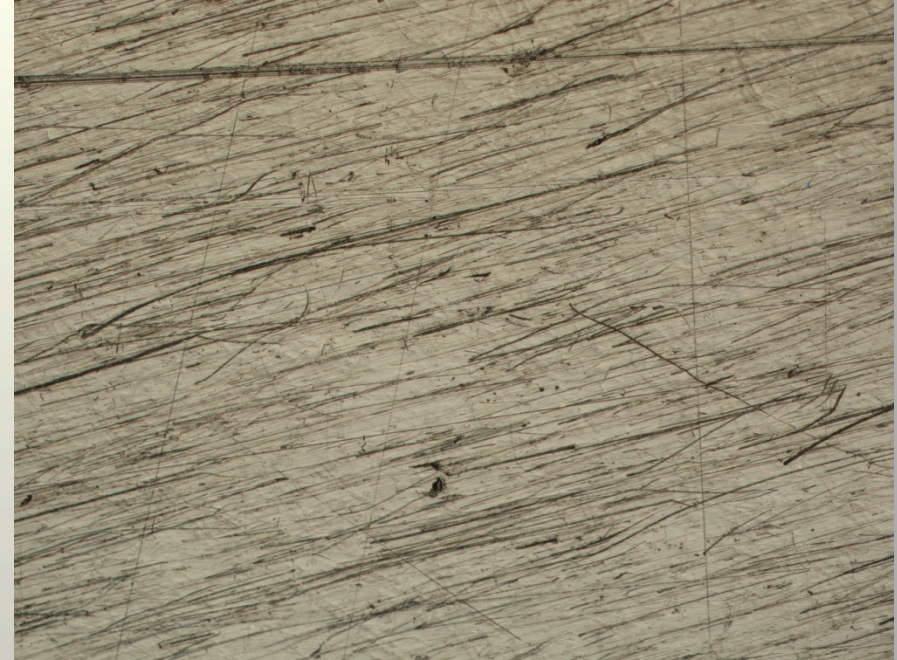
Same area Linseed oil coating has been removed by ethanol.

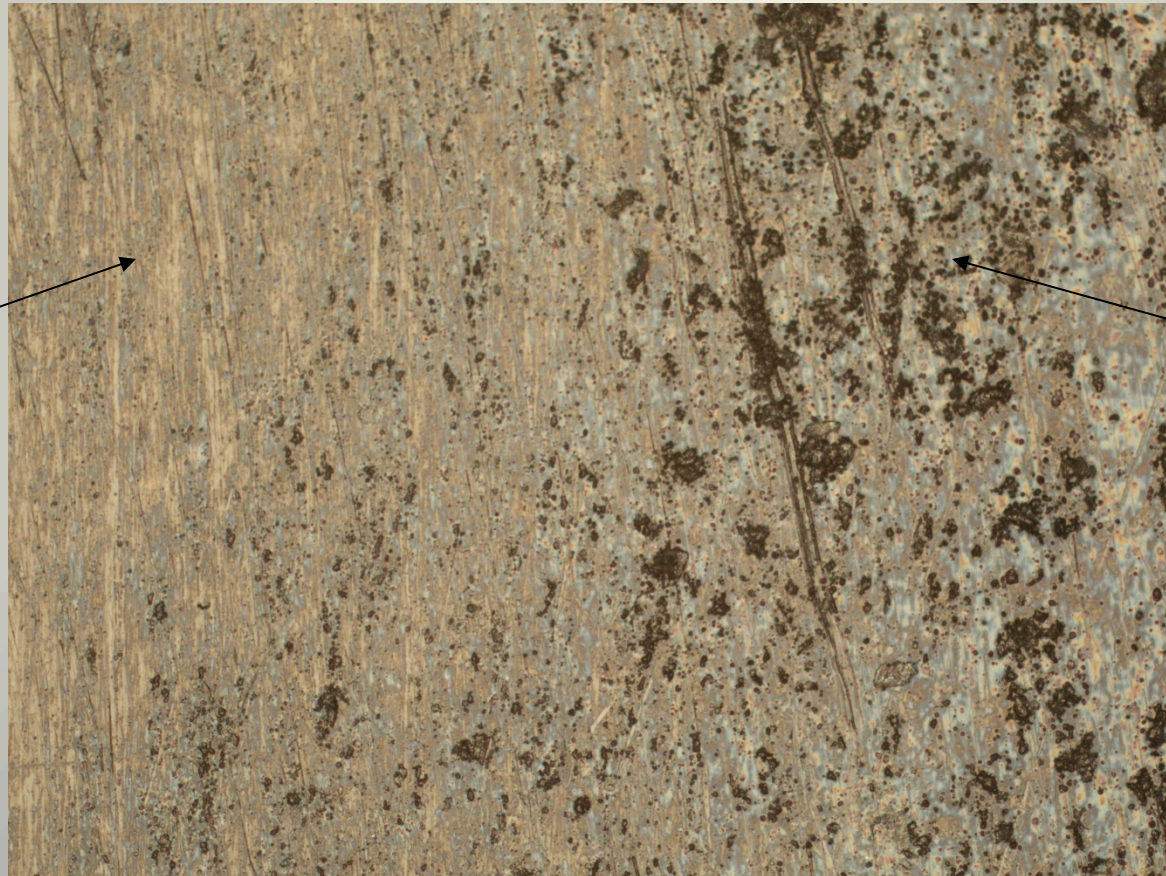
Less discolored area sample (cont'd)

Sample from low particle flux region:

Oil coating
removed
area

Oil coating
remained
area, the
dark spots
might be the
damaged oil
coating film.
