## Vacuum Seal R&D

LLNL-PRES-495331

# We are prototyping the rotating vacuum seal and the pulsed flux concentrating magnet

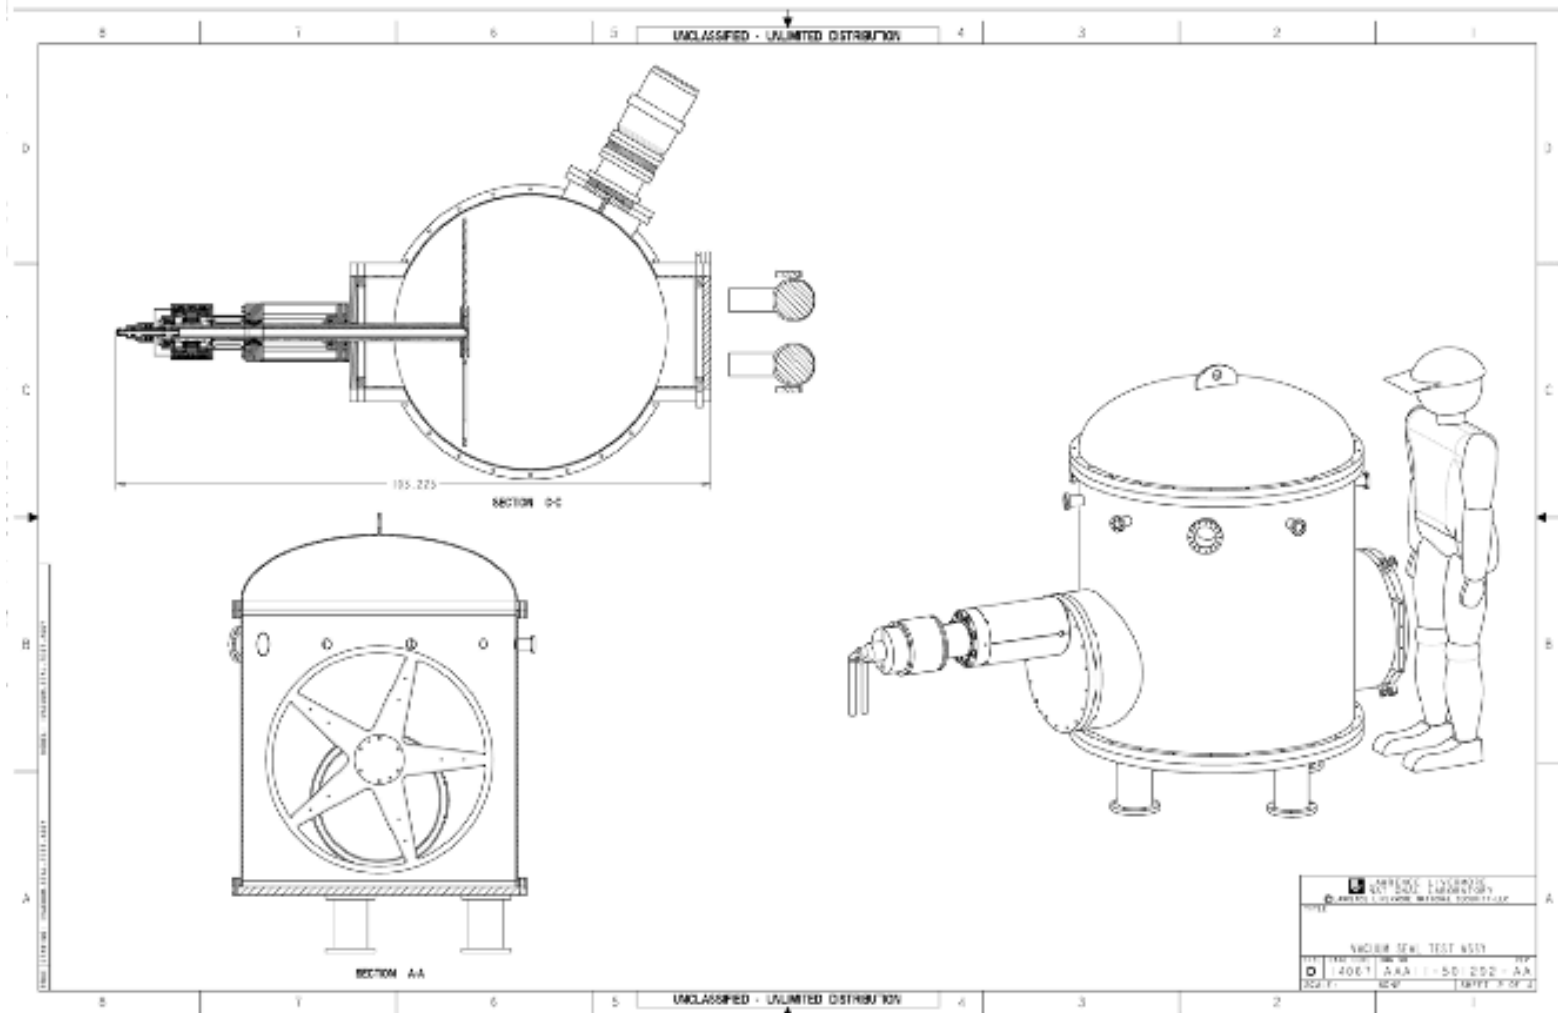
# We have acquired a vacuum tank large enough to accommodate the full size wheel

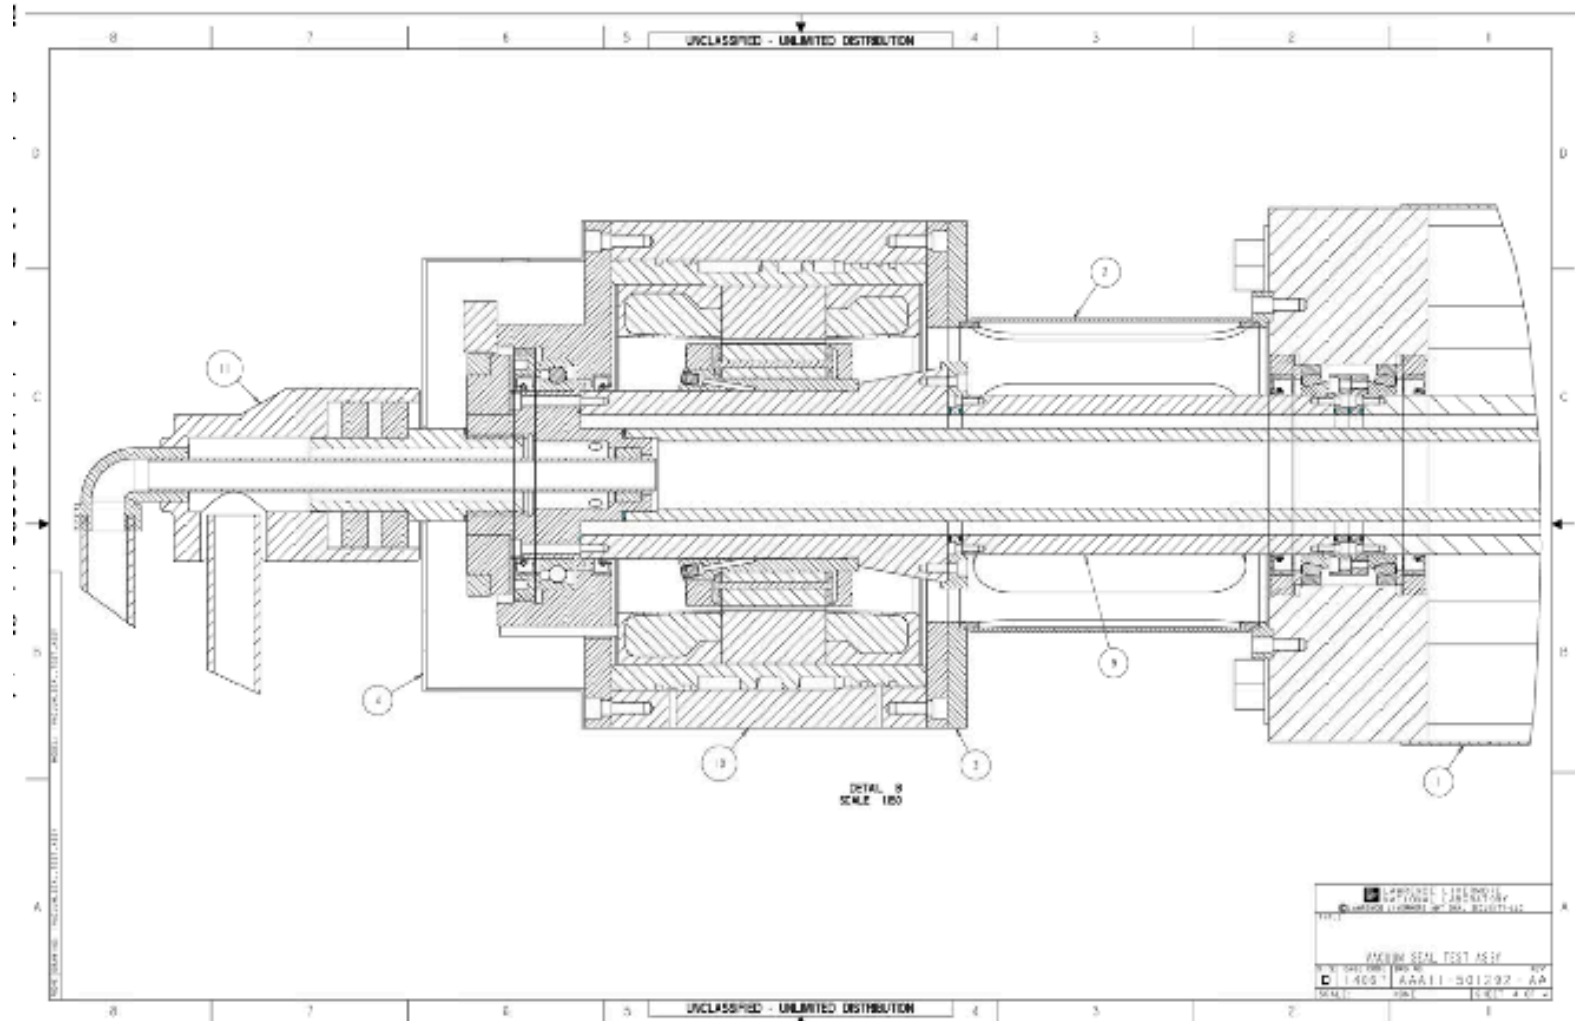
# Drive motor and rotating cooling water coupling will mount directly on the shaft

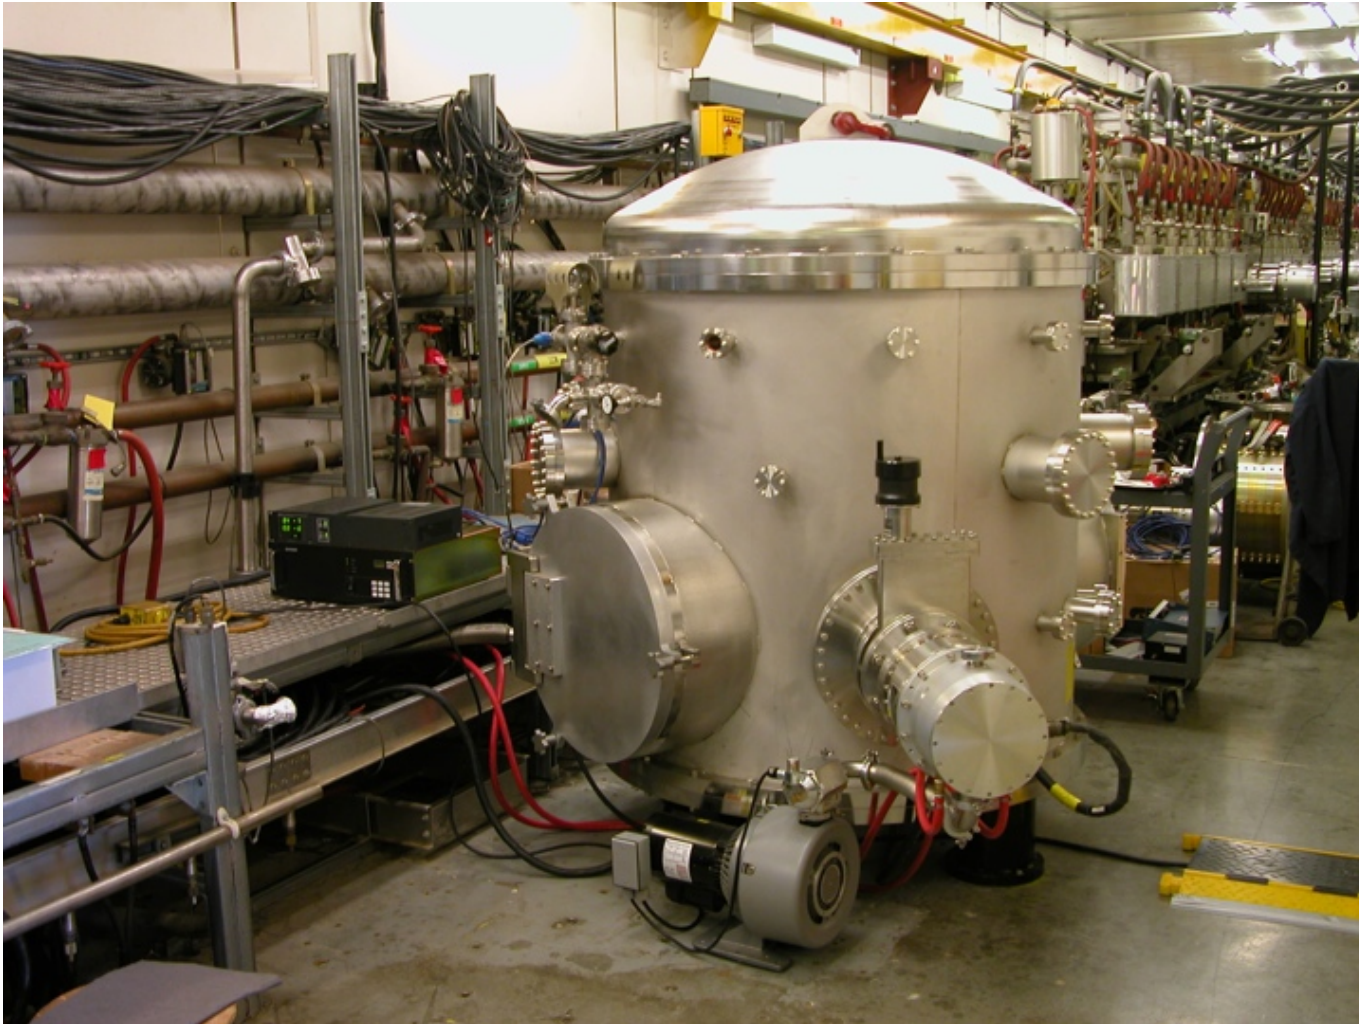
# The vacuum tank is setup and under vacuum

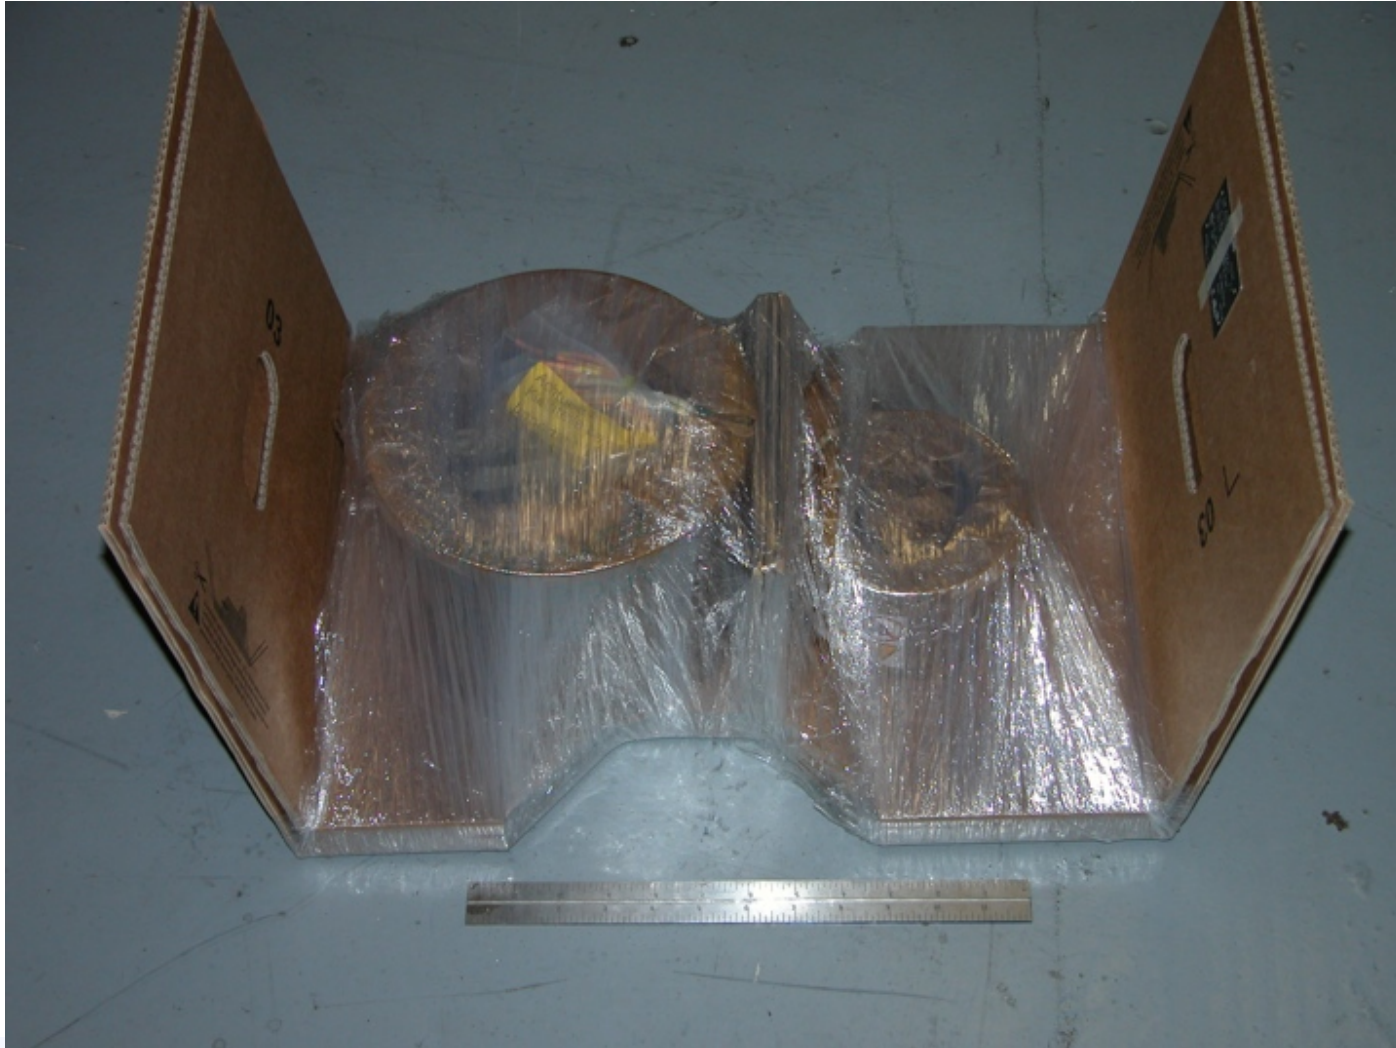
# Siemens hollow shaft motor is ready for mounting

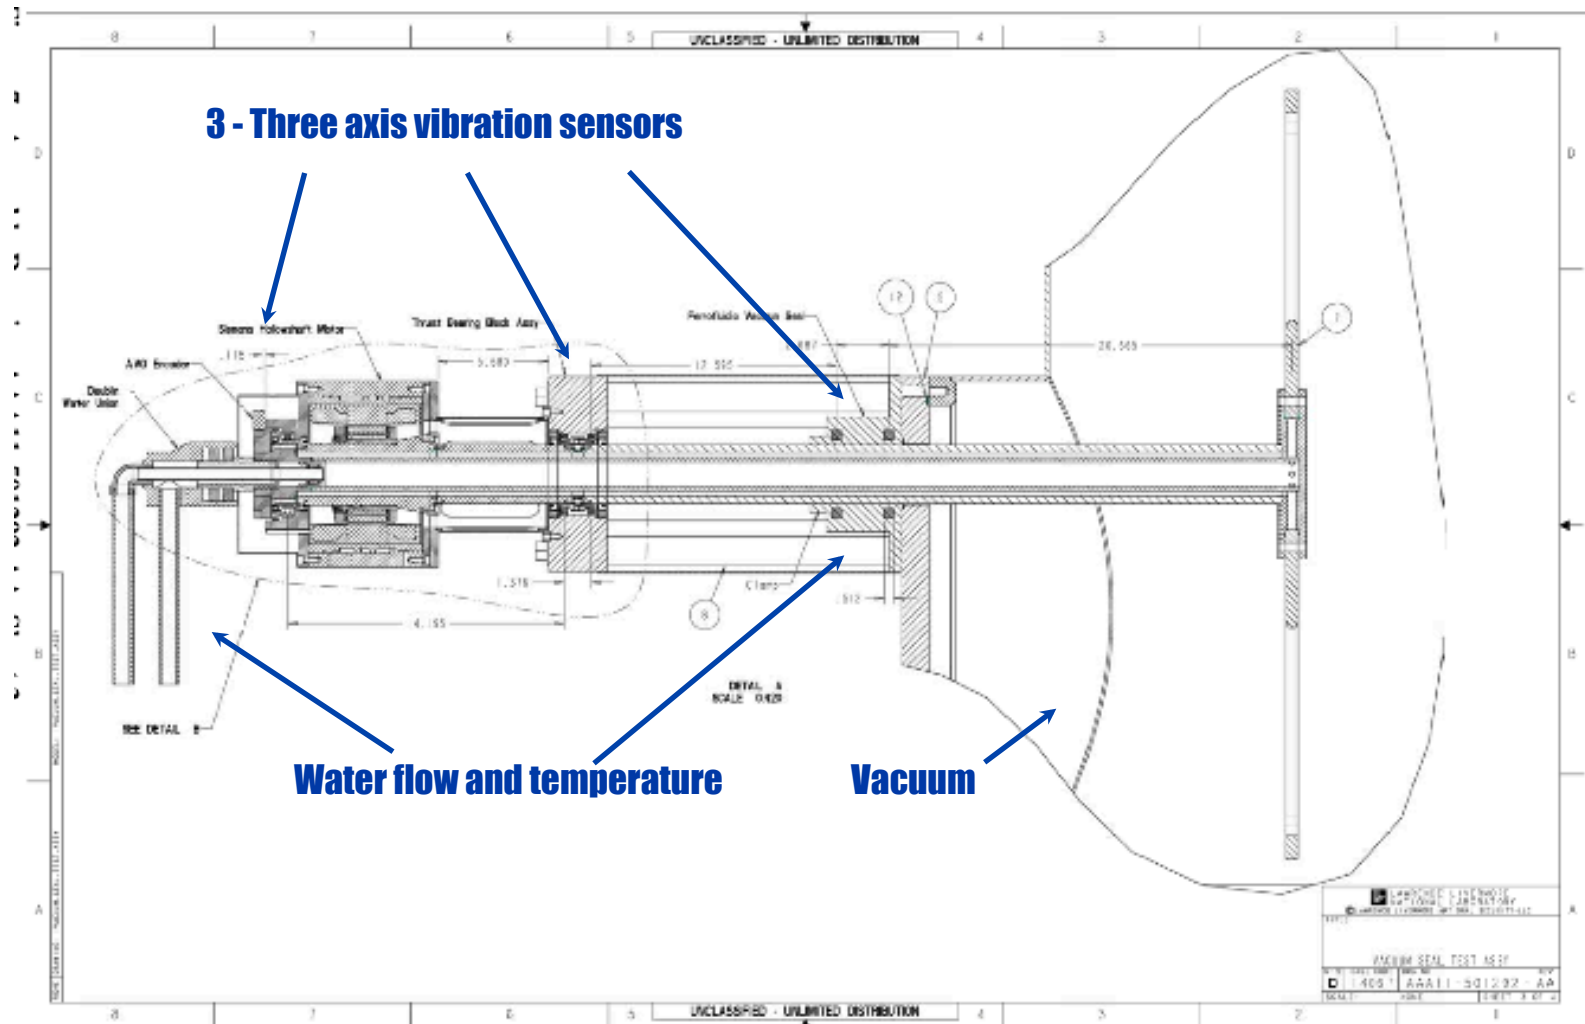
# The shaft will be constantly monitored during operation

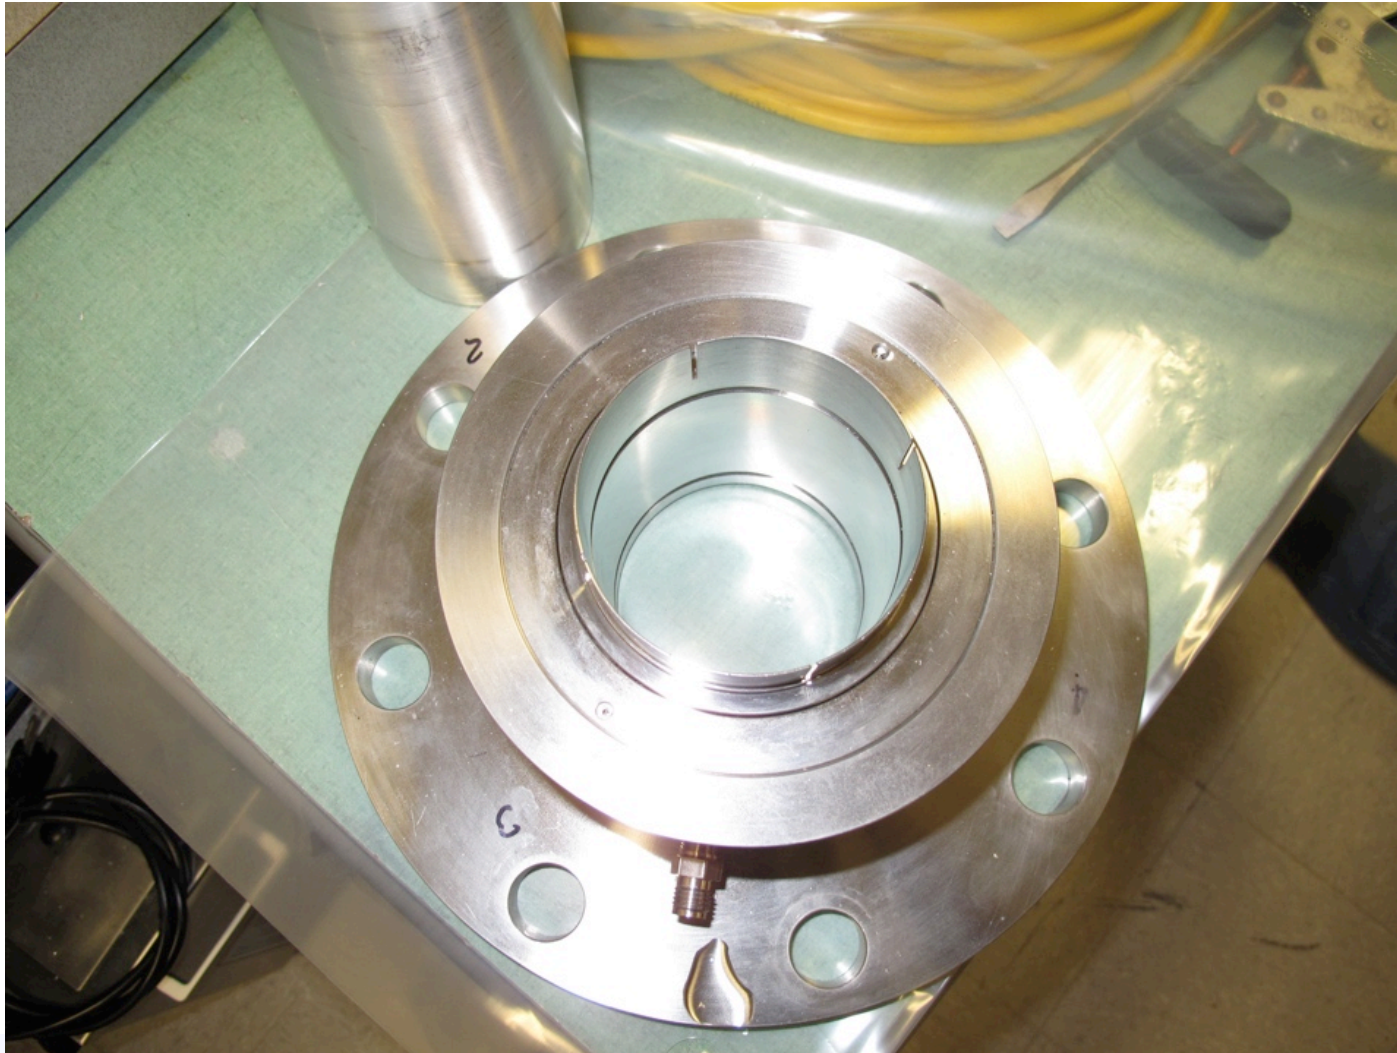
# We have begun initial vacuum testing of the Rigaku Ferrofluidic Seal in a separate test stand

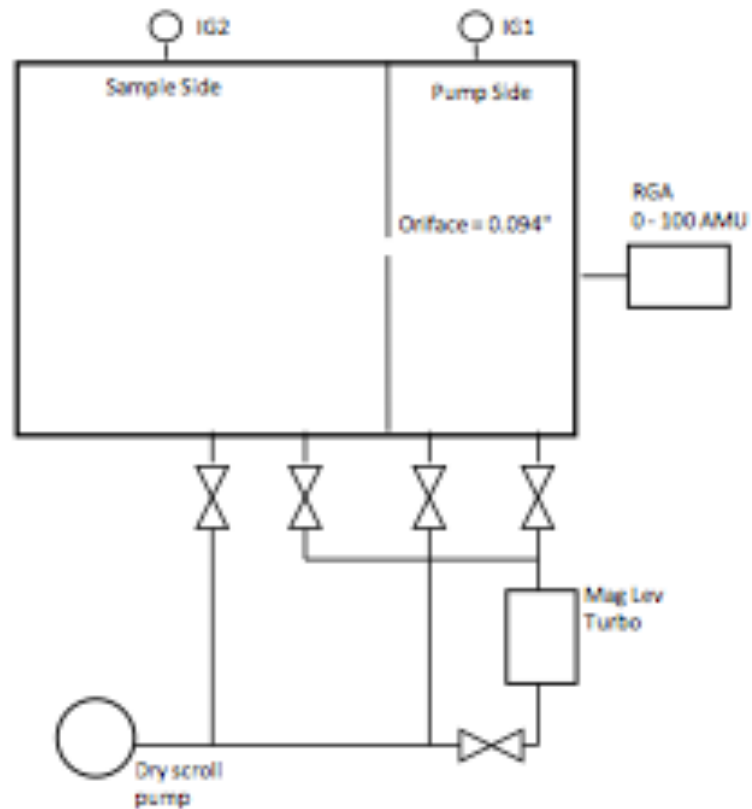
## Vacuum Sciences and Engineering Lab Outgassing Measurement Test Stand

# We have an existing outgassing test stand that we have modified to test the Rigaku seal

Sample Side Volume = 216 Cu. in.  
Sample Side Surface Area = 5,575 cm<sup>2</sup>  
Conductance = 0.52 L/s for air at 20C  
 $Q = C(P_{IG2} - P_{IG1})$

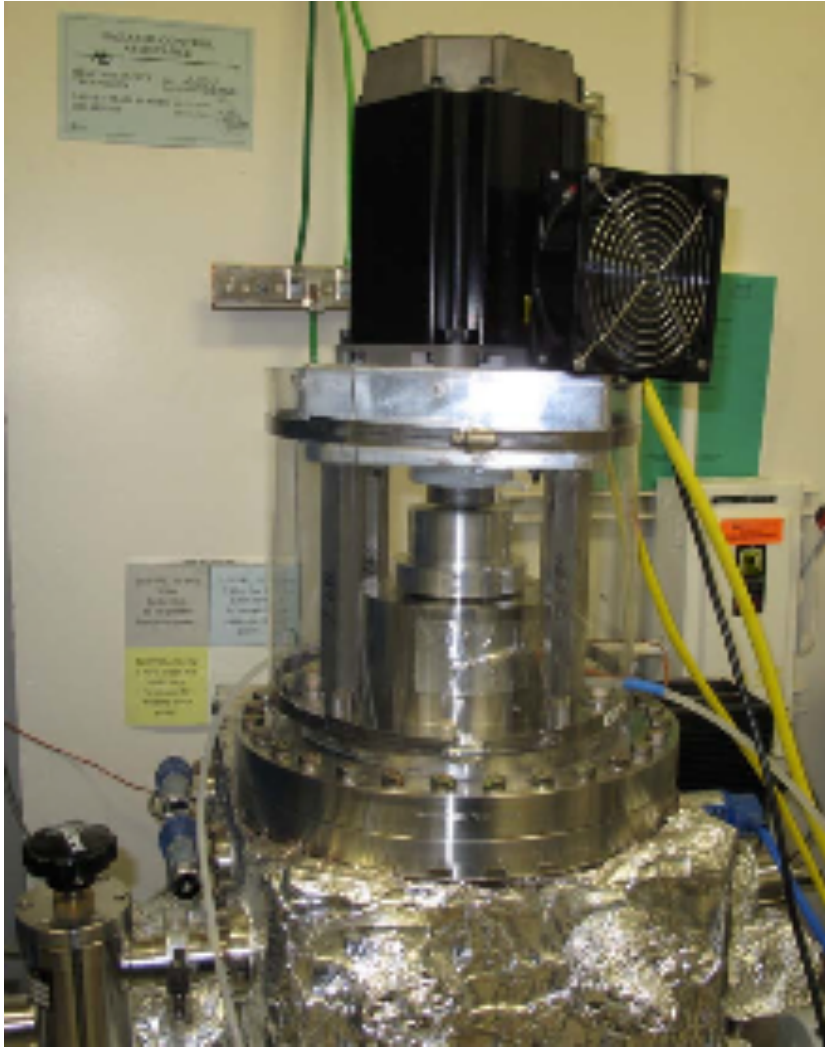
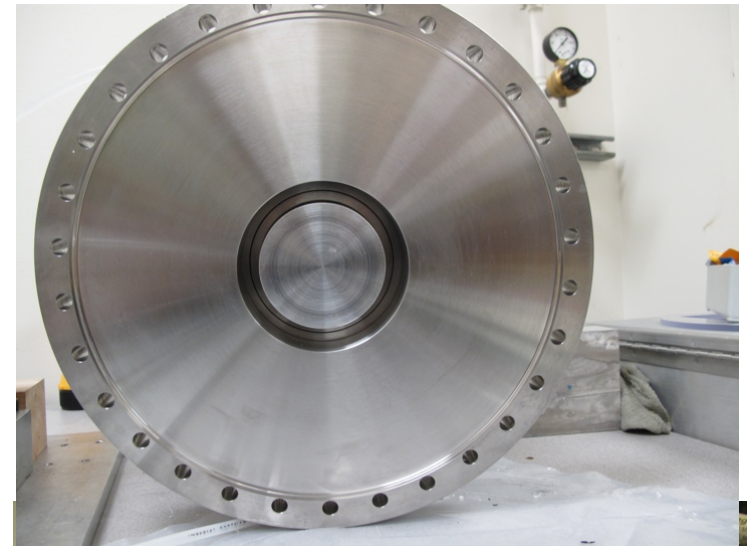
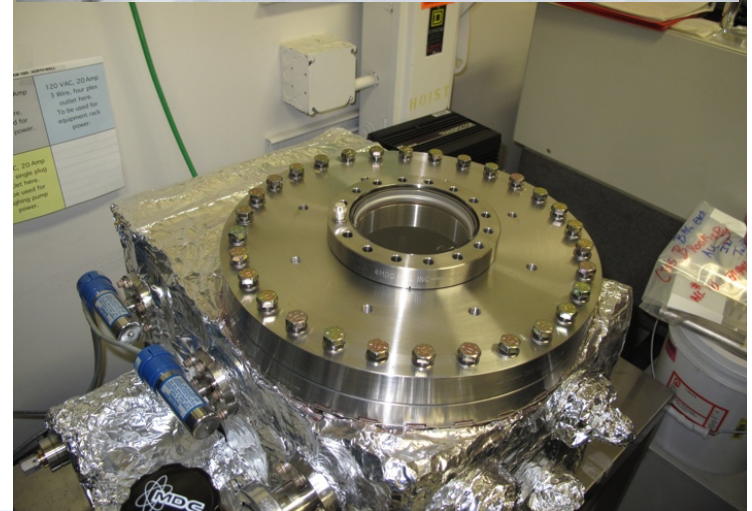
# The test stand allows us to rotate the seal up to 2000 RPM with pressure and outgassing measurements

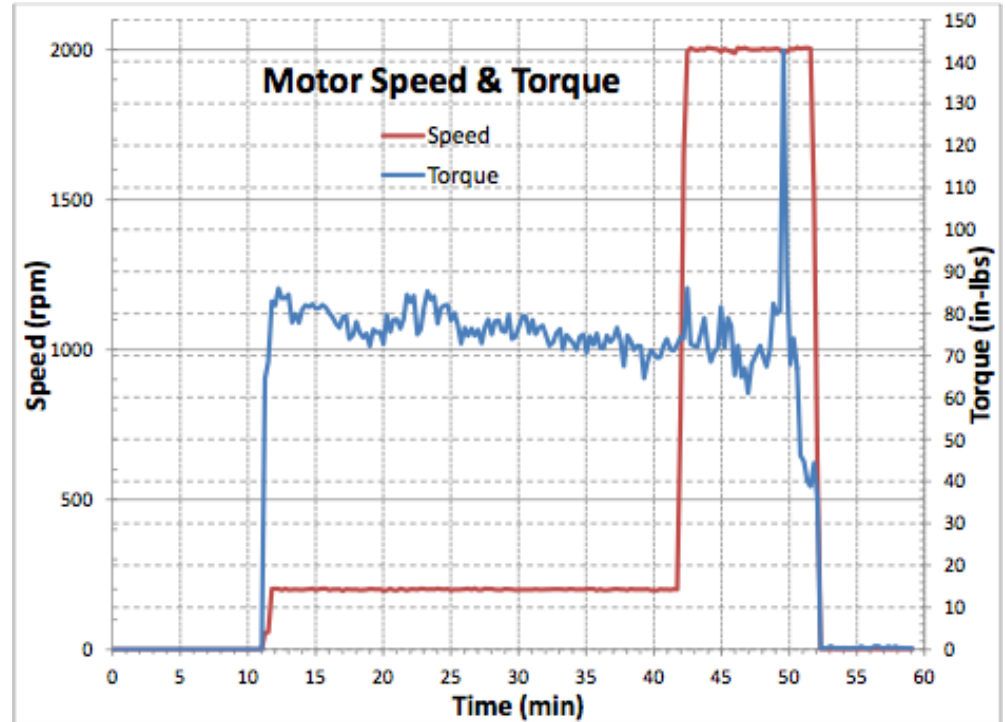
# October 3rd we did our first full test of the Rigaku seal

Scan #	Time	Time	Speed	
	H:M:S	min	rpm	Comments
1	10:32	0	0	started data recording
17	10:35	3	0	took full RGA Scan
20	10:36	4	0	took full RGA Scan
40	10:41	9.2	0	took full RGA Scan
43	10:42	10.2	0	took full RGA Scan
47	10:43	11.2	200	
123	11:03	30.5	200	took full RGA Scan
162	11:13	40.5	200	took full RGA Scan
168	11:14	42	2000	
191	11:20	48	2000	took full RGA Scan
197	11:22	49.6	2000	Torque ramped up & vacuum leak occurred
208	11:24	52.3	0	Stopped motor
235	11:31	59.1	0	Ended data recording

... and we killed it.

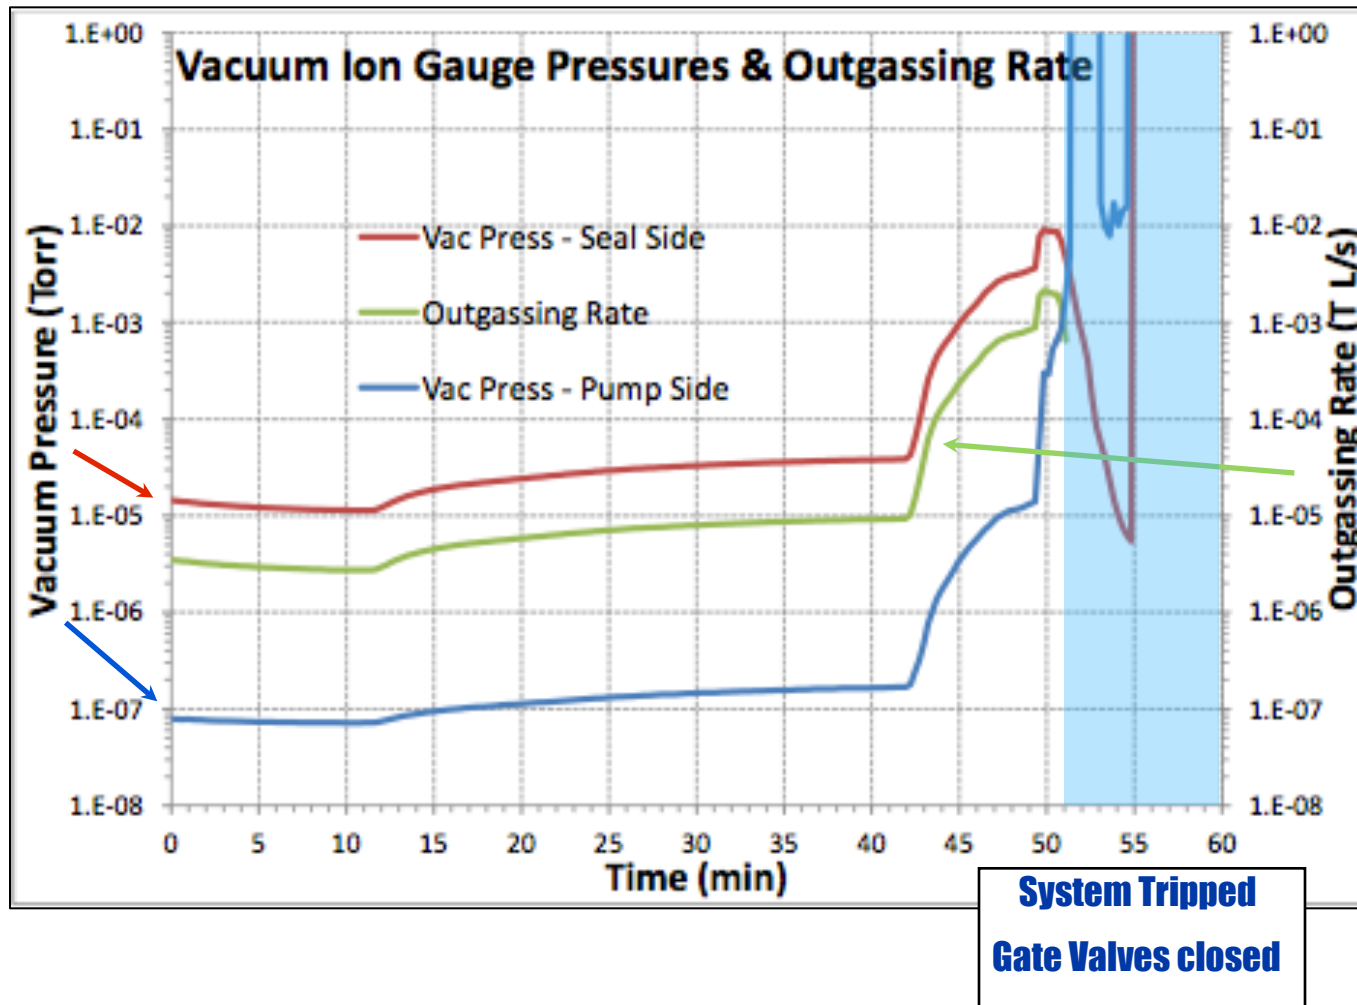
# Outgassing looked like it was stabilizing when the seal failed

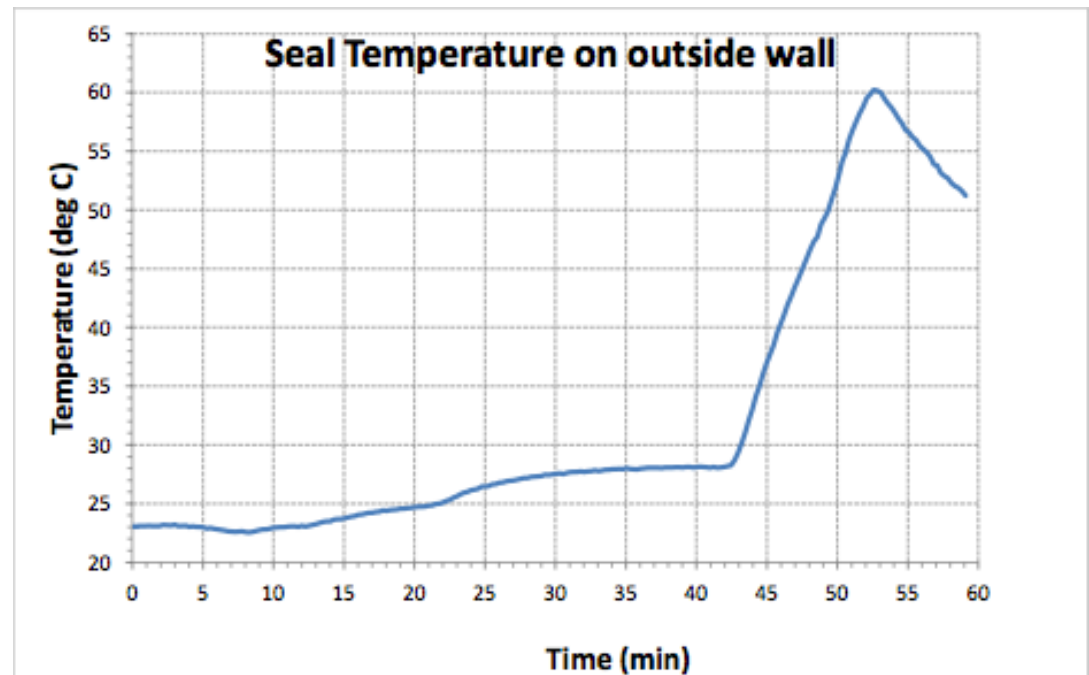
# Temperature data showed no sign of plateauing

- Rigaku reports running at 55 °C without problems
- Temperature was still rising when we turned it off

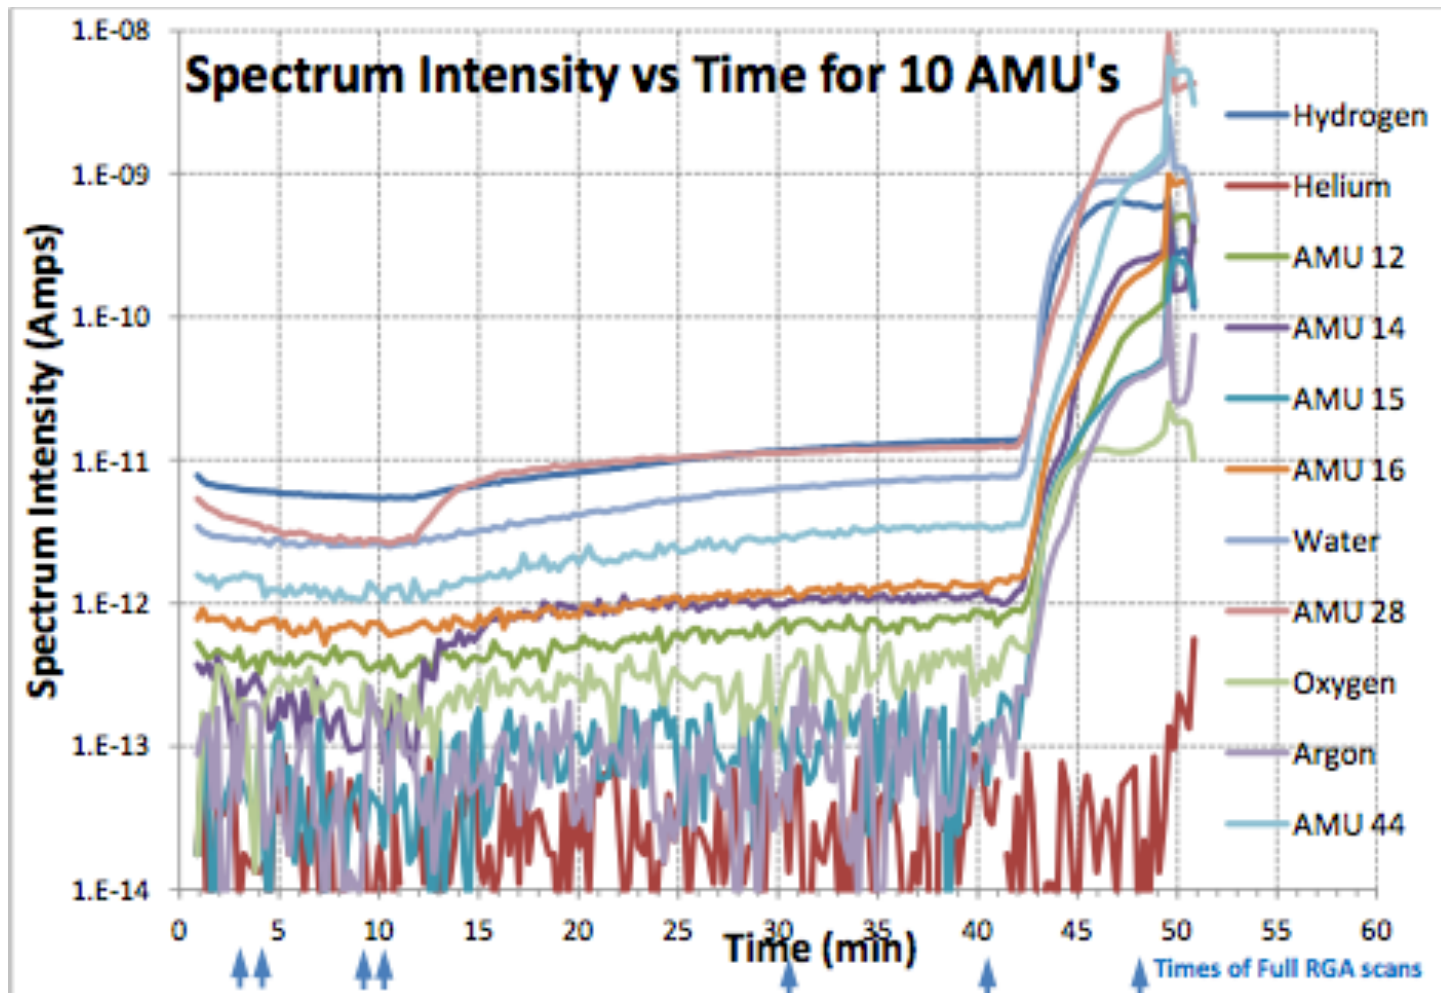
# Residual Gas Analyzer output showed a spike

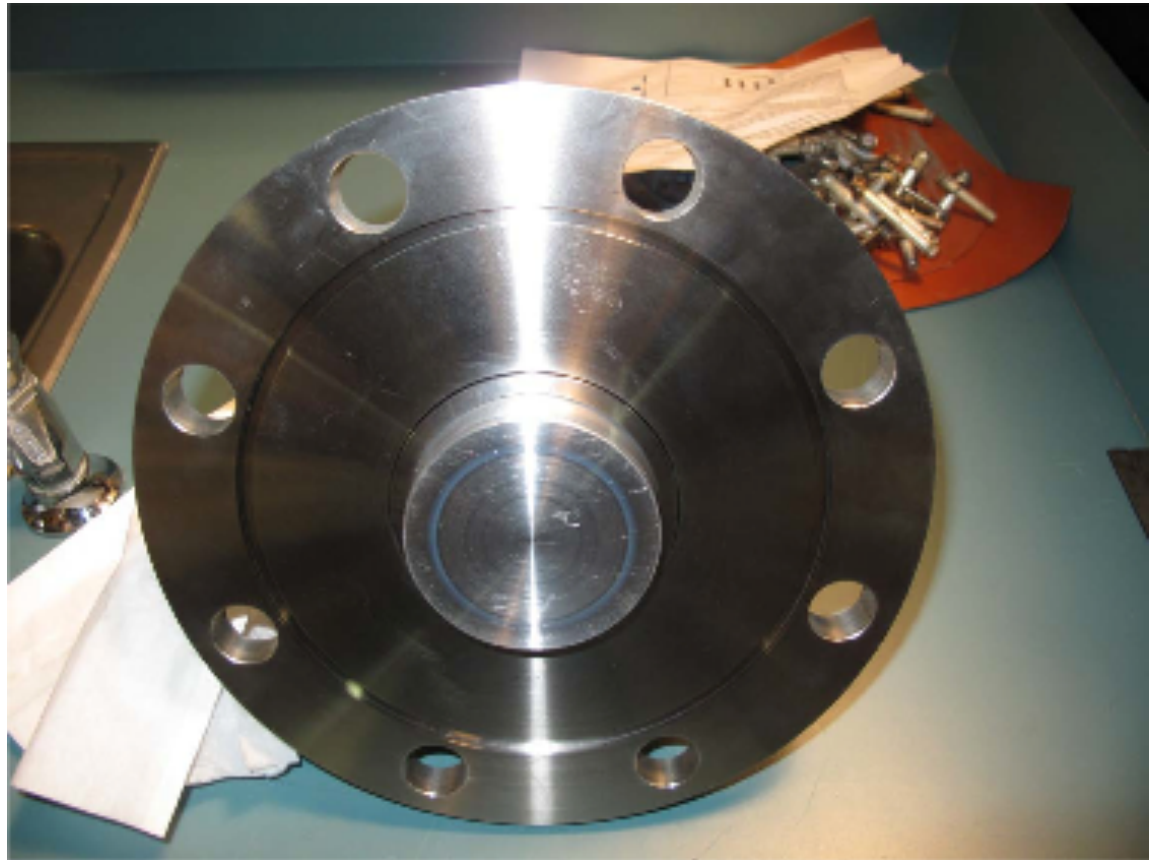
# Seal inspected after failure

- No visual signs of failure or residue
- No signs of residue inside the chamber

- Both Ferrotech and Rigaku assert that these seals should run at 2000 RPM as long as there is cooling water flow
- We are acquiring a plug compatible replacement from Ferrotech
- The Rigaku seal will be returned to Rigaku for post-mortem and repair
- We will continue with assembly of the prototype shaft
  - but we will wait to mount the new seal until after it runs successfully on the test stand

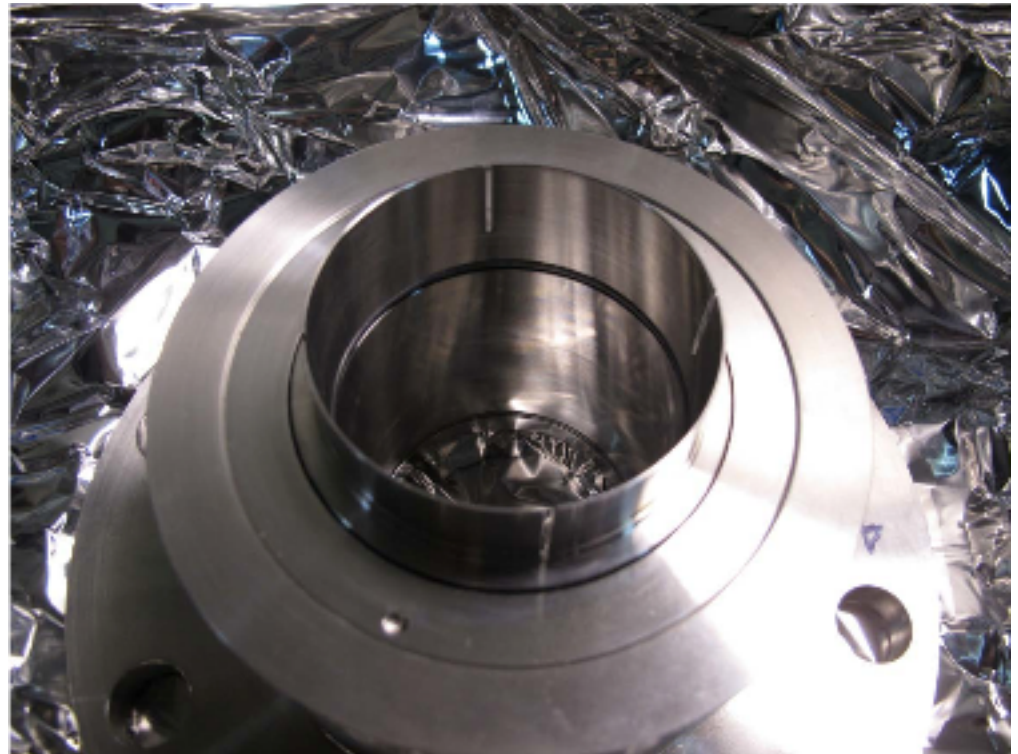
# Checked whether there was a problem on the shaft seal

- O-rings were good.
- No sign of slipping
- No indication of any problem here

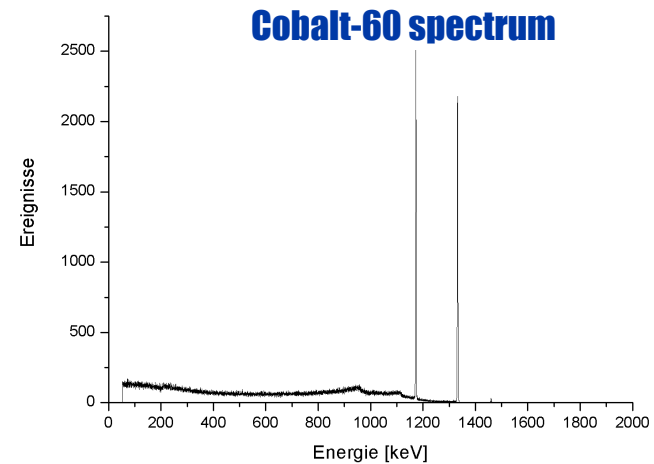
# Possible Radiation Damage Testing using the Test Stand

- Ferrofluid is an oil with suspended magnetic particles
- Radiation damage is a concern
- Cobalt-60 Irradiation facilities exist
  - Only  $de/dx$
  - Below photoneutron threshold – no activation

- Propose to acquire second seal for destructive testing
- Facilities exist that can provide 300kGy/hour
