ATF2 Laserwire update Oct – Dec 2011

L. Corner, L.J. Nevay, R. Walczak, JAI, Oxford

ATF2 project meeting 11th Jan 2012

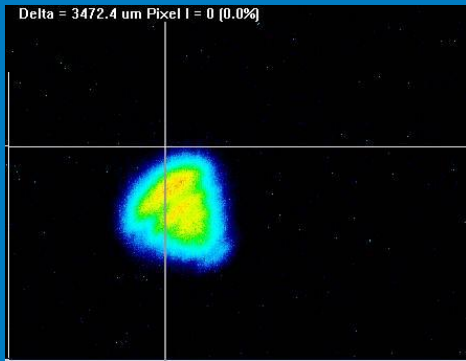
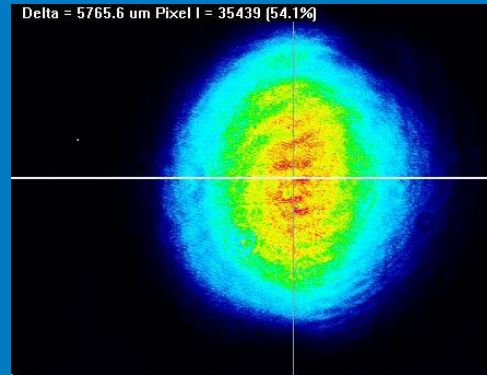
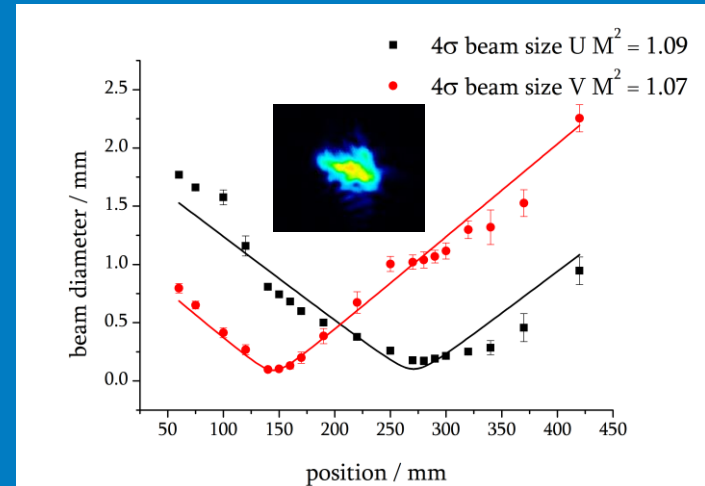
- M^2 at test IP in laser lab 1.07/1.09 – cf. previous measurements of ~ 2 .
- Reduces beam size at focus by factor of 2.
- This measurement is scaled version of LWIP focus – predicts $\sigma_{IV} = 0.8\mu\text{m}$.
- Laser energy in green up to 220mJ – fine for experiments.
- Telescope in lab fitted with actuator for remote control of laser beam size on final focus lens.

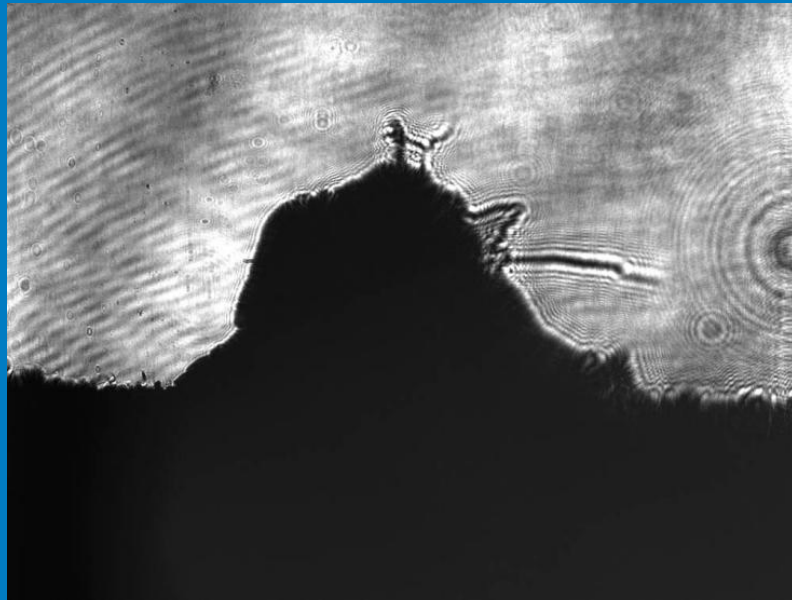
OTR screen illuminated with alignment laser showing notch

- Background $\sim 1V$ on detector (cf 500mV last year).
- Alignment procedures – temporal: overlap signal from attenuated laser pulse and OTR from screen near beam on post-IP APD as before.
- Spatial alignment: notch in OTR screen and wire scanner detector used to find position of beam $\sim \pm 50\mu\text{m}$ horizontally and vertically.
- Larger horizontal beam size at this location means vertical position harder to find ($\sim \pm 10\mu\text{m}$ at previous location).
- Several vertical scans performed at different horizontal positions – no signal.
- Upstream IPBPM scanned across full mover range – no effect on background.
- LWIP- detector alignment problem?

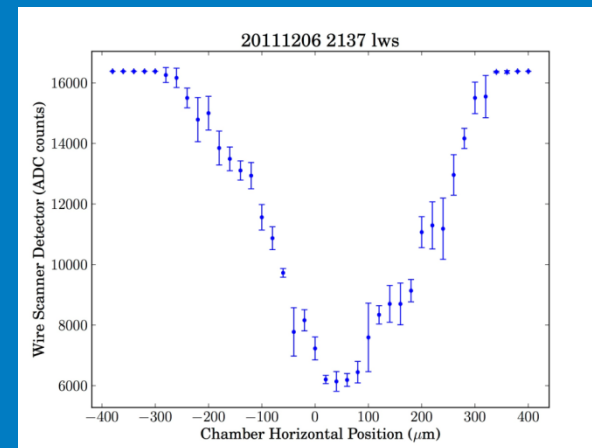
Horizontal scan of chamber

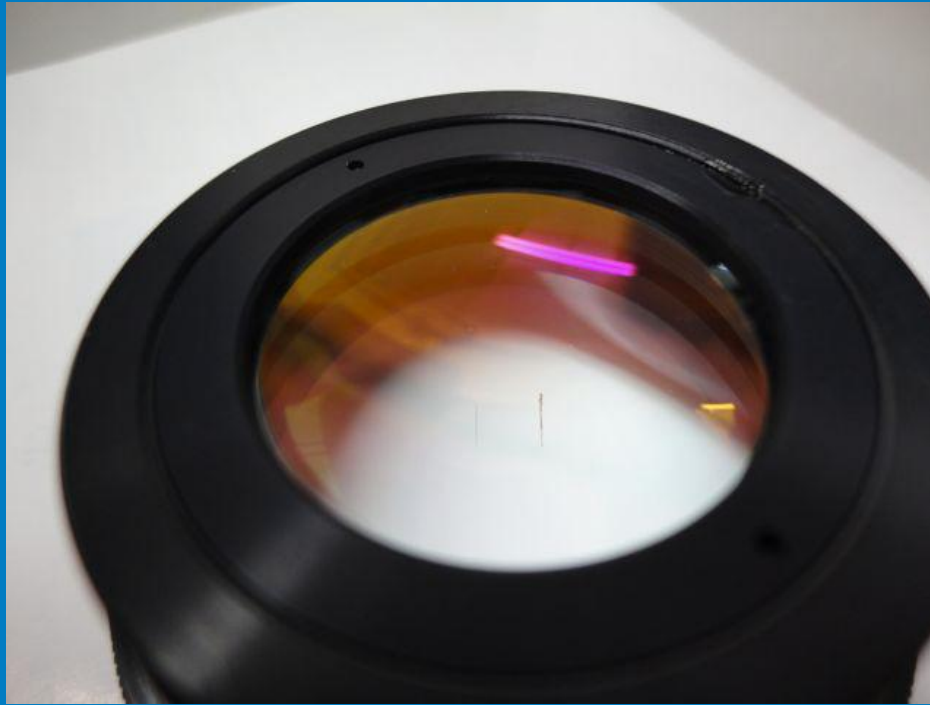
Lens damage

- During weekend work after this shift it was noticed that the LW final focus lens was badly damaged.
- Suspect focused reflection from post-IP recollimating lens.
- This lens removed and post-IP laser simply turned onto beam dump.
- Final focus lens replaced with spare from RHUL kindly brought out by Pavel.

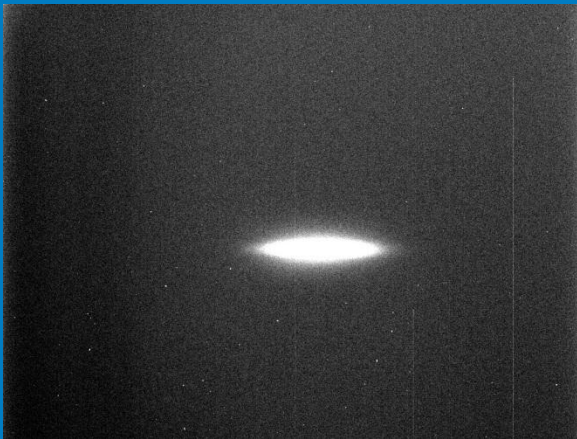
- Before running, alignment team surveyed dipole before LW detector.
- Moved ~ 1mm – too small to account for no observed laserwire signal.
- Access to replace final focus lens, realign system and install OTR filter and polariser.
- 1.5 hours to restore beam condition after previous shift.
- Tried new optics to move waist from MF2BFF closer to LWIP but this produced very large backgrounds so abandoned.
- Took OTR images with shorter (200ms) exposure time. Single beam image.
