**Lawrence Livermore National Laboratory**

**Prototyping and Testing of the  
Rotating Target FerroFluidic Seal**

**Sep 5, 2012 - PosiPol 2012**

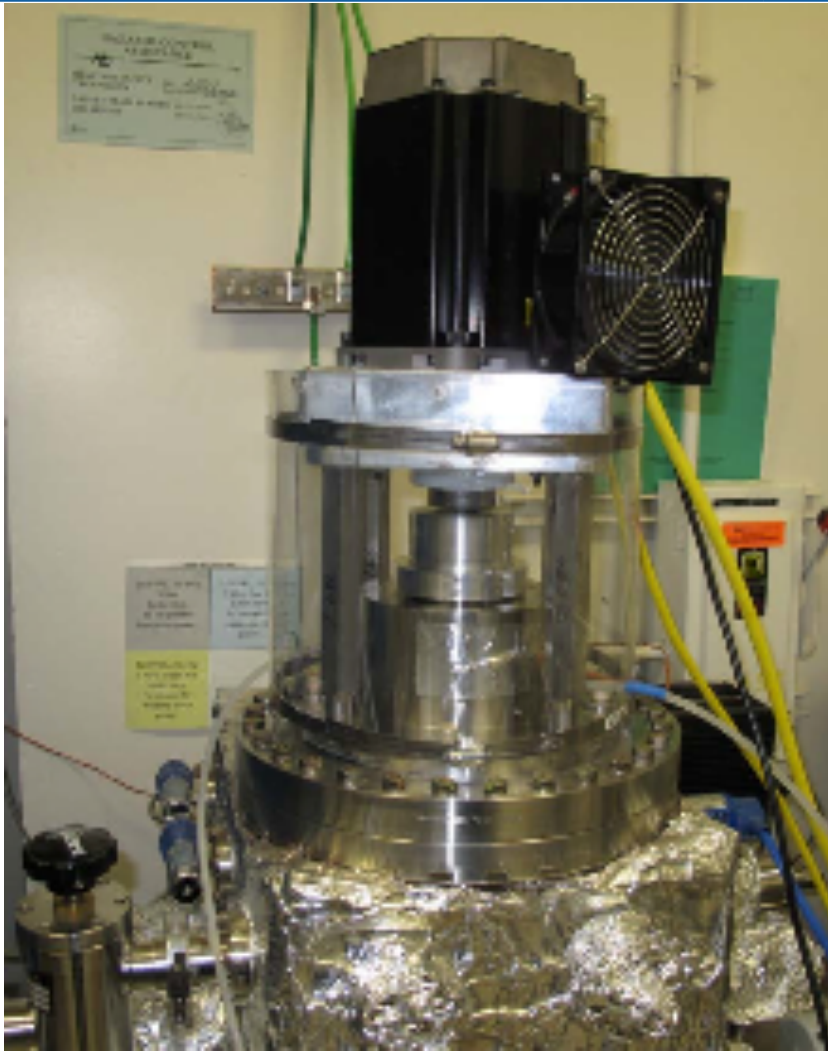
# The test stand allows us to rotate the seal up to 2000 RPM with pressure and outgassing measurements

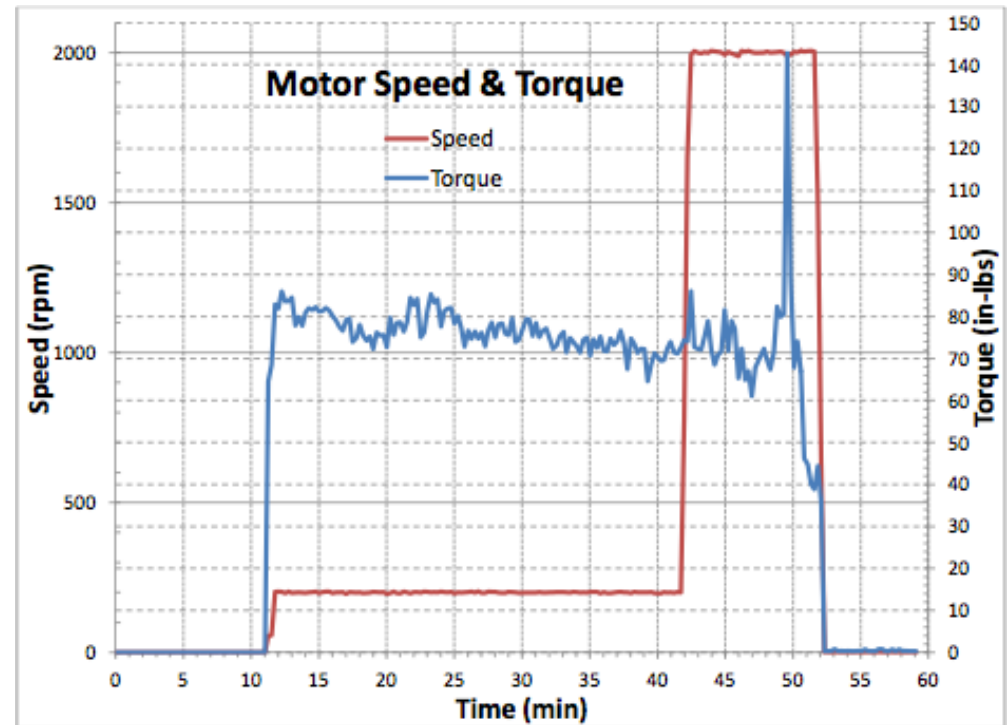
# October 3rd, 2011 we did our first full test of the Rigaku seal

... and we killed it.

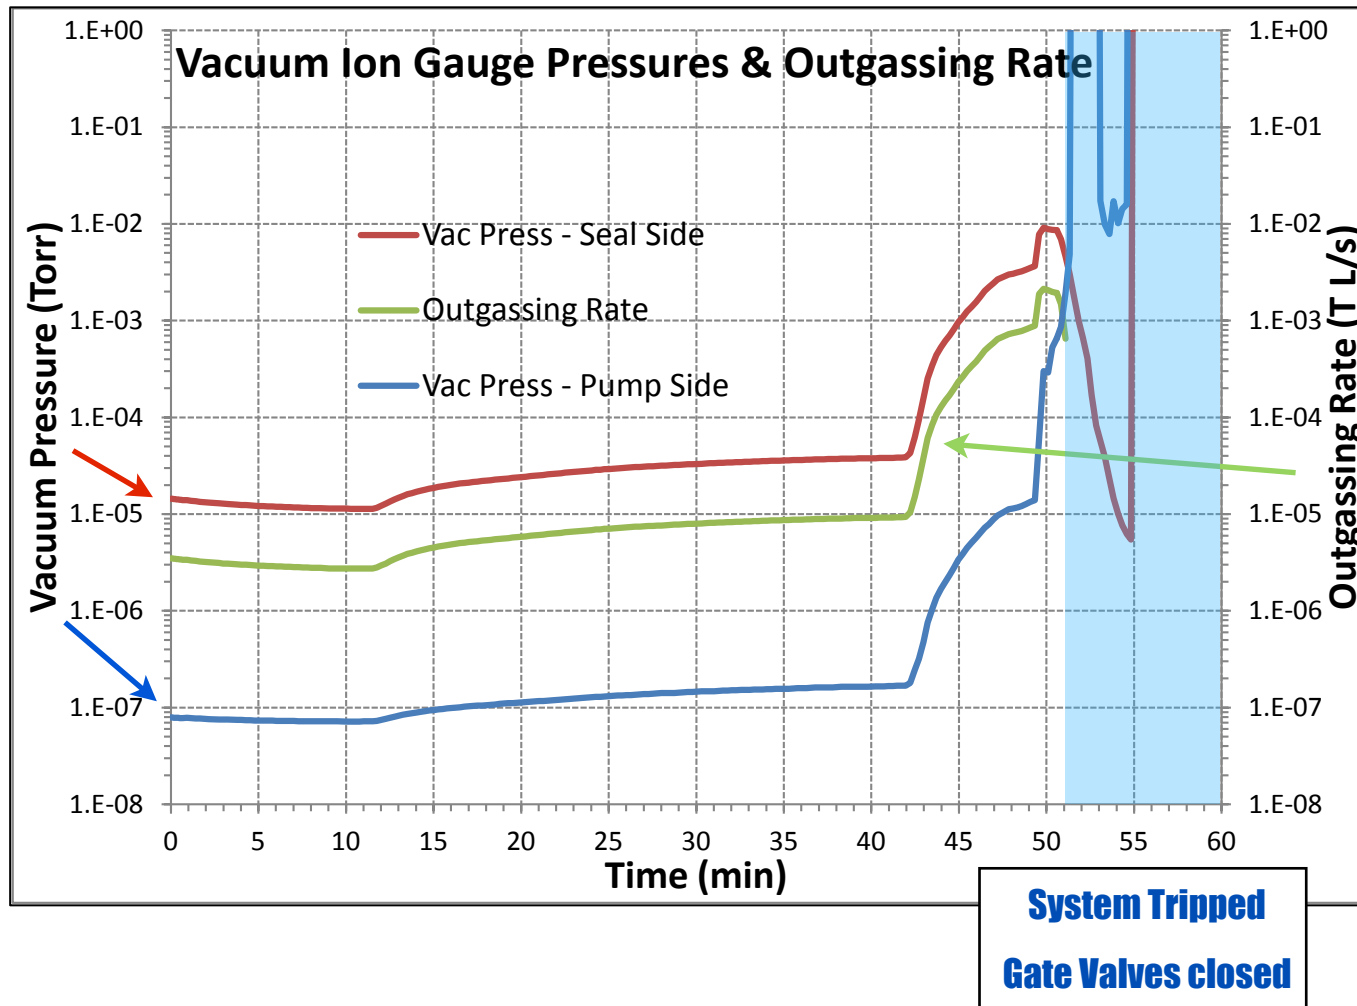
# Outgassing looked like it was stabilizing when the seal failed

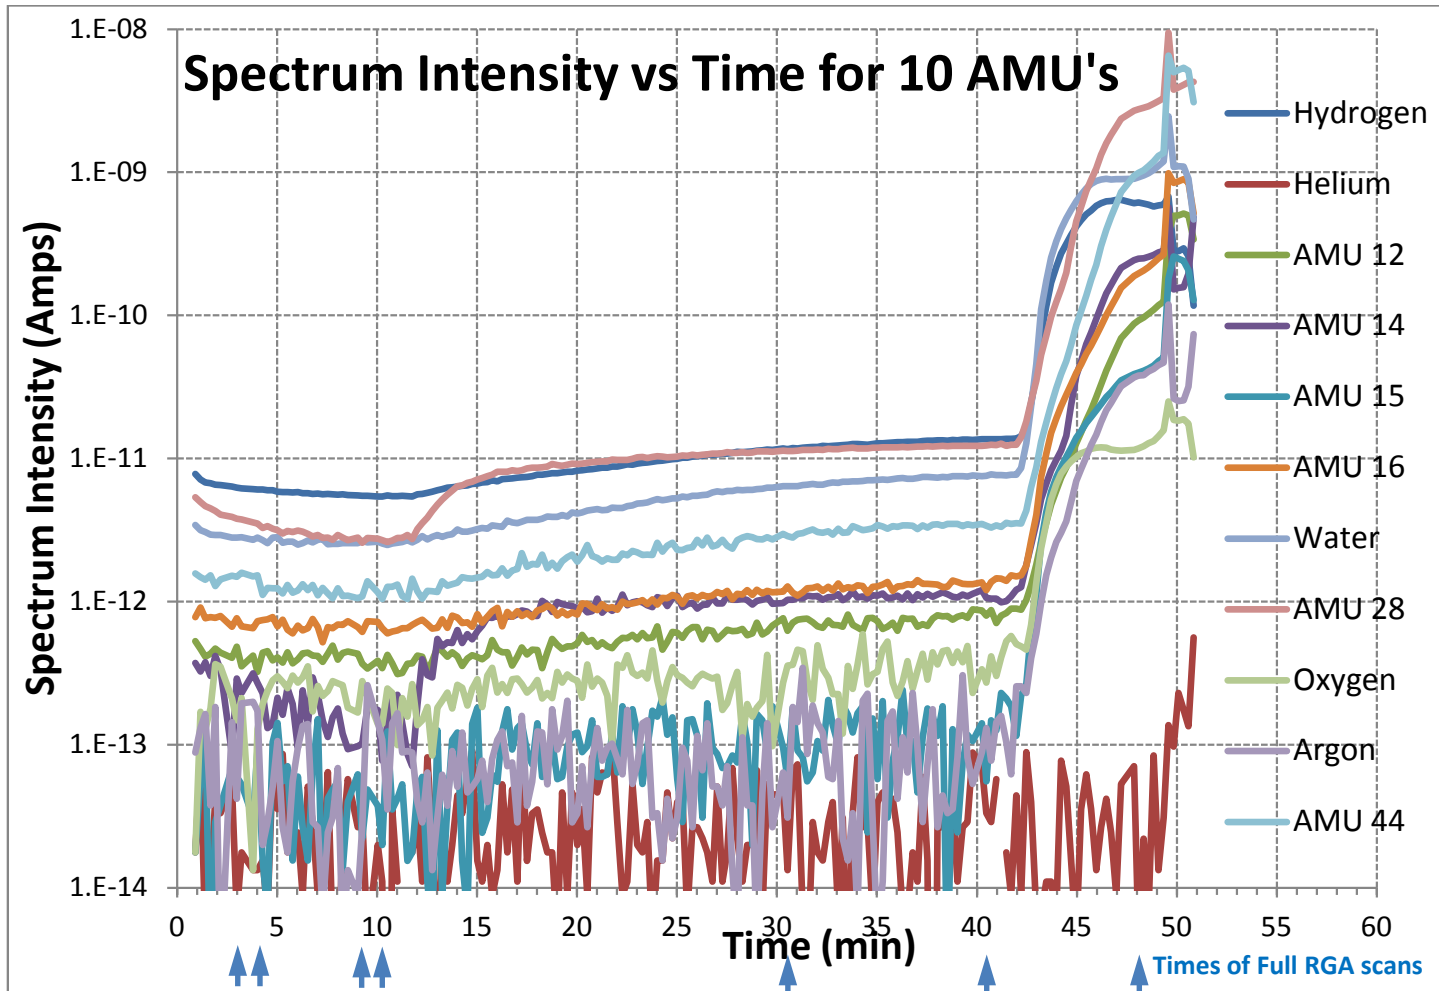
# Residual Gas Analyzer output showed a spike

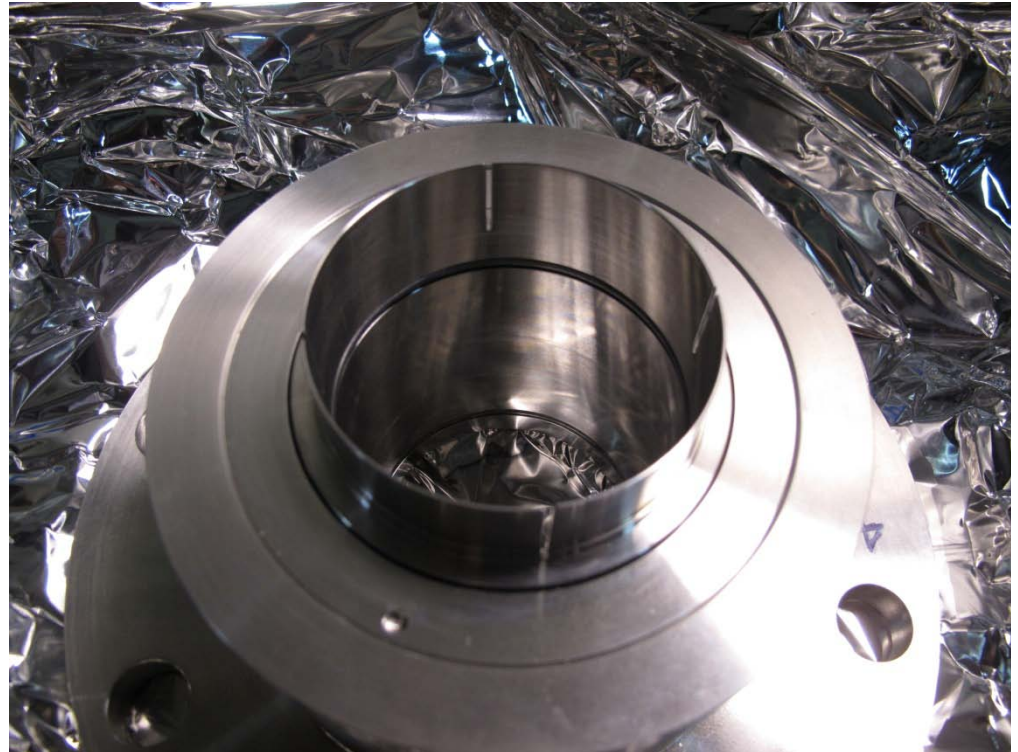
# Checked whether there was a problem on the shaft seal

- O-rings were good.
- No sign of slipping
- No indication of any problem here

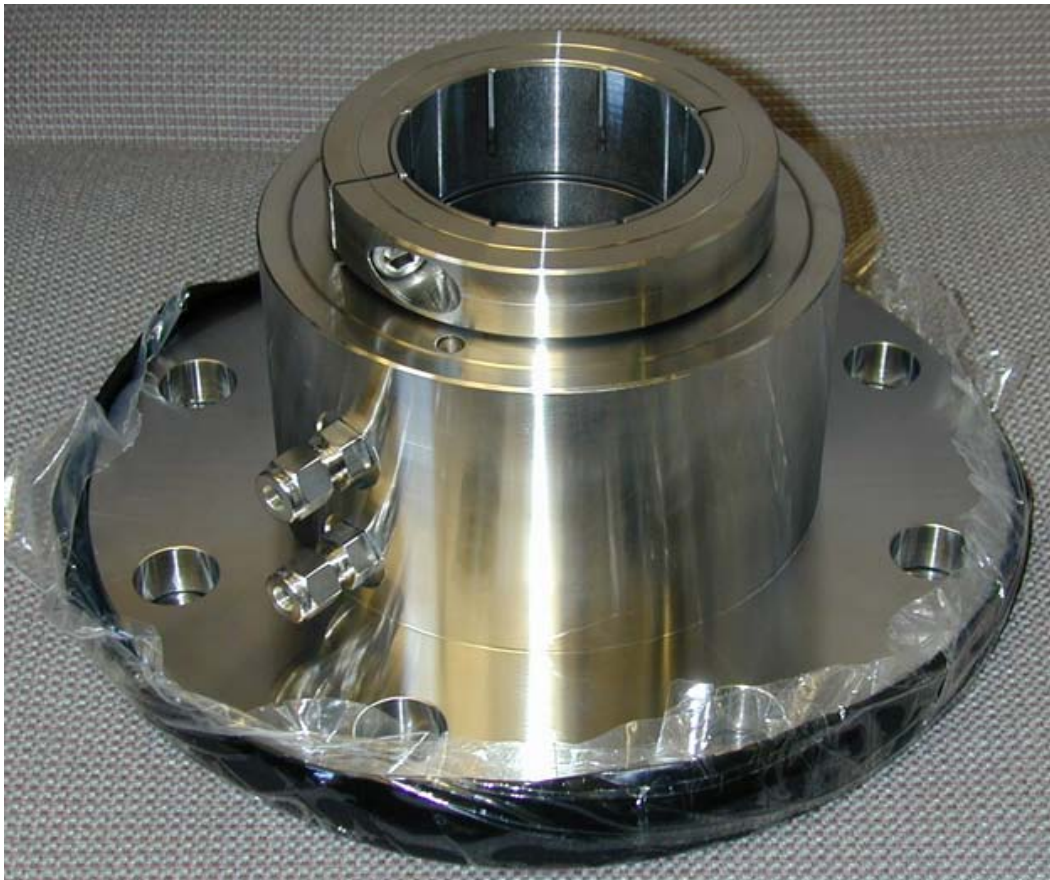
# While waiting for feedback from Rigaku we acquired a second plug compatible seal from FerroTec

- Since it seemed that we had a heating problem with the Rigaku seal we chose a lower viscosity / higher outgassing ferrofluid.

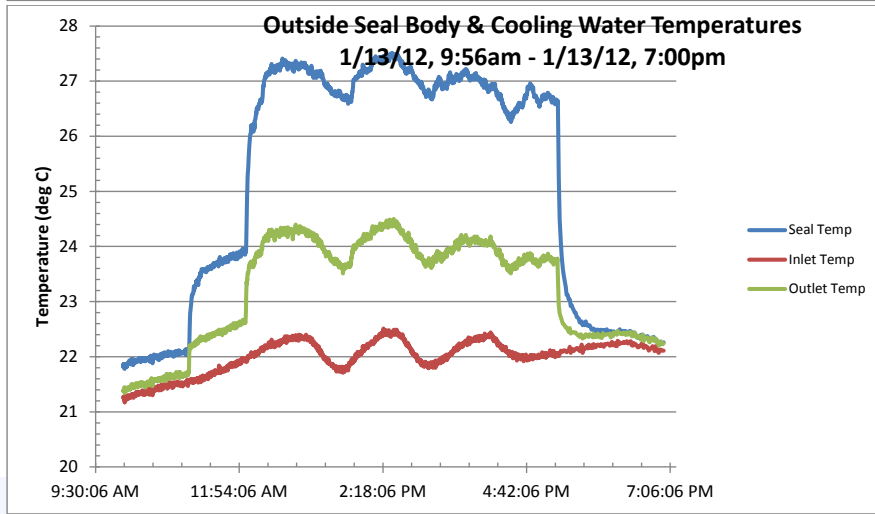
# Temperature was stable, outgassing rate was falling over the 5 hours at 2000 RPM

- Seal seemed to be performing normally

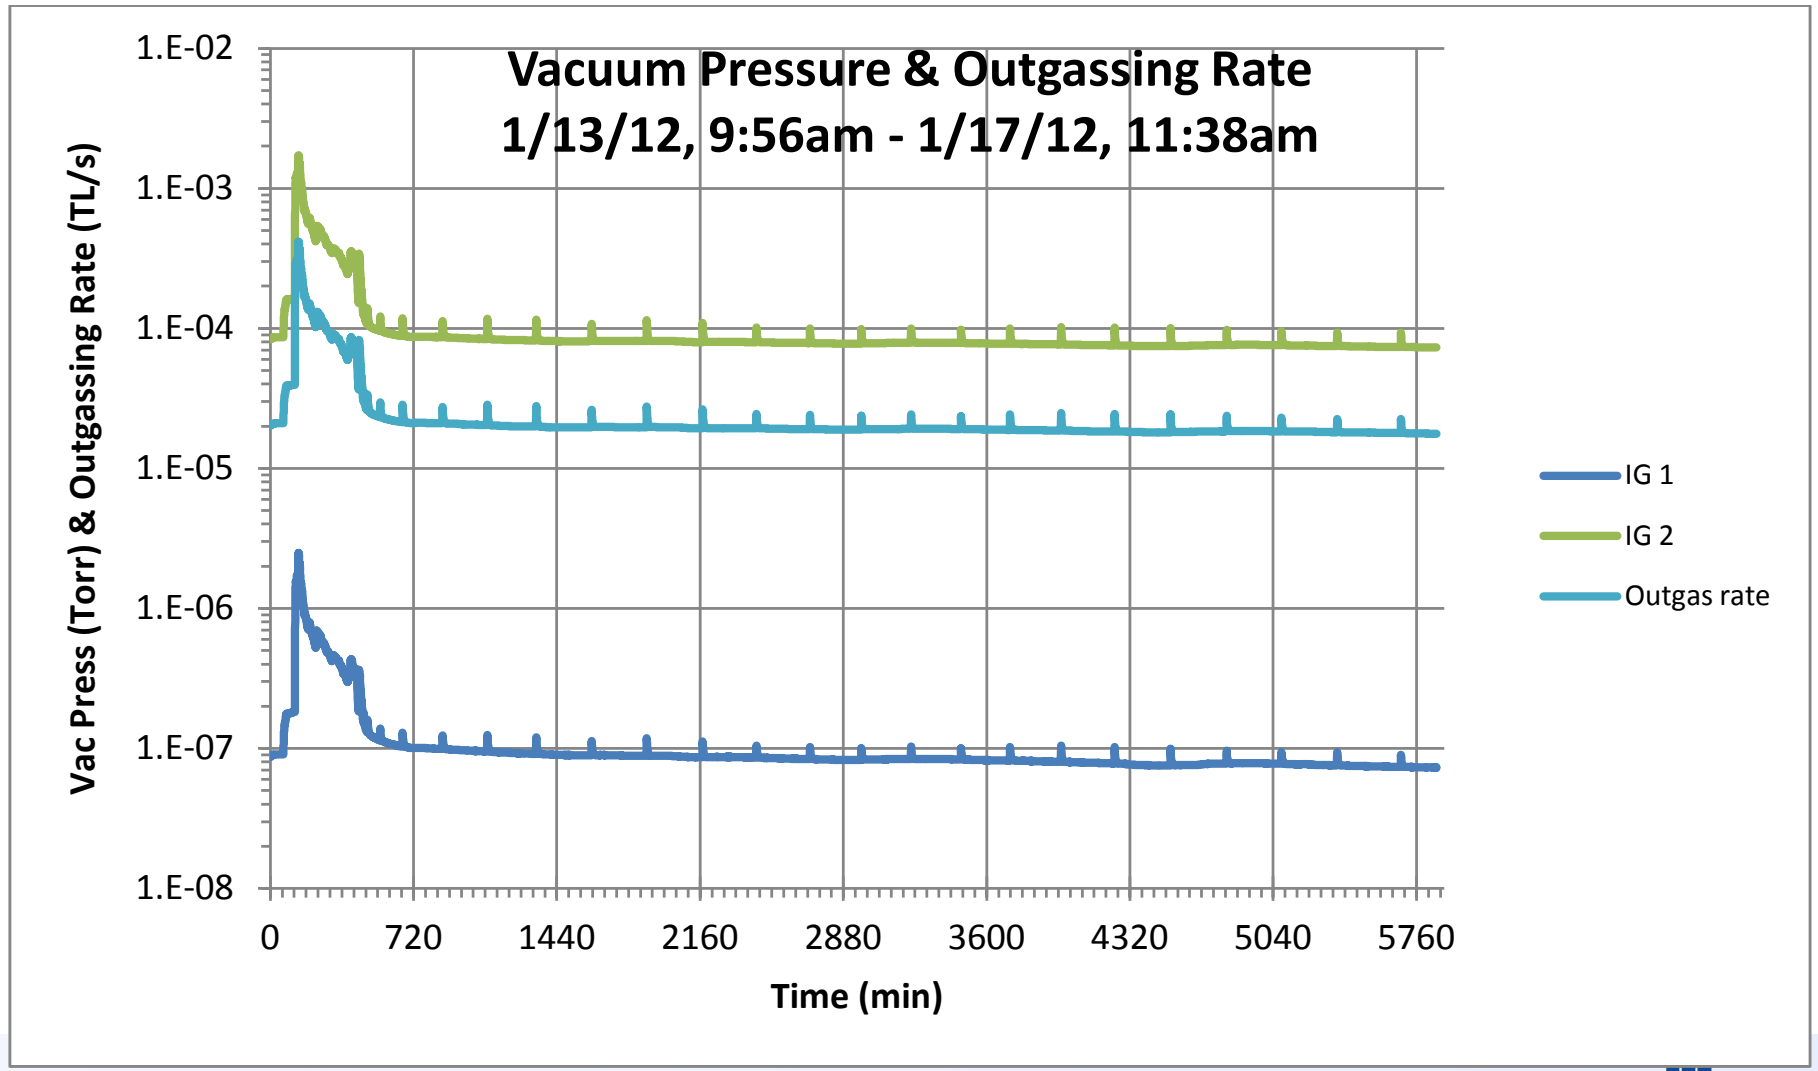
# After operation took data at 0 RPM: outgassing was stable but the seal outgassing spikes regularly

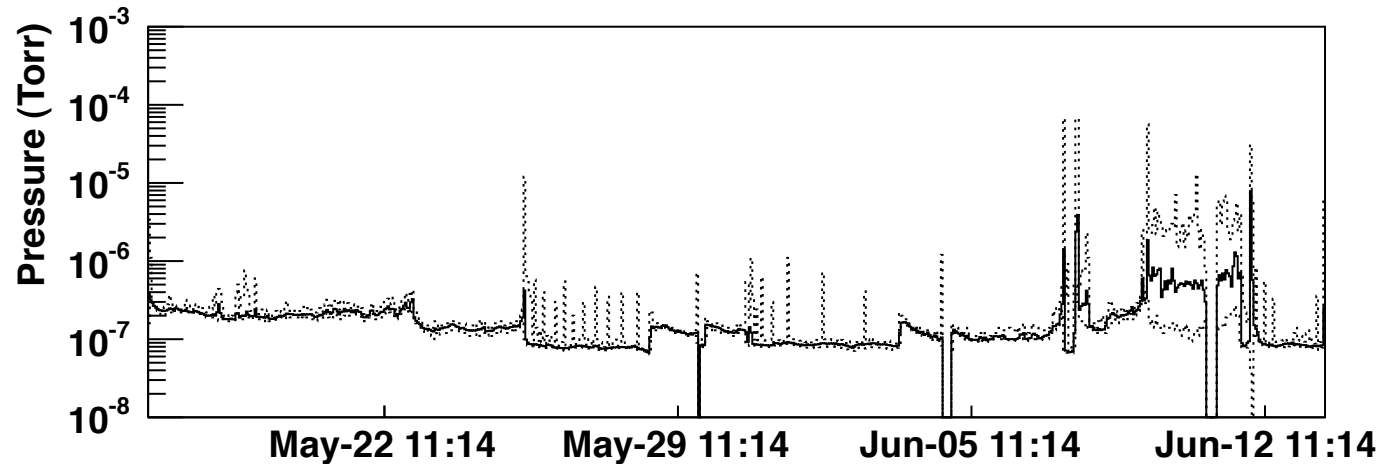
# FerroTec Seal #1 ran for 1 month (450 hours up)

**Pressure Trip**  
**System Trip**  
**Planned Down**

- 1 - Pressure Spike**
- 2 - DAQ software change**
- 3 - Cooling water flow**
- 4 - Vibration Limit**
- 5 - Pressure Spike**
- 6 - Wheel stopped for pressure test**
- 7 - System down for rework**

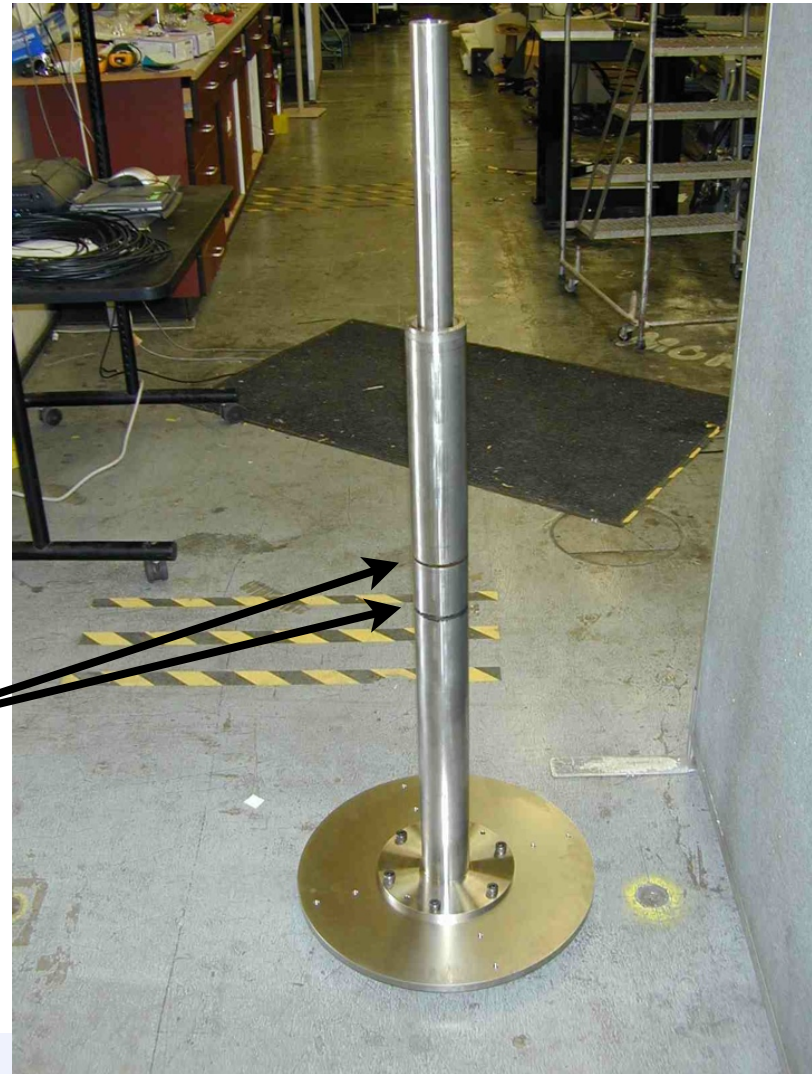
# The ferrofluid seal didn't fail

- The collar which is supposed to clamp the seal to the shaft had been left off
- The O-rings became the components that transferred torque from the shaft to the seal
- Eventually the O-rings were destroyed

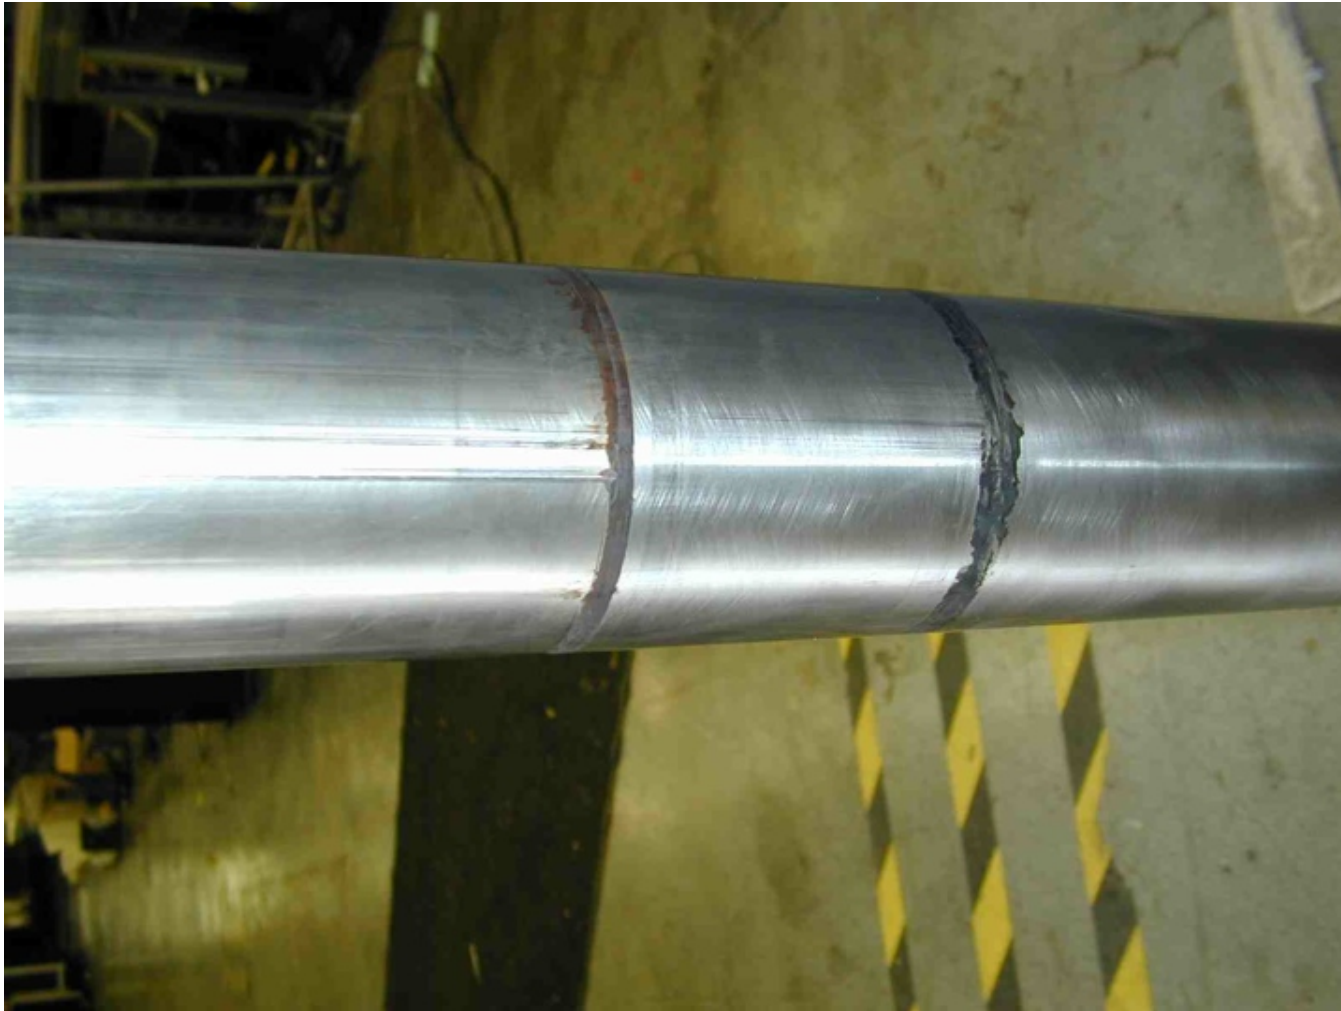
# The remains of the O-rings melted to the shaft

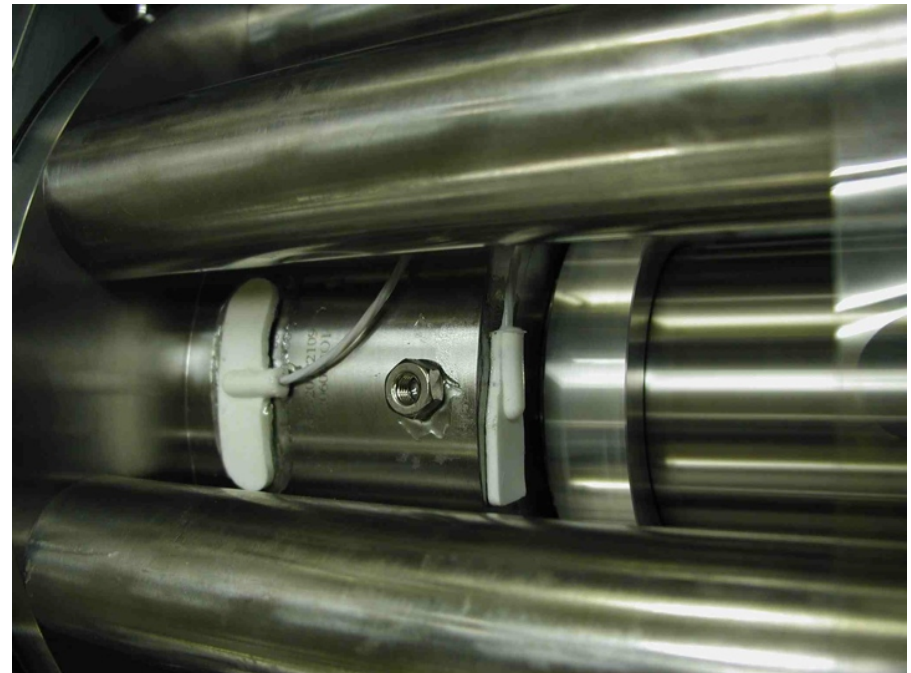
# The Rigaku seal was not able to be run successfully at 2000 RPM

- Seemed OK when run unloaded on the vertical test stand
- Under load there was a large acoustic noise from the bearings
- Repeated pressure spikes
- High Temperatures on the case at 1000 RPM
  - 31 C on case
  - 46 C on the end
