# Choice of single or double RF windows

Eric Montesinos (cern)

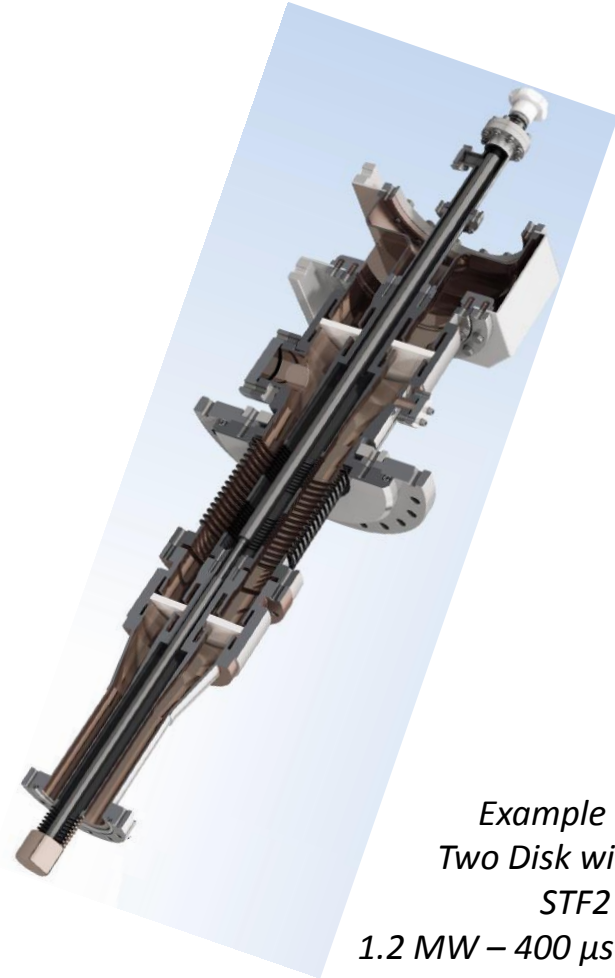
*Example of a  
Two Disk windows  
STF2  
1.2 MW – 400  $\mu$ s – 10 Hz TW*

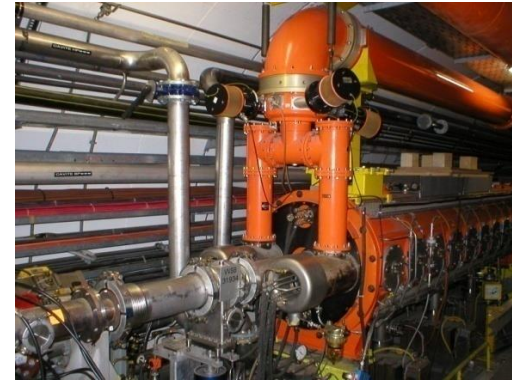
- 16 couplers in operation
- Few prototypes broken during 70's
- From 1975 to 2000, two couplers broken in 1998
- Since 2000, new coupler design without a single trouble

*SPS cylindrical window 1975-2000*

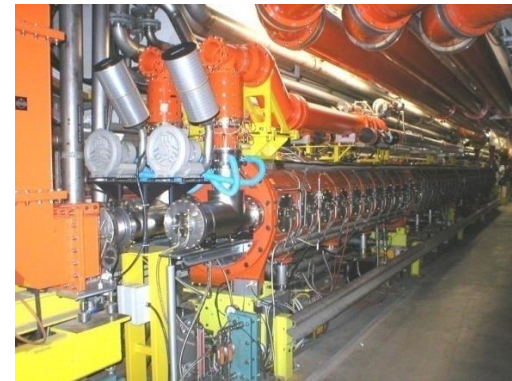
*SPS disk window 2000-...*

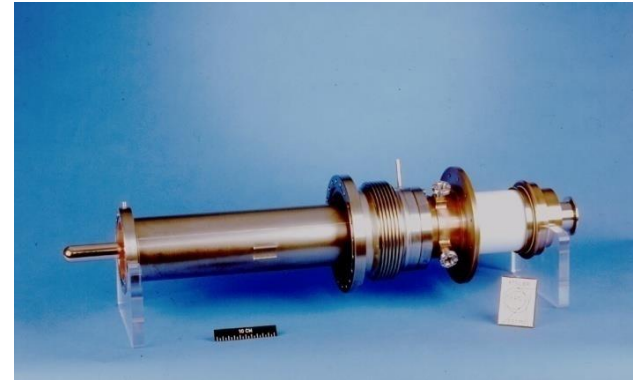
- 288 couplers in operation from 1994 to 2000
- Not a single coupler broken during operation
- After dismantling in 2001, few couplers were found strongly metalized

*LEP II cylindrical window 1994-2000*

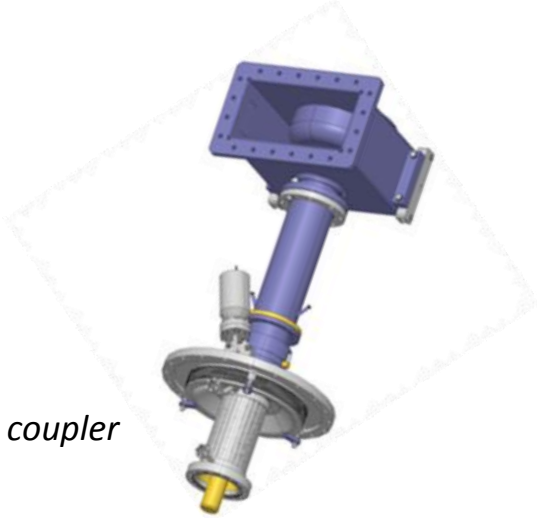
*ESS-CEA coupler*

- 120 cavities @ 704 MHz
- 1.1 MW - 3.5 ms - 14 Hz
- Average power = 54 kW
- CEA (Toshiba) one window couplers

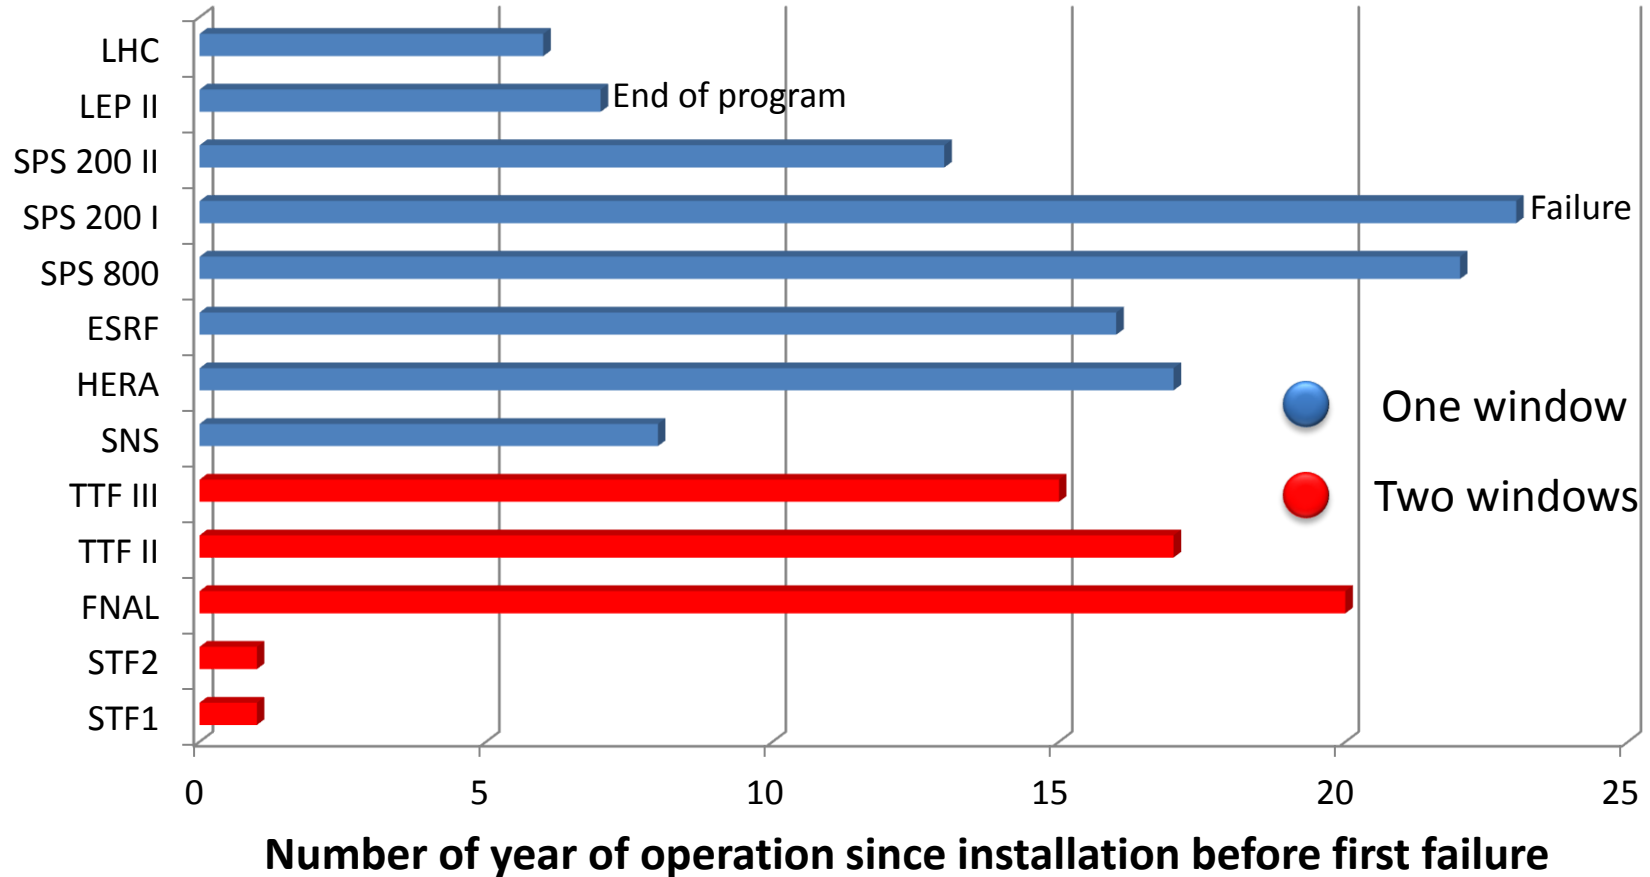
Maximum lifetime before first failure : 15-20 years ?
