Vertical Electro-Polishing at CEA Saclay: update January 22th 2014

S. Berry, P. Carbonnier, J-P. Charrier, F. Eozénu, L. Maurice, F. Peauger, D. Roudier, C. Servouin

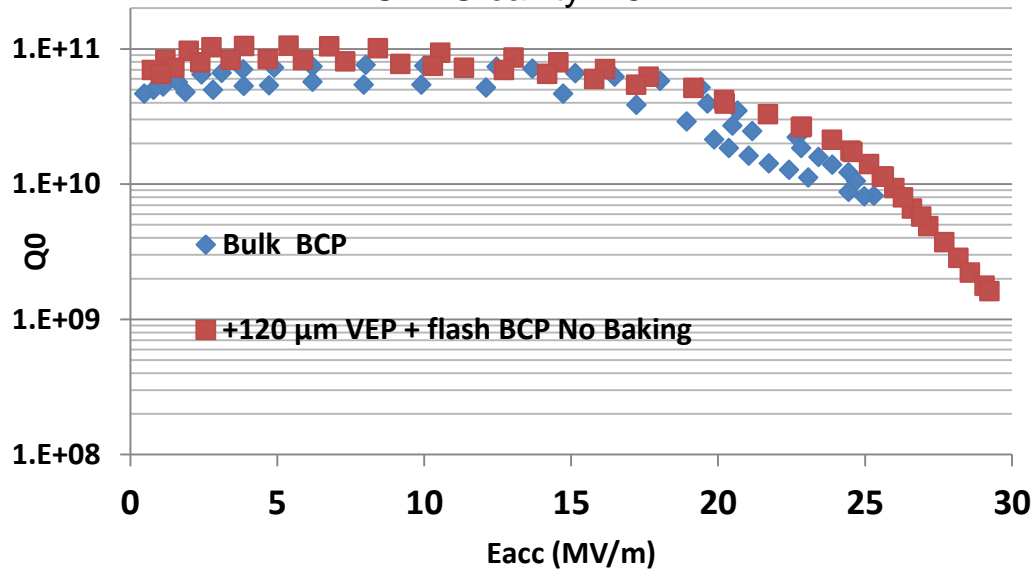
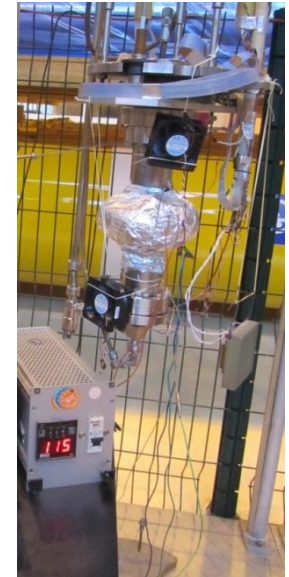
Nice Q0 after VEP on 1AC1 cavity

1AC1 1C cavity 1.3 – 1.7K

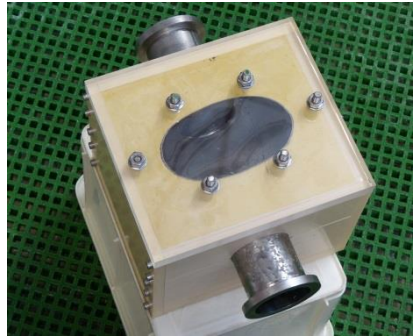
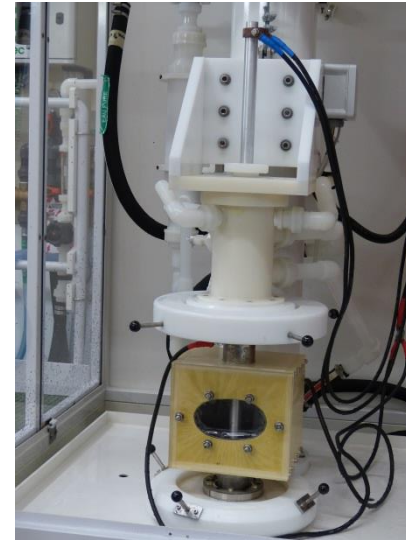
1AC1 baking at 115°C

- 1AC1 baked at 115°C Test Week#4
- 1AC2 baked at 115°C after VEP Test Week#5
- 1AC3 (Quench at 35MV/m): Replica of the inner surface of the cavity
 - Morphology depends on location in the cell
 - Outlook: Quench area morphology & Ra at different locations

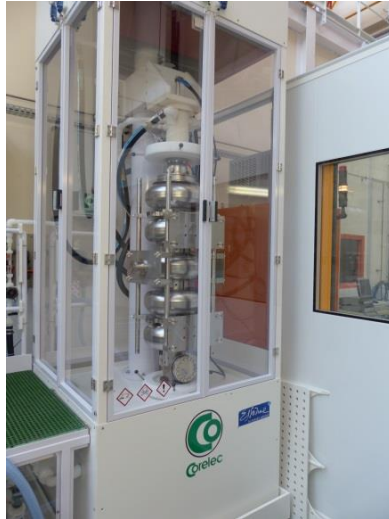
- Set-up to investigate inner surface of the cavity during VEP:
1.3 GHz 1C cavity cut and embedded in resin
- Goal: investigate the effect of the acid flow, viscous layer during VEP
- Explanation for asymmetry?

First test with acid ($\text{\O}30\text{mm}$ rod cathode):

- Hydrogen bubbles flow alongside the cathode
- Air bubbles might be trapped at the cavity surface if the acid flow is too high during filling

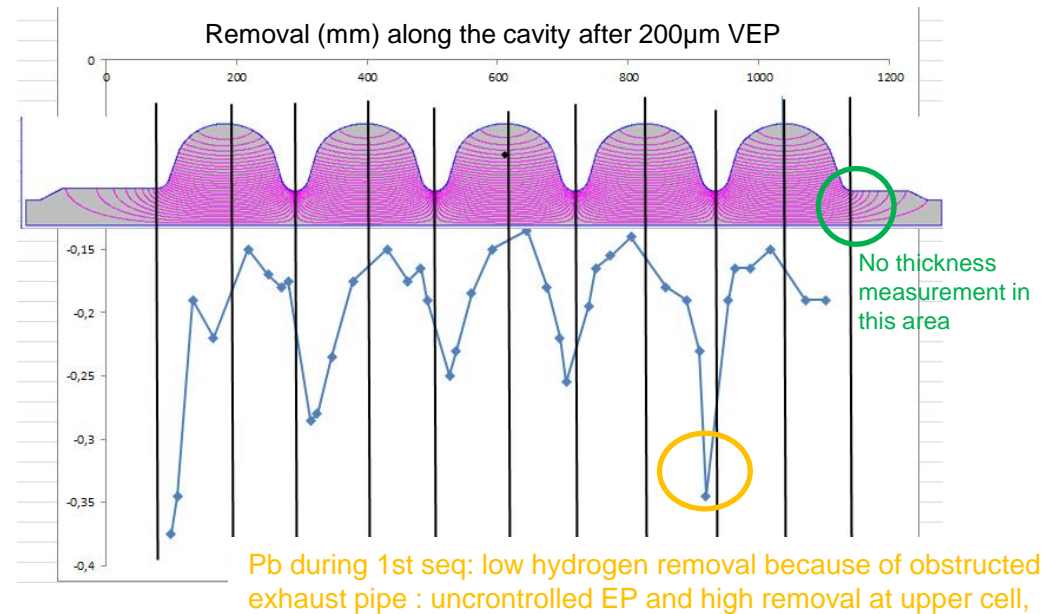
- 4 sequences with turning of the cavity in between
- Exhaust problem discovered (acid condensation) and solved
- 200 µm average removal
- Resulting removal ratio equator/iris ~ 1/2

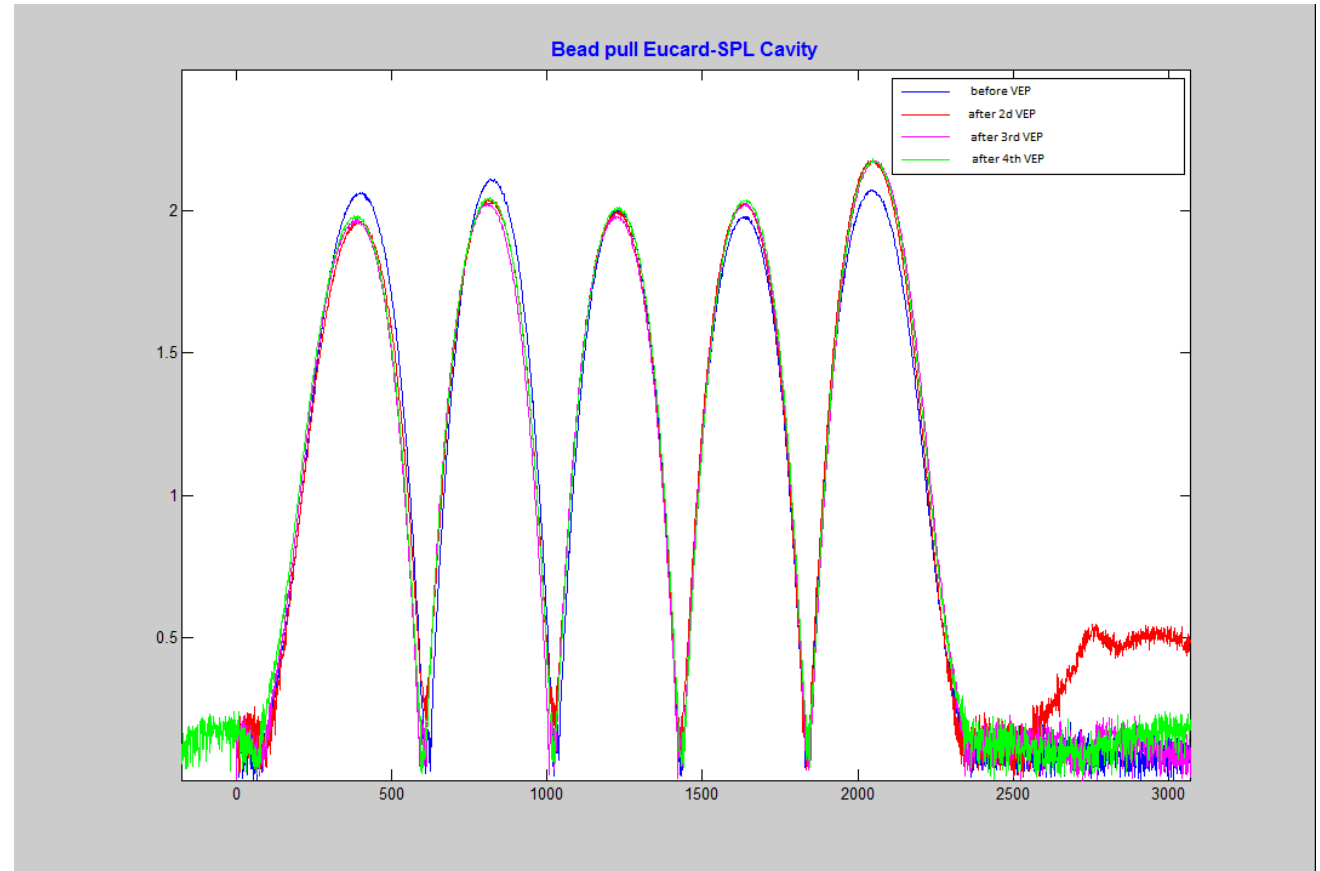
- Field flatness modified after uncontrolled VEP
- Once the problem solved, no field flatness modification
