# Pressure and Venting Tests

Lutz Lilje

4.3.2008

# Cavity with He-Vessel – XFEL version

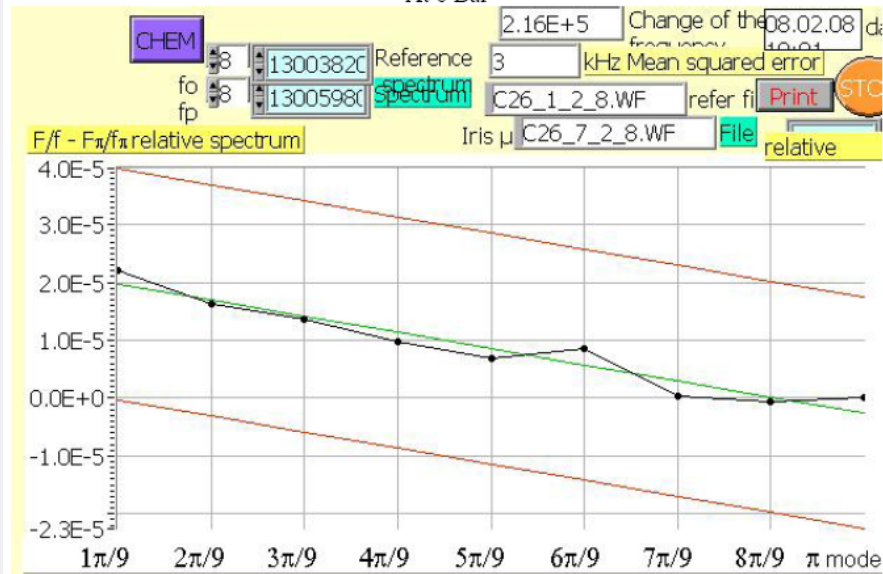
2K at 6bar

Spectrum of cavity C26 changed proportional from the pressure in the tank.

At 6 Bar

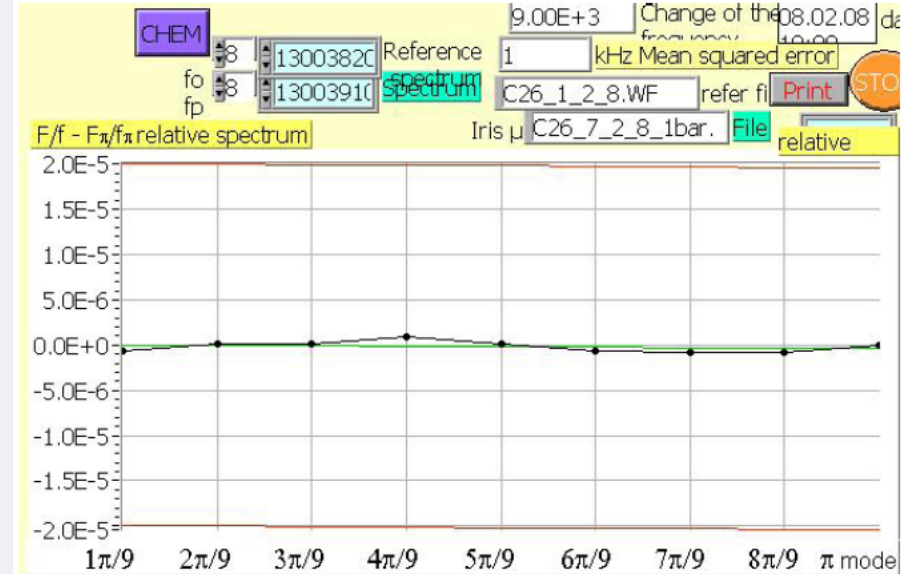
2K at 1bar

At 1Bar

There was no change of the field in cavity

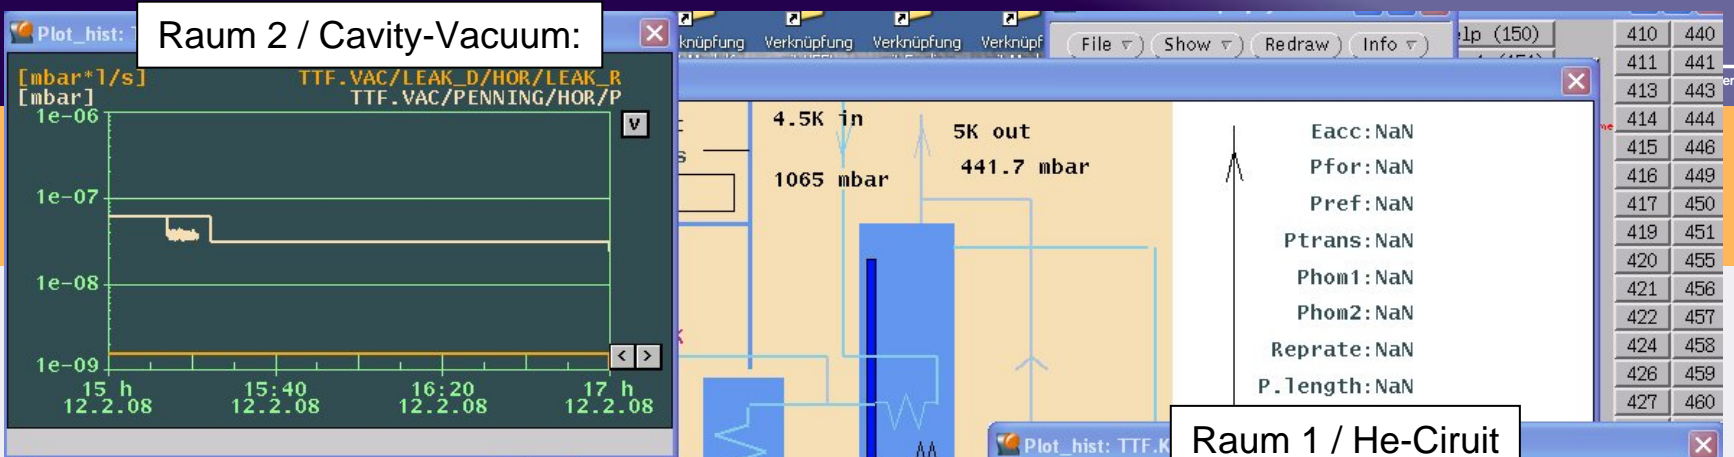
- **Test procedure:**
- C26 ~290K
  - Raum 1: 1,0bar / Frequency measured
  - Raum 2:  $\sim 3 \times 10^{-8}$  mbar
  - Raum 3:  $\sim 1,6 \times 10^{-5}$  mbar
- He-Raum (1) in steps to impress with warm He:
  - 2,0 bar / Frequency measured
  - 1,0 bar / fr measured
  - 3,45 bar / fr measured
  - 1,0 bar / fr measured
  - 4,2 bar / fr measured
  - 1,0 bar / fr measured
  - 5,3 bar / fr measured
  - 1,0 bar / fr measured
  - 6,2 bar / fr measured
  - 6,2 bar for a 1/2h / fr measured
  - 1,0 bar / fr measured
- Above 6,2 bar fr  $\sim 100$  kHz higher on 1,0 bar before pressure test.
- Up to 5,3 bar steps no fr shift vs. 1.0 bar measurements.
- None detection of pressure or leak rate increase in the cavity or insulation vacuum

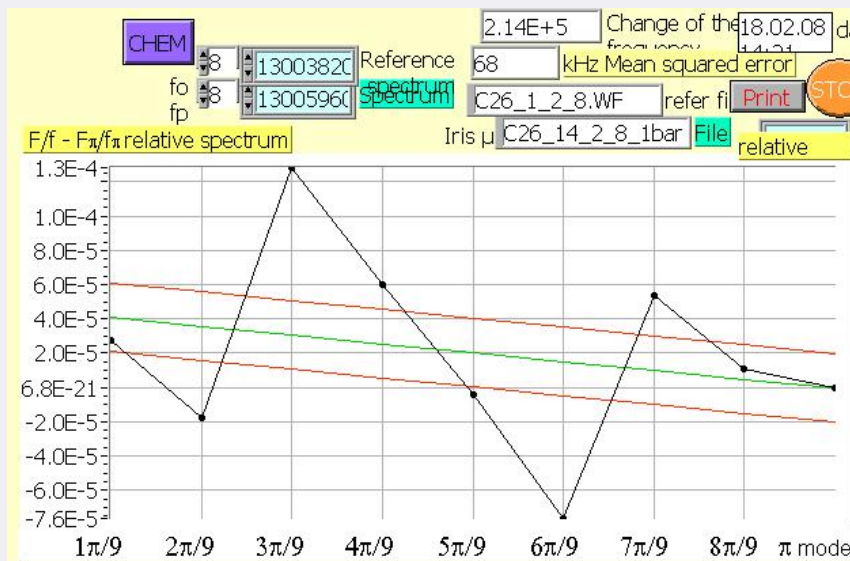
4K

# Cavity Spectrum at 4 a. 2K

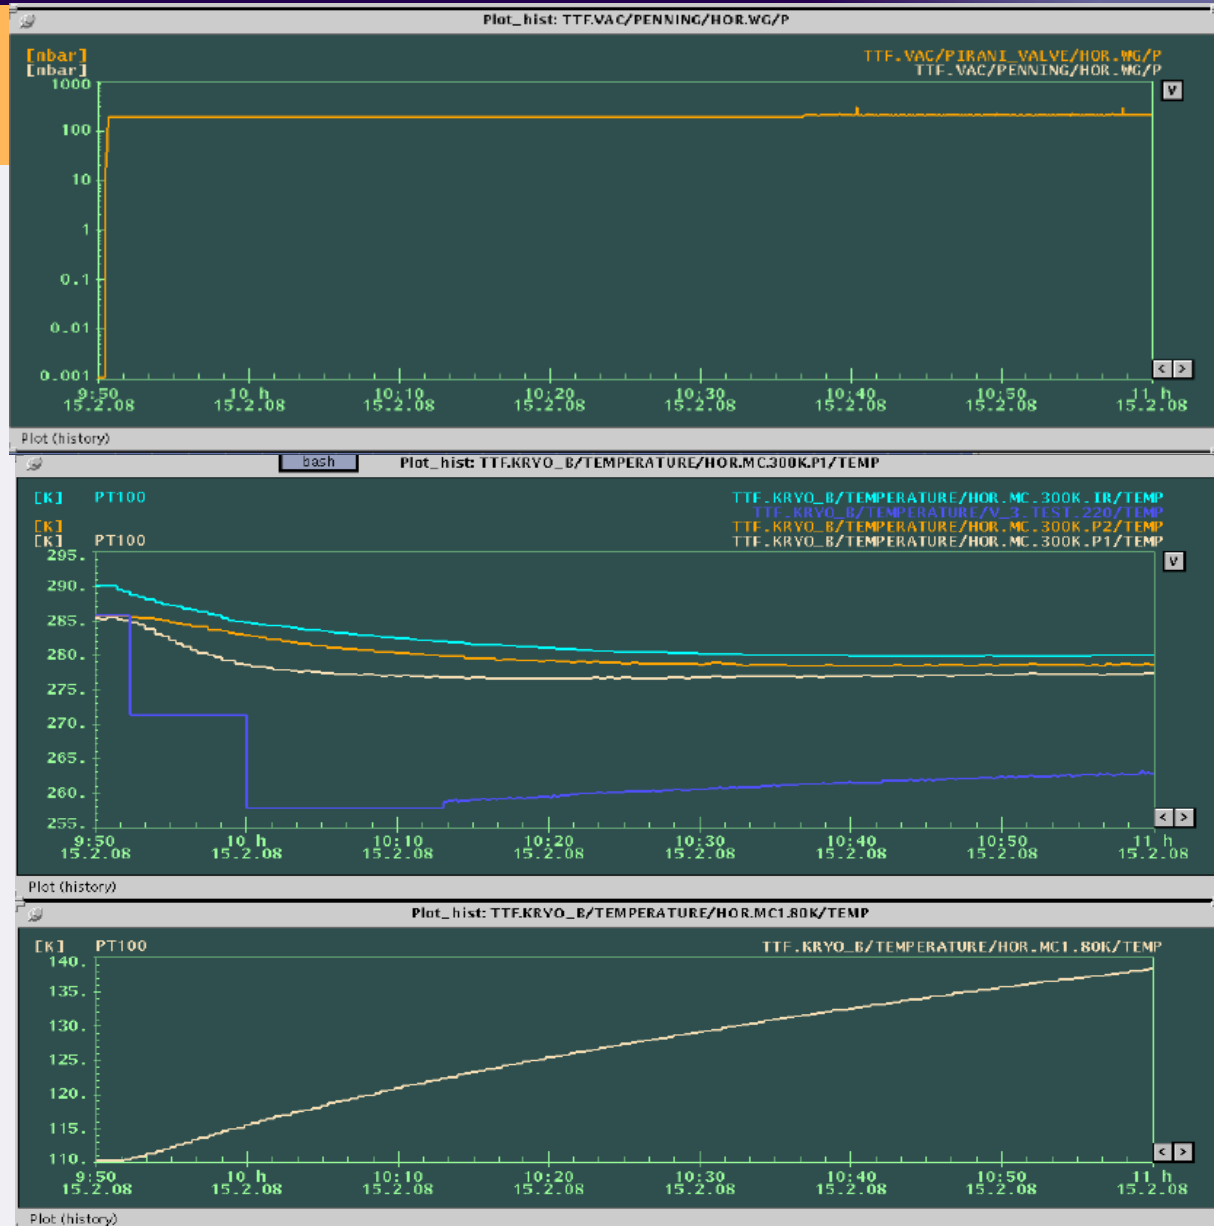
- Opening needle valve
  - about 1 min for full vent
  - Nitrogen, not air
  - Gauge calibrated for air
- 
- Results:
  - Ceramic does not break
  - No leak

- Preparation for crash tests
  - would like to escalate the disaster level in a reasonable way to maximise information from test
    - » Correct scheduling of tests is important
  - In other words: At which stage are we seriously start destroying things?
- Check whether ceramic breaks in a fast vent with nitrogen
- Results
  - Ceramic does not break
  - No leak occurred
    - » Cross-checked after pumpdown
