# Setups for SiPM+Tile mass characterisation

Konrad Briggli,  
Rene Hagdorn  
Kirchhoff-Institut für Physik  
Ruprecht-Karls Universität Heidelberg

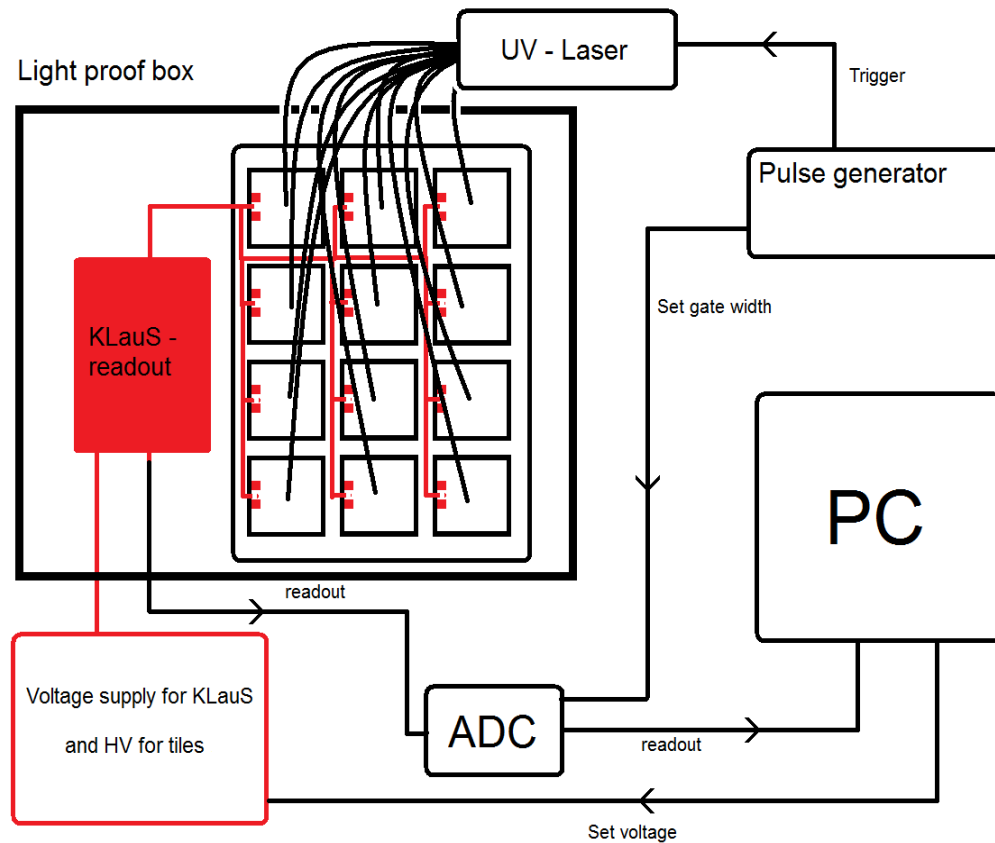
## Setup:

- KLauS ASIC for readout
- 12 channels
- UV-Laser and fiber system
- External peak sensing ADC
- Common HV source

- Readout software
  - Speed increase - single point Measurements in  $\approx 2s$
  - Labview  $\rightarrow$  ROOT & bash/tcl
  - Online analysis
- Reduced electronic noise
- Temperature Monitoring
- Tuning of system parameters
- Good spectra for both MEPHI and Uni Hamburg tiles

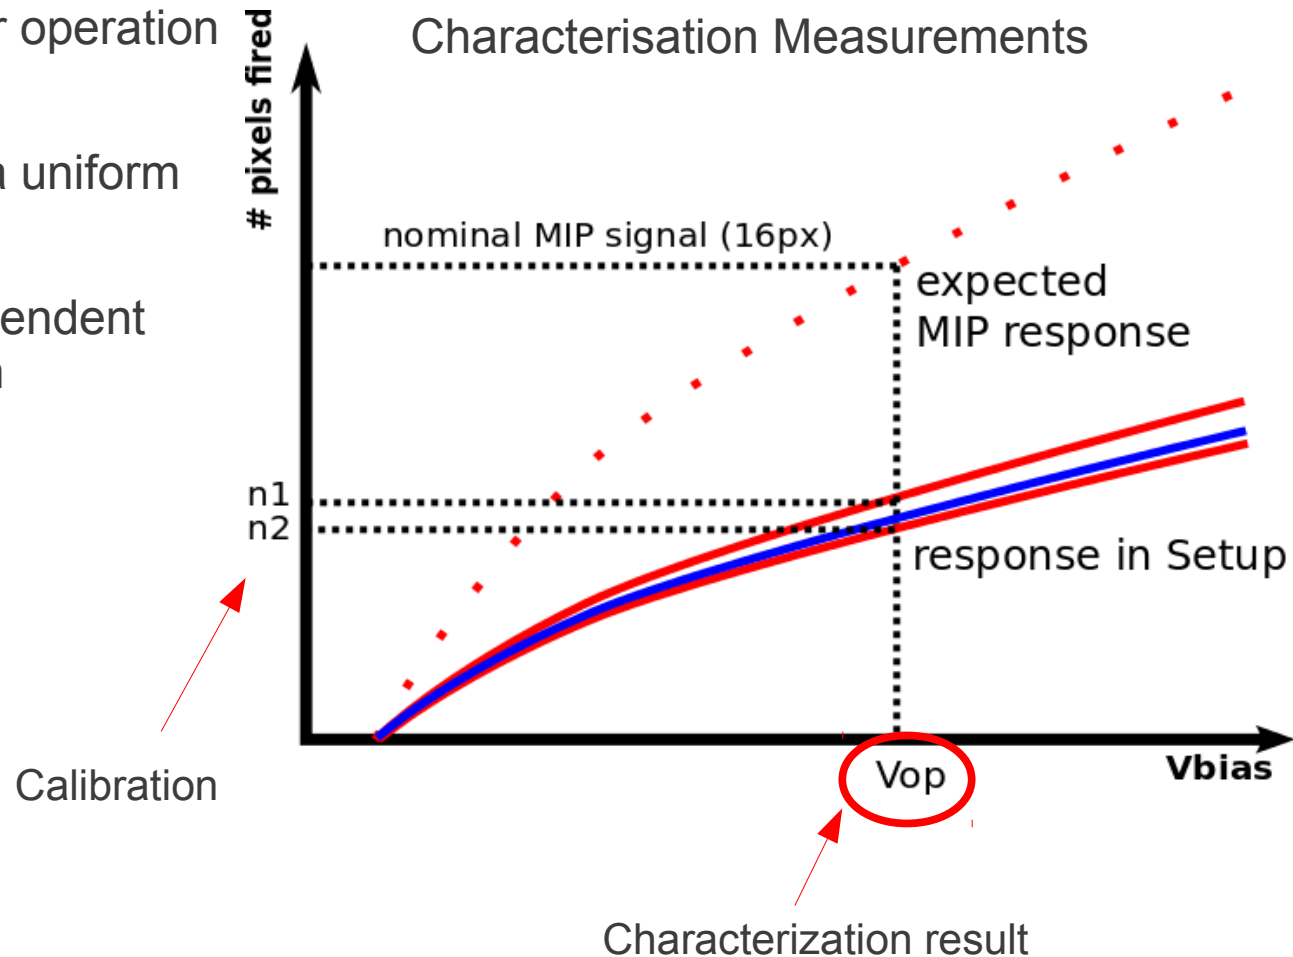
# Measurement procedure: Operating voltage estimation

- Silicon Photomultipliers in linear operation region
- Estimate operation voltage for a uniform MIP response:

Bias voltage at the channel dependent expected signal from calibration measurements

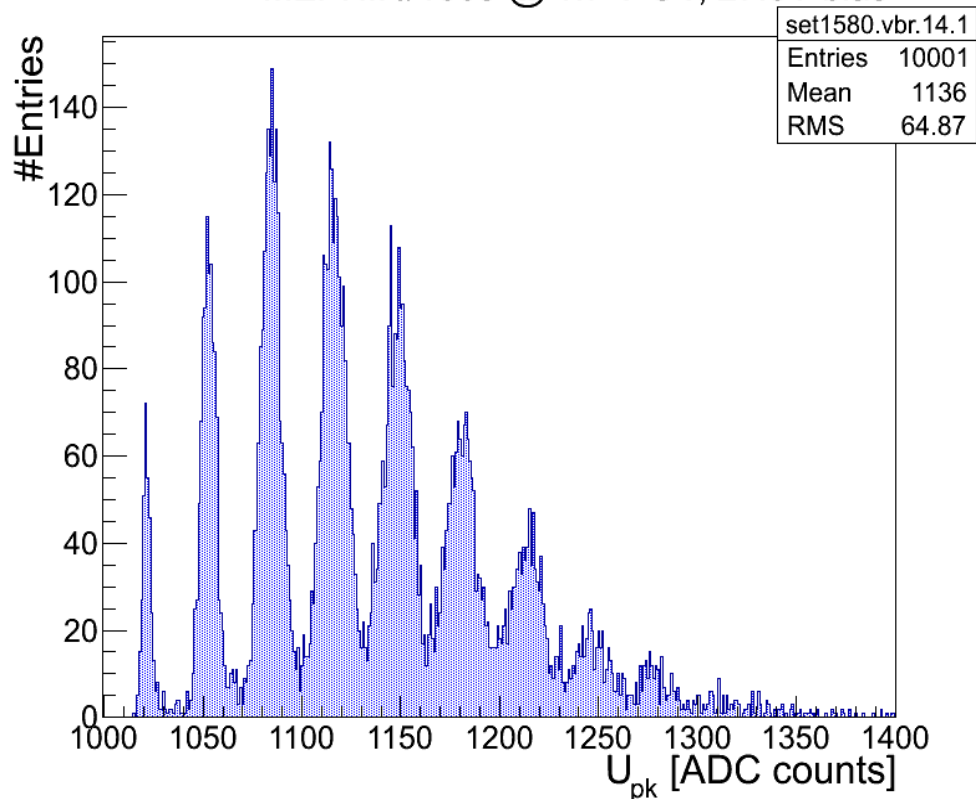
MEPHII #1009 @ 1.7 V OV, 27.5V bias

- Characterization of O(100) wrapped tiles from Uni HH planned
- Commissioning of system concentrated on Tiles with reflecting foil on top, shooting light through foil

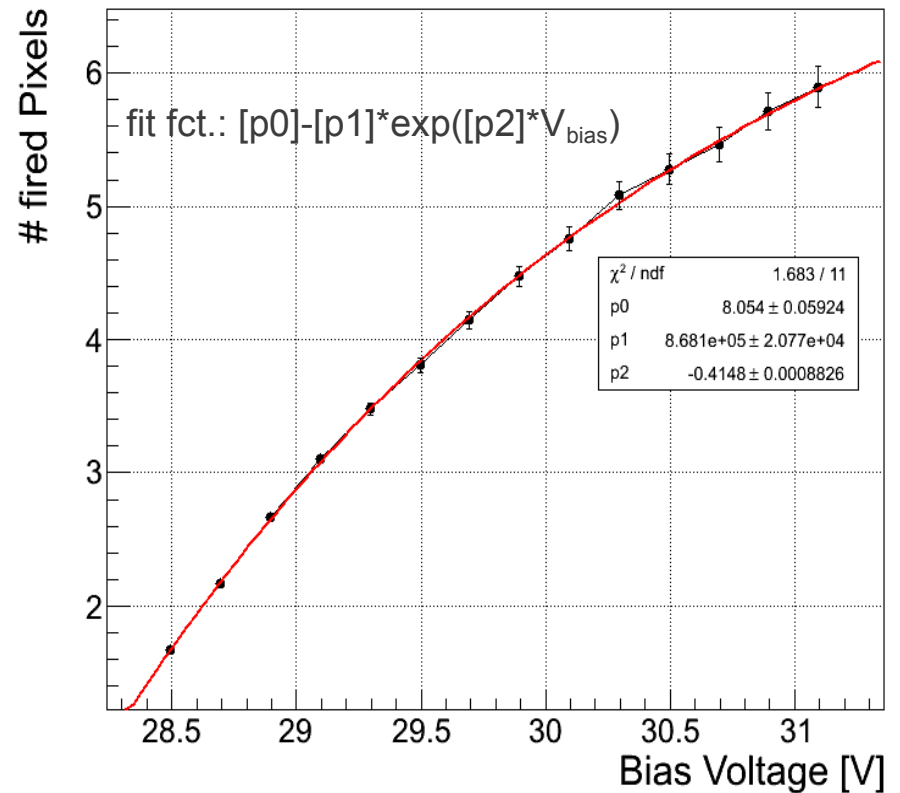
Uni HH wrapped tile

## Number of fired Pixels

Fired pixels for 2V Overvoltage:

Uni HH **4.02px**

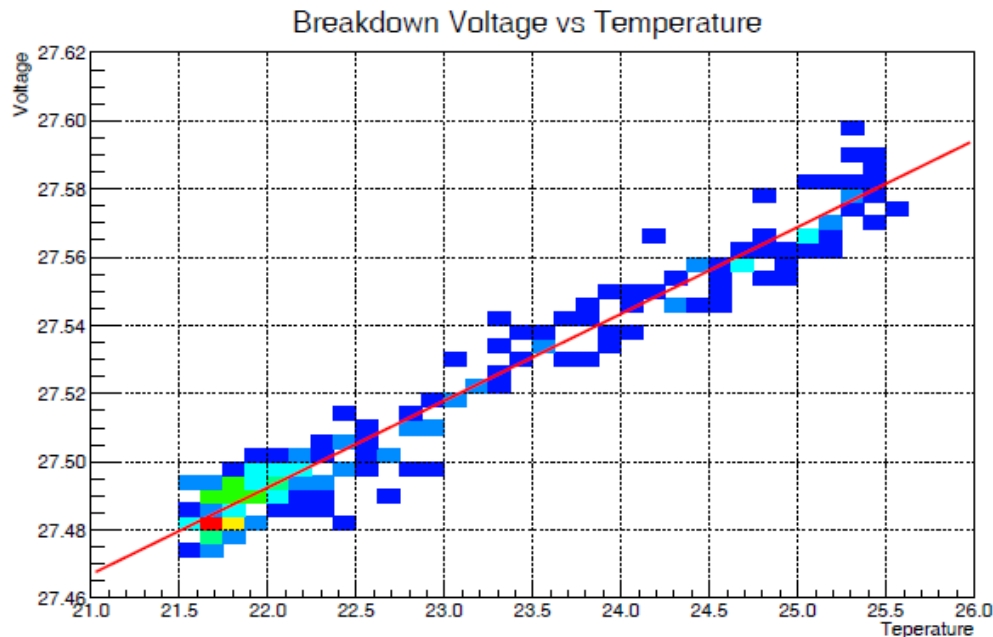
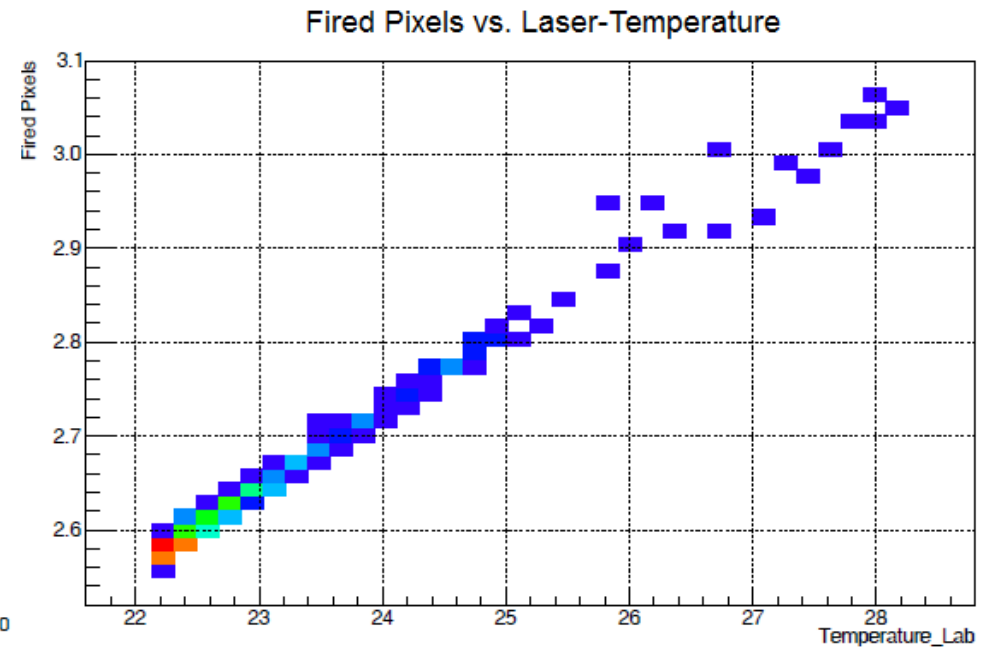
- Breakdown voltage shows good correlation with Temperature in SiPM box
- Temperature differences between lab (Laser) and SiPM box for fast temperature changes.
  - number of fired pixels does not correlate with SiPM box temperature (but w. ambient lab/laser temperature)
  - additional temperature monitoring of ambient lab temperature

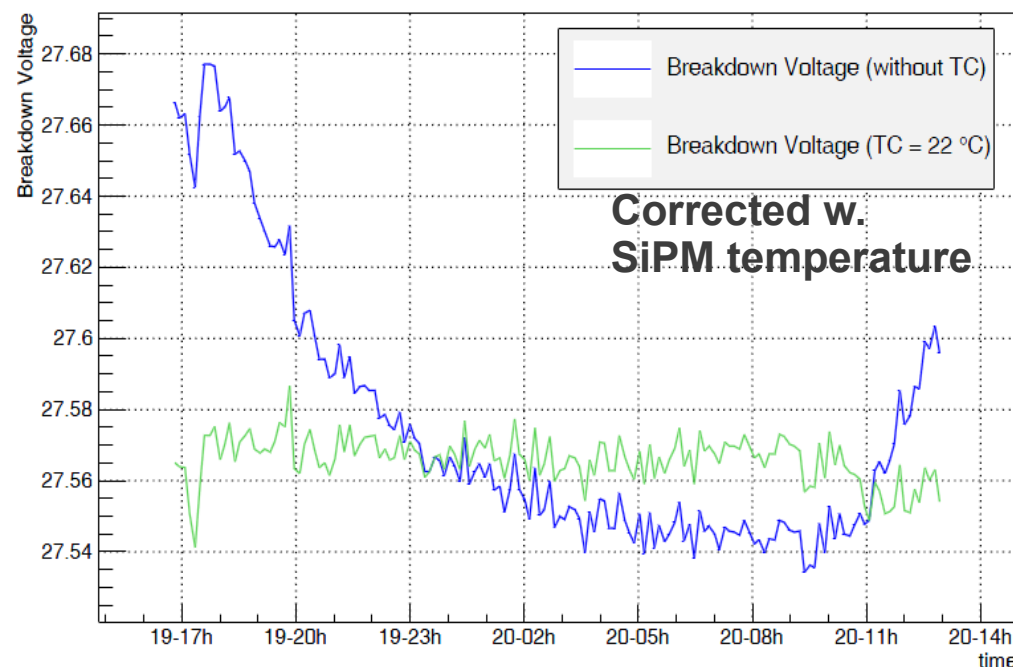
- Breakdown voltage shows good correlation with Temperature in SiPM box
- Temperature differences between lab (Laser) and SiPM box for fast temperature changes.
  - number of fired pixels does not correlate with SiPM box temperature (but w. ambient lab/laser temperature)
  - additional temperature monitoring of ambient lab temperature

- Spread of breakdown voltage: 6.5mV RMS
- Spread of mean Signal: 0.013px RMS (mean signal 2.65px)

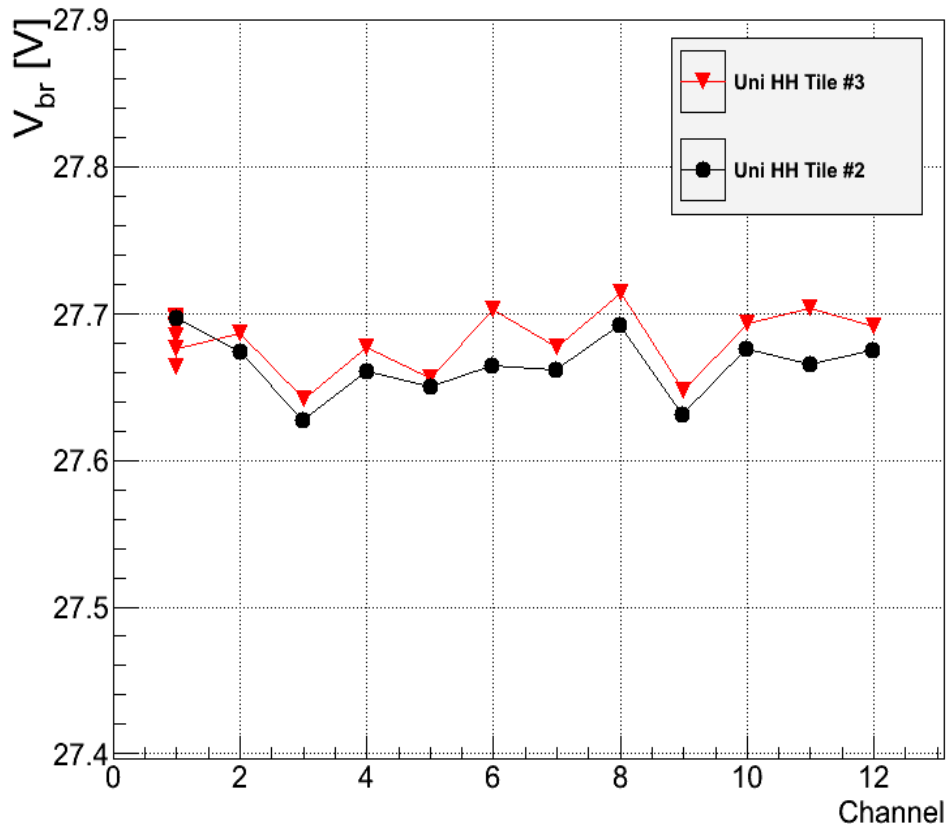
## Breakdown voltage measurements

Same tiles measured in each channel of the system

Slight channel to channel variations

Tile insertion and measurement repeated several times in Channel 0

All variations  $< 80\text{mV}_{\text{pp}}$

- Small scale system rebuild,  
large scale system ready for first tests.
- Temperature correction or further stabilization needed for optimal results.
- Measured channel to channel breakdown voltage variations within 80mVpp
- Reproducibility issue in measurement of number of fired pixels with small scale system.  
→ leads to high uncertainties in the estimated operation voltage.
- Some work on fiber system and tile holder needed to increase stability.
- Large system might not have these problems.

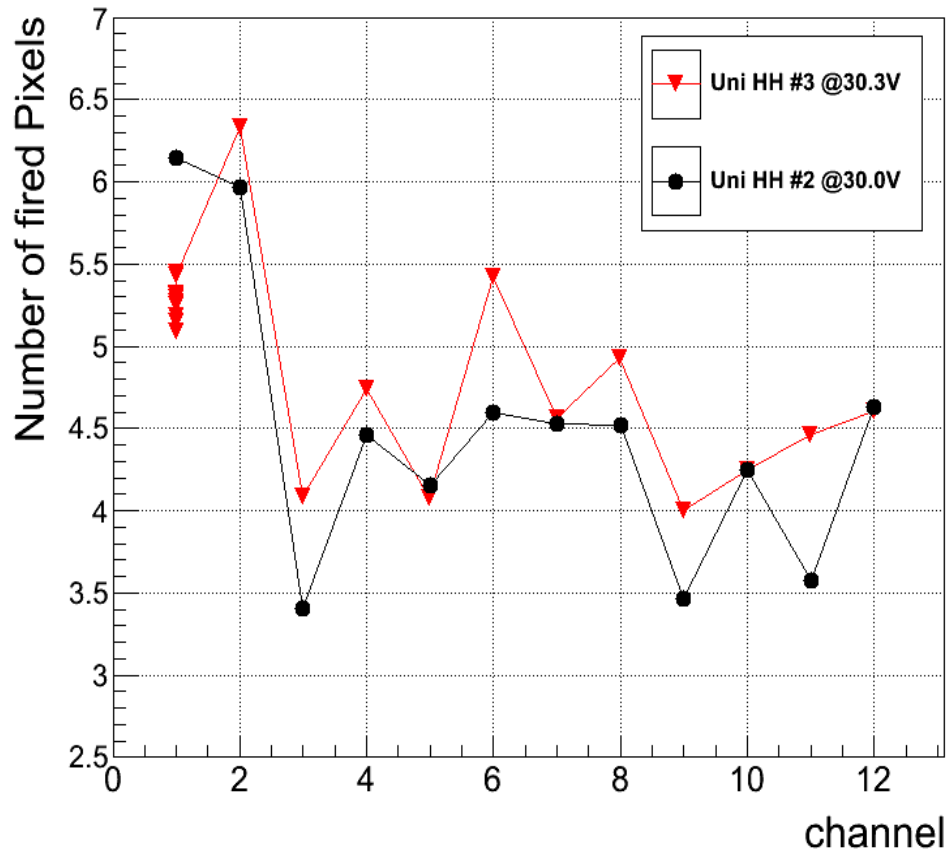
## Two characterized tiles from Uni HH

- Known voltage to MIP response and Temperature dependence
- Measure Tile signal response for both tiles
- Using one as reference, the calibration can be tested with the other tile

- Used operation voltages from measurements in Hamburg
- Measured signal for operation voltage with uniform MIP response (30V and 30.3V resp.)
- Response should be the same for both tiles
- Deviations lead to large spread of estimated operation Voltage from channel to channel
- Corresponding peak to peak spread in MIP response of  $\approx 1\text{px/MIP}$
- Seems to be a reproducibility issue!
- Mechanical flaws of the system/Tile?
- Smaller Variations for MEPHI Tiles ( $\rightarrow$  Backup)

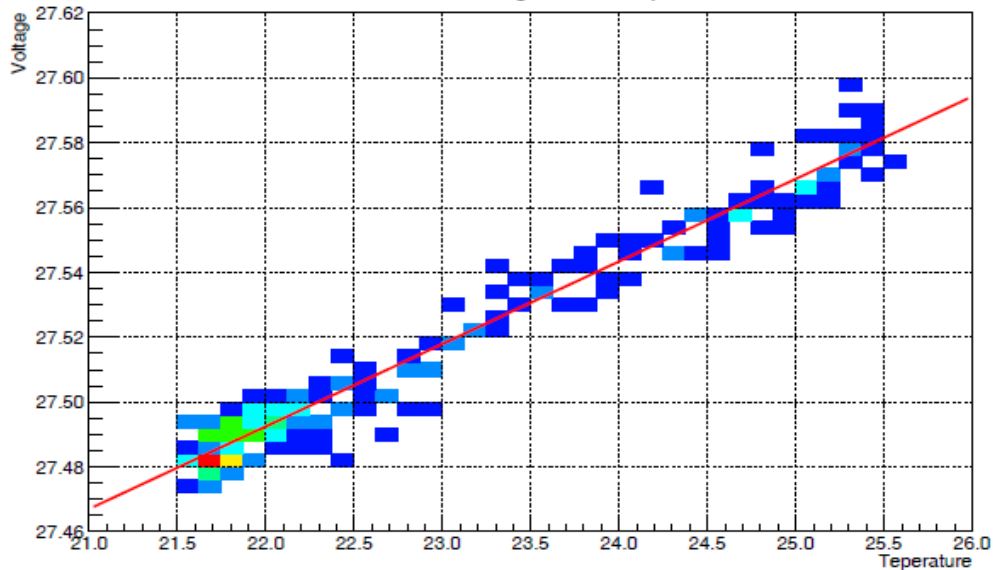
Breakdown Voltage vs Temperature

Number of fired pixels show no clear temperature relation when plotted against SiPM-Temperature  
Assumption: Additional temperature effect from laser. → Monitoring of laser/lab temperature
