Performance studies of the LC-TPC GEM module using a UV laser system

Tokyo University of Agriculture and Technology

Index

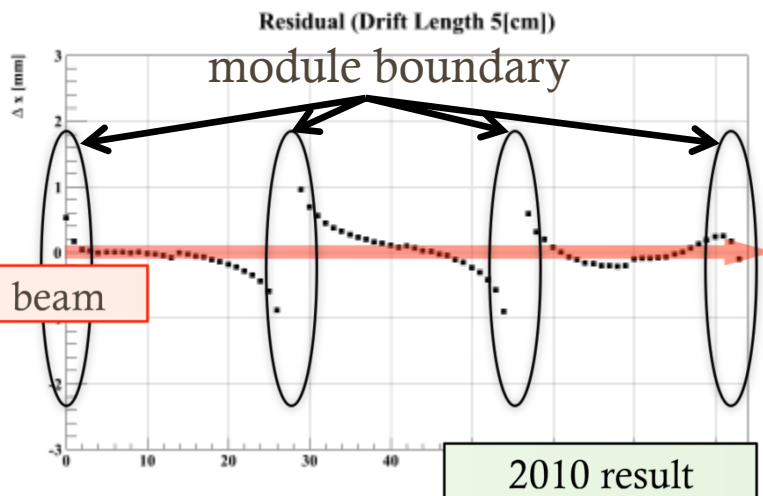
We found the big Distortion.

Reason of this Distortion;
The electric field of the
GEM module was bent.

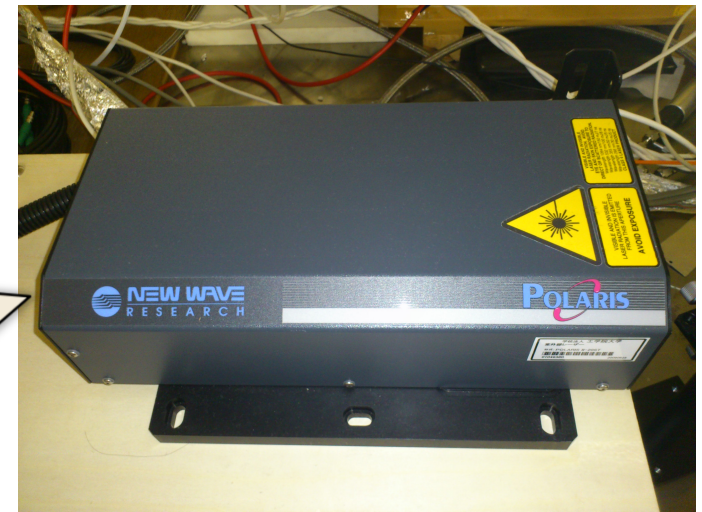
Laser

Nd-YAG laser wavelength: 266nm
rate: 1~20Hz (Using 10Hz)

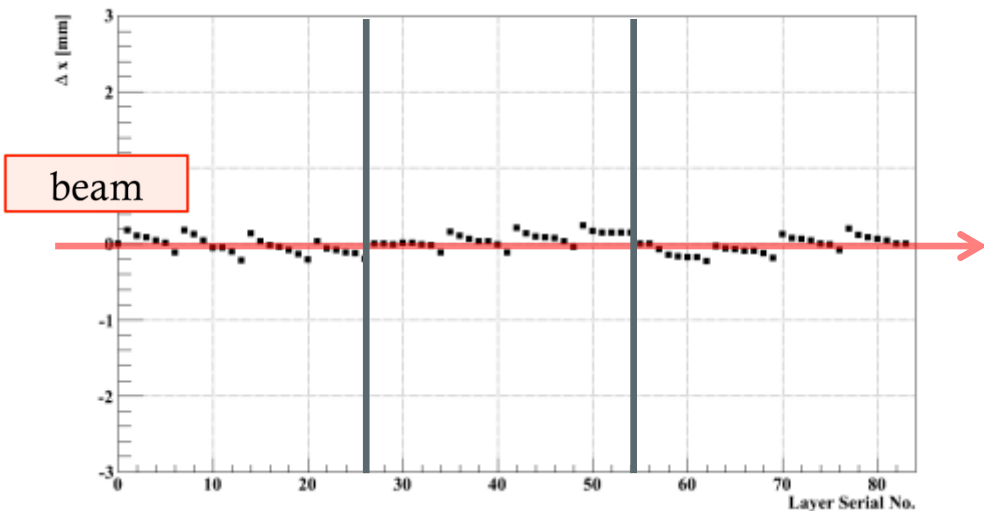
Residual (Drift Length 5[cm])

The result of beam test is also identical with laser test.

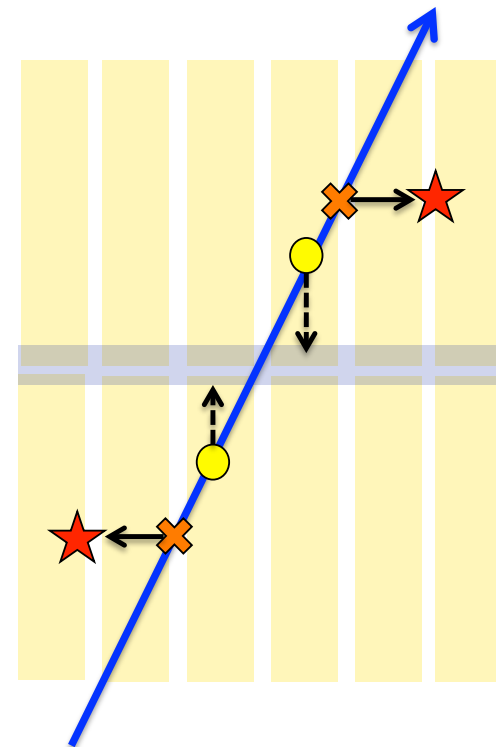
Electric field around GEM boundary

The schematic near the boundary

●:electron

✕:correct hit

★:real hit

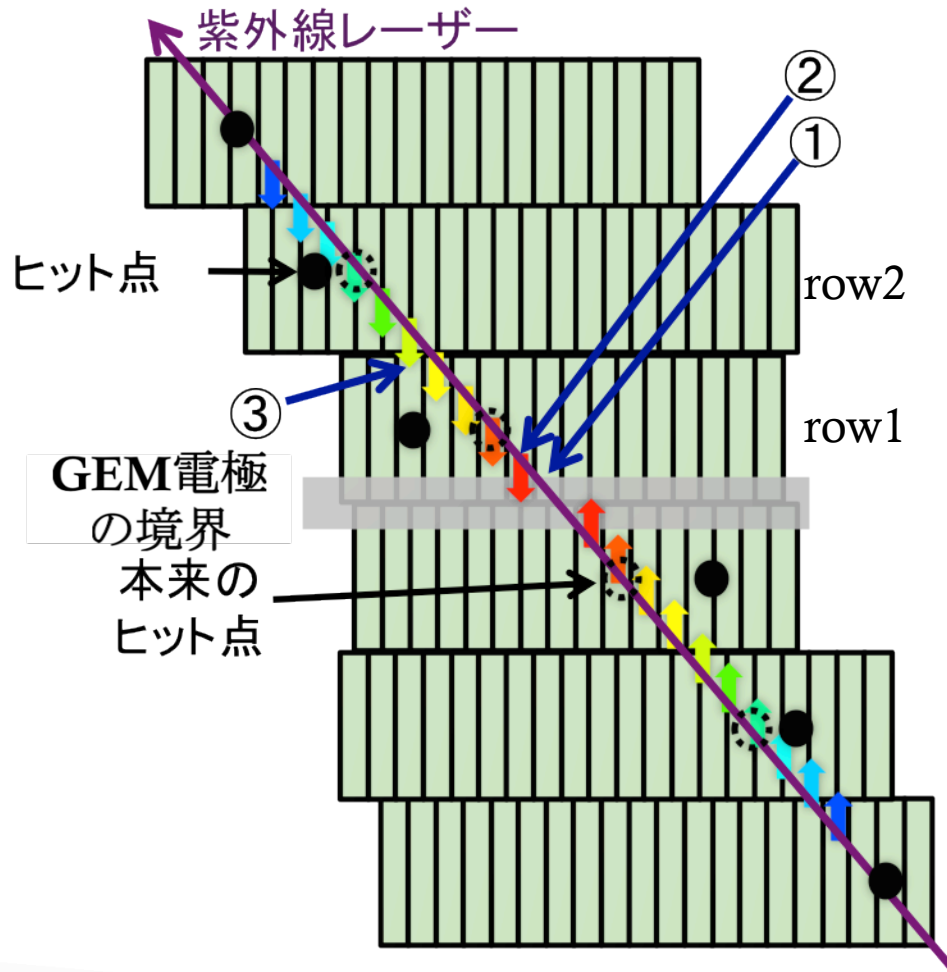
考察

row1の①のパッドに到達するはずの電子はGEMの境界に阻まれ到達できない

row1の②のパッドに到達するはずの電子は境界へ向かう電場の歪みにより到達できない

③の本来row2に到達する電子は境界へ向かう電場の歪みによりrow1のパッドに到達してしまう

これらにより **Distortion**が発生
