LINAC/DR stabilization and Monitor hardware improvement

17th ATF project meeting
2014/02/12 T.Naito

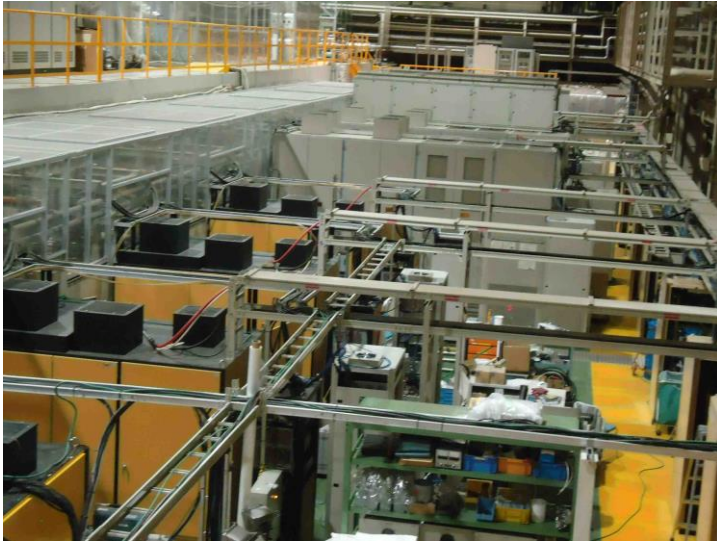
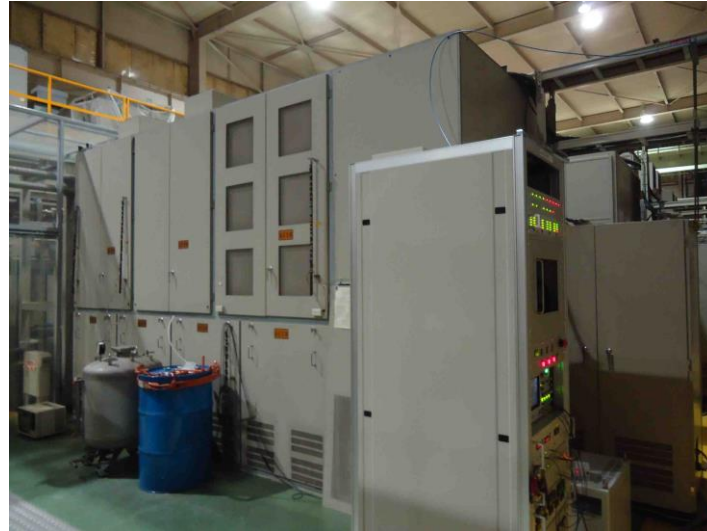
Apr.2013

Renewal of the klystron modulators

- 1. Renewal of the klystron modulators
#1~#4 completed(2013/June-Sep)
#0 in progress
The hardware bugs(HV PS) will soon be over.*
- 2. Renewal of the cooling water system for the Linac
accelerator components(2013/June-Sep)*
- 3. Replace to new klystron (#0)
The power drift come from the old klystron which was
almost end of life.*

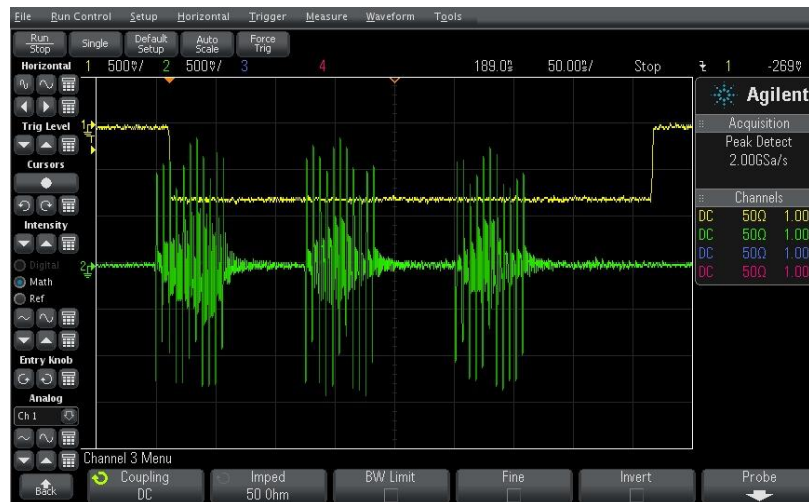
Extracted bunches at ATF2

The stored current was over 40mA in the DR and the beam could extract to the ATF2. The radiation loss was small at the condition.

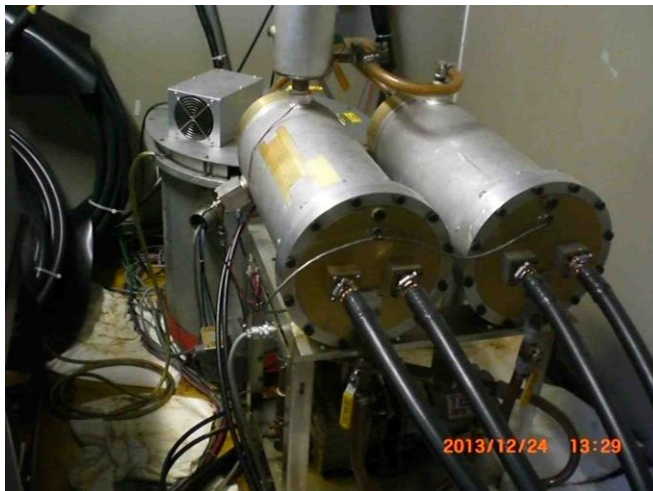
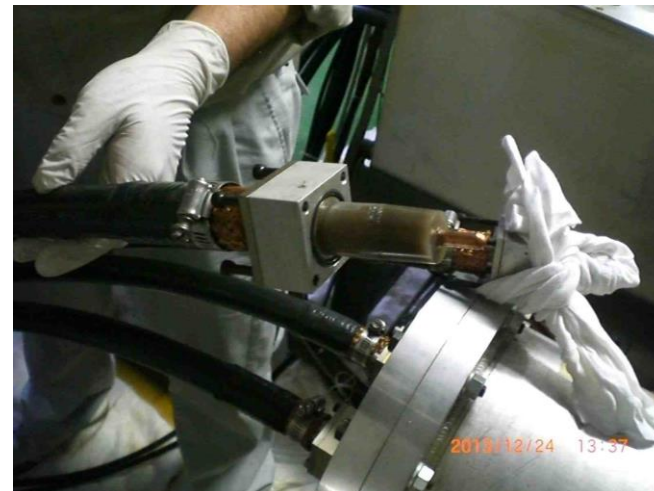
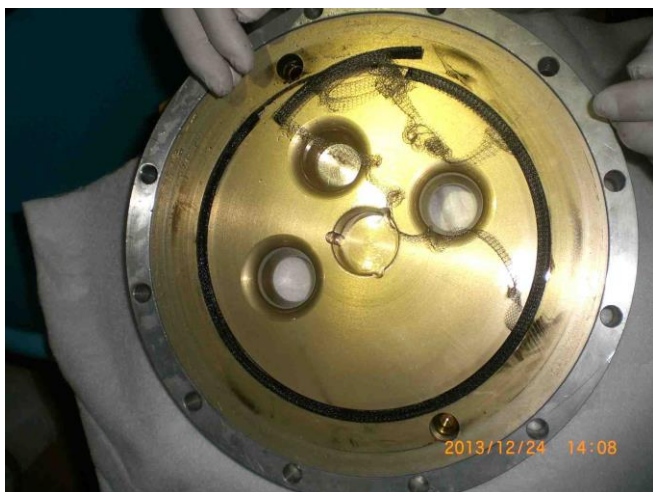
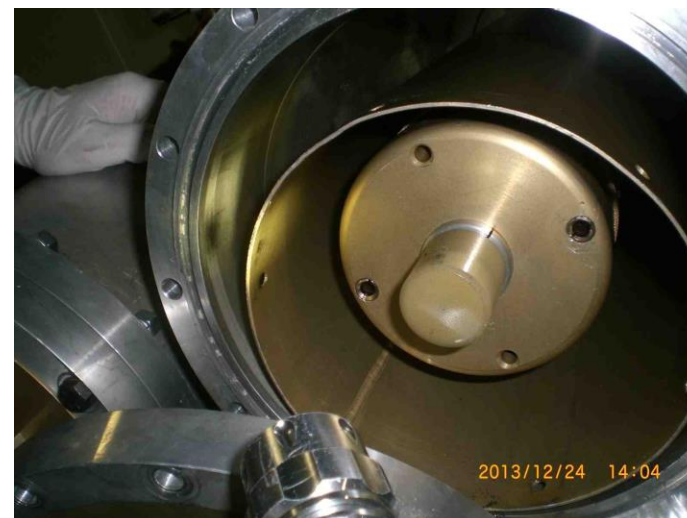
Injection kicker Trouble

The damage at the GND contact was found. The O-ring does not work to make the contact.

- 1. Injection kicker HV PS was broken(Dec/2013). After replaced the HV PS, we found the damaged dummy load. According to the instruction of J.W. Krzaszczak(SLAC), the dummy load was repaired.*
- 2. The new installed HV PS of the modulator(fabricated by TDK-Lambda) had the hardware bugs(low noise immunity). We had to replace the troubled HV P.S. some times. The reason was found out, already.*
- 3. The RF gun laser(5.6ns spacing) had trouble(Jan/2014). The spare laser(2.8ns spacing) was used for Jan/Feb operation.*

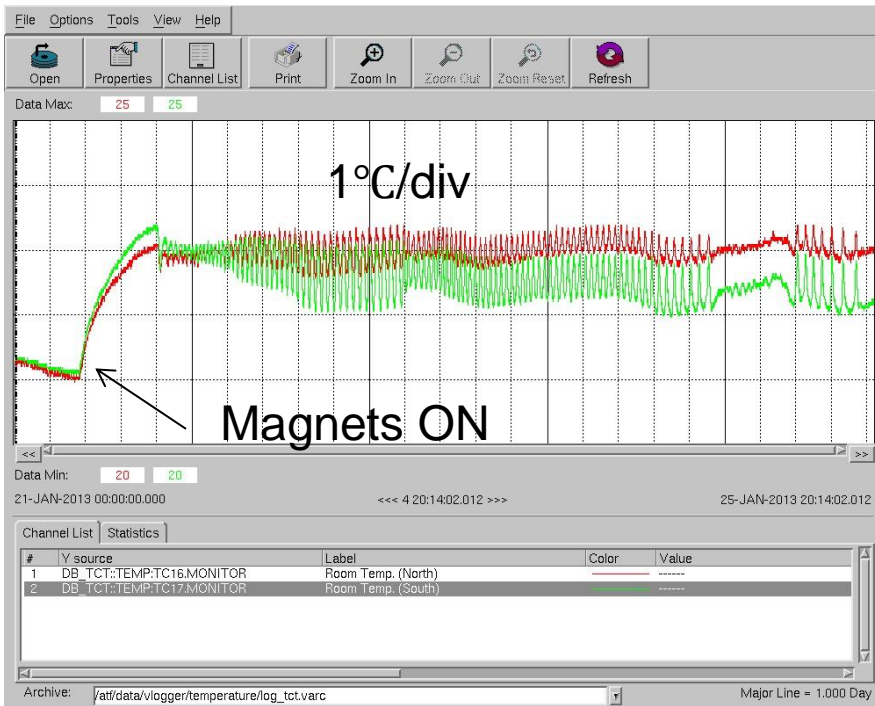
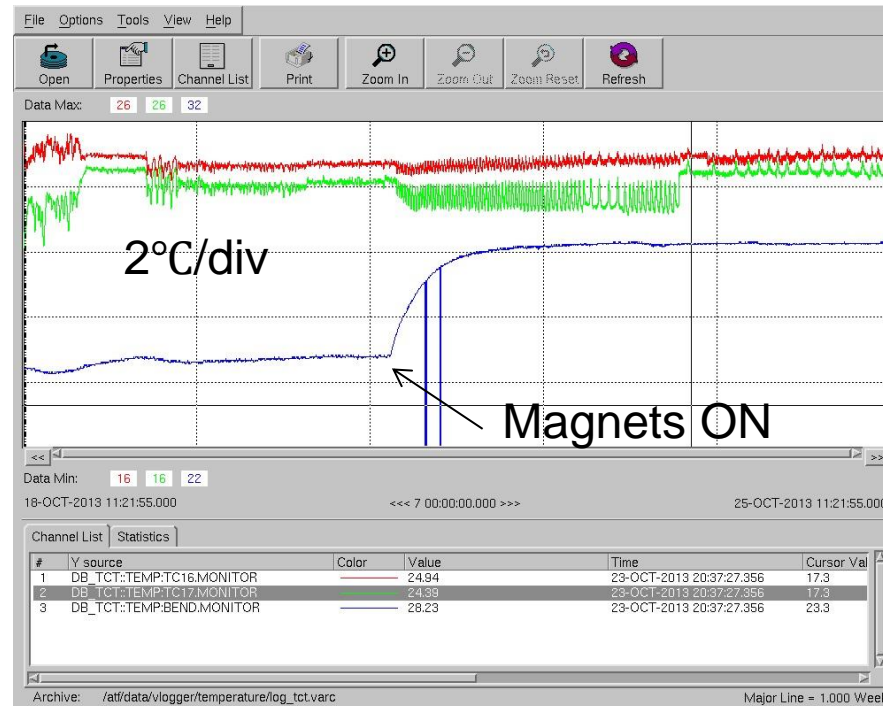
Before summer shutdown

After summer shutdown

The Temperature in the tunnel was changed when the magnets were turned on. After moved the censer location, the temperature change was reduced.

- 1. DR tunnel temperature stabilization
The air conditioner censer location moved from the return to the output.*
- 2. Cooled air introduced to the DR Nakanoshima area.*

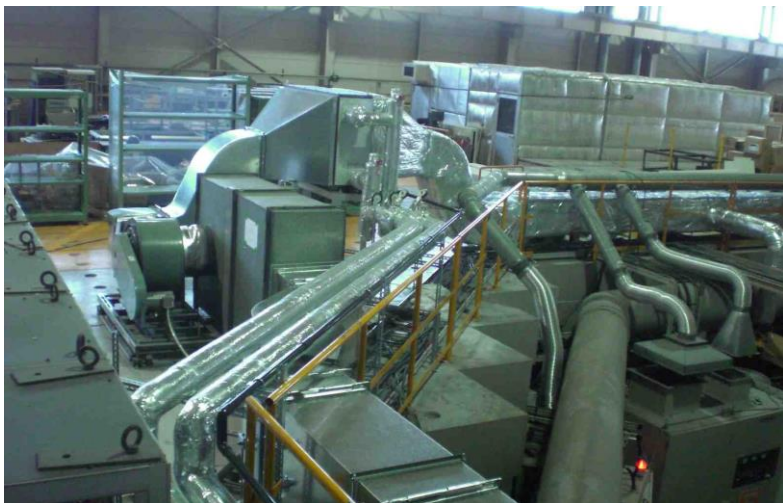
Cooled air introduced to the DR Nakanoshima area

The previous air cooling was the outside air introduced Nakanoshima. The temperature was changed during day and night. The constant temperature air blow using a 45kW chiller, which was used at linac, was introduced.

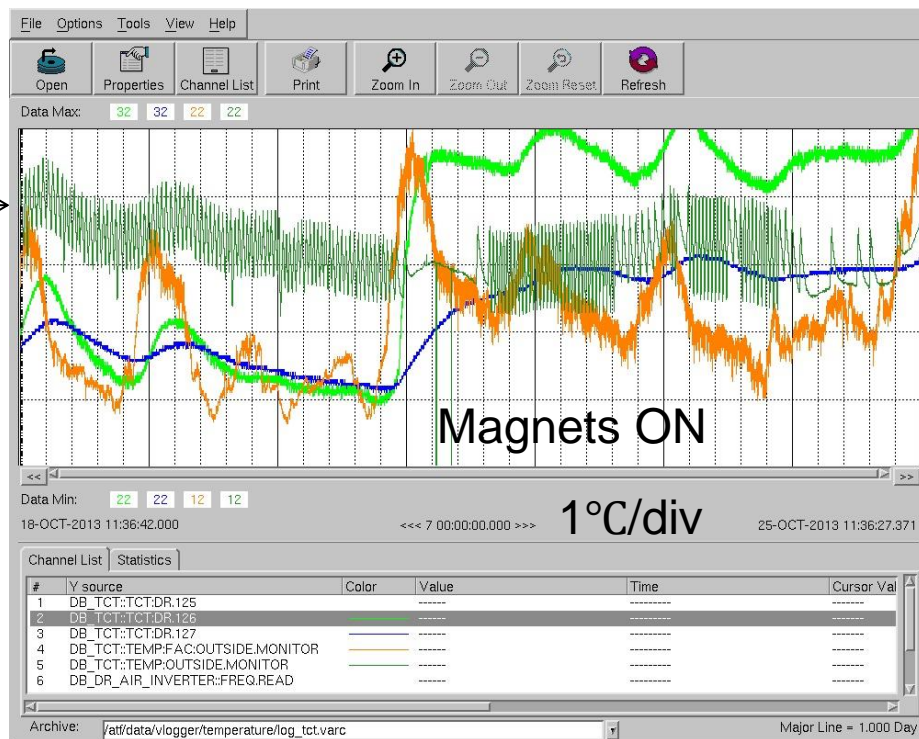
Cooled air(green) →

Nakanoshima floor(blue) →

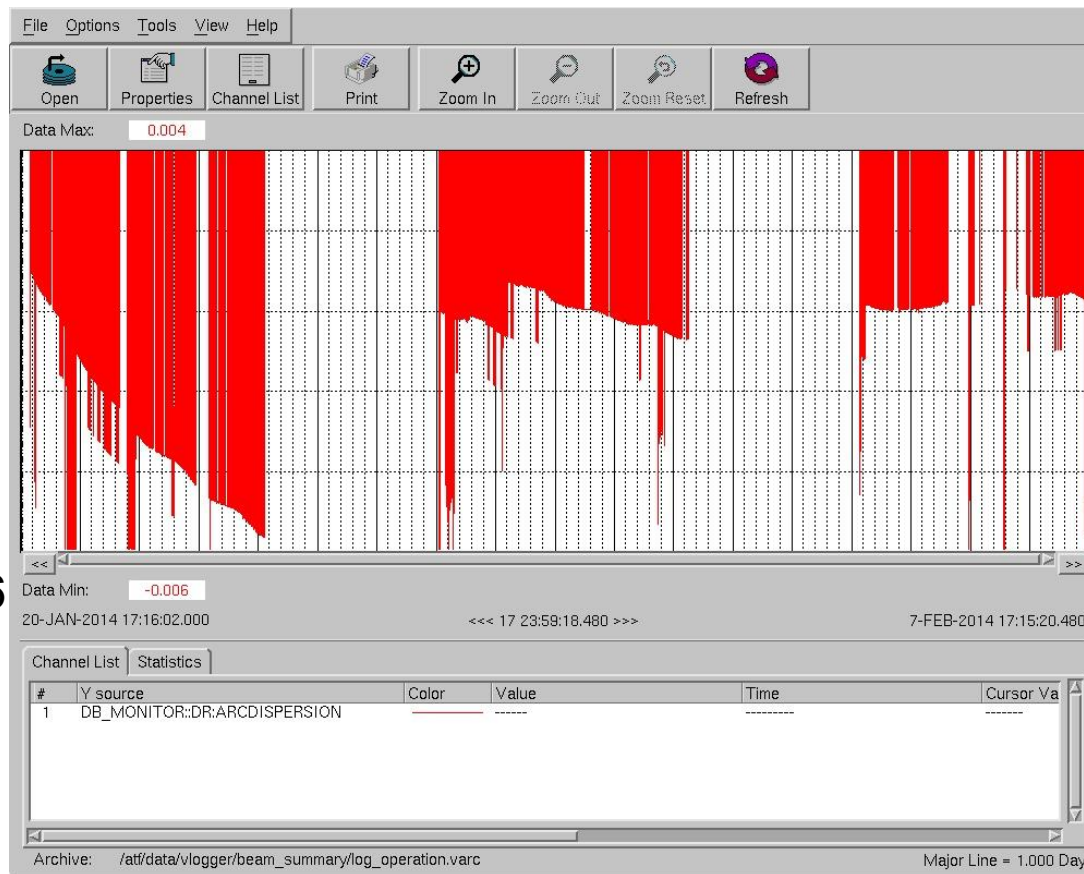
DR circumference

20/Jan/2014~7/Feb/2014

$\Delta F = 1428.058 - 1428.030$
 $= 28\text{kHz}$
 $\Delta C = \sim 3\text{mm}$

The circumference changed 3mm during two weeks.

All of the power off during the winter shutdown and the cooling water temperature was reduced to prevent the frozen water trouble.

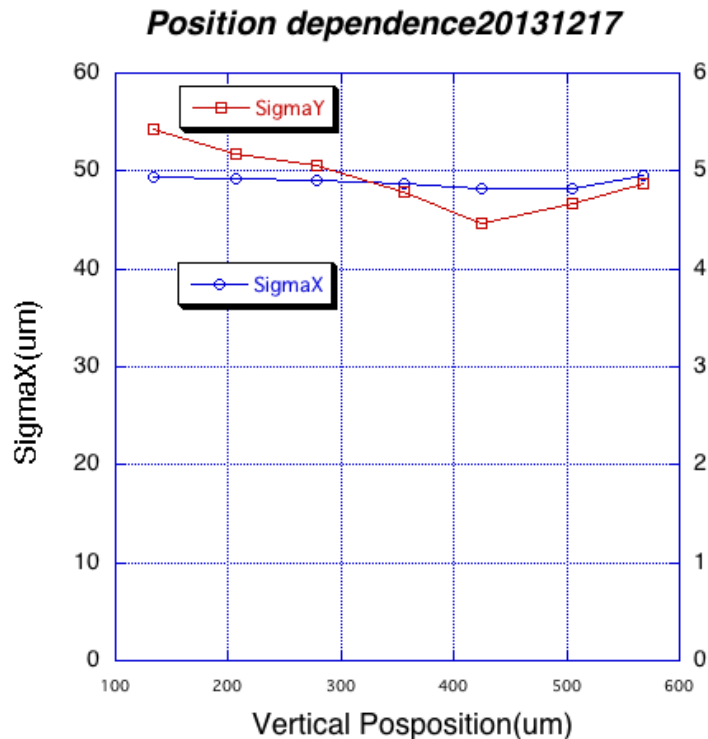
XSR monitor problem

The measured vertical beam size changed about 20% according to the vertical position. The focus scan result showed the evidence of the astigmatism of X-ray optical device. We suspected the deformation of the Si mirror which was replaced 3 years ago.

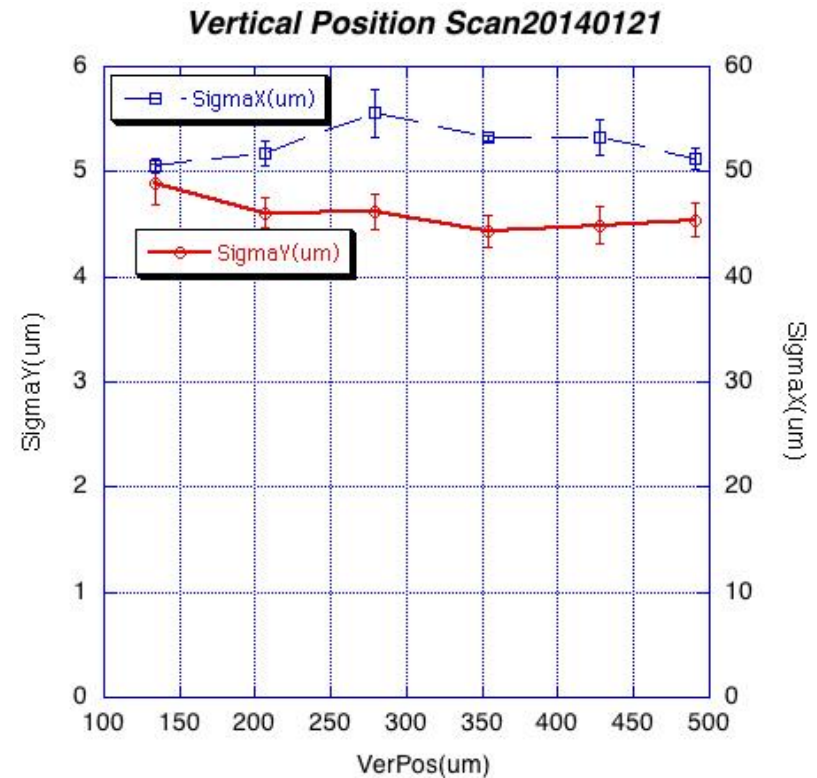
XSR monitor problem

The Si mirror was replaced to previous one then the position dependence was almost cured.

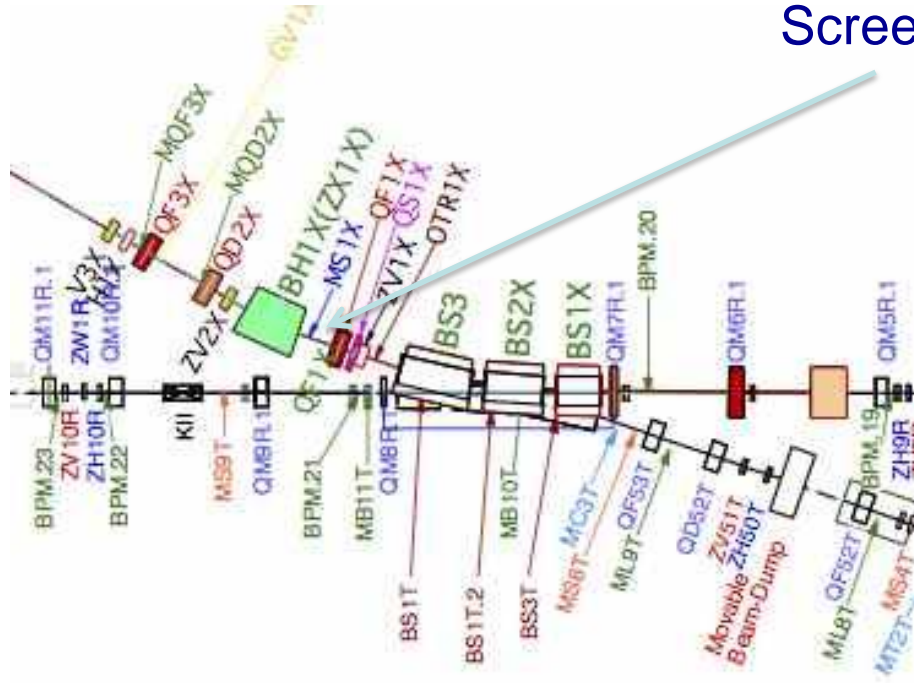
MS1X
Screen monitor

A new screen monitor using YAG:Ce scintillator was tested.

- 1) To measure the beam tilt at the exit of the DR
- 2) To measure the momentum spread
- 3) To measure the vertical beam size

A high resolution lens was adopted to the modified screen monitor chamber.

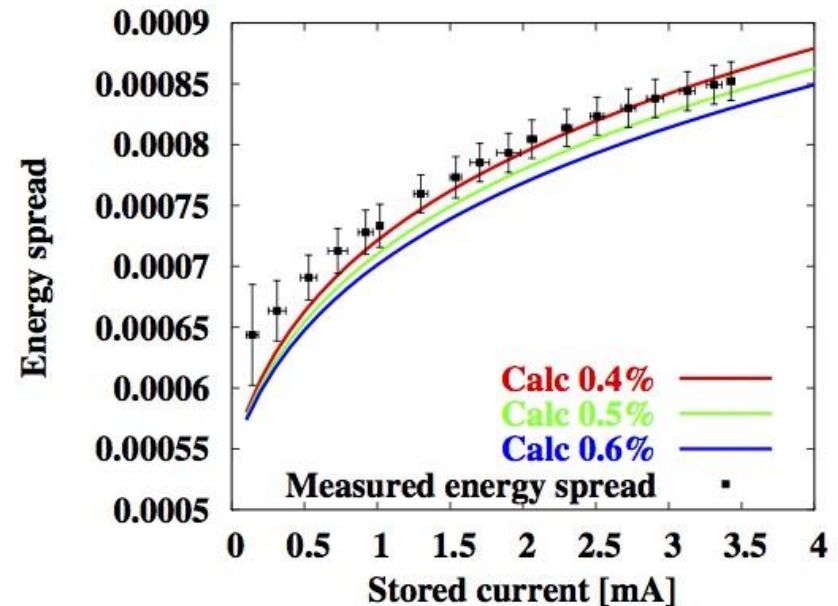
Example of energy spread meas.

Beam size calculation from design parameters and measured emittance,

$$\begin{aligned} \text{Sigmay} &= E_y \times \text{Betay} = (14 \times 10^{-12} \times 8.5675)^{1/2} = \underline{11 \mu\text{m}} \\ \text{Sigmax} &= ((E_x \times \text{Betax})^{1/2})^2 + (E_{\text{tax}} \times dp/p)^2)^{1/2} \\ &= ((1.3 \times 10^{-9} \times 2.2148)^{1/2})^2 + (0.4868 \times 0.6 \times 10^{-3})^2)^{1/2} \\ &= (53.6 \mu\text{m}^2 + 292 \mu\text{m}^2)^{1/2} = \underline{297 \mu\text{m}} \end{aligned}$$

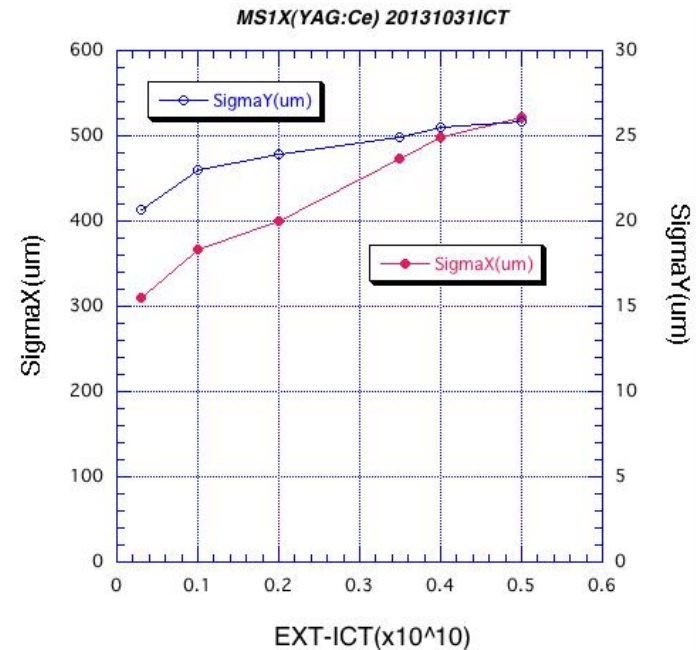
2013/10/31

Ver $1.8\text{ch} \times 11.5\mu\text{m}/\text{ch} = 20.7\mu\text{m}$
Hor $41\text{ch} \times 8.1\mu\text{m}/\text{ch} = 332.1\mu\text{m}$

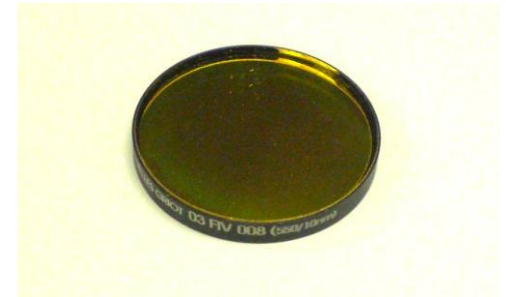
Beam test 2013/11/22

The lens was replaced to high magnification lens (6 μ m resolution) and an optical filter (500nm/10nm bandwidth) was installed to avoid the saturation.

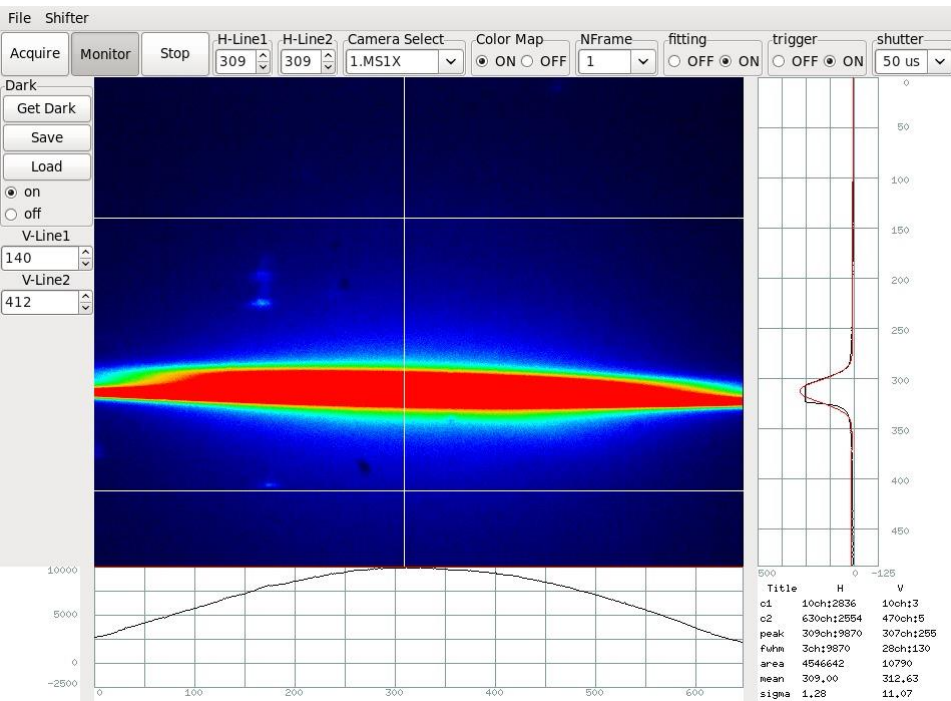
Without BPF
Trigger delay : 44.7 μ s

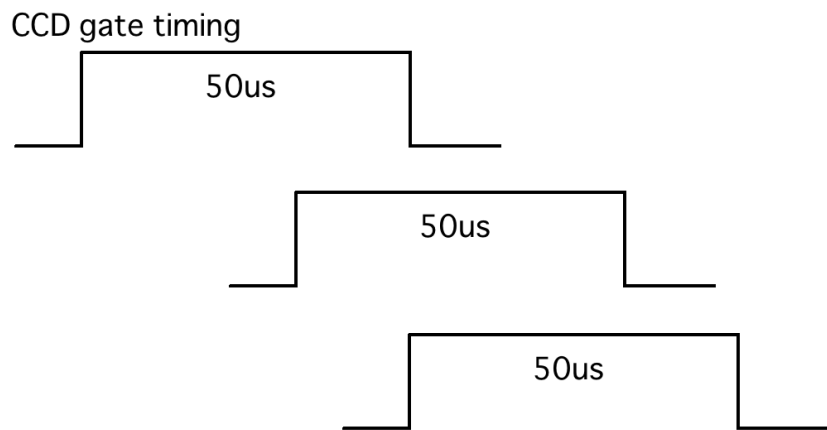
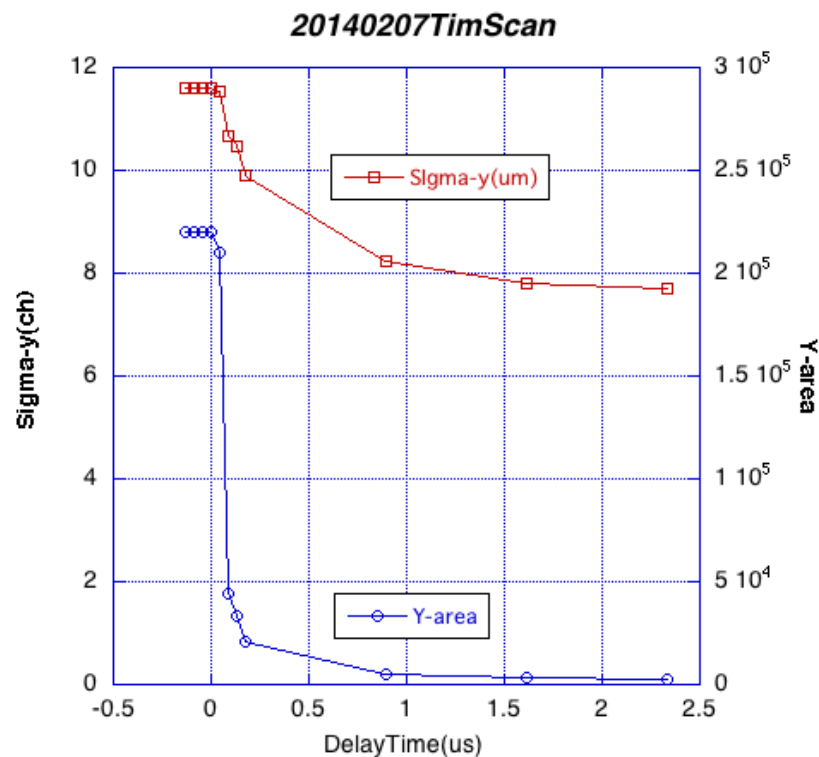
The shutter timing characteristics (electric shutter width 50us)

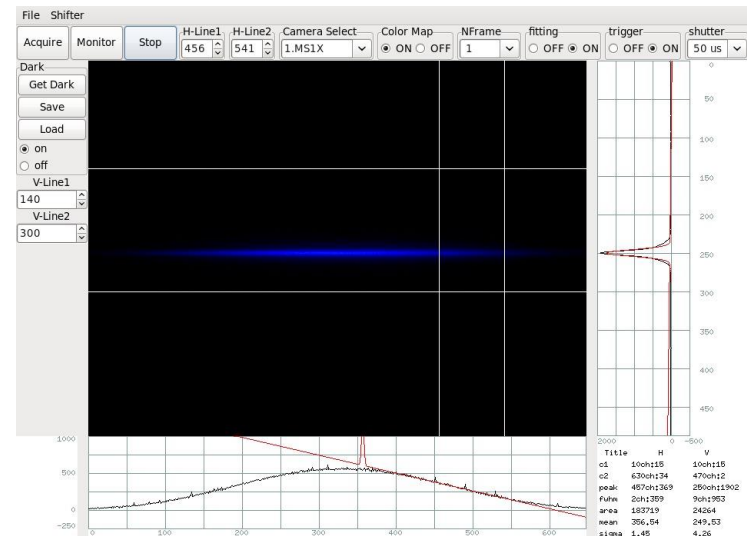
$$4.26\text{ch} \times 7.4\mu\text{m}/\text{ch} \times 1/2 = 15.7\mu\text{m}$$
