# Silicon sensor study for ILD ECAL

Tatsuhiko Tomita

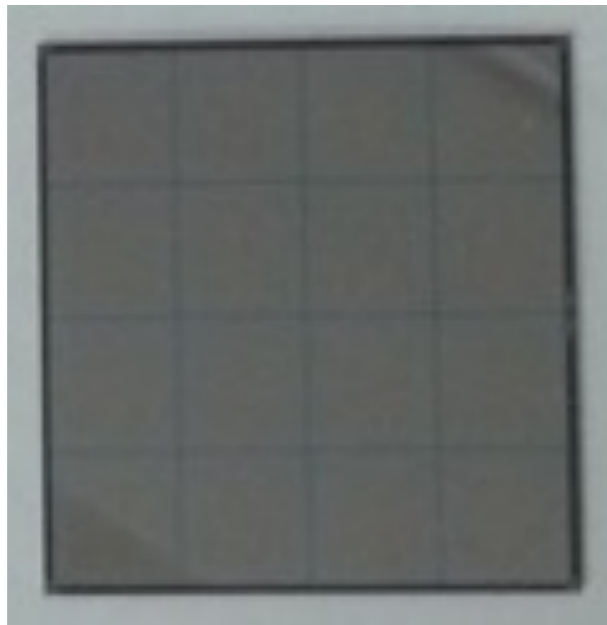
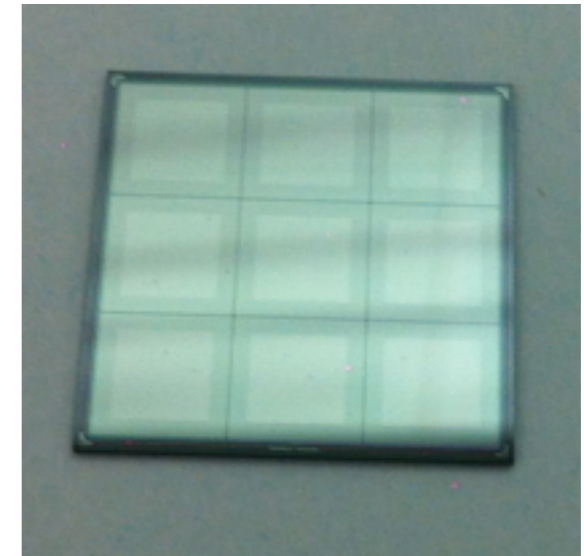
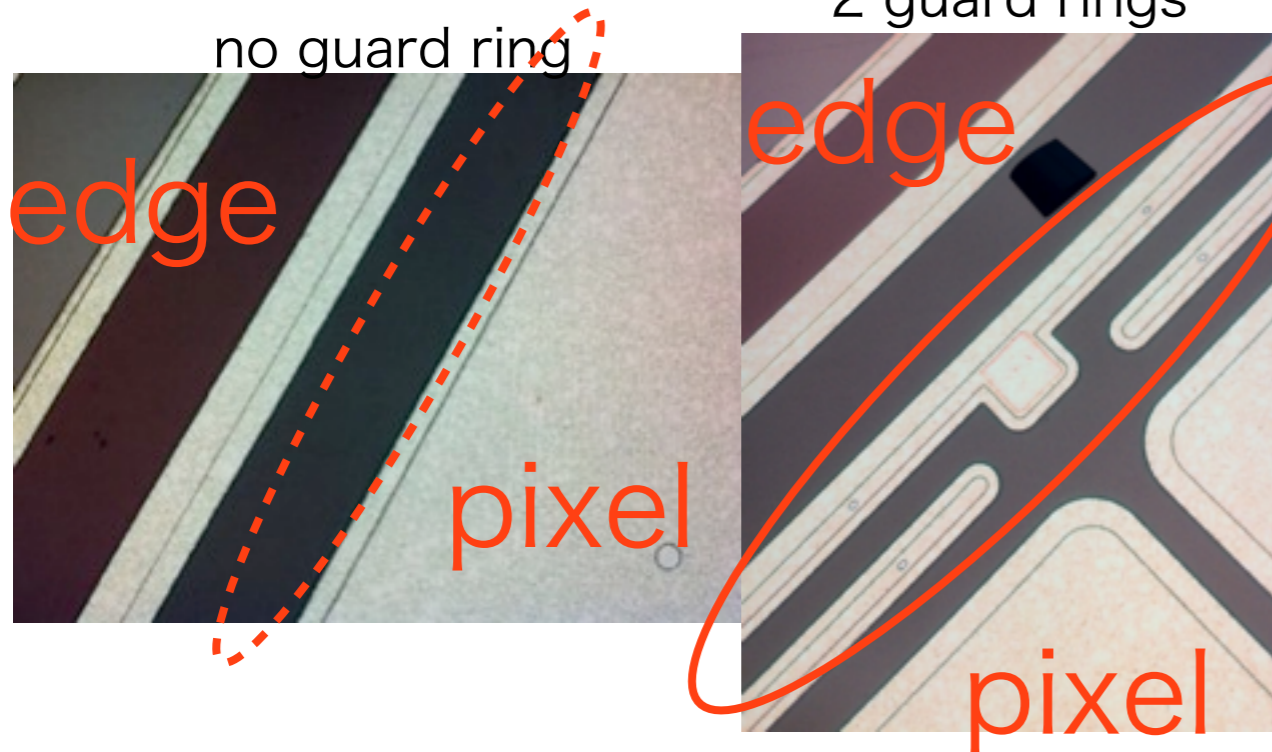
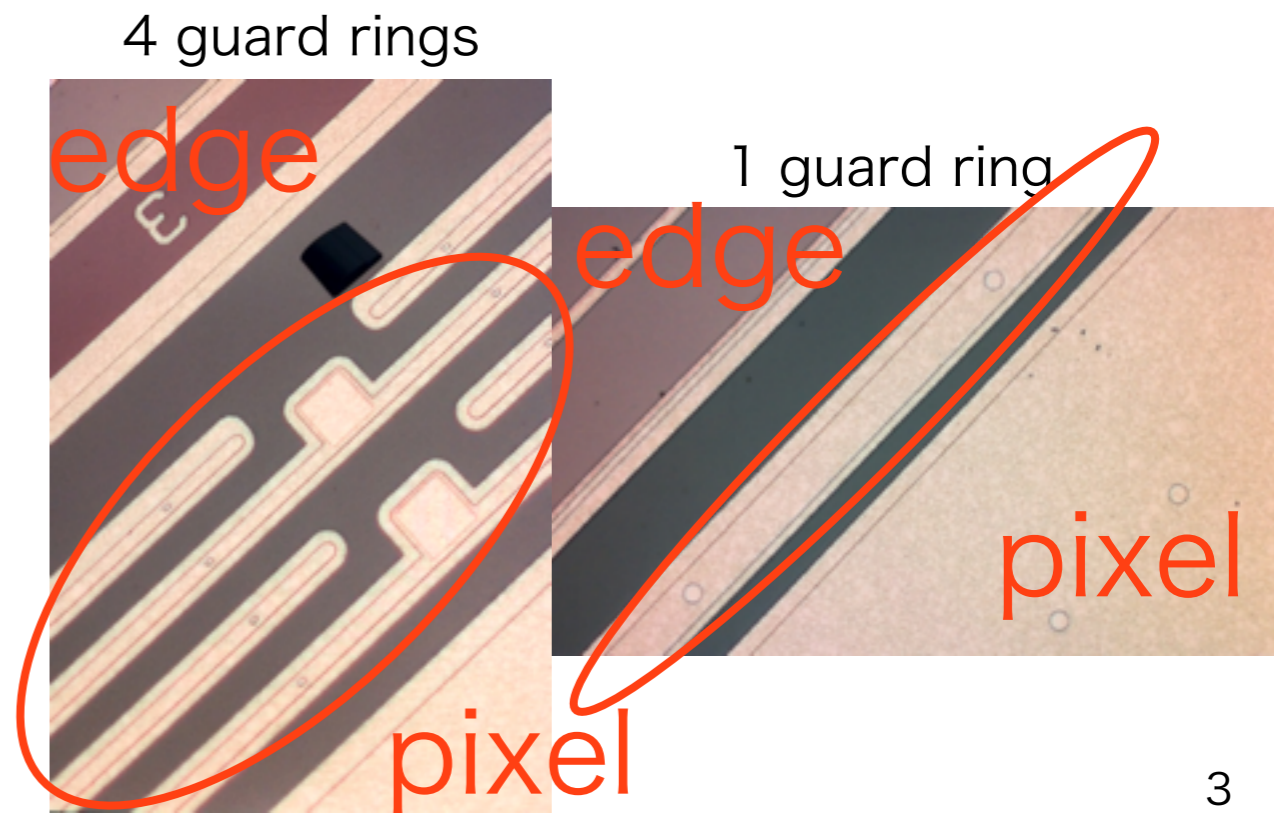
- We have four types of sensor (currently only in small chips).

Their guard ring structures are slightly different from each other.

The guard rings can collect surface current and moderate electric field distribution of edge, but it also limits sensitive region and make non-uniformity in gap area.

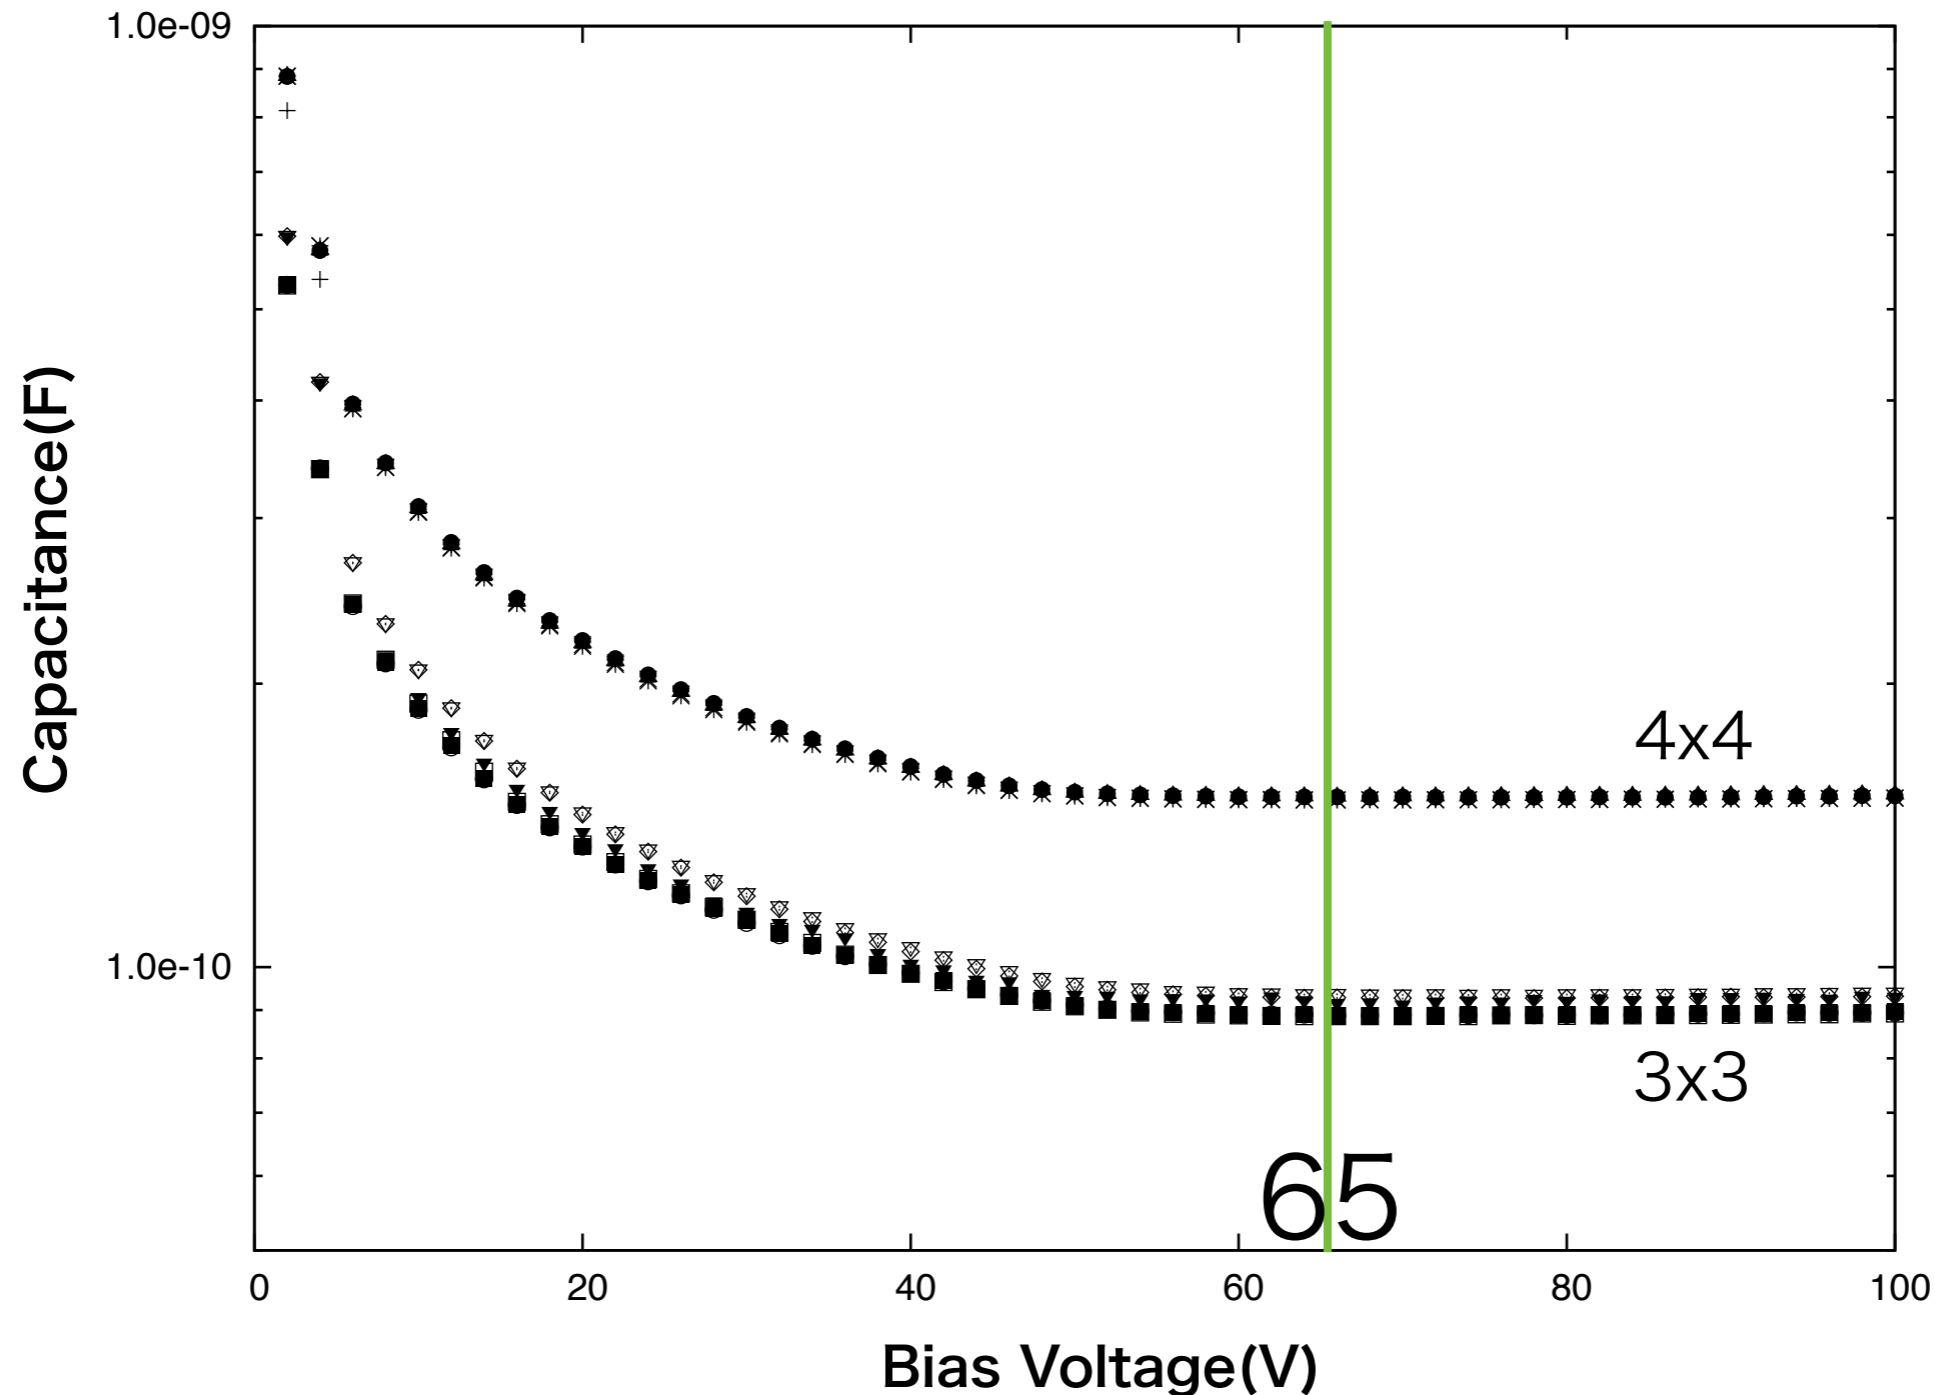
Since chip area is different between 3x3 and 4x4, capacitance value is slightly different.

Full depletion voltage is about 65 V,

and this value is consistent with specification from Hamamatsu.

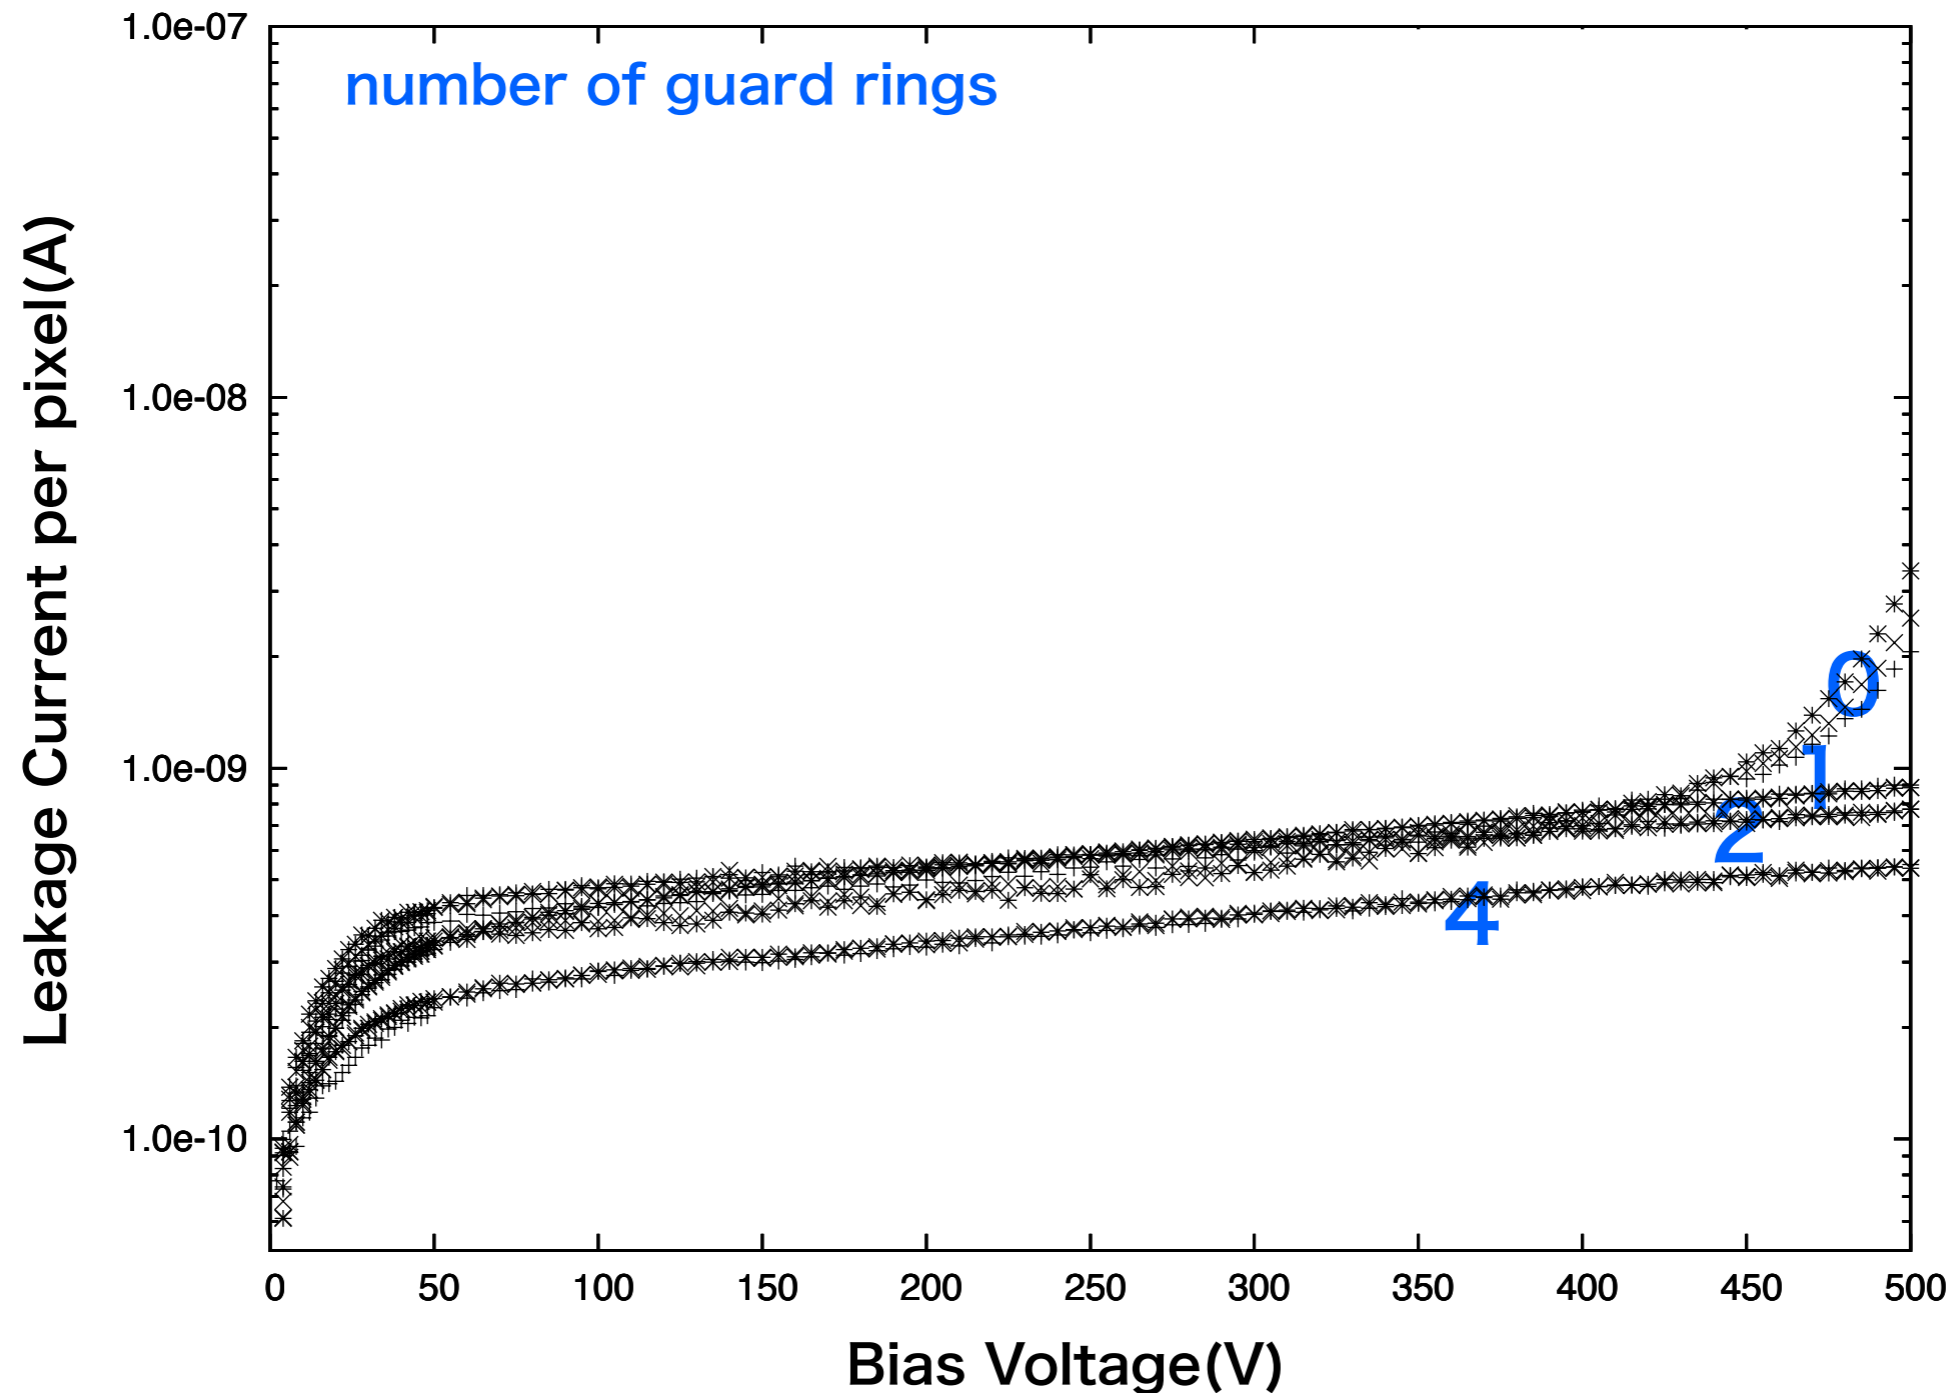
- Chip leakage current is shown below.  
The shape of leakage current is almost the same in all type.  
Break down voltage is higher than current operation voltage. (120 V)

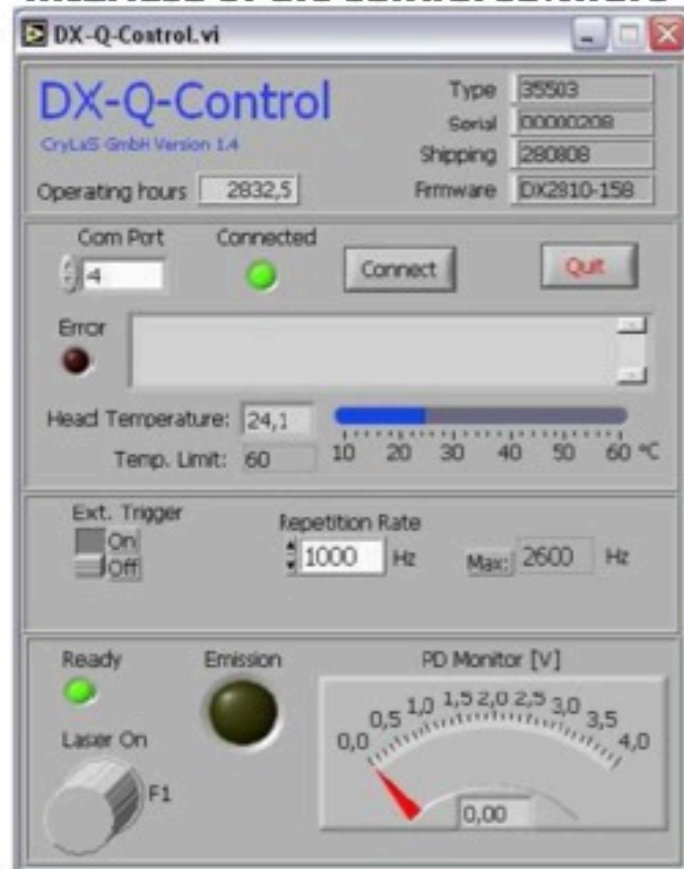
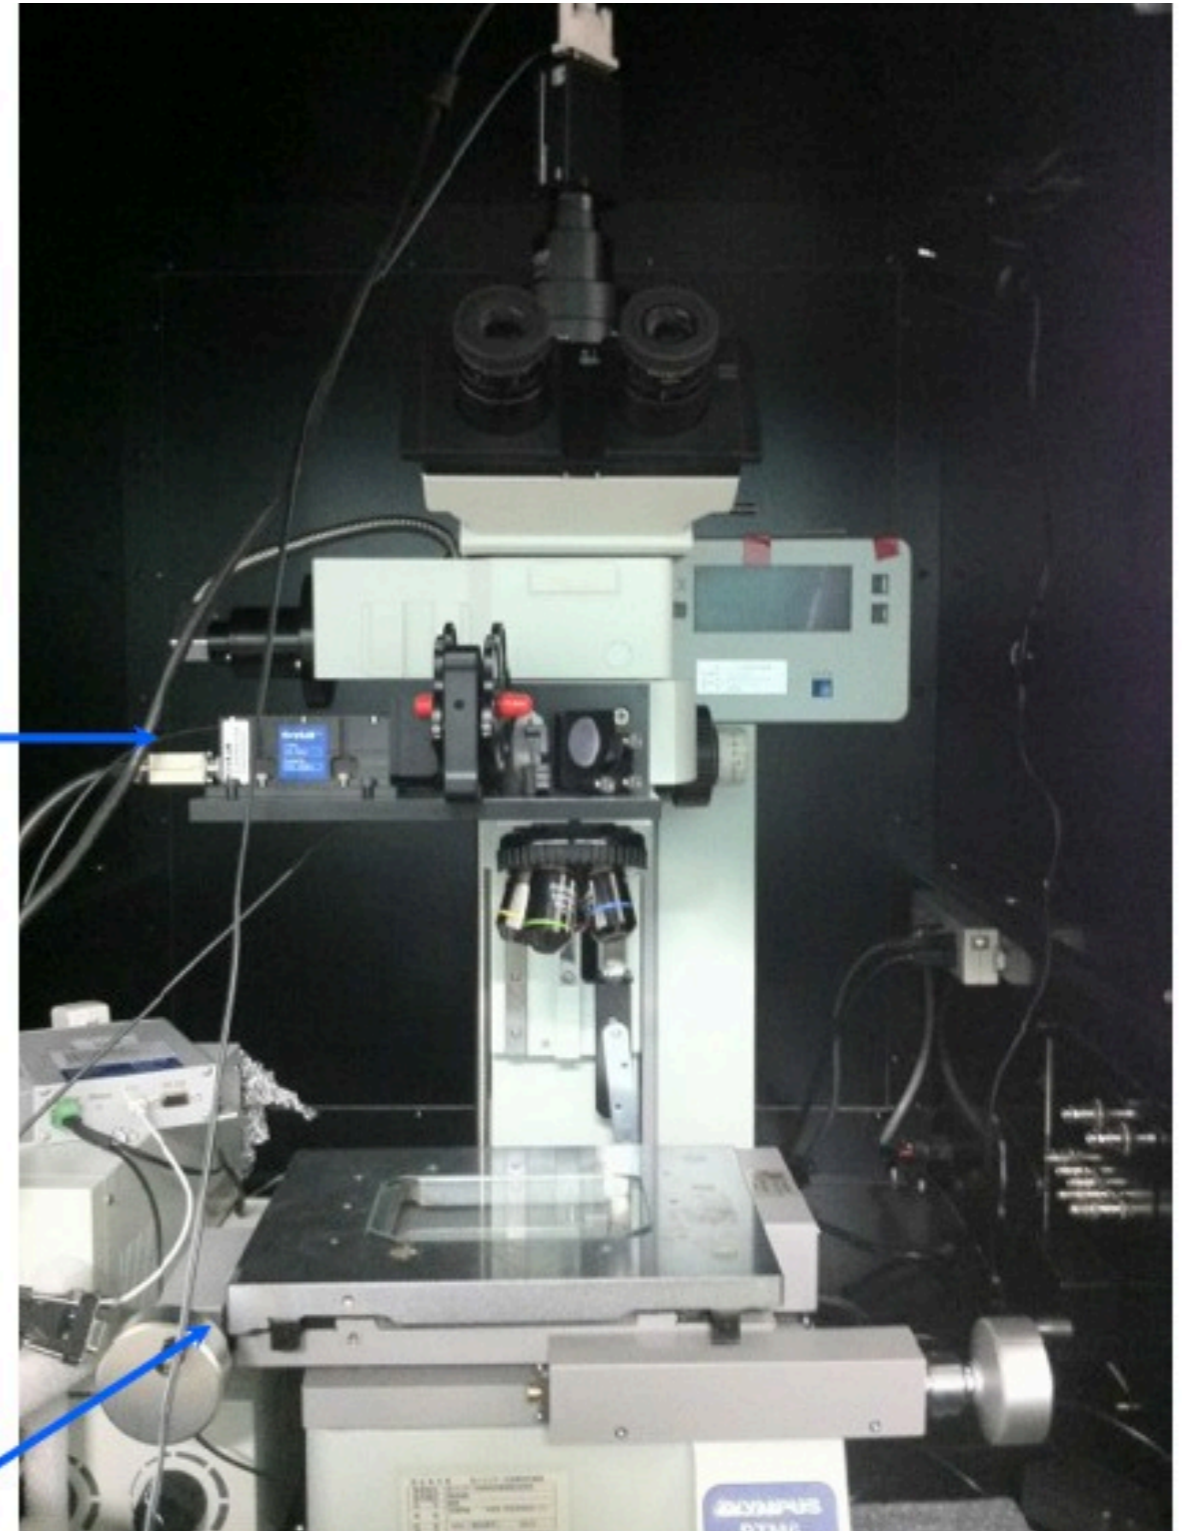
CRYLAS GmbH

DSS1064-Q2 (Class 3B)

Wave length : 1064 nm → 1.16eV

Pulse width : ~ 1.5 ns

Pulse energy : > 20  $\mu$ J/pulse  
~  $10^{14}$  photons/pulse

Peak power : > 13kW

Repetition rate : 1 ~ 10kHz

Interface of the control software

Laser  
Trigger  
ND-filters  
mirror

x-y stage

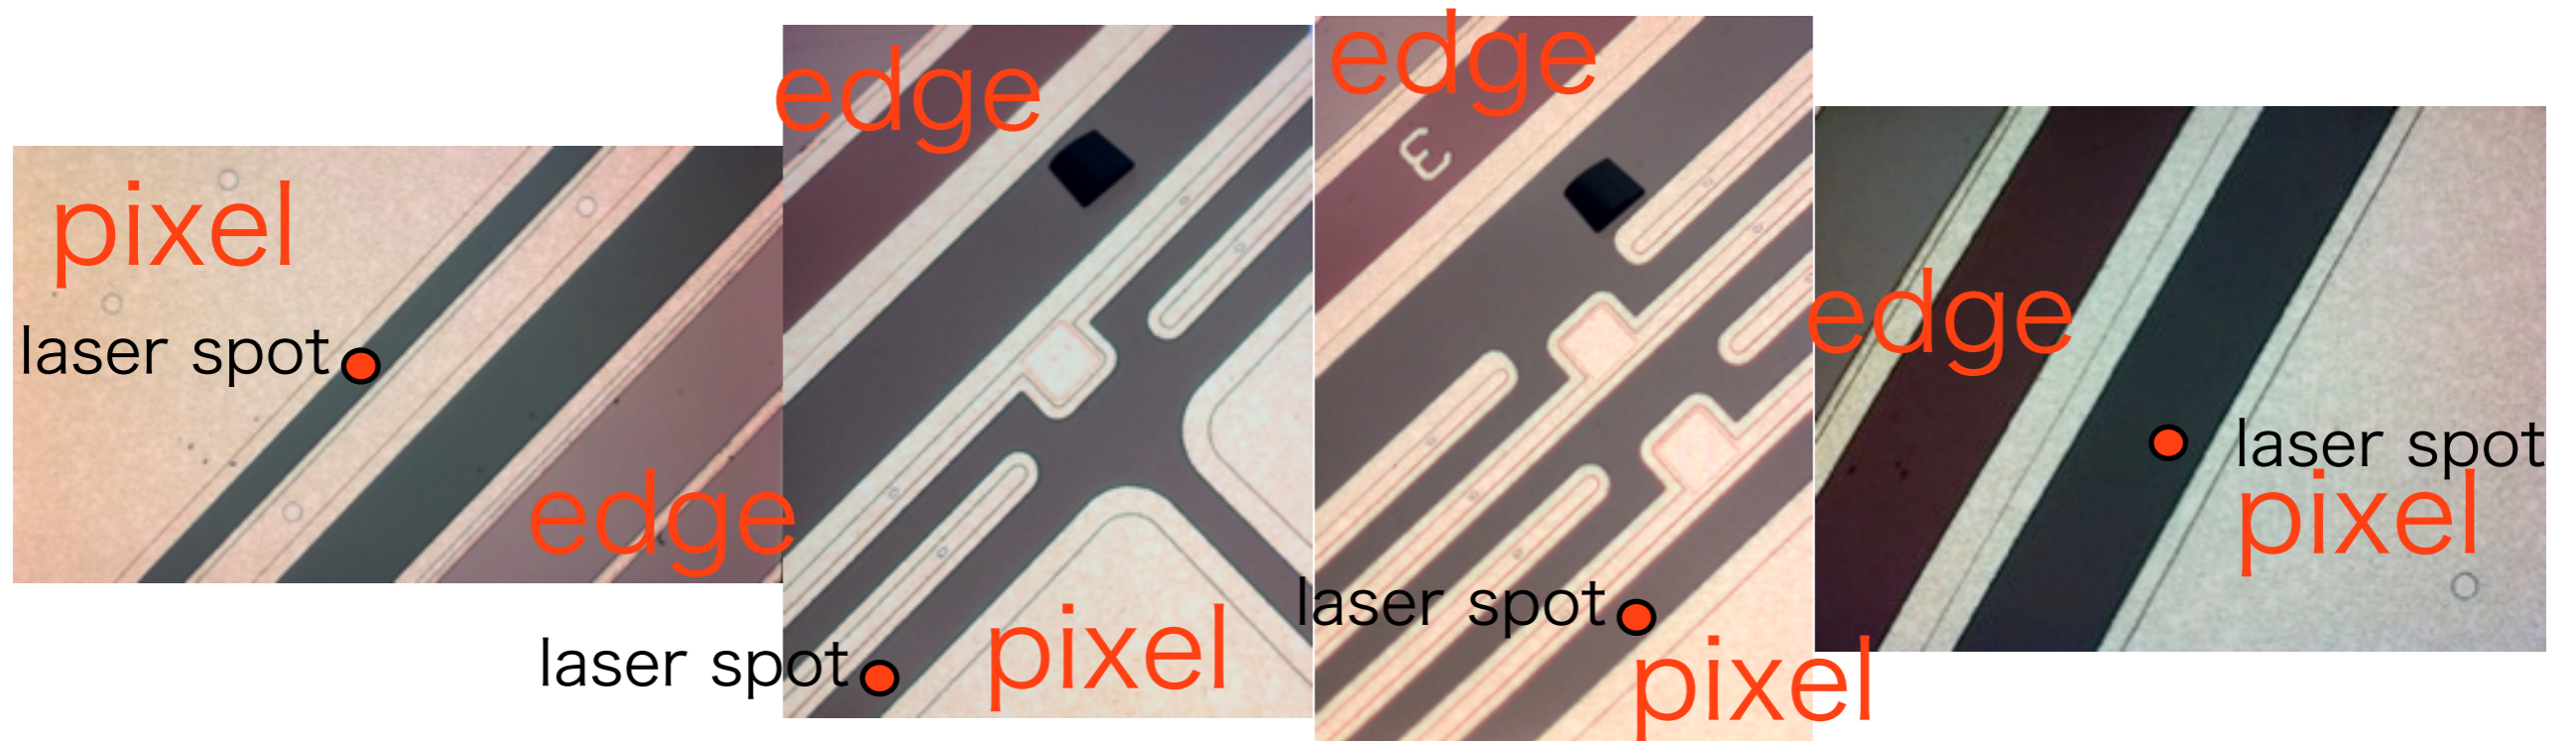
- We shoot the infrared laser between guard ring and a pixel.

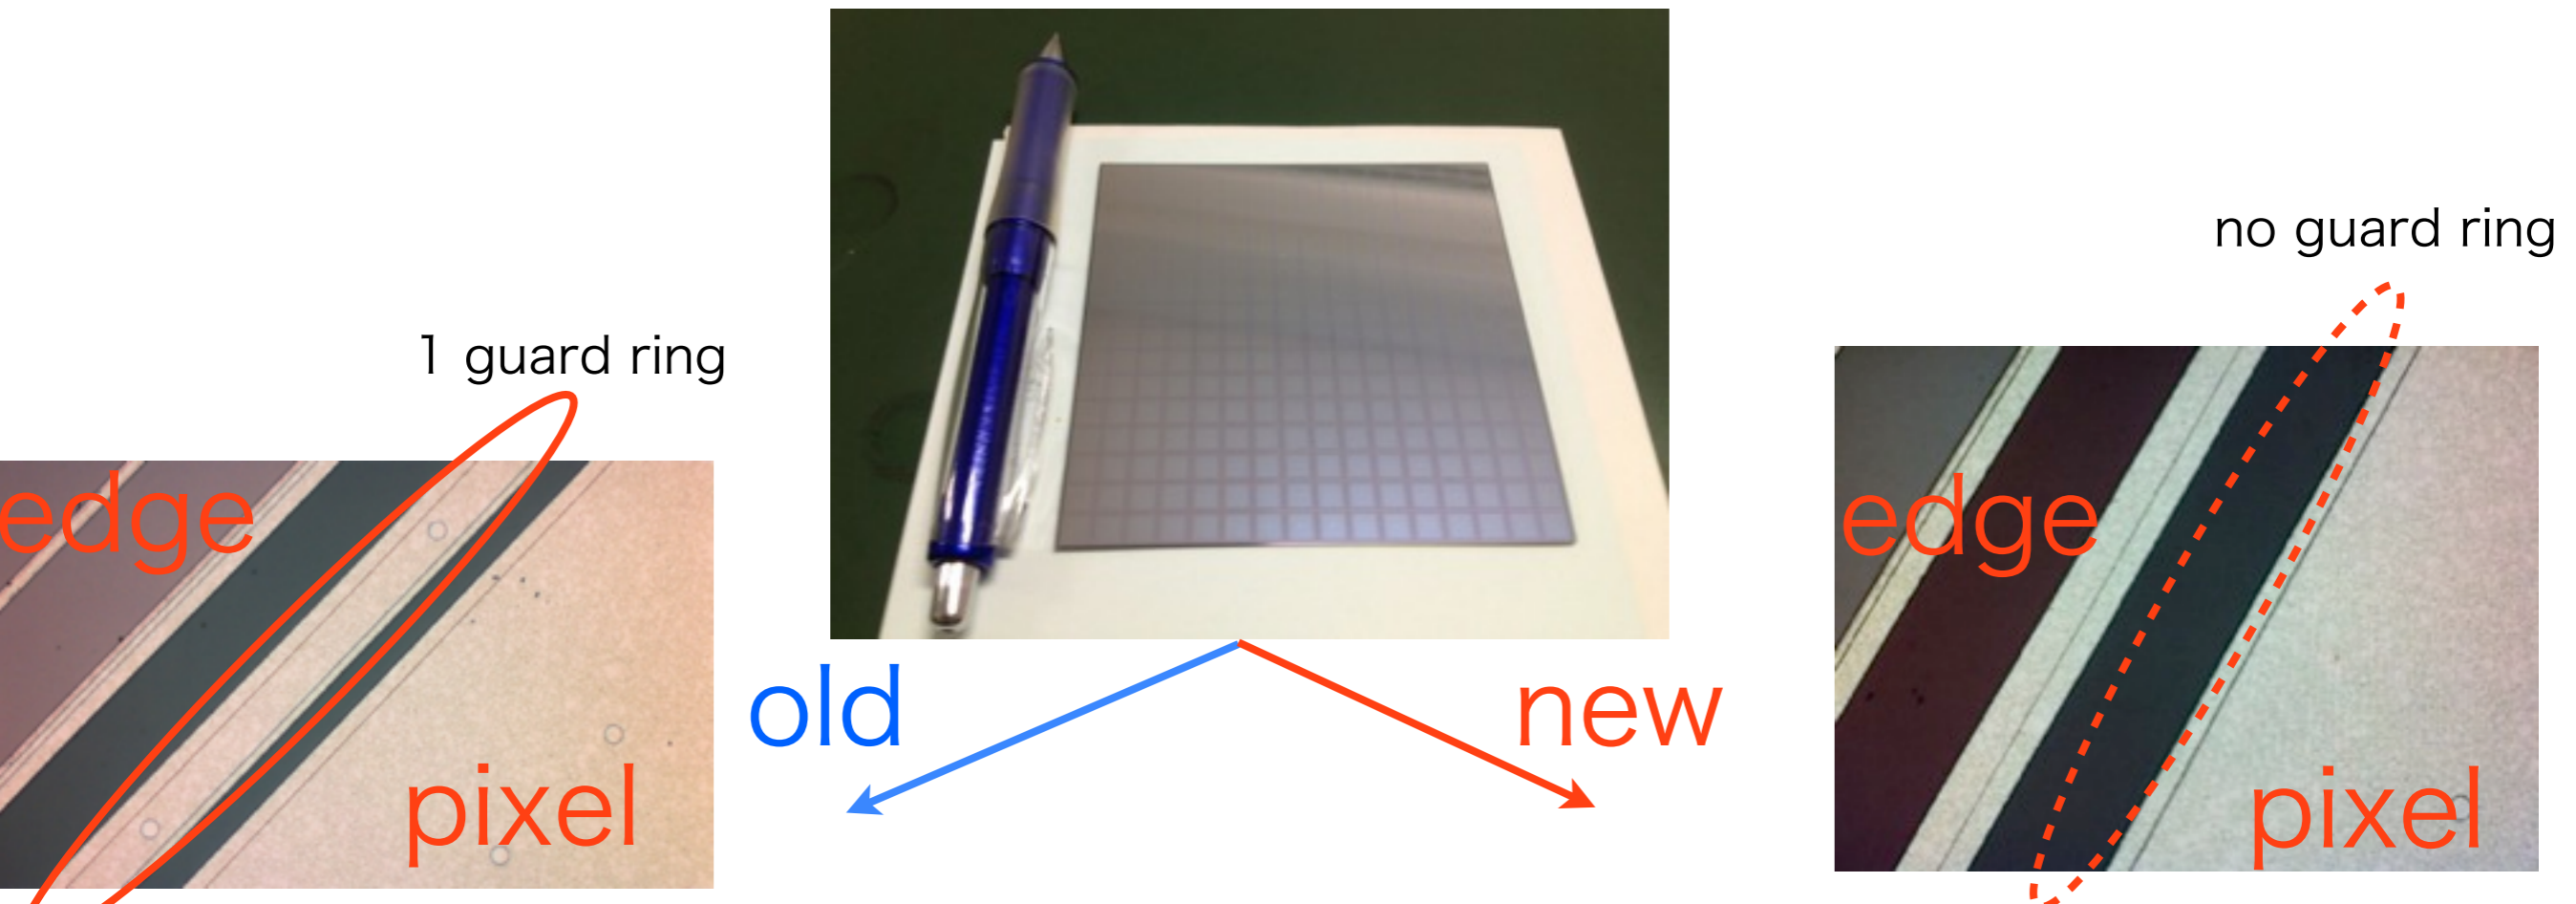
- Hamamatsu made new prototype with no guard ring structure.

pixel size : 5.5 x 5.5 mm	same	pixel size : 5.5 x 5.5 mm
thickness : 320 $\mu\text{m}$	same	thickness : 320 $\mu\text{m}$
number of pixels : 256	same	number of pixels : 256
guard ring : 1	different	guard ring : 0
resistivity : unknown	higher as Hamamatsu said	resistivity : unknown

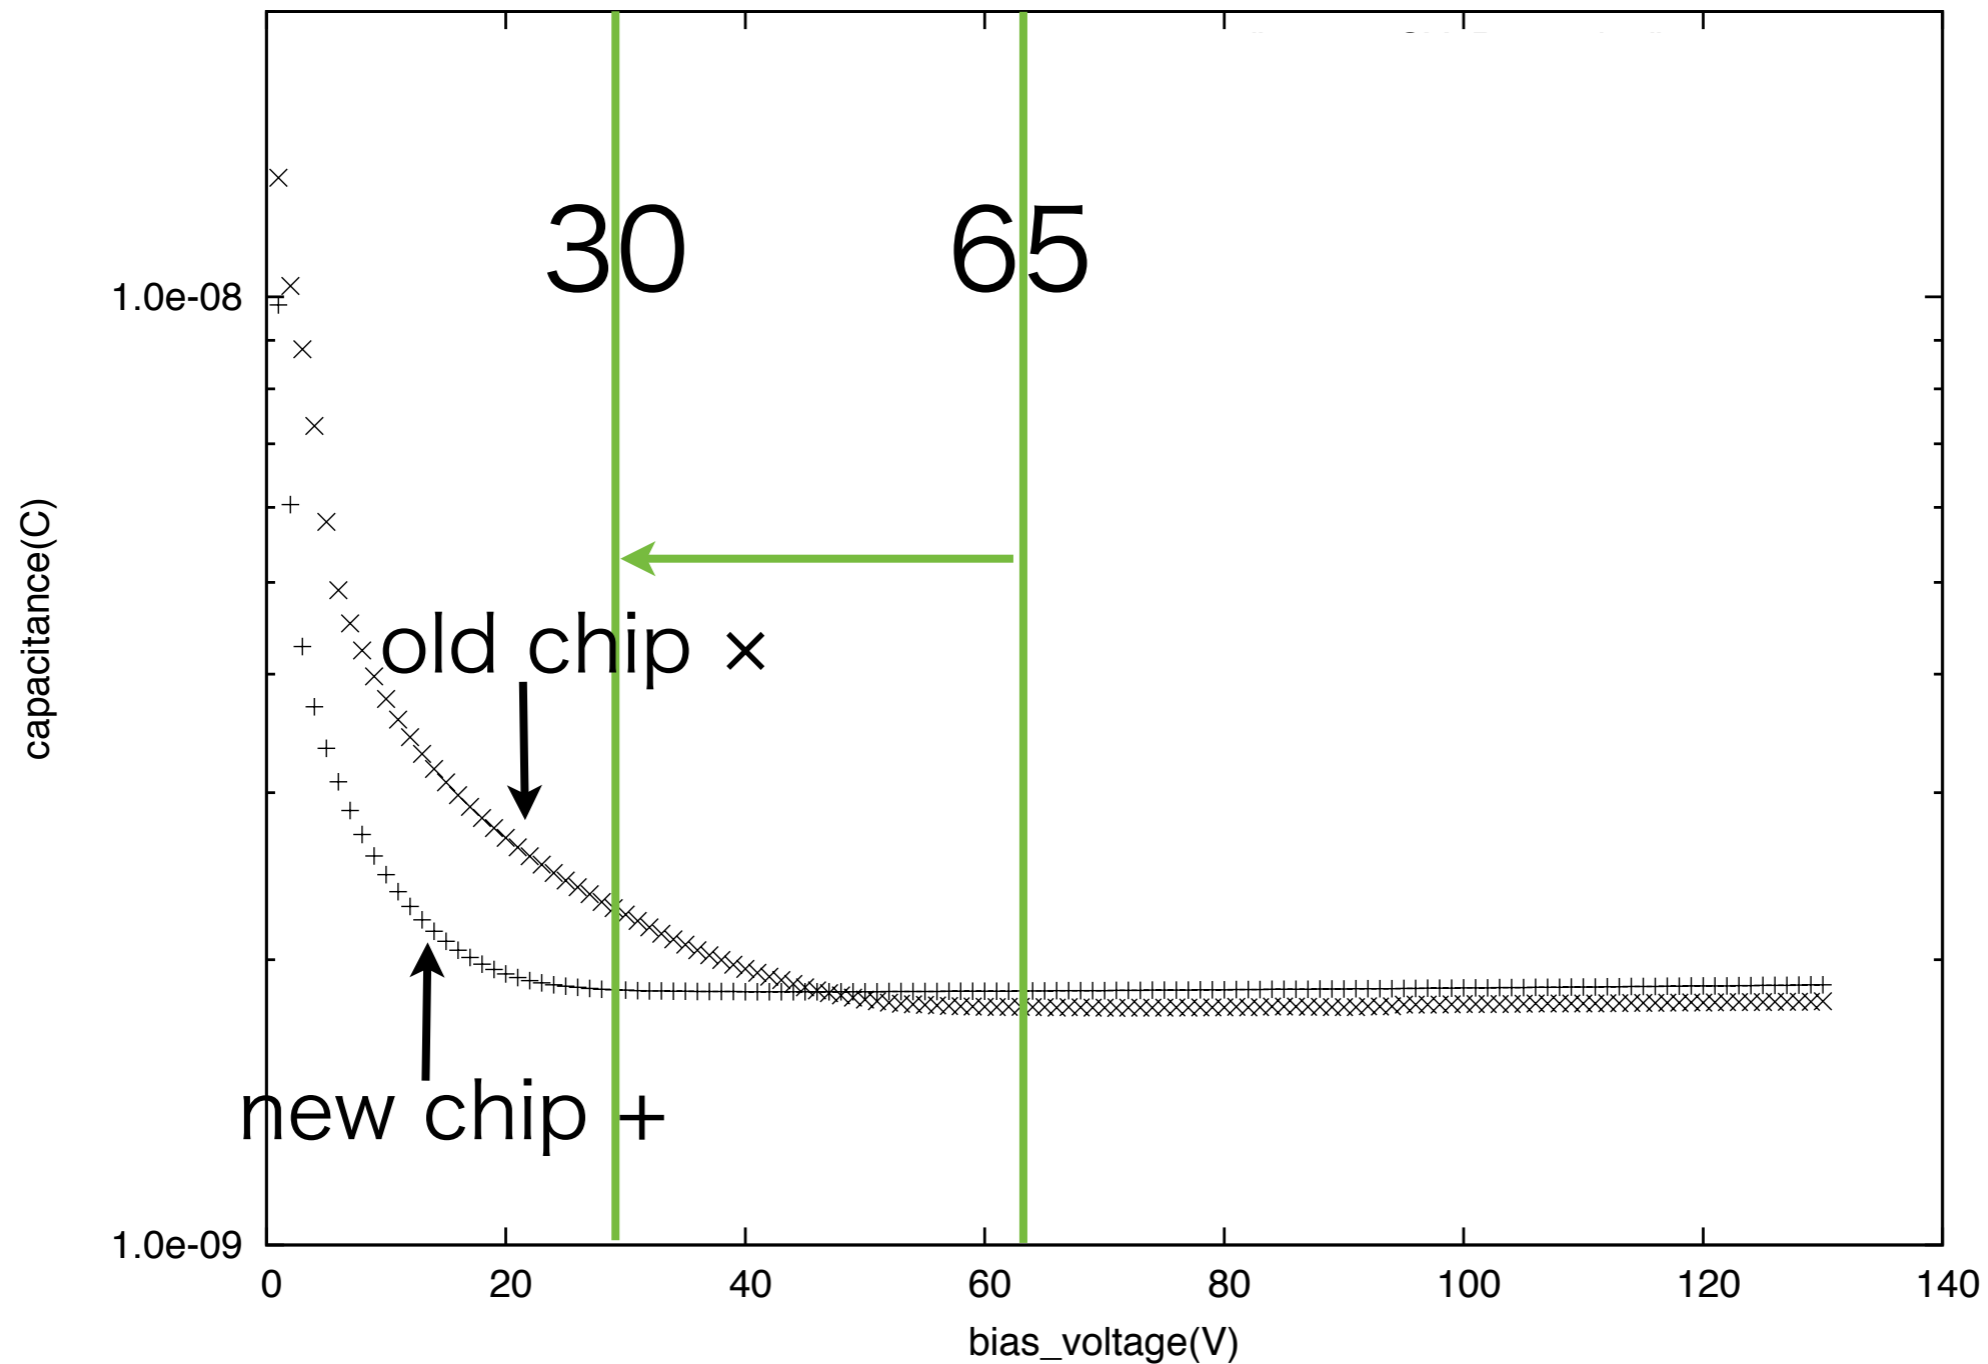
The chip capacitance does not change,  
because new prototypes' thickness is same as old one.  
However, since chip resistivity increased, full depletion voltage went lower.

- New sensor chips have higher resistivity than the previous one.  
->Hamamatsu said that they can get this high resistivity one easier.  
: Now they are preparing for mass production phase.
- High resistivity means high purity of silicon.  
->Depletion region can expand easily.
- Since full depletion voltage went lower, we can apply less operation voltage on chips. (eg. 60 V)

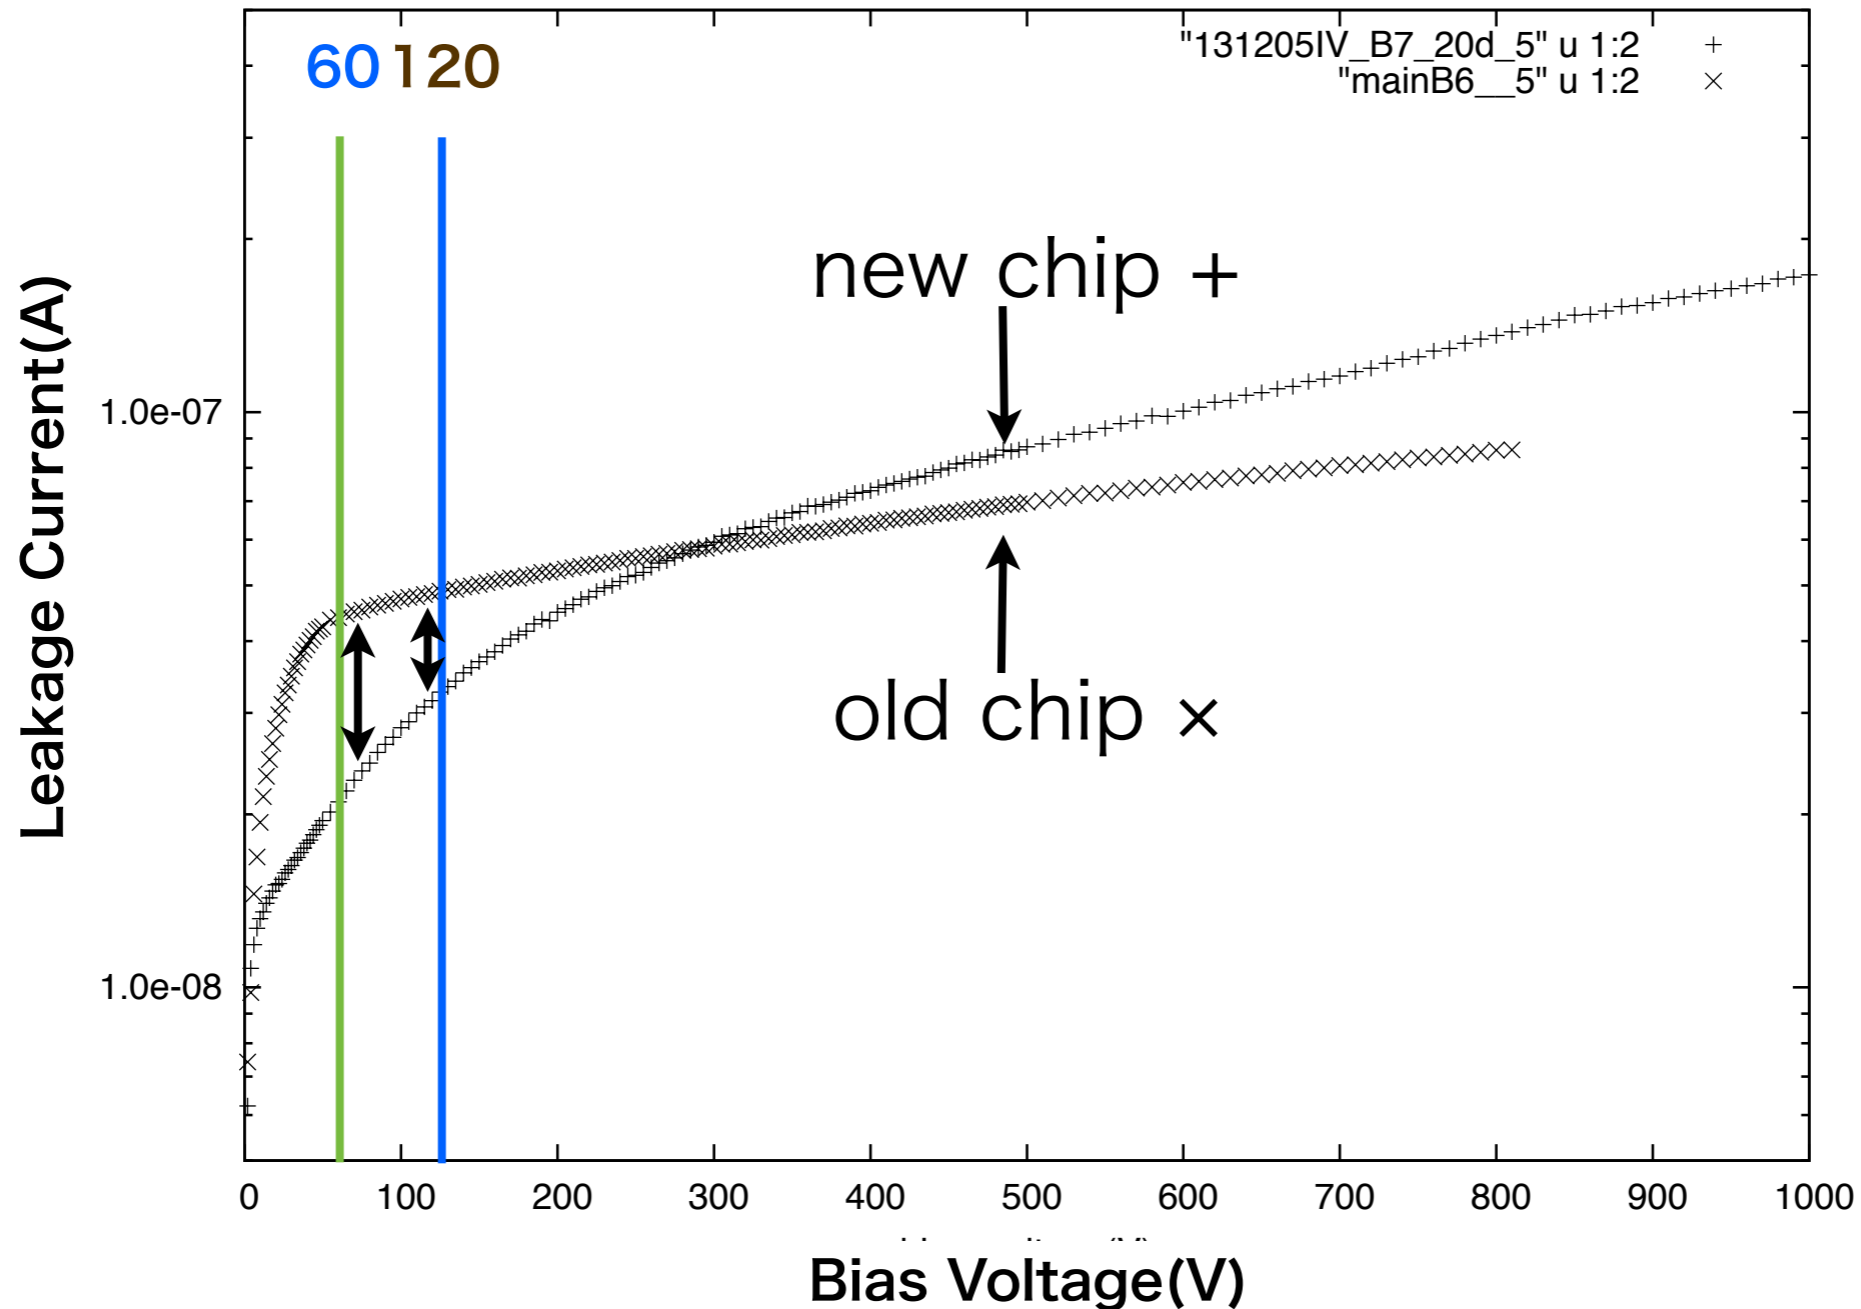
- The leakage current at 120 V is **31 nA** (old : 48 nA),  
at 60 V is **21 nA**.

This value is twice lower than old prototype.

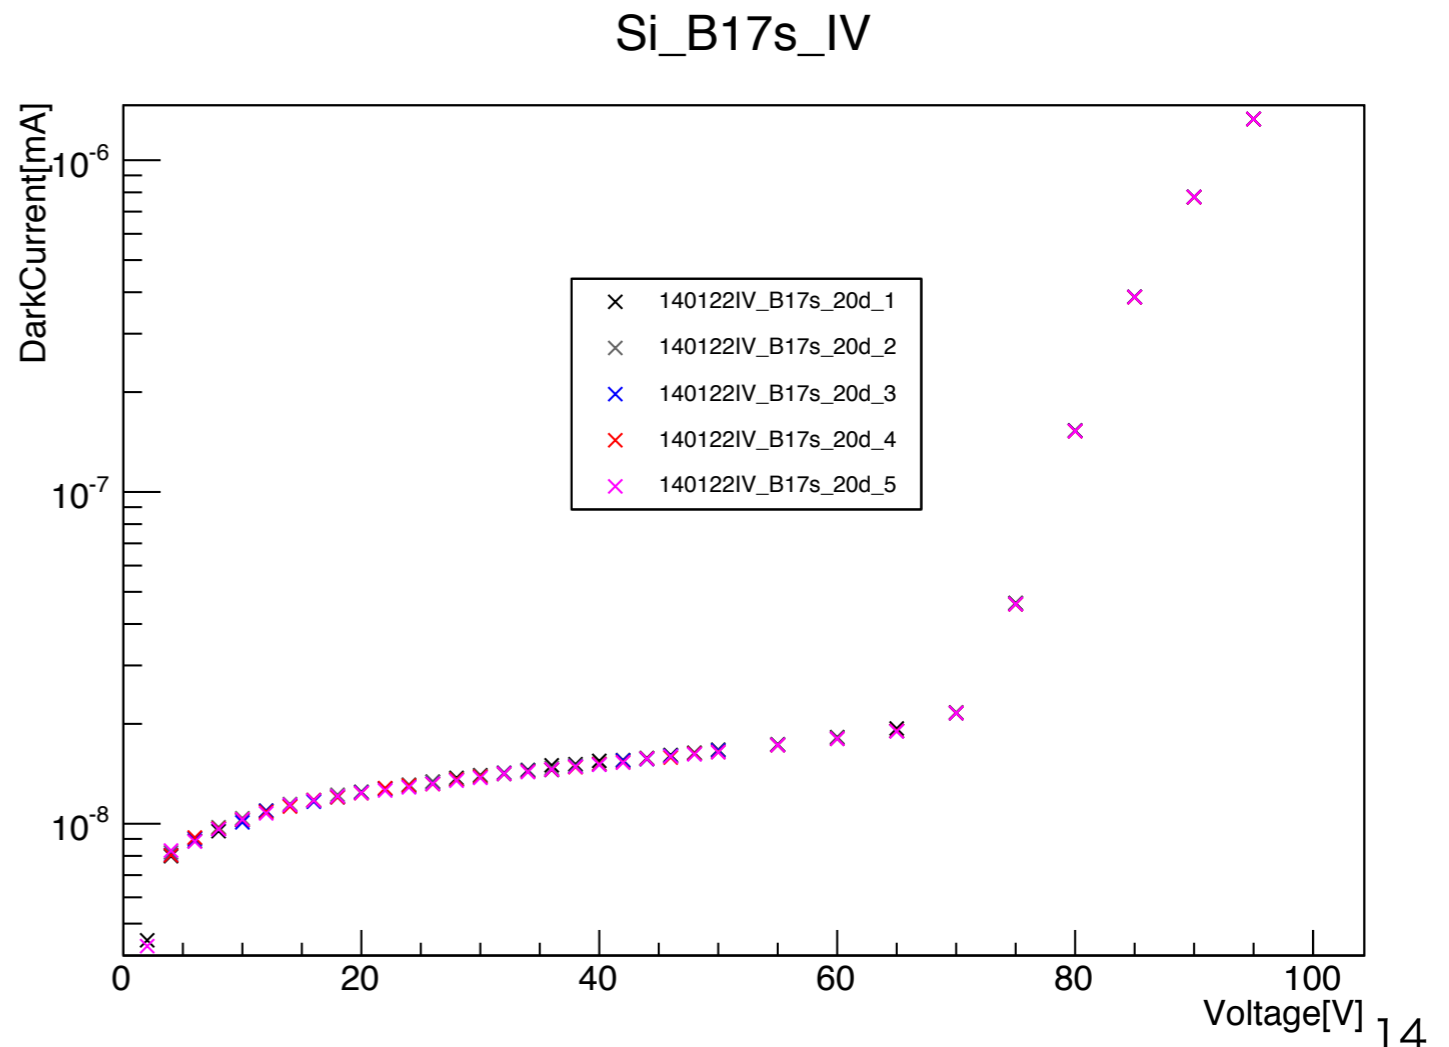
- We have two samples with “NG channel” in chip. One of them has “over limit” channel. In plot of Si\_B17s, we can see the effect of the bad pixels as the breakdown at lower voltage.
- If we set the operation voltage at 120 V, this chip is no use. However, if we set the operation voltage of 60 V, we can use this chip.

If we masked over limit channel and its surroundings channel, this break down voltage went higher slightly (about 140 V).
