# Silicon sensor study for ILD ECAL

Tatsuhiko Tomita

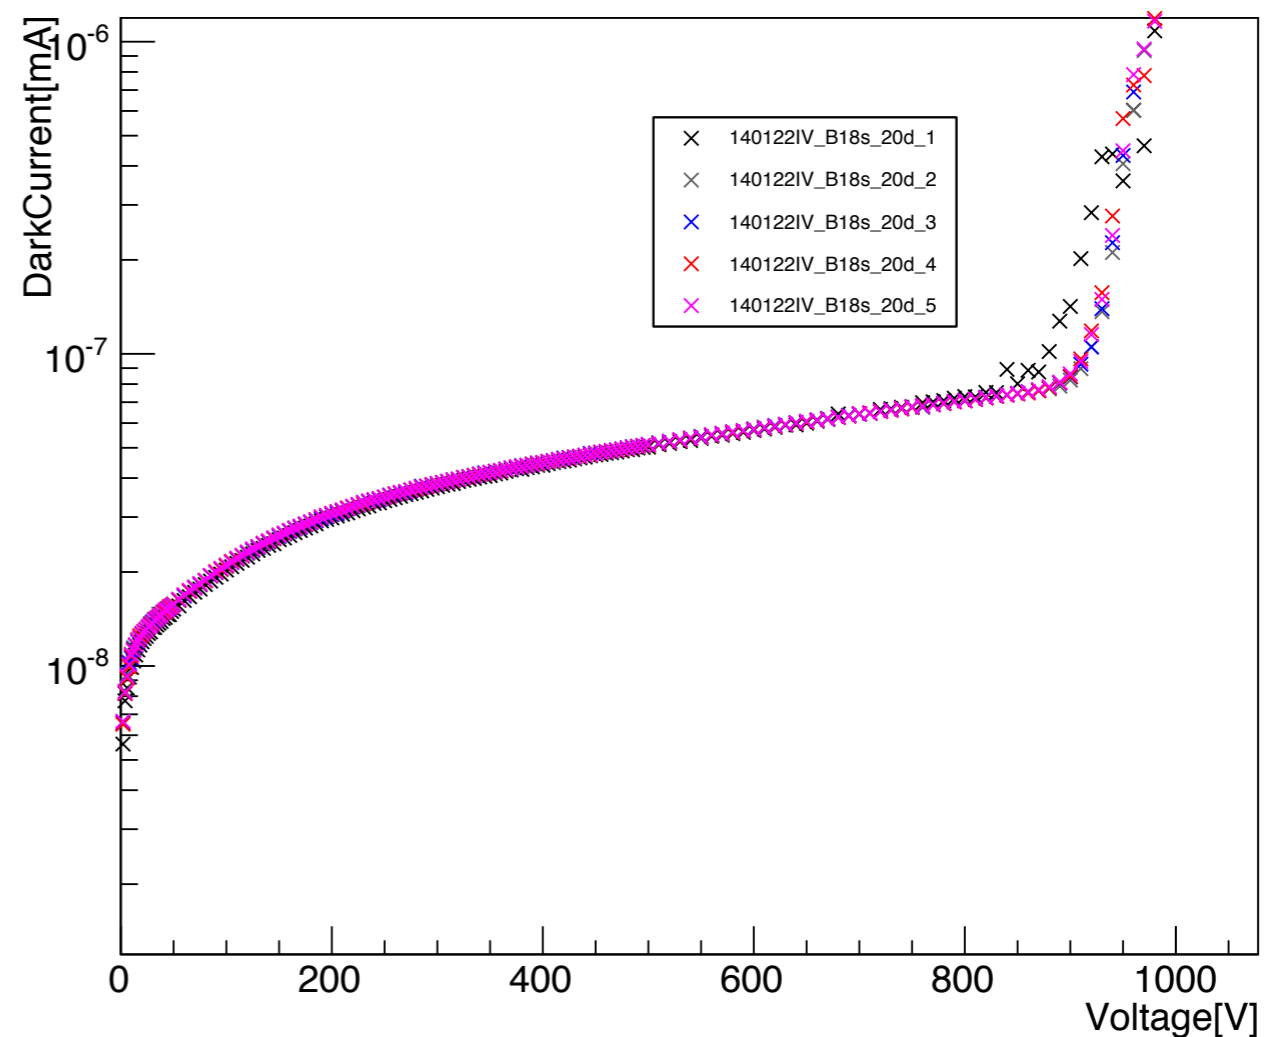
Si\_B18s\_IV

- The other NG chip has shorted channel.  
This caused merged channel in chip.
- In this case, chip granularity will decrease in such shorted channel.  
However, from leakage current measurement, chip break down voltage is higher than the operation voltage of 120 or 60 V.
