Design, production and integration issues of the ATLAS Pixel detector

D. Giugni

INFN Sez. Milano

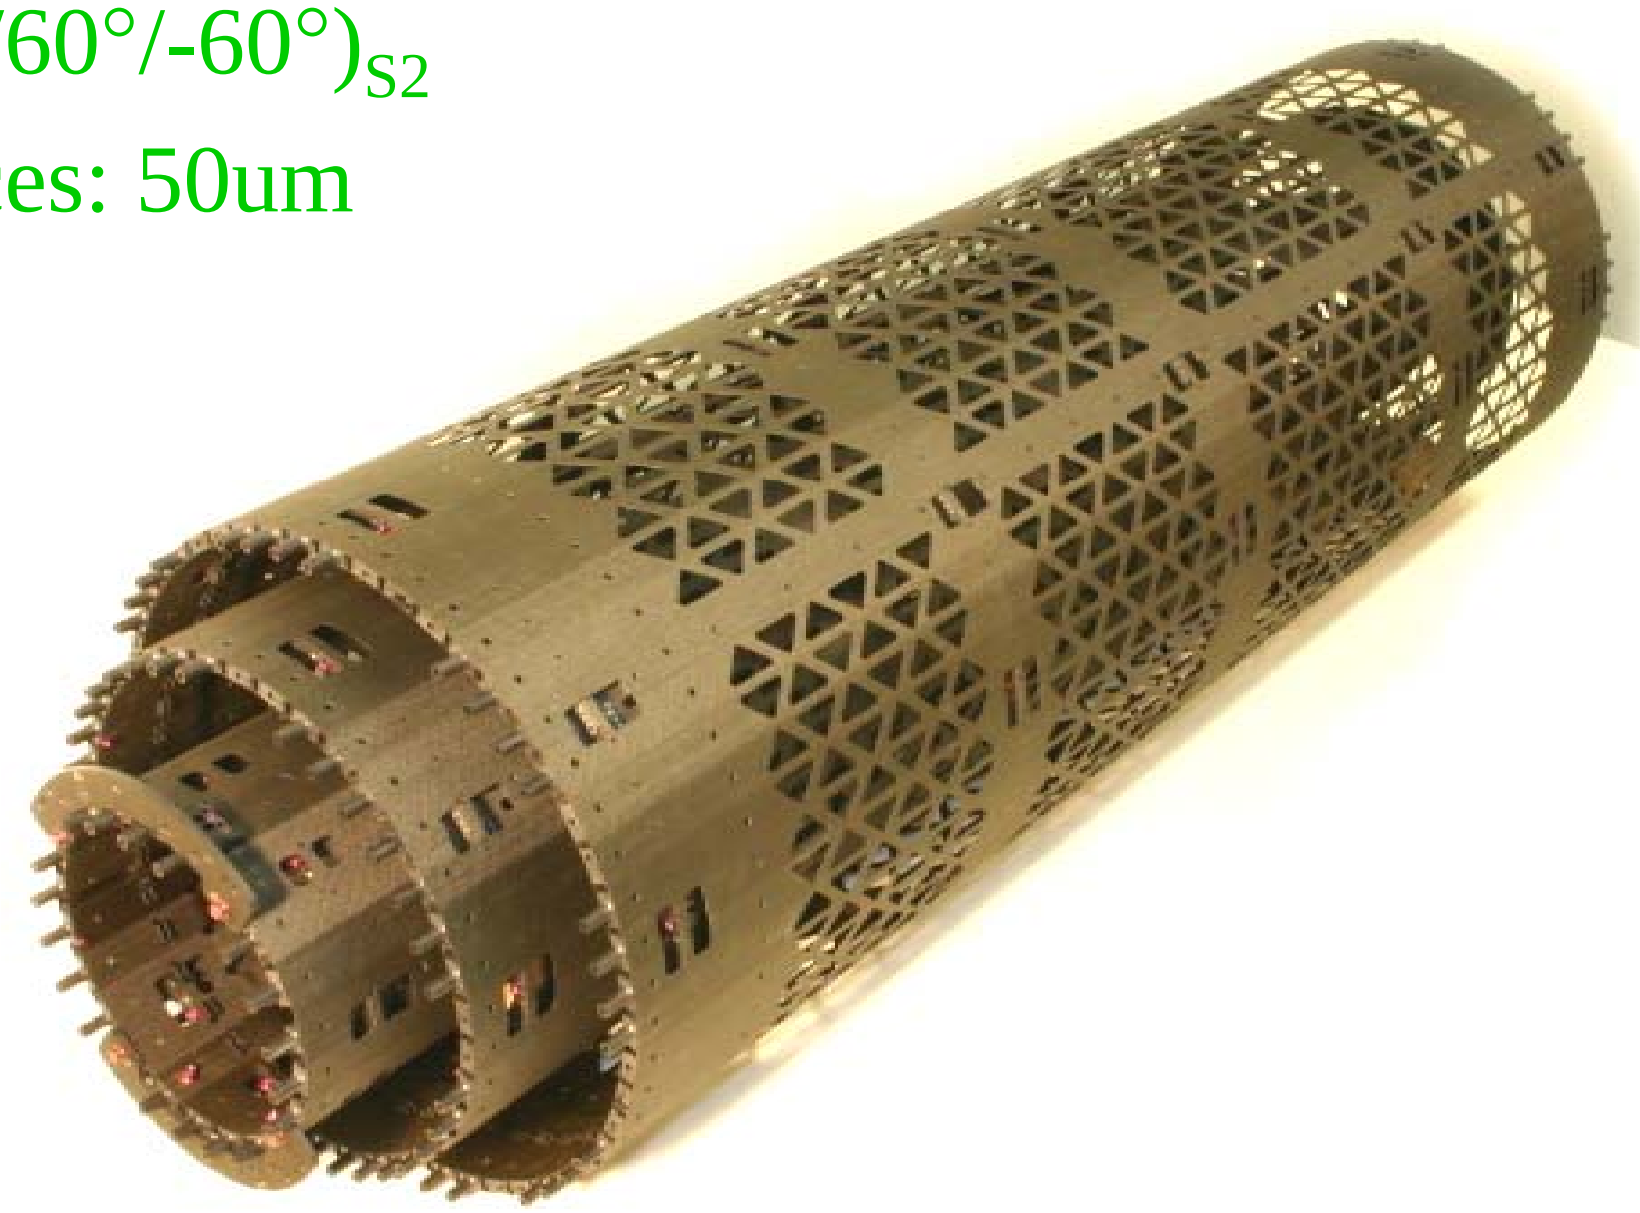
Survey of the shell “as built”

- Green arrows set the displacement with the tolerance: 50µm
- Blue arrow is “slightly” off tolerance by 10µm .

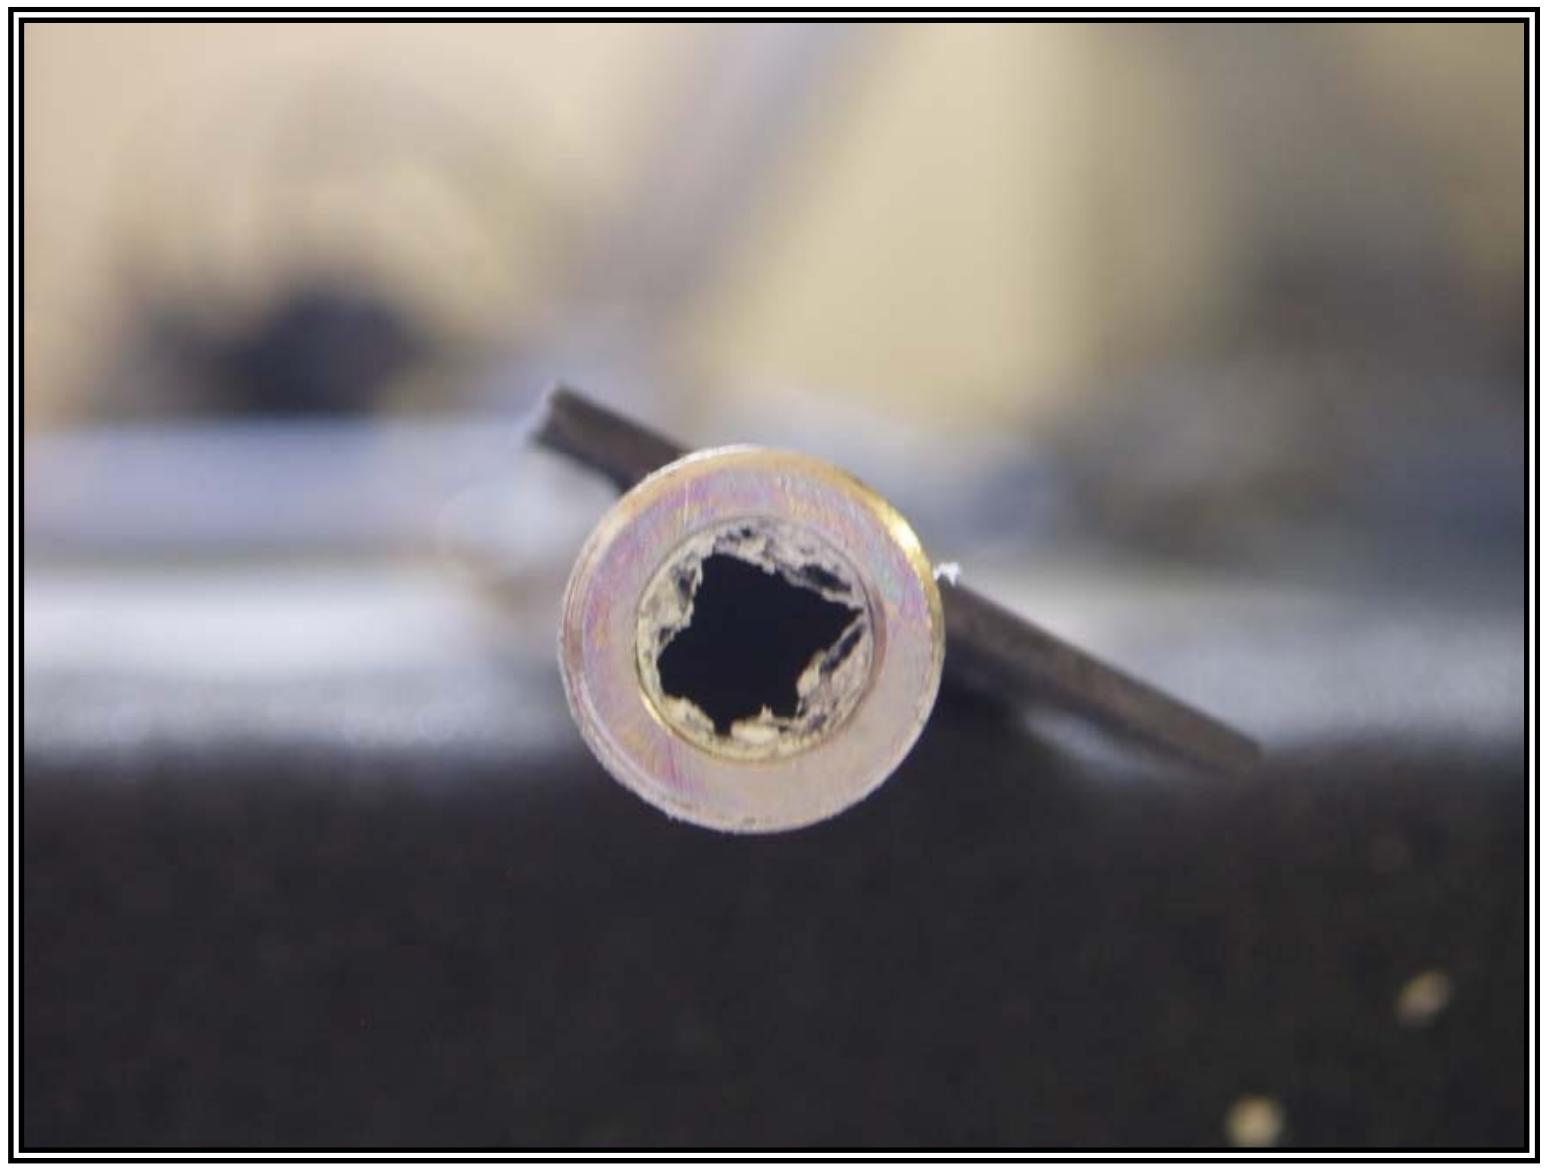
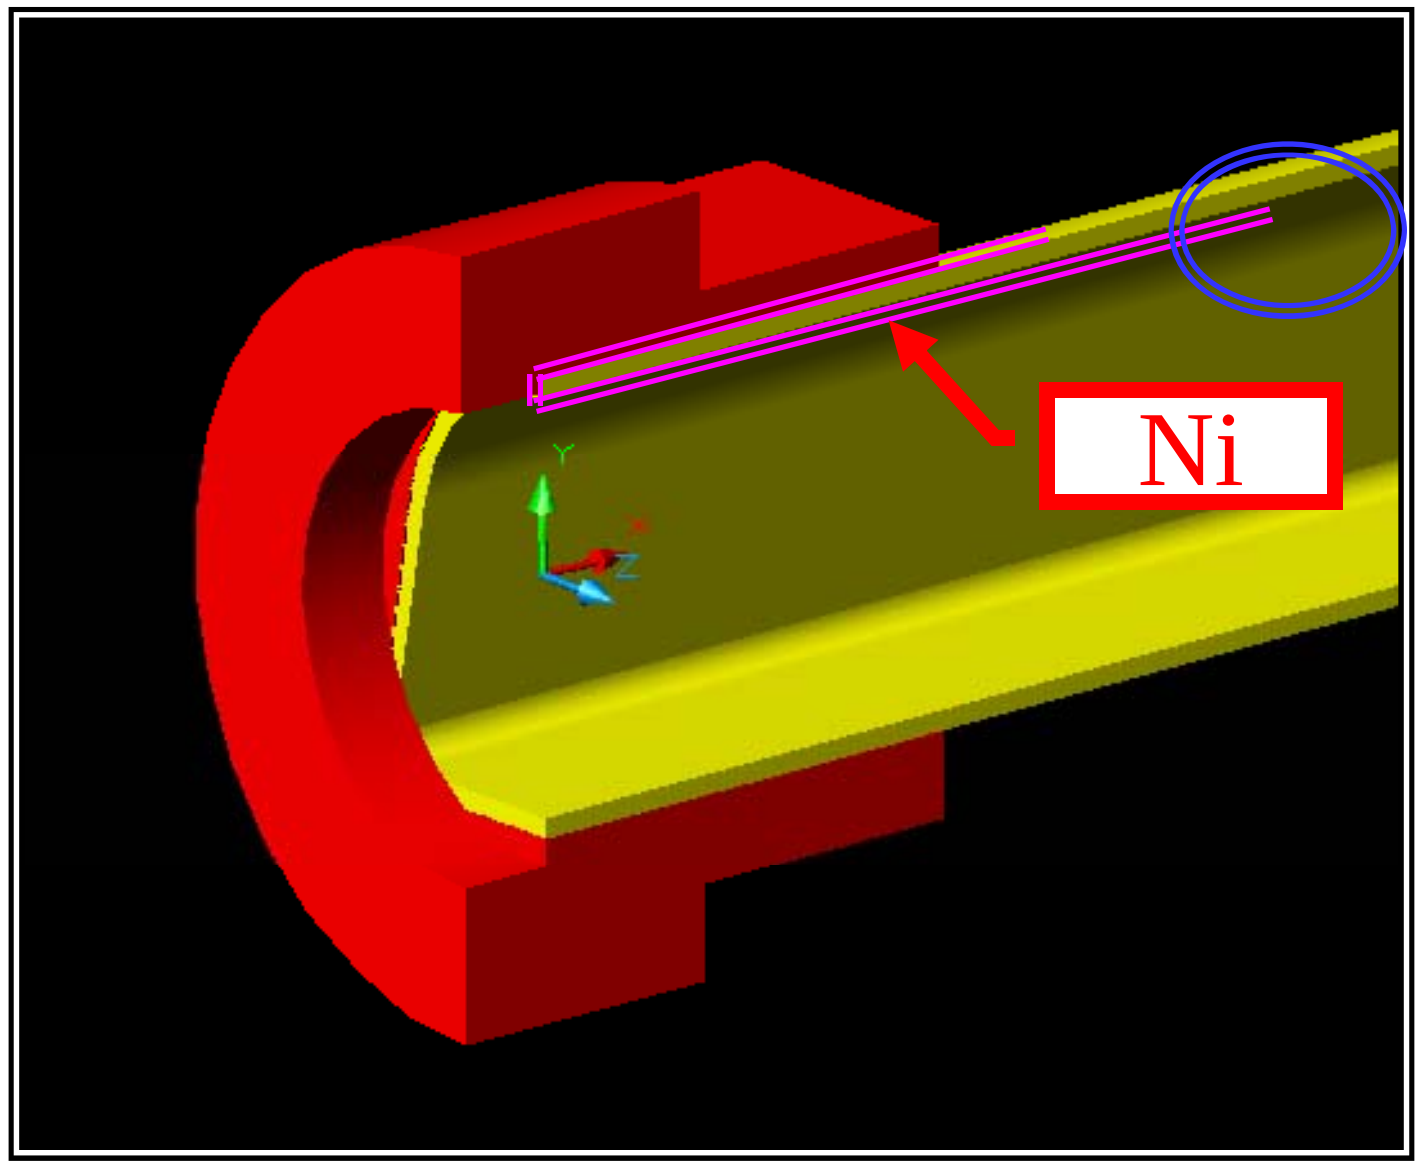
Corrosion in the cooling channel

- Originally the cooling channel was a D-shape an Alu [6061-T6] pipe, 200um thick. *Fitting is brazed* with a silver alloy 3.5AgSn after nickel plating of around 10µm .

This generates a *galvanic couple* at the interface that could, in presence of an electrolyte and defects in the nickelization, trigger a fast corrosion process.
- The corrosion appears with the presence of *white aluminum oxide* and significant erosion of the aluminum alloy through the pipe wall.

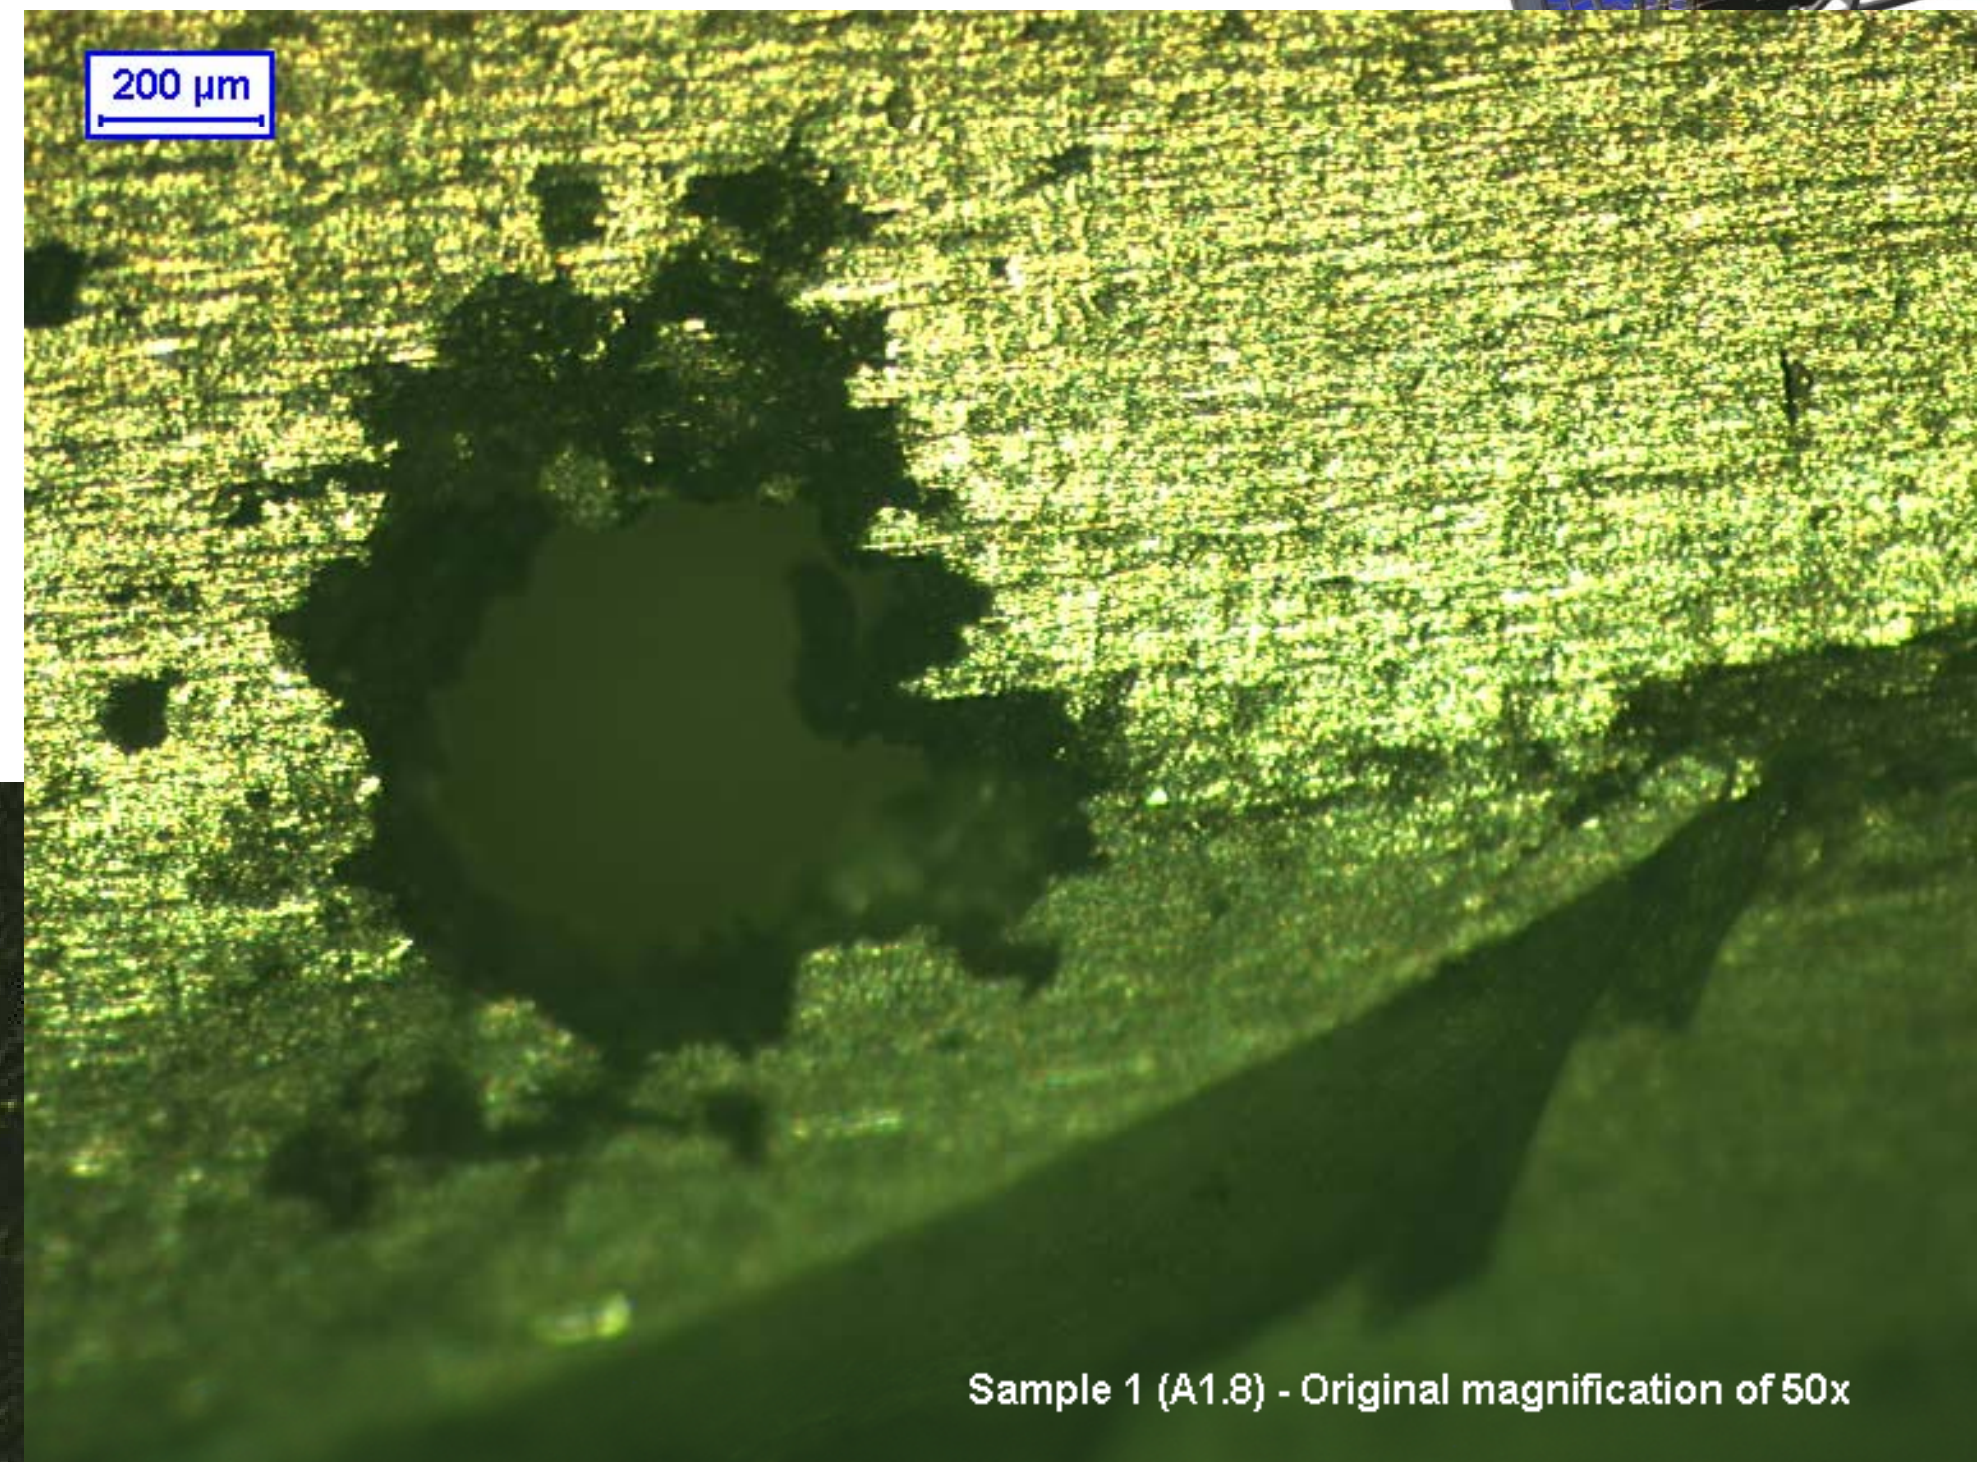
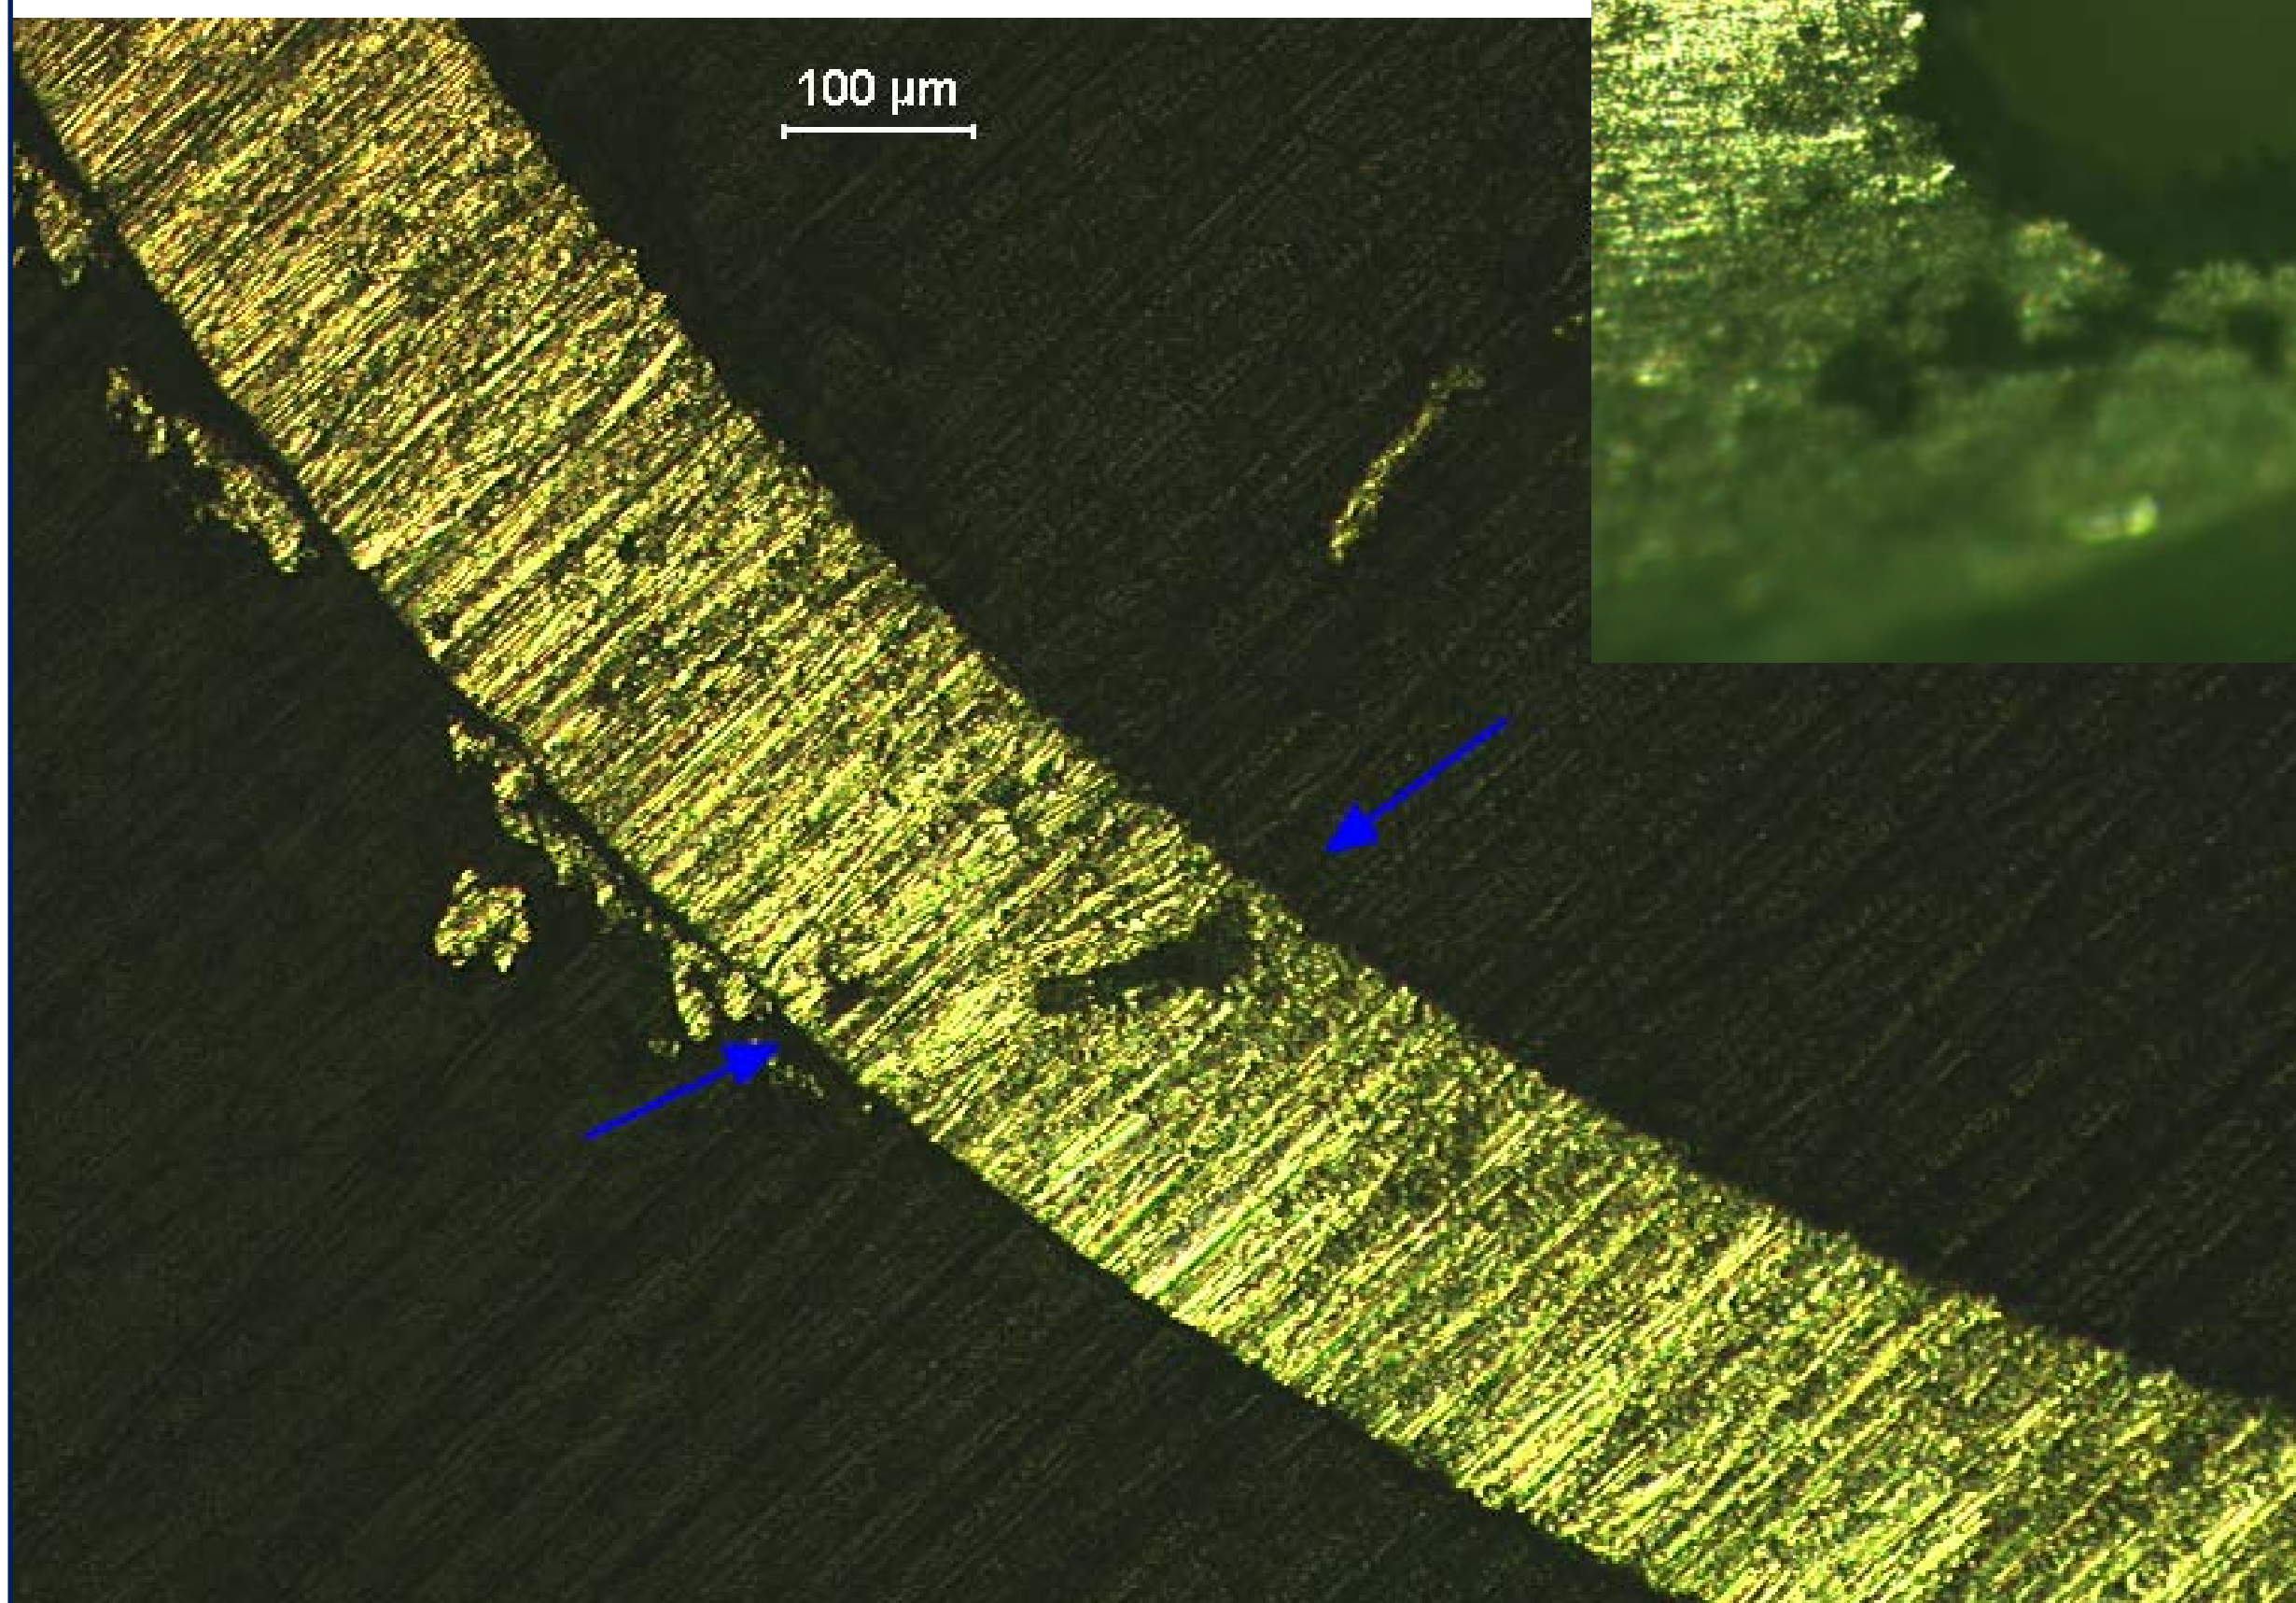
Corrosion effects

On the right picture the corrosion generated a passing through hole in the pipe and consequent loss of tightness.

Bottom picture shows a typical pitting phenomena also induced by the galvanic couple shown in the sectioning plane.

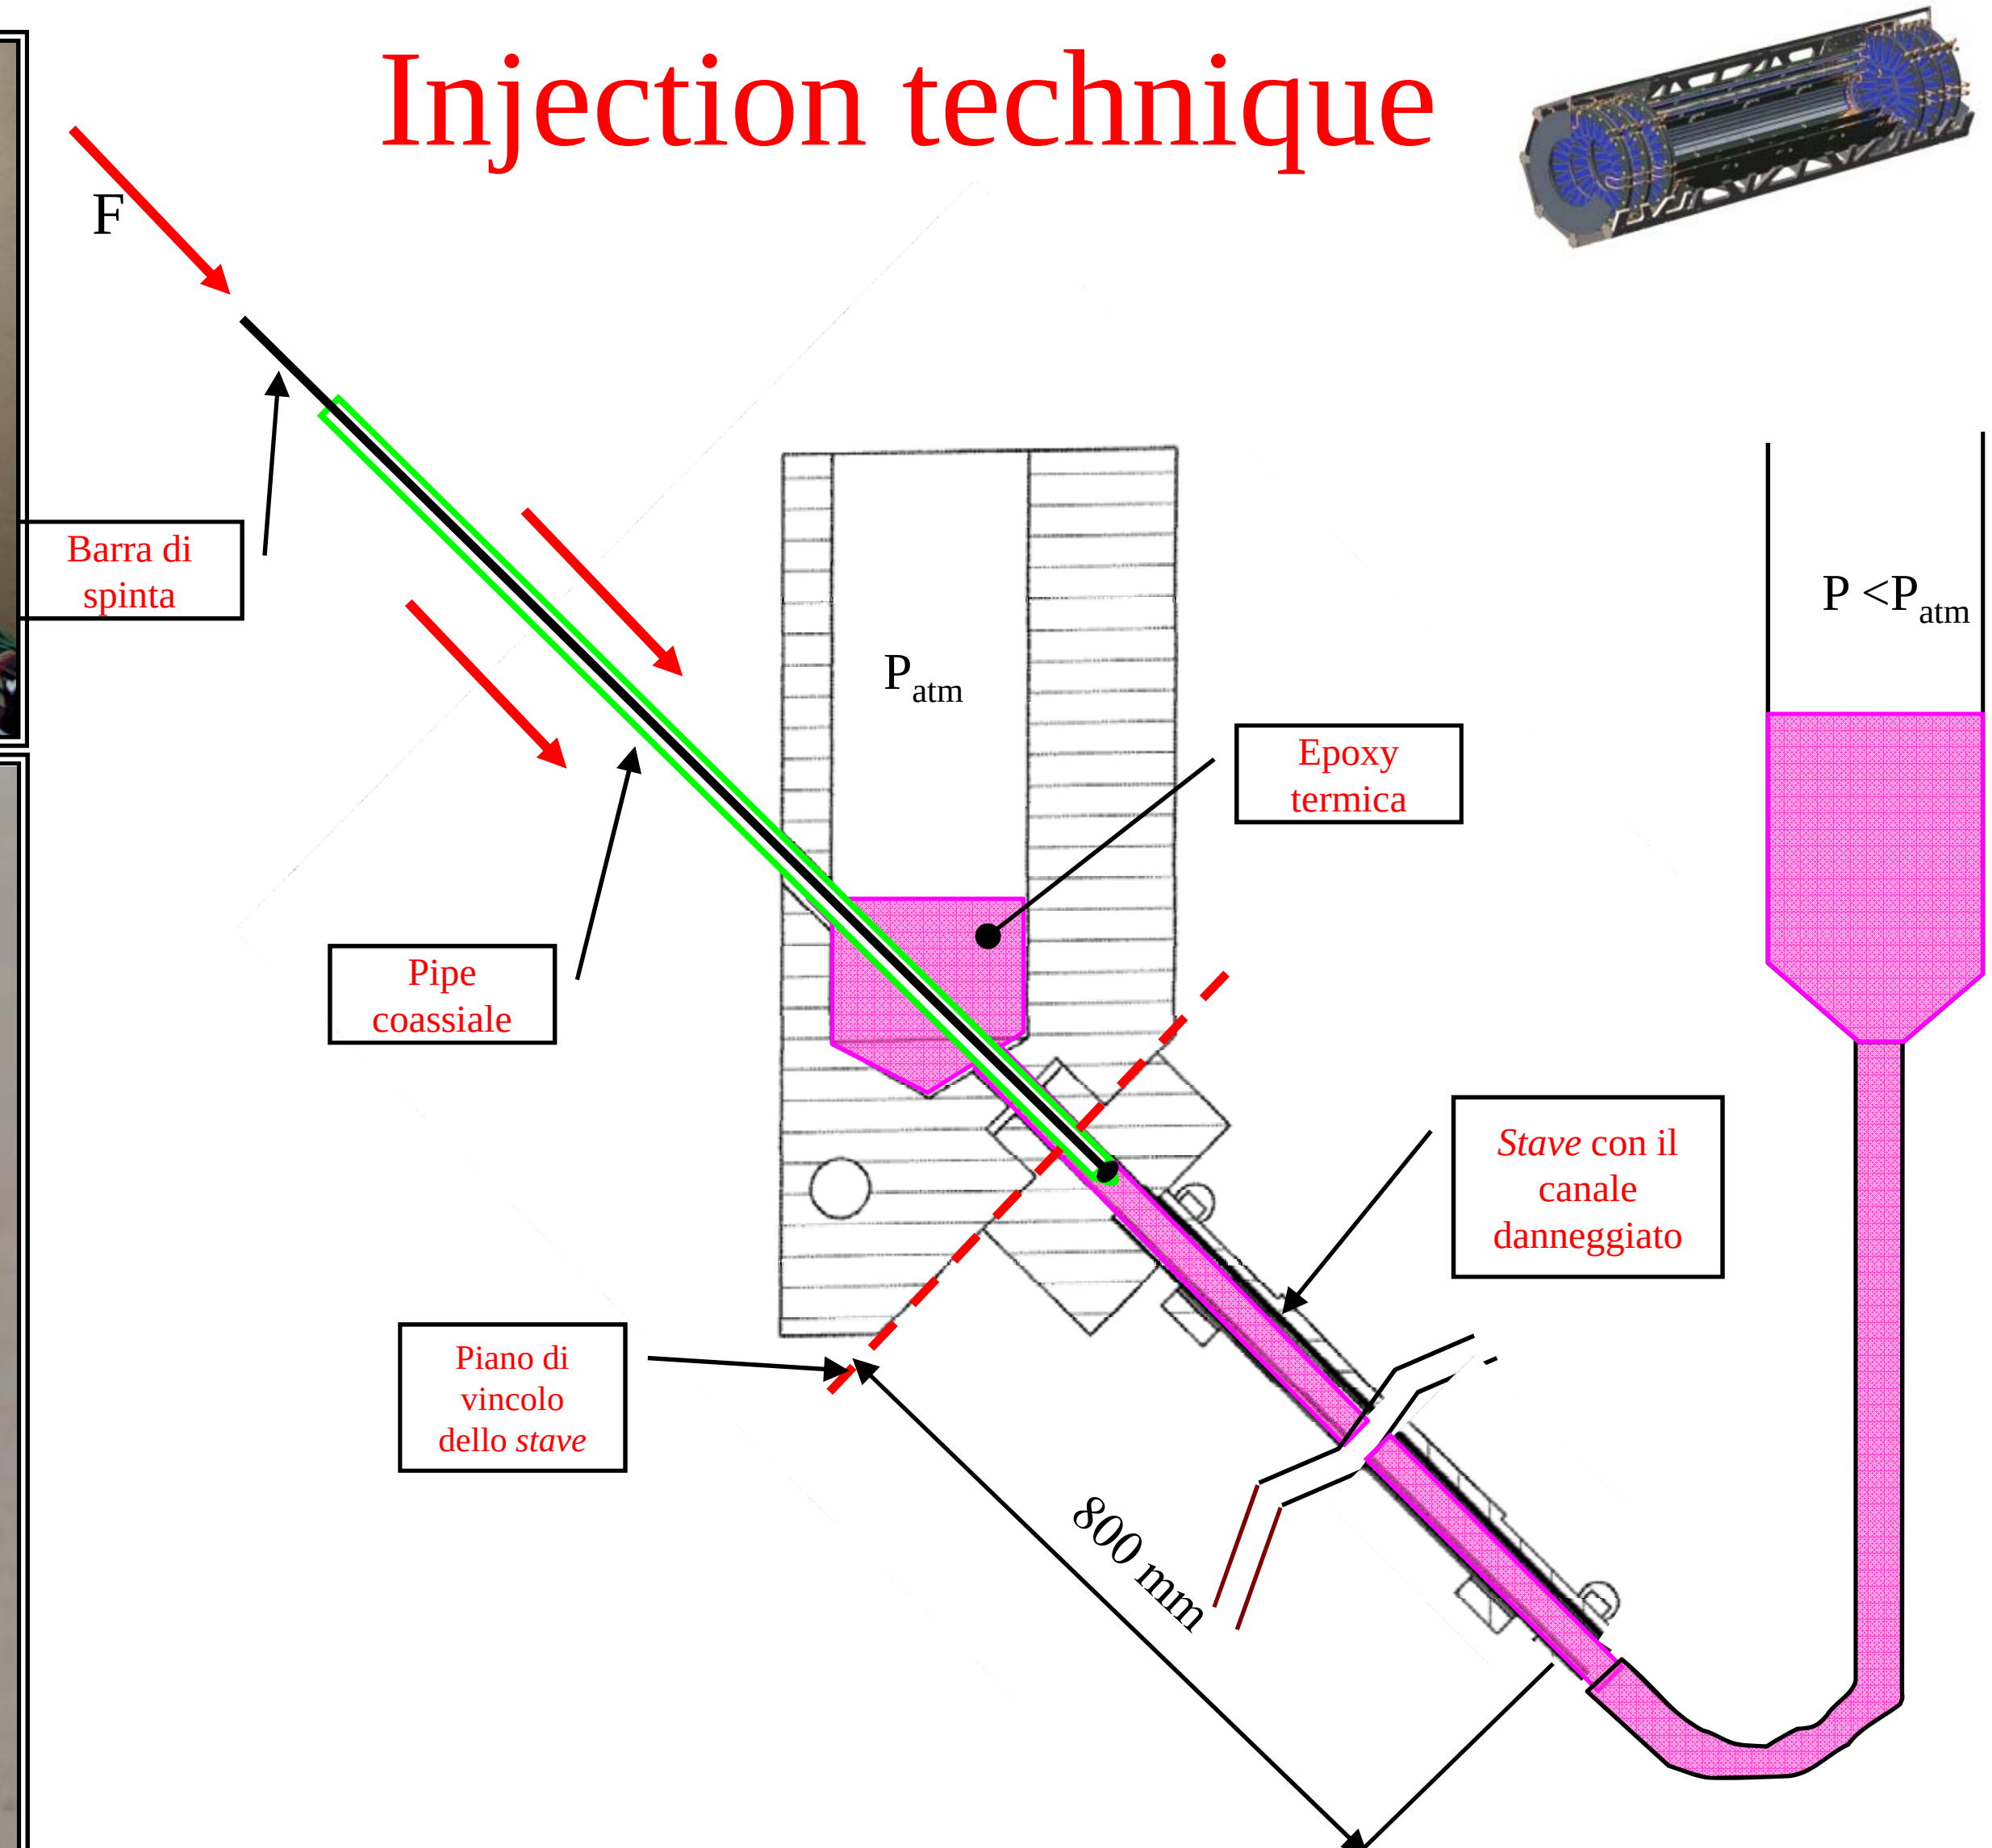
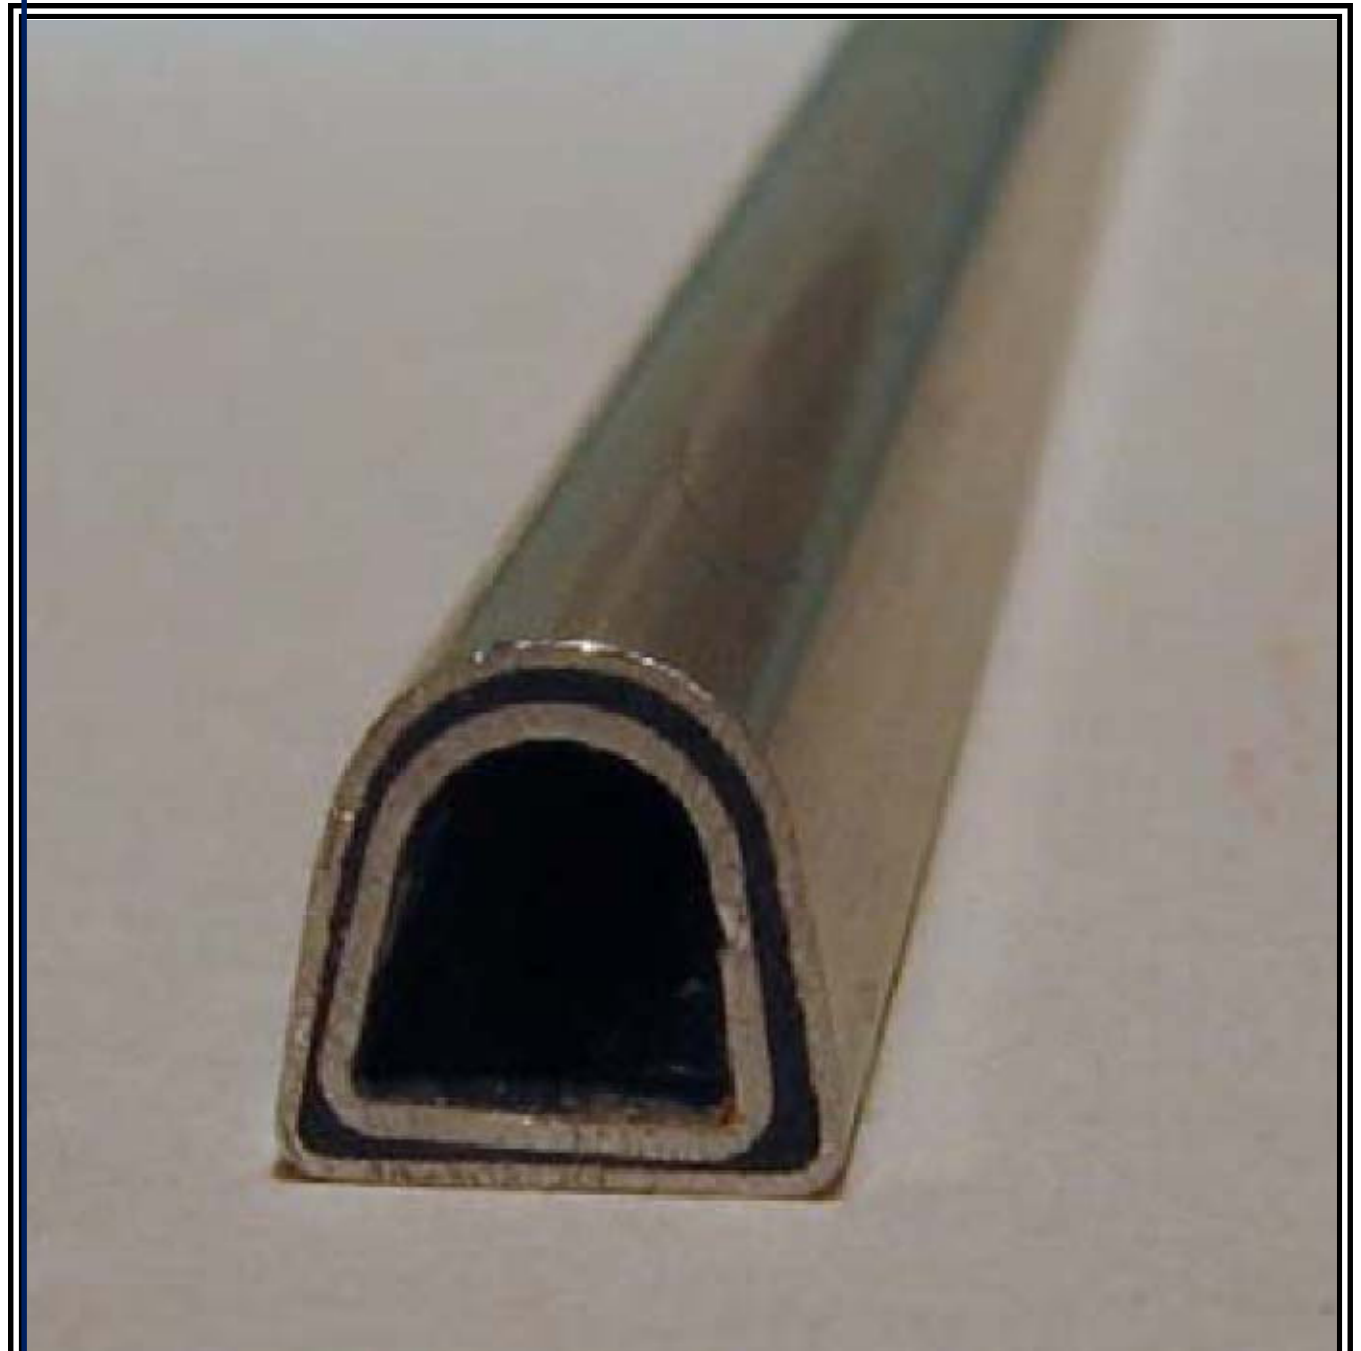
Injection technique

View of the section of the "inserted" pipe. Note the excellent coverage of the thermal compound

The inner pipe is inserted when the thermal compound is already filling the corroded pipe. The top vessel provide the fluid displaced by the insertion avoiding voids and bubbles.

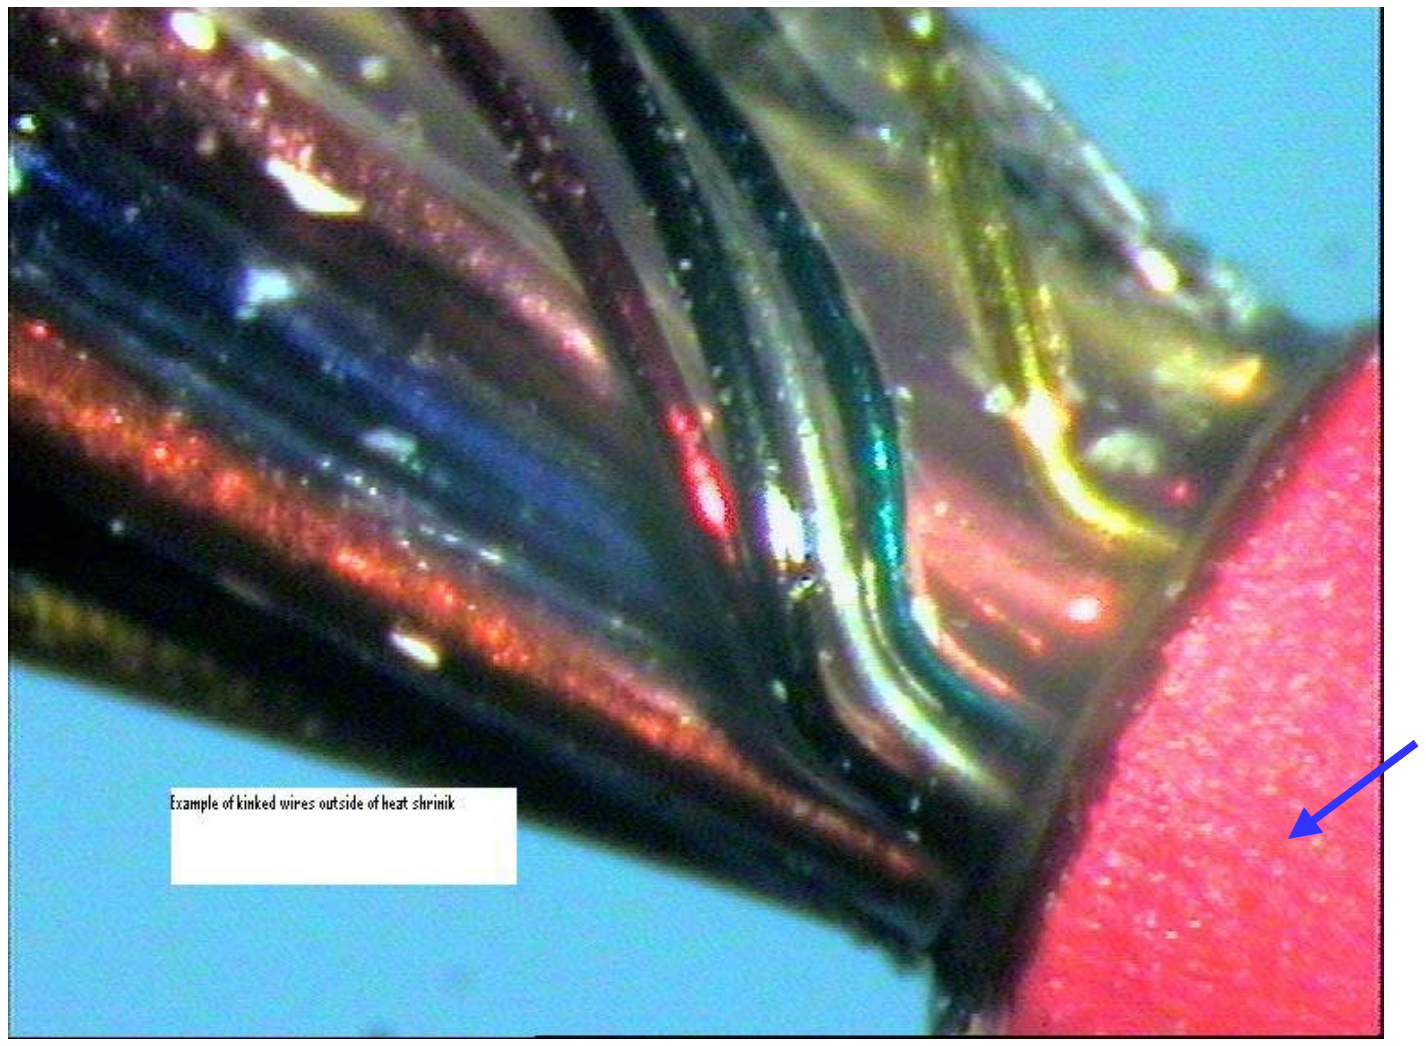
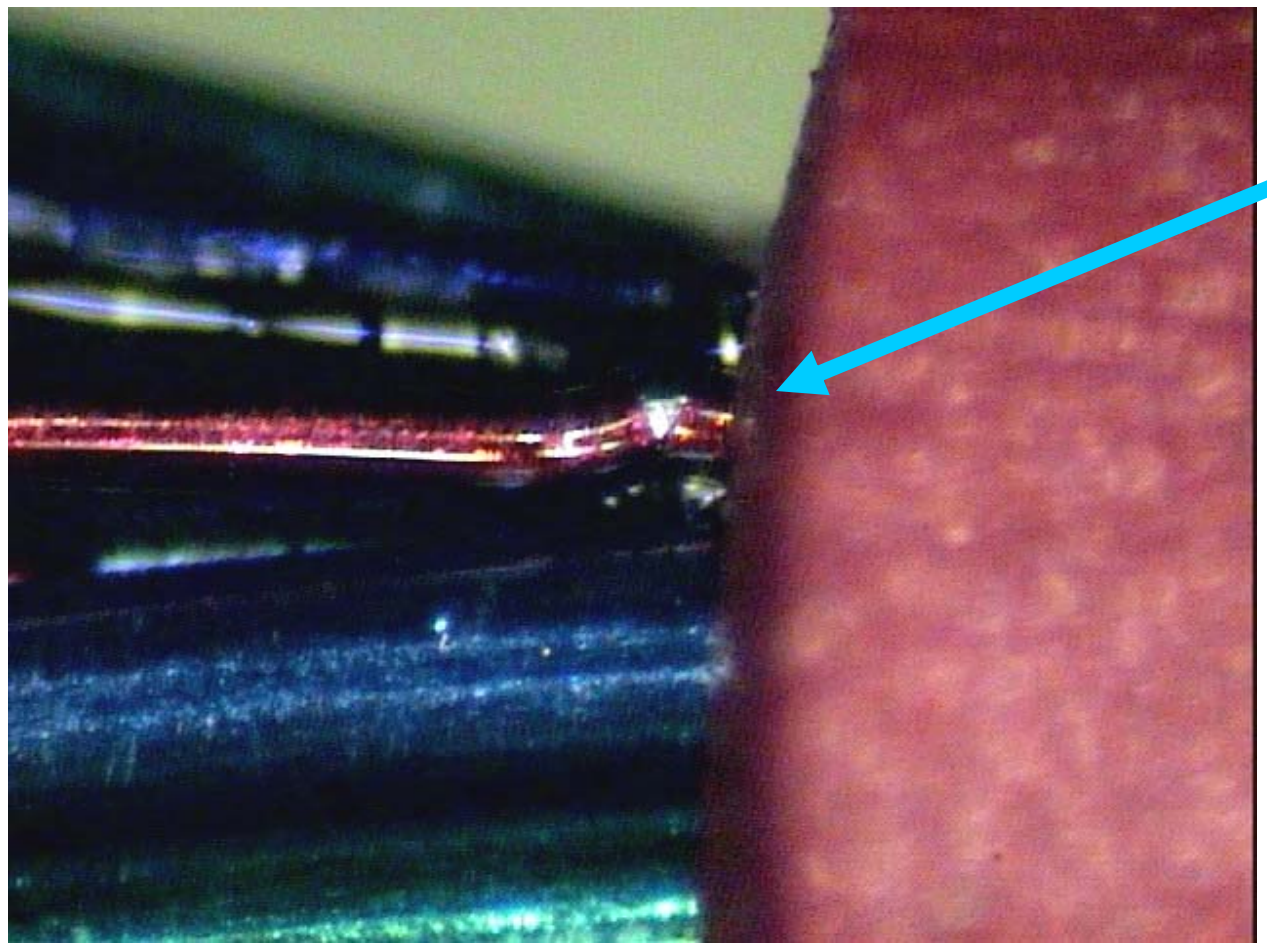
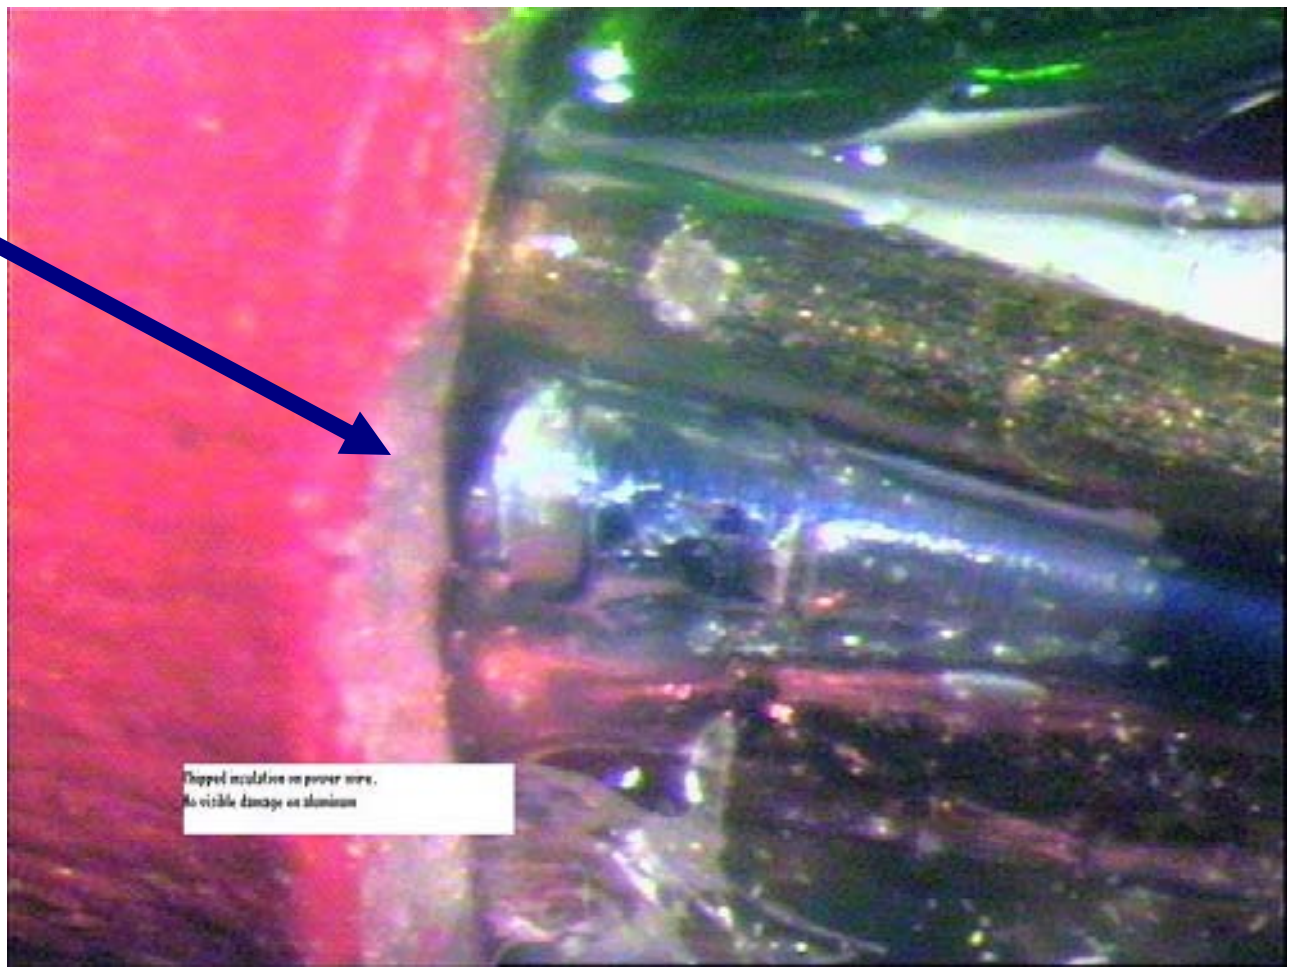
Pictures of damage

Close-up of typical cable
Close to the heat shrink
tubing

Examples of damage.
The insulation is
broken. This leaves
the aluminum
vulnerable to failure
with even very
delicate handling or
with thermal cycling.

- Wires were bent before stripping. Thin and thick wires were separated to be stripped in two different phases.
- Stripping solution is molten NaOH; T~400C
- What happens to the insulation when heated above 250C:
