Design, production and integration issues of the ATLAS Pixel detector

D. Giugni

INFN Sez. Milano

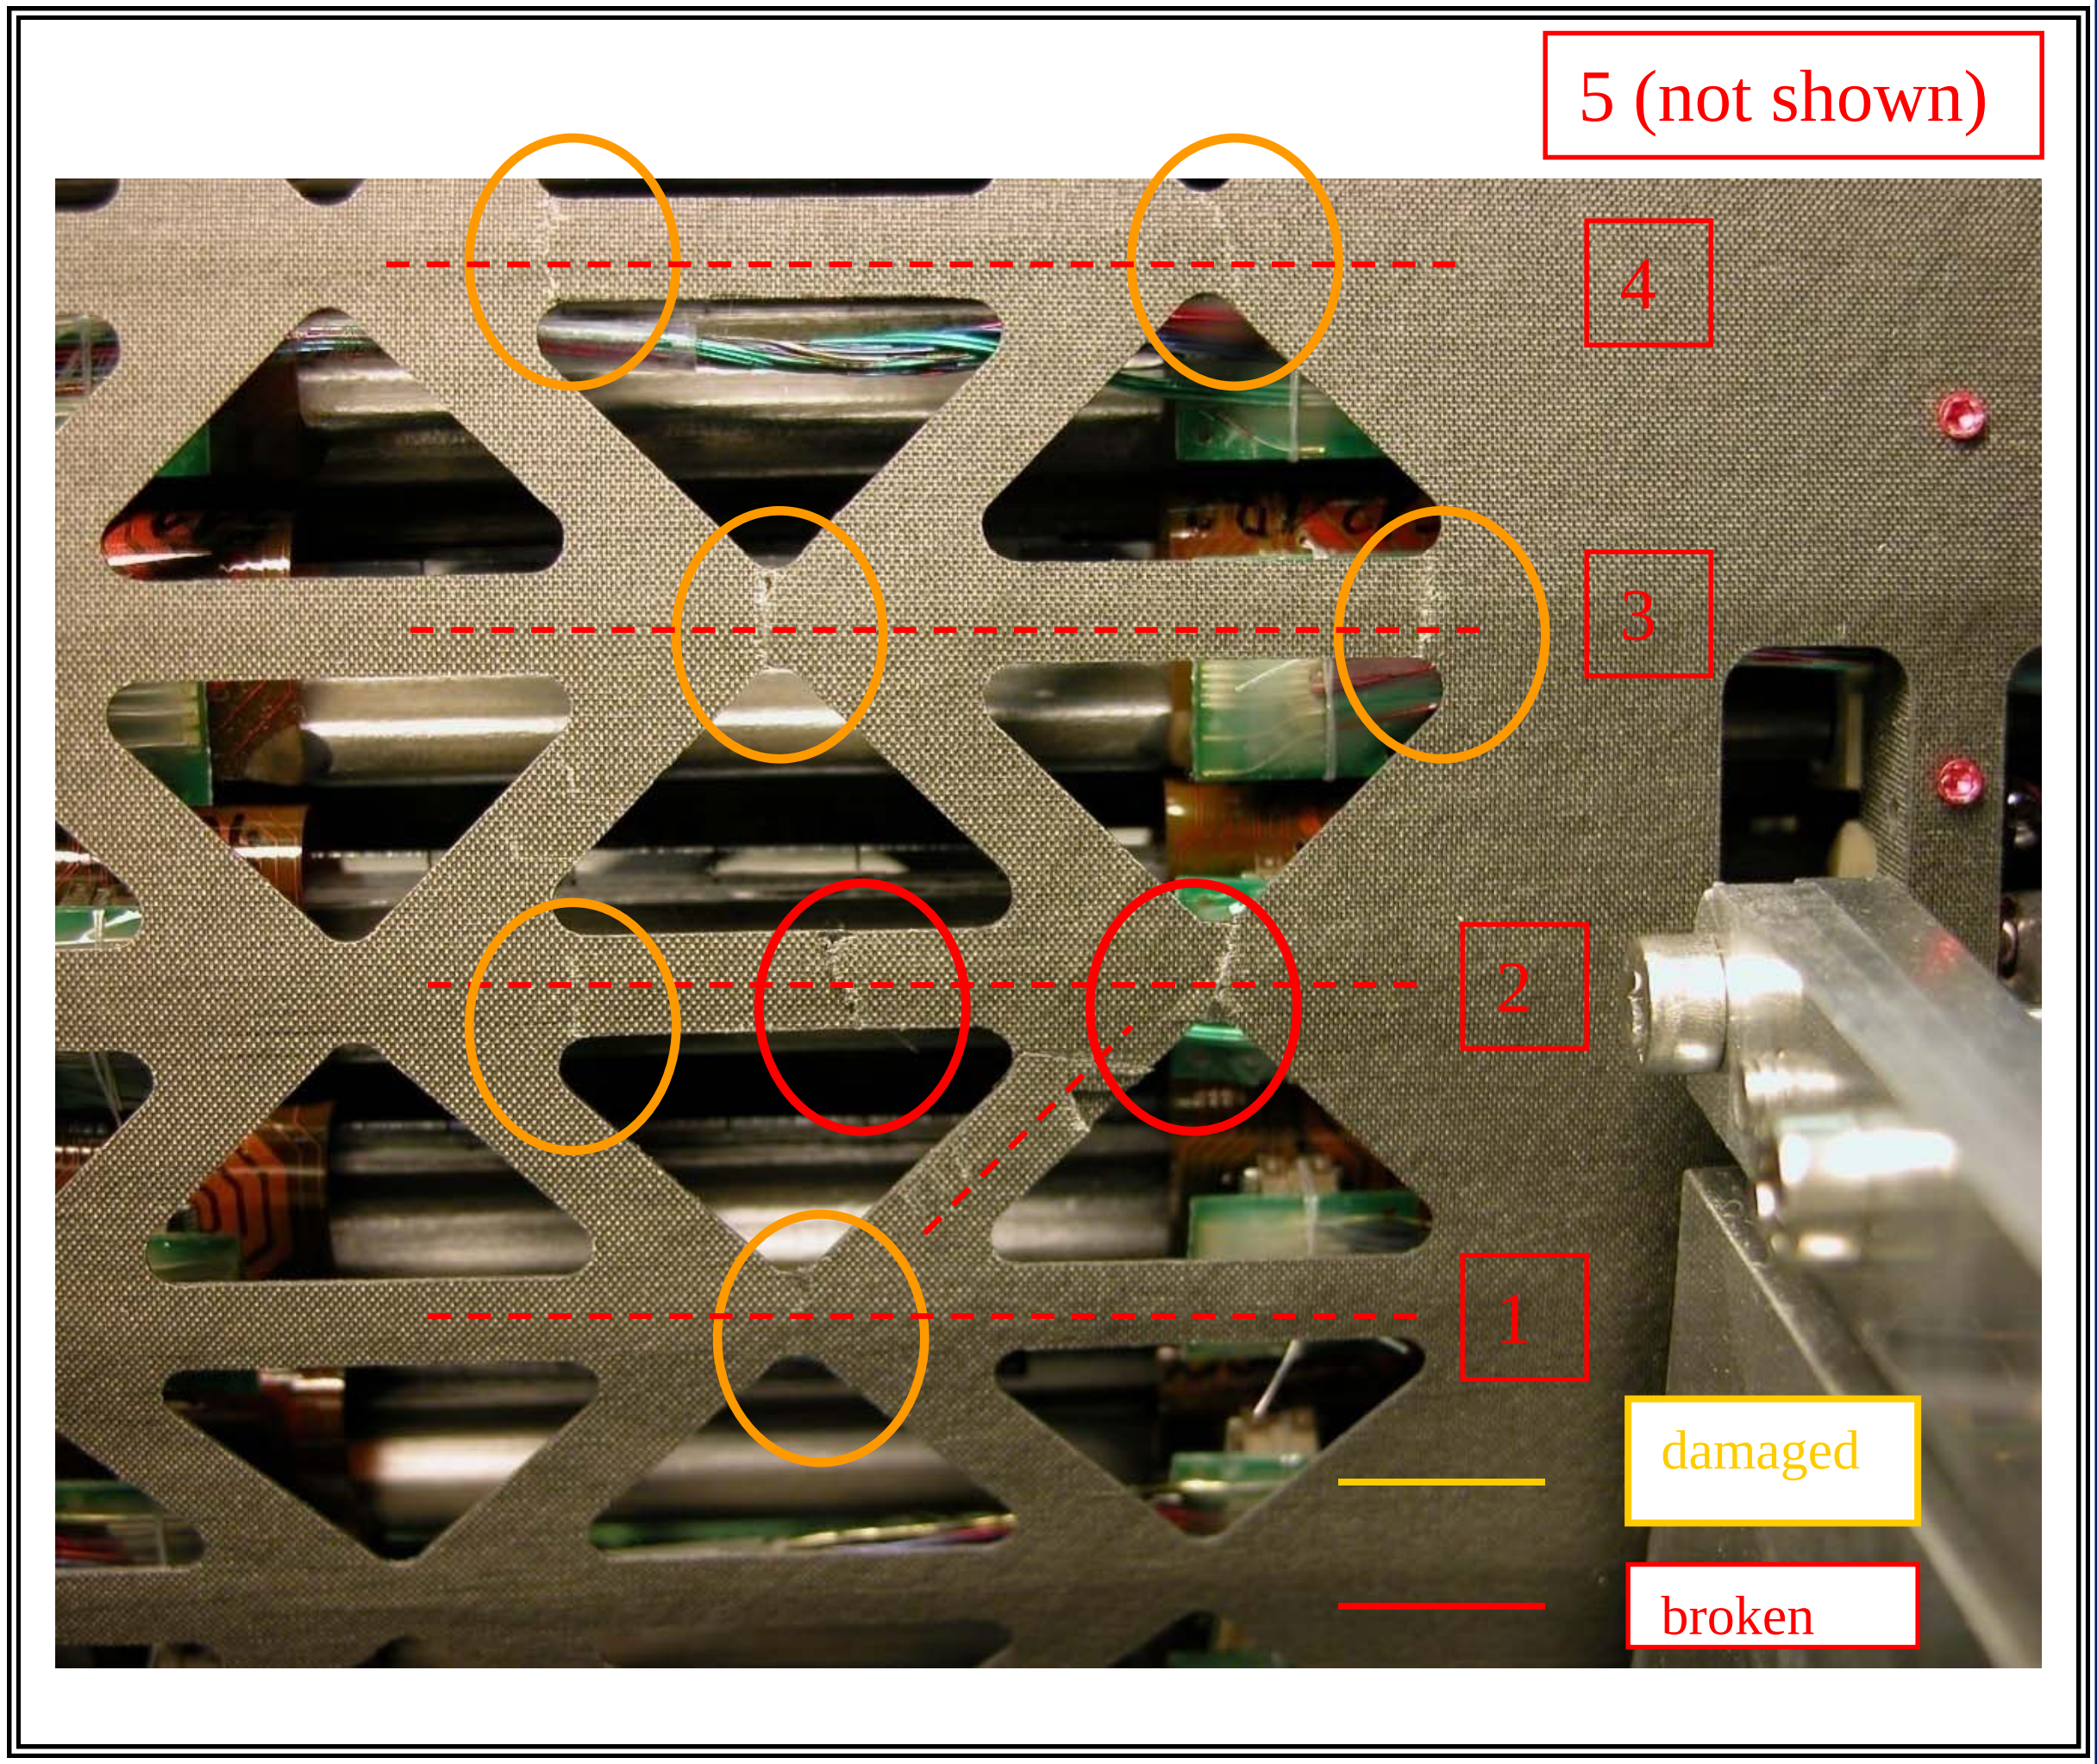
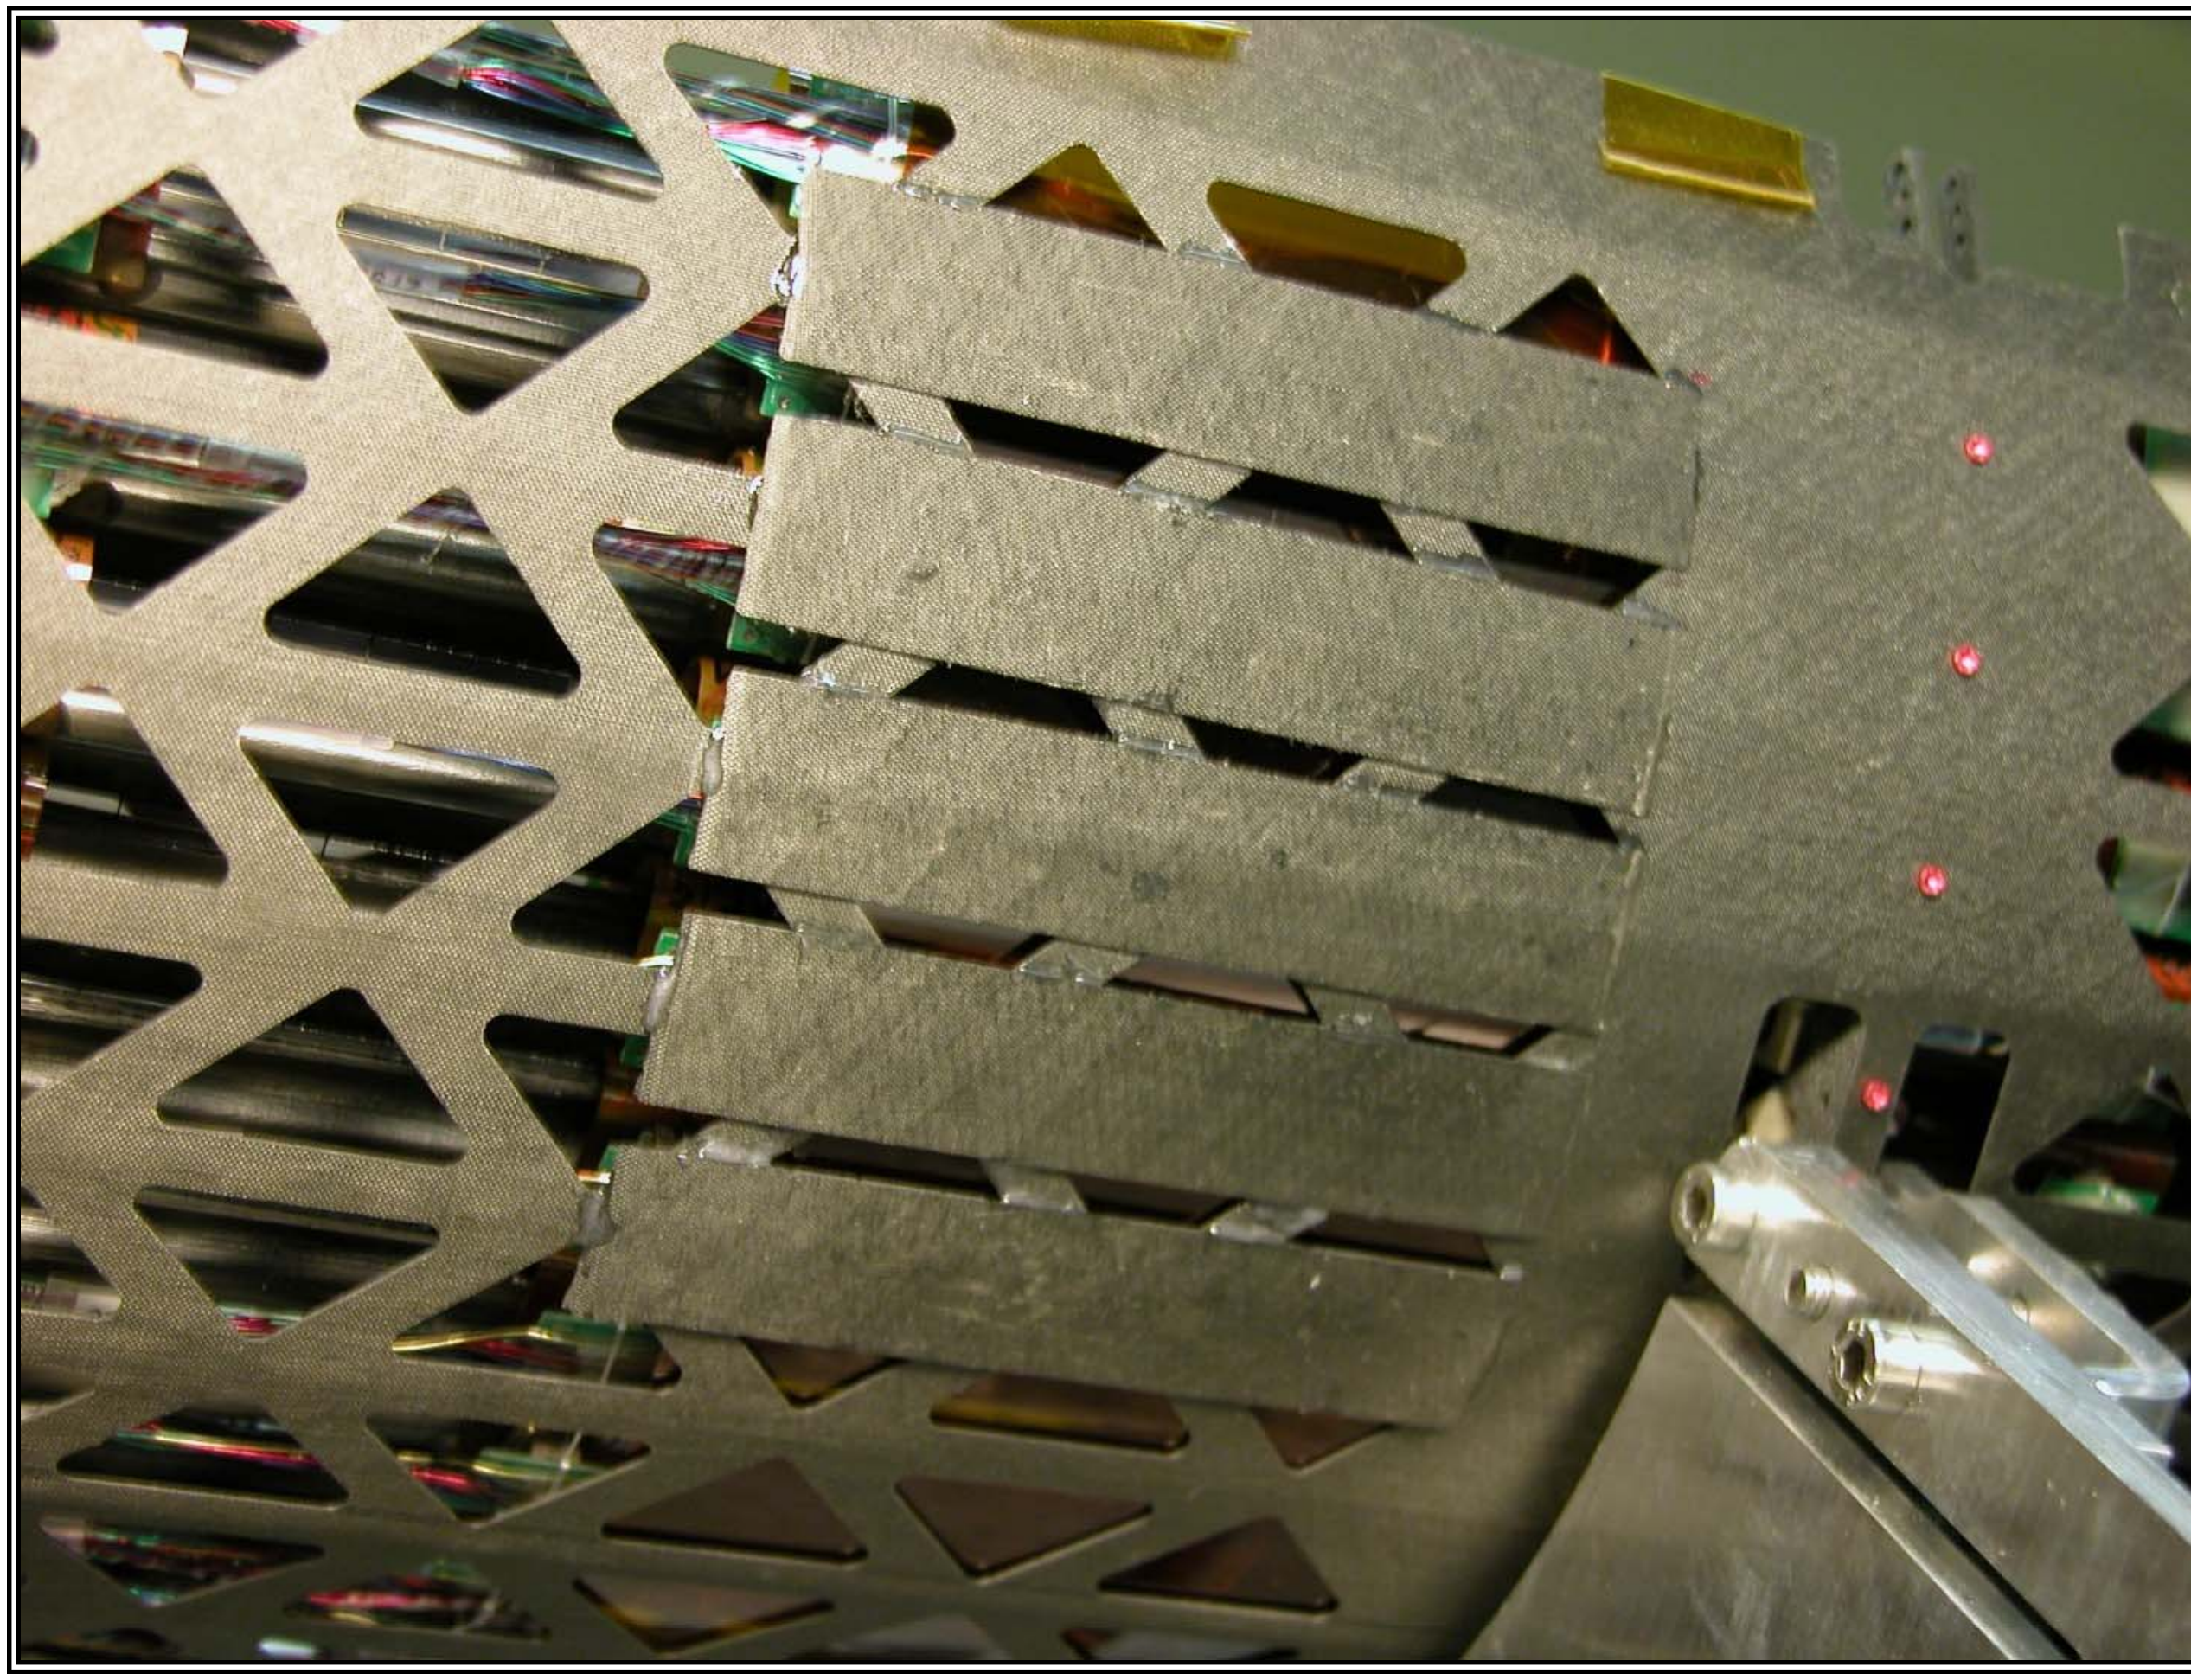
Detector Integration:
damage and repair of the HalfShell

- L1 clamping was done late in October 06.
- During the preparation of the HalfShell bottom the structure was severely damaged.

The structural integrity was compromised and a repair was necessary.
- Almost ¼ of the section of the HalfShell was affected.
- Detailed report is available here:
  http://dgiugni.web.cern.ch/dgiugni/integration/half_shell_repair/halfshell_repair.pdf

- No modules have been fortunately affected; therefore the repair was just a mechanical issue.
- Five patches 15x75mm made of the same material have been glued on top of the damaged zone.
- No damages to the staves or to the modules behind the affected area.

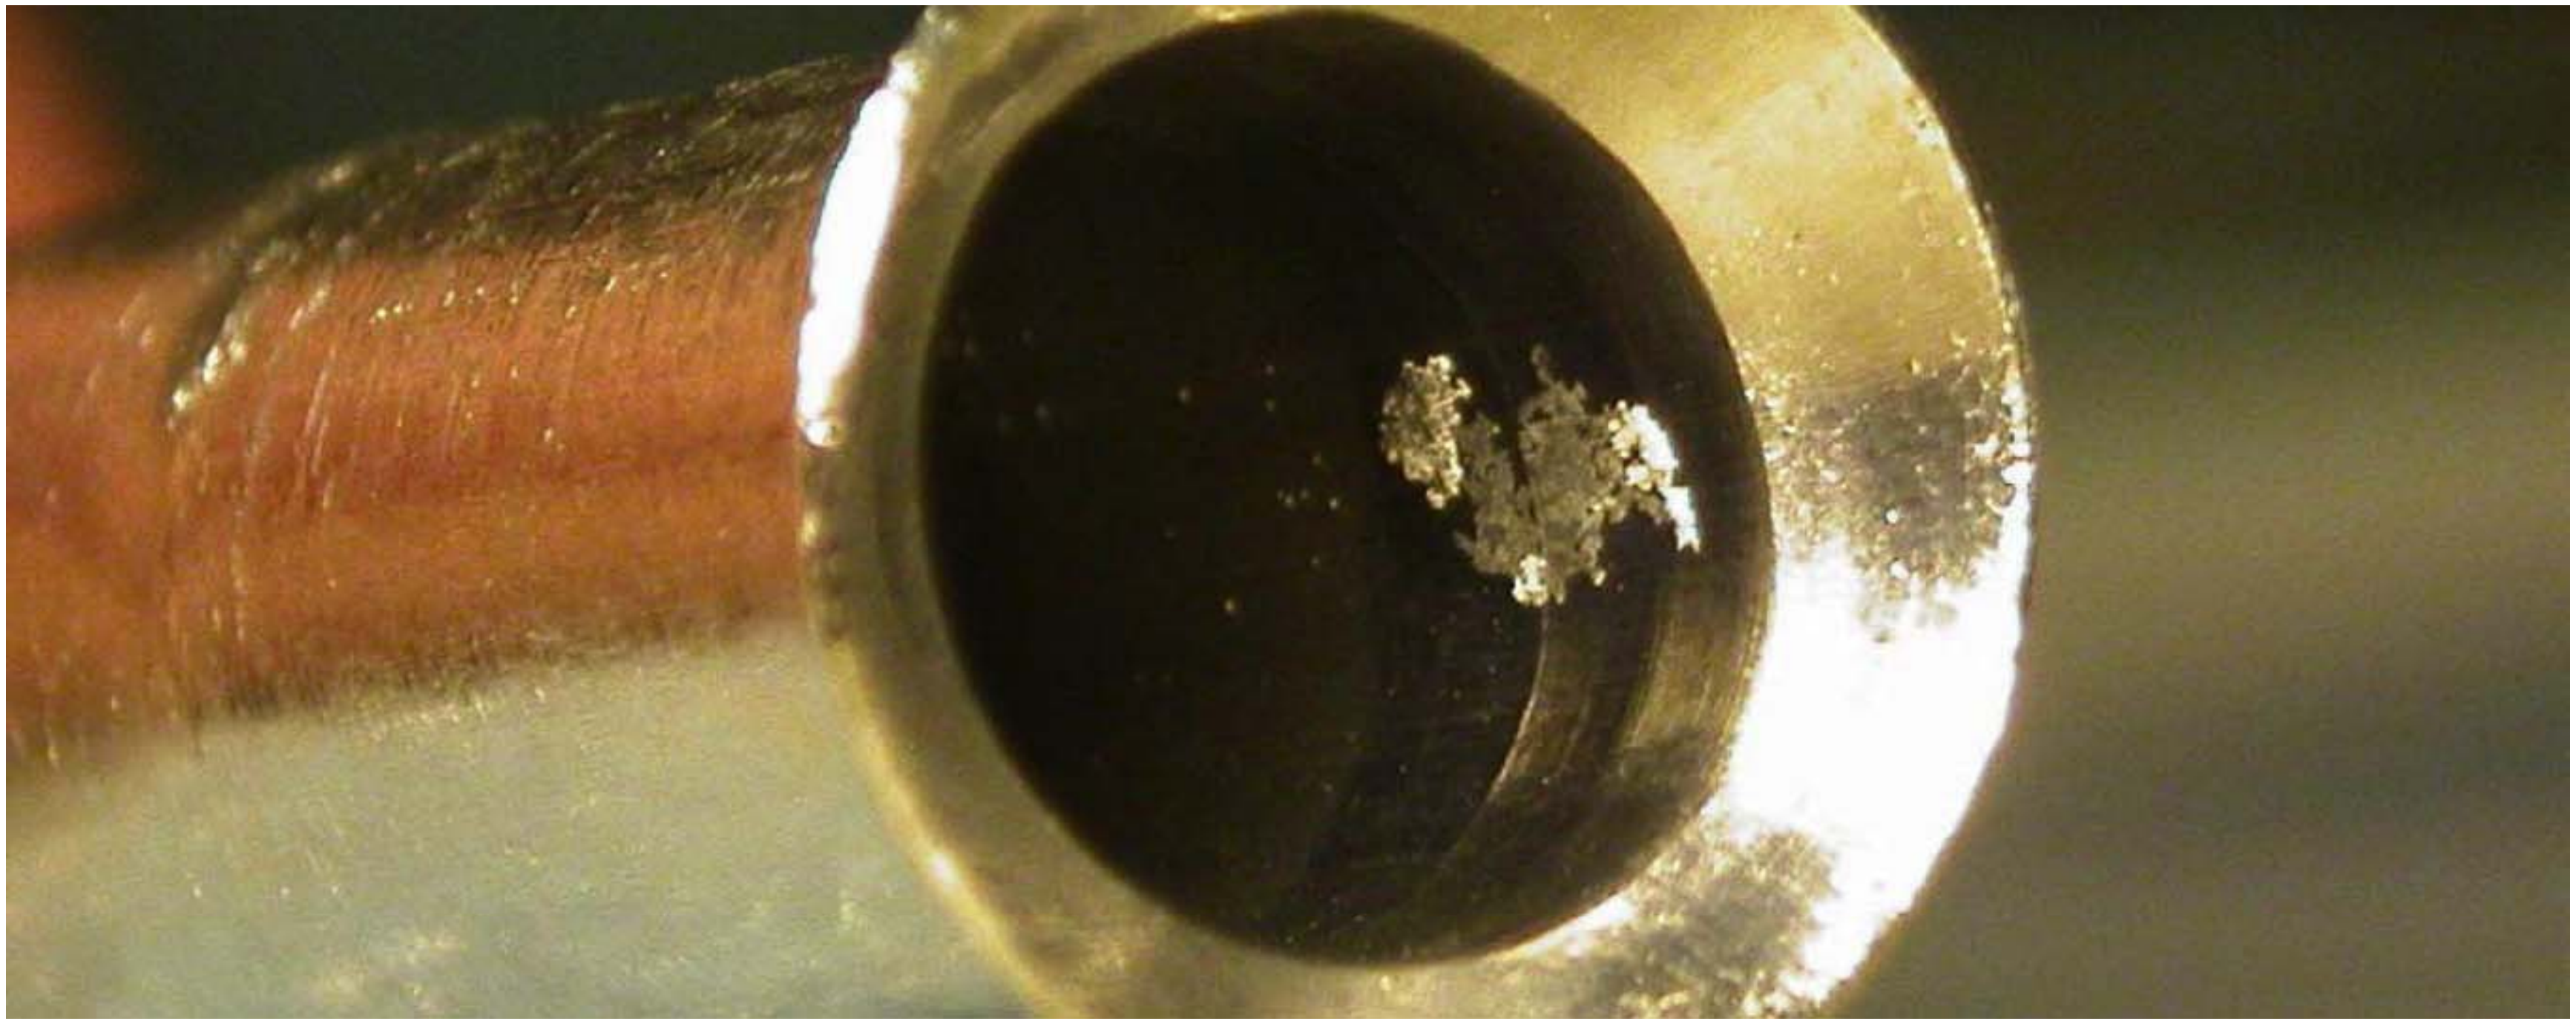
Corrosion again !!!

- During the installation of the last section of pipes right before the commissioning, *defects* inside the pipes have been noticed.
- The analysis revealed a *pitting corrosion* induced by chemical contamination.
- Pipes assemblies have been re-built under rush… and again a *corrosion* patterns have been found.
- Still the event has not been properly analyzed but preliminary indications exclude evident mistreatments.
