# Beam-induced EMI and detector electronics

Gary Bower, SLAC LaVonda Brown, Norfolk State University Nick Sinev, University of Oregon Yasuhiro Sugimoto, KEK

# **VXD electronics failures: observations**

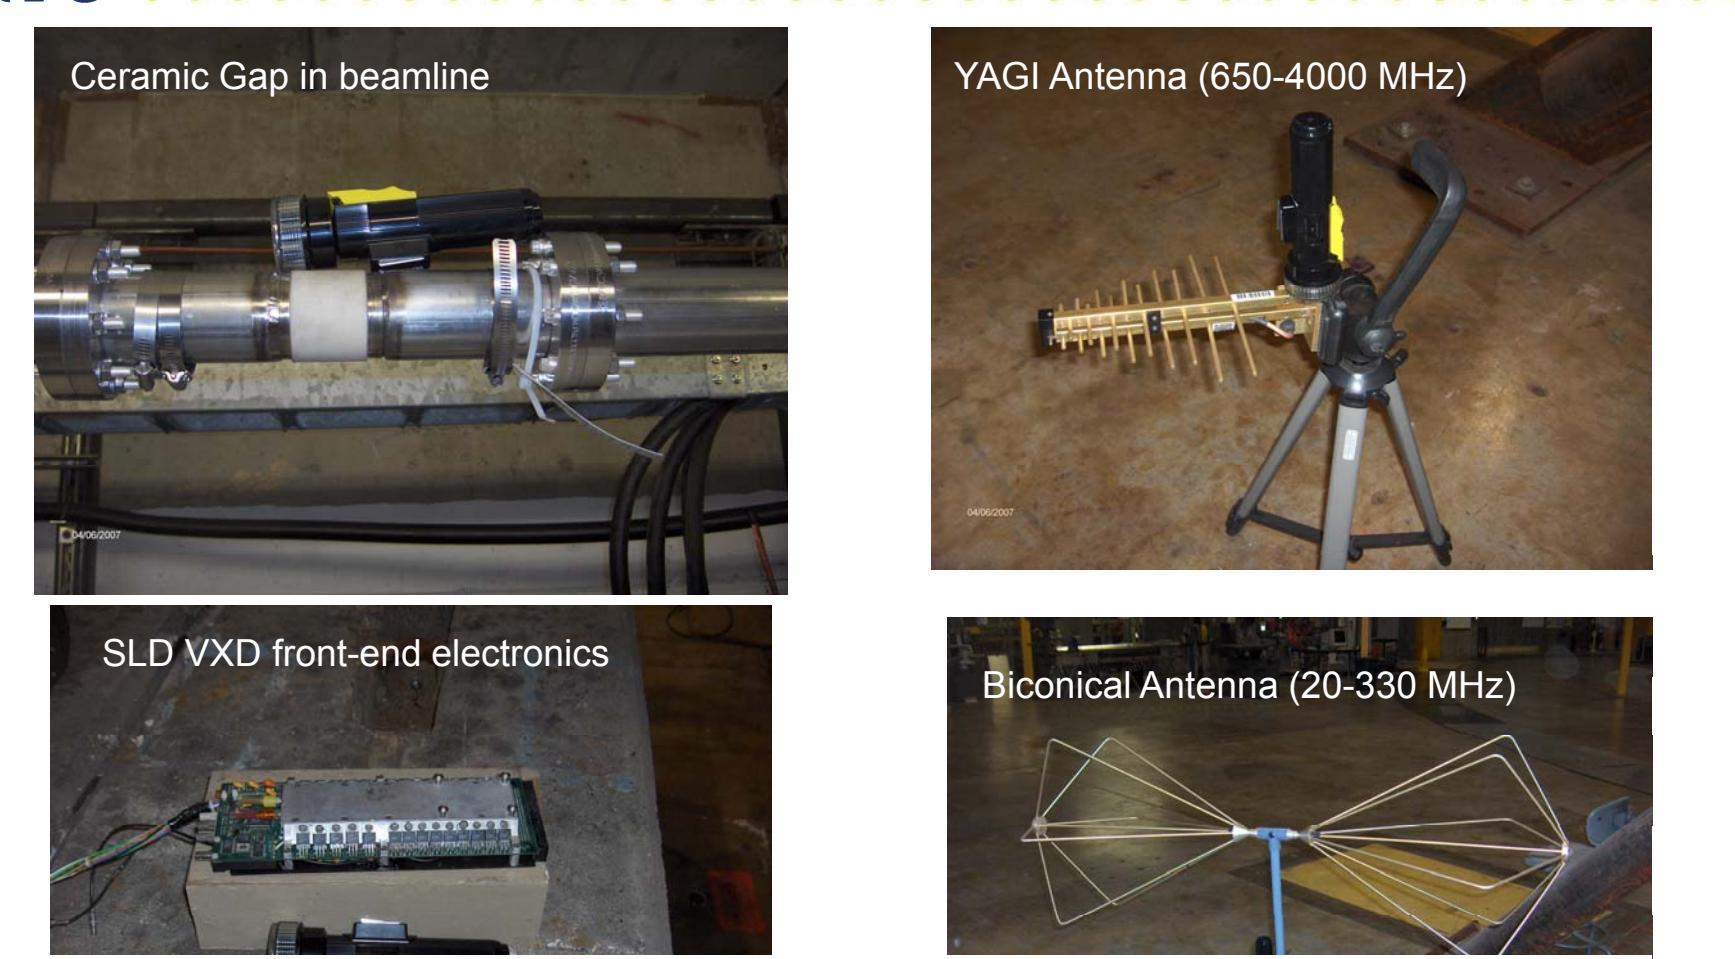
## **EMI Studies at SLAC ESA**

- EM fields within the beam pipe are contained by the small skin depth.
- But dielectric gaps emit EM radiation out of the beam pipe.
- Common "gaps" are camera windows, BPM feedthroughs, toroid gaps, etc.

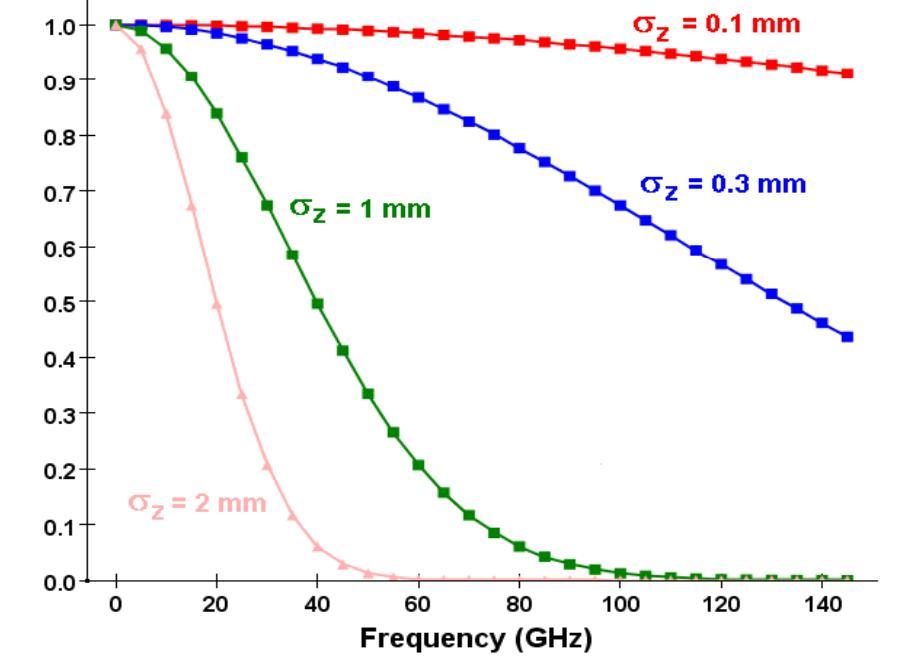
Radiated Power Spectrum at Ceramic Gap

From our observations:

23GHz Diode was insensitive to bunch length

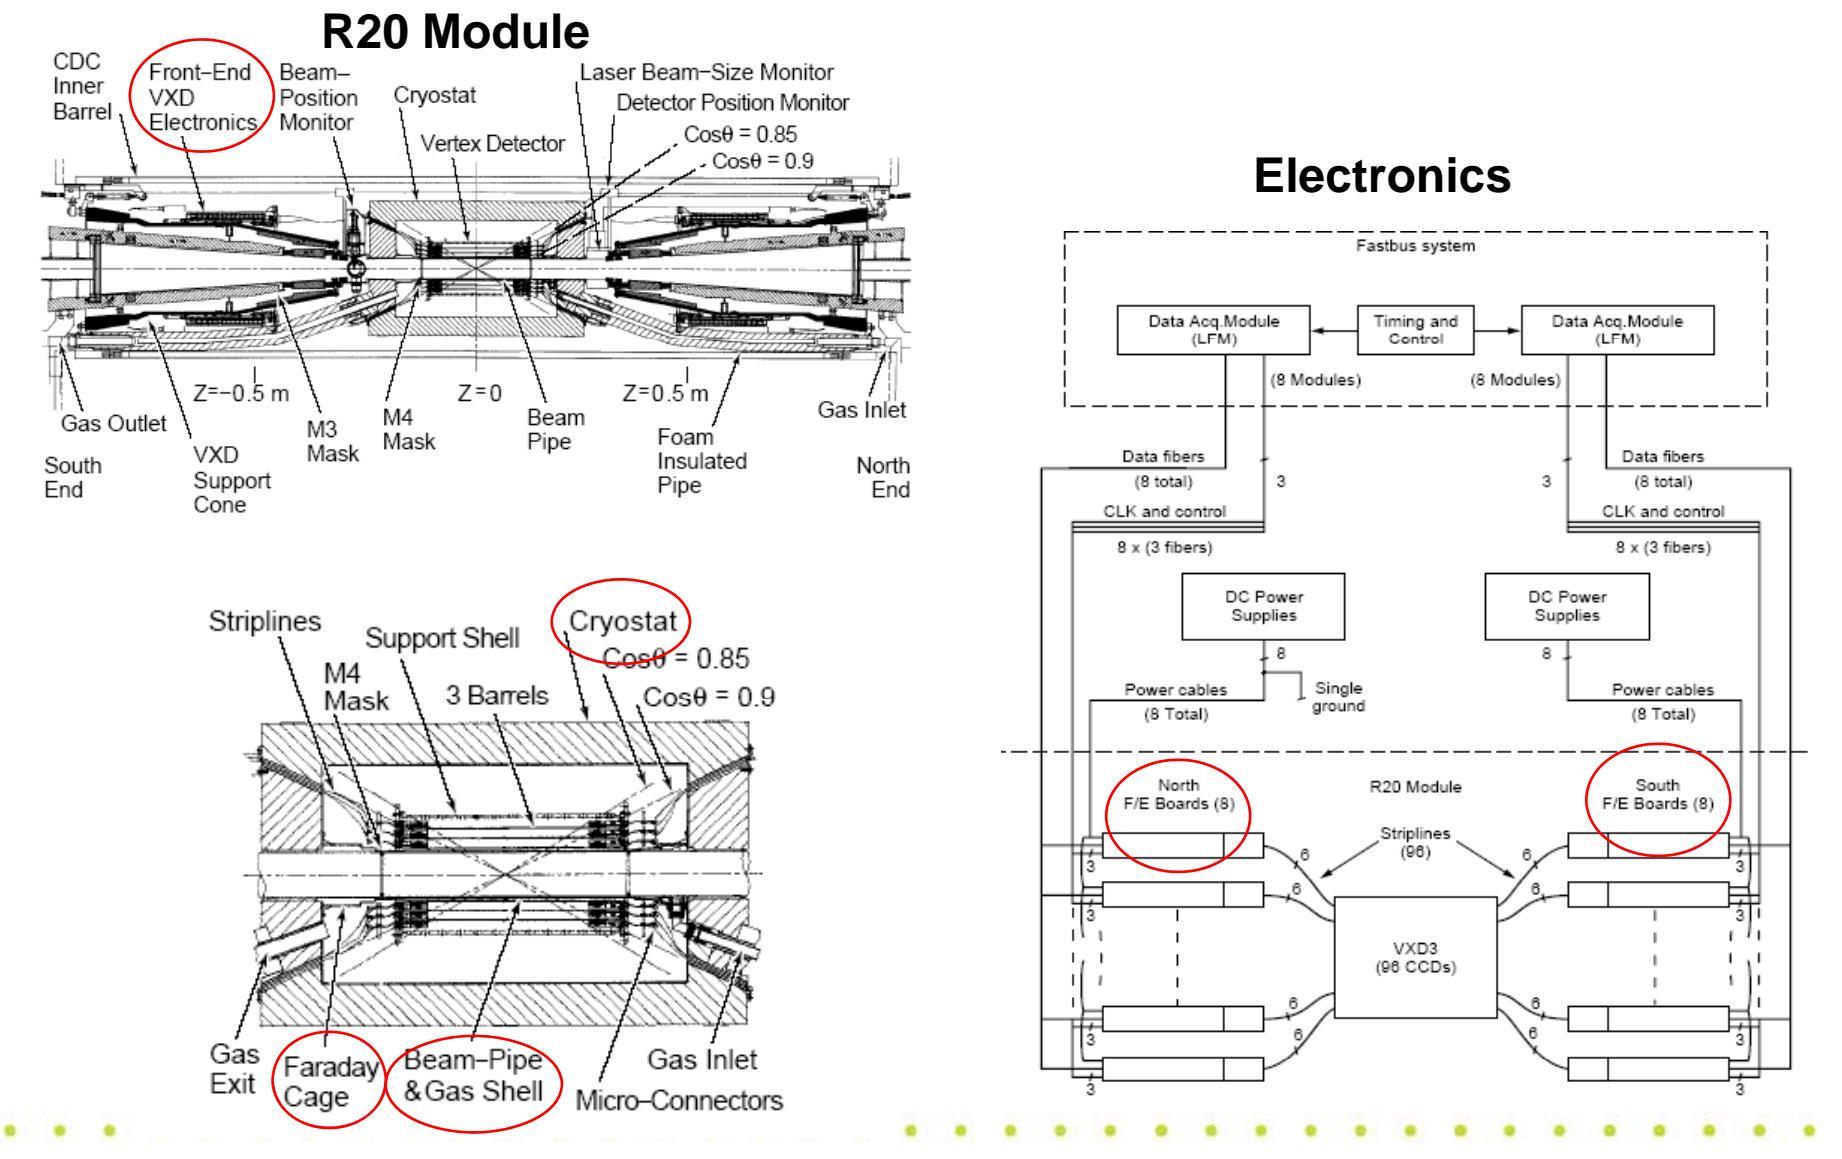
#### **SLD Vertex Detector**

- → VXD front-end electronics placed near ceramic gap. When exposed to sufficient EMI the phase-lock loop monitor signal drops.
- Phase lock loop lost lock on about 85% of beam crossings when the module was at location where antenna observed ~20 V/m (YAGI measurement on 2.5GHz bandwidth scope)
- Phase lock loop lost lock failure rate drops to 5% at ~1 V/m signal from antenna.
   September 19, Nick Sinev
   IRENG, SLAC, September 17-21, 2007
   10
