New Optical Inspection Results at JLab

An in-depth update since Chicago meeting ILC08

Rong-Li Geng

TILC09, April 17-21, 2009, Tsukuba, Japan

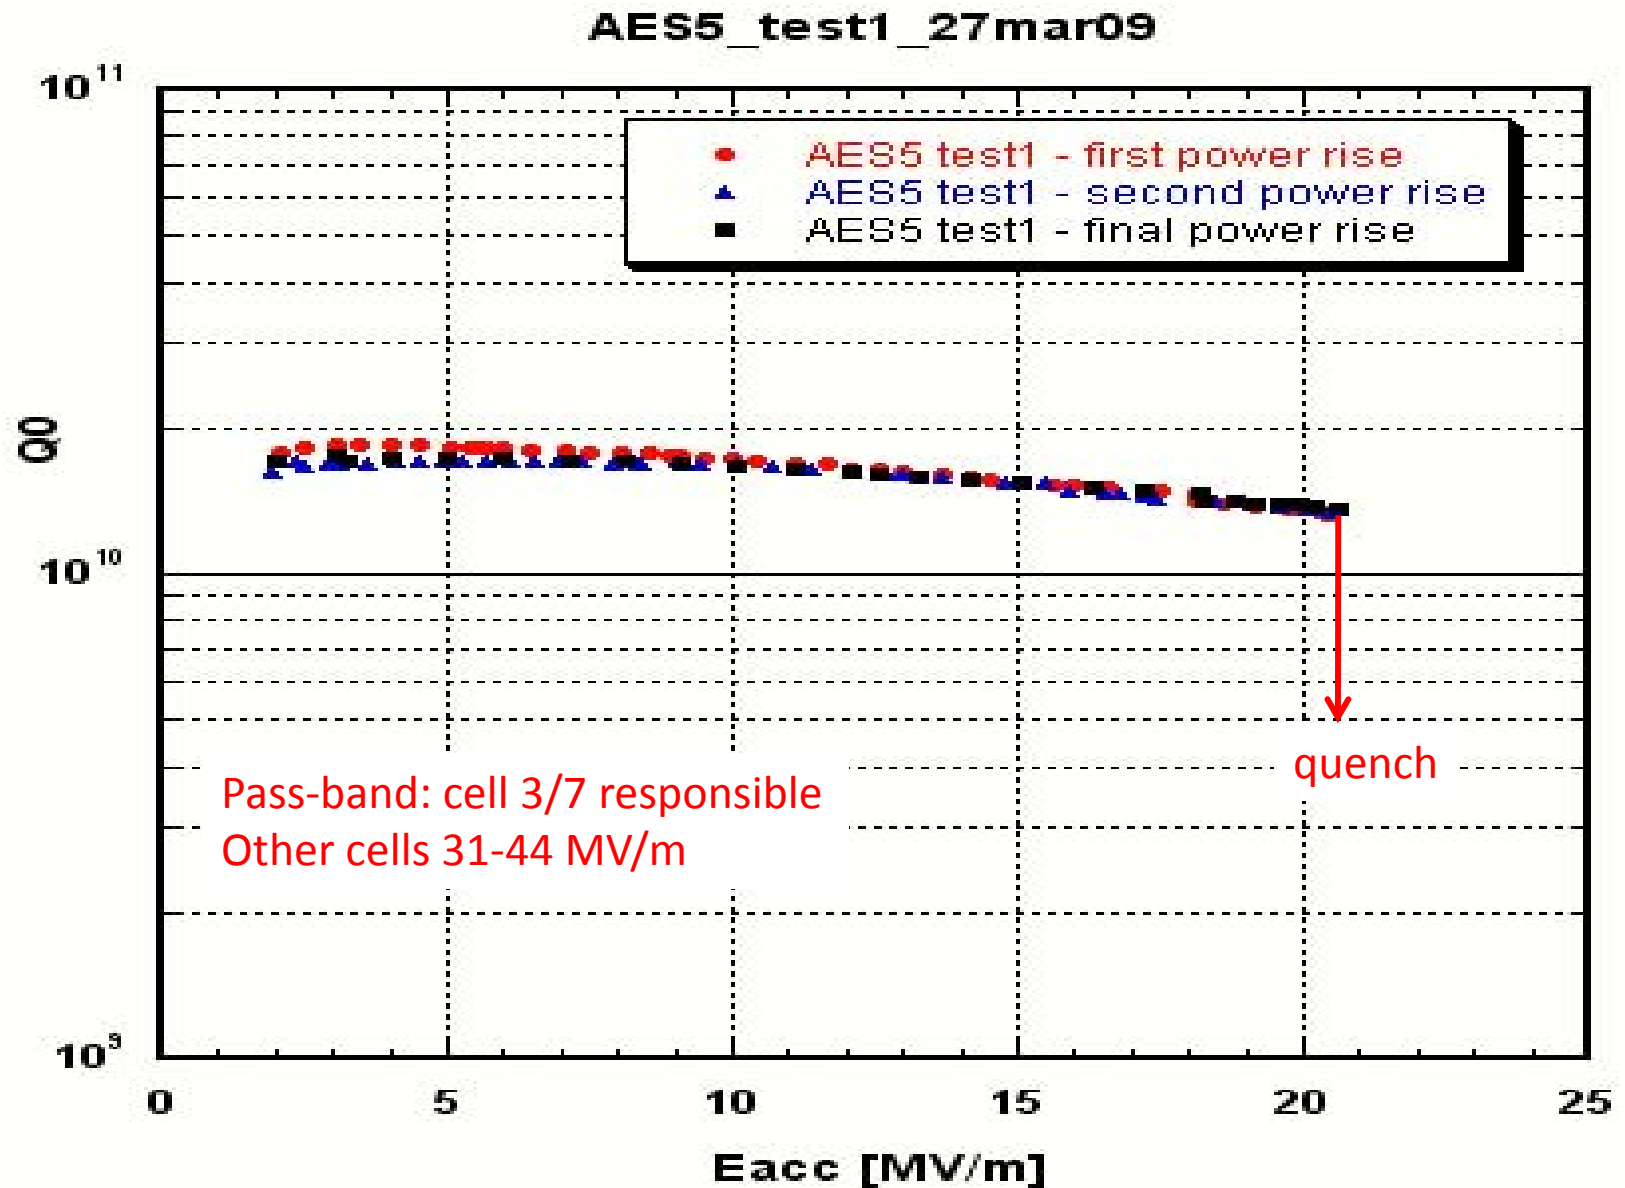
New 9-cell AES5 1st RF Test after 1st Light EP

Cell 3 just below quench

A 700 μm defect observed near T-map hot spots

~700 μm dia.

- 8mm away from seam
- azimuthally near overlap

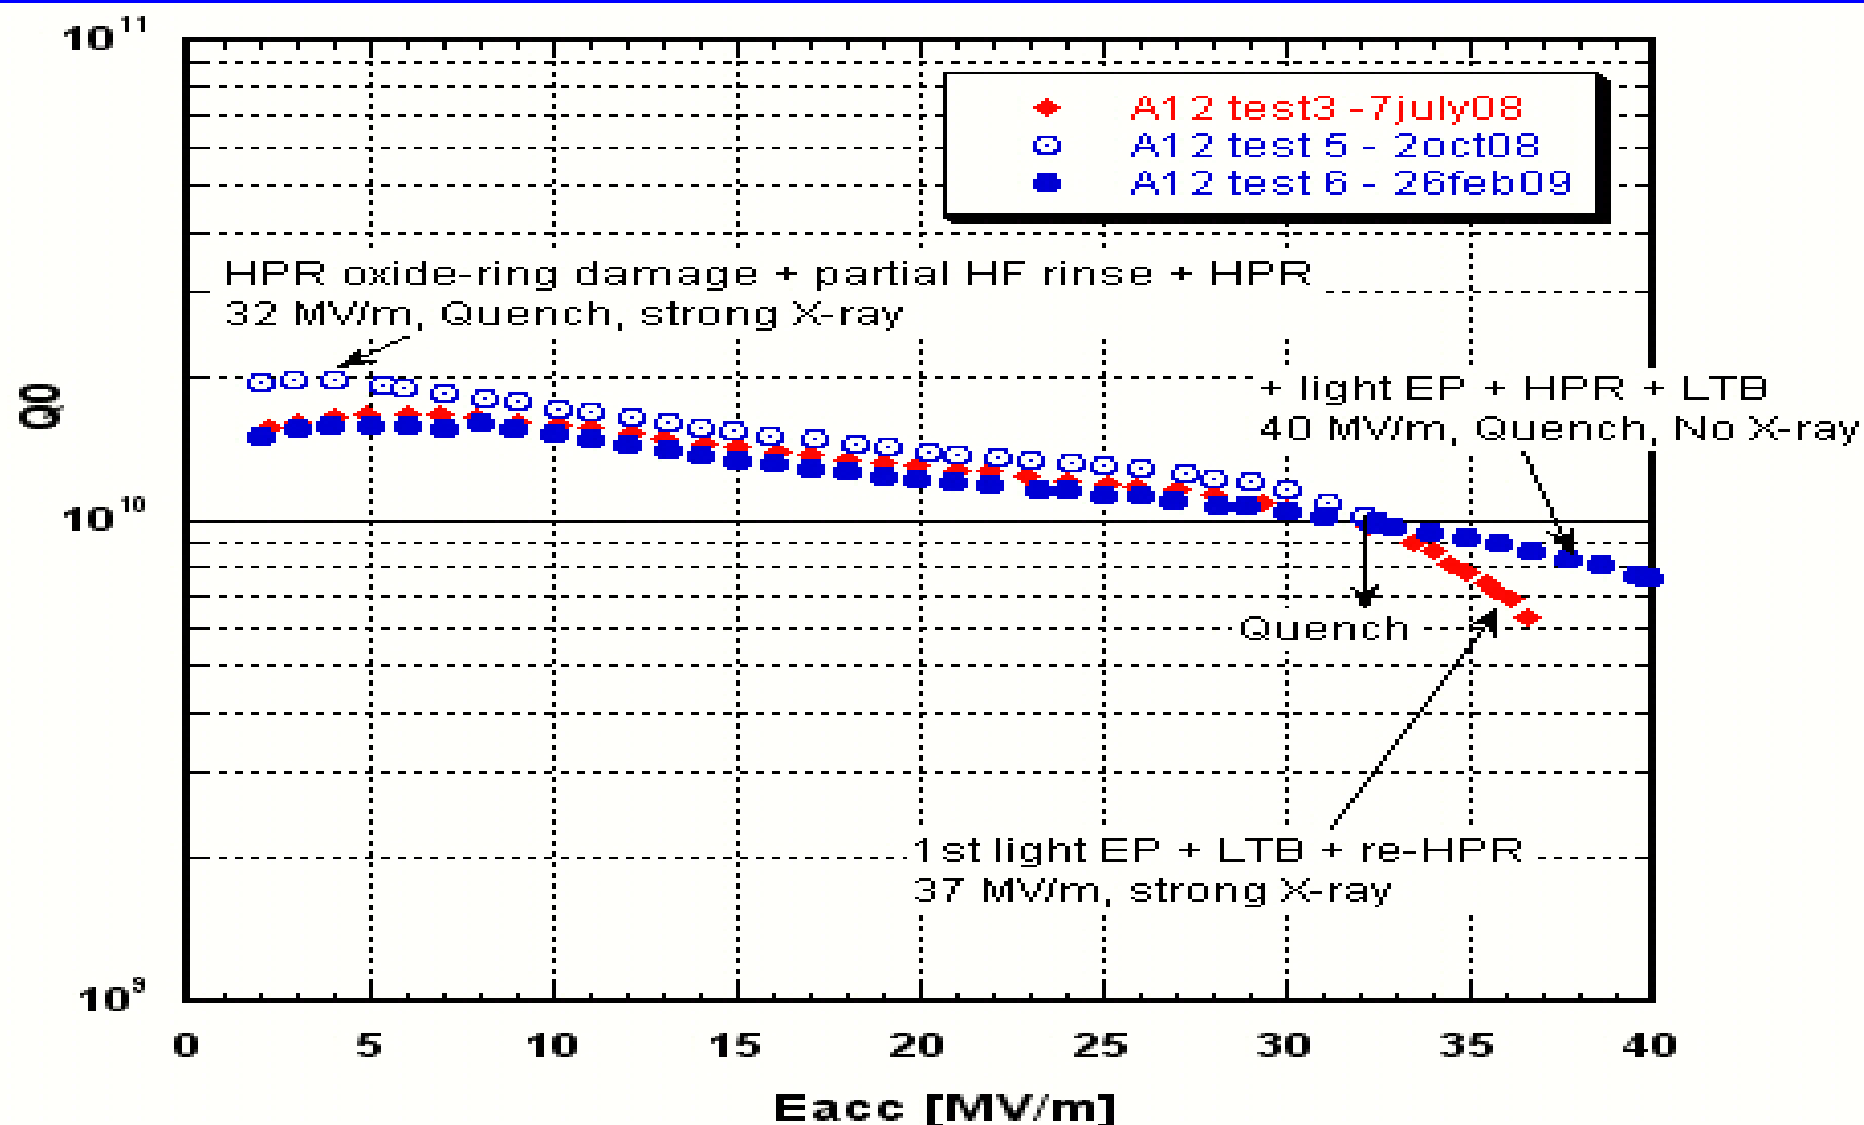
A12 Degradation due to Tool Failure and Recover by Re-EP

A12 (30 MV/m quench) T-mapping hot spots in Cell#7

No gross defect observed
